**CONSERVATION DISTRICT USE PERMIT APPLICATION
GARRETT SINGLE FAMILY RESIDENCE AND FARM
TMK: (3) 1-5-010:009**

Lands of Maku‘u, District of Puna, Island of Hawai‘i

Applicant: Kamahele Farms, LLC

**Prepared By: James M. Leonard
J M Leonard Planning, LLC**

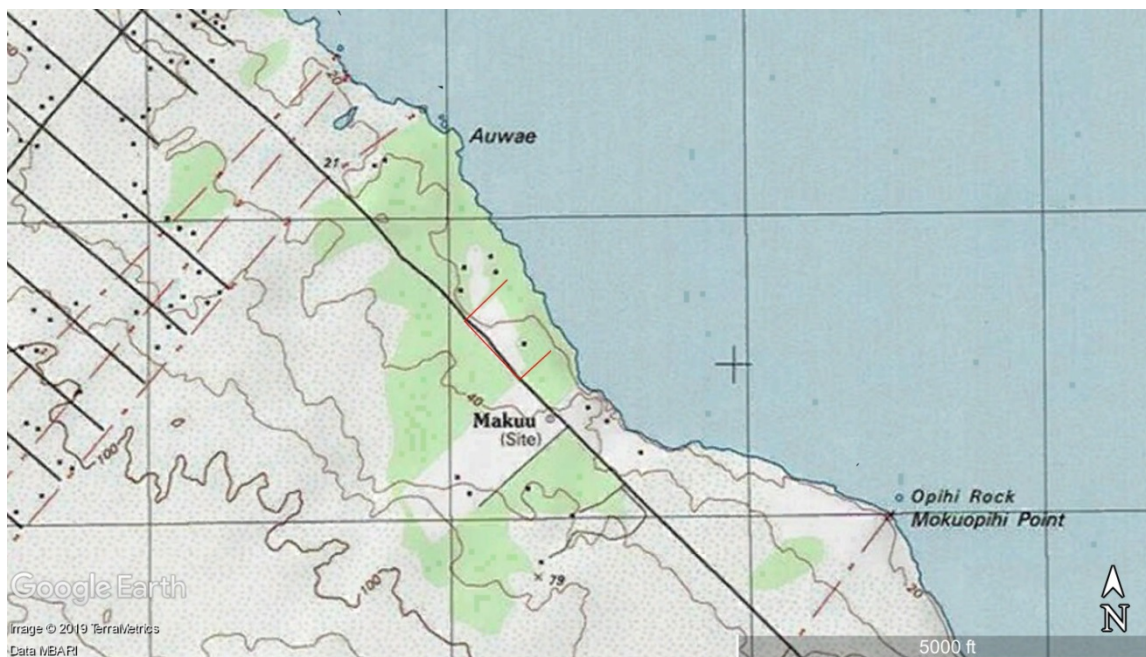
The Kamahele Farm Property is a parcel of oceanfront land between the “Old Government Beach Road” and the sea. It is near the ancient village of Makuu in lower Puna District. The property is about halfway between the subdivision of Hawaiian Paradise Park and Mokuopihi Point (see Figure 2). A notable feature of the property is the high hill or “pu`u” that fills the greater part of the southeast portion. This feature (a “littoral cone”) can be seen on the USGS topographic map (Figure 2),

Figure 2 “Pahoa North” (USGS 1994), approx. property boundaries in red.

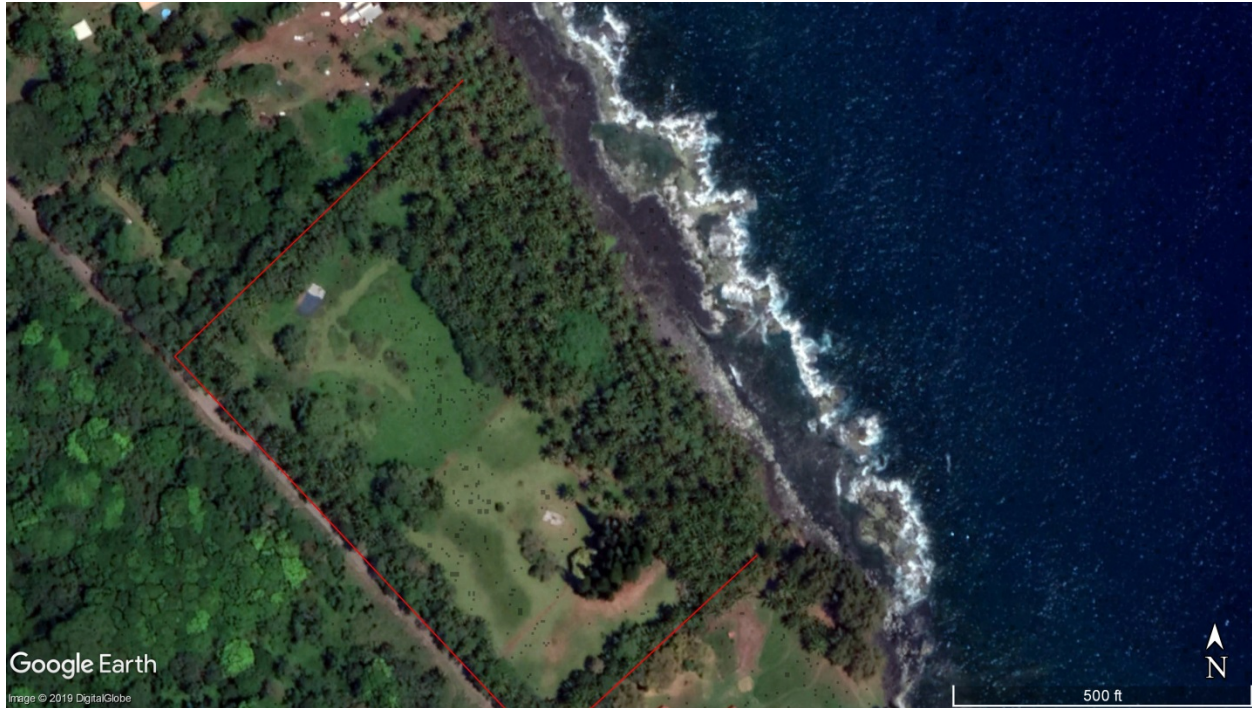
The property has approximately 915 ft. of ocean frontage (see Figure 3). The coastline is characteristic of the low-lying rocky geology of this part of Puna. There are no perched sand beaches above the high tide line. The water’s edge can be perilous especially during episodes of large surf. The pahoehoe lava extends out a large distance from the vegetation-defined shoreline (a minimum of 195 ft. and a maximum of 242 ft. as measured from aerial photographs), and ends abruptly in deep water. This bench lies less than 3 ft. above the waterline at high tide and contains numerous tide pools (visible in Figure 3). The southern third of the property’s coastline contrasts with the former. A boulder beach has formed on top of this bench at this end. In Figure 3, the bench can be seen extending out from the “boulder beach” to a similar width, though it is now partially submerged.

Figure 3 Google image (March 16, 2017) with approximate subject property boundaries in red.

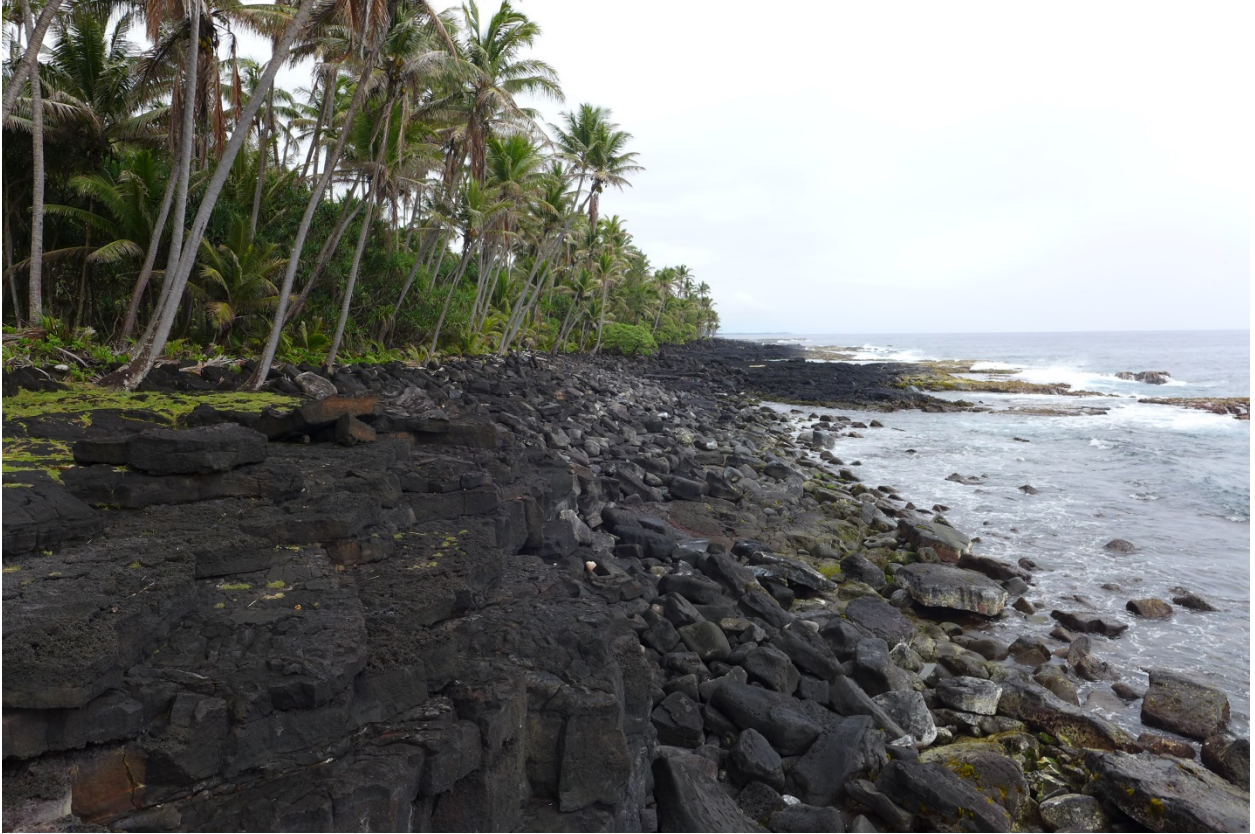
Photo 1 The Kamahele property coastline, view to northwest from southeast corner

Photo 1, below is an overview of the Kamahale shoreline taken from a sea cliff at the extreme southeast corner of the property. This cliff is formed by a more recent lava flow that just covered this portion of the property (see Geology, below). As such, it stands 12 ft. above the ocean surface (at high tide, see below Marine Conditions). Photo 1 also shows the boulder beach and its stable angle of repose of 35 degrees). In the distance, on the right of the photo the pahoe-hoe bench mentioned above is notable.

Another feature of note is the high hill behind the shore, also visible in Photo 1. It rises abruptly from about 80 ft. behind the shoreline (the vegetation line) to an elevation almost 40 ft. above sea level. The tall palm trees and lush vegetation attest to the relative stability of the strip behind the beach and create a “littoral terrace” between the shoreline and the pu`u. The cliff, boulder beach and coastal bench all provide ample buffer to the littoral terrace from all but the most extreme events. These are discussed in more detail below.

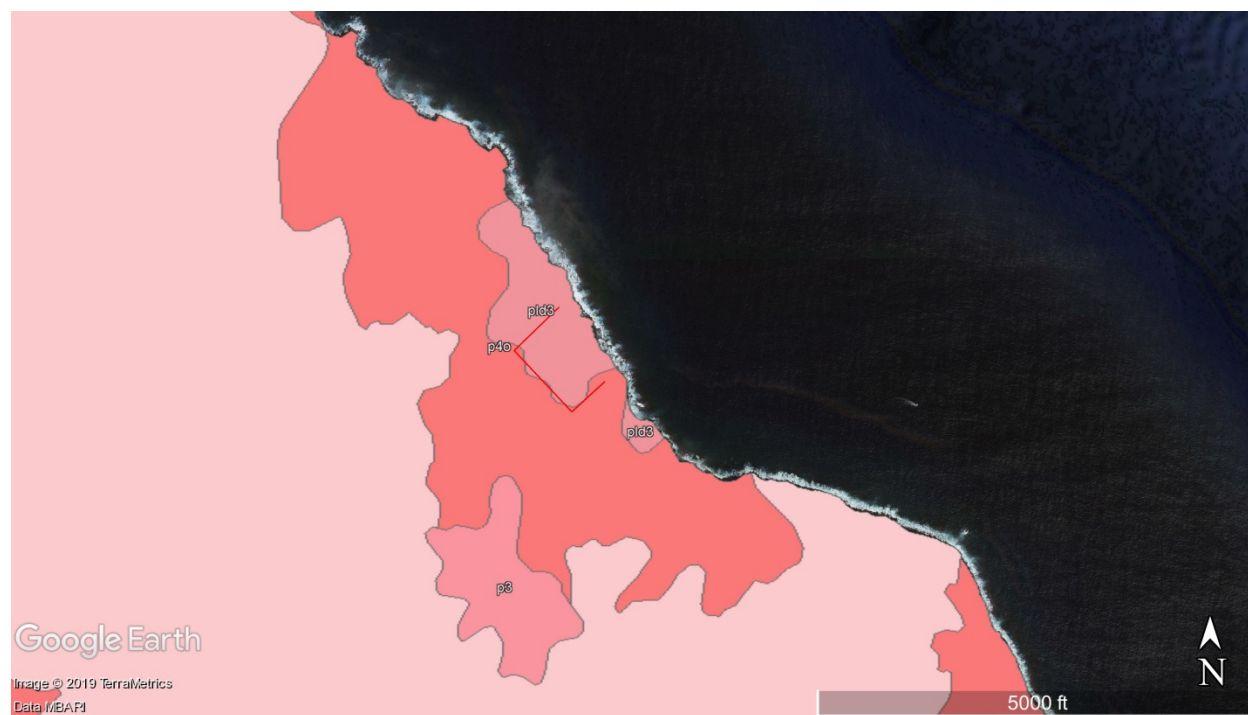
Figure 4 Portion of Geologic Map (Trusdell et al. 2006) with property boundary in red.

The Kamahele Farm consists largely of portions of “p4d”, which are littoral cone cinder deposits. It is one of few littoral cone formations on Kilauea’s coastline. Due to Kilauea’s frequent activity in historic times, these formations are well described geologically (Moore and Ault 1965). The process has also been described for the larger scale but similar littoral features of Mauna Loa volcano (Jurado-Chichay, Rowland and Walker 1996).

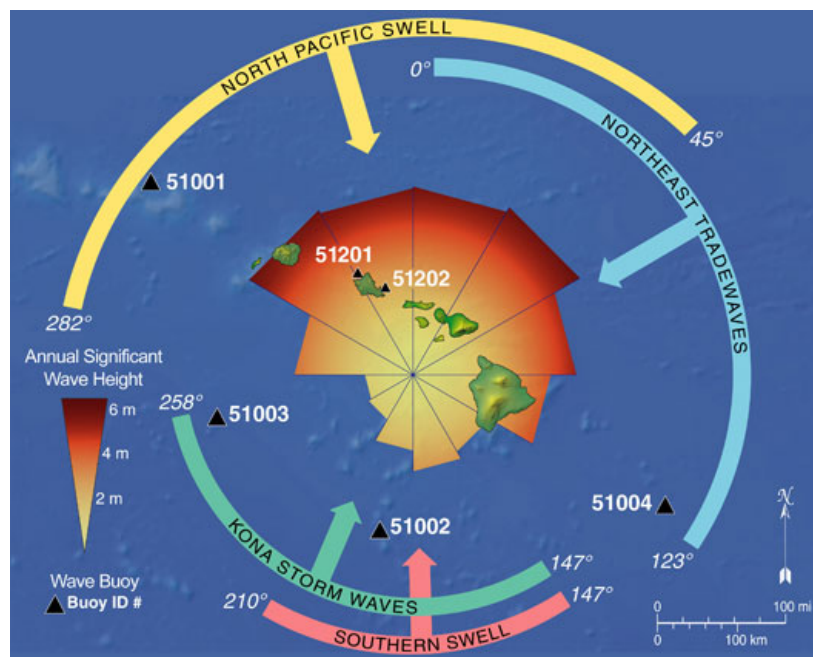
Figure 5 Frequency and magnitude of waves affecting Hawaii (www.soest.hawaii.edu).

The coast of this part of the Puna District faces the open ocean with no submerged barriers such as offshore reefs or sand bars. The submarine slope is approximately 1300 ft/mile for a distance of roughly 6 miles, descending into the deep water Puna Canyon. The extremely long fetch of waves crossing the Pacific creates a situation where big, long period swells rising to significant heights slam into the island's flank. Large waves reaching the coast are predominantly related to trade wind conditions, though the coastline is also exposed directly to the largest North Pacific swells (Figure 5).

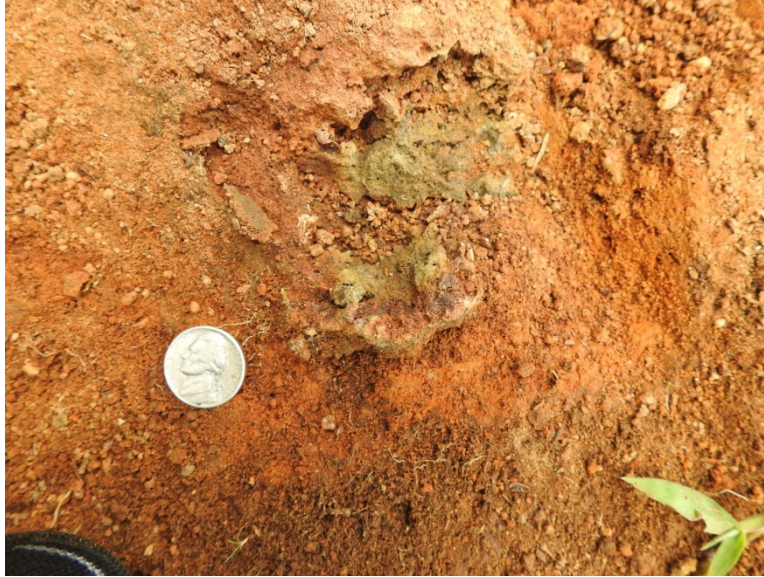
Photo 2 Spatter bomb embedded in Kamahele Ash

It is axiomatic that littoral cones form on the coast. There is ample physical evidence at Kamahele to substantiate this. The following photos (2, 3 and 4) illustrate a spatter bomb, ash layering, and glassy fragments that are typical of hydrovolcanic interactions. Together this evidence suggests that this littoral cone formed at the ocean entry, although it is *further* from the ocean today than when it formed (see Evolution of Kamahele Coastline, below).

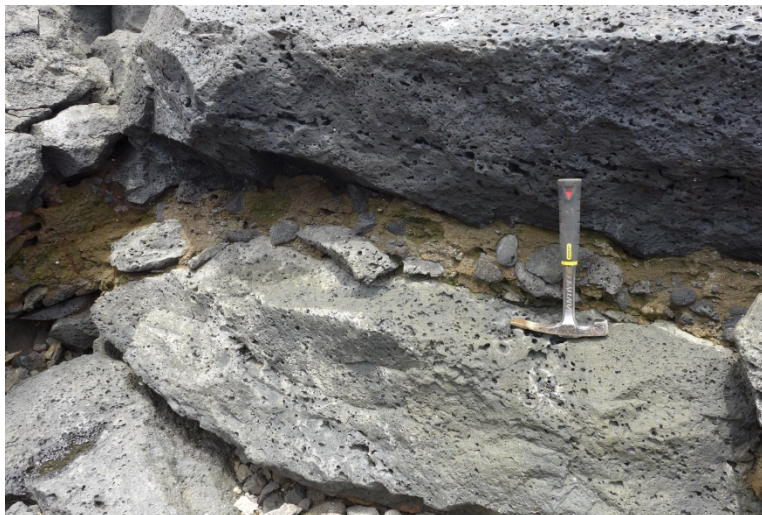
Photo 5 Redeposited Kamahele ash

The ash and cinder from the Kamahele littoral cone have been altered and redeposited. The discovery of ash deposits in the interstices and matrix of conglomerate *on top* of the coastal bench gave another clue to the evolutionary processes active on this coastline. Placing these events in time and space is critical to the model presented below and employed in estimating the overall erosion rate on site.

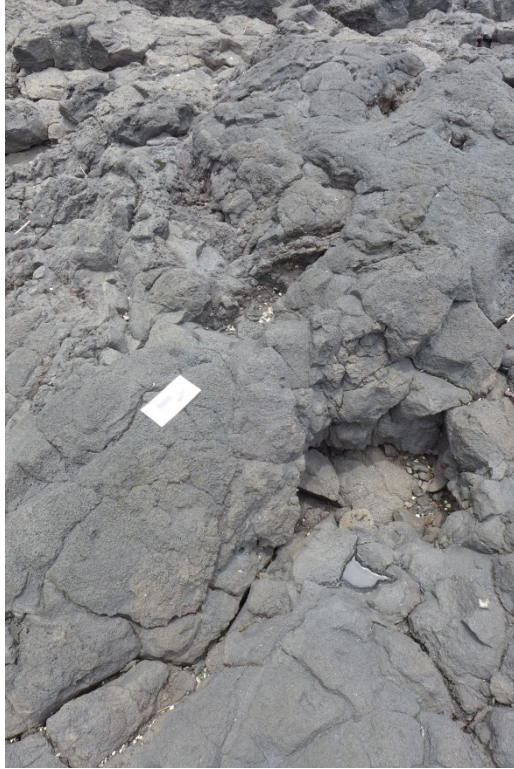
Photo 6 Steam explosion pit

There is abundant evidence that the lava flows along this shoreline were also emplaced very near or at the coast. This implies that little erosion of the original deposits has occurred. For example, Photos 6 and 7 show two different results when hot lava encounters seawater. The first are several pits in the pahoehoe that have been literally blasted out with the force of steam explosions. The second is a similar less intensive disruption of viscous flow by the introduction of water. The “frothy” pahoehoe pictured in Photo 7 is a result.

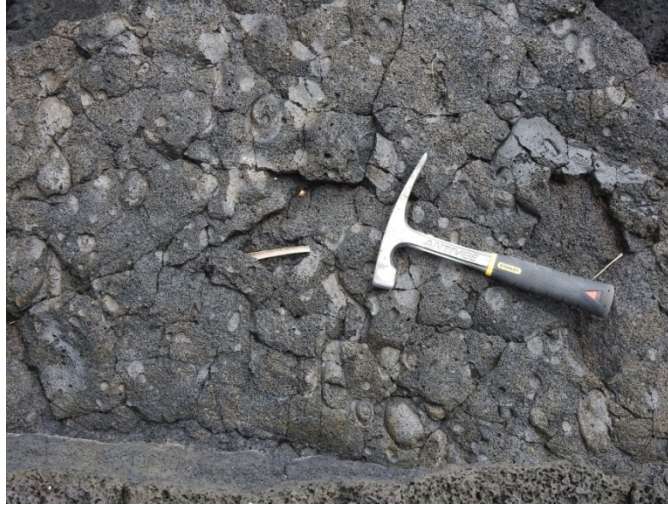
Photo 8 Ponded pahoehoe and fossil gas bubbles.

Photo 8 illustrates another example of the interaction of water and hot lava. These indications were ubiquitous on the coastal shelf. The image is of the top of thick, ponded pahoehoe layer at northwest margin of Property. “Fossil gas bubbles” are shown, suggesting this flow overlay seawater. The seawater rose to the surface of the flow as steam forming bubbles where it encountered an impermeable surface layer of quenched glassy basalt. This surface layer has since been eroded away, revealing the underlying bubble.

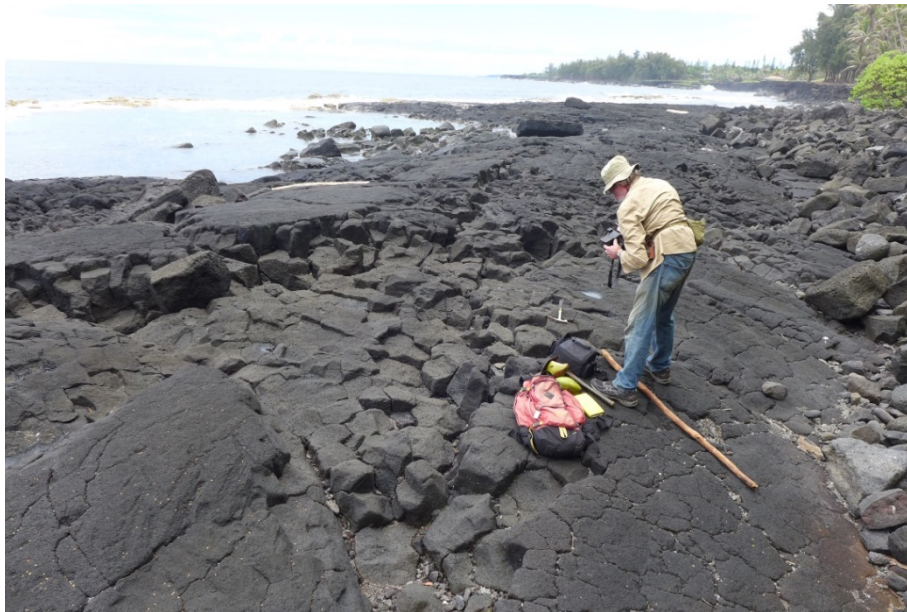
Photo 9 Columnar jointing on coastal shelf, view southeast

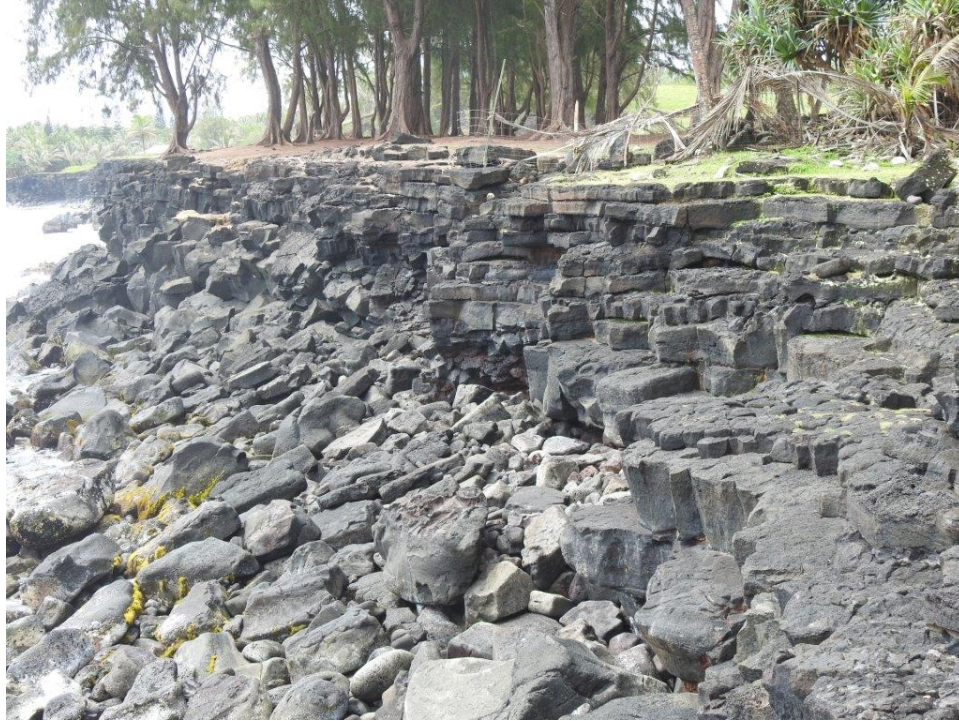
Photo 10 Sea Cliffs at southeast property corner, view south

These cliffs are the remains of the most recent lava flow (“p4o”) to have impacted the property and are they are limited to a small corner of the property.

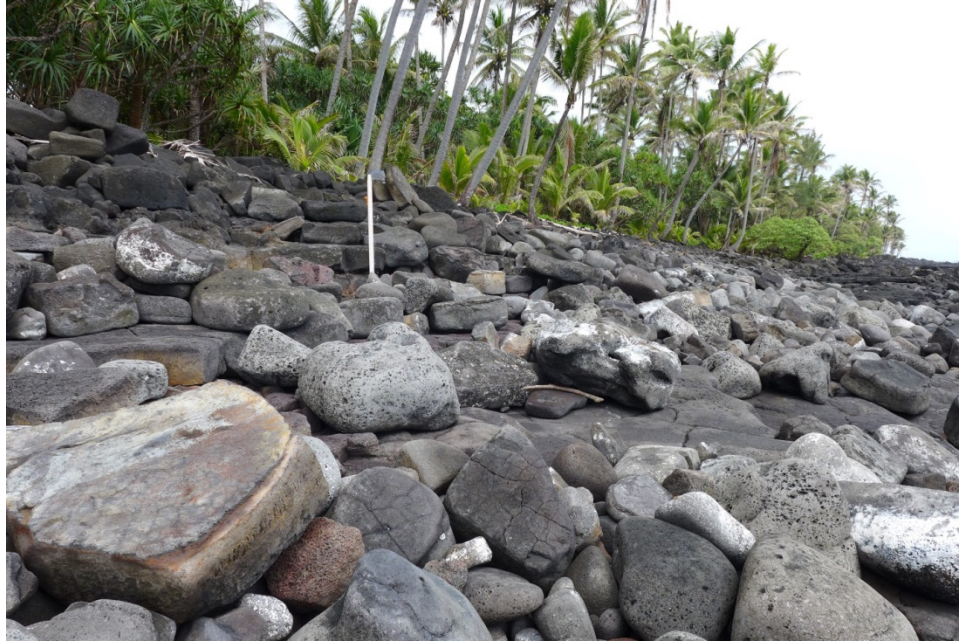
Photo 11 Boulder Beach, view west-northwest

The boulder beach occupying the southern third of the property's ocean frontage (Figure 11) is about 300 ft. long. Closer inspection revealed large, well rounded boulders atop scoured pahoehe bedrock. The boulders are very well sorted and it seems these boulders absorb a great deal of energy from pounding waves. However, their organization and regular slope (angle of repose) indicate some equilibrium has been achieved. Examination of a 63 year old aerial photo bears this conclusion out (see below).

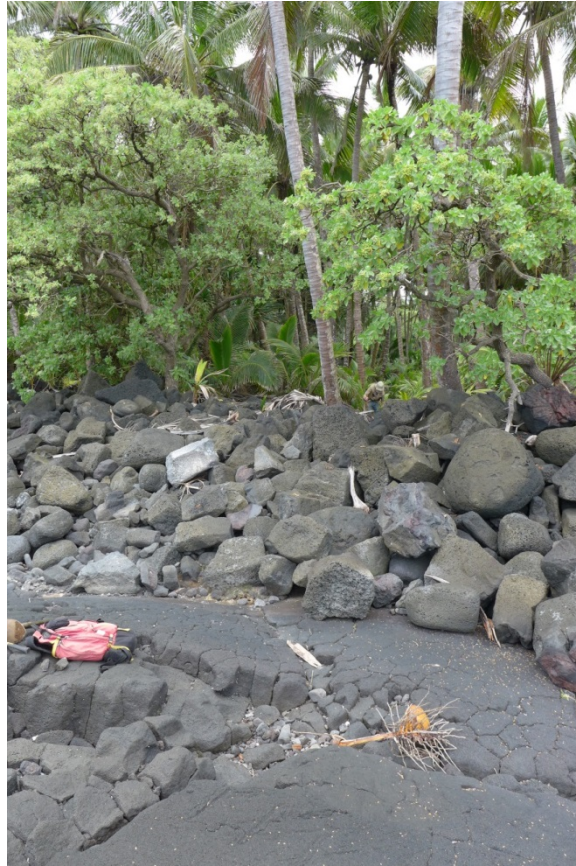
Photo 12 Boulder Berm, view southwest

Behind the boulder beach and extending the length of the property is a significant berm of boulders and cobbles. The berm is 500 ft., or more, long extending beyond the northern property boundary. It is less conspicuous behind the boulder beach, but remnants are indicated (see below). The berm is between 15 – 20 ft. wide and at least 6 ft. high. Its origin relates to periodic storm waves that wash materials up the beach and stack them further inland, much like a levee forms alongside a periodically overbanking river. The berm's linearity and regularity suggest that along with the boulder beach it also has formed over a significant amount of time and is not eroding. It is largely covered with vegetation, and presumably marks the "shoreline".

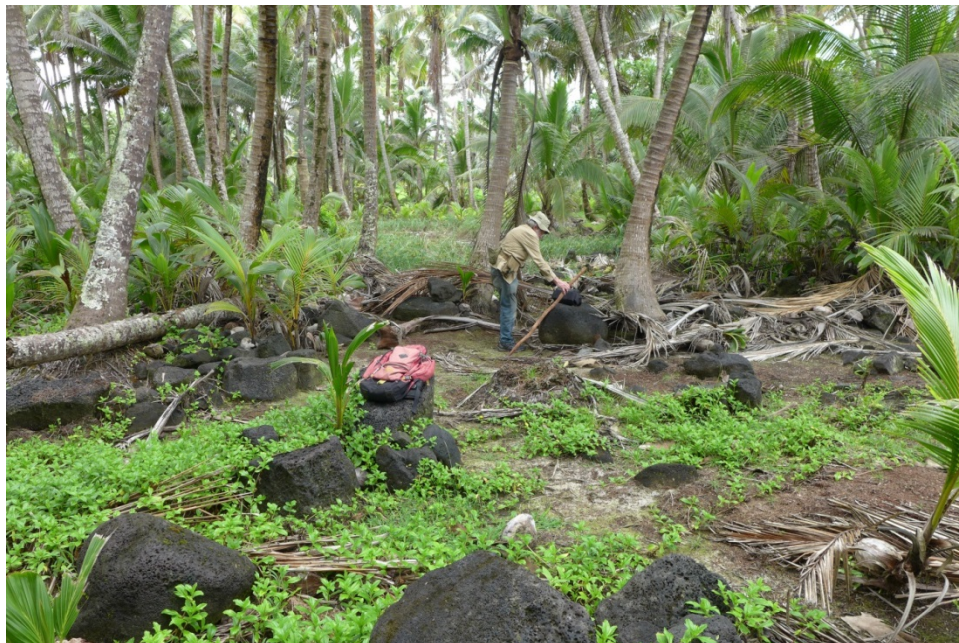
Photo 13 Back beach storm boulders, view southwest

Behind this berm is an area of scattered boulders. These rocks are similarly well rounded and indicative of being worn by the water. Unlike the organized linear pile of stones making up the back-beach berm, these boulders are haphazardly strewn up to 60 ft. inland. This is particularly true at the northwest corner of the property. These rocks were most likely tossed beyond the berm into this low-lying area during extreme storm events.

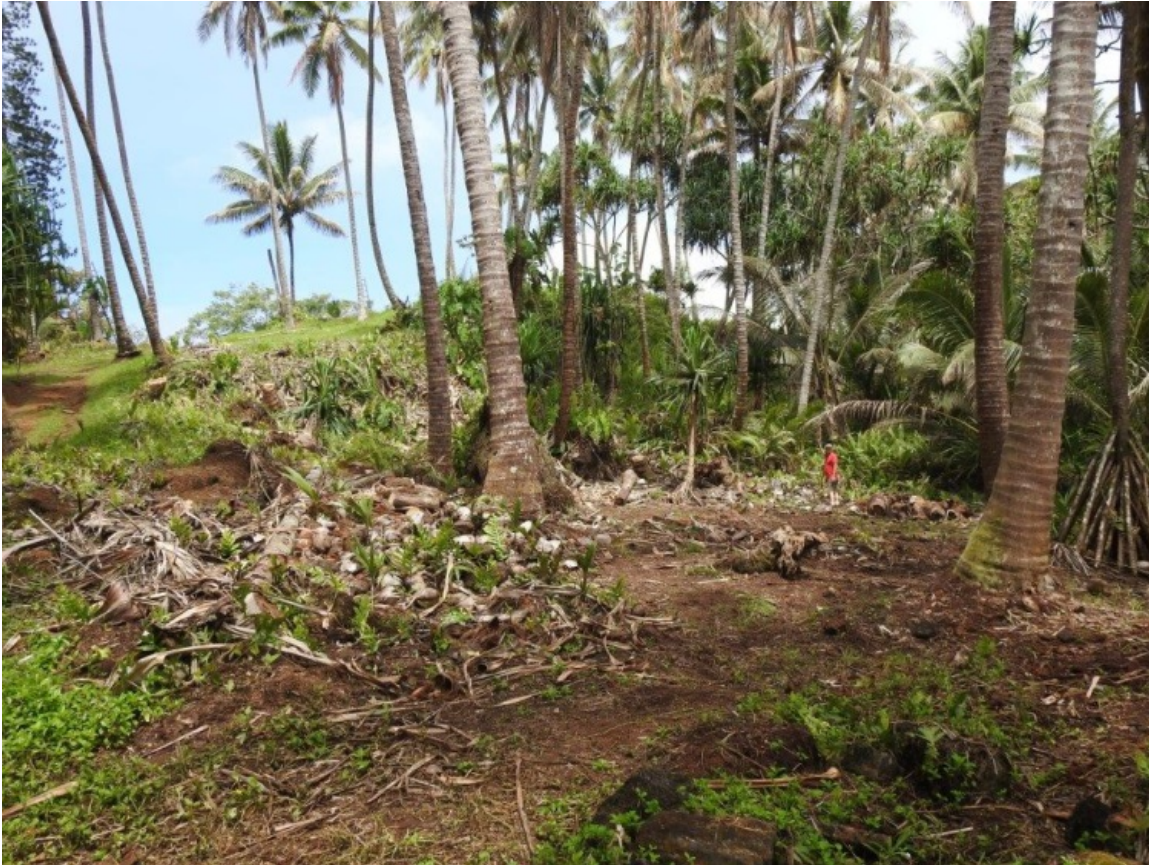
Photo 14 Littoral bench, view west-northwest

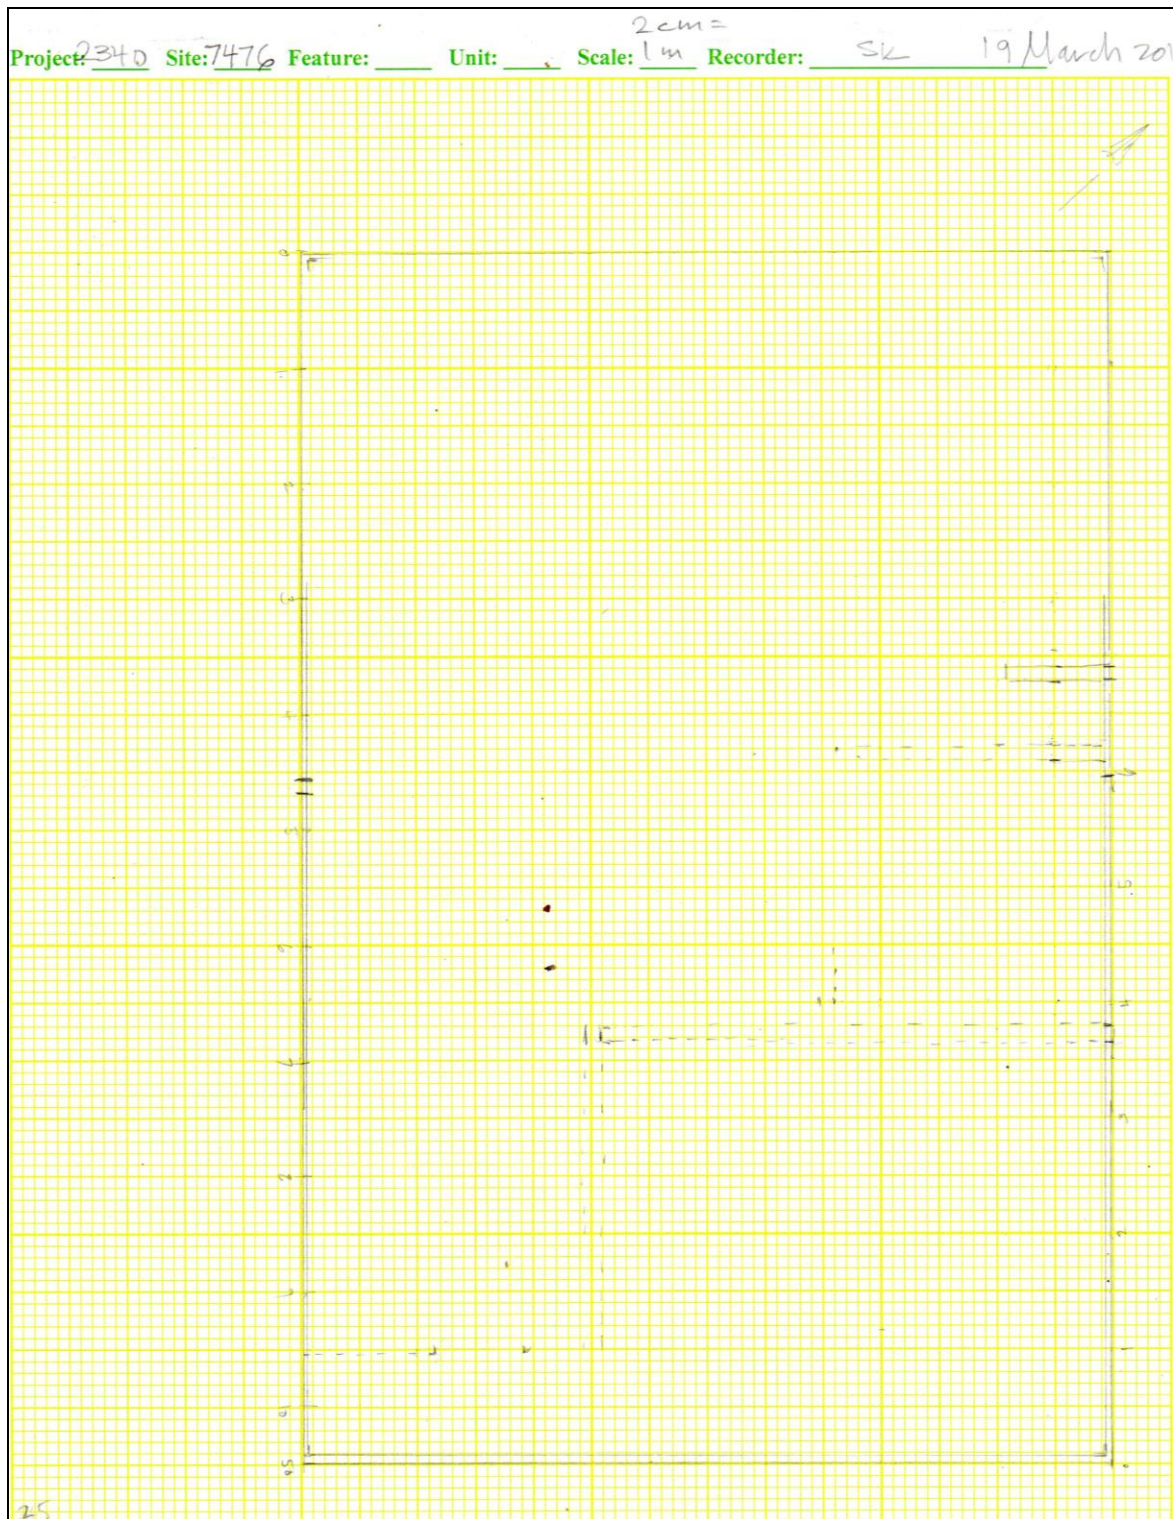
Figure 19: Site 7476 Foundation Plan View Map.

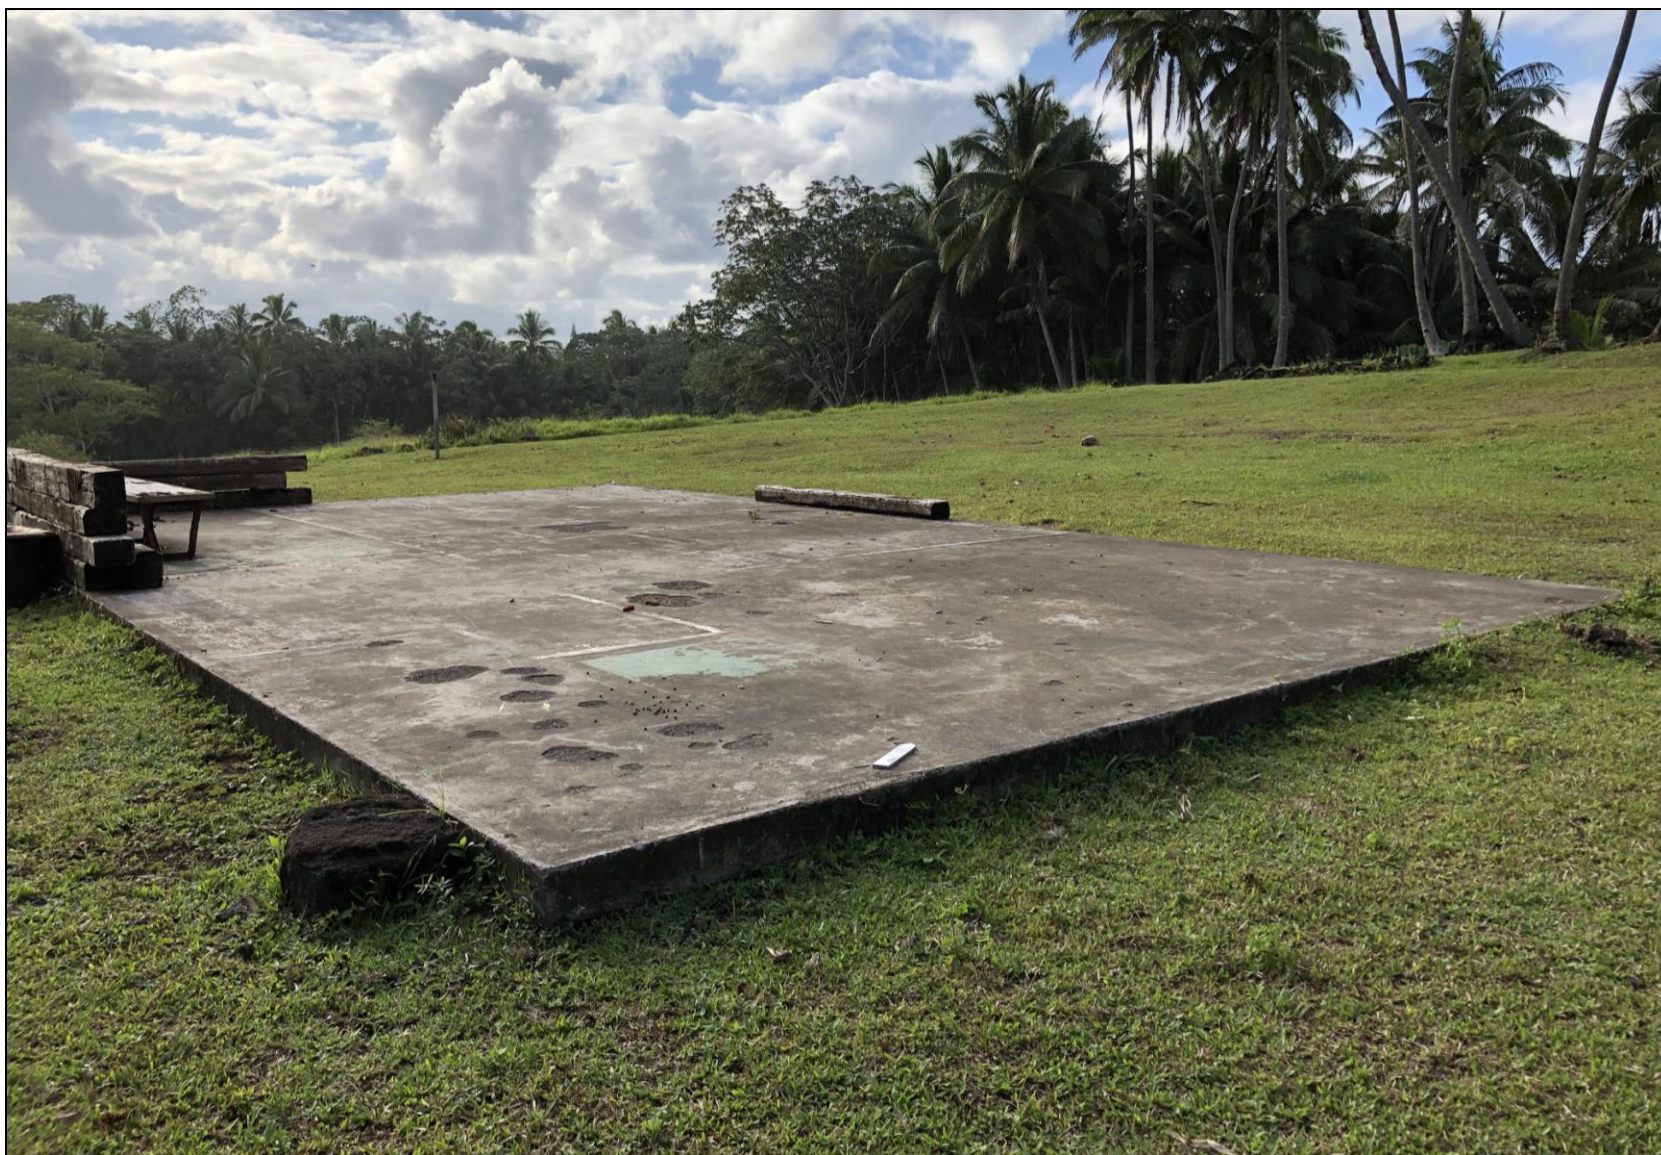
Site 7476 is the foundation located where the Kamahele House once stood (see Figure 17). The foundation is toward the center of the project area in an area of mown grass, northeast of two avocado trees, and northwest of a large stand of Cook pines (Figure 18). The concrete foundation is 10.37 m (34 ft) long by 6.1 m (20 ft) wide and is raised approximately 16 cm (6.3 inches) above ground surface (Figure 19 and Figure 20). The house burned down in 2014 during Hurricane Iselle and is no longer present. Family members remembered the house was a post-and-pier wood structure with wood floors boards. They didn't recall a cement foundation and this might have been poured by the subsequent owner. Site 7476 was destroyed by an accidental house fire in 2014, is in poor condition, is no longer present and lacks formal integrity. No further work is recommended at Site 7476.

Figure 20: Photograph of Site 7476 Foundation Looking North.

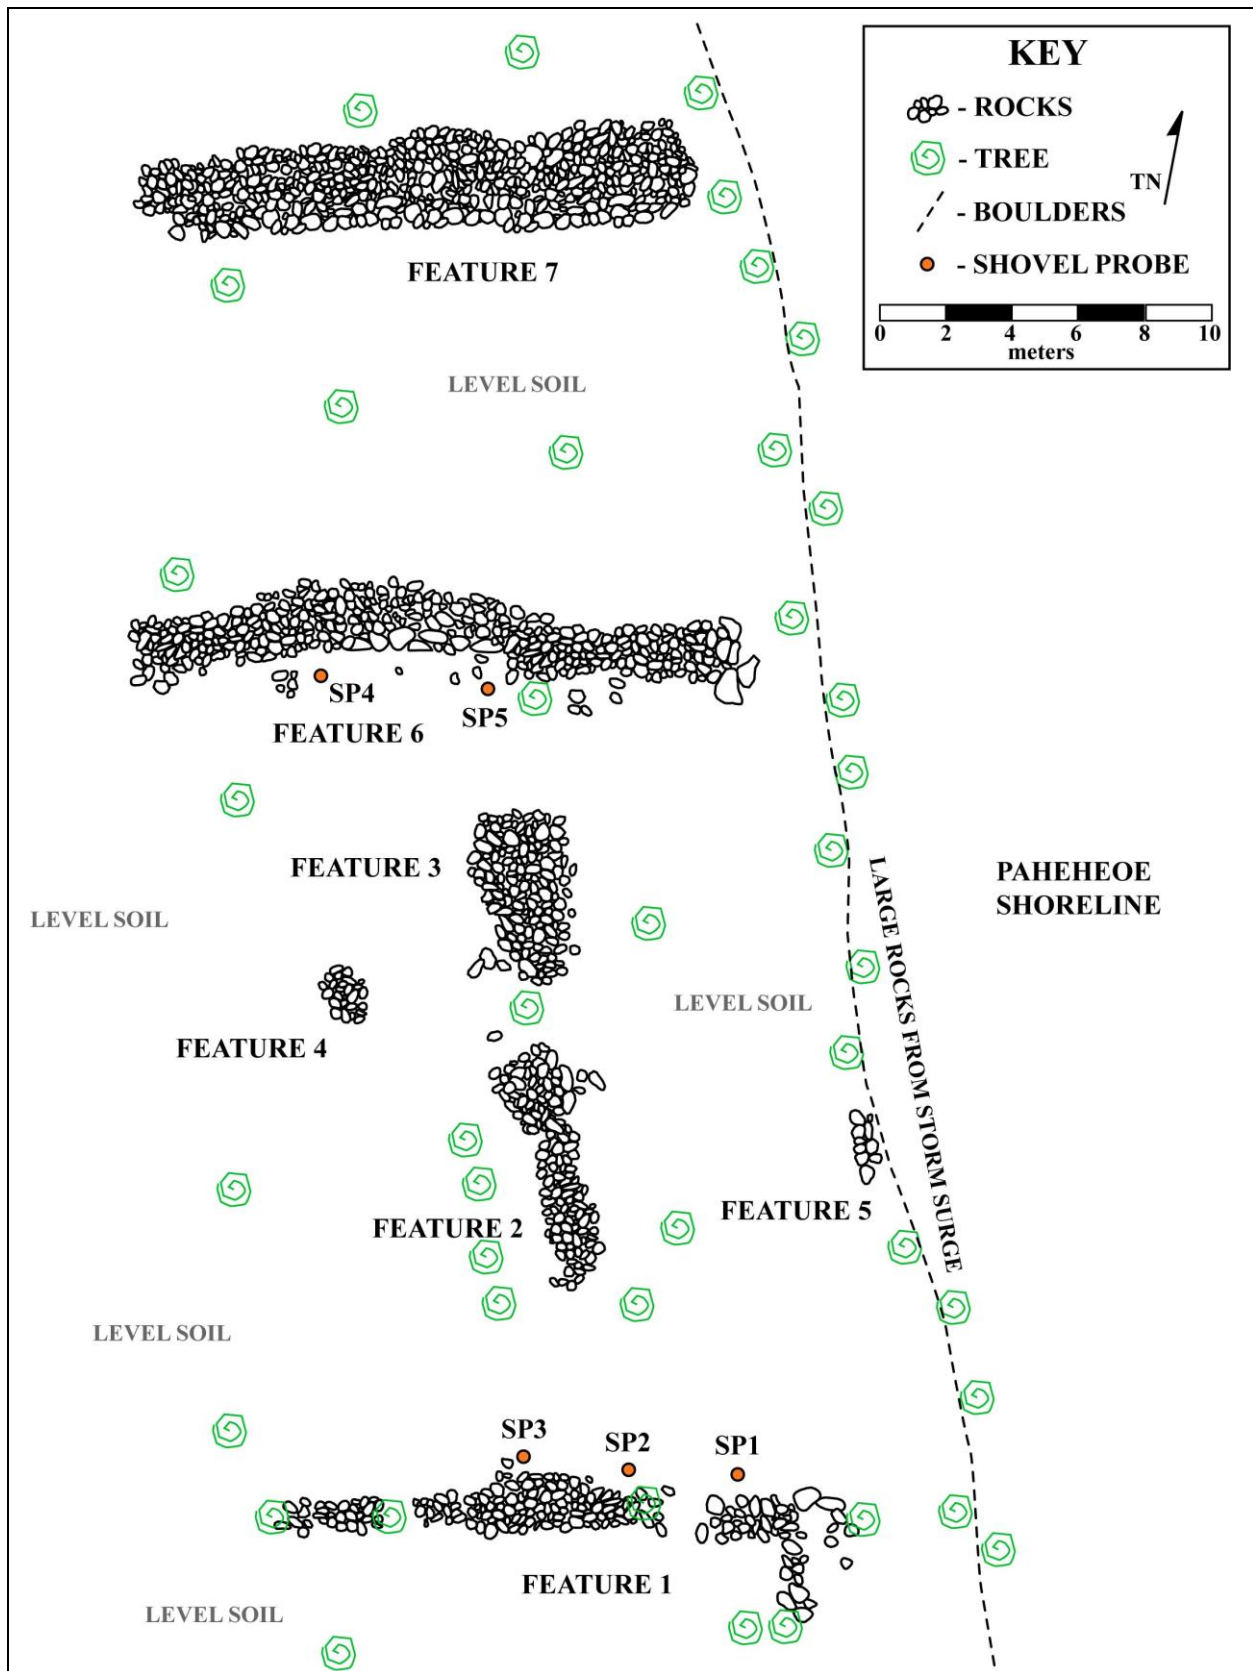
Figure 21: Site 18980 Plan View Map.

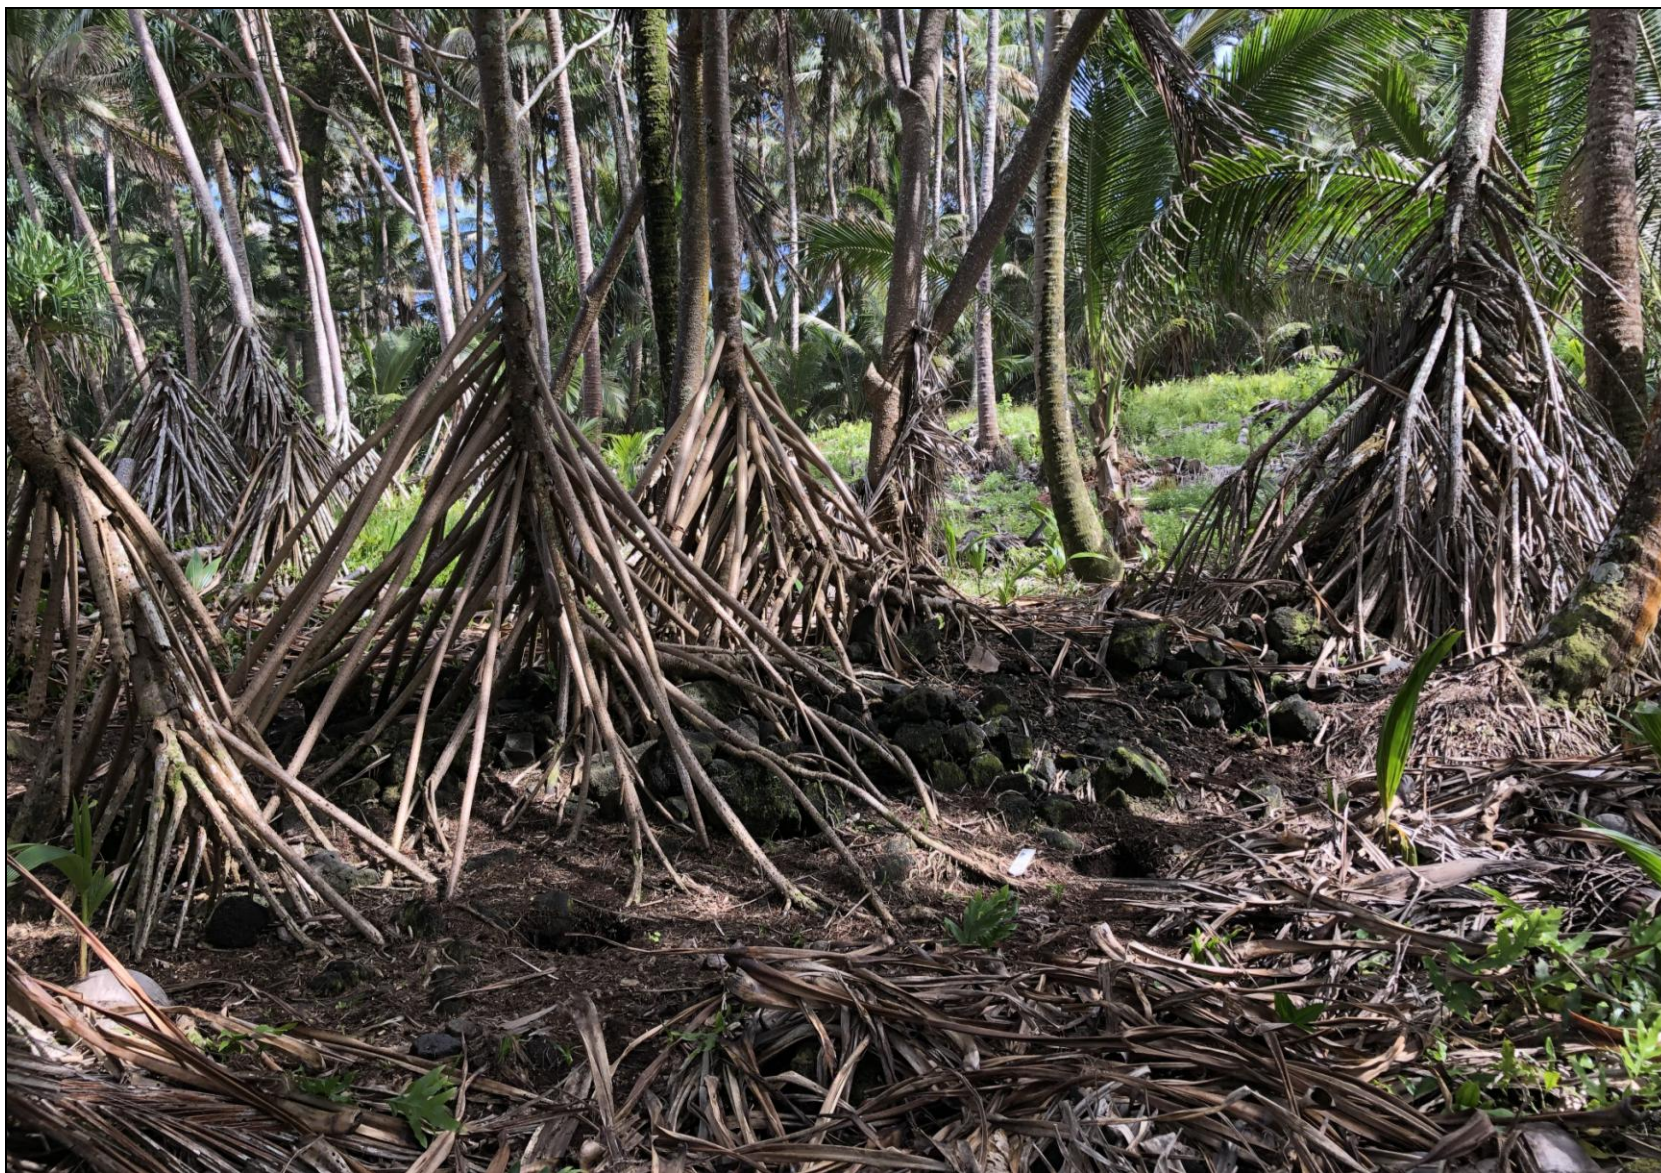
Figure 22: Photograph of Site 18980 Feature 1 Linear Rock Mound Looking South.

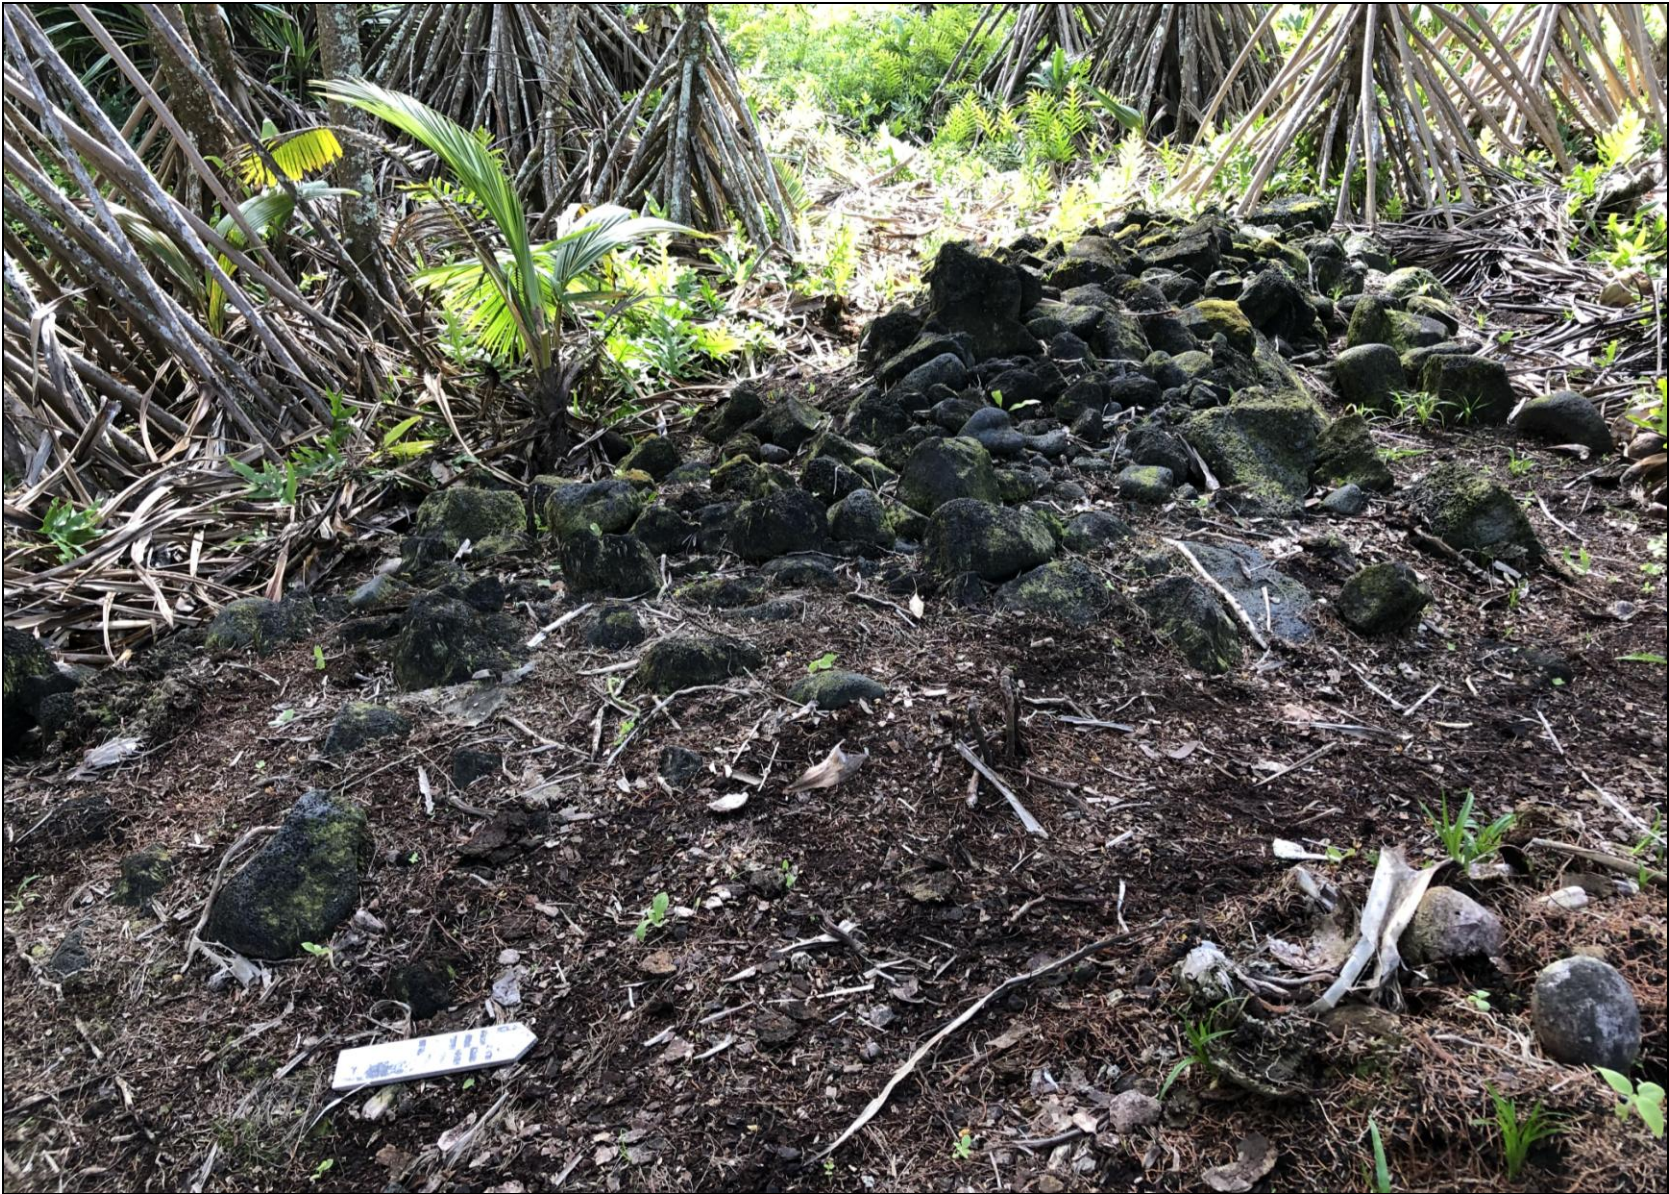
Feature 2 is a low linear rock mound 5.4 m north of Feature 1. Feature 2 is 6.8 m long (NW/SE) by 1.1 to 2.5 m wide and has a maximum height of 0.62 m (Figure 23). The rock mound is constructed of angular and subangular basalt cobbles and small boulders piled on the ground surface. There is no stacking or facing evident in the feature construction. The rock mound appears to be a clearing or planting, possibly a sweet potato planting mound. Feature 2 appears to be unaltered and is in good condition.

Figure 23: Photograph of Site 18980 Feature 2 Rock Mound Looking West.
