**CONSERVATION DISTRICT USE PERMIT APPLICATION
GARRETT SINGLE FAMILY RESIDENCE AND FARM
TMK: (3) 1-5-010:009**

Lands of Maku‘u, District of Puna, Island of Hawai‘i

Applicant: Kamahele Farms, LLC

**Prepared By: James M. Leonard
J M Leonard Planning, LLC**

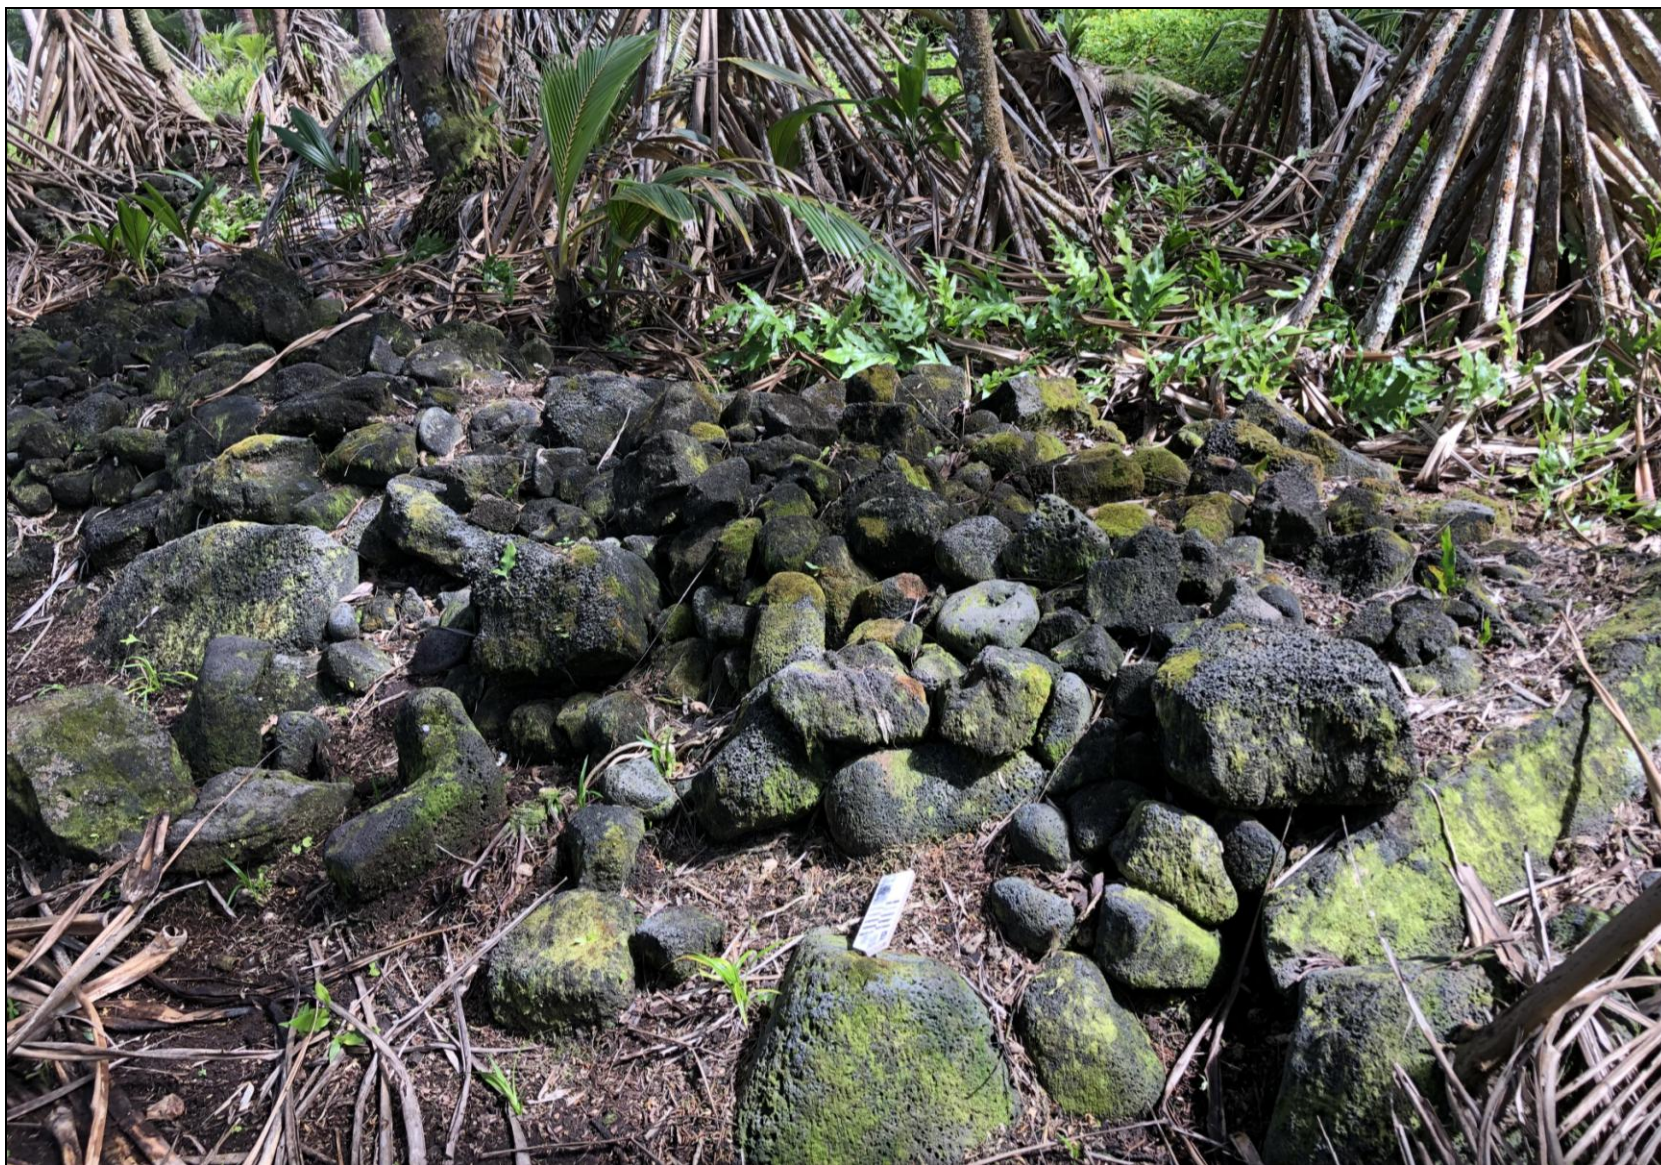
Feature 3 is a low linear rock mound 1.7 m north of Feature 2. Feature 3 is 4.8 m long (NW/SE) by 2.3 m wide and has a maximum height of 0.54 m (Figure 24). The rock mound is constructed of angular and subangular basalt cobbles and small boulders piled on the ground surface. There is no stacking or facing evident in the feature construction. The rock mound appears to be a clearing or planting, possibly a sweet potato planting mound. Feature 3 appears to be unaltered and is in good condition.

Figure 24: Photograph of Site 18980 Feature 3 Rock Mound Looking South.

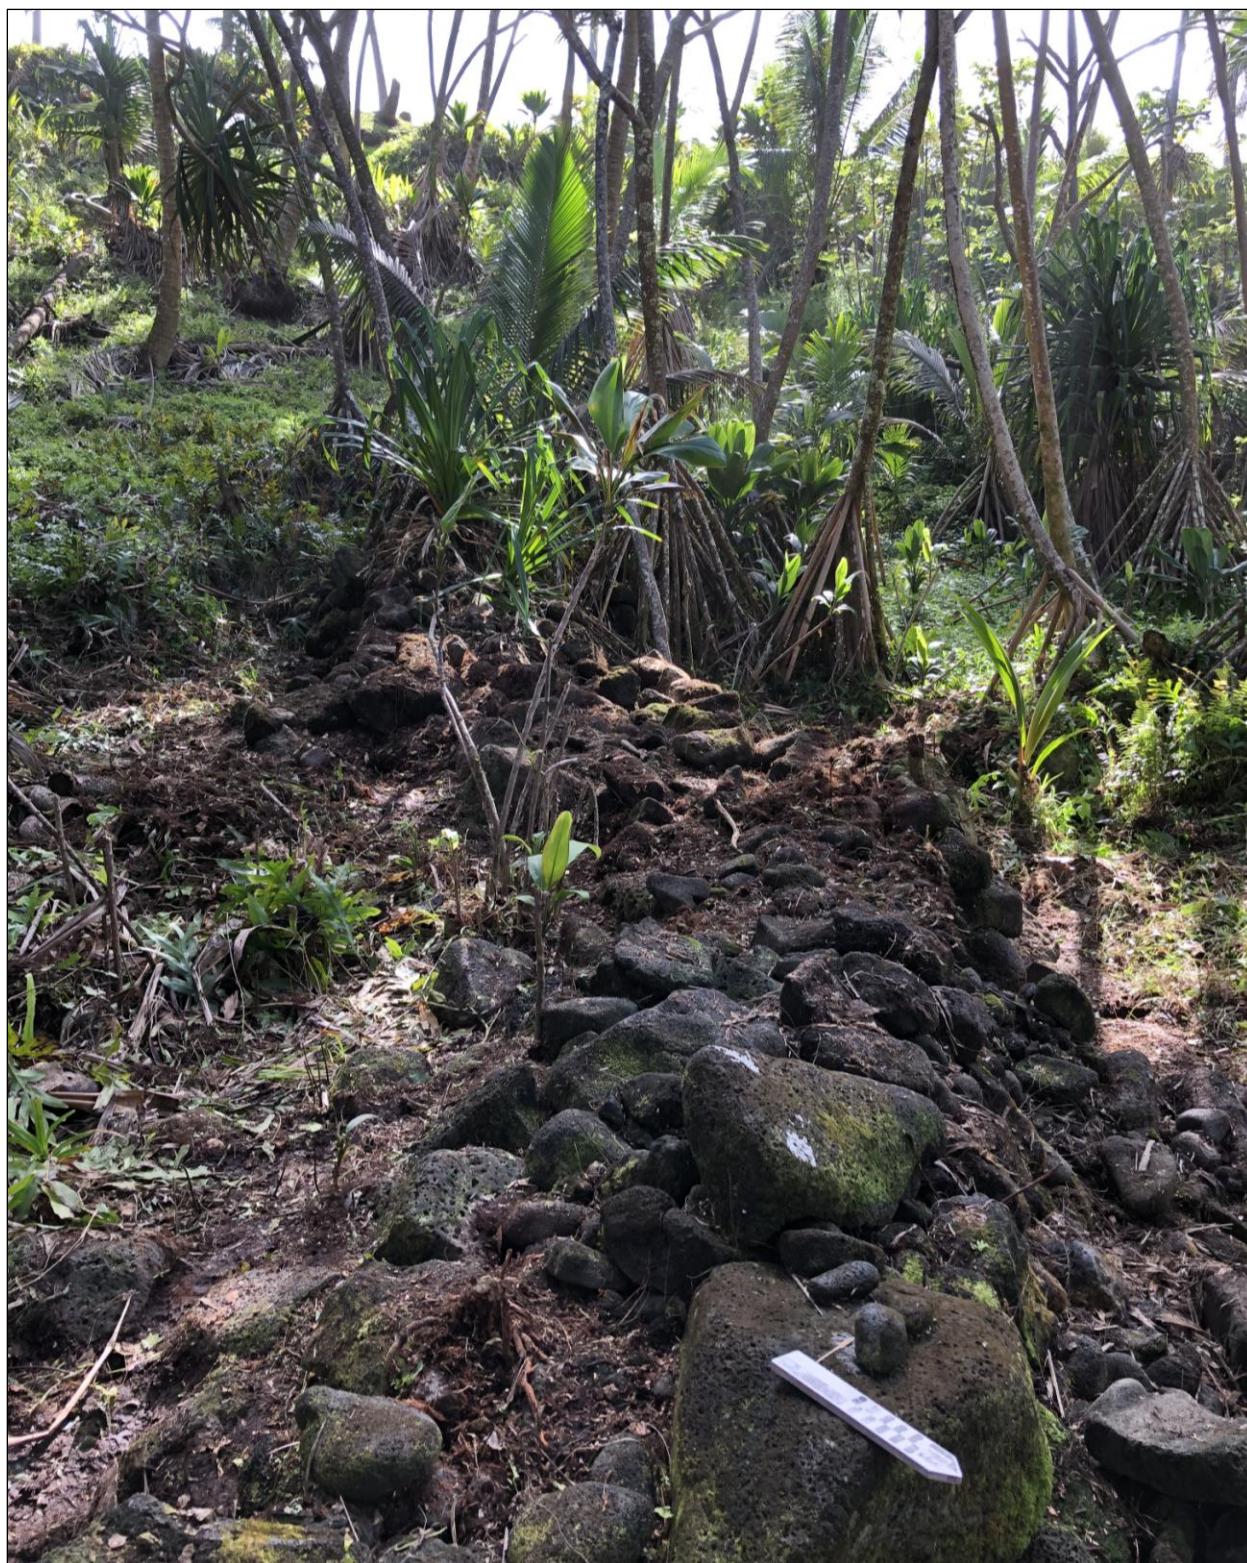
Feature 6 is a rock wall located 5.2 m north of Feature 3. Feature 6 is 19.4 m long (E/W) by 1.4 to 2.0 m wide and has a maximum height of 0.38 m (Figure 25). The rock wall is constructed of angular and subangular basalt cobbles and small boulders stacked three to five courses high on the ground surface. The wall is bi-faced with slightly larger rocks, and filled with rocks that are slightly smaller than the facing rocks. The north edge of the wall is raised higher above the ground surface than is the south edge. The largest rocks in the wall are along the base of the north edge. Those rocks were placed with their flattest largest sides facing the outside edge (north edge) of the wall. The rock mound was constructed to delineate space, possibly marking a division in the garden area. Feature 6 is partially collapsed in places (Figure 26) and is in good condition.

Figure 25: Photograph of Site 18980 Feature 6 Rock Wall, Overview Looking Southwest.

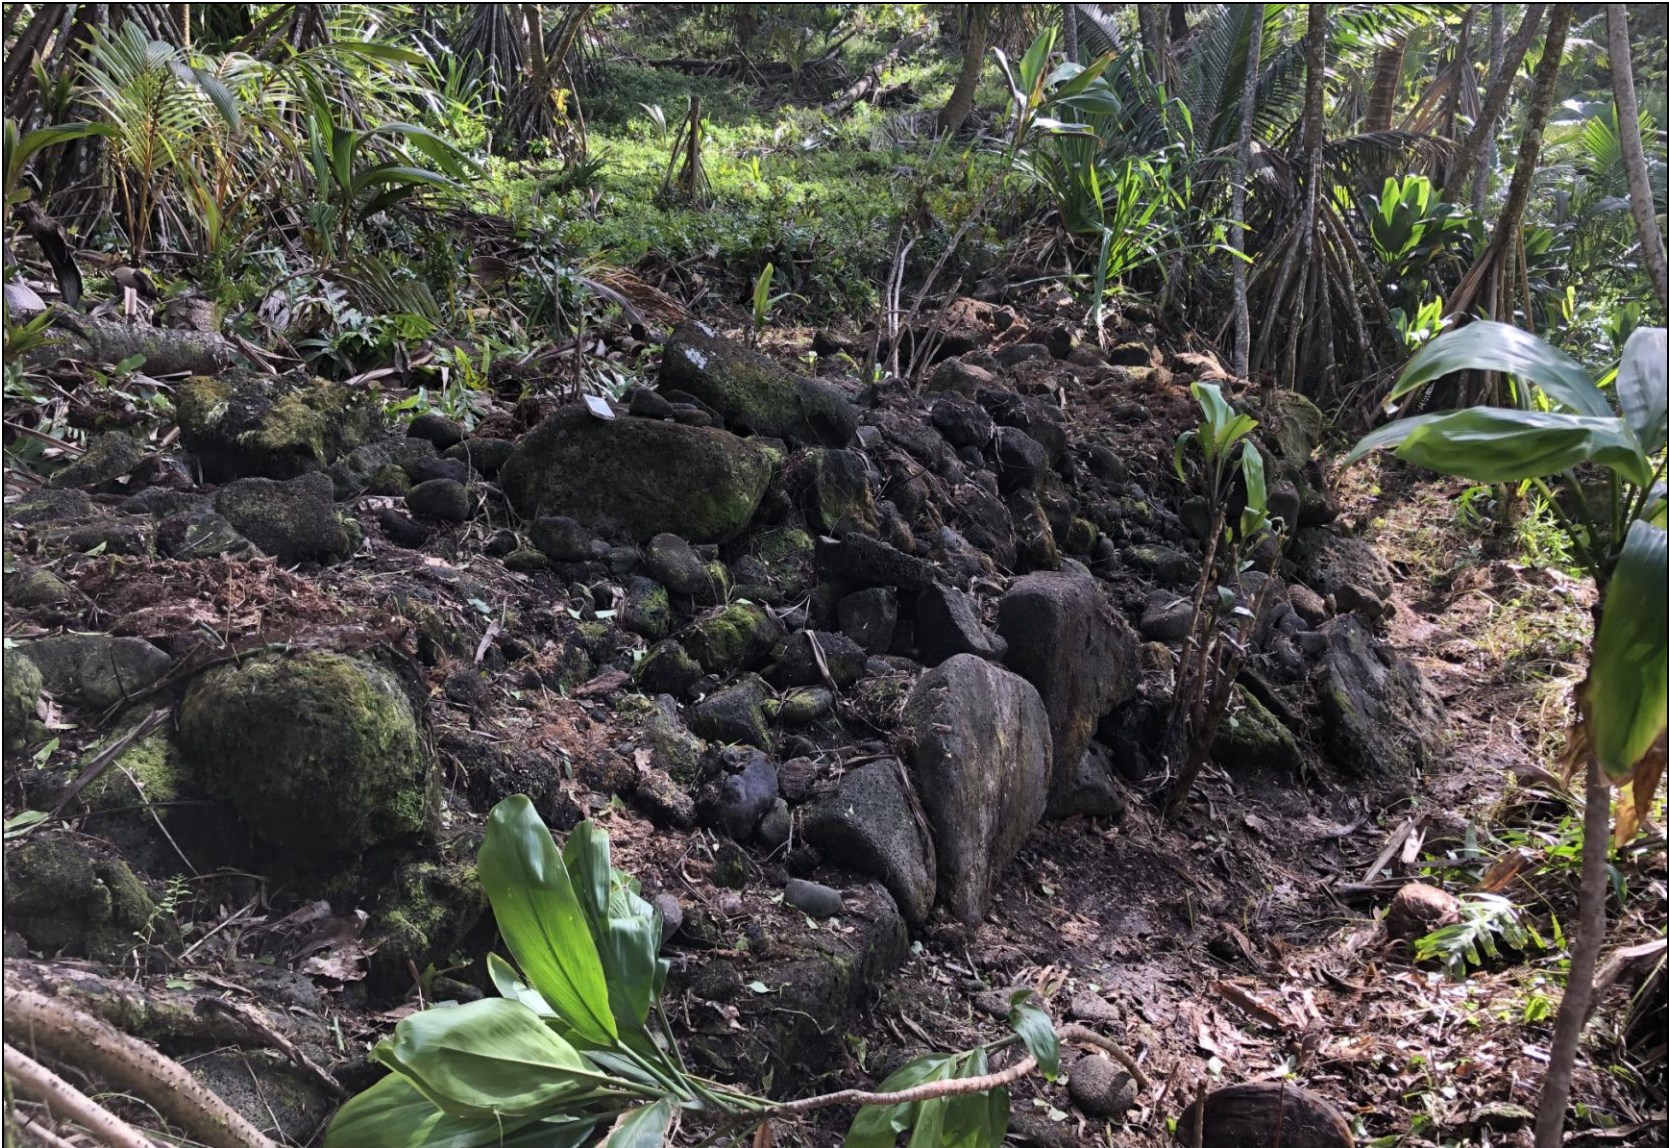
Figure 26: Photograph of Site 18980 Feature 6 Rock Wall Showing Partial Collapse, Looking West.

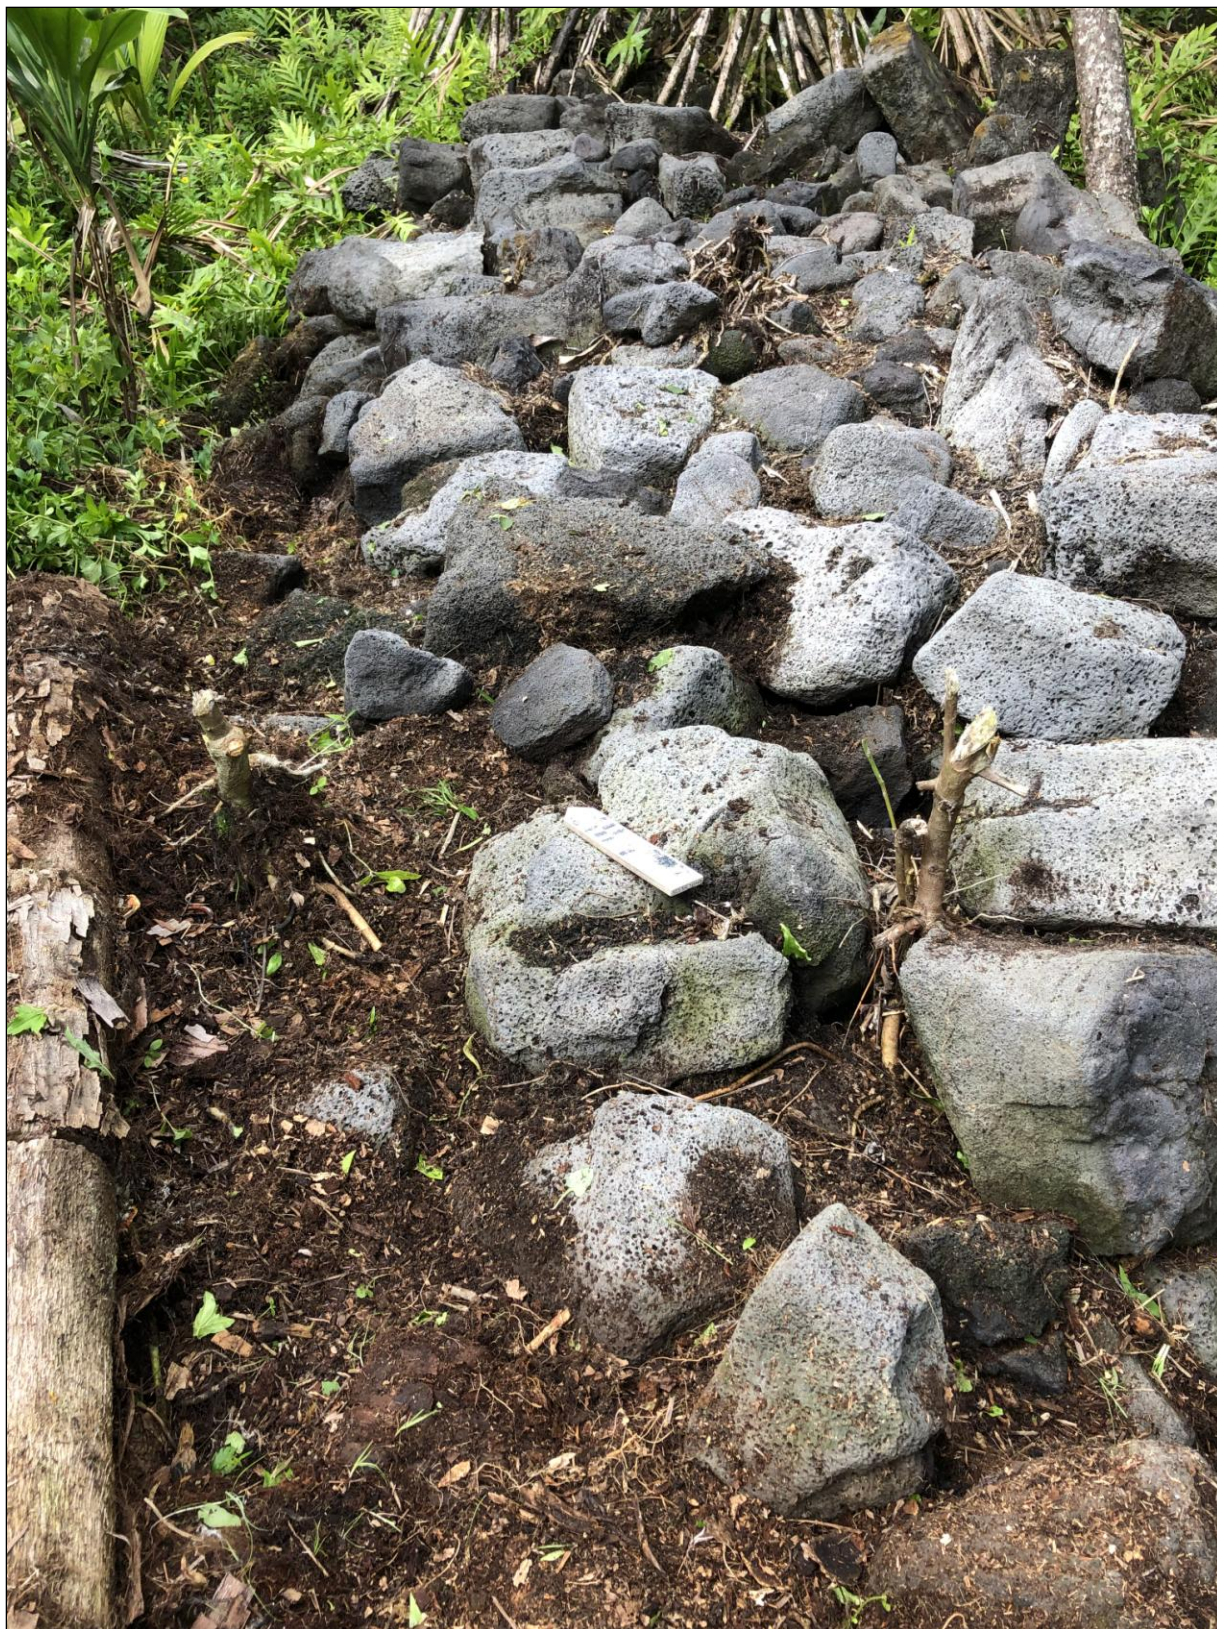
Figure 27: Photograph of Site 18980 Feature 7 Rock Wall, Overview Looking Northeast.

Feature 7 is a rock wall located 12.0 m north of Feature 6. Feature 7 is 16.8 m long (E/W) by 1.1 to 2.3 m wide and has a maximum height of 0.74 m (Figure 27 and Figure 28). The rock wall is constructed of angular and subangular basalt cobbles and small boulders stacked four to five courses high on the ground surface. The wall is bi-faced with slightly larger rocks, and filled with rocks that are slightly smaller than the facing rocks. The largest rocks in the wall are along the base of the wall. Those rocks were placed with their flattest largest sides facing the outside edge (north and south edges) of the wall. The rock mound was constructed to delineate space, possibly marking the northern boundary of the garden area. The west end of the rock wall is covered by fallen trees and dense vegetation. Feature 7 appears to be unaltered and is in good condition.

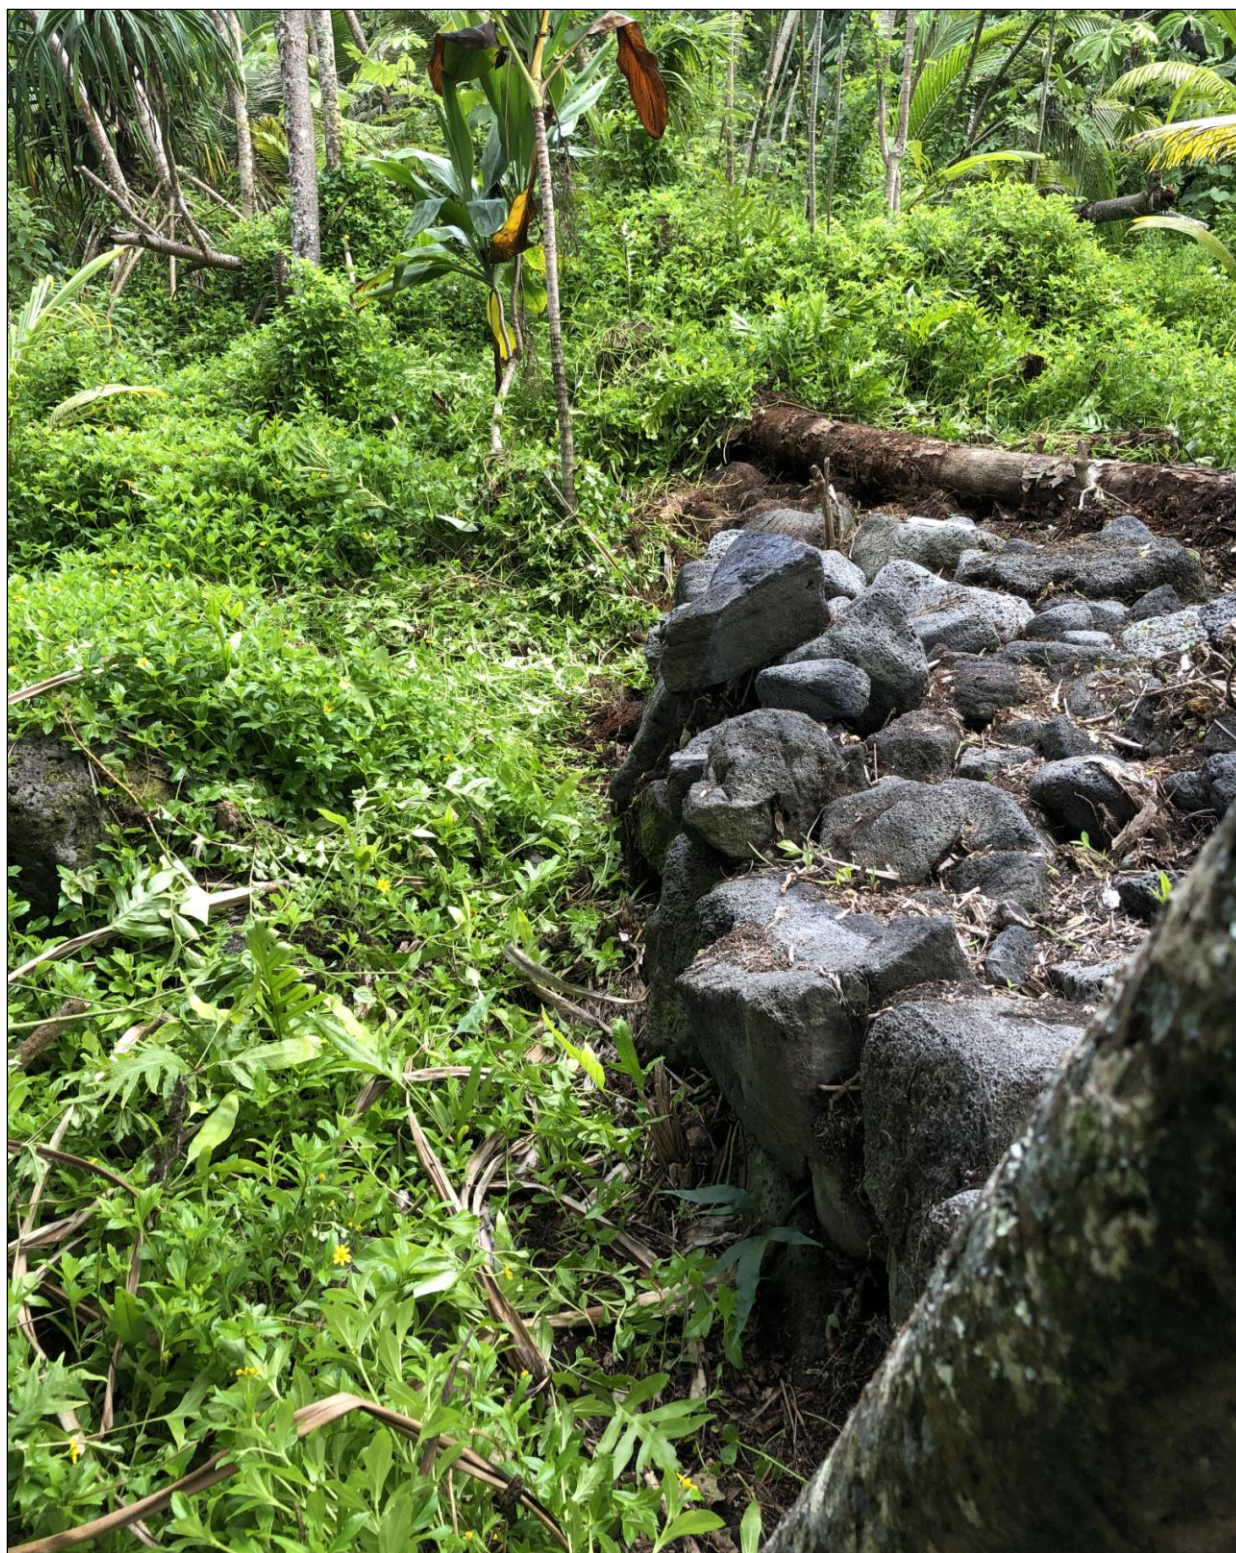
Figure 28: Photograph of Site 18980 Feature 7 Rock Wall, South Edge, Looking Southwest.

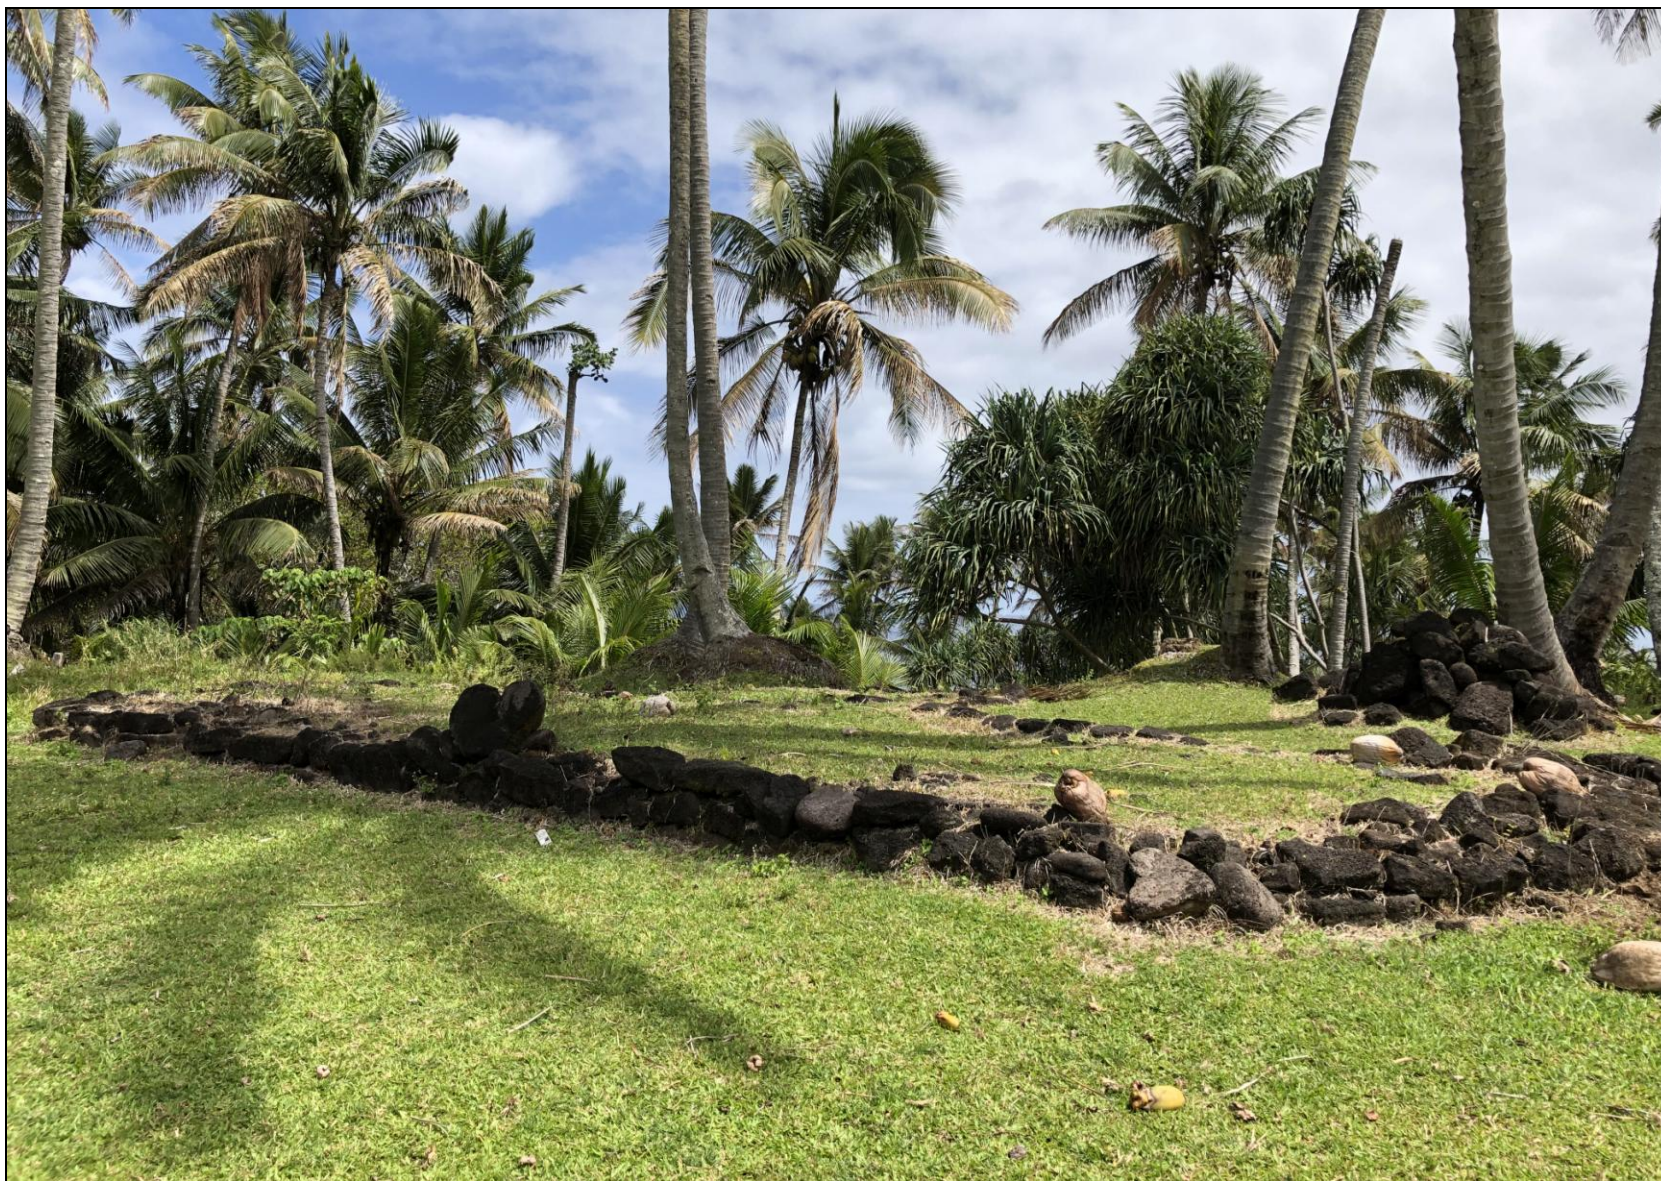
Figure 30: Photograph of Site 18987 Family Burial Plot Looking North.

FUNCTION:	Burial
AGE:	Historic Era
DIMENSIONS:	22.2 m NW/SE by 9.6 m
CONDITION:	Good
INTEGRITY:	Unaltered: retains integrity of location, setting, feeling, materials, and workmanship
SURFACE ARTIFACTS:	None
EXCAVATION:	None
DESCRIPTION:	Site 18987 is a family graves plot located near the center of the property (see Figure 16). It is located in an area of mown grass under coconut palms. The plot is 22.20 m long (NW/SE) by 9.6 m long and has a maximum height of 0.29 m (Figure 29). The plot is trapezoidal in shape with a rectangular extension along the center of the northeast side. The plot is constructed of a perimeter of angular and subangular cobbles and small boulders stacked one to two courses high and one to two courses wide on the ground surface (Figure 30 and Figure 31). The top surface of the plot is level with low cut grass growing on it. There is a pile of loose cobbles and small boulders piled against a palm tree from rock clearing that is not part of the grave plot.

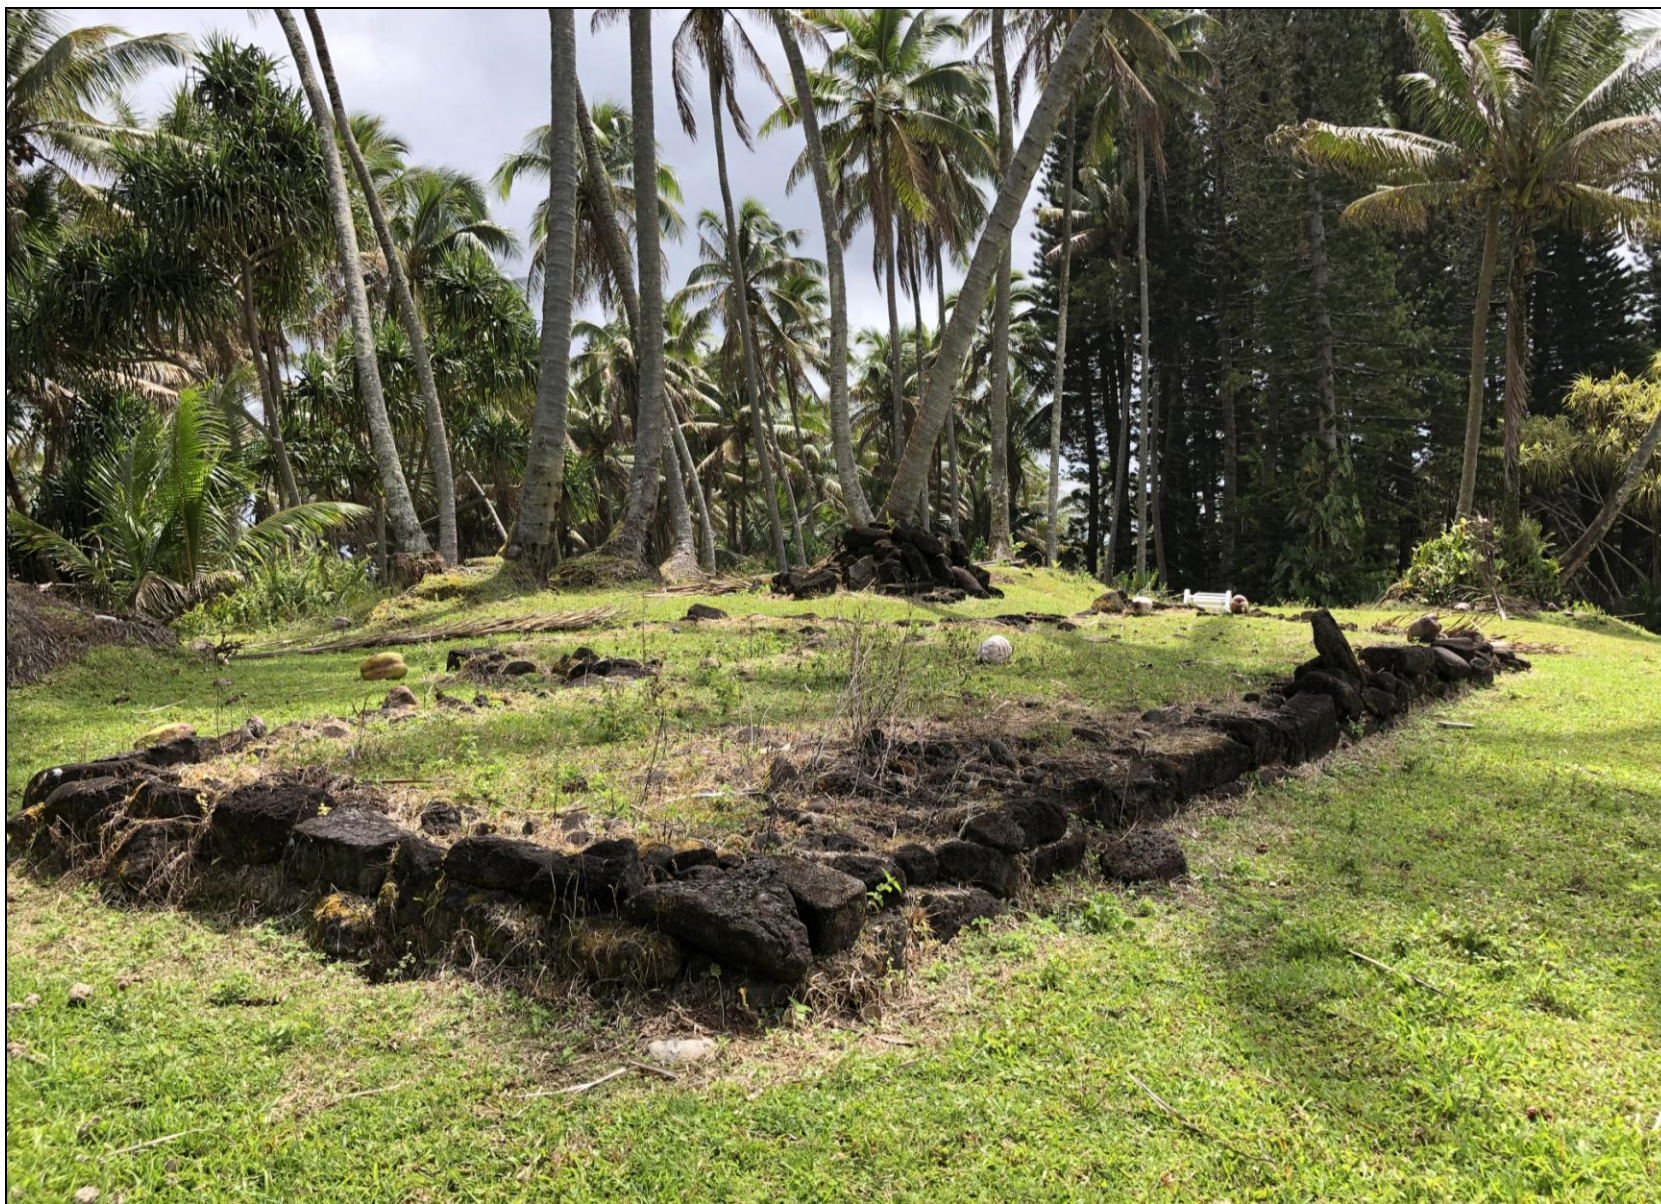
Figure 31: Photograph of Site 18987 Family Burial Plot Looking Southeast.

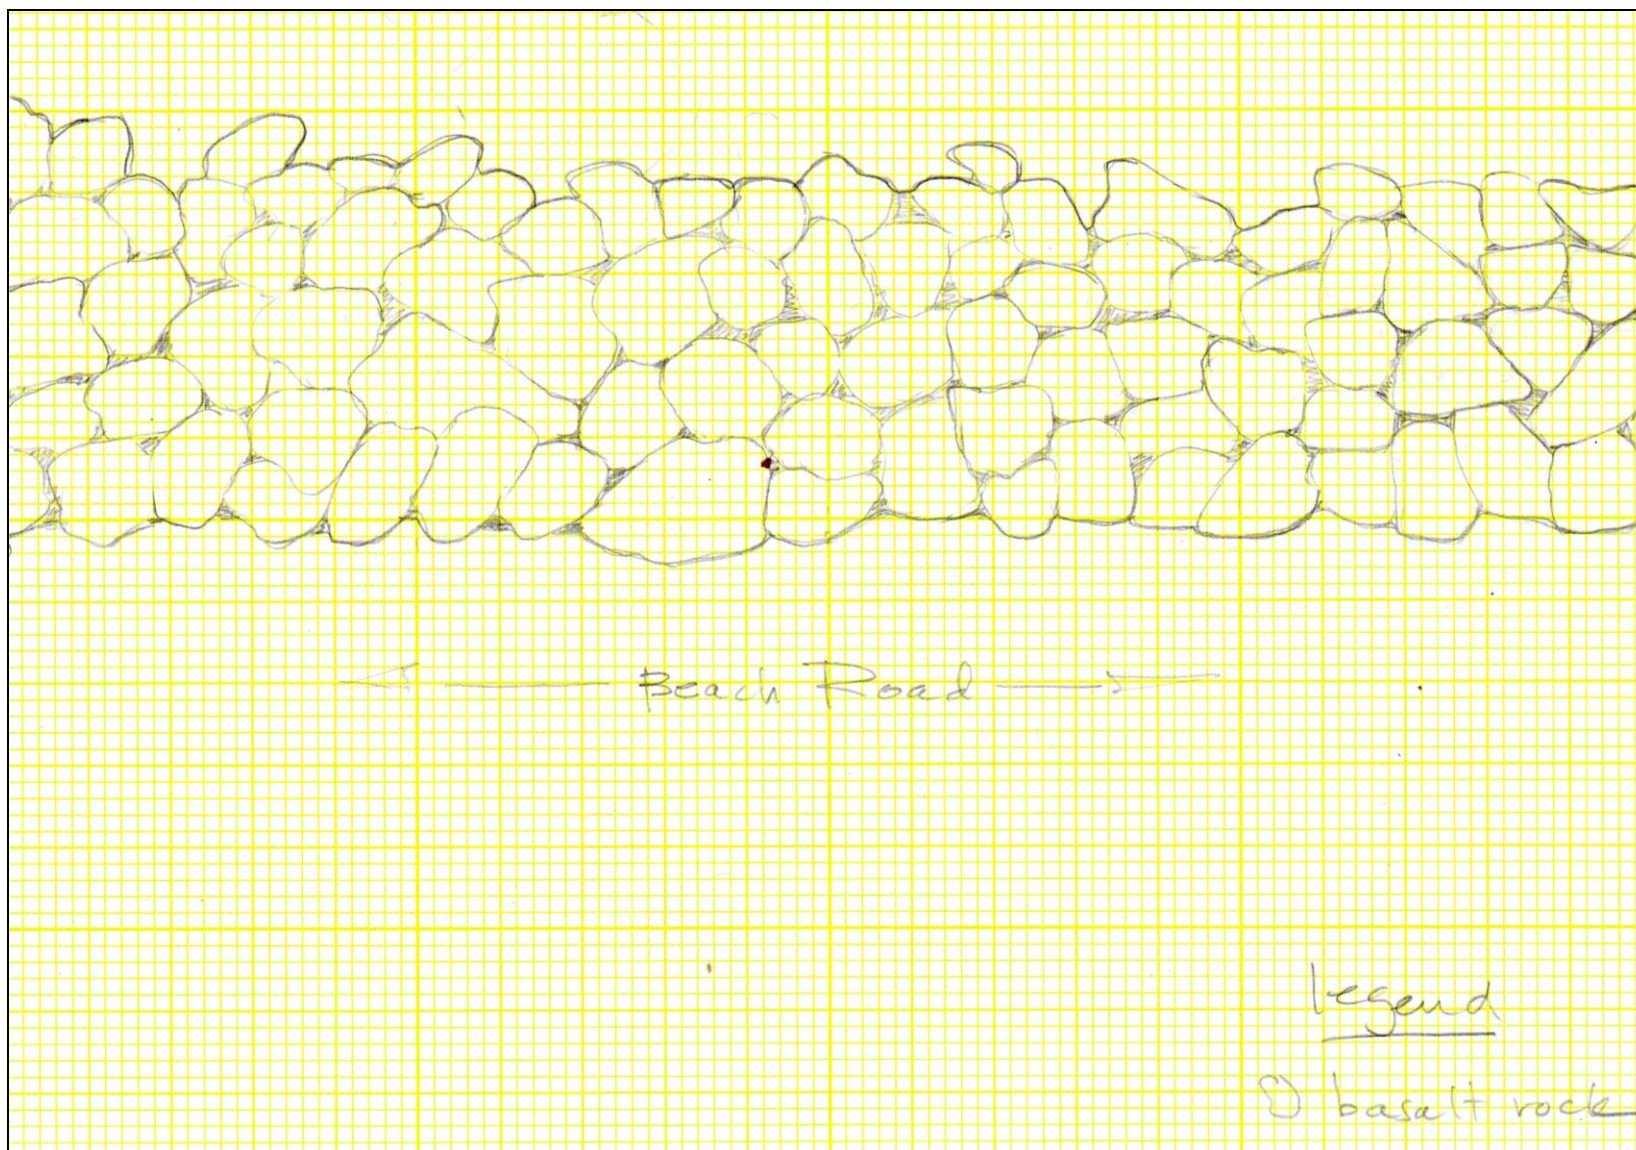
Figure 32: Site TS-1 Southwest Rock Wall Profile Showing Typical Wall Construction.

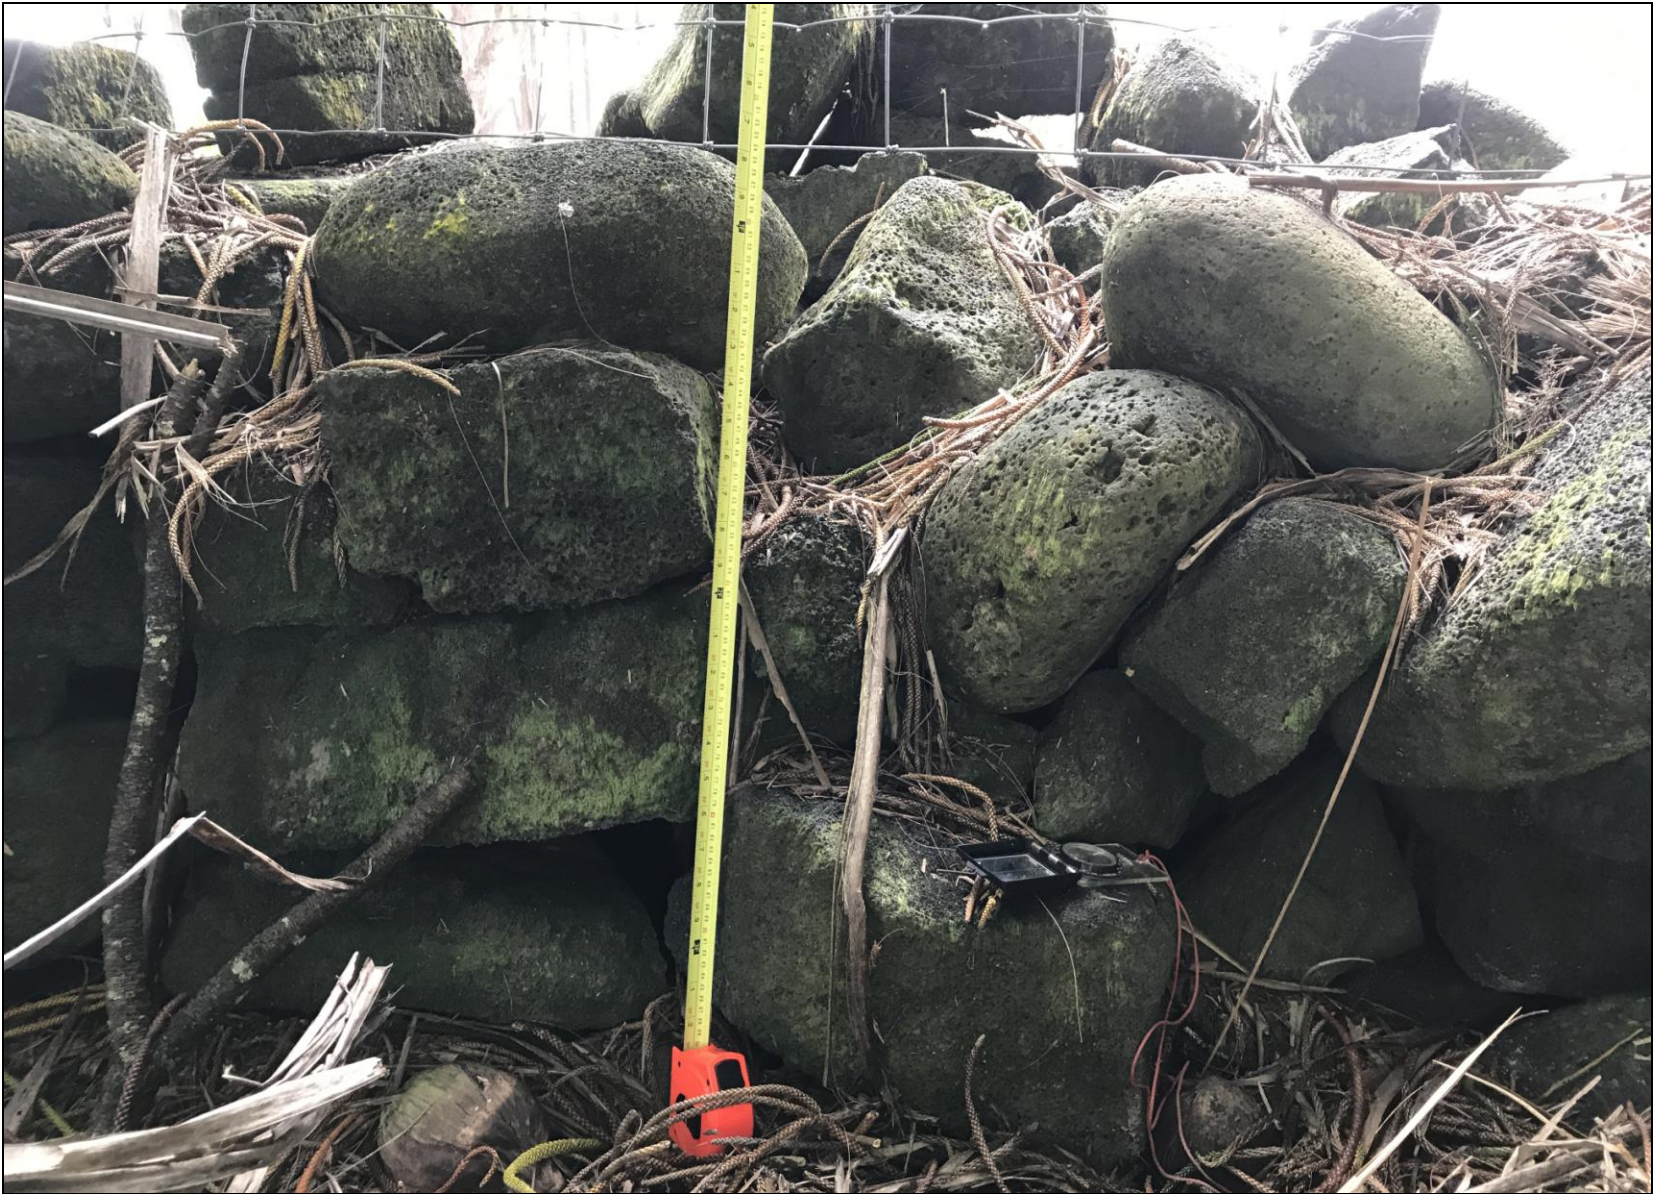
Figure 33: Photograph of Site TS-1 East End of South East Wall, Near Ocean, Looking Southeast.

DESCRIPTION: Site TS-1 is a Historic era rock wall along the southeast, southwest and northwest boundaries of Parcel 009 (see Figure 16). The wall is approximately 670.0 m long by 0.5 m to 1.1 m in maximum height. The wall is constructed of angular and subangular cobbles and small boulders stacked up to five courses high (Figure 32 through Figure 36). The wall is bi-faced with good facing. The wall is primarily perpendicular to the ground surface and slopes very slightly inward toward the top in places. There are two entrance gates in the wall, the main entrance-driveway gate along the southwest wall, and a small wooden gate along the southeast wall. The wall is partially collapsed in places and is in good condition. No further work is recommended at Site TS-1.

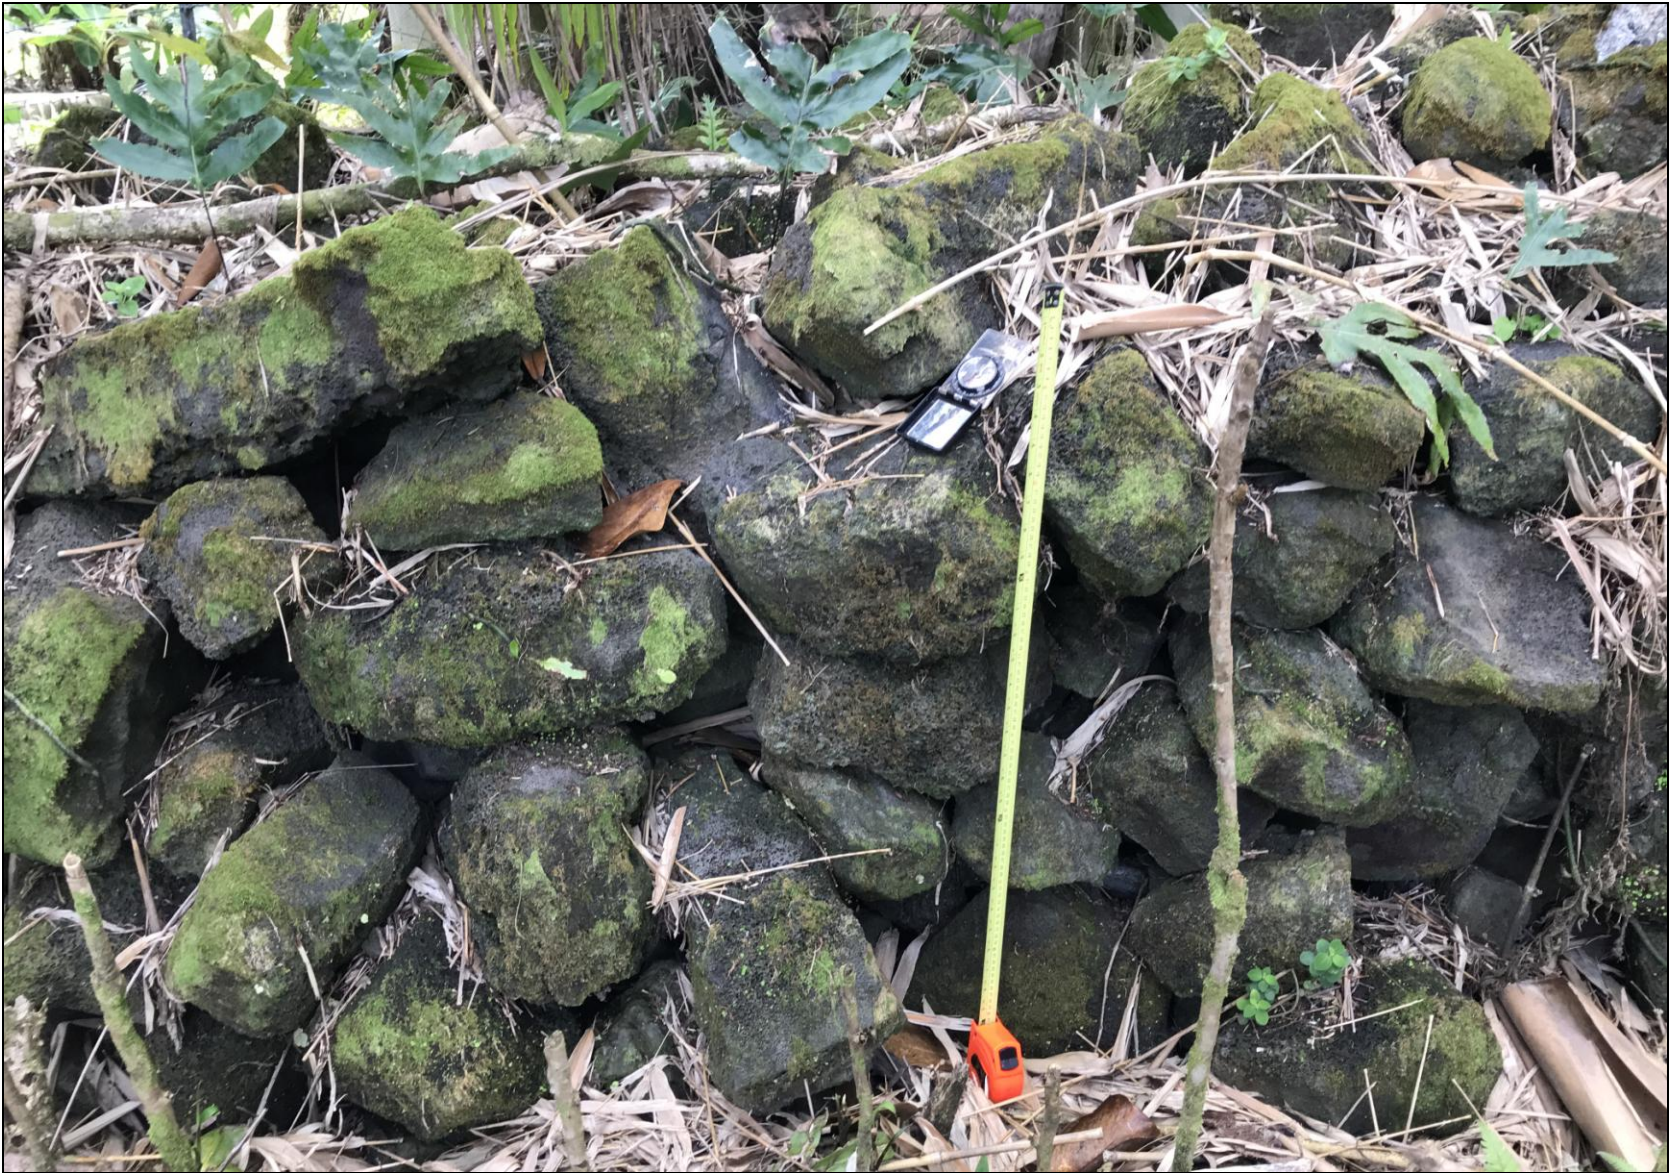
Figure 34: Photograph of Site TS-1 Southeast Wall Near South Corner, Looking Southeast.

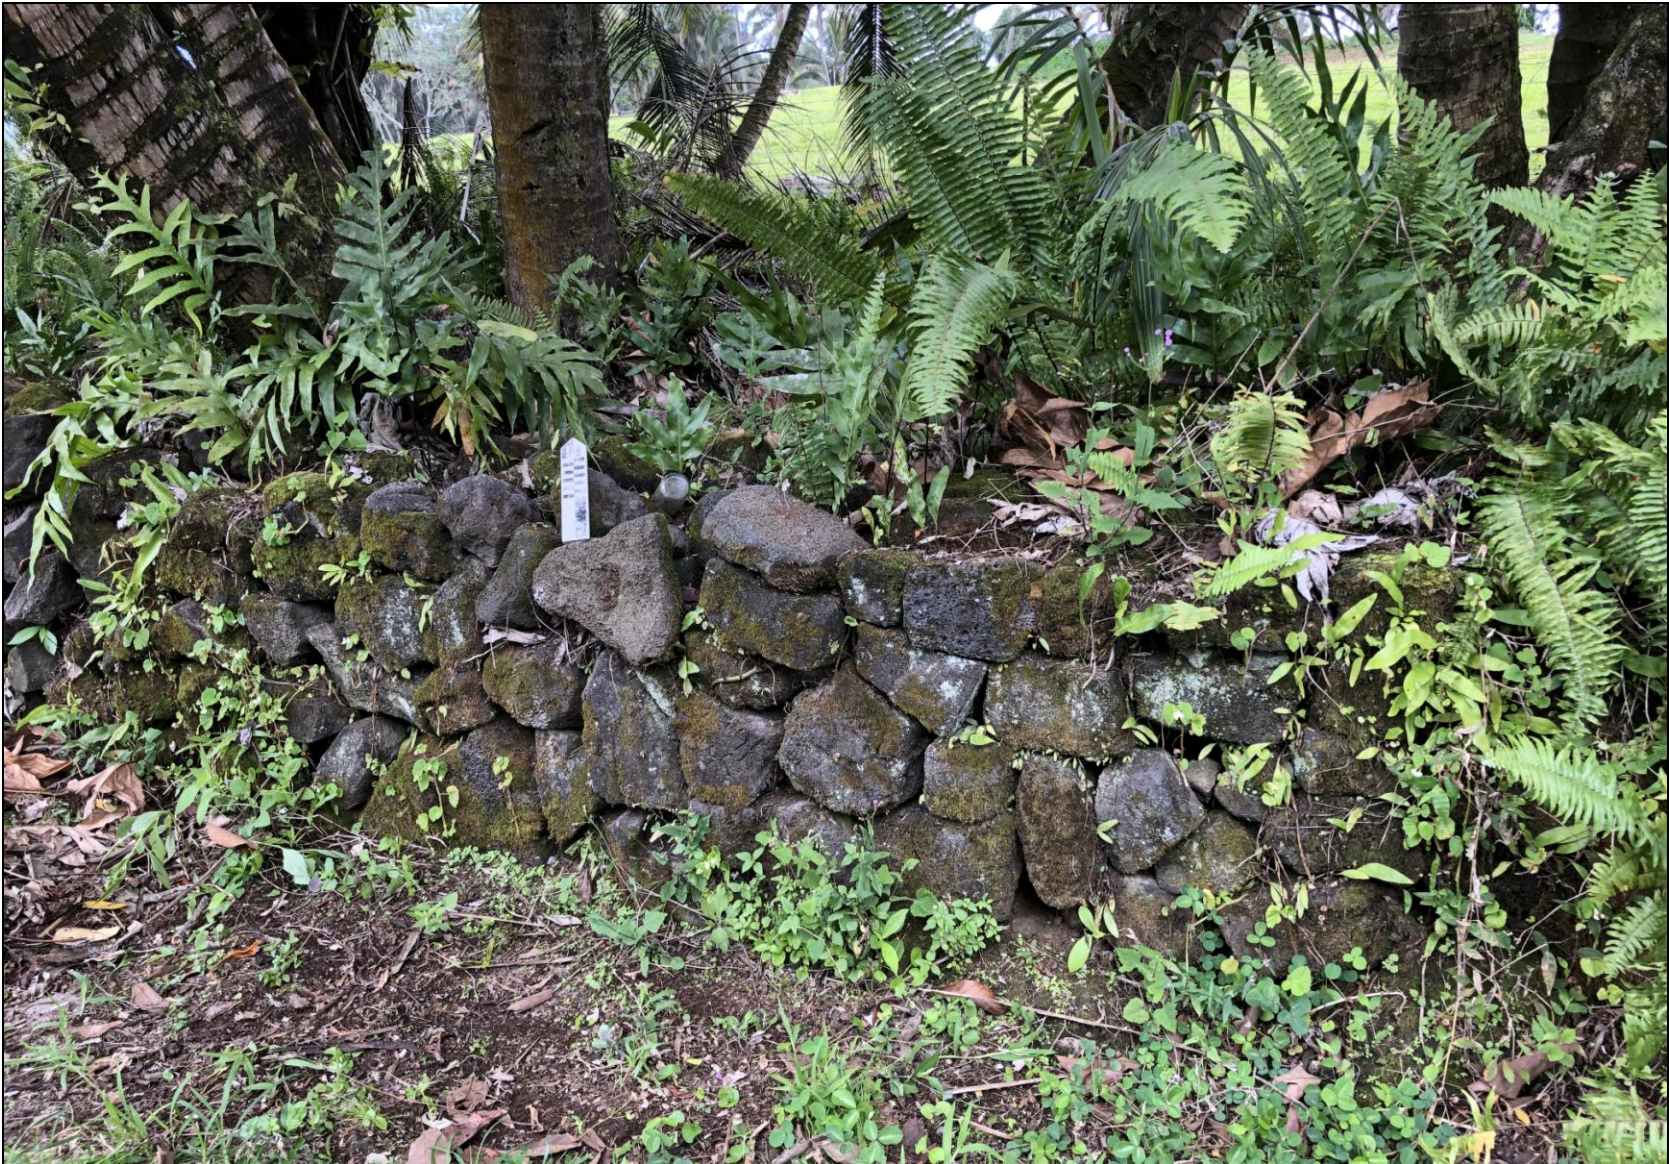
Figure 35: Photograph of Site TS-1 West Wall along Beach Road, Looking North.
