**CONSERVATION DISTRICT USE PERMIT APPLICATION
GARRETT SINGLE FAMILY RESIDENCE AND FARM
TMK: (3) 1-5-010:009**

Lands of Maku‘u, District of Puna, Island of Hawai‘i

Applicant: Kamahele Farms, LLC

**Prepared By: James M. Leonard
J M Leonard Planning, LLC**

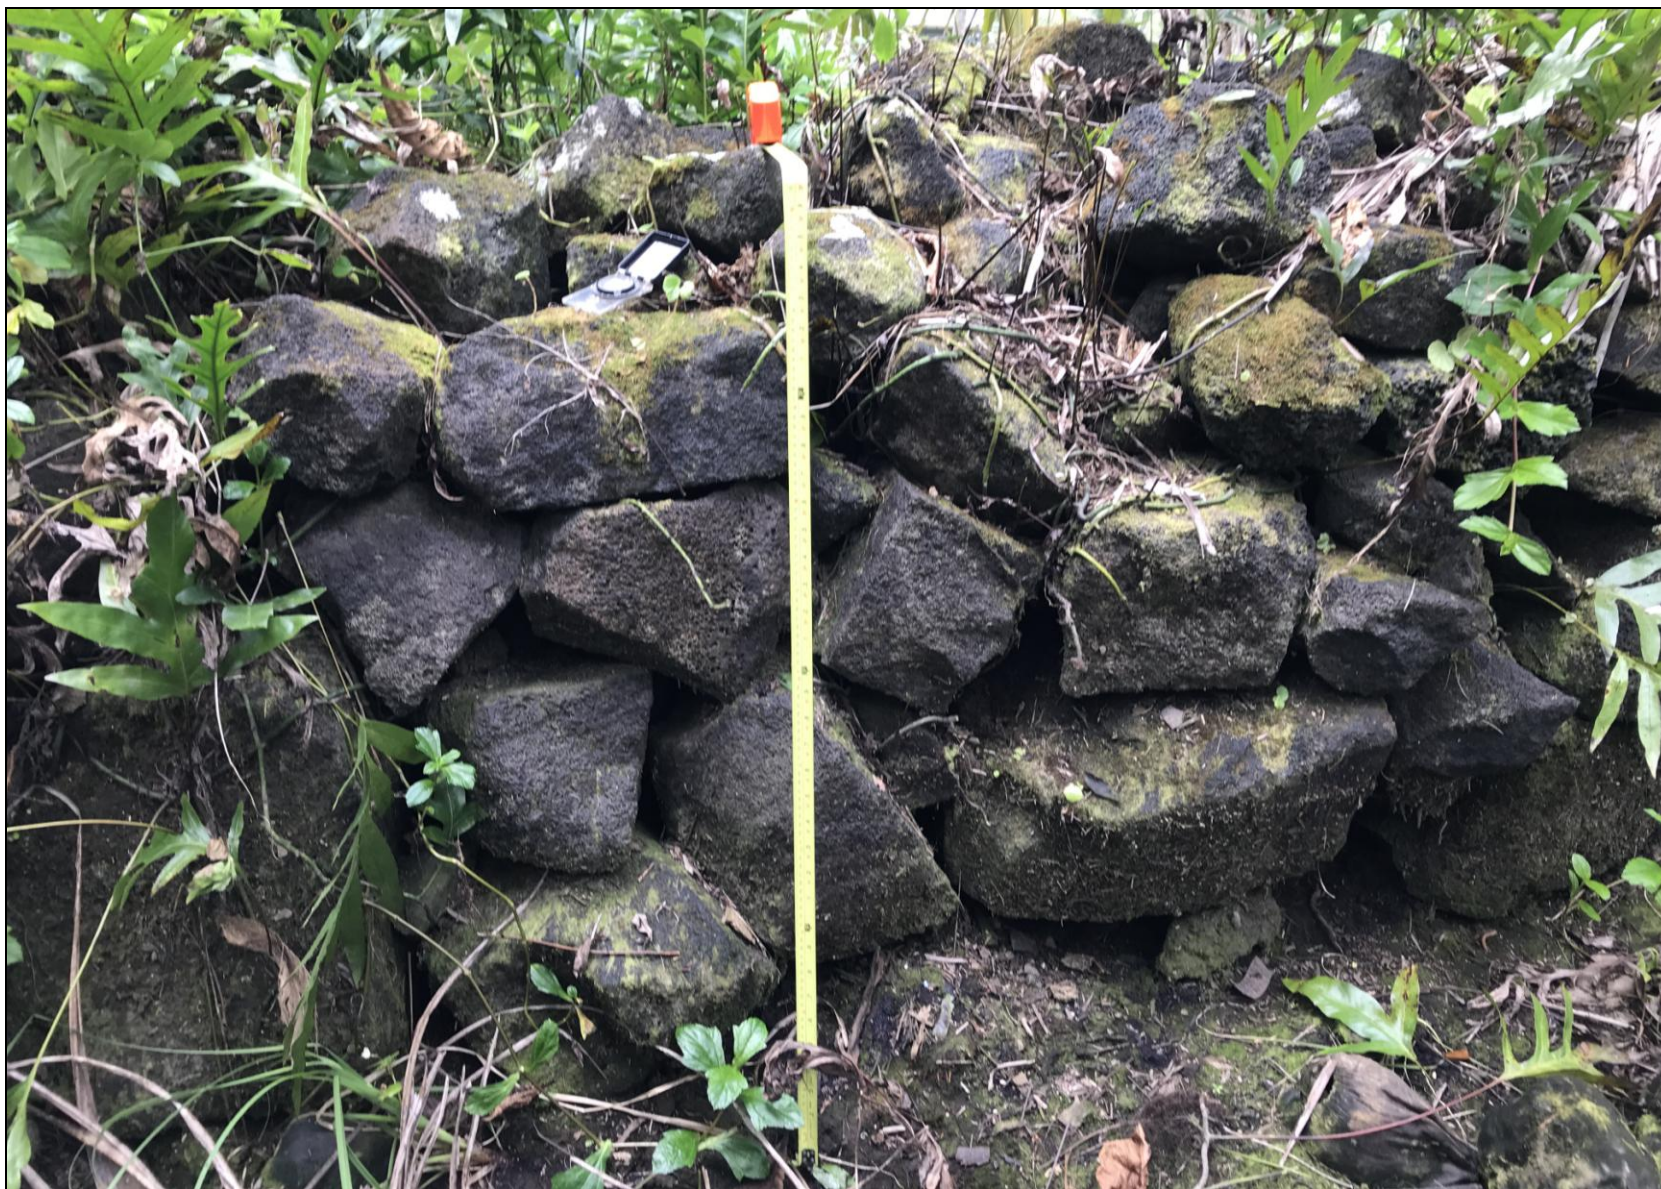
Figure 36: Photograph of Site TS-1 Northwest Wall, Looking Northwest.

DESCRIPTION: Site TS-1 is a Historic era rock wall along the southeast, southwest and northwest boundaries of Parcel 009 (see Figure 16). The wall is approximately 670.0 m long by 0.5 m to 1.1 m in maximum height. The wall is constructed of angular and subangular cobbles and small boulders stacked up to five courses high (Figure 32 through Figure 36). The wall is bi-faced with good facing. The wall is primarily perpendicular to the ground surface and slopes very slightly inward toward the top in places. There are two entrance gates in the wall, the main entrance-driveway gate along the southwest wall, and a small wooden gate along the southeast wall. The wall is partially collapsed in places and is in good condition. No further work is recommended at Site TS-1.

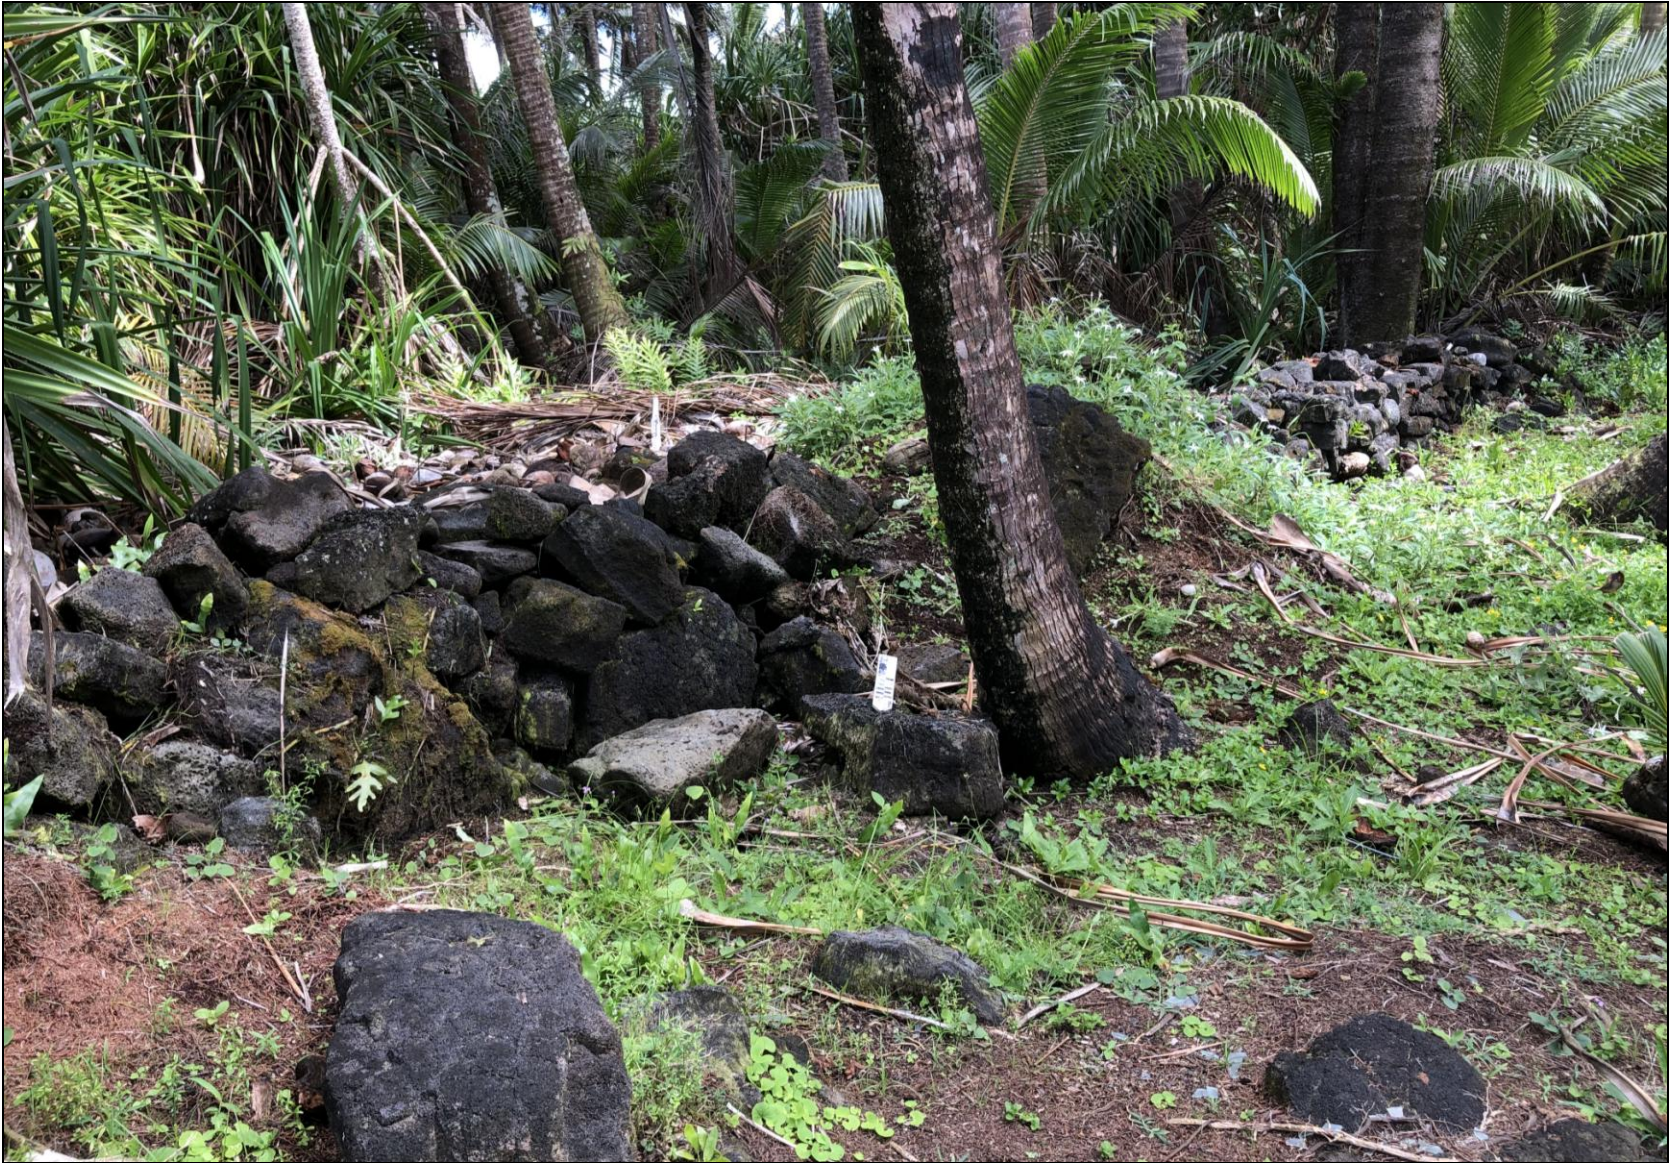
Figure 38: Photograph of Site TS-2 Rock Wall Segment, Looking South.

DESCRIPTION: Site TS-2 is a Historic era rock wall segment located in the southeast quadrant of Parcel 009 (see Figure 16). The wall is 15.0 m long by 0.7 to 1.0 m wide and is 0.91 m in maximum height (Figure 37, Figure 38 and Figure 39). The wall is constructed of angular and subangular cobbles and small boulders stacked up to four courses high. The wall is bi-faced with good facing. The wall is along the southeast edge of a short dirt road leading from the old house site to the coastline. The wall is partially collapsed in places and is in good condition. No further work is recommended at Site TS-2.

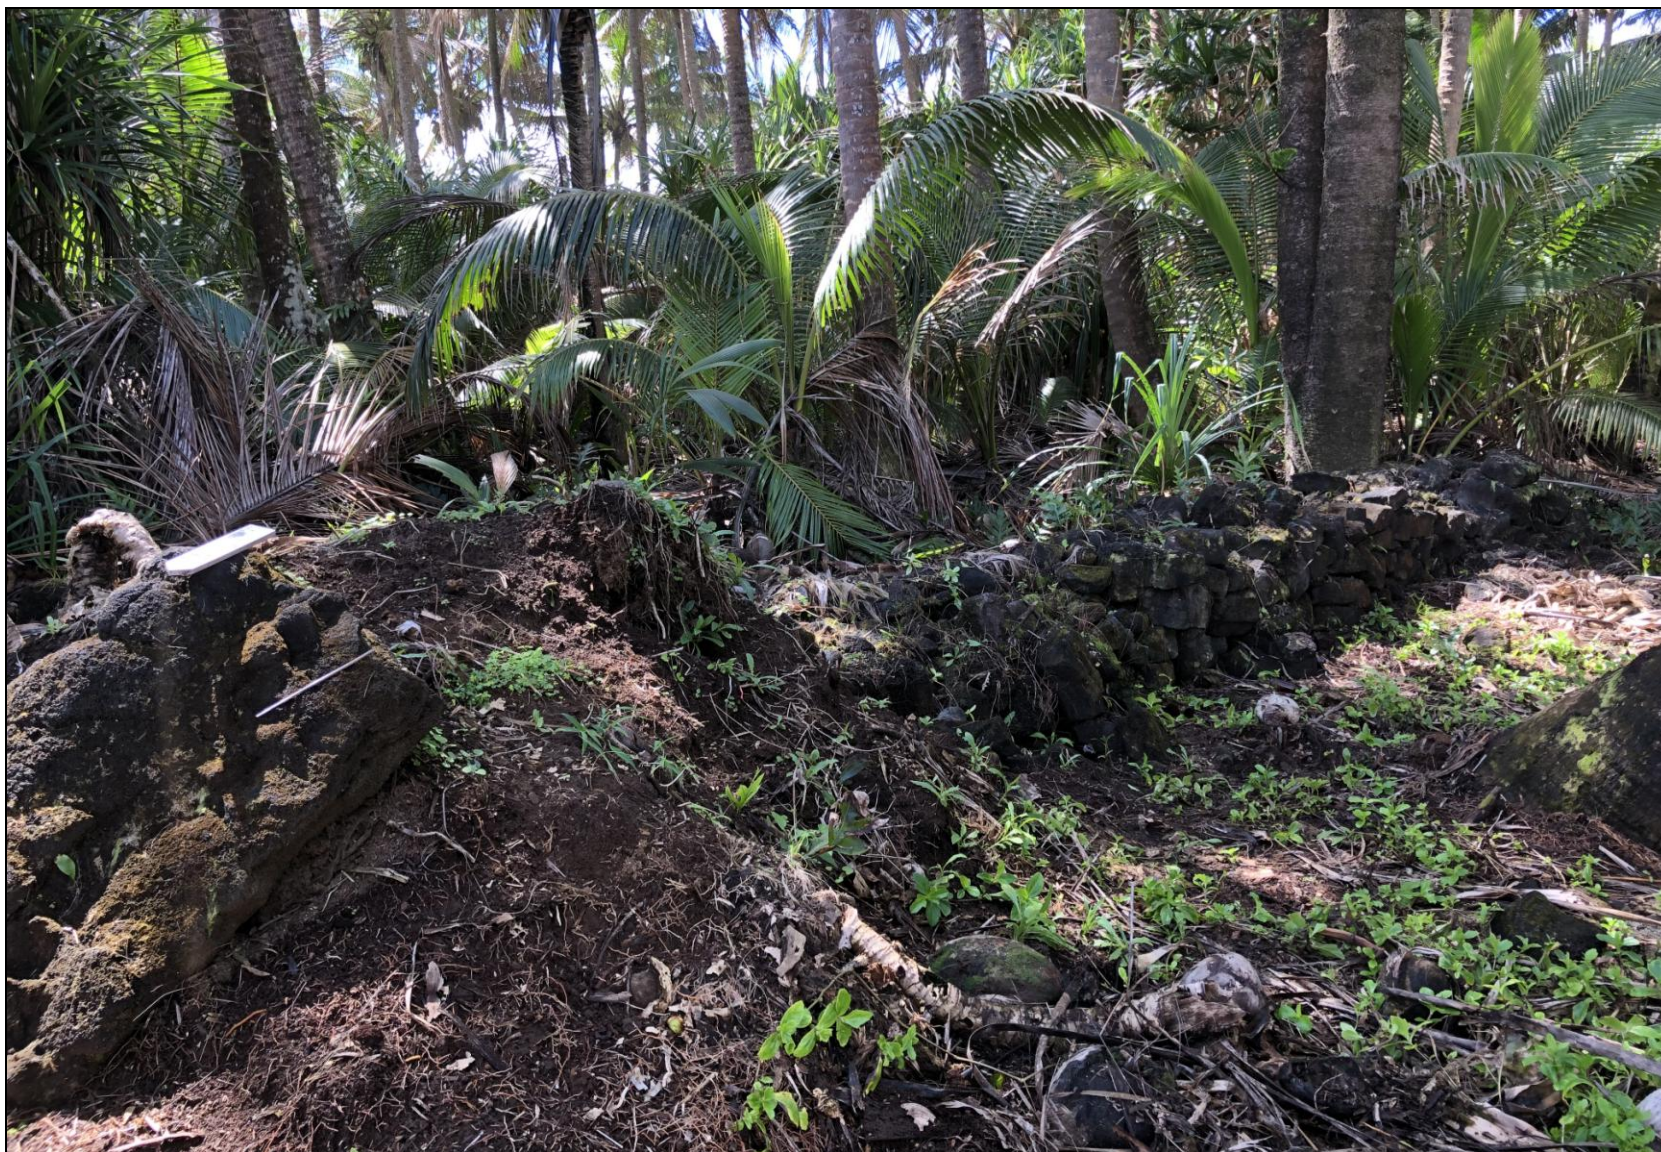
Figure 39: Photograph of Site TS-2 Rock Wall Segment, Looking South.
