National Register of Historic Places Registration Form

Historic name: 2336 Oahu Avenue

Street & number: 2336 Oahu Avenue

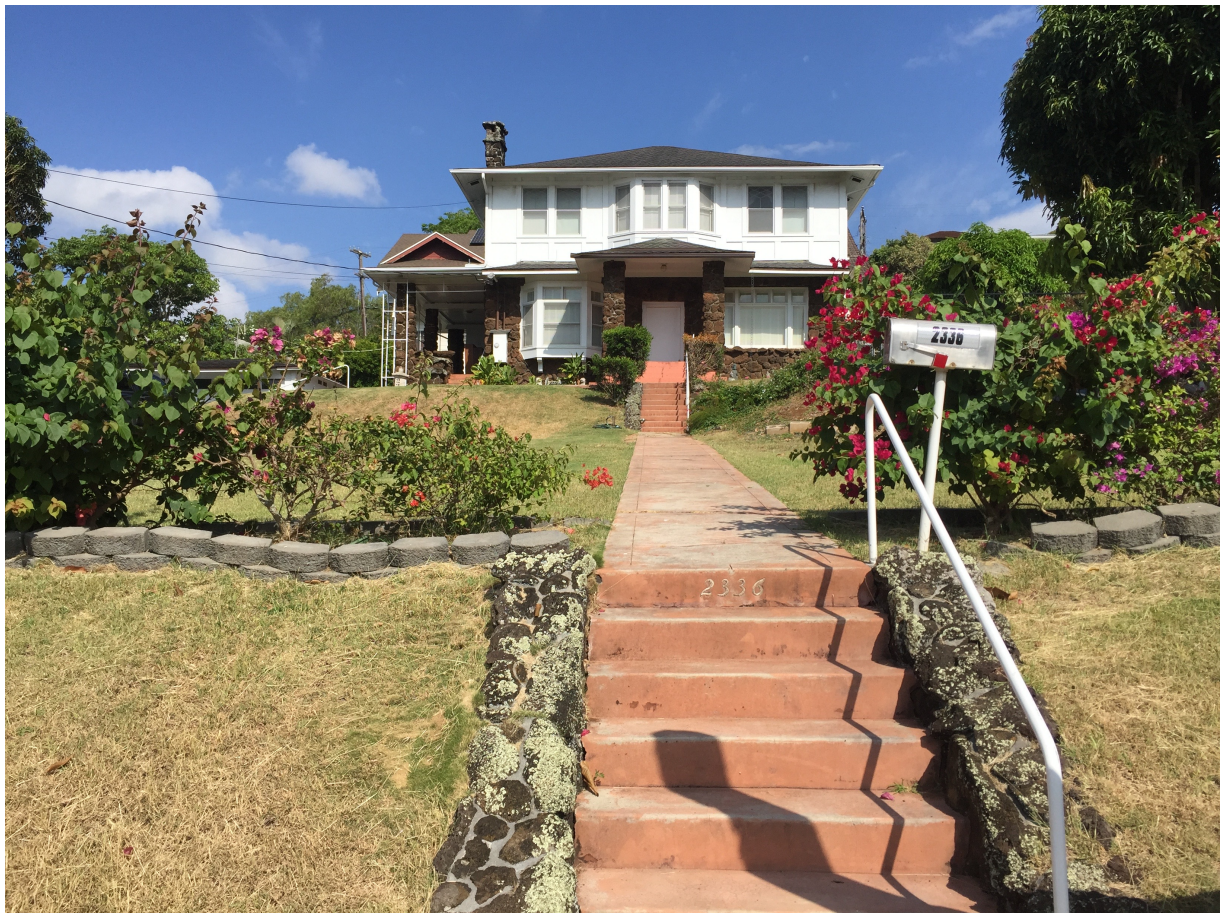
Photo 1 of 15:

Description of Photograph: Main façade from street, camera facing northwest.

The main façade of the home faces southeast towards Oahu Avenue. The exterior of the first floor is stone with a central portico covering the main entry flanked by two sets of windows. The entry door and portico are accessed by a set of five red stained concrete ascending steps. The platform of the portico has an overall measurement of 12' wide by 8'6". The portico has an extended roof and one stone support column on either side of the staircase allowing for a 7'6" opening between the two pillars. To the right of the entry, covered by the extended portico roof, is a broad picture window with sidelight pane with transom window. To the left of the portico, between the front entrance and the side porch, is a 3 pane bay window. The bay window is mounted on a thick sill (with two support brackets) and has three casement windows and three transom windows (center transom is divided with mullion). The second floor of the main façade is symmetrical stucco with linear moldings patterns surrounding the windows. The focal point of the second floor is the central 4-pane bay window located just above the roofline of the front portico. On either side of the second floor bay window are identical sets of two double-hung windows with a single-pane bottom sash and triangular glazed design in the top window.

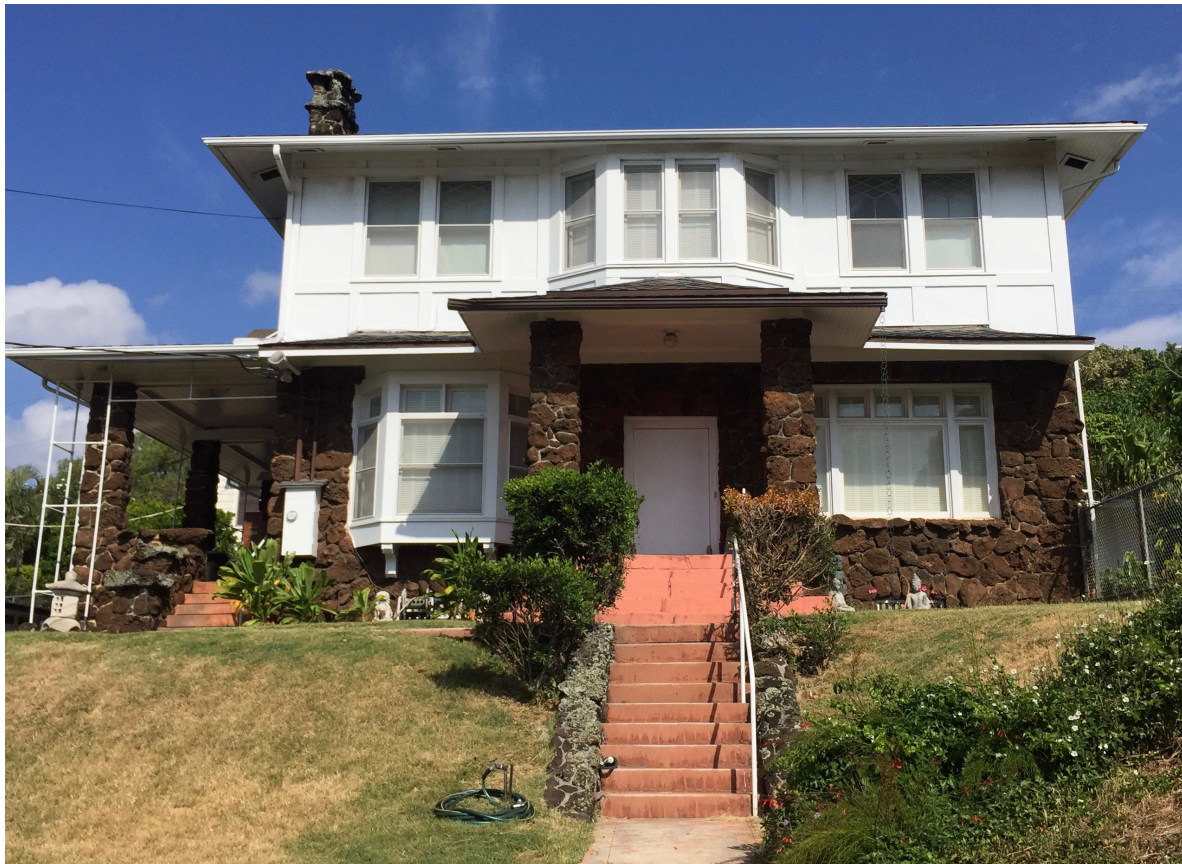
Photo 3 of 15:

Description of Photograph: View of front entrance, camera facing northwest.

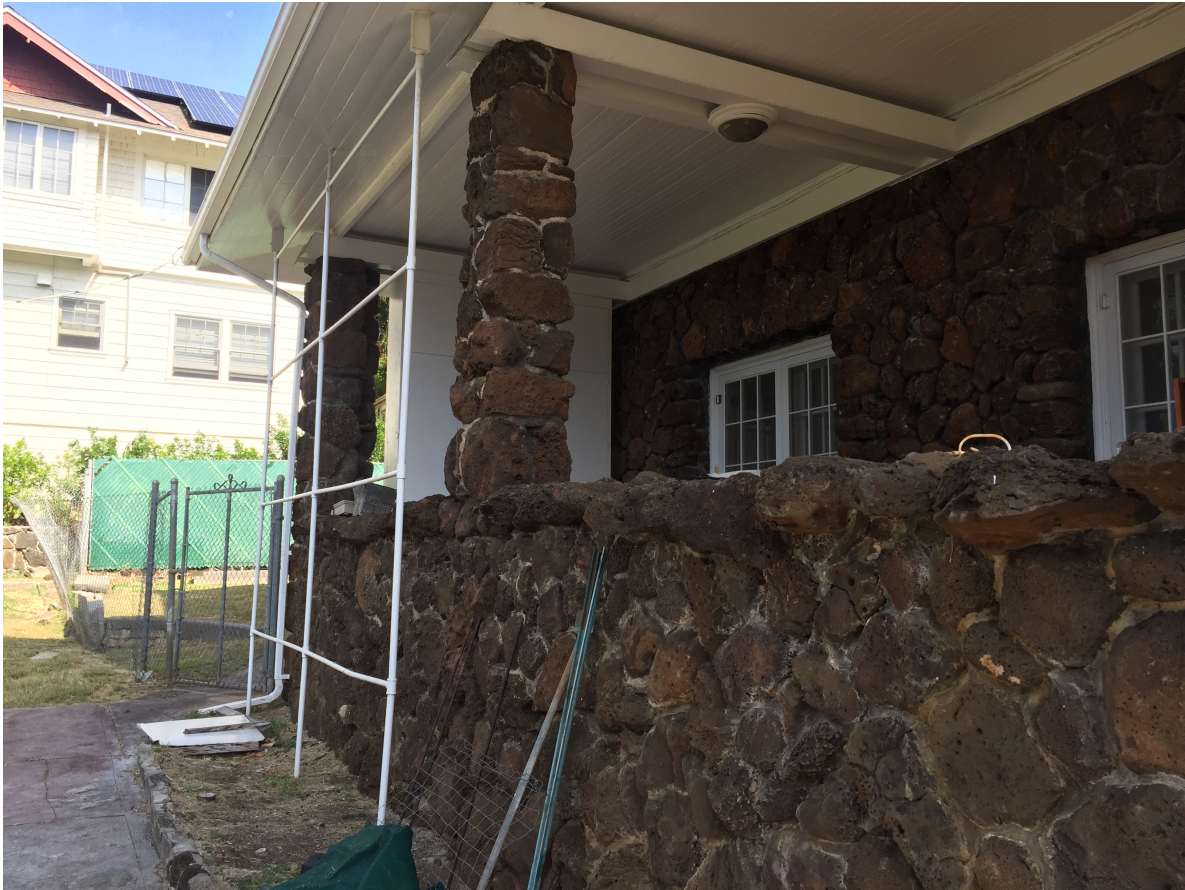
Photo 4 of 15:

Description of Photograph: Side elevation of porch, camera facing northeast.

it is a character design feature of the Hawaiianized Craftsman Style. The porch measures 27 feet across and 9 feet deep with double access doors to the main residence on the side closest to the back of the home. The porch is accessed by a second set of concrete stairs on the front façade and is enclosed by the stone perimeter wall. Three massive rectangular stone pillars are spaced evenly across the porch. The roof extends past the pillars offering a substantial amount of protection from sun and weather. The floor of the porch is stained red concrete coursed to look like tile. Within the porch (on the sidewall of the residence) is a chimney, window, and two sets of doors.

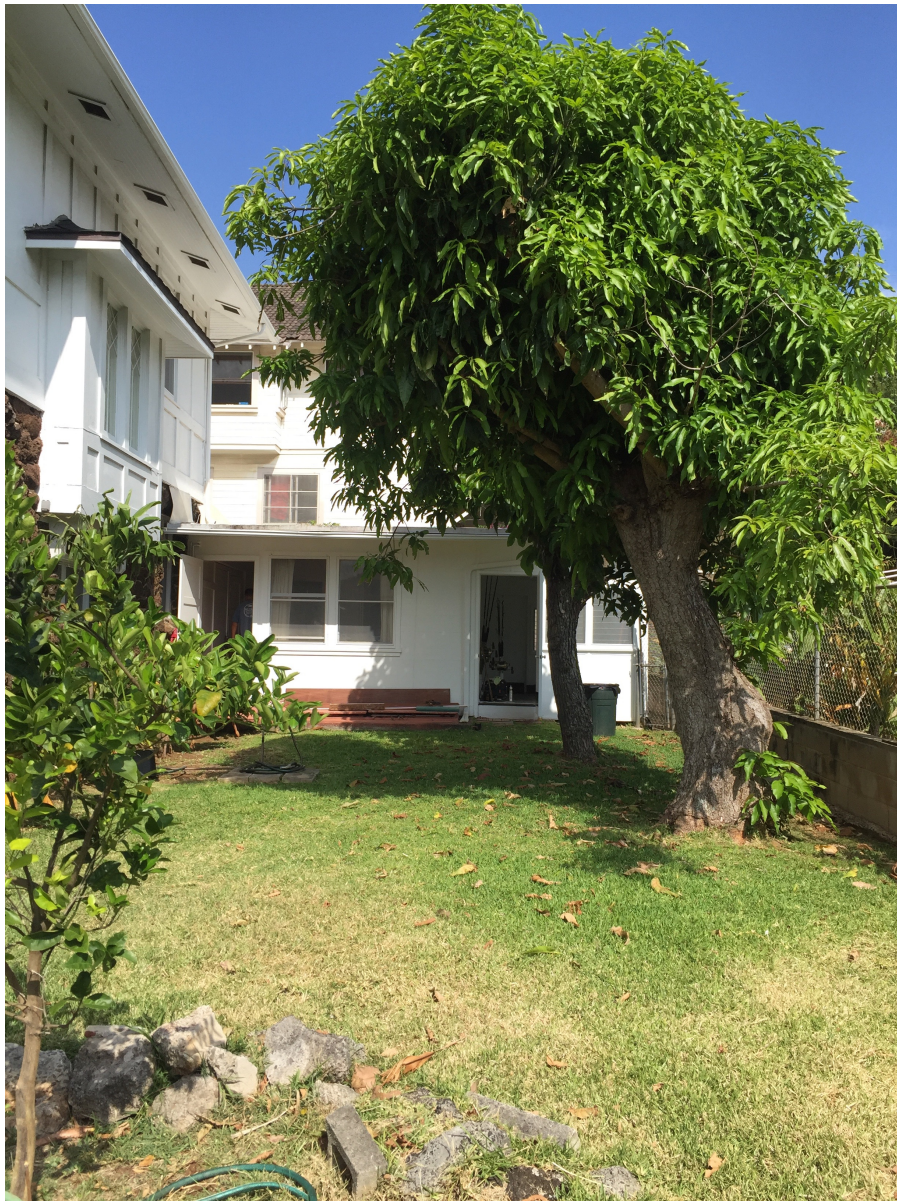
Photo 7 of 15:

Description of Photograph: View of side elevation, camera facing west.

The northeast side elevation has an extruded section with a window in the center. The windows in the center are casement windows with diagonal mullion detailing. The extruding box window has a roof and broad base supported by brackets. The bottom level of this elevation is stone and the top portion of the elevation is white painted wood paneling that maintains the linear themed molding pattern. The single level addition extruding from the side of this elevation has two doors and two windows and faces southeast to the enclosed side yard.

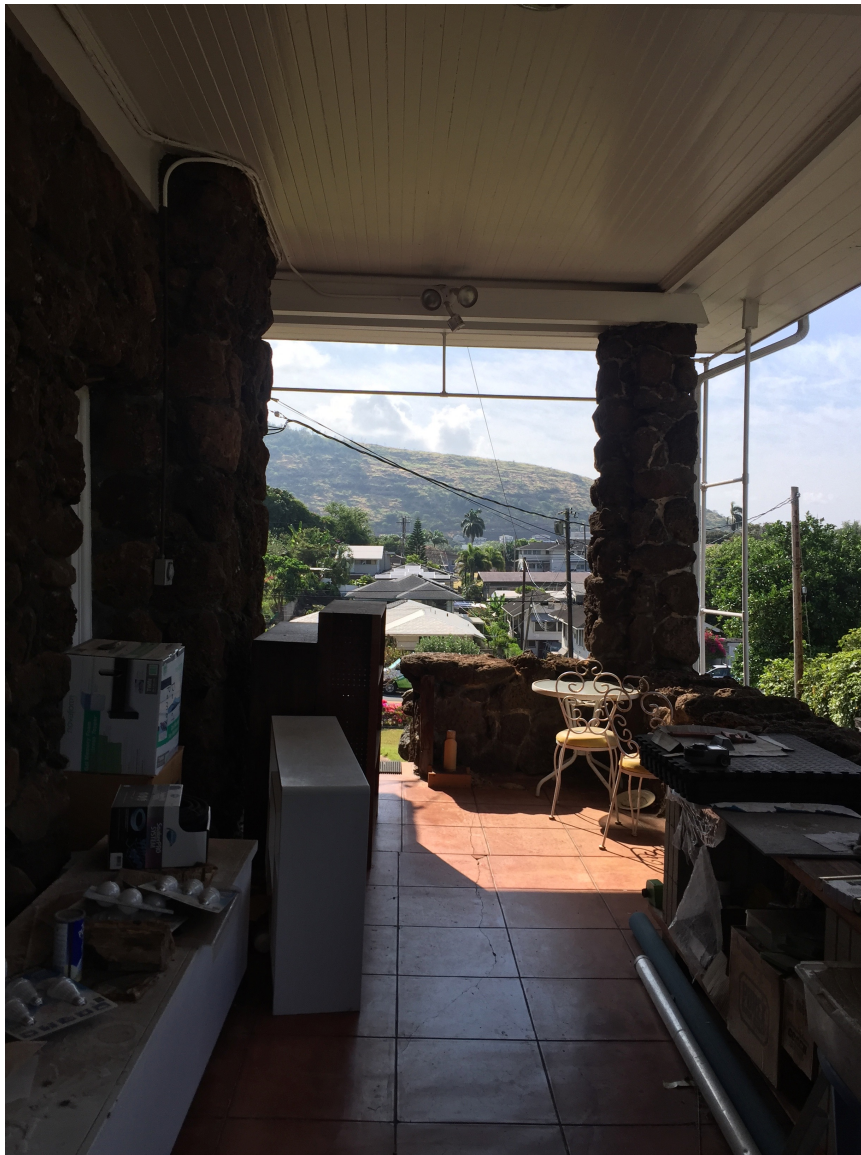
Photo 8 of 15:

Description of Photograph: View of side porch camera facing southeast

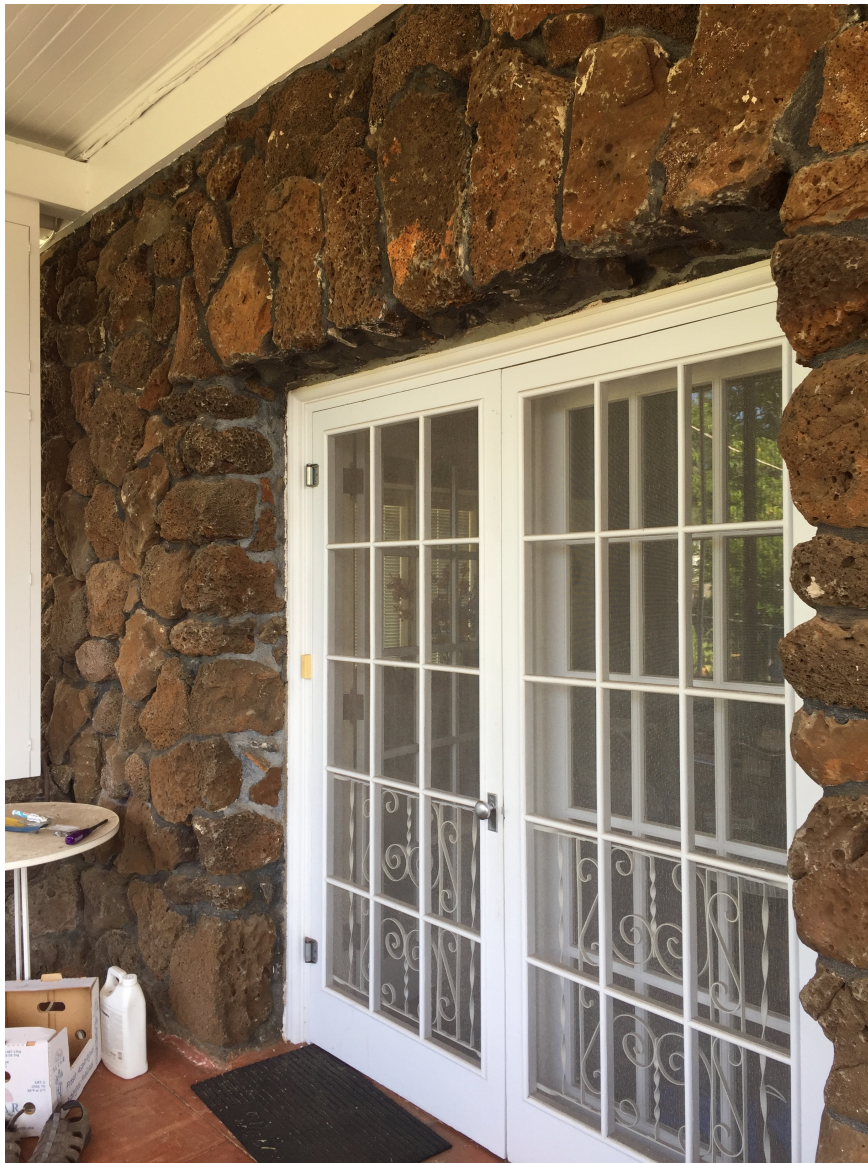
Photo 9 of 15:

Description of Photograph: View of entry door into House from porch

The window is located on the right side of the chimney and is a single light double hung window with transom. The chimney is stone (like the rest of the exterior) and extrudes from the wall about 9 inches. The single door on the opposing side of the chimney is multi-light with access to the living room. The main doors on this elevation are to the very left of the porch and are double out swinging doors with multi-lites and access to the dining room.

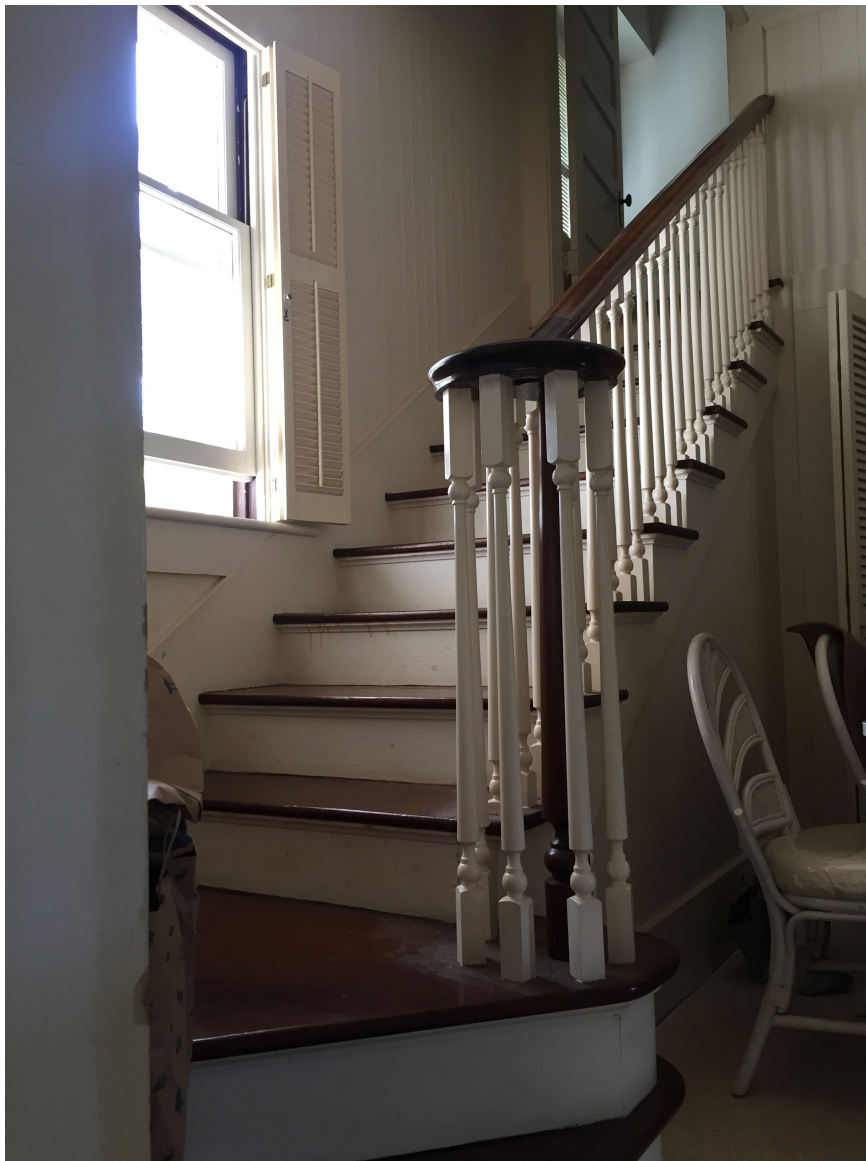
Name of Property: Mirikitani Residence
City or Vicinity: Honolulu
Photographer: Natalie Besl
Date Photographed: April 2017
Description of Photograph: View of Kitchen staircase

The kitchen is located in the back of the main residence, looking onto the backyard. The kitchen was updated in the 1970s. there is an original walk in pantry on the southeast side. A hallway extends out from the backside of the kitchen (towards the backyard) with bathroom and laundry room access on the southwest wall of the hallway. A door at the end of the hallway leads out onto a concrete pad with a basement access door, and side cottage access door. There is a large stairway on the northeast side of the kitchen with a koa wood handrail leading to the second floor.

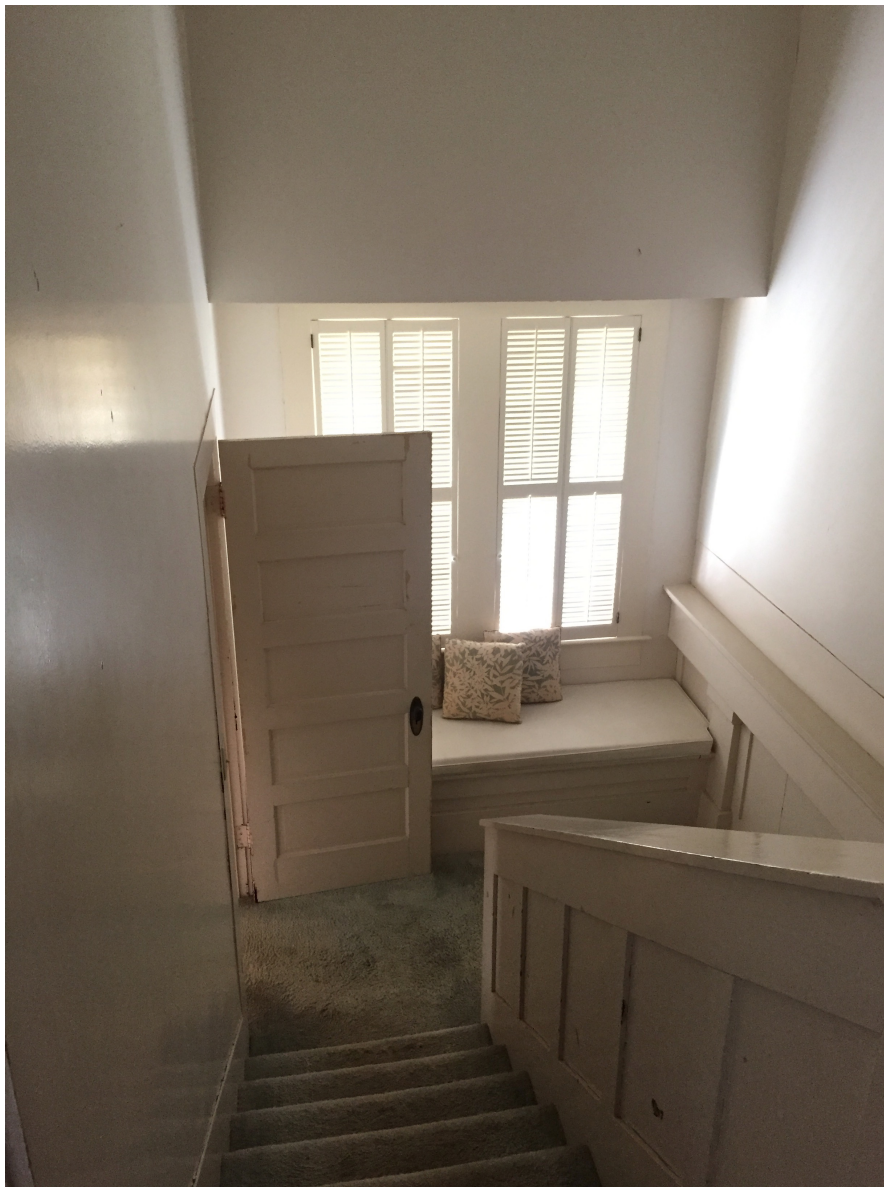
Photo 13 of 15:

Description of Photograph: View of staircase platform from 2nd floor

kitchen or the living room. The platform where the two stairways meet has two double-hung windows centered above a built in window bench.
