United States Department of the Interior
National Park Service**National Register of Historic Places Registration Form**

1. Name of PropertyHistoric name: Chun ResidenceOther names/site number: Lot 1 in Block 37 (TMK: 3-2-021-001)

2. LocationStreet & number: 808 10th AvenueCity or town: Honolulu State: HI County: HonoluluNot For Publication: ☐Vicinity: ☐**3. State/Federal Agency Certification**

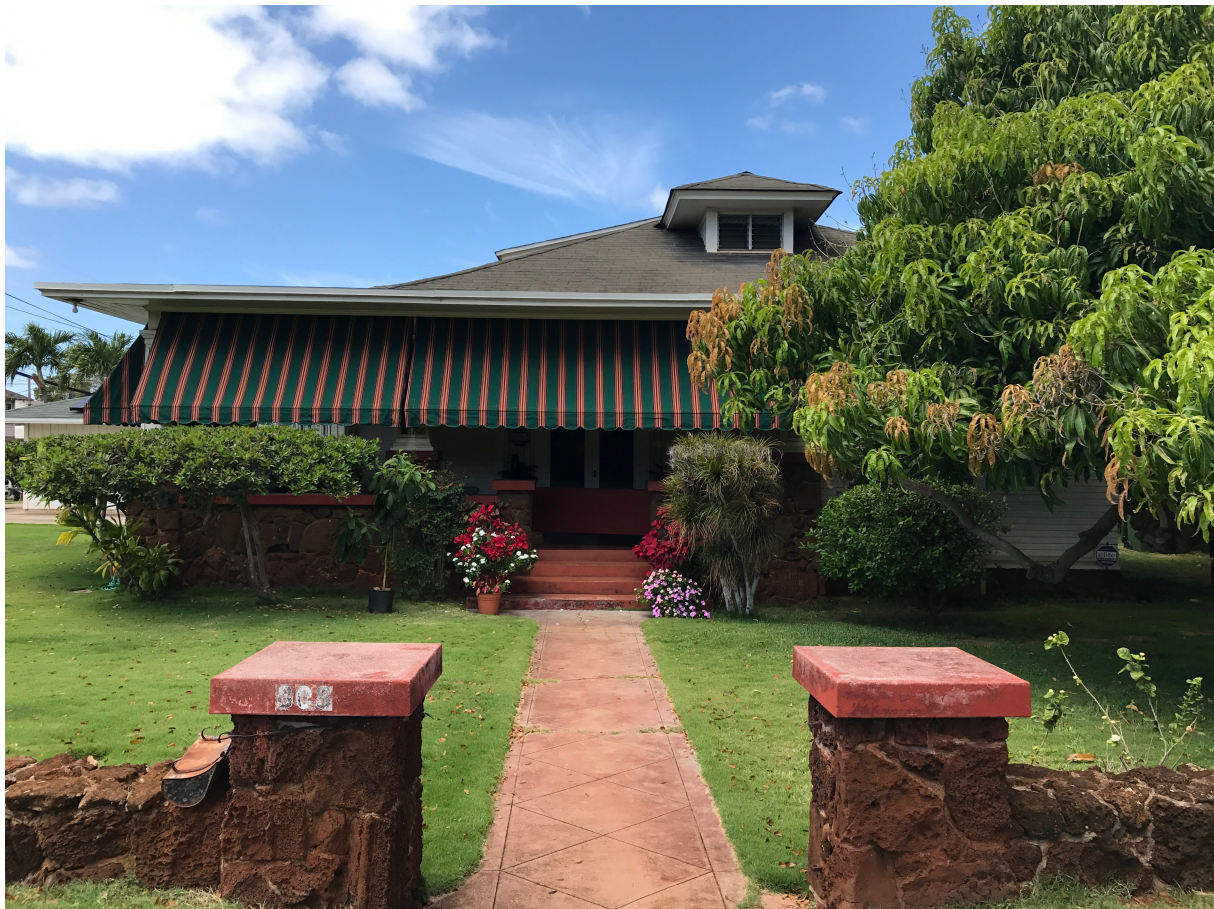
Photo 1 of 15:

Description of Photograph: Main façade, camera facing towards northeast.

The front façade of the house faces east, towards 10th Avenue, and is asymmetrical. The main façade is dominated by the covered front porch with a lava rock perimeter foundation wall and recessed front entryway, shaded by large green and red striped awnings. The right side of the front façade, the master bedroom, is inset from the perimeter walls of the porch with white wood siding elevated slightly on a lava rock foundation with 3 connected double hung windows and one green and red striped awning.

The covered front porch on the southeast corner of the home is the highlight of the home. The porch is accessed by a set of four stairs ascending from the front walkway off of 10th Avenue. The porch perimeter walls are made from natural rock found in the Kaimuki area, with white mortar between the rocks. The rock wall is capped with a two-inch high red-colored concrete cap. Five support piers with inward sloping sides and are located at even spacing along the porch perimeter. The ceiling of the covered porch is painted wood panels and the floor is red-stained concrete with grooves. The south side of the porch has been enclosed with bi-folding windows and transoms above, which sit directly on the concrete cap of the perimeter wall.

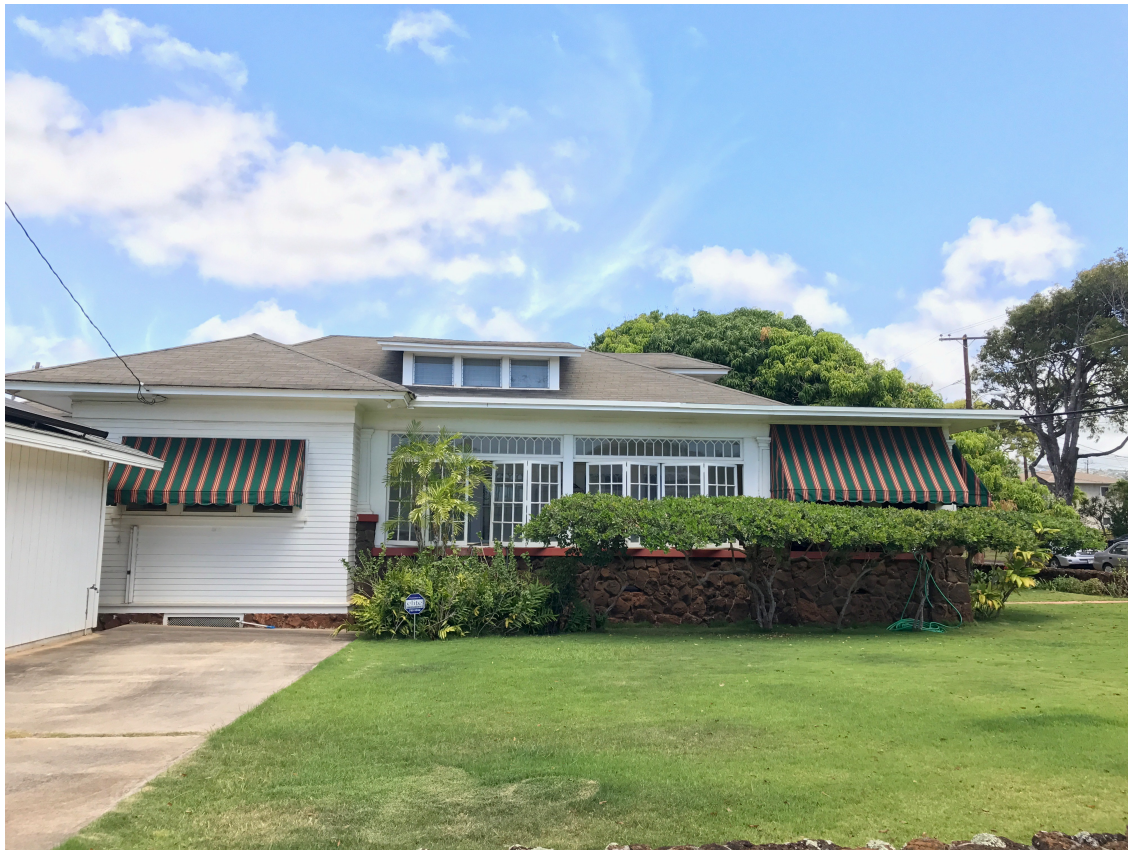
Photo 4 of 15:

Description of Photograph: Side elevation, camera facing northeast.

The left side, facing Maunaloa Avenue is partially obstructed by the detached garage. The partially obstructed portion is white wood paneled siding with inset section that has a backdoor with three concrete steps leading from the kitchen to the concrete back patio.

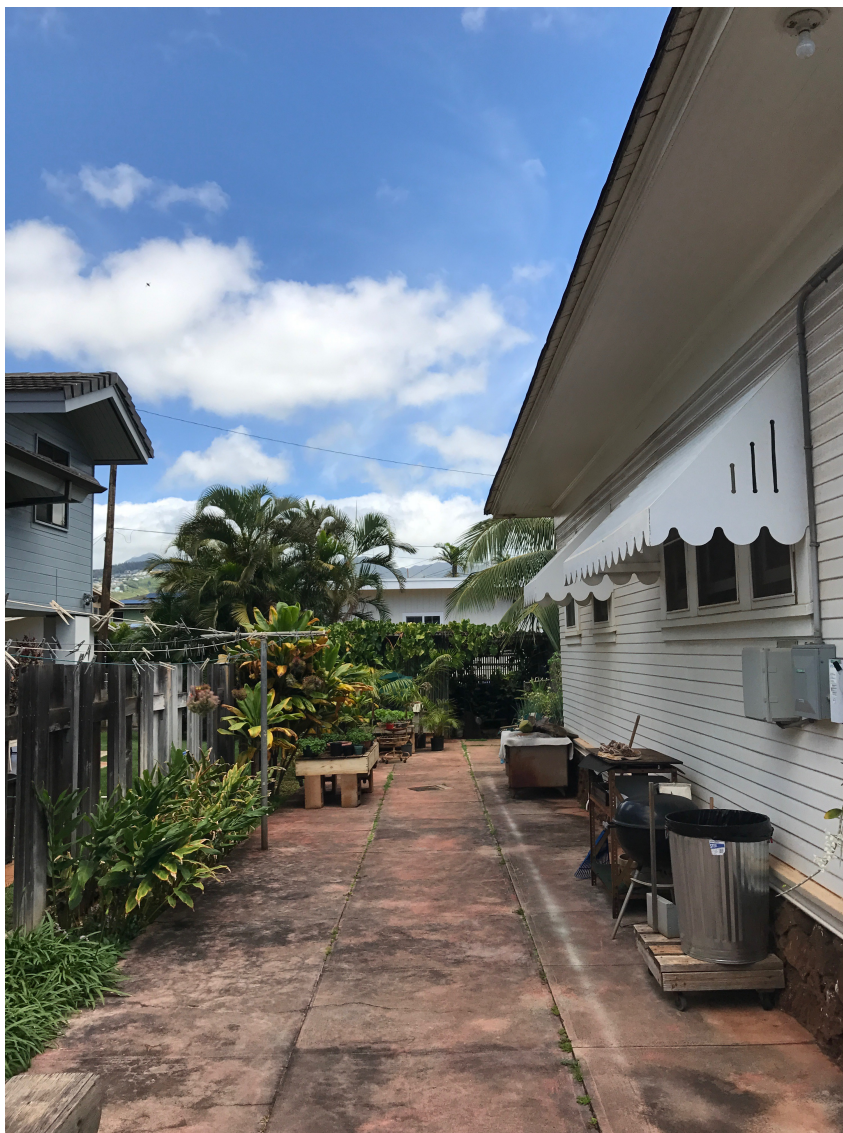
Photo 6 of 15:

Description of Photograph: View of Rear elevation, camera facing northeast.

The rear façade, where the kitchen is located, contains three windows, one set of three – two individual, spaced across the rear elevation and encased with wooden box awnings. The rear of the property is shallow and has a concrete patio in place of a backyard. There is a wooden fence on the back property line separating this lot from the neighboring lot. Between the concrete patio and wooden fence is a small space where bushes and greenery has been planted to give the area more privacy.

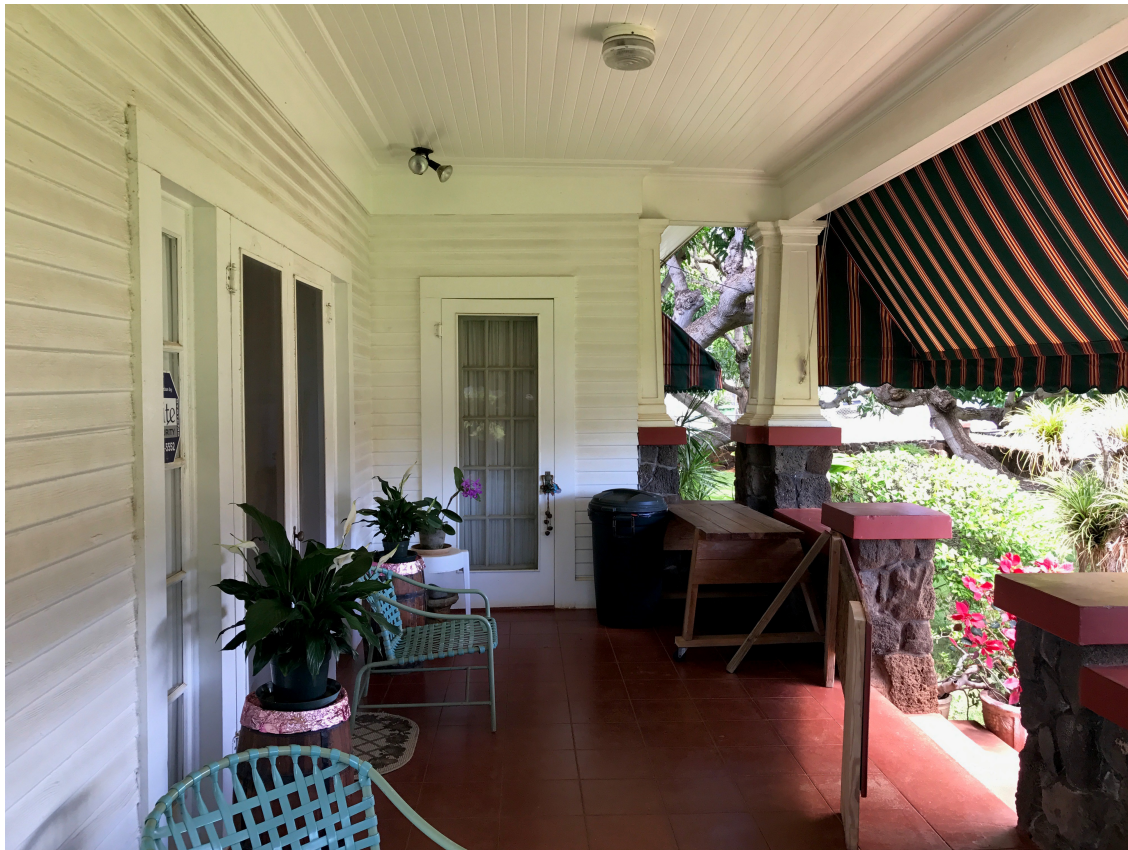
Photo 10 of 15:

Description of Photograph: View of porch entry doors, camera facing northeast.

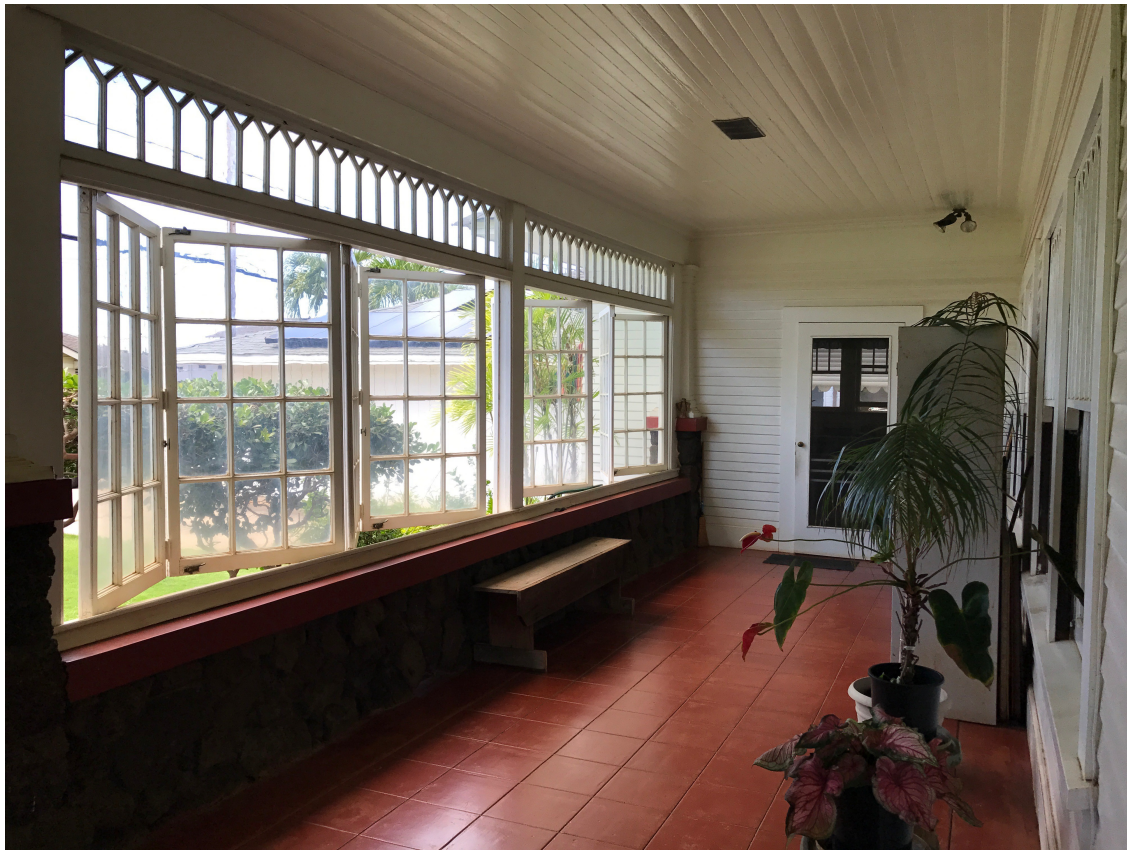
Photo 11 of 15:

Description of Photograph: View of main entry door, camera facing northwest.

The main entry door is a double door located accessed off of Maunaloa Avenue. The main entrance leads into a living room. There are two other entries from the porch. One is off of the end of the porch that leads to the dining room, and the other is at the other end of the porch leading into the master bedroom. The service entry is located at the rear of the homes off of the garage.

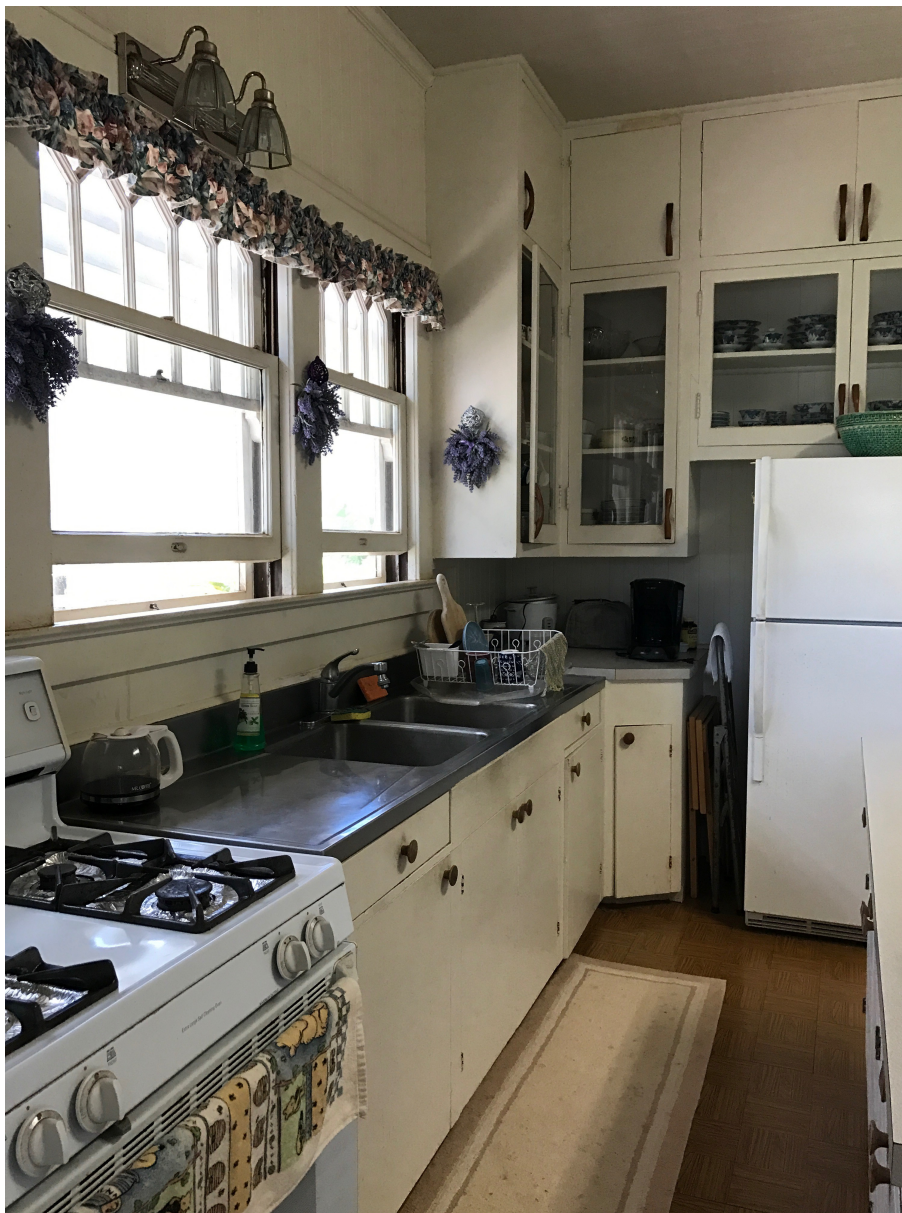
Photo 13 of 15:

Description of Photograph: View of Kitchen

The kitchen is one of the largest rooms in the house with three doorways, and the stairs leading to the attic room. There is one large set of three double hung windows centered on the back wall of the kitchen, above the sink, overlooking the back yard. The sink is part of the continuous countertop that runs from the sink, and around to the side wall of the kitchen complete with original built in cabinets and cupboards. There is an island in the center of the kitchen that offers more cabinet and drawer space. The floors are faux wood vinyl tile. The front of the kitchen, east, is occupied by a small dining space and unique built in walk in pantry.

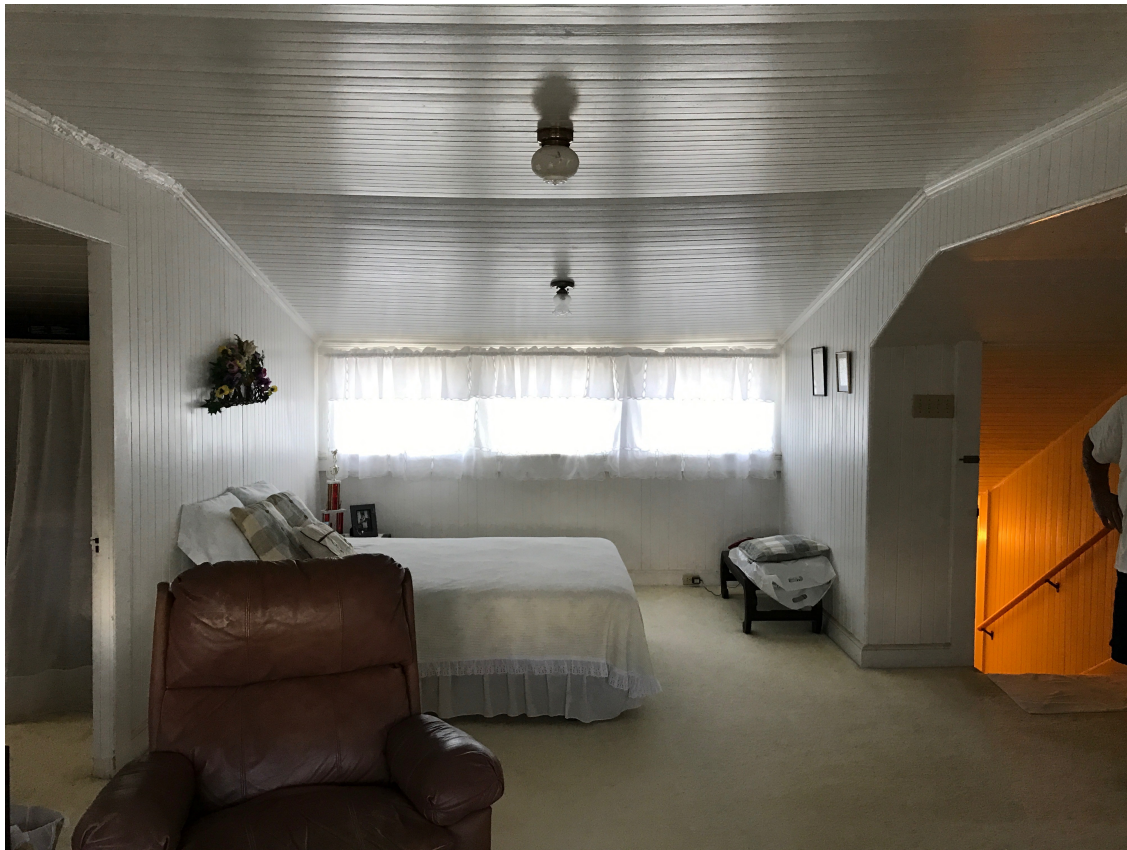
Photo 15 of 15:

Description of Photograph: View of Attic Space, camera facing southwest.

The staircase to the second level is located in the kitchen. The painted wood stairs are semi enclosed between the wall of the entry room and half ascending wall in the kitchen. The second floor has a low wood paneled ceiling and wood paneled walls. The ceiling follows the form of the roof but is flat in the middle at its highest portion. There are four dormer windows, one on each elevation. There is a half bathroom on this floor.

The second floor of the house has windows on the dormers that were originally double hung similar to the rest of the house, but have been replaced with jalousie windows that help with circulation of air especially during the warmer months when the second floor increases greatly in temperature.
