National Register of Historic Places Registration Form

Historic name: Yim Quon Building

Street & number: 75 North King Street

City or town: Honolulu State: HI County: Honolulu

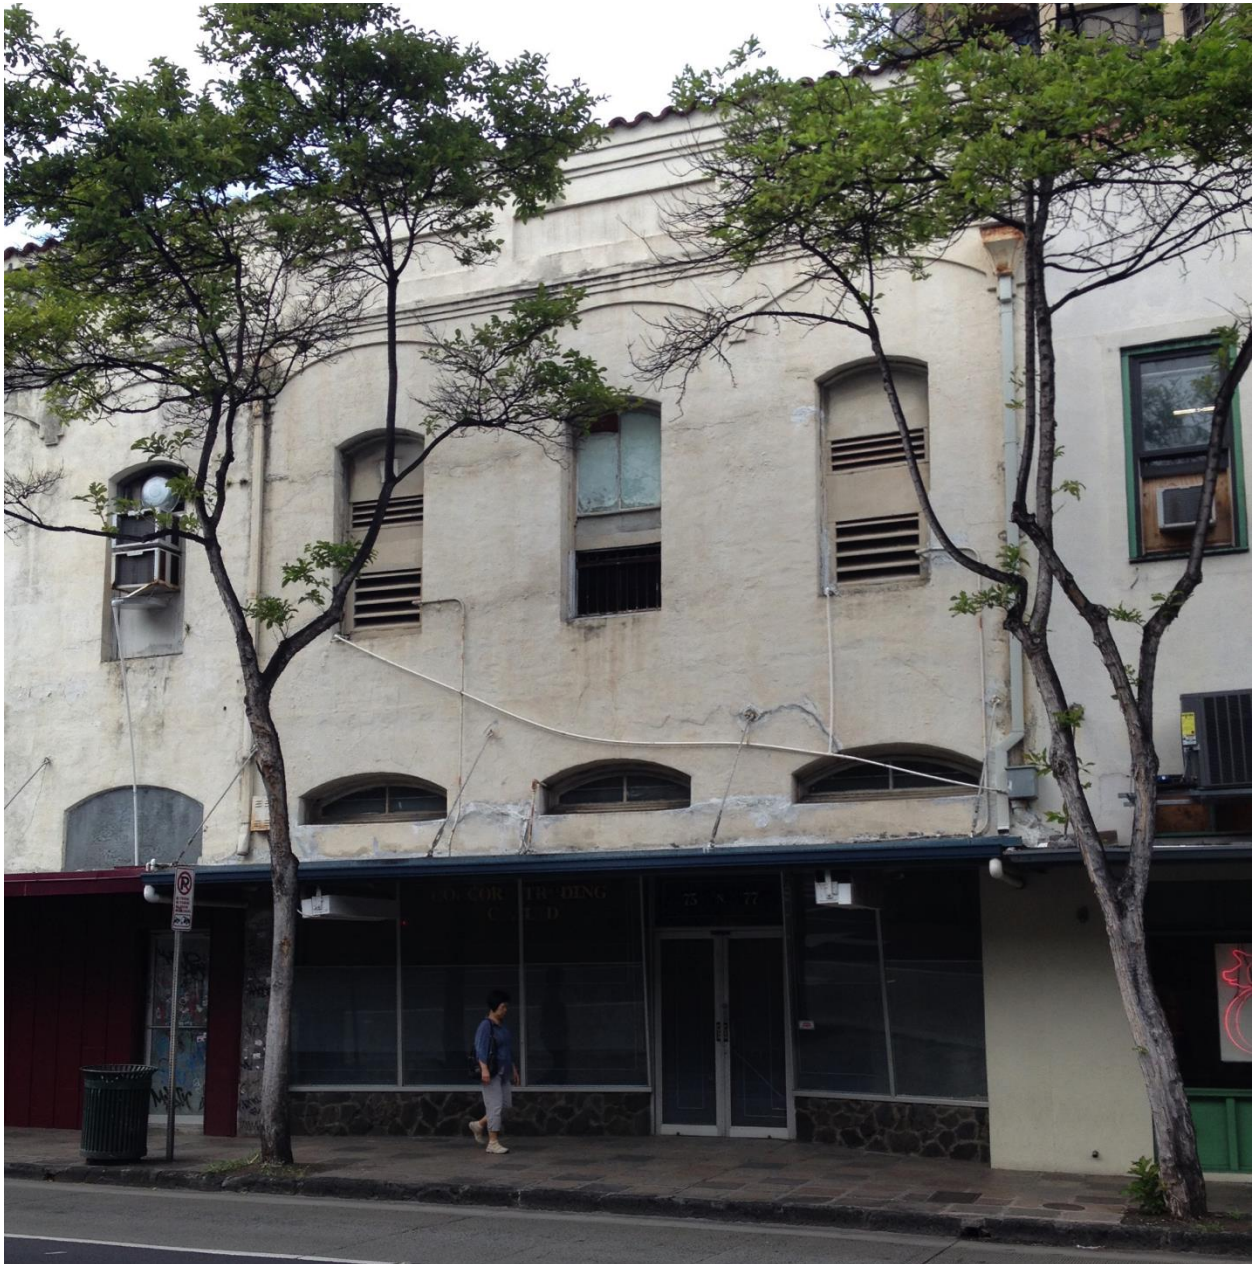
Photo 002 (HI_Honolulu_YimQuonBld_002). Front (Northwest) façade before rehabilitation, camera facing Southwest.

In 1938, the adjacent building at 83 N. King Street was renovated in a Chinese Vernacular style. It is likely that semicircular clay roofing tiles were added atop the cornices of both 83 N. King Street and 75 N. King Street at the time of this alteration project (Photo 2).

As a consequence of alterations to the building occurring around 1955, the original storefront was replaced with a six-bay inclined Modern anodized aluminum and lava rock storefront with a single first floor entry (Photo 2). At the same time, on the ground floor of the front façade, the three original segmental arched wood transoms were partially blocked by the installation of a concrete beam that carried the upper story when the modern storefront was added. A modern sheet metal canopy was also anchored to the beam, secured with metal tie-rods to the upper façade, to provide shade for the storefront below.

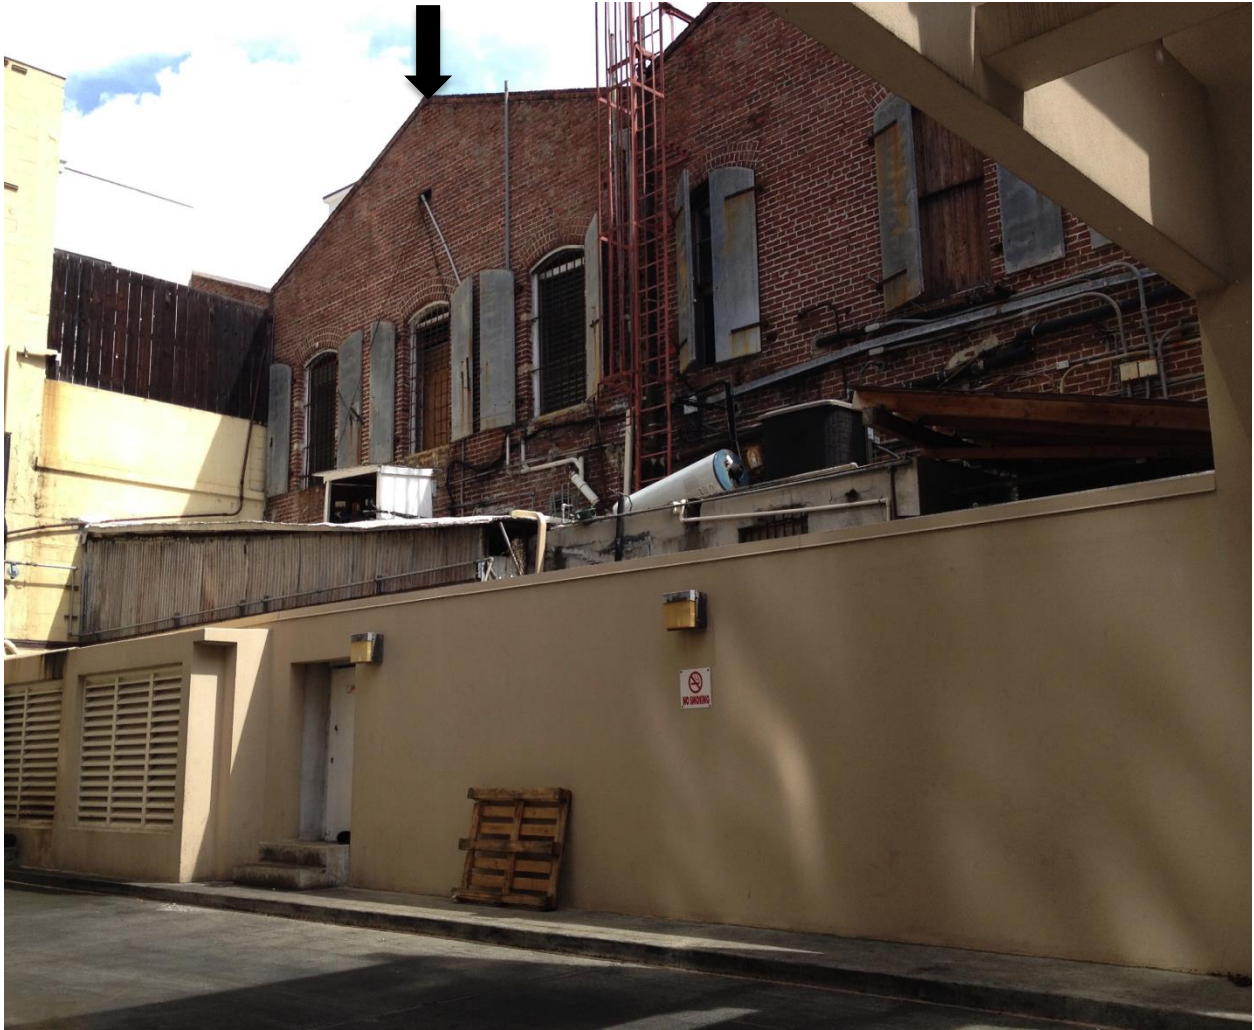
Photo 003 (HI_Honolulu_YimQuonBld_003). Rear (Southwest) façade before rehabilitation, camera facing North (2015). Yim Quon Building indicated by arrow.

The southwest, or "makai," rear end wall is un-plastered brick also laid in American bond (Photos 3-4). A gabled parapet extends slightly above the roofline. The brick gable end is finished with a double-header course that forms a rudimentary cornice. Originally, the first floor of the rear façade included two windows and an entry with segmental arched transoms. The second floor, intact today, includes three segmental-arched windows, similar to the front façade, but augmented by heavy metal industrial shutters.

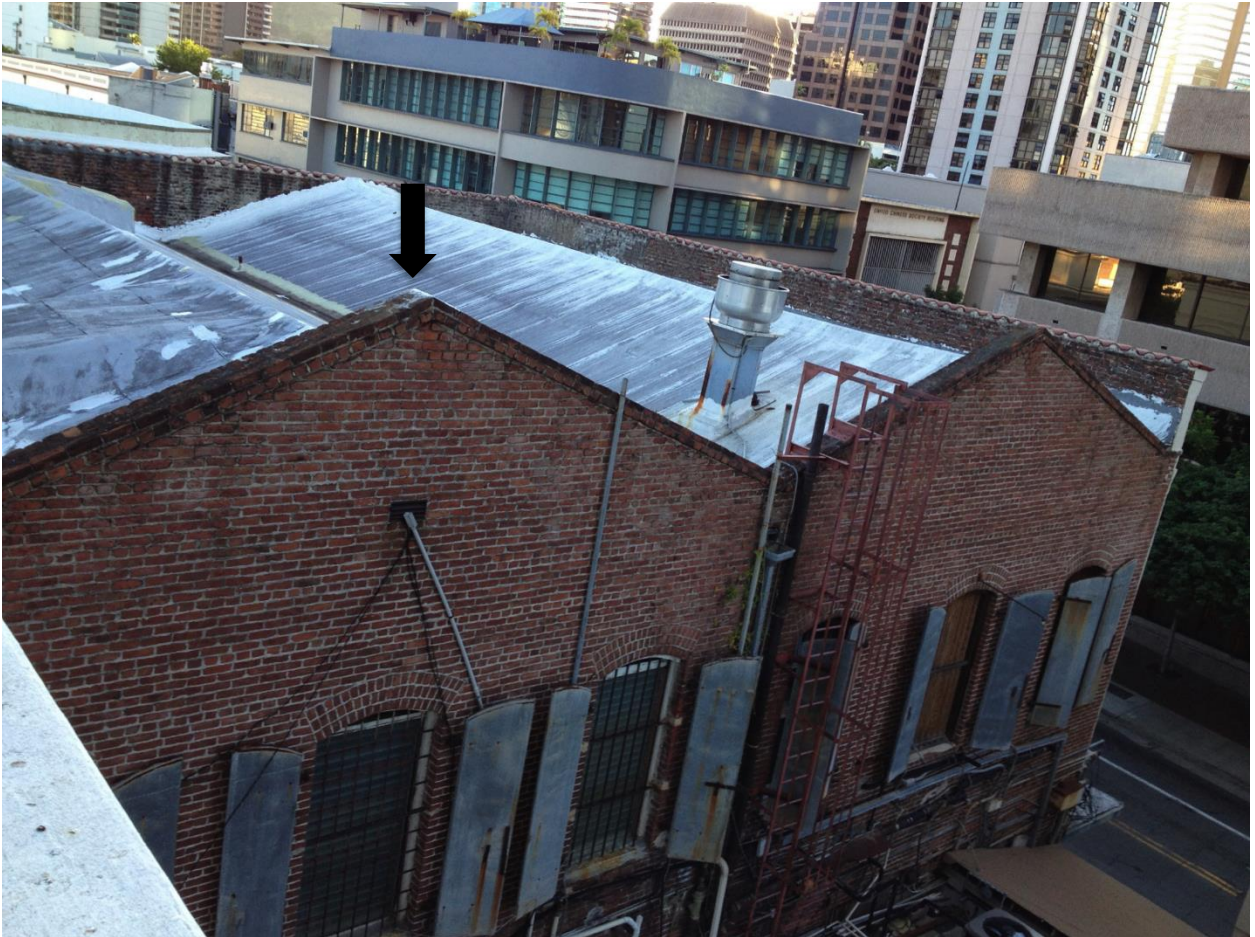
Photo 004 (HI_Honolulu_YimQuonBld_004). Rear (Southwest) façade before rehabilitation, aerial oblique, camera facing North (2015). Yim Quon Building indicated by arrow.

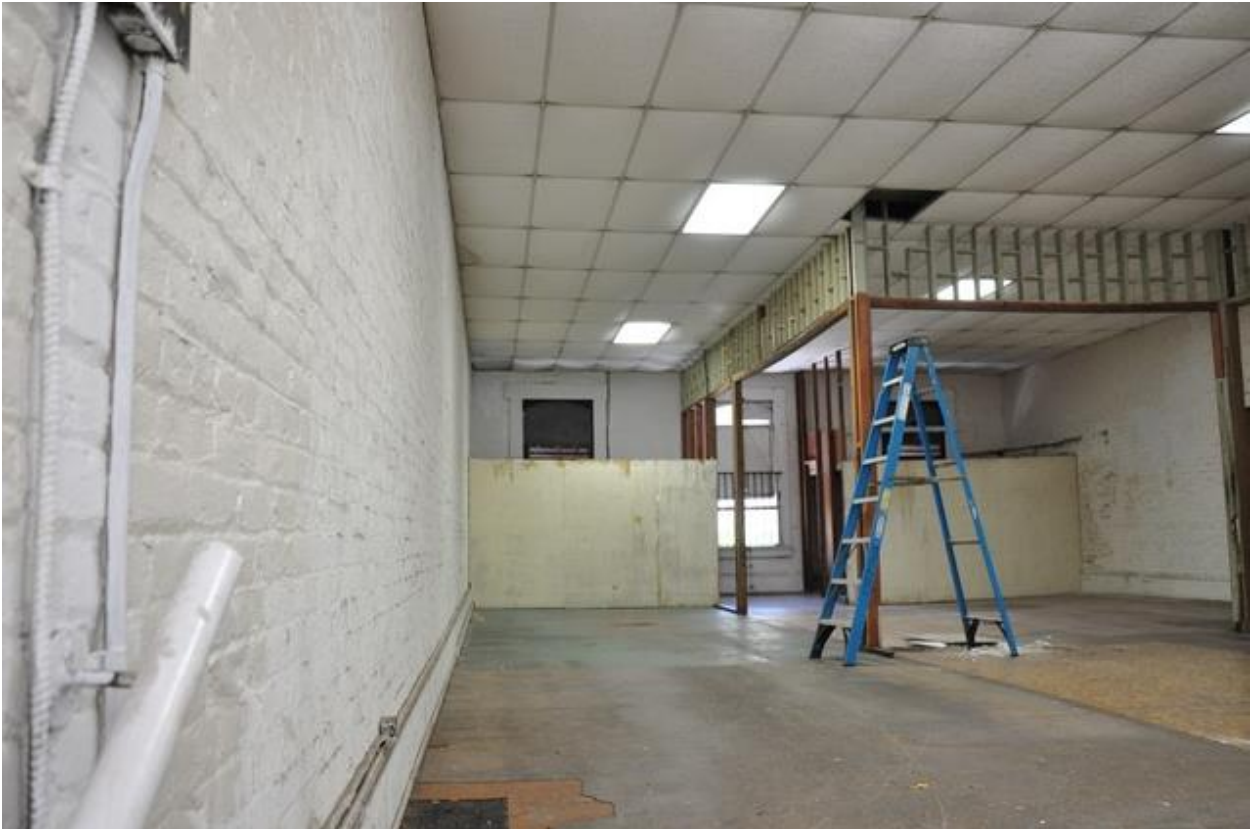
Photo 007 (HI_Honolulu_YimQuonBld_007). Second Floor interior before rehabilitation, camera facing Northeast (2015).

At some point, the original stair leading from the storefront to the second floor was removed and replaced with a small stair at the back of the building (Figures 2 and 3). On the second floor, before rehabilitation there was a wood-framed demising wall that extended from the interior of the front facade to the southwest and terminated into the interior brick face of the rear facade. The wall was of indeterminate though modern date, and featured a decorative wood lattice that had been rendered in a Vernacular Chinese design (Photos 7 and 8).

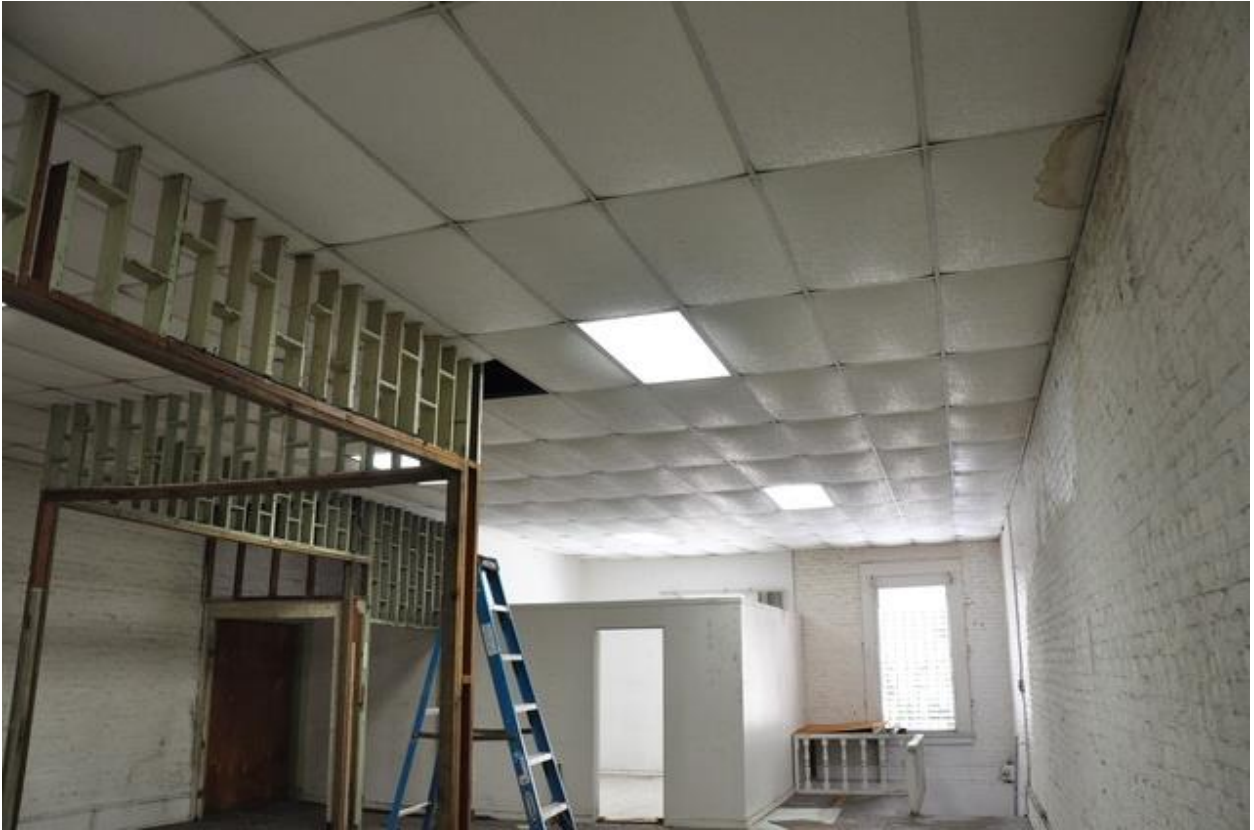
Photo 008 (HI_Honolulu_YimQuonBld_008). Second Floor interior before rehabilitation, camera facing Southwest.

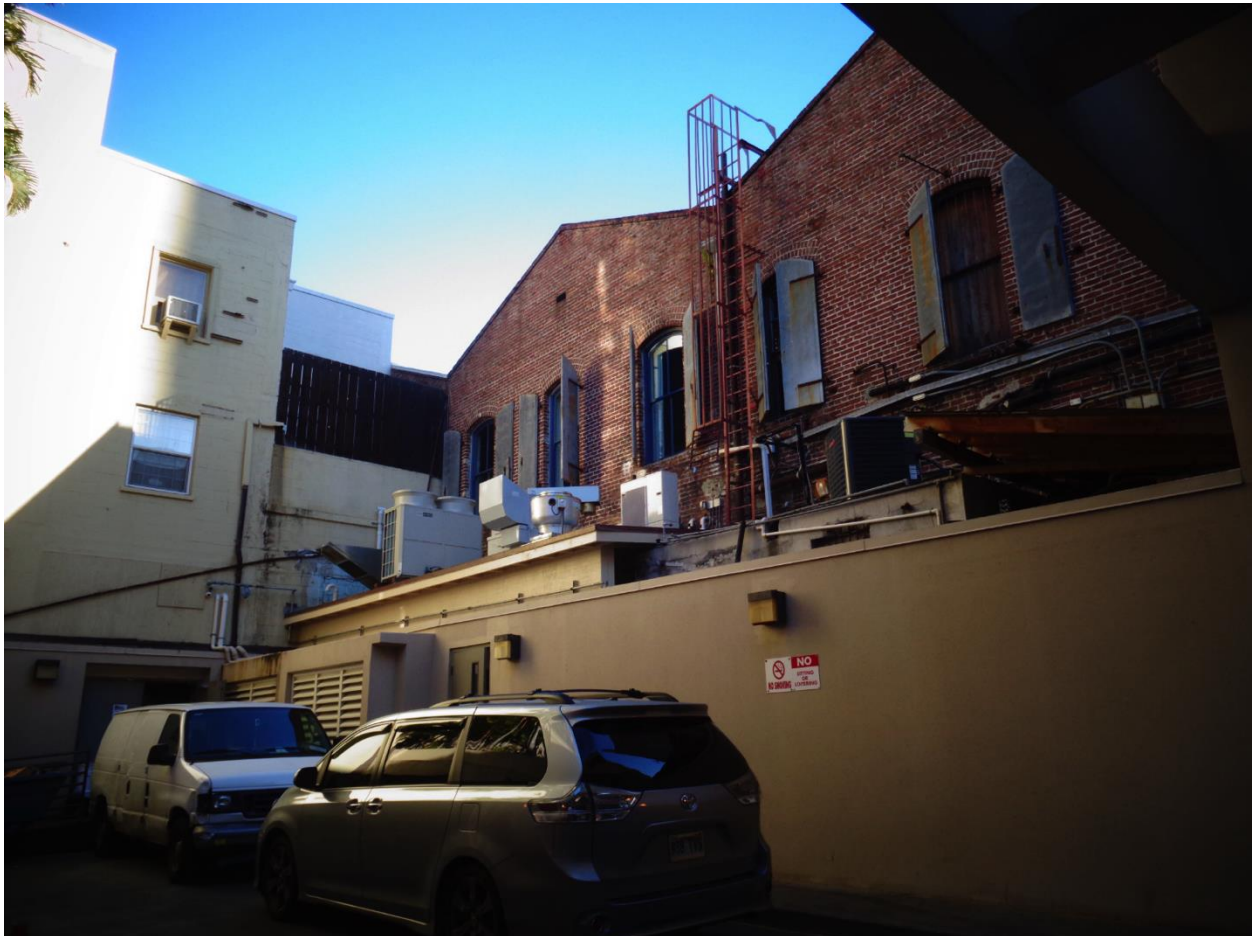
Photo 010 (HI_Honolulu_YimQuonBld_010). Rear (Southwest) façade after rehabilitation, camera facing North (2017).

As shown by the Sanborn Fire Insurance Map from 1955 (Figure 6), this phase of alteration also entailed removing the older series of one-story rear additions and replacing them with a larger, consolidated rear addition. Like the additions before it, the ca. 1955 addition encloses the rear façade of the building's first floor, concealing the two original windows and entry which featured segmental arched transoms. The rear addition is finished with exterior plaster, and provides an enclosed corridor with additional storage space. Access is provided through a first floor entrance that is located in the middle of this ca. 1955 single-story addition. This ca. 1955 rear addition remains generally intact today (Photo 10).

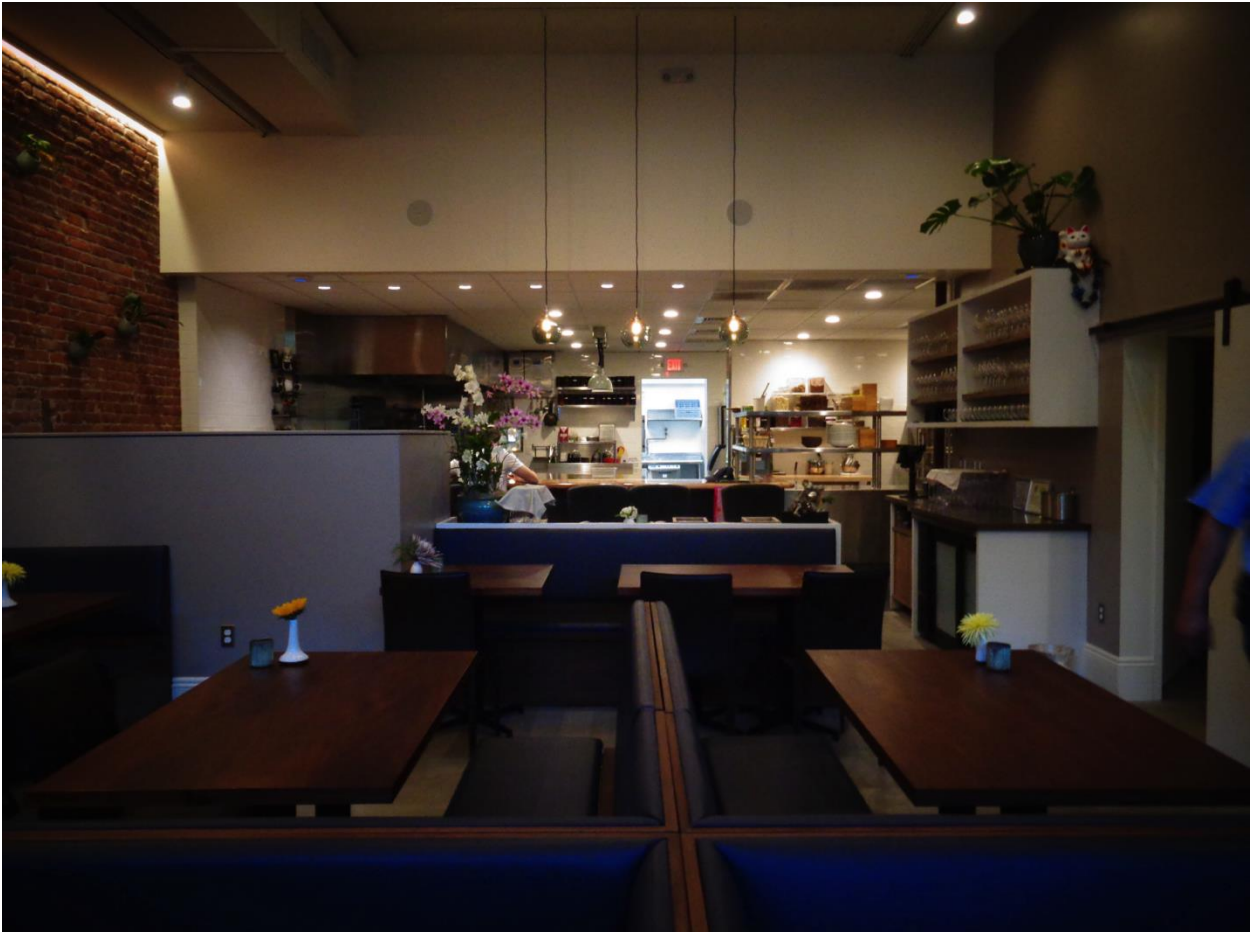
Photo 012 (HI_Honolulu_YimQuonBld_012). First Floor interior after rehabilitation, camera facing Southwest (2017).

After rehabilitation, the original stair connecting the storefront with the second floor was restored (Figures 4 and 5). The mezzanine was removed and access to the second floor was provided by a new stair. The wood-framed demising wall on the second floor also was removed, and the second floor was subdivided into two residential units (Photos 12-14).

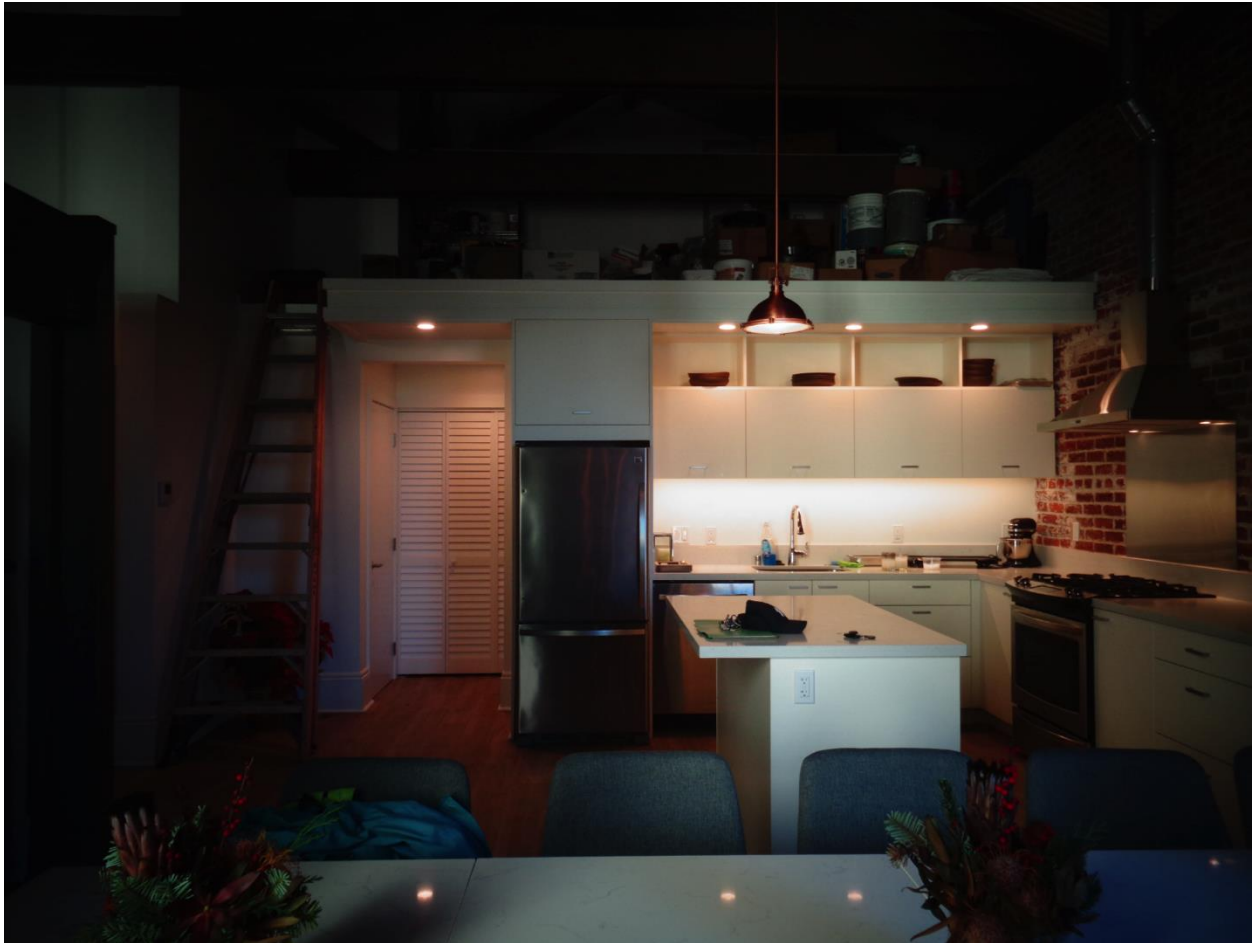
Photo 013 (HI_Honolulu_YimQuonBld_013). Second Floor interior after rehabilitation, camera facing Northeast (2017).

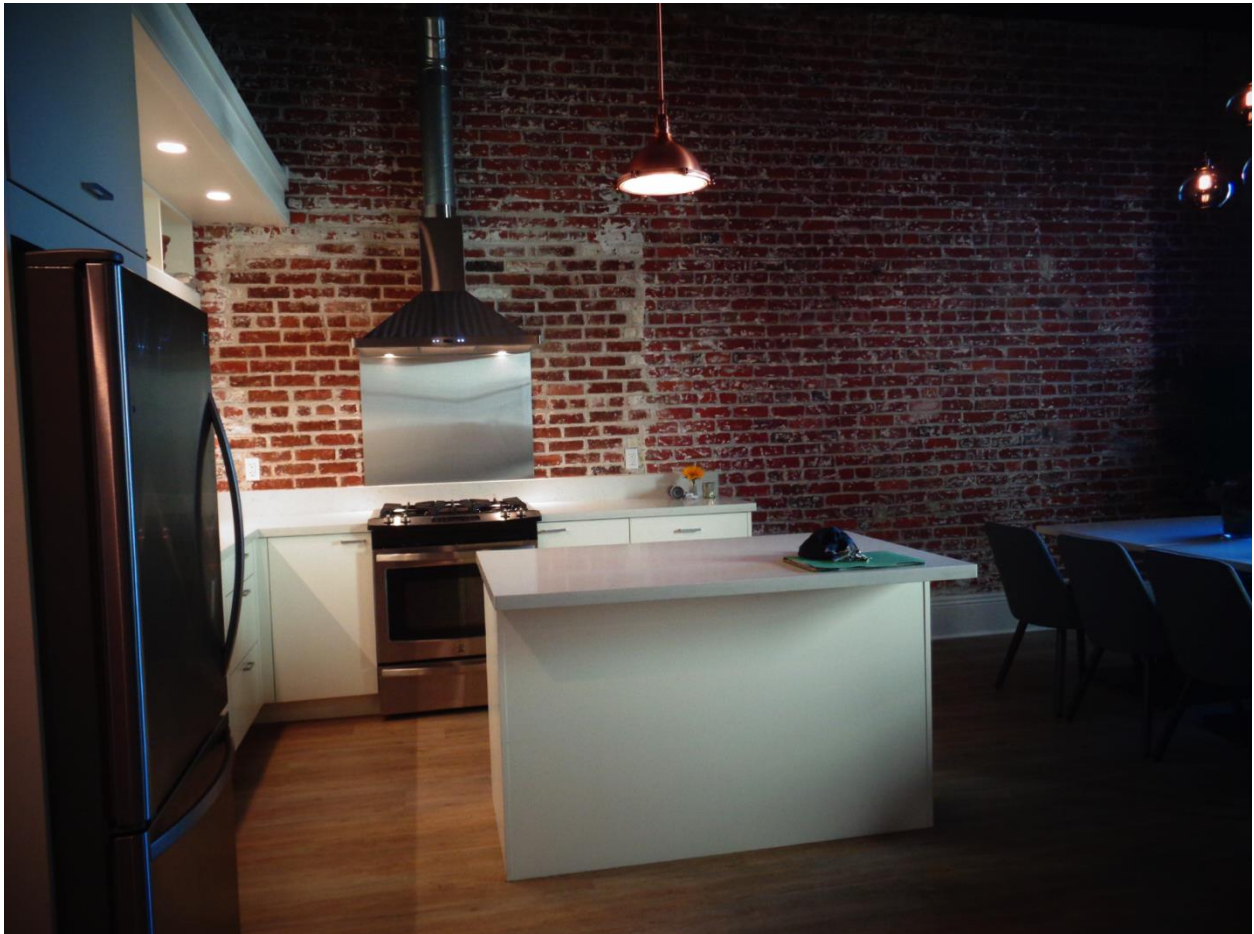
Photo 014 (HI_Honolulu_YimQuonBld_014). Second Floor interior after rehabilitation, camera facing Southwest (2017).
