National Register of Historic Places Registration Form

1. Name of Property
Historic name: Sakuichi and Chieko Matsumoto Residence
Other names/site number:
Name of related multiple property listing:
N/A
(Enter "N/A" if property is not part of a multiple property listing
2. Location
Street & number: 2257 Kuai Road
City or town: <u>Poipu</u> State: <u>Hawaii</u> County: <u>Kauai</u>

Sakuichi and Chieko Matsumoto Residence Name of Property Kauai Hawaii County and State

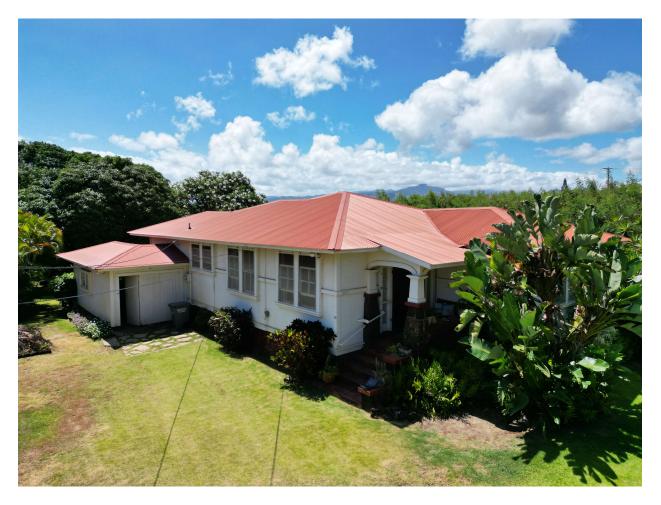
1 of 13

Drone view of the front of the house from the southeast

The Sakuichi and Chieko Matsumoto residence is located in a quiet, residential neighborhood at the end of Kuai Road in Poipu, a block from the beach. The building faces east, sits on a flat, 15,676 square foot lot and is in excellent condition. It is a single-story, single wall, bungalow, which follows an irregular, zig-zag footprint, with a 220 square foot, single car, attached garage and laundry room. It sits on a post and pier foundation and its walls are of 7" tongue and groove boards and have an exterior girt. A lattice apron with a square pattern runs around the foundation. The house's corrugated metal hip roof has open, overhanging eaves with exposed rafter tails. The three bedroom, one bath house, 980 square feet of living space under roof, and retains its historic integrity of design, materials, workmanship, setting, location, feeling and association.

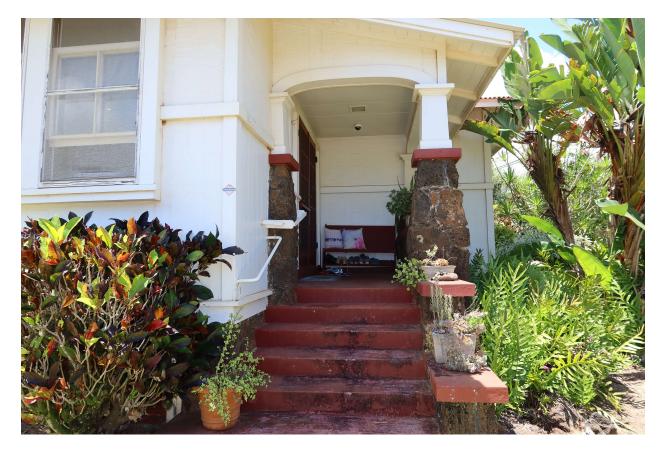
2 of 13

View of the front porch from the south

A bedroom wing, with a pair of 2 x 2 double hung sash windows, projects from the front of the house on its north end, and a lava rock porch sits in the intersection of the wing and the main body of the house. The porch runs parallel to the front of the house and six concrete steps run up to it from the south. The steps have a lava rock cheek wall, which runs across the front of the porch. The cheek wall has a 4" high, 16" wide concrete cap. At the top of the steps is a segmental arch which is echoed on the front of the porch. The arches are supported by short, battered, wood columns which rise from battered lava rock columns, with the two end columns attached to the walls of the house. The porch has a concrete floor and a 7' - 11" high, canec ceiling with a recessed square light. The entry to the house is in the porch's west wall, and features a set of ten pane, double doors with five pane side lights. Matching, original screen doors allow the front doors to be open without worry of insects entering. All the doors have their original knobs and hardware.

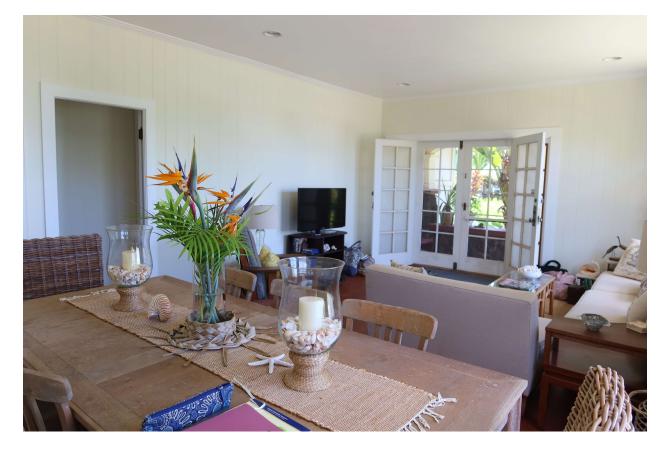
3 of 13

View of the living room from the southwest

The entry opens directly on the living room. The room has a pine floor with a 4" base board, both of which are found throughout the house, unless otherwise noted. The 8'-10" high ceiling is of gypsum board, which replaced the original canec ceiling after Hurricane Iniki blew the roof off the house. The ceiling is the same throughout the house and has a simple crown molding. Two pairs of original 2 x 2 double hung sash windows are in the living room's south wall, and an opening, without a door, is on the north side of its rear, west wall. This opening leads into the kitchen, while a single panel door, with its original art deco knob and hardware is centered in the living room's north wall and opens on a front-to-rear running hallway. All interior doors are similar to this living room one, unless otherwise noted.

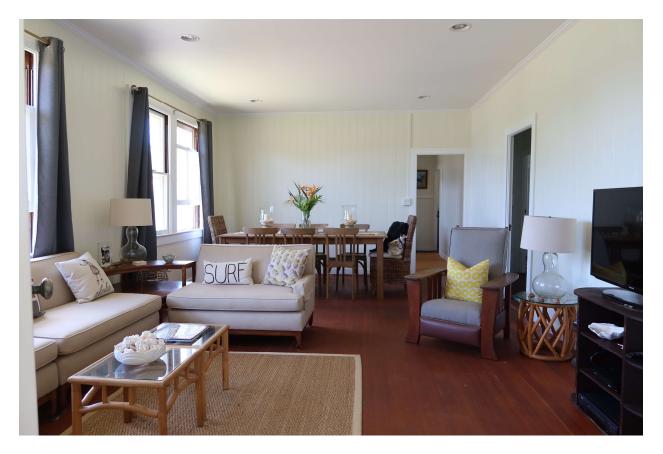
4 of 13

View of the living room from the east

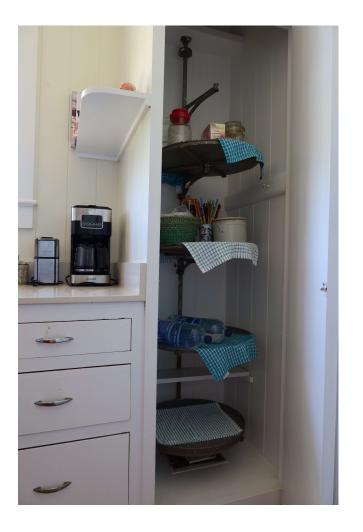
6 of 13

View of the Lazy Susan in kitchen closet, from the north

The kitchen has a pair of 2 x 2 double hung sash windows in its south wall. It features its original cabinets and drawers on its east, south and north walls, and a stainless steel sink and drain boards below its windows. The drawers and cabinets retain their original handles and pulls. At the west end of the cabinets on the south wall is a tall cabinet which features an original metal Lazy Susan shelving unit which rotates around a central pole. Adjacent to the Lazy Susan cabinet at the south end of the west wall, a door exits the kitchen into the laundry room. This door has a screened upper opening which can be secured by a sliding wood panel. Another distinctive feature of the kitchen is its center island which is on wheels. Originally it could be stored in a niche which projects from the kitchen's west wall, but a stove and counter space now occupies this space. Above the stove is a lozenge shaped, screened opening which exhausts into the laundry room. Beyond this wall, to the north a door opens onto a sewing room.

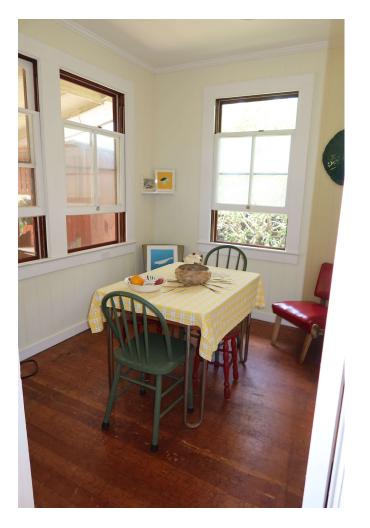
7 of 13

View of the sewing room from the kitchen from the southeast

The sewing room has a pair of original 2×2 double hung sash windows in its west wall, and a similar single window in its north wall. The northwest corner of the room features a triangular shelf. A 1" x 4" interior girt, with rounded edges, is on the east and south walls. A single panel

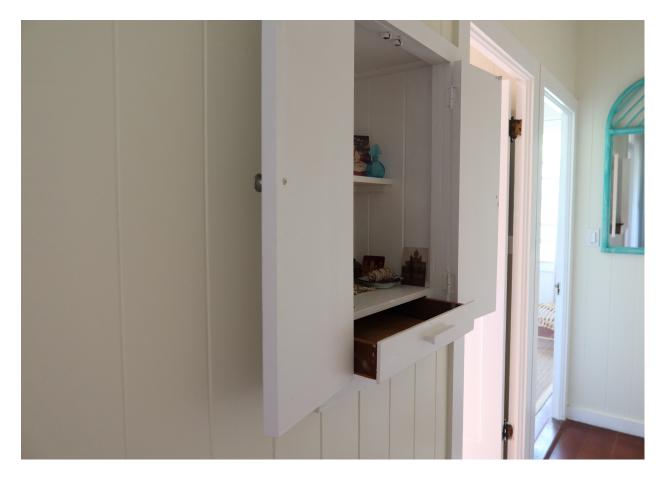
8 of 13

View of the *butsudan* from the southwest

Between the middle bedroom and bathroom doors is a *butsudan* (shrine for ancestors) built into the hall's north wall. It has two shelves and a lower drawer, and a pair of doors. The bathroom is between the middle bedroom and front bedroom. It has been partially remodeled with a new vinyl floor and a tile wainscot. However, it retains its original sink and tub, as well as a projecting, tongue and groove cabinet with drawers and a vented hamper. Its 2×2 wood double hung sash window is new, having replaced jalousies, which replaced the original double hung sash windows.

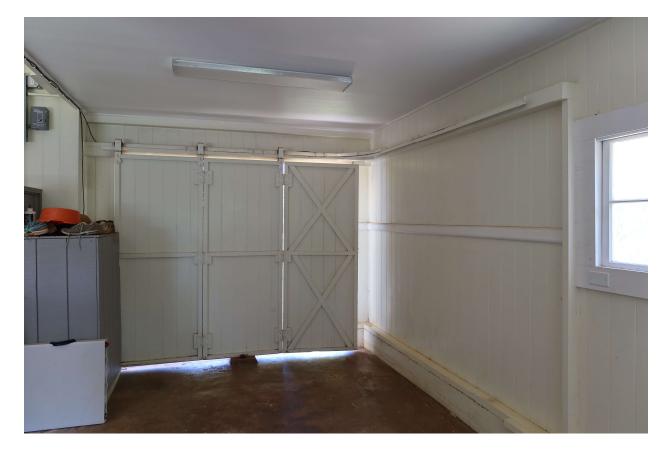
9 of 13

View of the garage door from the west

The attached garage is located on the south side of the house, and has a lower, corrugated hipped roof. It retains on its east side its original sliding door which is mounted on a curvilinear metal track and has three tongue and groove panels. The single car garage has a pad of concrete pavers outside its entrance, and has a concrete floor with an approximately 8" high curb, which decreases in height from east to west, following the slope of the land. The garage has tongue and groove walls and an 8'- 4" high ceiling. A pair of original, six pane sliding windows are in its south and west walls. There is an interior girt on its north and south walls.

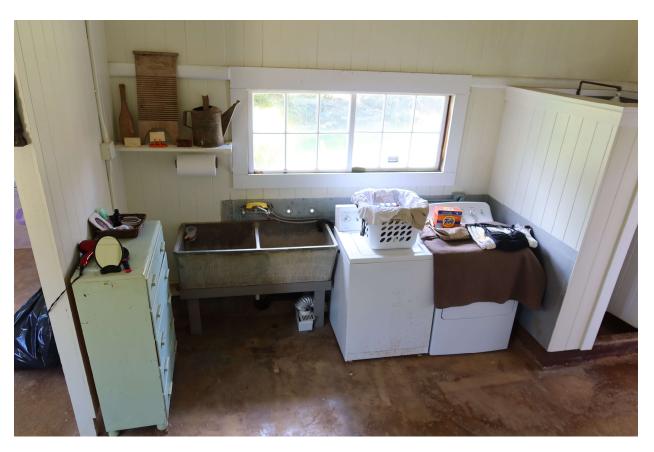
10 of 12

View of the laundry room from the east

Name of Property County and State A 9'- 6" wide and 9'- 7" high opening in the garage's north wall flows into the laundry room. The concrete floor of the garage continues into the laundry room and the ceiling rises to a height of 12'- 7" being a hip extension off the roof of the main body of the house. The room has a pair of sliding windows similar to those in the garage in its west wall. A pair of concrete sinks are below the windows as also are a washer and dryer. On the laundry room's east side a set of wood steps ascend to the kitchen's back door. Two steps lead to a landing where a quarter turn to the right is made allowing four steps to parallel the back wall and ascend to a landing outside the door. A 2" x 4" railing has 2" x 2" balusters. At the far end of the laundry room, in the north wall, a three panel door with its original knob and hardware leads to the outdoors. The door is accessed from a short "hallway" with a shower on its west side and a toilet on its east side. Both the shower and toilet are separated from the main room by a tongue and groove wall which is 6'-8" high. The shower has a tongue and groove door with its original knob, while the toilet has an abbreviated door with openings above and below.

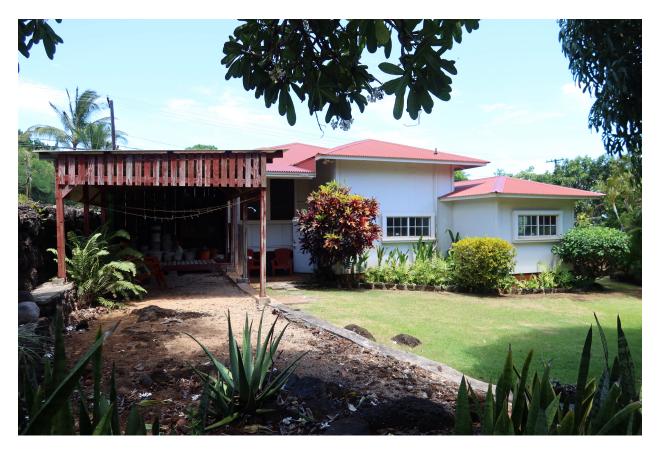
11 of 13

View of the rear of the house from the northeast, shade house to the left

The door to the outside opens on a concrete and lava rock patio which is partially protected from the elements by the eave of the house. To the north of the patio and running towards the rear of the property, in front of the north side boundary wall, is a raised terrace with an approximately 20" high lava rock retaining wall. Two sets of two steps access the terrace. Built on top of the terrace is a shade house, which contributes to the historic character of the property and is noted in section five of this nomination as a contributing structure. It has a corrugated metal shed roof which is supported by eight, paired 2" x 4" posts. It is open on its north, south and west sides, while the east end is enclosed by vertical tongue and groove and corrugated plastic walls on three sides, with the west side open. The east end is elevated off the earthen floor by a wood slat floor and is used to store potting supplies. A wood food safe is located along its back wall and is also used for horticultural supply storage. Vertical, 1" x 4" slats form a clerestory on the shade house's south and west sides.

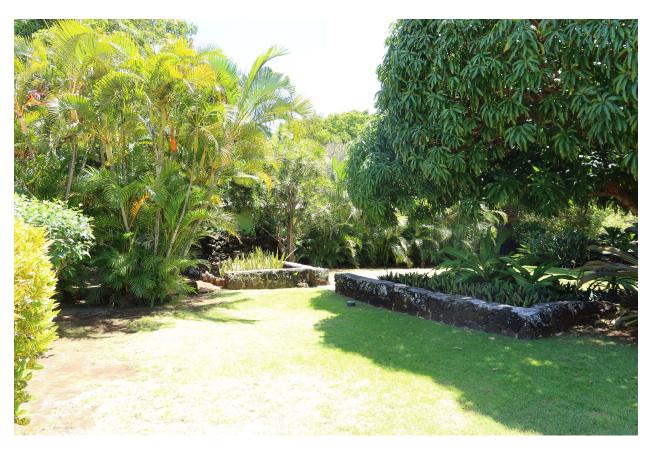
12 of 13

View of the foundations of former shade and hot houses from the northeast

The back and south side yards are characterized by the low lava rock walls which formed the foundations for other shade and hot houses. The remnants of a small, former water feature are also still extant. A mature plumeria and two mango trees provide shade to the back yard.

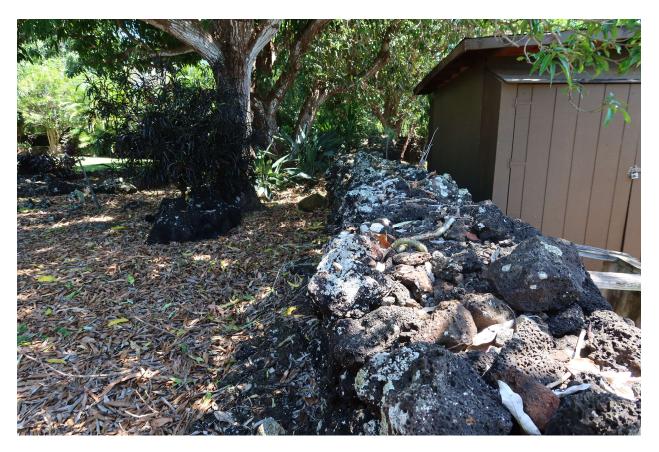
13 of 13

View of the rear, ahupuaa wall from the north

Name of Property County and State driving over the lawn to reach the garage. Lava rock walls, approximately 56" high define the side boundaries, and an approximately 41" high lava rock wall, reputedly a pre-contact ahupuaa wall, runs across the rear of the property.
