Kwo On and Ho Kan Kam Residence
Name of Property

Honolulu, Hawaii
County and State

7. Description

Narrative Description

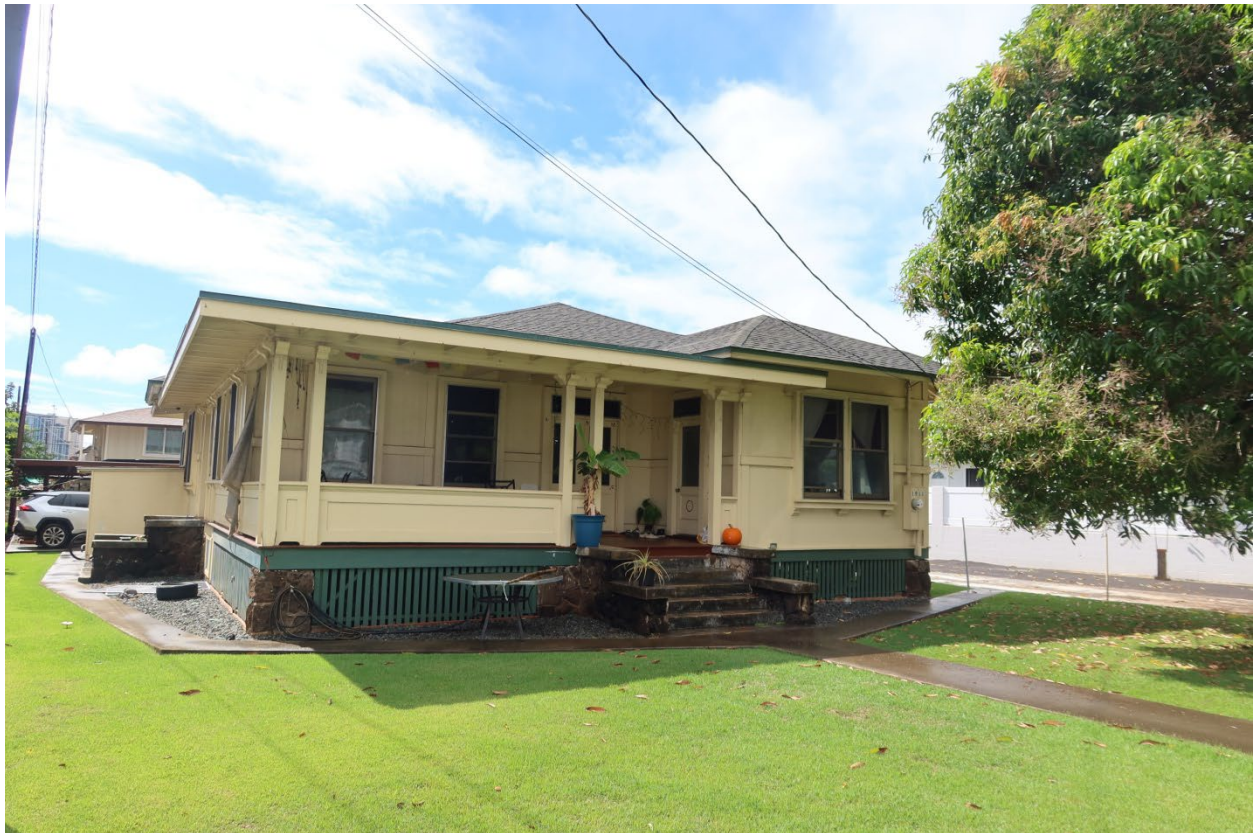
1 of 17

View of the front from the northeast

A concrete walk runs from the gateposts to the front steps of the house. Six concrete steps are centered on the house and lead up to a front porch which runs across the east side of the façade. The steps have lava rock cheek walls. Originally the porch wrapped around the east side of the house, but at some point prior to World War II the section running down the east side was enclosed in a sympathetic manner. The 8'-6" x 22'-7" porch has a paneled balustrade from which 6" x 6" columns rise. A pair of columns is to the east of the porch entry and to the west is one column and a pilaster. A set of three columns grace the northeast corner of the porch. The columns have cyma reversa brackets as capitals. The porch has its original tongue and groove floor and an 8'-11" high, scored tongue and groove ceiling. The porch's flat roof's exposed, 2" x 12" joists support the ceiling.

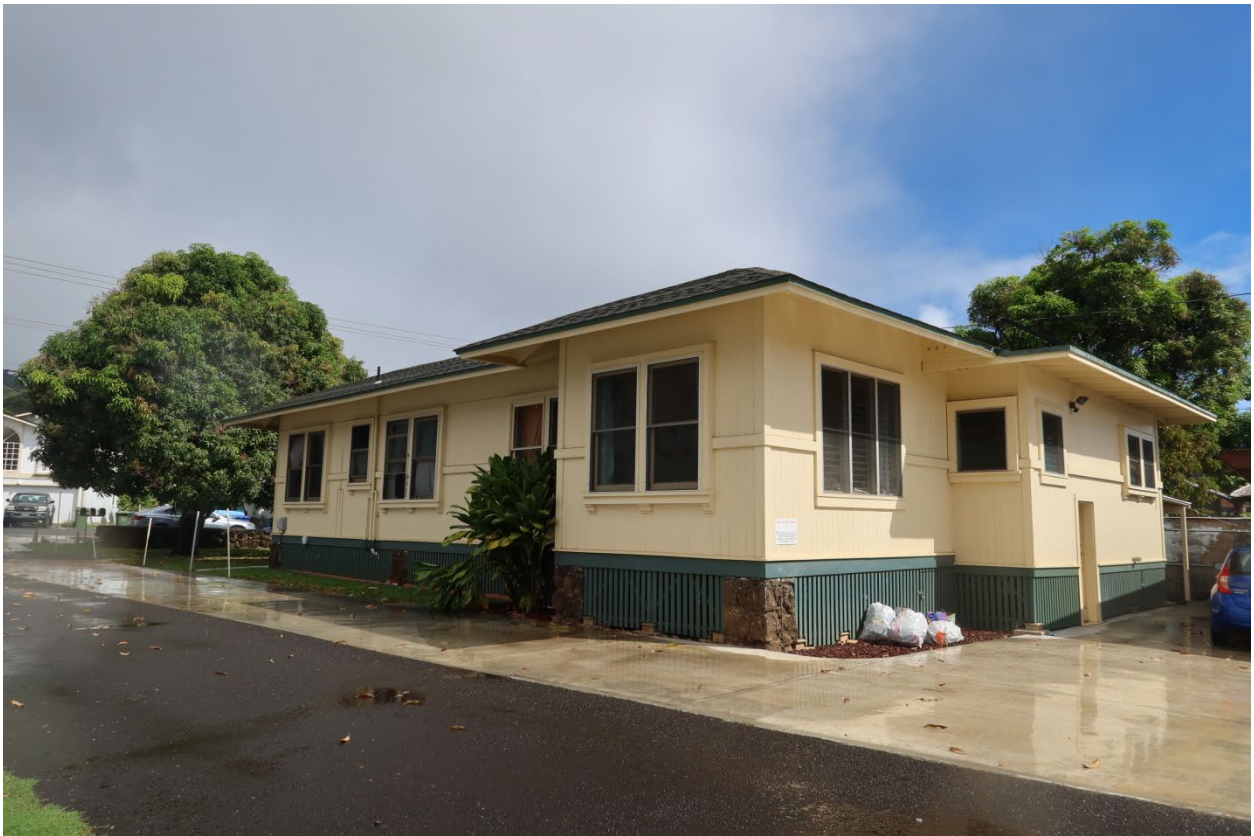
2 of 17

View of the west side and rear of the house from the southwest

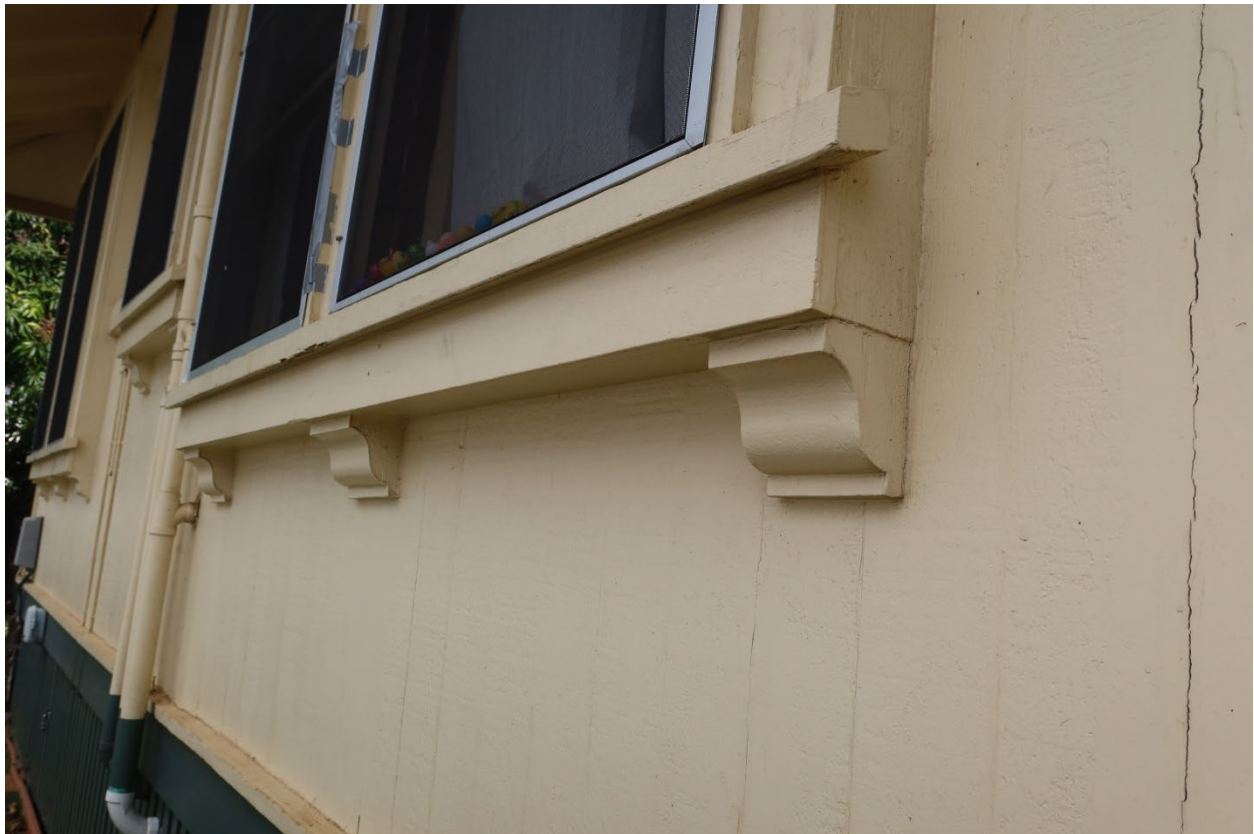
3 of 17

View of the cyma recta bracket under window frame, from the southwest

In the south wall of the porch is the house's entry and to the east of the entry are two 1 x 1 double hung sash windows. The projecting windows are "supported" under the corner of their sframes by cyma recta brackets, which is true for all windows in the house, unless otherwise noted. The front entry features a set of original double doors with a single panel below and a tall window above. The hardware is original, but the knobs and locks are not. A single pane transom is above the doors and it retains its original hardware. In the porch's west wall is a hinged single door which enters on a front bedroom.

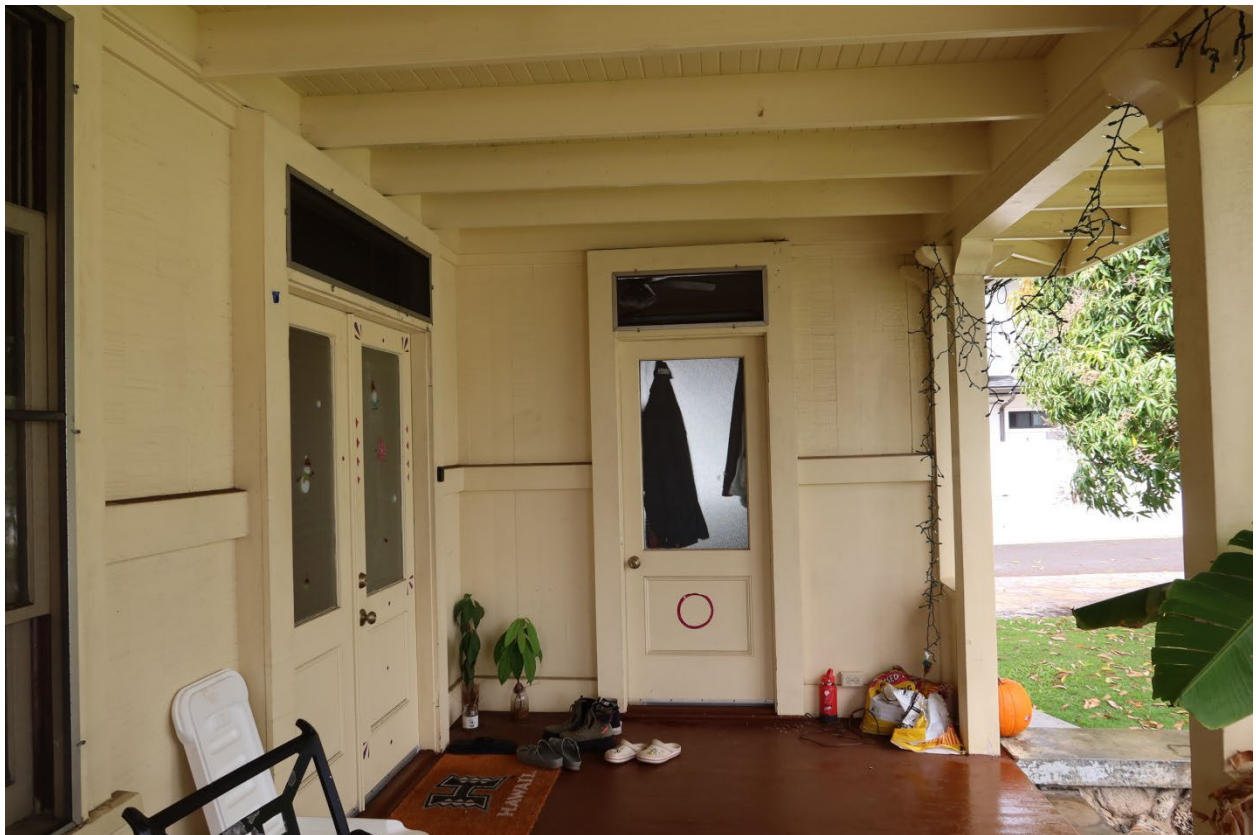
4 of 17

View of the front entry and door into front bedroom from the east

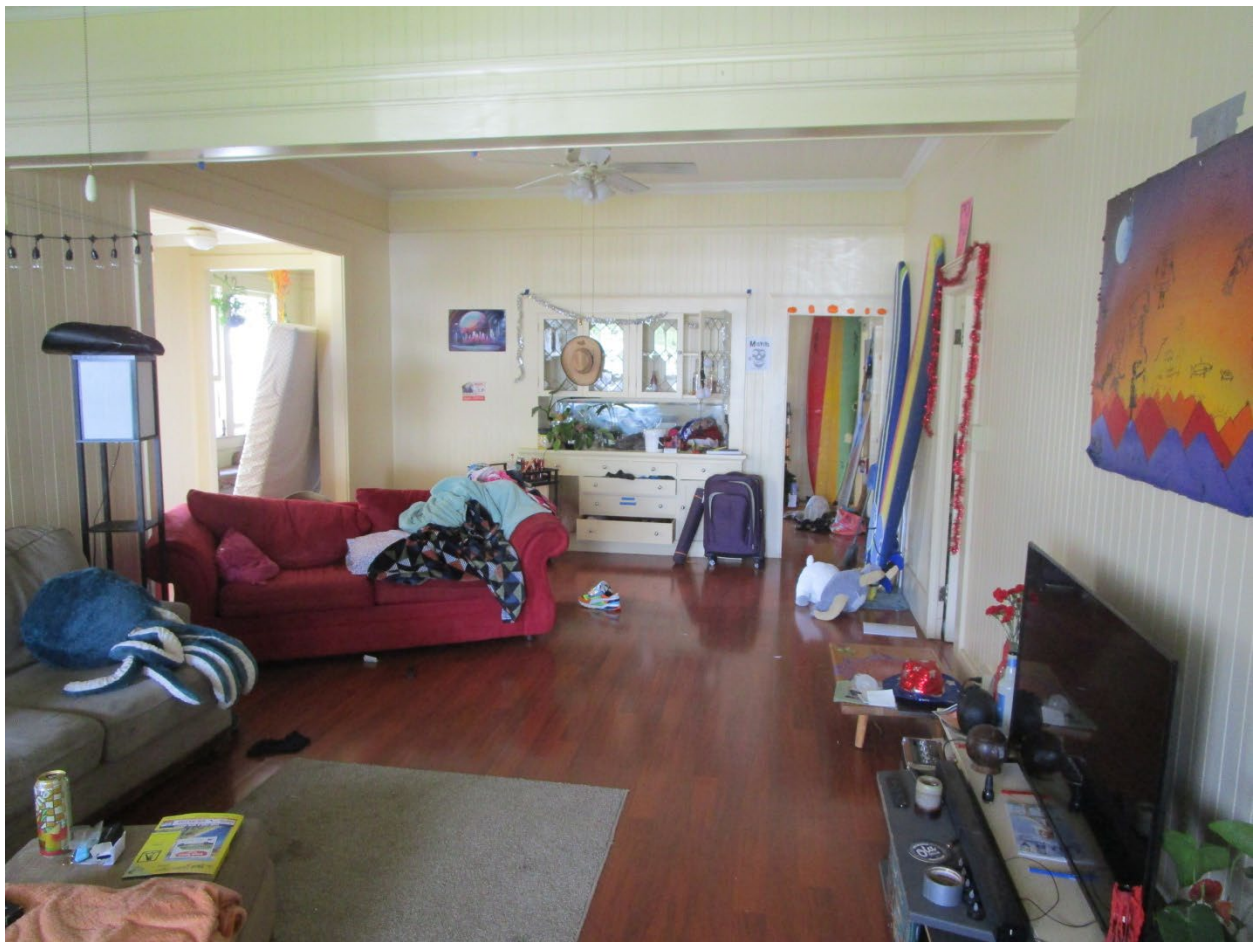
5 of 17

View of the living room-dining room from the north

The entry doors open on the living room-dining room, which is one continuous flowing space, demarcated solely by a beam which runs east-west across the space and is adorned with a cavetto, above which a short scored tongue and groove wall with a picture rail and crown molding rises to the ceiling. The living room has new laminate flooring, which covers the badly termite eaten, original flooring throughout the house, unless otherwise noted. The living-dining room retains its original vertical, scored tongue and groove walls and ceiling, both of which also are found throughout the house unless otherwise noted. The living room ceiling is 9'-10" high, and the walls feature a picture rail and crown molding and retain their original 9" high baseboards. In the south wall of the dining room space is a built-in buffet with drawers and cabinets below its wood counter and two cabinets above. Each of the upper cabinets have a pair of leaded glass doors. On the wall behind the counter is a beveled mirror. The buffet is crowned by a cavetto. Adjoining the buffet on its west side is a doorway with no door, which leads into an informal dining room.

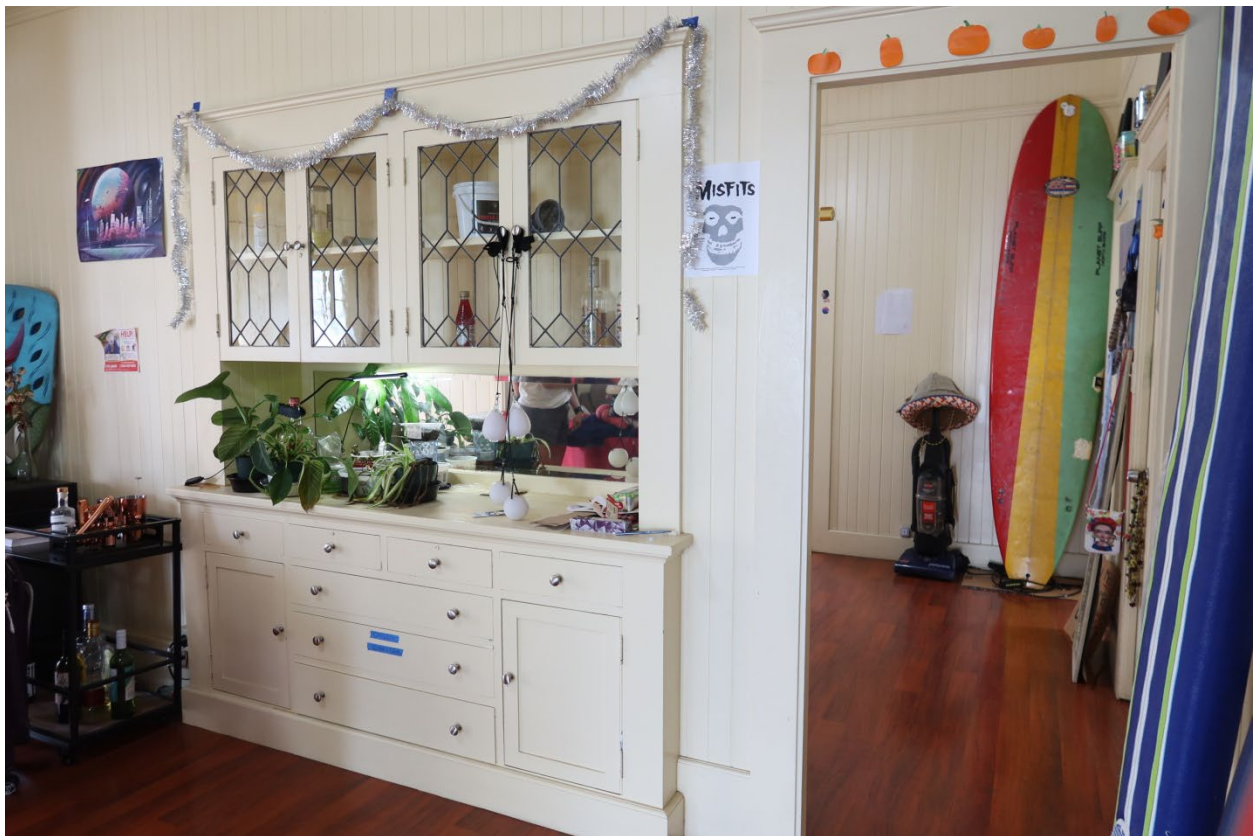
6 of 17

View of the living-dining room buffet from the northwest:

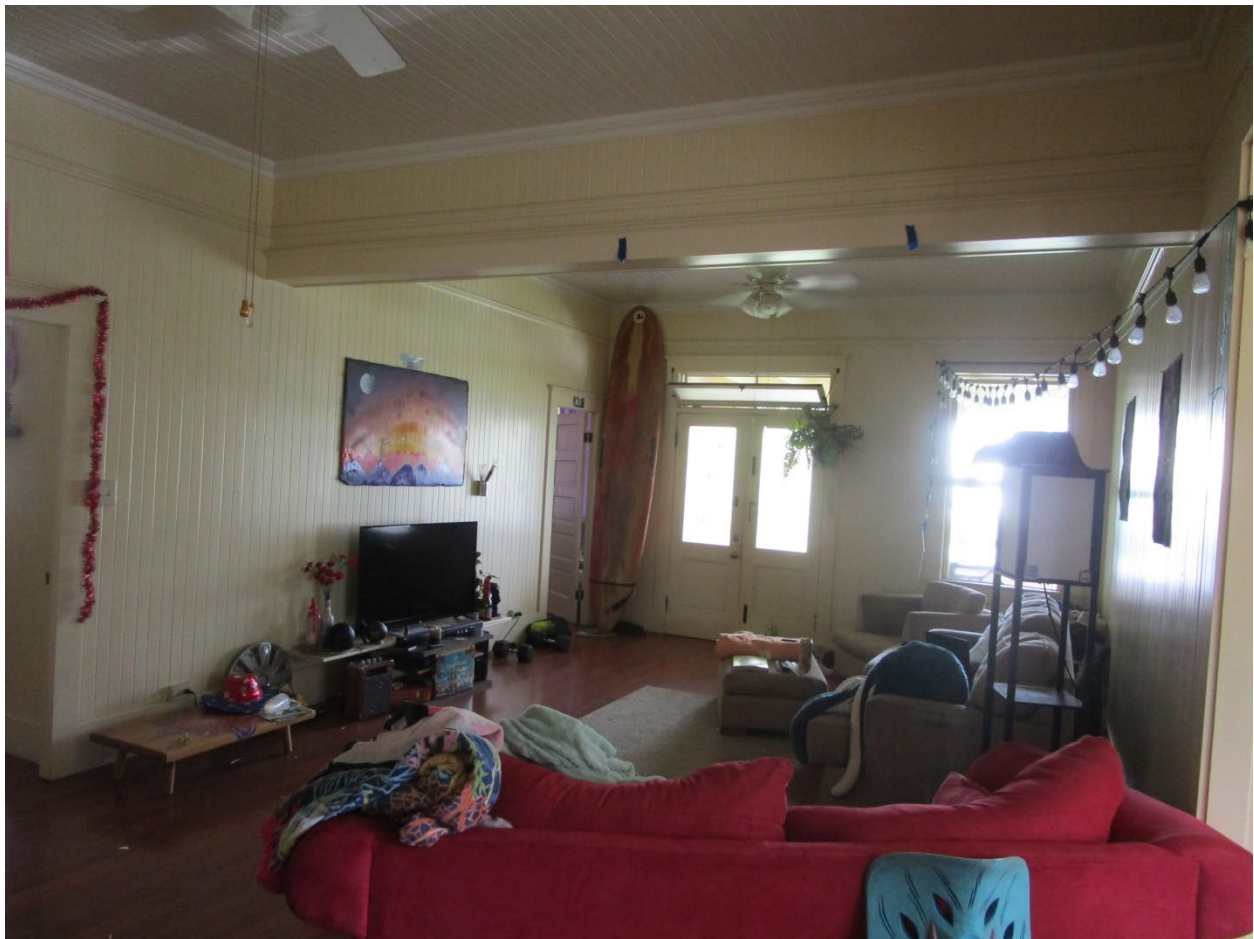
7 of 17

View of the living room from the southeast

Two original five panel doors, which have new knobs, are in the living room's west wall and open on bedrooms. A cavetto is above both these doors, as well as above the front entry's transom and the doorway between the informal dining room and the living/dining room. The wall and ceiling treatments in these two rooms are the same as the living room. The front bedroom has a pair of 1 x 1 double hung sash windows in both its north and west walls. In addition to the door from the living room in the east wall, a second door in that wall opens on the front porch. This door is similar in design to the double doors serving as the entry to the house. A single pane transom with a cavetto is above this door. A closet with a pair of solid sliding doors is in the south wall of the room. Also in this wall is a five panel door which accesses a bathroom. Both the bathroom and closet doors are jointly enframed with a single cavetto running across the top of their frames.

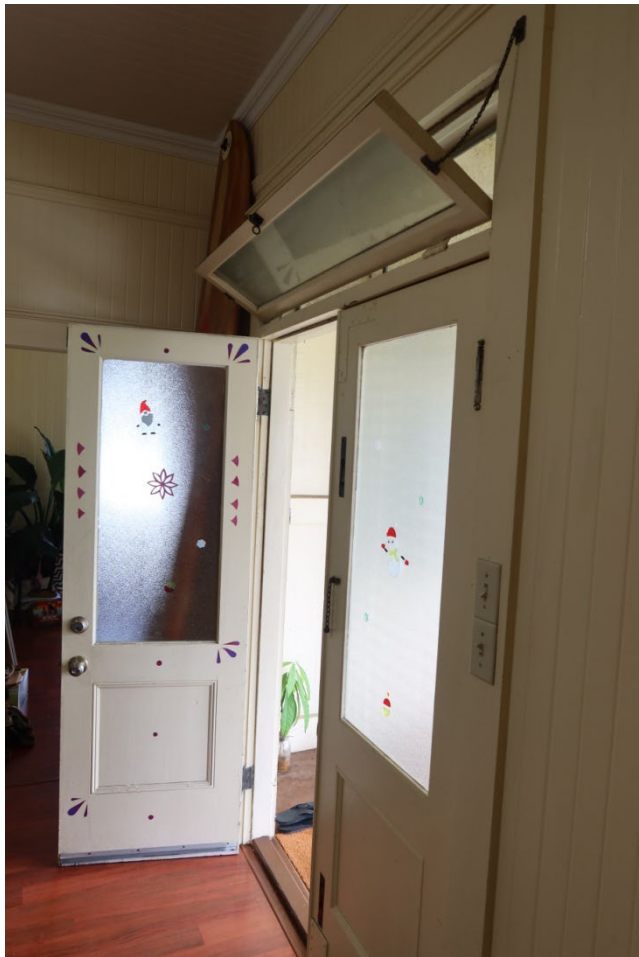
8 of 17

View of the front entry's transom from the east

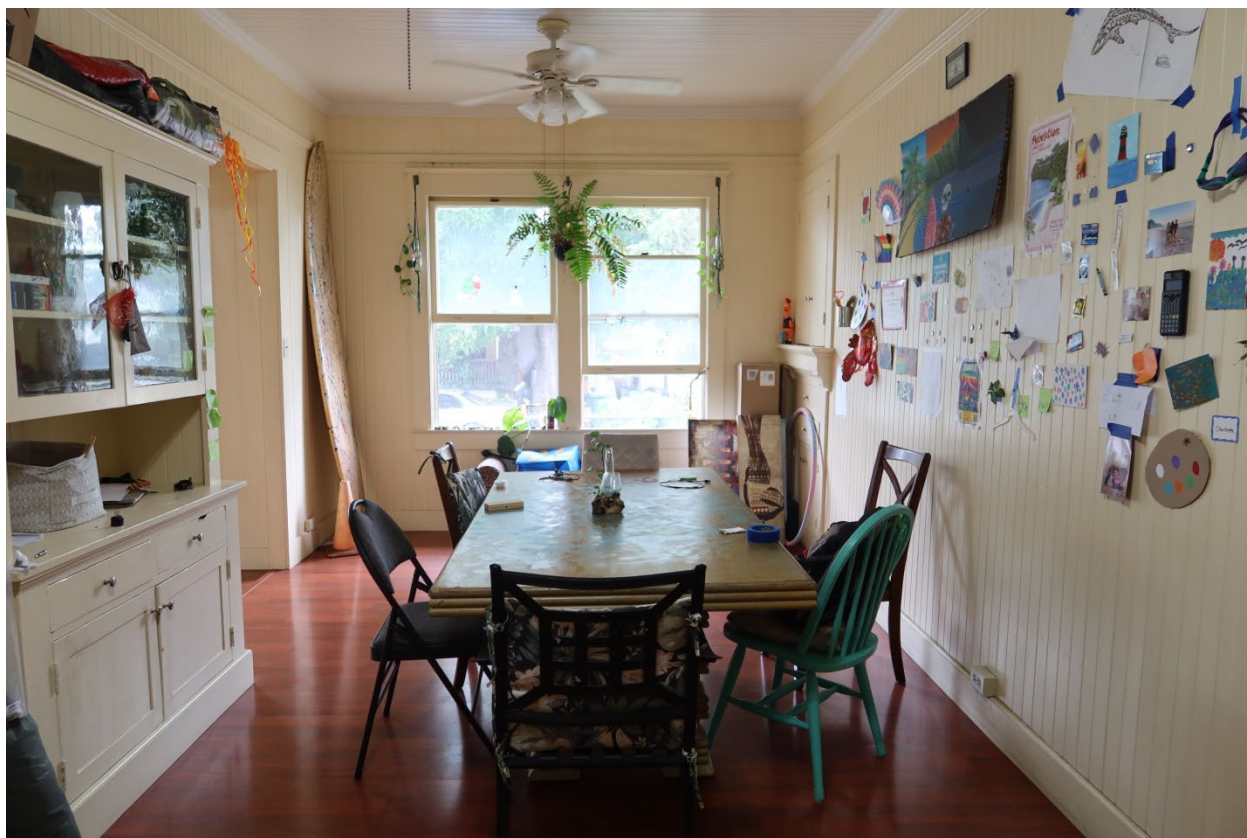
9 of 17

View of the informal dining room from the west

The informal dining room runs in an east-west direction and is to the south of the side entry foyer and the living-dining room. It has scored tongue and groove walls and ceiling, and its walls feature crown molding and a picture rail, but its baseboard is only 6" high. Its north wall is dominated by a projecting, built-in buffet with two drawers and cabinets below a counter and two glass doors above. In the east corner of the south wall is a former shrine with two tall cabinet doors above and two drawers and a pair of cabinet doors below. The shrine's shelf is supported by a modest cornice and cyma recta brackets. The shrine is no longer occupied, as the deity travels to the home of the eldest son upon the death of the family patriarch. There is a pair of 1 x 1 double hung sash windows in the room's east wall, and in its west wall is the five panel door to the third bedroom and an opening with no door which opens on a small hall that accesses a bathroom and a rear bedroom. An opening with no door in the south wall leads into the kitchen.

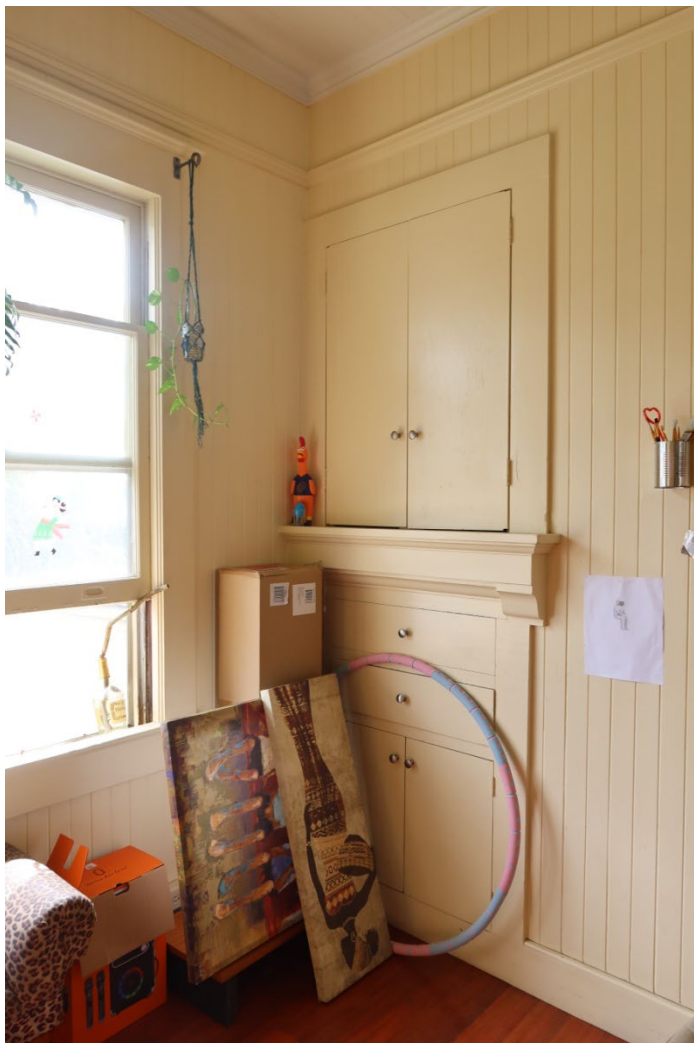
10 of 17

View of the shrine cabinet from the northwest

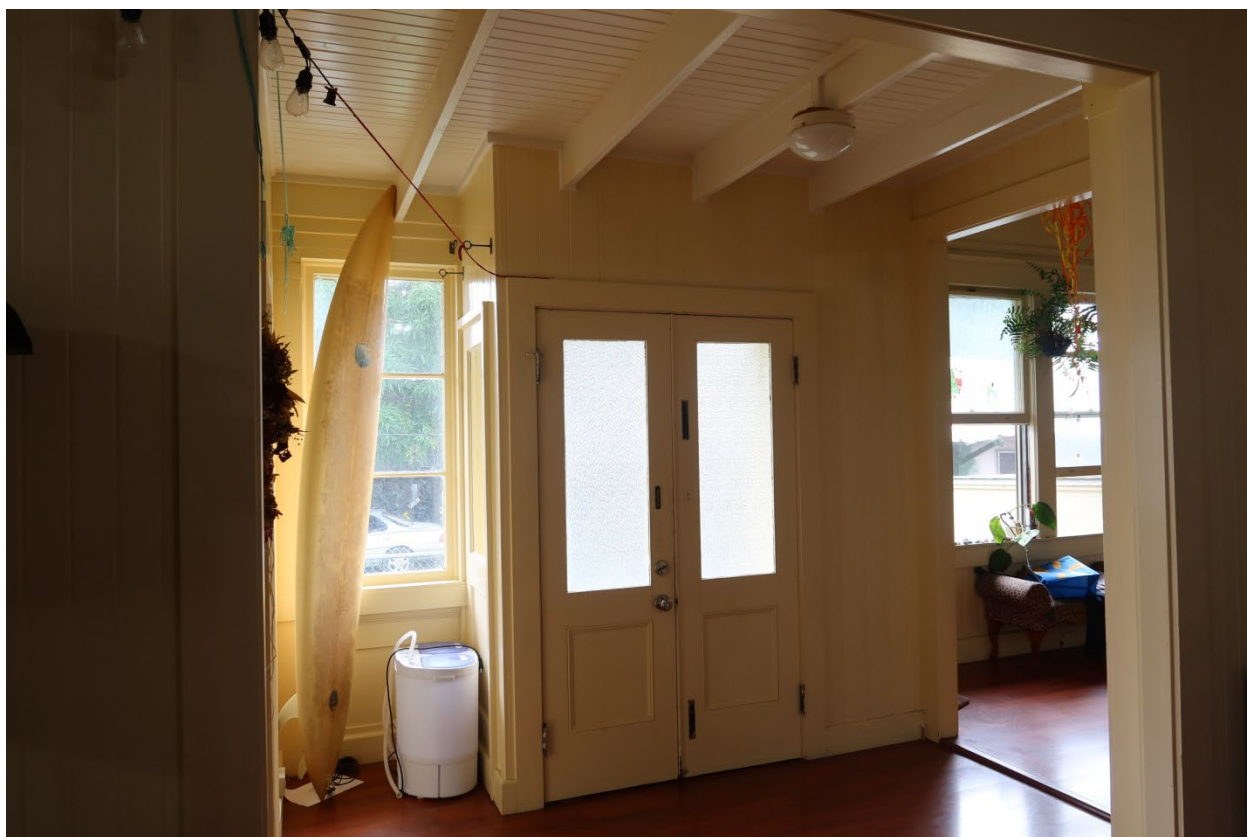
11 of 17

View of the side entry foyer from the west

A large, 7' x 7'-10", flat arched opening is in the east wall of the living/dining room at the dining room end. This opens onto a foyer for the side entry to the house. This was originally the last bay of the wrap-around porch's east side, and has the same 8'- 11" high ceiling as the front porch. The walls of the foyer are vertical tongue and groove. The side entry has a set of double doors which are similar to the front entry doors, but have obscure glass in the upper windows. The obscure glass is in a star burst pattern. The doors retain their original hardware but have new knobs and locks. This doorway projects 34" into the foyer. To the north of the doors in a niche resulting from the inseting of the doors from the exterior, is a fixed window with three horizontal panes, which rises from the original porch's balustrade. In the south wall of the niche is a single pane fixed window. On the exterior of the double doors is a wood landing, part of the original porch floor, with seven concrete steps with lava rock cheek walls descending to the side yard.

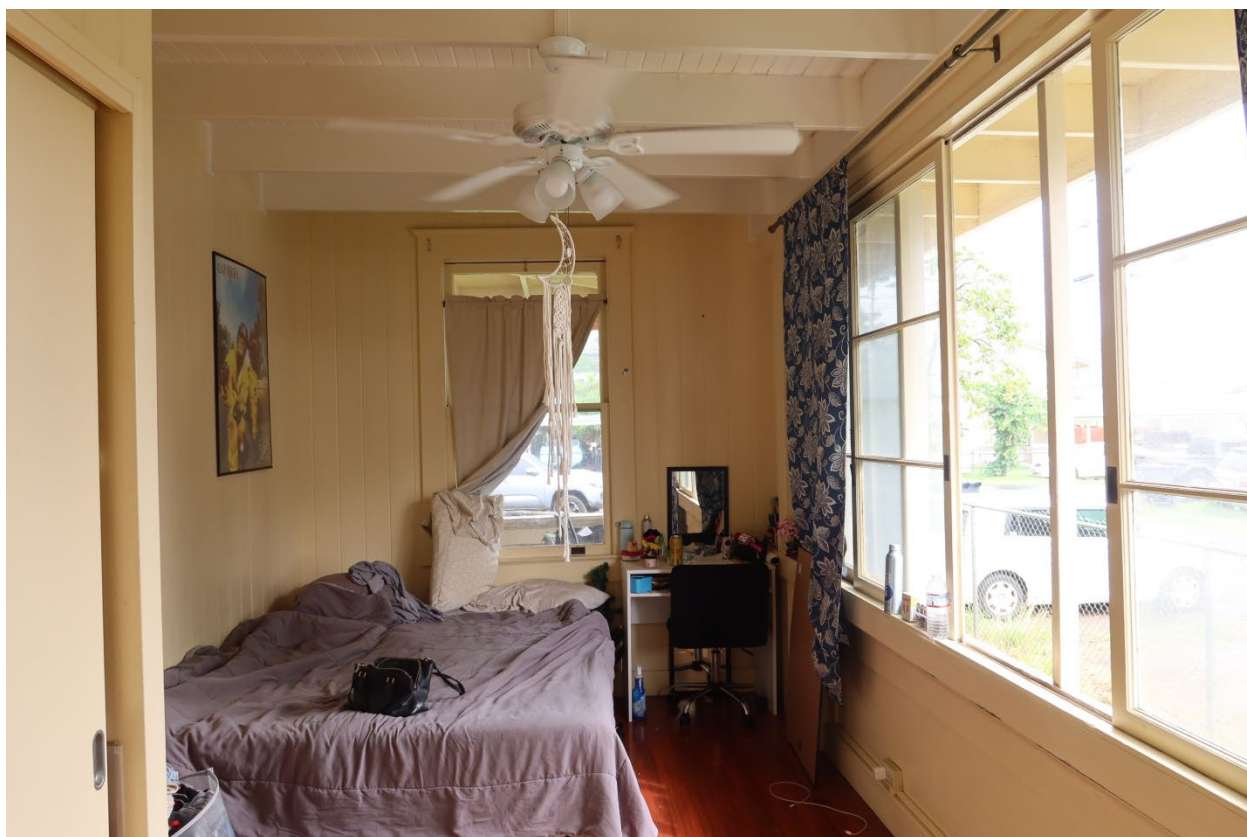
12 of 17

View of the bedroom in enclosed porch area from the south

front porch and vertical tongue and groove walls. A 1 x 1 double hung sash window in its north wall looks out on the front porch and two pairs of sliding windows rise from the former porch balustrade on its east side. The sliding windows each have three horizontal panes and retain their original hardware, including their brass peg locks. A closet with a pair of sliding doors is on the west wall near the door to the room.

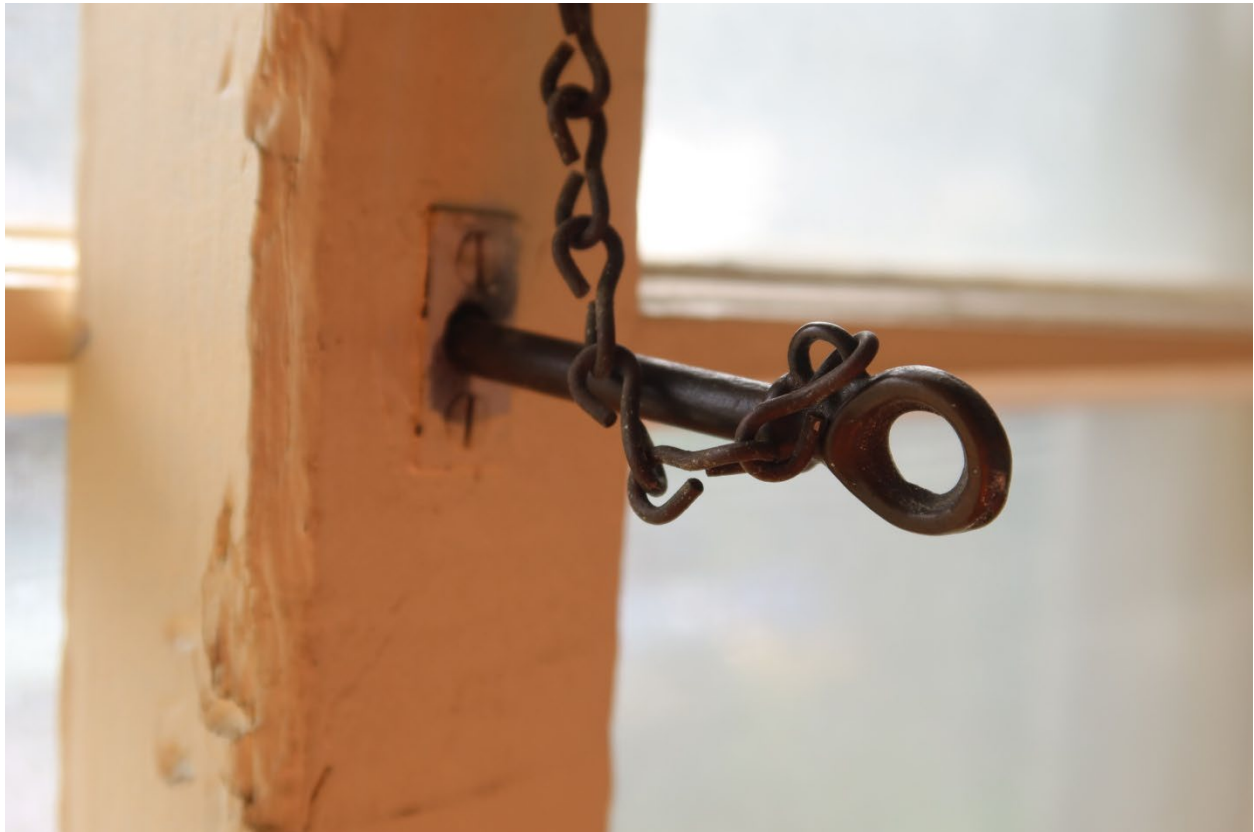
13 of 17

View of the sliding window lock in former porch bedroom from the northwest

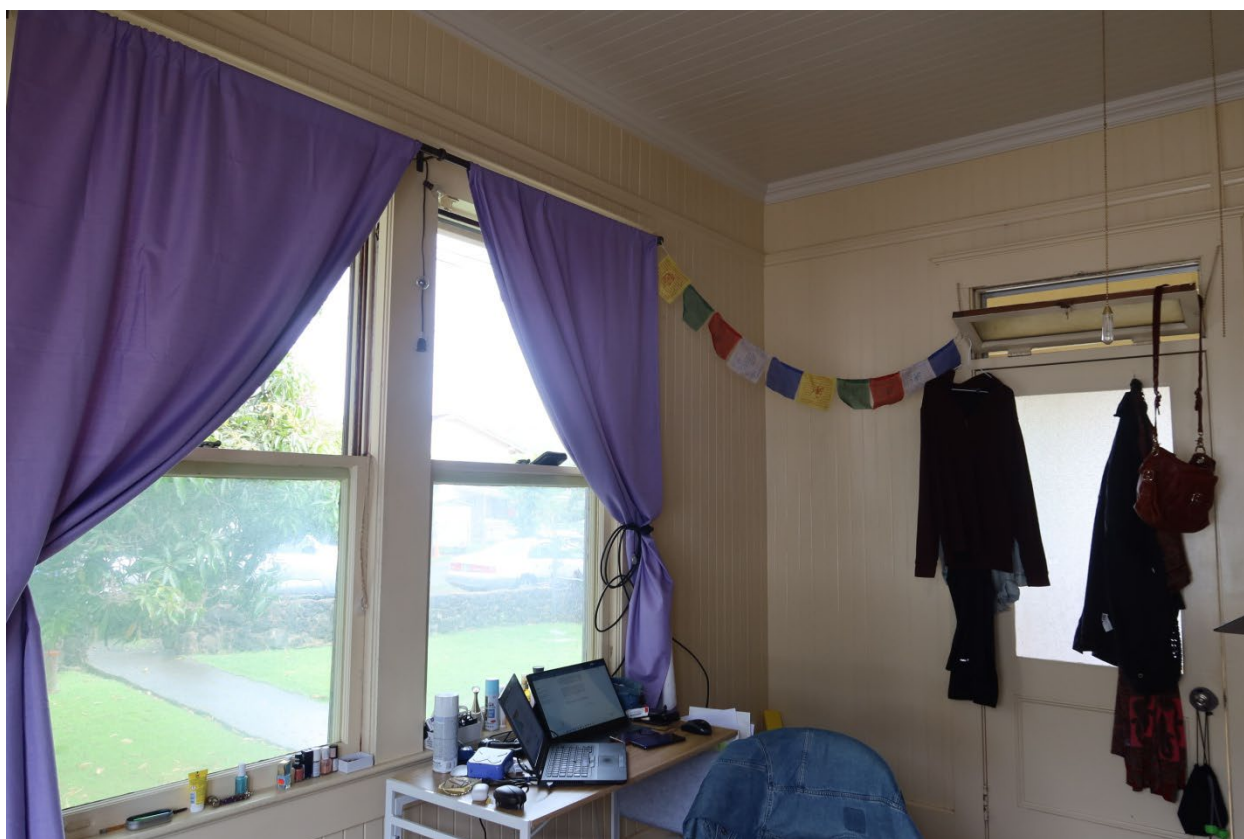
14 of 17

View of the front bedroom from the west

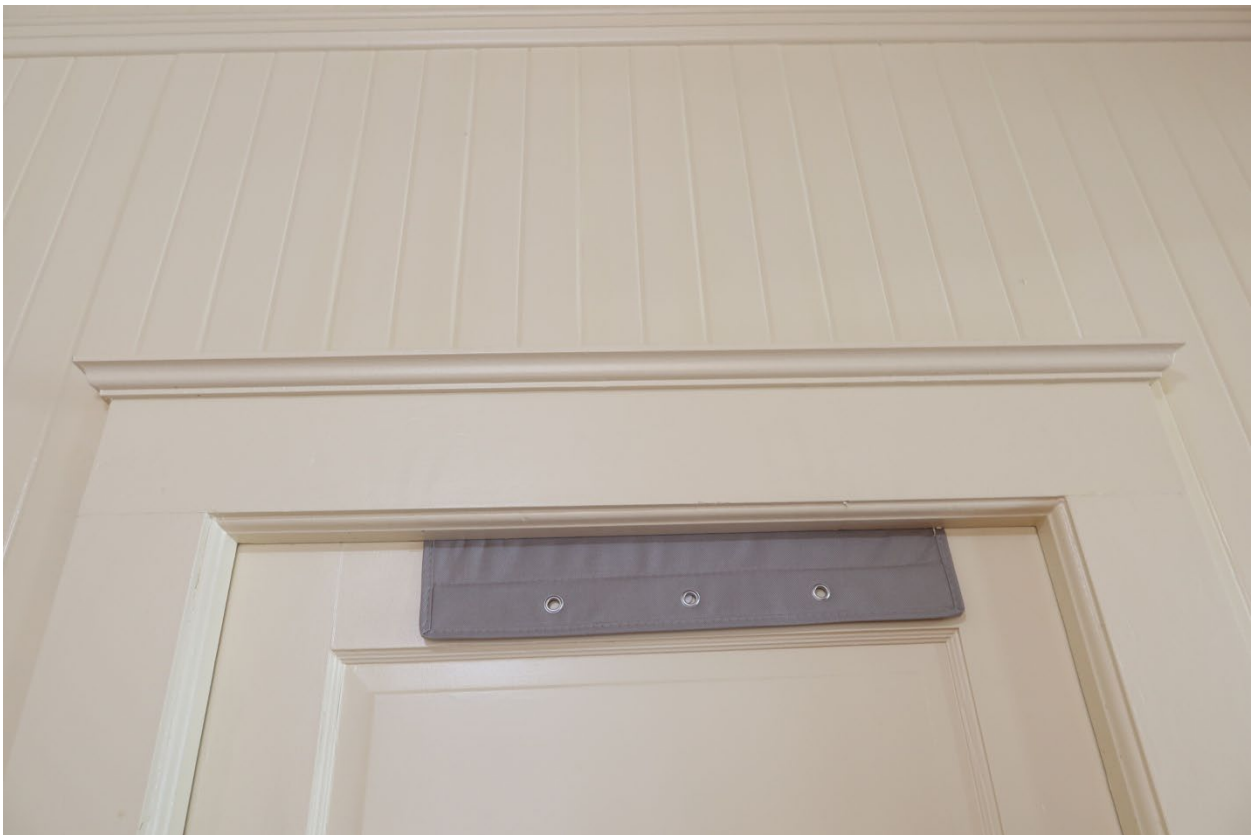
15 of 17

View of the cavetto over a bedroom door frame in the living room from the east

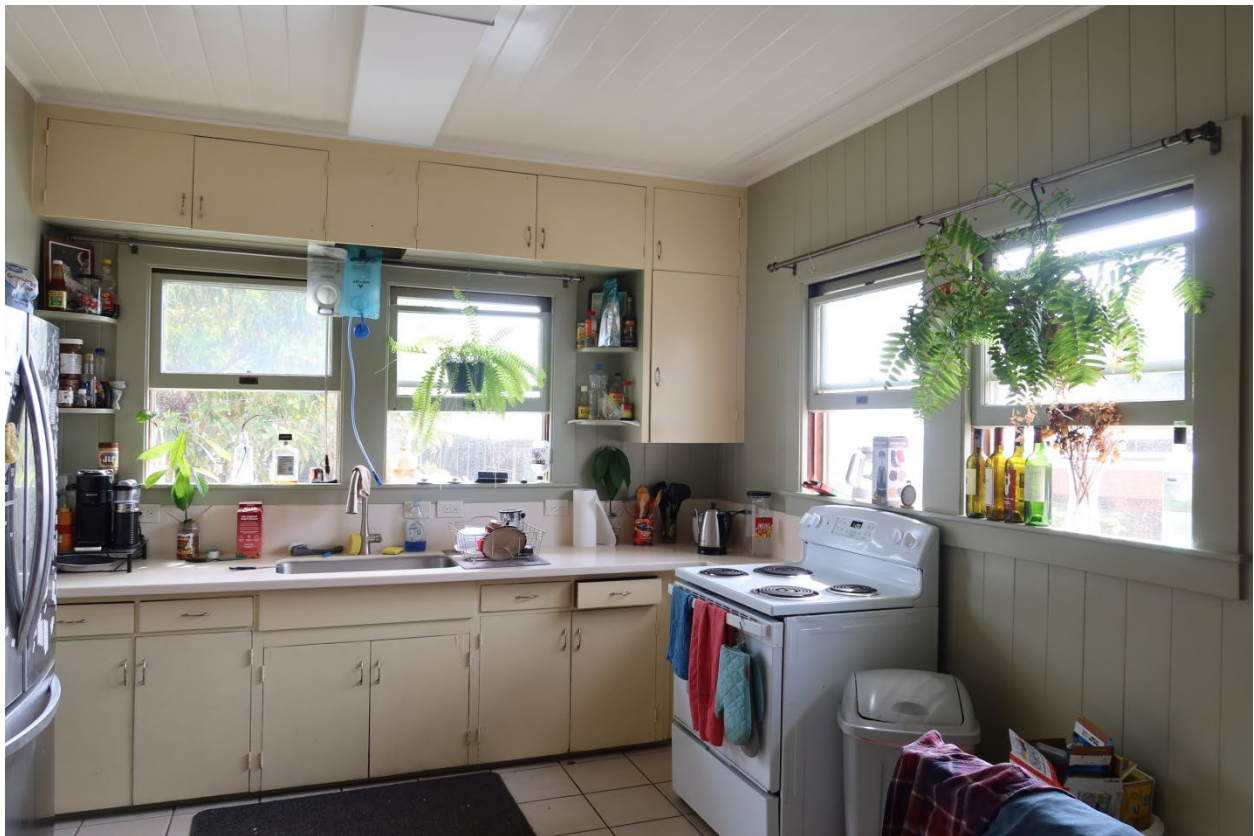
16 of 17

View of the kitchen from the west

The kitchen was part of a remodeling of the rear of the house which transpired in 1959. It has a 8'- 10" high tongue and groove ceiling and a vinyl tile floor with 5" high baseboards. Its walls are of vertical tongue and groove, and it is sheltered by a flat roof. A pair of 1 x 1 double hung sash windows is in both its east and south walls. The cabinets date from the remodeling, but the countertops and pulls are new. A stair with six steps runs parallel to and adjoins the south wall, descending to a door which opens on a niche in the back wall of the house.

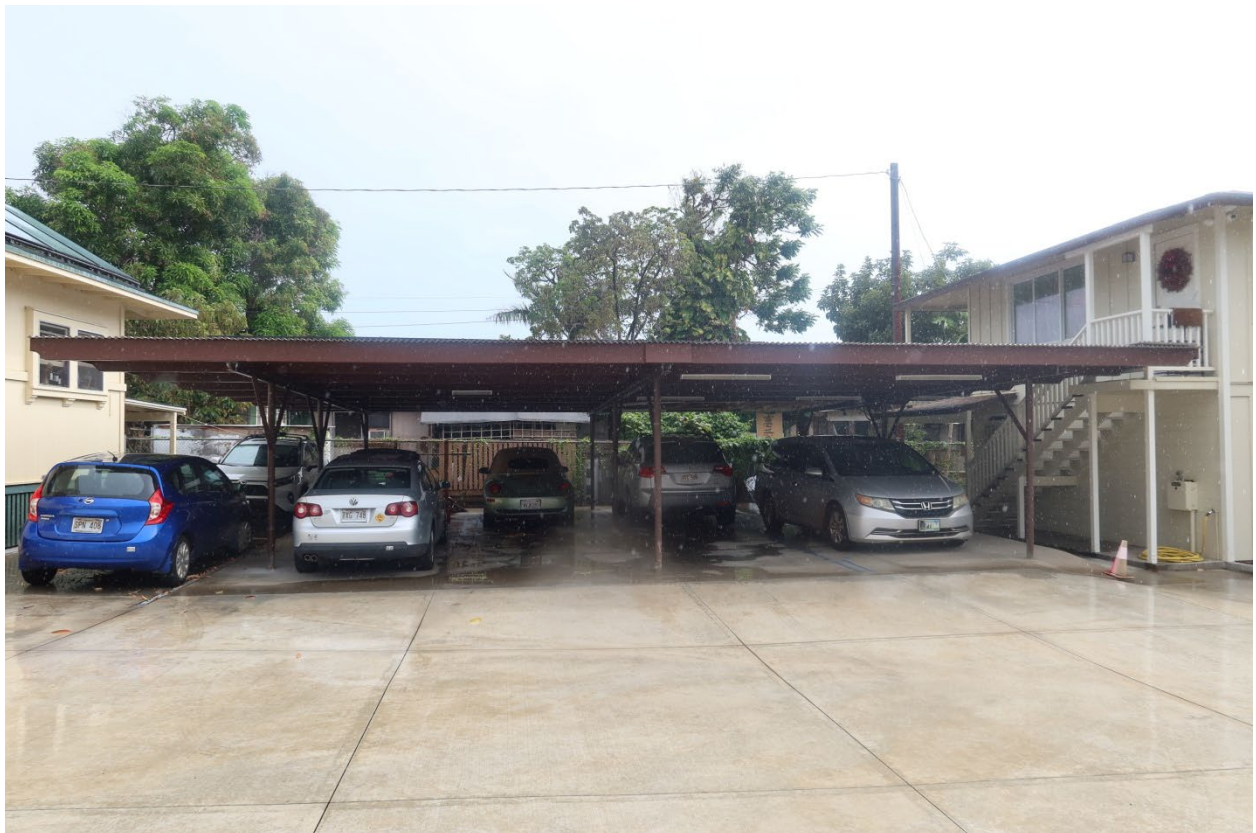
17 of 17

View of the carport from the west

Behind the house is a 30' x 34' rectangular carport, which was built in 1959 and contributes to the historic character of the property. This structure has no walls, a concrete floor, and features a corrugated metal, flat roof. Nine pipe columns, 4" in diameter, each with two 2.5" diameter pipe braces, support three east-west running, 3" x 4" I-beams, which in turn carry the roof's 4" x 12" joists.
