Kahuku Wind Power Habitat Conservation Plan FY-2011 Annual Report- Year 1

Kahuku Wind Power, LLC
56-1050 Kamehameha Hwy
Kahuku, Hawaii 96731
August, 2011

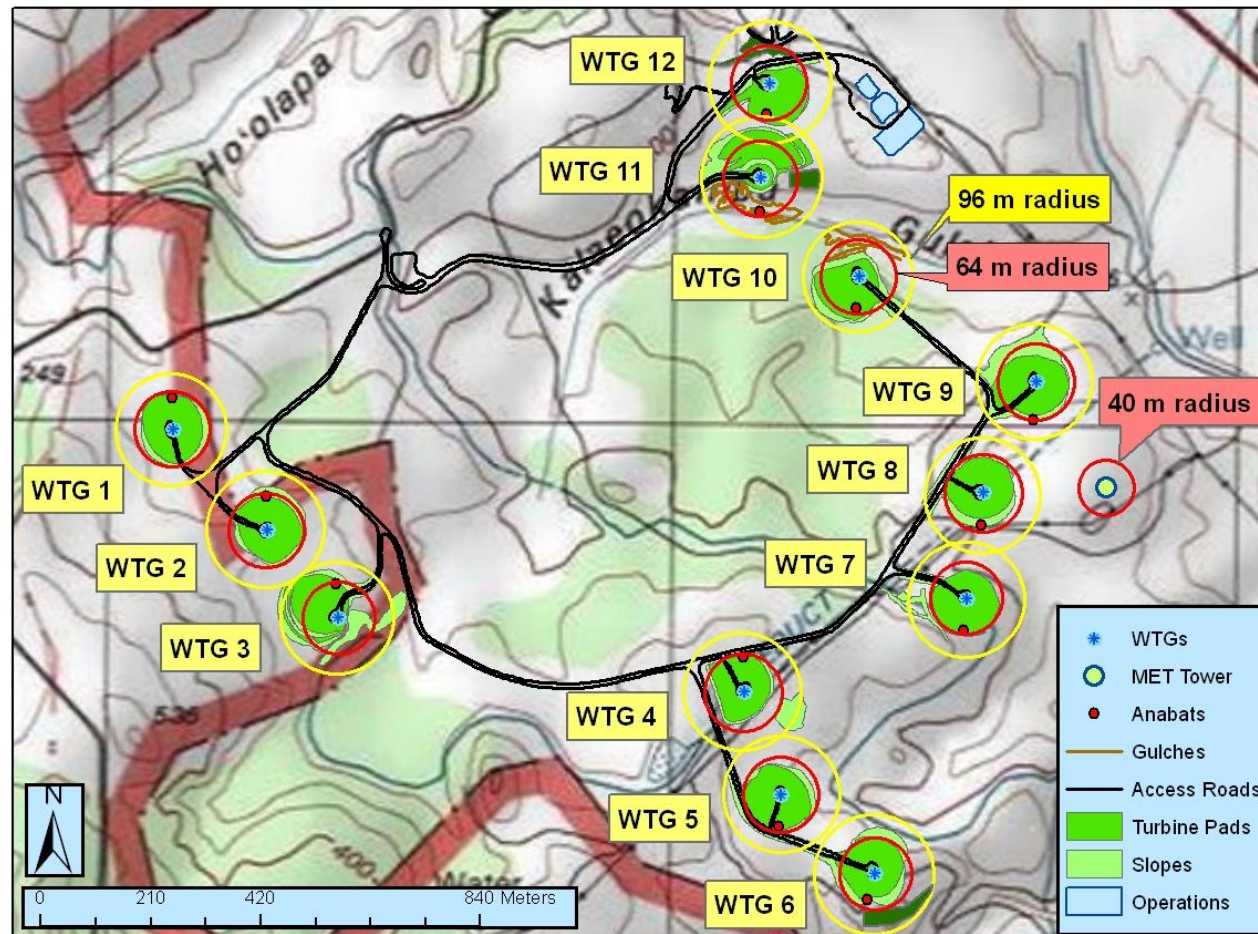
By the end of December 2010 the basic downed wildlife search plot perimeters and transect markers had been established. WTG search plot perimeters measure 64 and 96 meters from the base of the turbines, corresponding to 50 % and 75 % of the maximum rotor-swept height of the WTGs. The permanent meteorological tower (MET) is searched to a distance of 40 meters from the base, which corresponds to 50 % of its height (Figure 1).

Figure 1. Kahuku Wind Power roads, operation's buildings, WTG's, MET tower, fatality monitoring plots and Anabat locations.

Kahuku Wind Power biologists have deployed 12 Titley Scientific Anabat ultrasonic bat detectors (models SD1 and SD2) on site since January 2011 (locations shown in Figure 1). Each detector is approximately 55 meters from each WTG either north (facing southwest) or south (facing northwest) attached on wood or

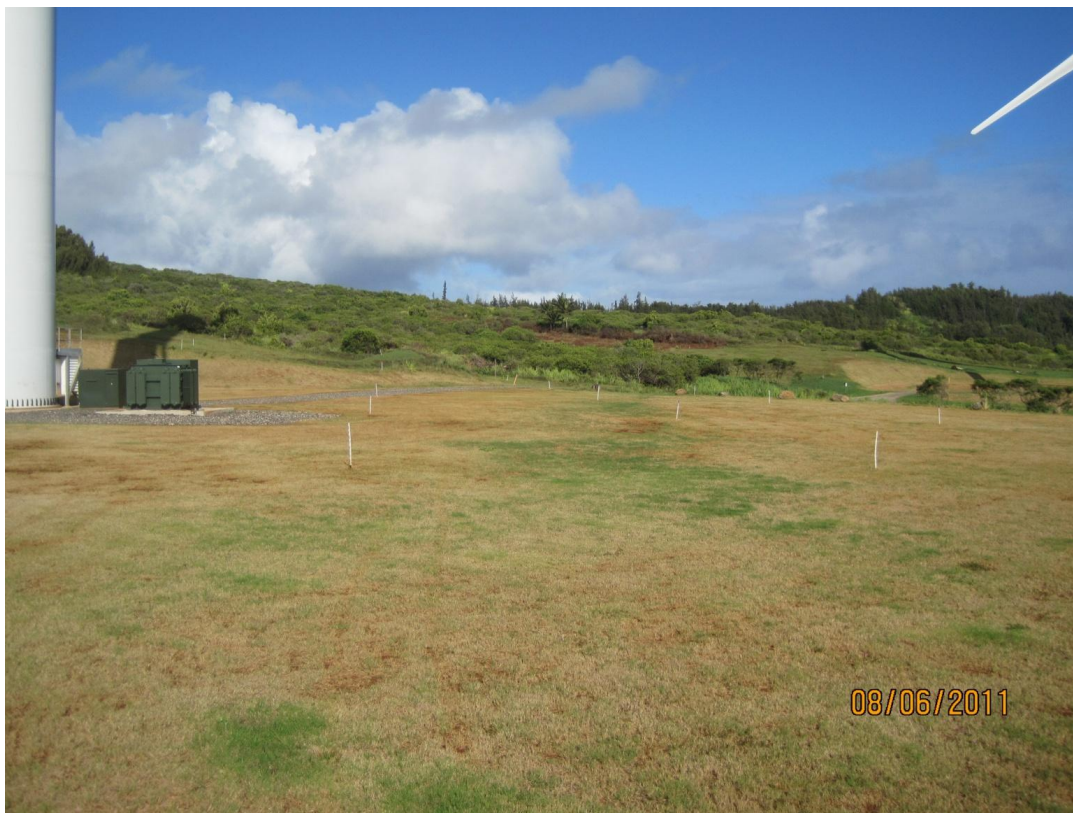
The marked straight-line transects within the search plots are spaced every 14 meters (Figure 2). When searching plots we follow these transect markers and unmarked transects half way between these markers so that the maximum distance between searched transects is 7 meters. Searching is conducted either by foot or all terrain vehicles (ATVs), by one or two persons. Slopes that are too steep to drive with ATV's are always walked horizontally along the slopes following transects that are also no greater than 7 meters apart.

Figure 2. Transect marking stakes at Kahuku Wind Power WTG 2. Staked rows are 14 meters apart.

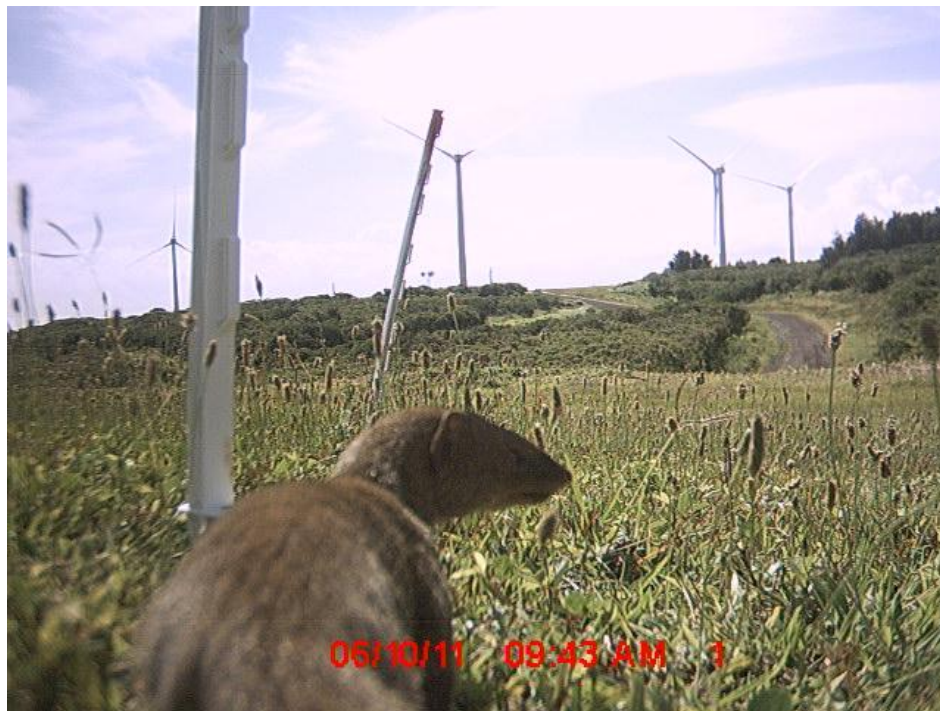
We use two motion sensing cameras (Moultrie Digital Game Cameras) during CARE trials in an attempt to record carcass scavenging. Photos taken at night show a mongoose and a cat scavenging trial carcasses (Figures 6 and 7). A Common mynah was photographed during the day in a swooping posture that suggested it was about to scavenge a rat visible in the foreground of the image (Figure 8). The rat was not seen in photos recorded 5 minutes later (or found anywhere in the vicinity in a subsequent search of the area) suggesting the mynah completely removed the rat. Cattle Egrets have also been recorded in photos near carcasses.

Figure 6. A mongoose visiting a CARE trial carcass near WTG 3 at Kahuku Wind Power.

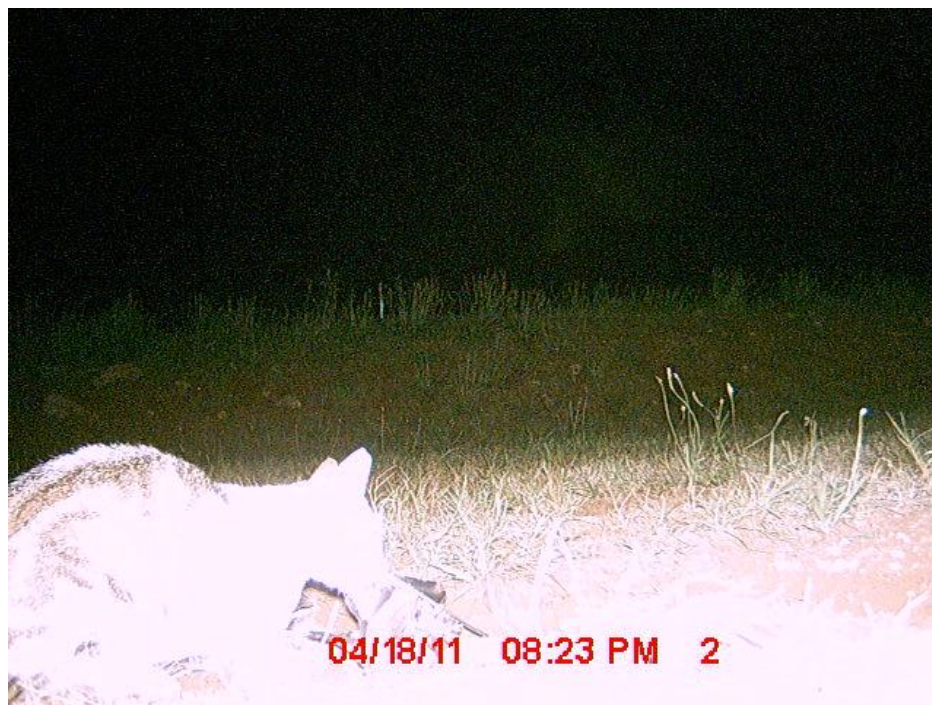
Figure 7. A feral cat eating a WTSH carcass near WTG 4 at Kahuku Wind Power.

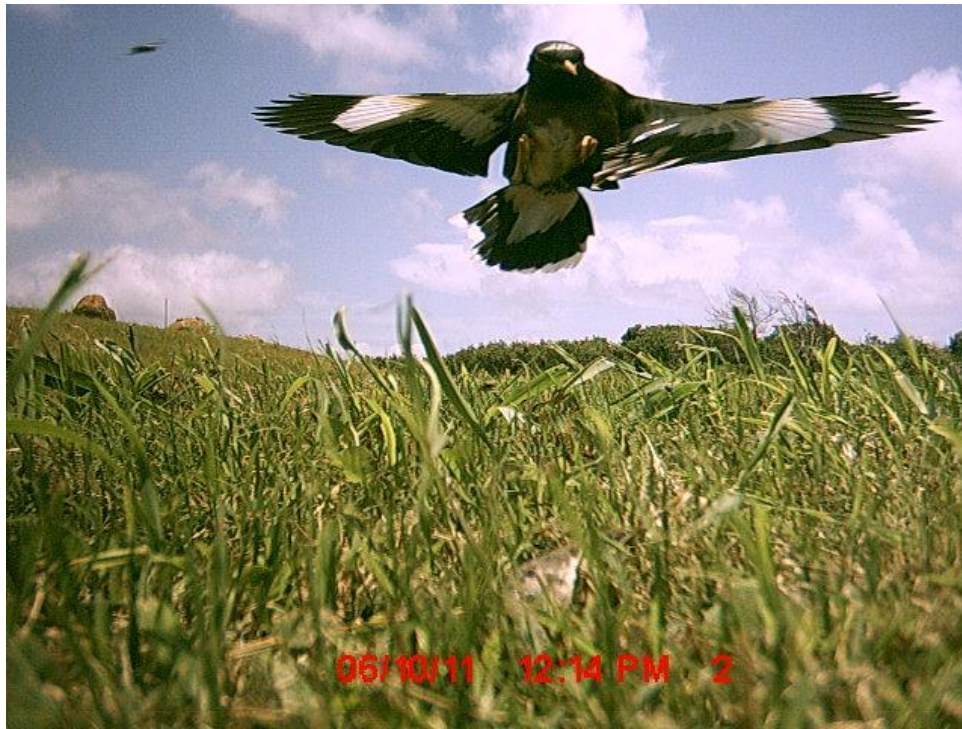
Figure 8. A Common mynah visiting a rat carcass (in the foreground) near WTG 1 at Kahuku Wind Power.

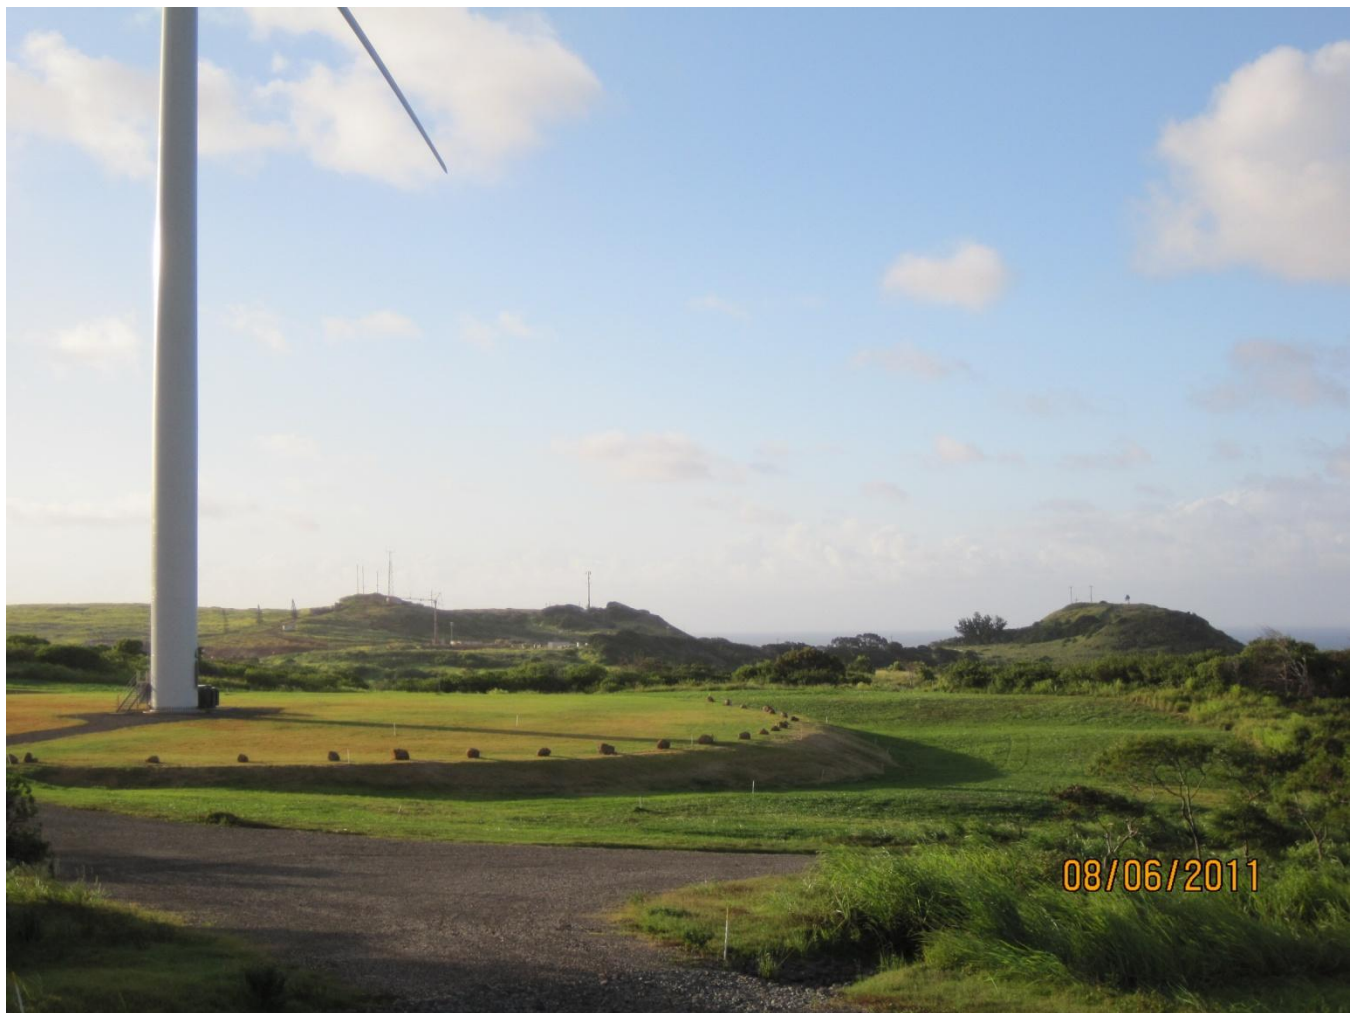
The HCP for Kahuku Wind Power stipulates that the fatality monitoring plots around the WTG's and MET tower be mowed every month. Monitoring staff have acquired 2 commercial turf mowers, a Caterpillar Compact Track Loader (CTL) with a brush cutter attachment, and commercial weed trimmers that facilitate meeting this obligation. Areas around the WTG's that are well-graded and flat (Pads) are mowed every 2-3 weeks to 2.25 inches (Figure 10). Graded slopes that cannot be mowed are weed trimmed to 2-3 inches. Other areas outside the pads and graded slopes (Offpads) are mowed with the turf-mower at 2.25 to 4 inches and /or brush cut-mowed with the CTL to 2 to 5 inches every 3 to 6 weeks. Herbicides (glyphosate) have also been used to retard growth.

Figure 10. WTG 1 pad, slope and offpad at Kahuku Wind Power.

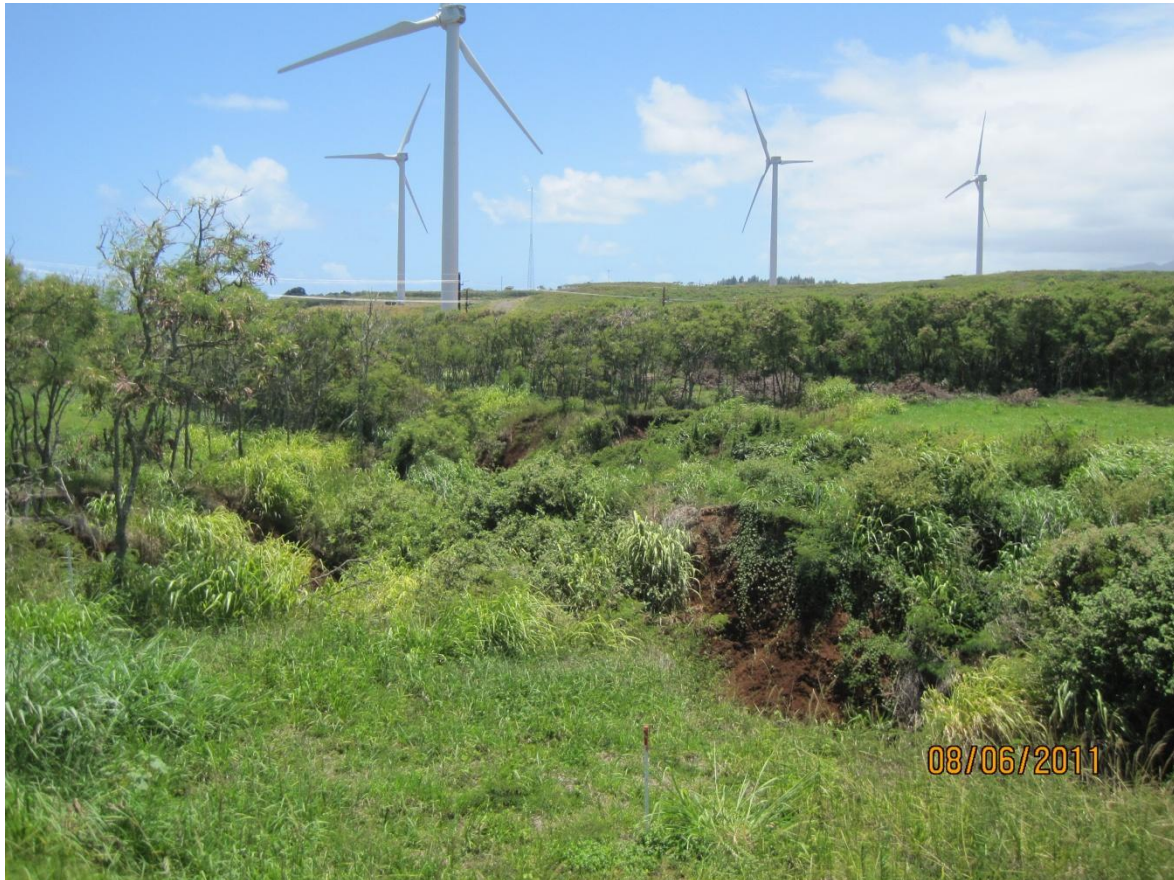
Prior to the end of construction, most trees (primarily Koa Haole, Ironwood, and Christmasberry) were mulched within the fatality plots. Areas with trees remaining post-construction have been gradually removed and chipped over subsequent weeks, with the goal of ultimately making it possible to manage all vegetation within the search plots. The Kalaheokahipu Gulch that passes through the WTG 10 and 11 fatality monitoring plots is considered unmanageable and adjustments to take of covered species will be made to account for fatalities that may occur but are not recovered from this unsearchable area (Figure 11).

Figure 11. Kalaheokahipu gulch near WTG 11 at Kahuku Wind Power.

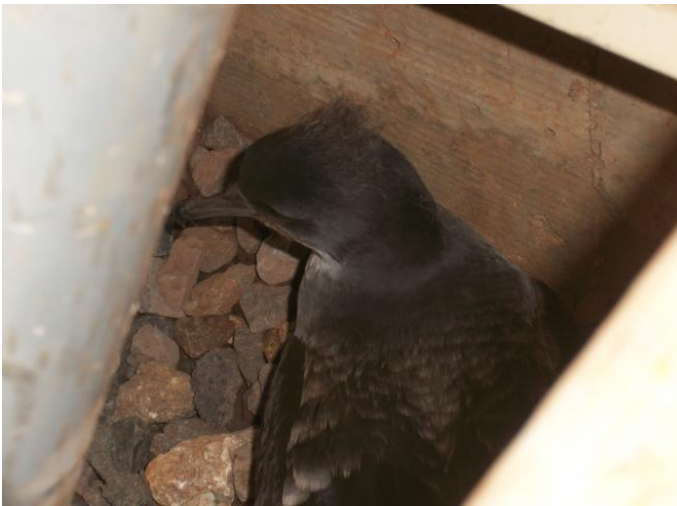
Condition of Specimen: No injuries, apparently in good condition. The bird was hiding in a shaded corner out of direct sunlight behind some PVC pipes on the south-west facing side of the BESS building (Fig. 1).

Figure 1. Wedge tailed Shearwater.

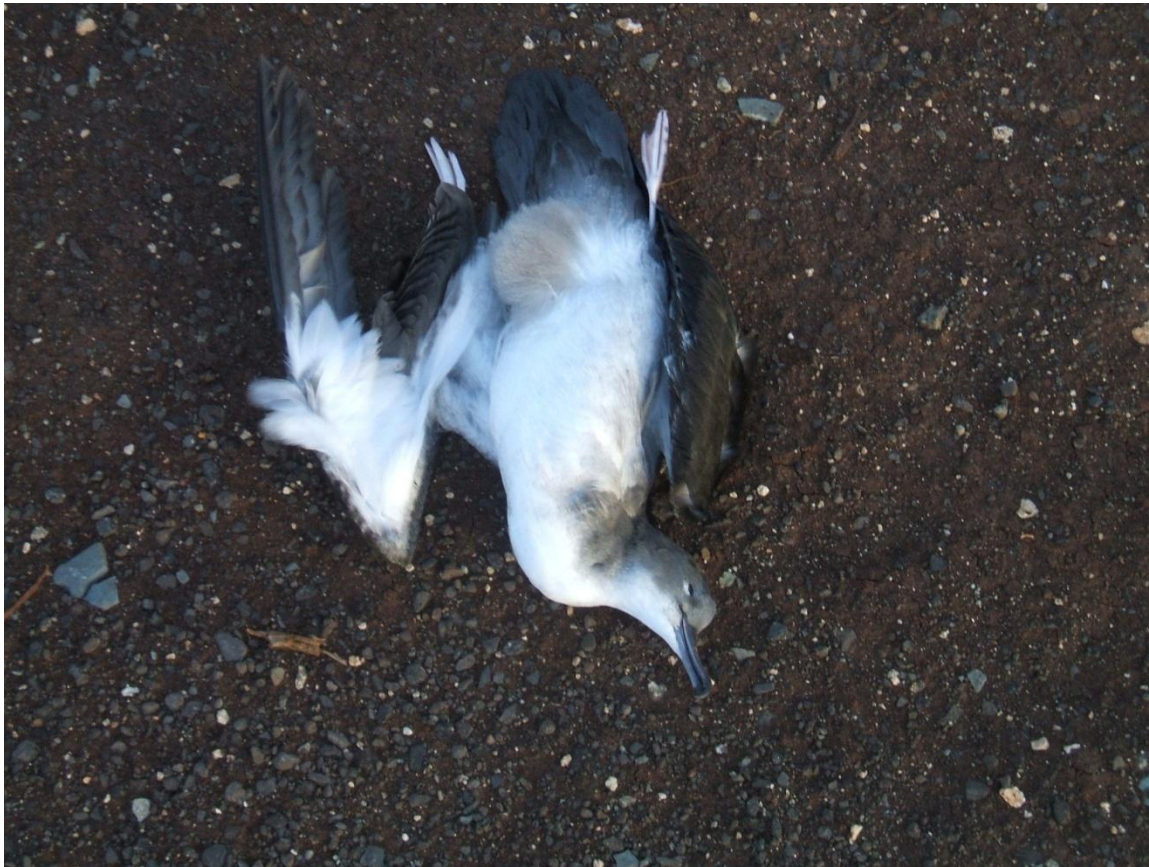
Date:	12/3/2010
Type of Discovery:	Incidental
Discovered by:	Steve Yoshida
Affiliation:	Siemens Engineering (contractor)
Species (Common name):	Wedge-tailed Shearwater (fledgling)
Time Discovered (HST):	21:00 12/3/2010
Time Initially Reported to Agencies (HST):	11:00 12/4/2010
Time Agency Responders Arrive/Advise (HST):	12:40 12/4/2010
Location Description:	In the middle of the access road to WTG 11
GPS Coordinates:	21° 41.171' N 157° 58.471' W
Date Last Surveyed:	11/30/2010
Distance of Carcass to Base of Nearest WTG:	68 m (WTG 11)
Bearing of Carcass from Base of Nearest WTG:	272°
Ground Cover Type:	Bare ground
Wind Direction and Speed (mph):	East 15-20
Cloud Cover (%):	10
Cloud Deck (magl):	-
Precipitation:	0
Temperature: (°F)	78
Condition of Specimen: Recently dead; no evidence of insects or decomposition. No external trauma or broken tissue observed (Fig. 1).	
Probable Cause of Injuries and Supportive Evidence: The location of the WTSH directly downwind of WTG 11 suggests it may have collided with the stationary turbine. Limited construction work lights were on from 18:30 to 20:30 on 12/3/2010 around the base of the overhead transmission line poles where work was being conducted (Fig. 2). It is possible the bird may have been attracted to the vicinity by these lights. SWCA biologists were on site for the duration of the night work and no birds or bats were observed around the lights.

Figure 1. Downed Wedge-tailed Shearwater.

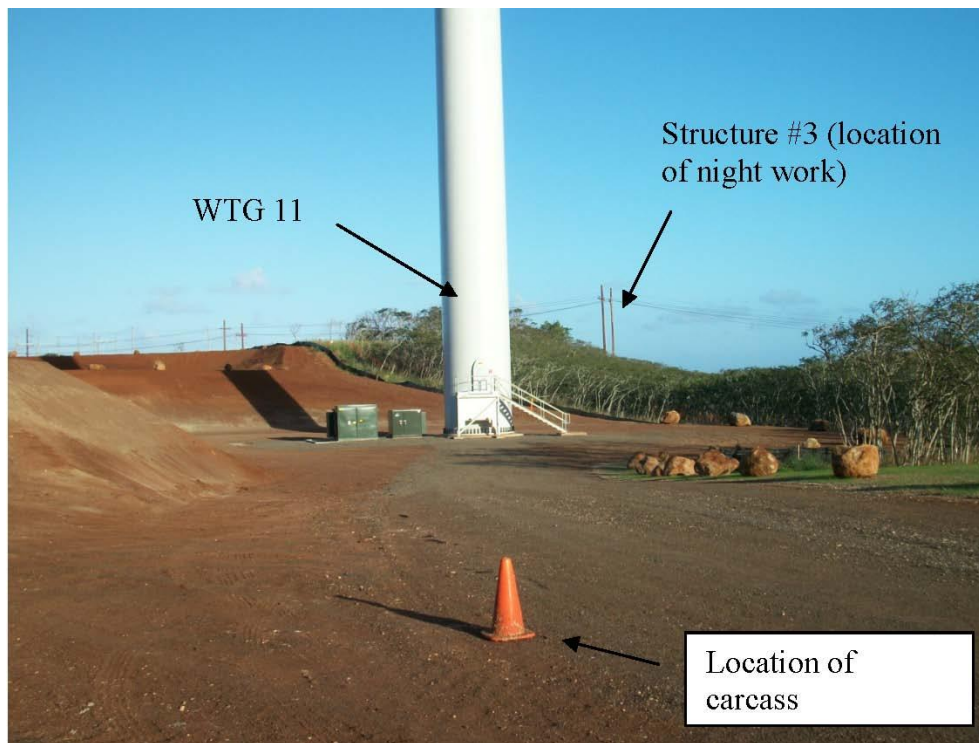
Figure 2. Photo of the carcass location looking ESE relative to light source and WTG 11.

This incident occurred just 2 days after an earlier incident involving a downed, but uninjured, Wedge-tailed shearwater. Light attraction was considered a possible factor in the previous incident due to ongoing night work in the vicinity of the substation facility. First Wind immediately advised all contractors that night-time work would be limited to time-critical activities and outdoor lighting be restricted to the minimum necessary, and directed downward. In addition, SWCA biologists were assigned to monitor all activities associated with night work. During the time the incident occurring no birds or bats were observed in the immediate or surrounding area while work was underway.

Night work was suspended at Kahuku for the next two nights following the second incident, and all lights were turned off and gates locked during that time. Night work has subsequently been allowed to proceed **indoors only**, with all outdoor lighting turned off.

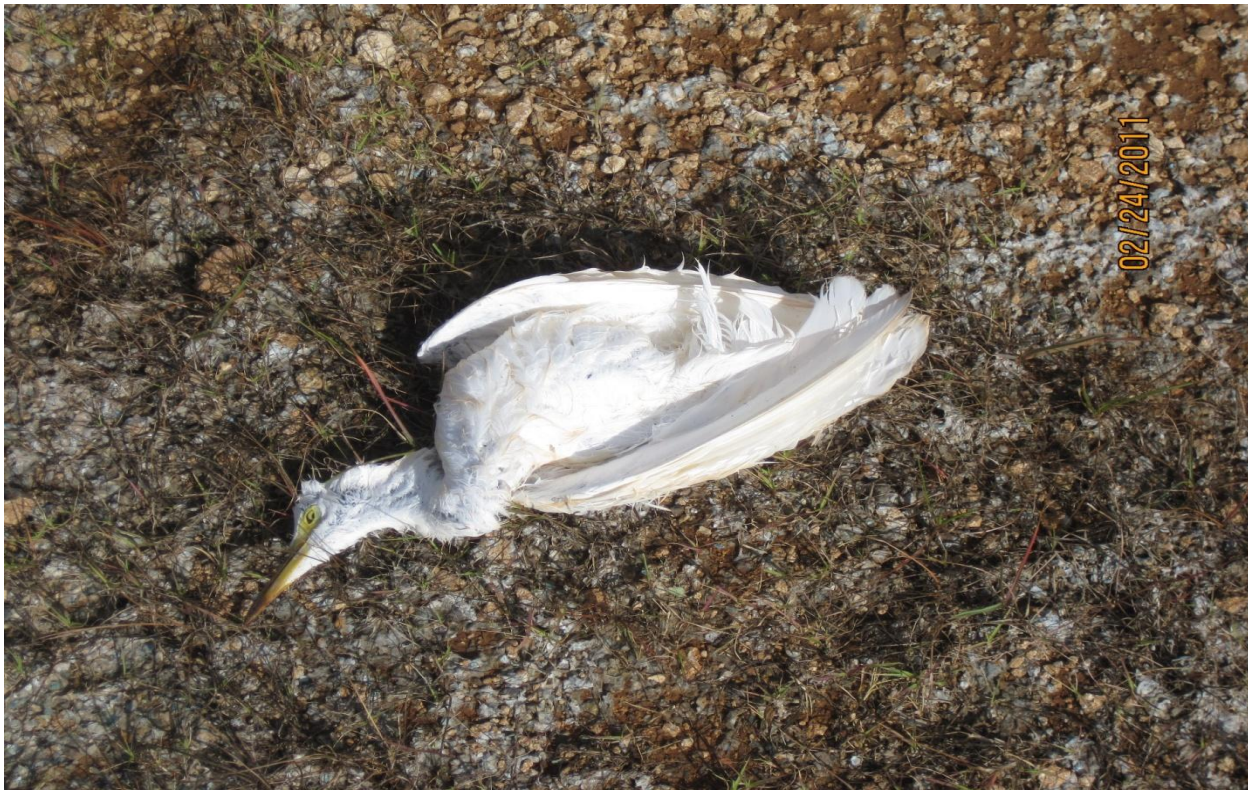
Observer Name	Paul Crossland
Date	February 24, 2011
Species (common name)	Cattle Egret
Time Observed (HST)	09:30
Time Initially Reported (HST)	
Time Responders Arrive (HST)	
Location	WTG 8
GPS Coordinates (specify units and datum)	21° 40'51" N, 157°58'12" W WGS84/UTM
Date Last Surveyed	February 23, 2011
Distance to Base of nearest WTG (m)	13
Bearing from Base of nearest WTG	South
Ground Cover Type	Bare
Wind Direction and Speed (mph)	South, 5-10
Cloud Cover (%)	10
Cloud Deck (magl)	>1000
Precipitation	0
Temperature (°F)	75
Condition of Specimen: Fresh. One leg was completely severed. The severed leg was 10 meters from the body (23 m from the turbine base).	
Probable Cause of Injuries and Supportive Evidence: Contact with turbine blade- severed limb.	
Action Taken: First Wind construction manager Paul Crossland found this carcass and immediately reported to Mitchell Craig at 09:30, February 24, 2011.

Figure 2. Dead Cattle Egret at WTG 8.

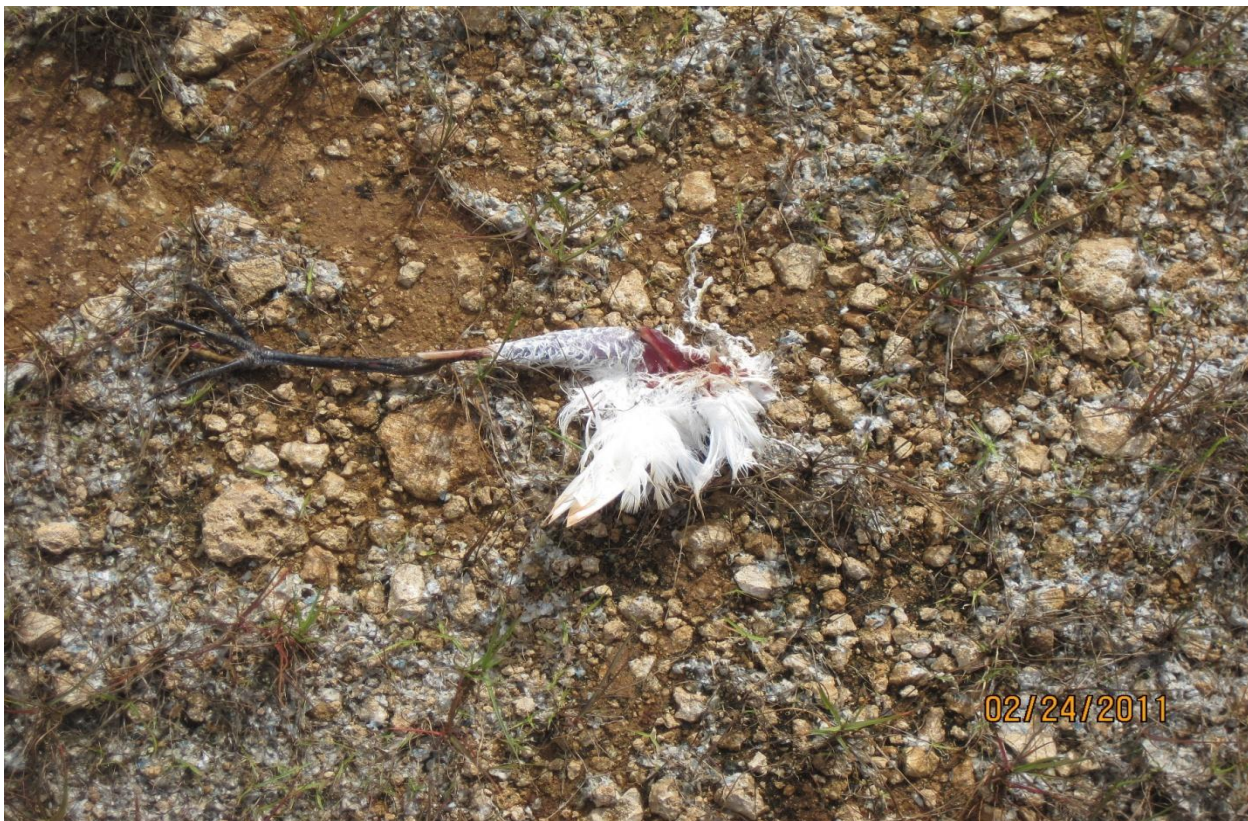
Figure 3. Cattle Egret leg severed.
