# **Kaheawa Wind Project II Habitat Conservation Plan FY 2020 Annual Report**

September 2020

**Incidental Take License ITL-15 / Incidental Take Permit TE27260A-1**

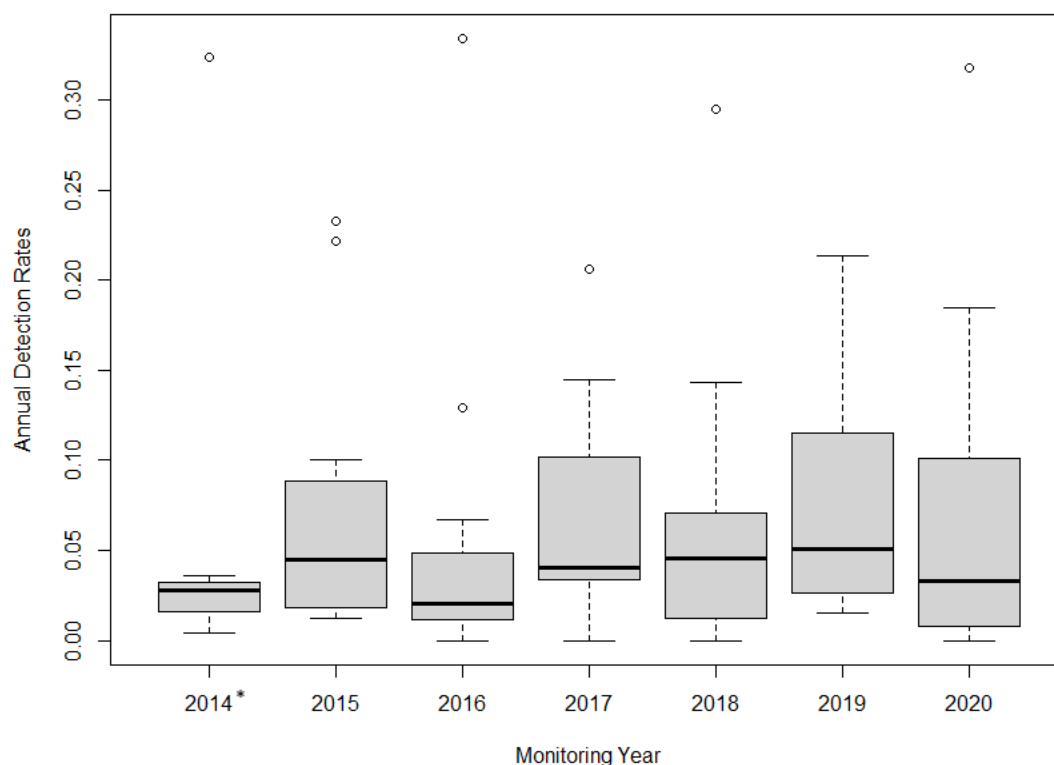
\*data from FY 2014 includes October 2013 through June 2014, missing July-September, which are typically peak activity periods.

**Figure 2. Annual Variation (Box Plots: Median, Interquartile Range and Outliers) in Bat Detection Rates at KWP II from FY 2014 to FY 2020**

Among all monitoring years, annual detection rates were consistently low regardless of variation in the sampling effort (Table 3); with no significant difference in the annual detection rates among years (Figure 4; FY 2015 – FY 2020; ANOVA:  $F_{5,18} = 0.14$ ,  $P = 0.981$ ). Across the FY 2015 to FY 2020 monitoring years there is a slightly increasing trend in the annual detection rate, although not significant (LM:  $R^2 = 3.77\%$ ;  $F_{1,18} = 0.38$ ,  $P = 0.545$ )

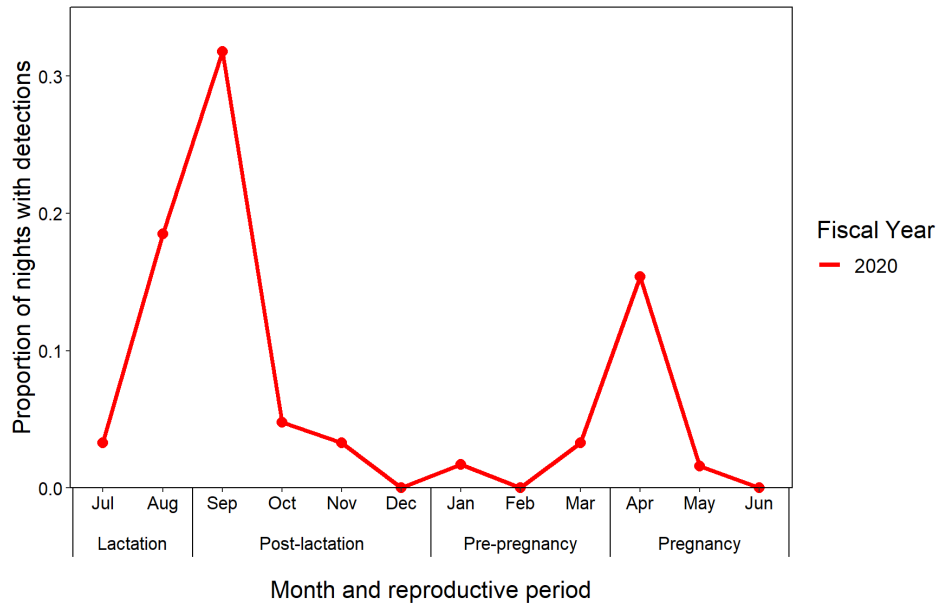
**Figure 3. Monthly Detection Rates at Kaheawa II in FY 2020 with Corresponding Reproductive Periods**

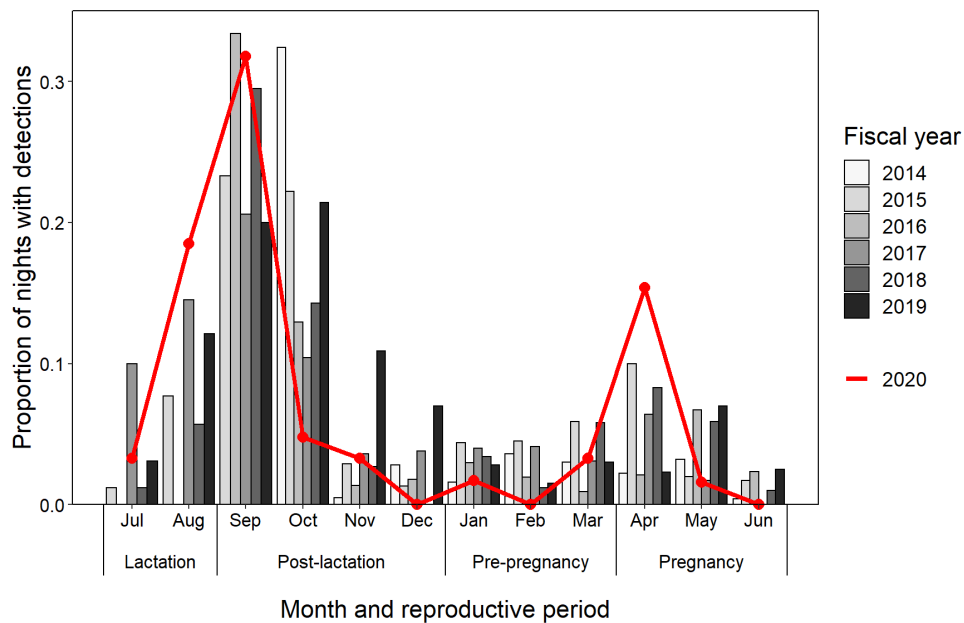
**Figure 4. Monthly Bat Detection Rates at Kaheawa II for FY 2014 to FY 2020 with Corresponding Reproductive Periods**

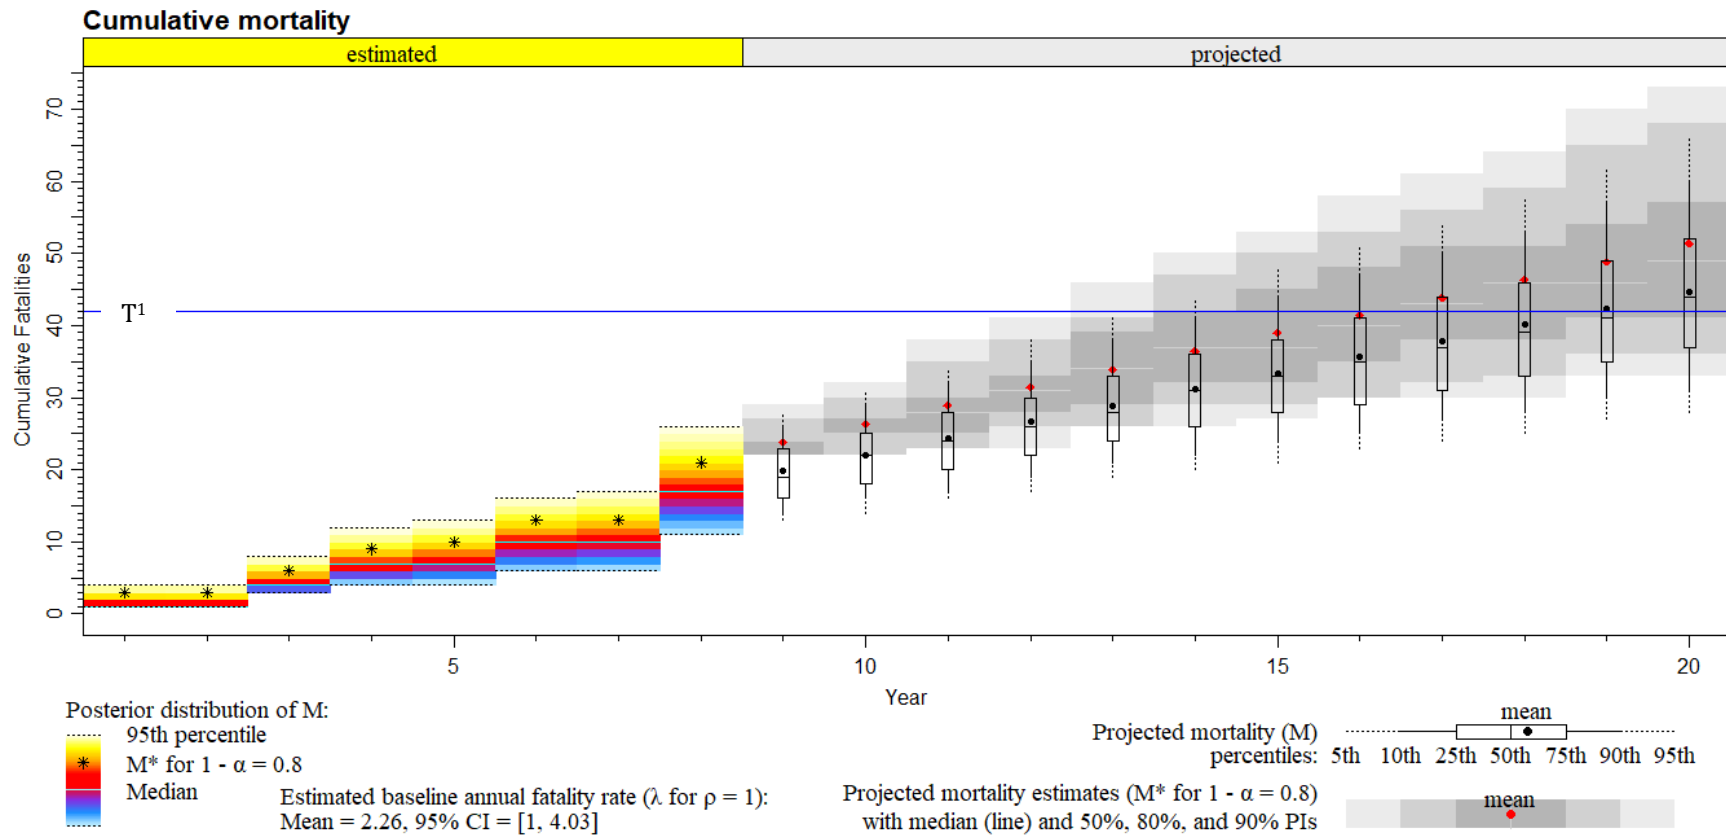
### Appendix 3a. Projected Cumulative Mortality for the Hawaiian Goose at the Project

1. Permitted take for the Hawaiian goose at the Project 44; however, take as calculated from EoA only includes direct take. To account for indirect take in this figure, an approximate take threshold (T) of 42 is shown, representing requested authorized Hawaiian goose take (44) minus 2 adult equivalents of indirect take (4.5 percent of the requested authorized limit). Currently, the proportion of total take that is attributable to indirect take is 3.7 percent.

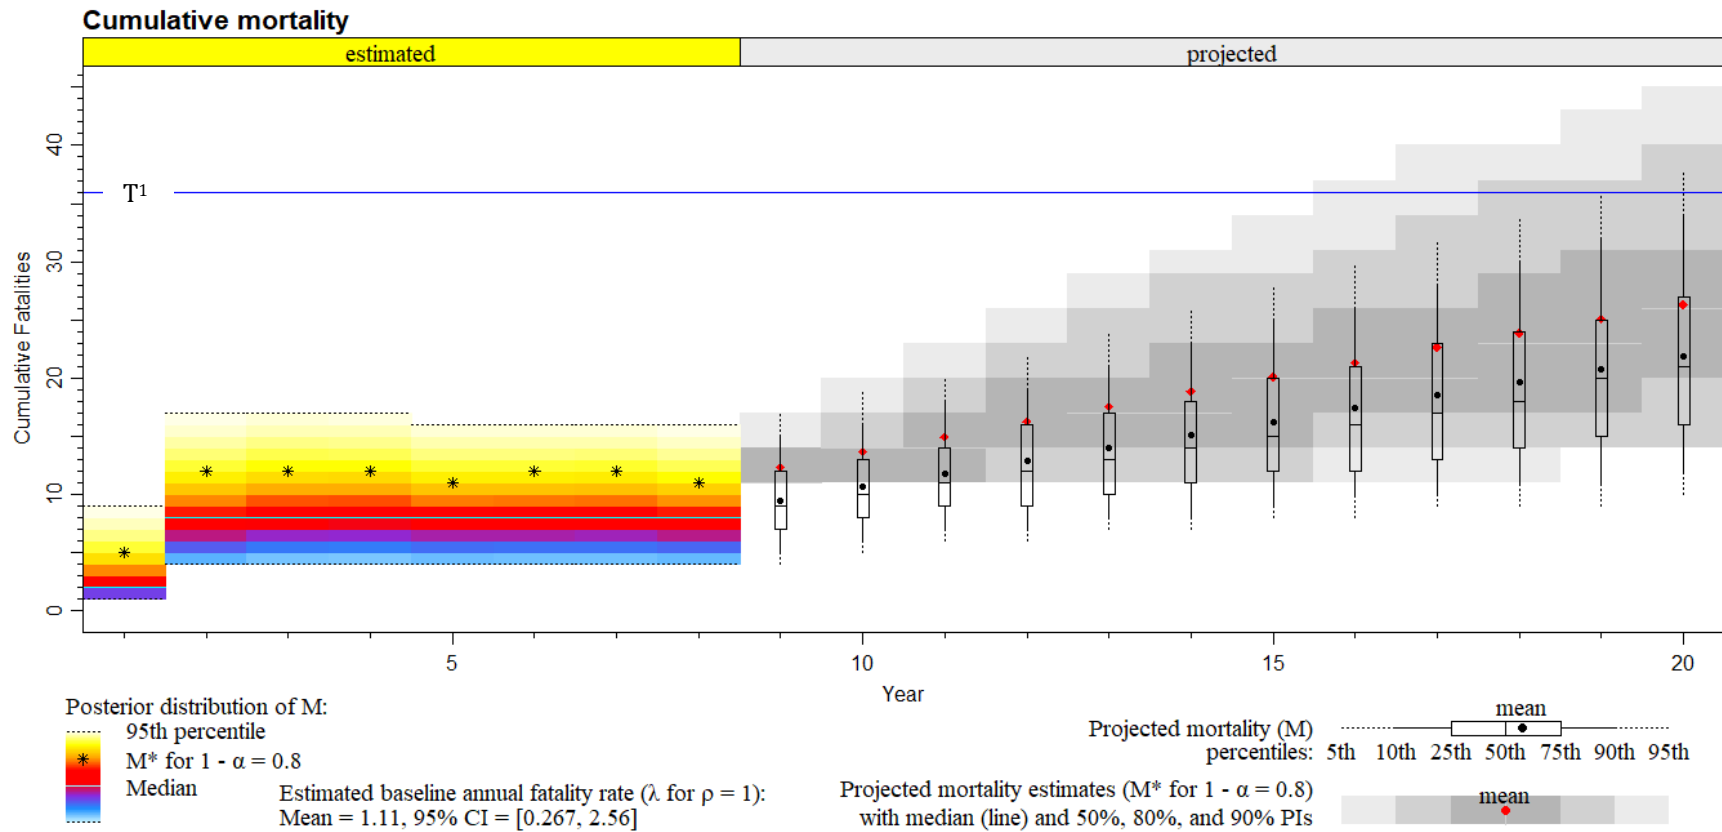
### Appendix 3b. Projected Cumulative Mortality for the Hawaiian Hoary Bat at the Project

1. Permitted take for the Hawaiian hoary bat at the Project is 38 under the HCP. Take, however, as calculated from EoA only includes direct take. To account for indirect take in this figure, an approximate take threshold (T) of 33 is shown, representing authorized bat take (38) minus 5 adult equivalents of indirect take (13.2 percent of the requested authorized limit). Currently, the proportion of total take that is attributable to indirect take is 4.3 percent.

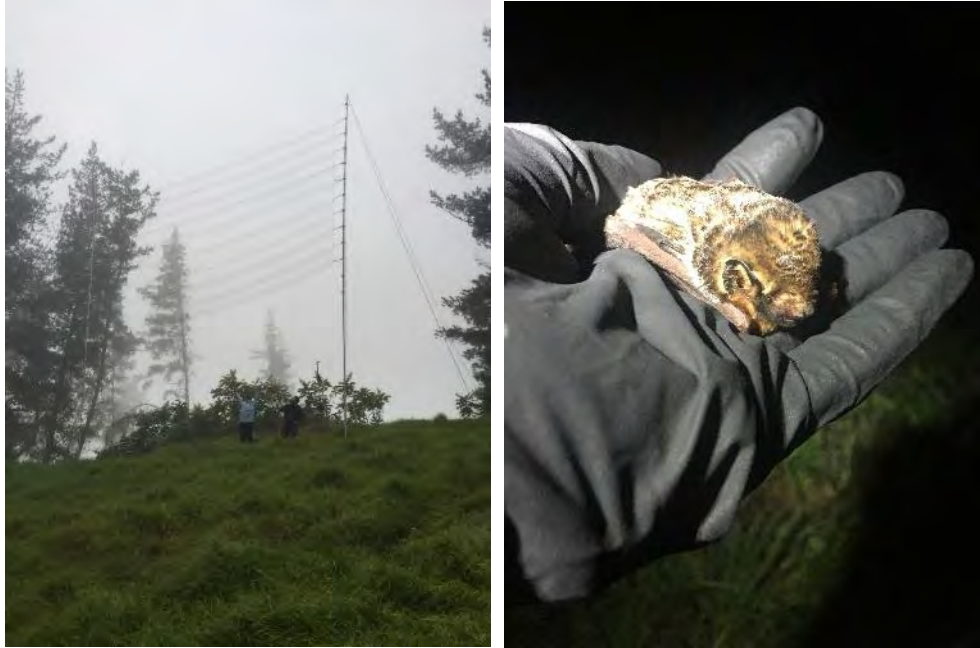
**Figure 2.** Mist nest set up to capture Hawaiian hoary bats (left) and captured bat (right).

Bat mist netting was conducted during 155 nights from 14 May 2018 to 24 July 2020 (2018: 36, 2019: 87, 2020: 32); bats were captured on 57 of these nights (Figure 2). Eighty-six individuals were captured and from all individuals tissue and hair samples were collected and morphometric measurements and reproductive status recorded. All bats were marked with unique color-coded bands. Radio-telemetry tags were affixed to 81 individuals. Additionally, six individuals were captured twice, four of which were radio-tagged twice.

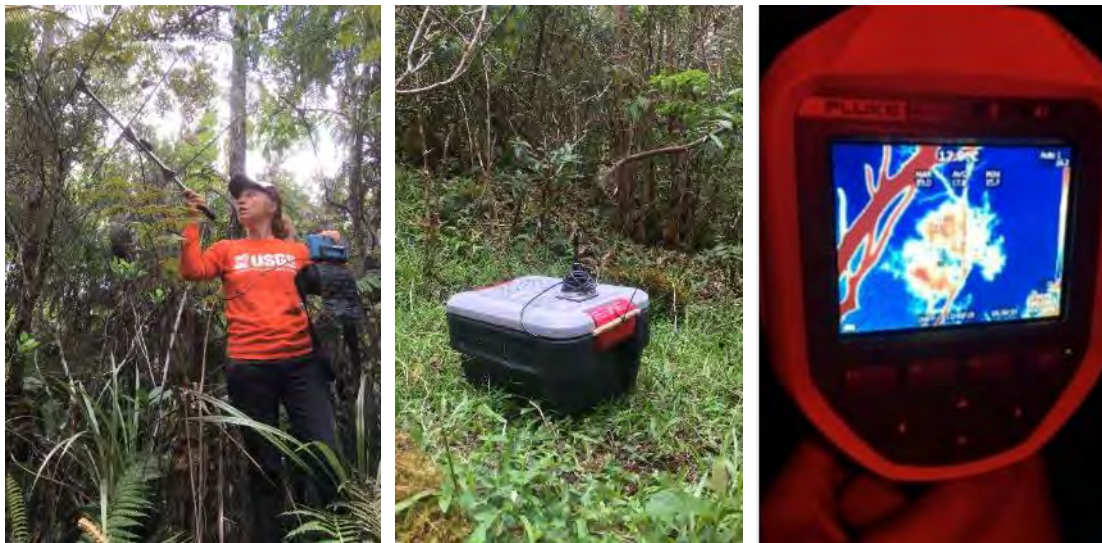
**Figure 3.** Radio telemetry effort to located day roost tree (left). Automated receiver station used to measure roost fidelity (middle). Thermal imager used for searches for roosting bats (right).

Roost ecology studies were a primary focus of field efforts during years one and two of the project. Once individuals are captured and radio-tagged, efforts to track the individual to a day roost tree commence within one day. Dense forest vegetation and a limited road network creates extremely difficult conditions for tracking individuals to their day roost resulting in significant effort devoted to this work. Radio telemetry (Figure 3) has been used to date to track a total of 22 bats to a day roost tree; an additional 32 bats have been tracked to the forest stand of their day roost (Figure 4). Three maternity roosts were confirmed in 2019 and three in 2020, and the number of pups is evaluated by repeat observations at each maternity roost (Figure 5). The maternity roosts have been monitored on a weekly basis using acoustic and thermal video recordings to obtain information on roost fidelity, the time of roost emergence/return, the within-night frequency and duration of foraging flights, time to pup fledging, and presence of potential predators (Figure 5). Regular monitoring of select non-maternity roosts is also being conducted to check for returning individuals to document fidelity and identify opportunities for video monitoring (Figure 6). Where possible, roost fidelity of bats with active radio tags is monitored using an automated receiver station near the roost (Figure 3). Data from these systems have been collected and downloaded at 21 tree or stand-level roosts since May 2019, when the system was first used.

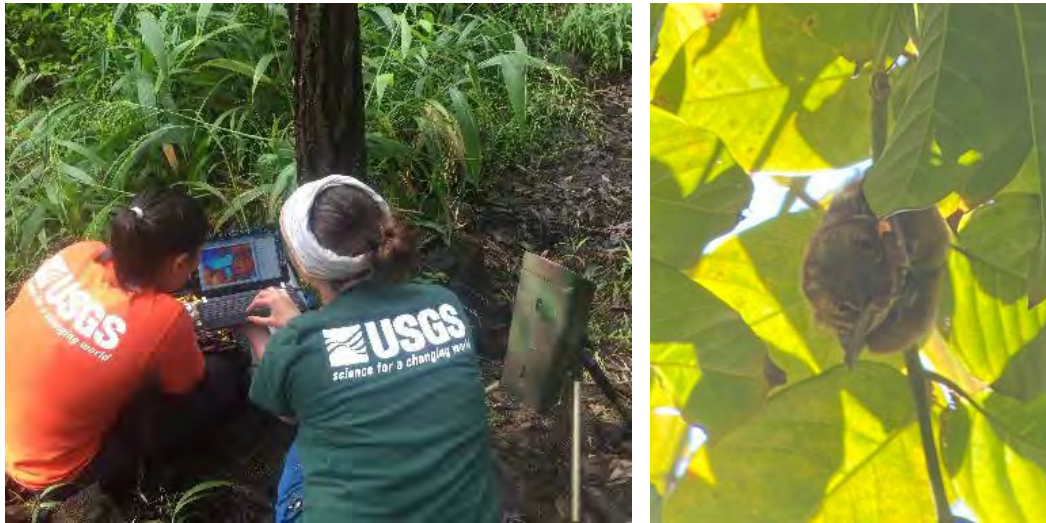
**Figure 5.** Thermal video camera deployment at maternity roost (left). A mother Hawaiian hoary bat with two pups observed during maternity roost monitoring (right).

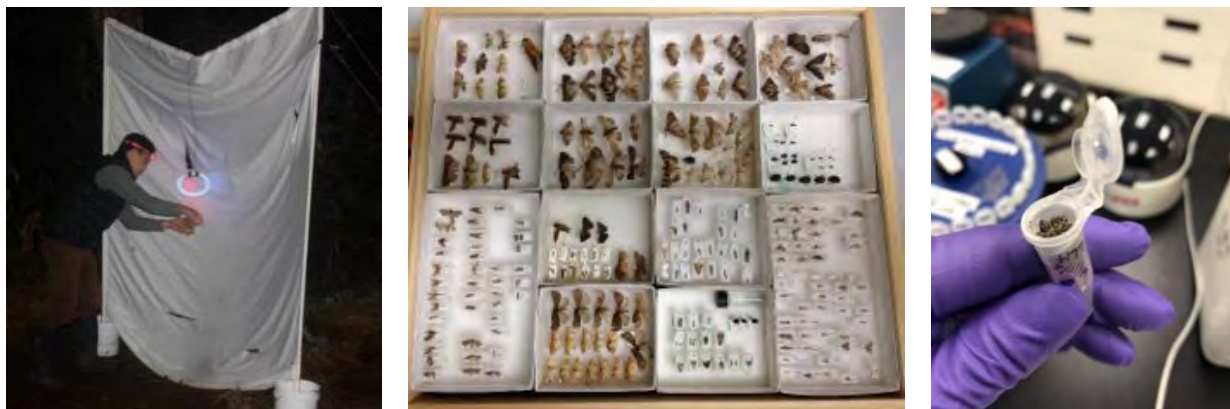
**Figure 7.** Insect collection using UV light trap (left). Potential bat prey collected and identified (middle). Hawaiian hoary bat guano sample being prepared for genetic meta-barcoding (right).

Insect collection commenced in February 2019. Nocturnal flying insects are collected using light traps (Figure 7) run at each fixed collection site concurrently with mist netting. Insect collection is conducted during two nights in each sampling cycle (i.e., 16 nights per cycle). Insects are categorized by size class and identified to the highest possible taxonomic classification; this lab work is underway (Figure 7). Additionally, DNA extracted from potential prey items have been and will continue to be submitted for genetic meta-barcoding to establish a reference library of potential bat prey items.

To identify bat prey, genetic meta-barcoding of guano samples is being conducted, and a bioinformatics approach used to match bat prey items in with the reference library (above) and public databases (see Pinzari et al. 2019). To date, 59 guano samples have been collected. Lab work to begin analysis of these samples commenced in early 2020 and is on-going (Figure 7). Genetic barcoding of potential insect prey commenced in June 2020 and is on-going.

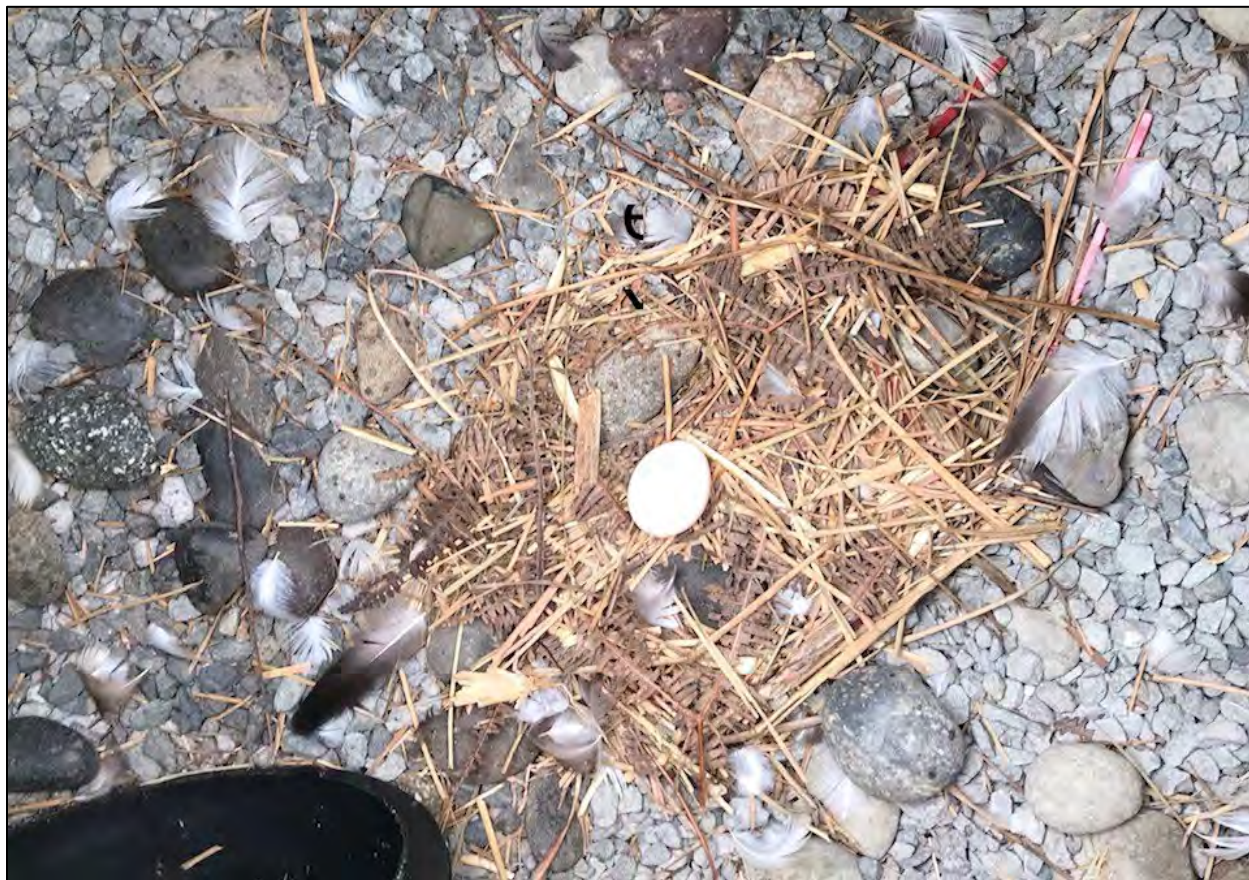
**Figure 1. Egg Observed at B-50 during Pre-Season Nest Box Inspections in Early March, 2019, and Believed to Belong to Bulwer's Petrel (or Related Species)**

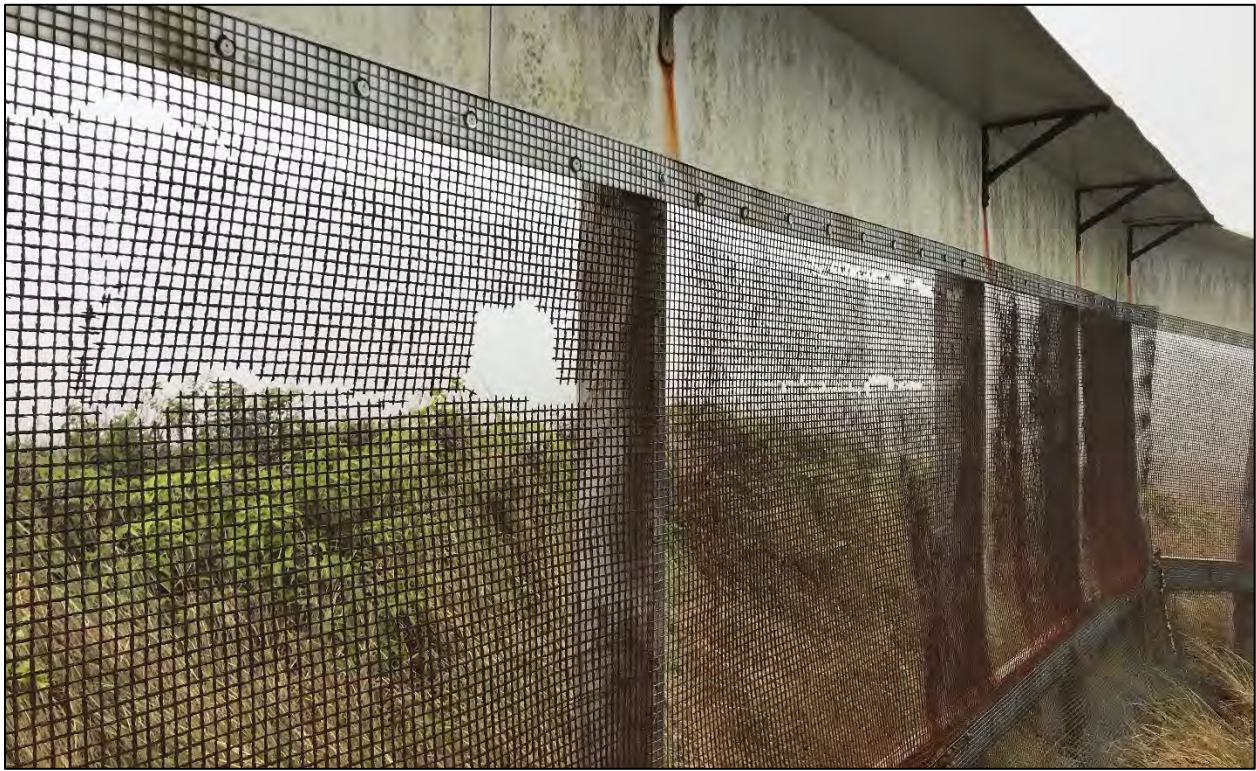
structure, threatening further damage and potential for unwanted breaches. Interim repairs to correct this damage are in progress and recommendations for additional fence repairs needs are outlined below.

**Figure 2. Fence Damage Caused by Excessive Rust Detected in August 2019**

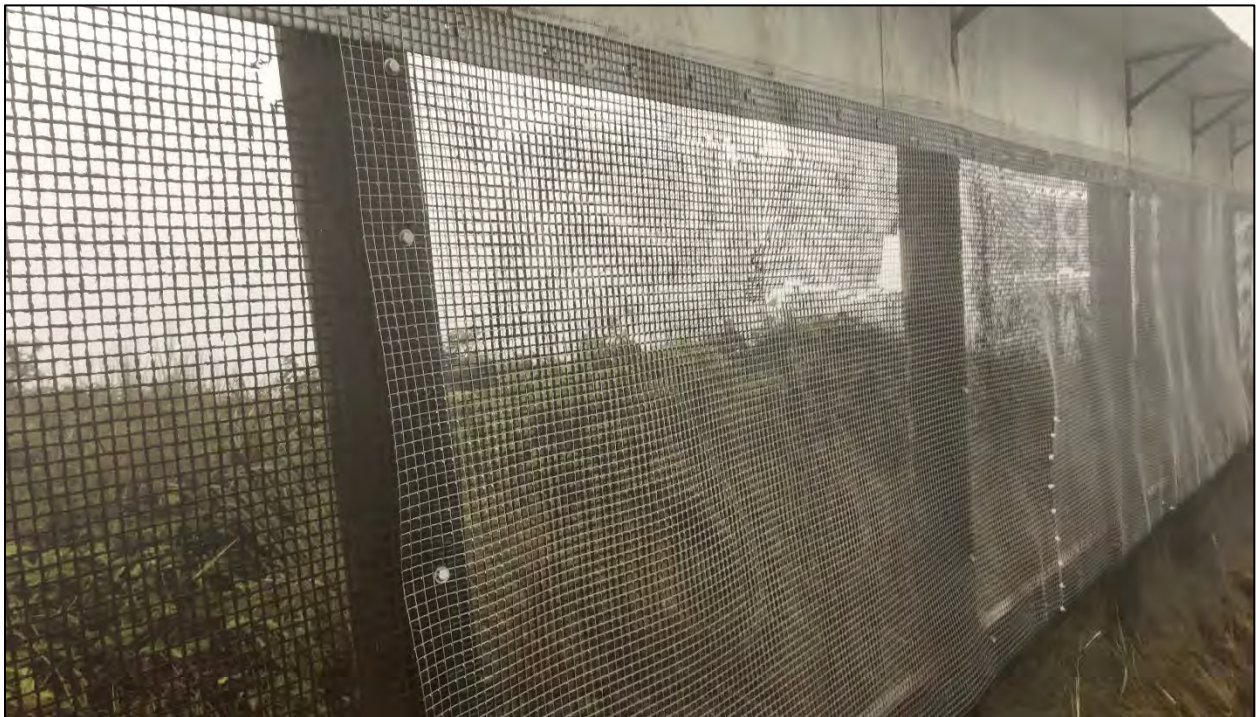
Until early August 2019, most interim repairs were limited to patching and plugging small holes, cracks, or crevices that sometimes form around the margins of the culverts. Numerous older brackets contain rust, and while quite a few have been replaced, especially in the lower sections of the enclosures (mostly Enclosure A), many brackets remain in need of replacement. We replaced some brackets based on the severity of rust and corrosion indicating a need for immediate repairs. The mesh on the windward (east) upper side of Enclosure A contains a substantial amount of rusted brackets and there are portions of the mesh that have become severely rusted. High winds in August caused mesh failure on two joining panels and we installed two new 25-foot long sections of mesh over the entire worn portion to ensure that any further disintegration of the original meshing would not result in a breach (Figures 2 and 3). Similarly, we replaced several brackets in this section to reinforce the connection to the adjacent hood.

**Figure 3. Fence Repairs Implemented in August 2019**

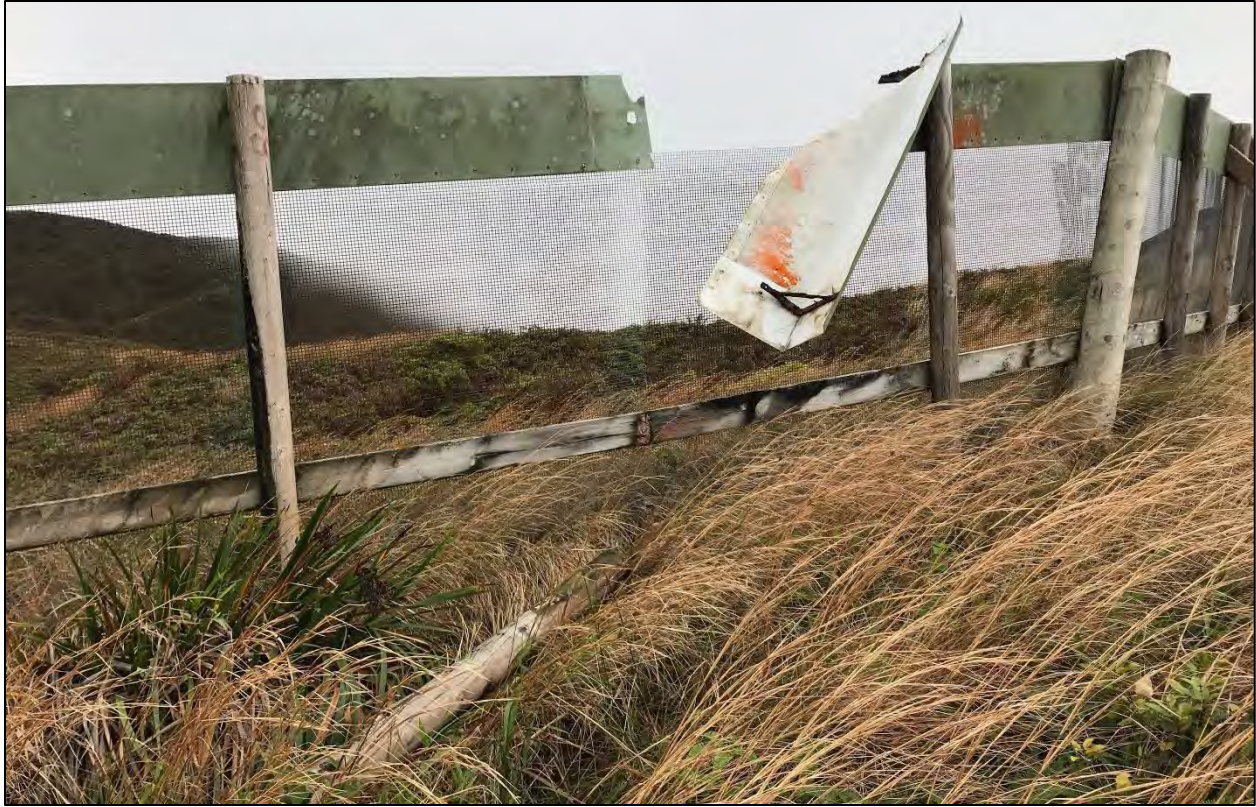
Figure 4. Damaged Section of Fence Detected in December, 2019

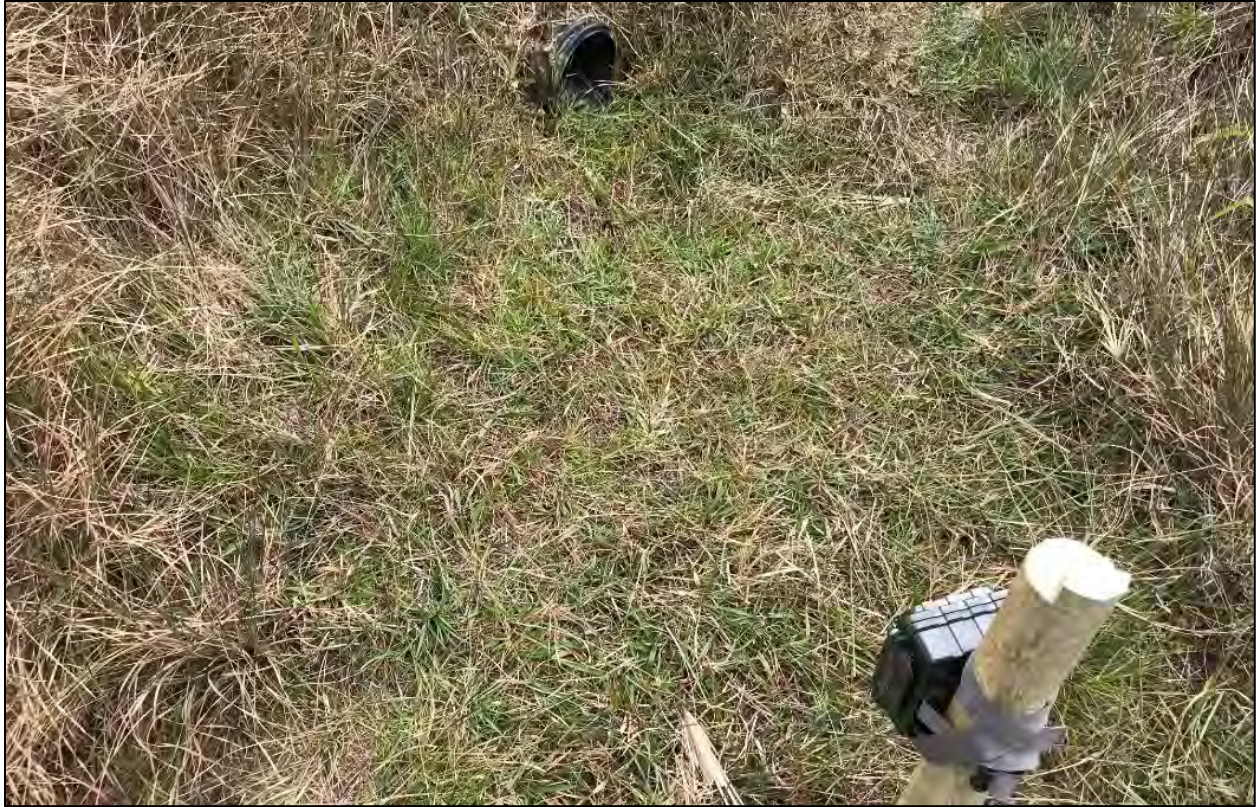
Data obtained with game cameras were entered into a data base, useful in characterizing the activities of seabirds associated with active nesting burrows. Behavioral changes observed over the course of the season were useful indicators of breeding status and the relative likelihood that pairs were involved. Such behaviors can indicate breeding, incubation, and/or chick provisioning, or whether birds visiting specific nest sites may have been simply prospecting or establishing their claim on nest sites that would be used for breeding in subsequent seasons.

Figure 5. Reconyx HyperFire 2 Camera Monitoring an Active Newell's Shearwater Nesting Burrow at Makamaka'ole in 2019

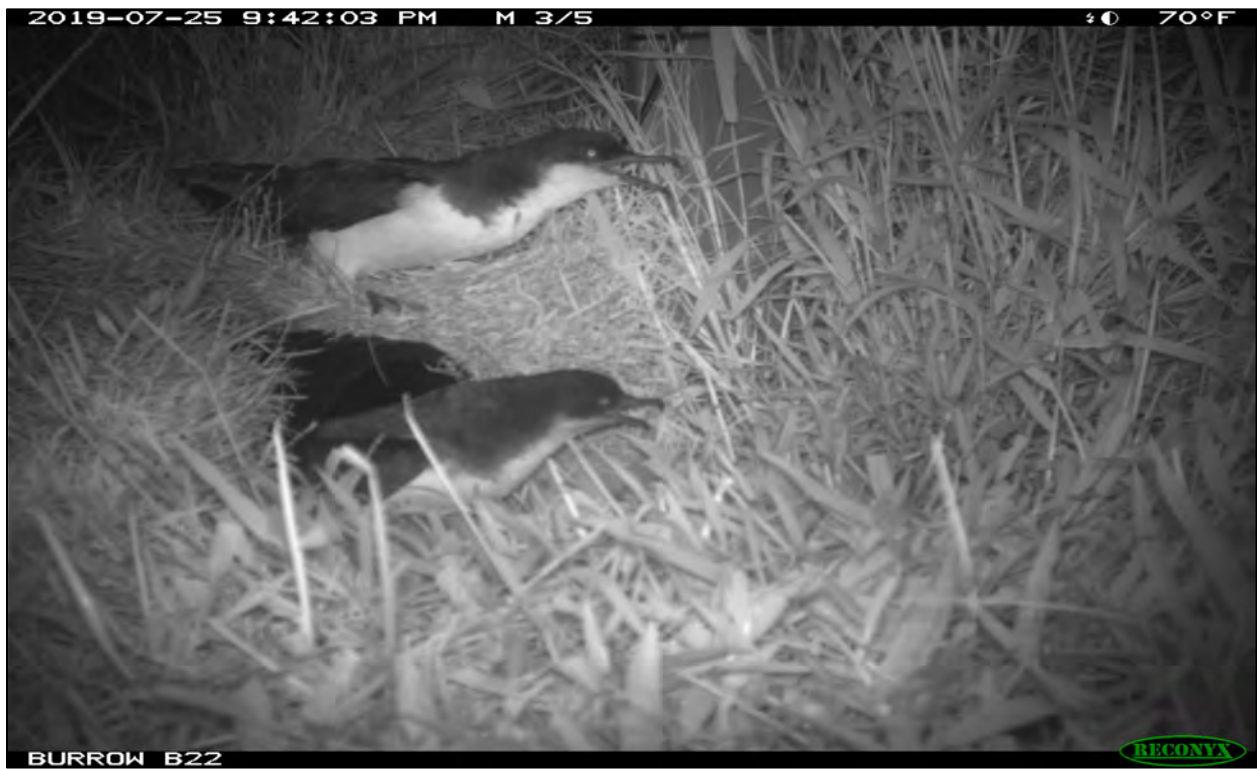
Figure 6. A Pair of Newell's Shearwaters Active at One of the Burrows in Enclosure B; the Camera was Positioned at this Site to Capture a Broader Field of View

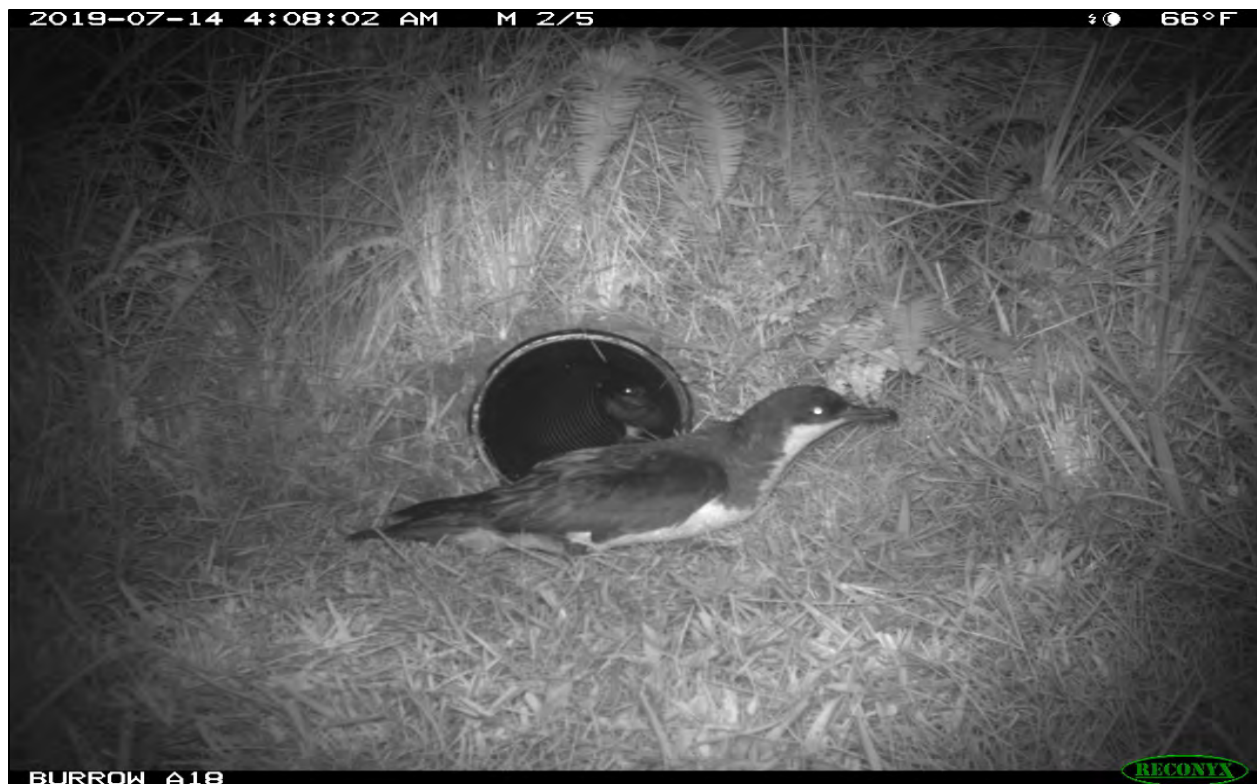
Figure 7. Newell's Shearwaters Documented at an Artificial Burrow in Mid-July, 2019 using the Reconyx HyperFire Camera Aimed Directly into the Burrow Passage

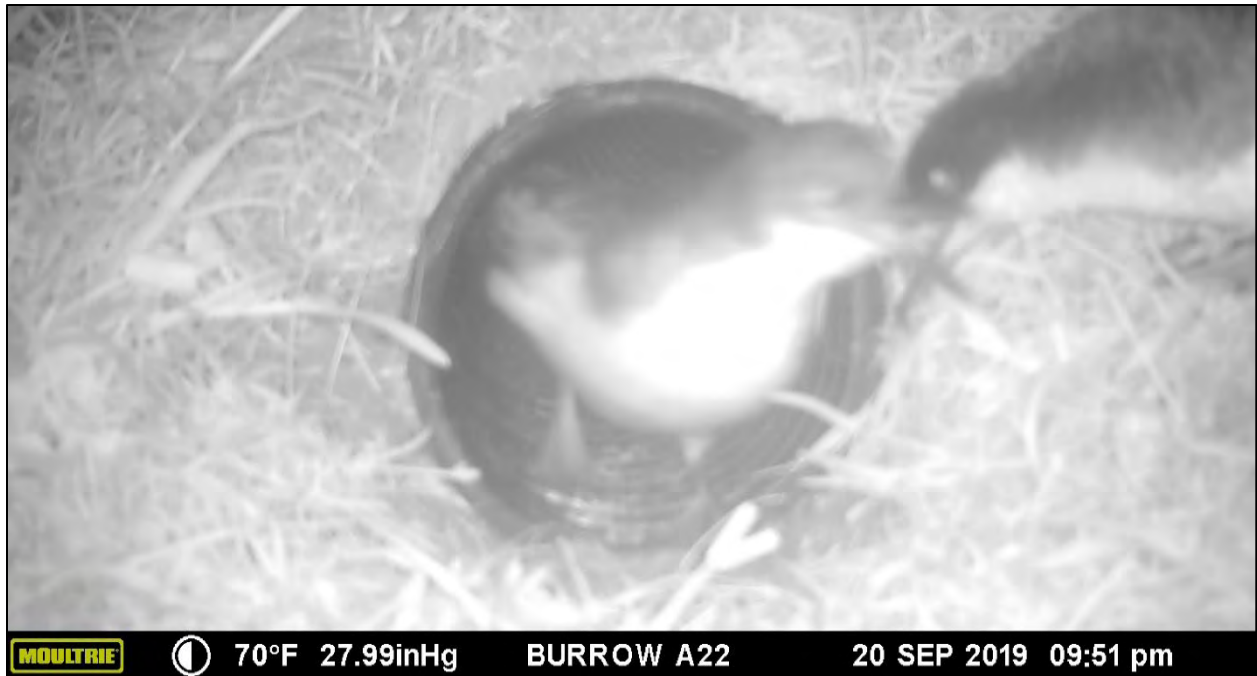
Figure 8. An Adult Newell's Shearwater Delivering Food to a Chick at the Entrance to Burrow A-22 at the Makamaka'ole Seabird Mitigation Area, September 20, 2019

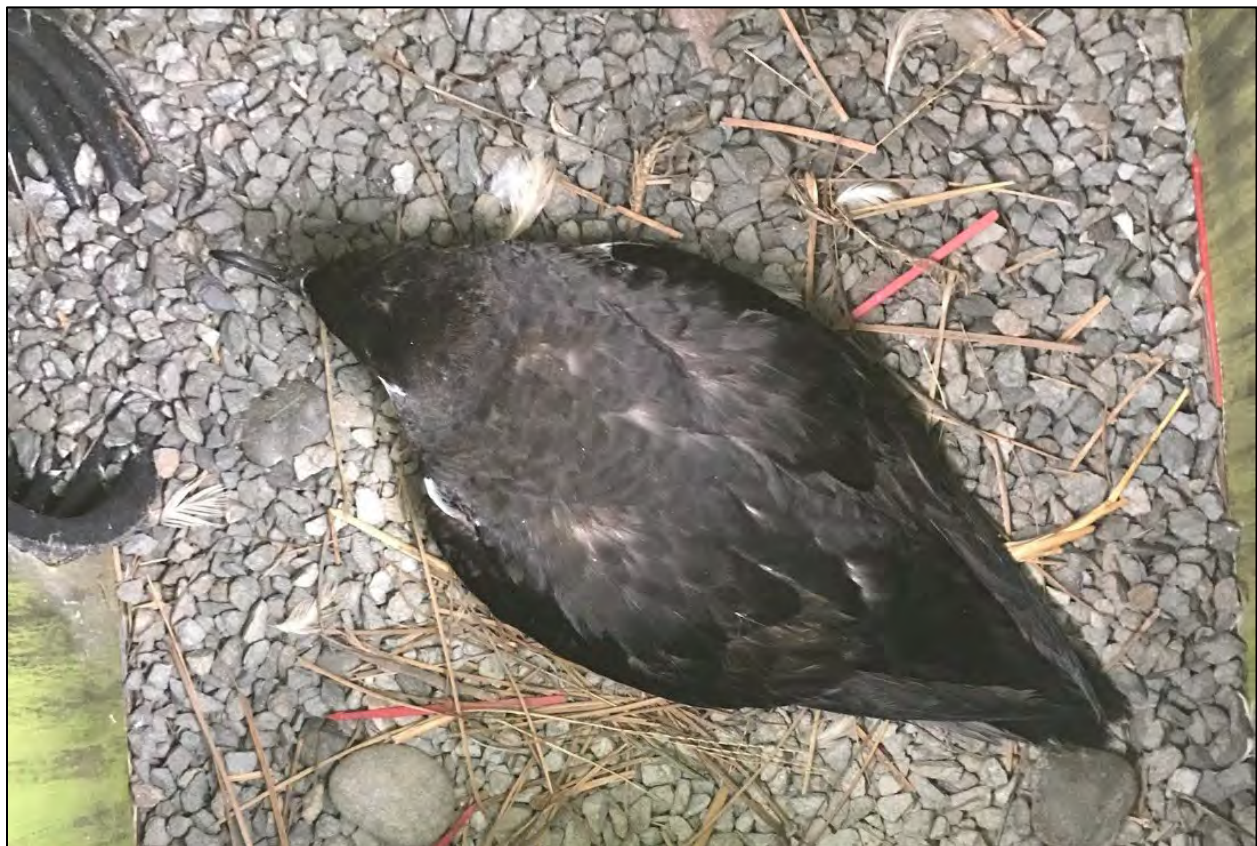
Figure 9. Newell's Shearwater Chick at Rest Shortly before Fledging from Artificial Nest Box A-22 at the Makamaka'ole Seabird Mitigation Area, October 2019

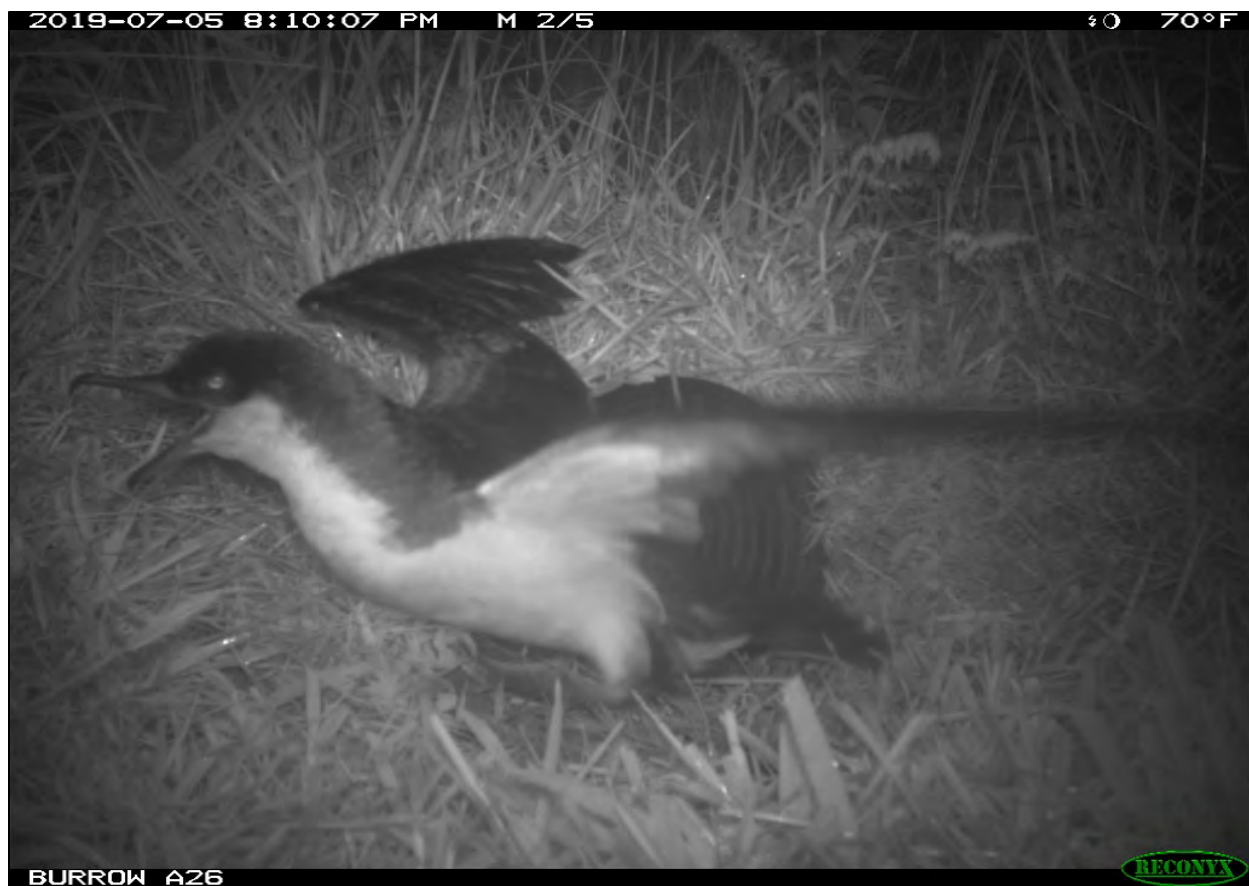
**Figure 10. Newell's Shearwater, Possibly a Male, Exhibiting Territoriality**

Hawaiian petrels have not been observed actively visiting any burrows at Makamaka'ole since 2017, when there were one or more birds associated with the "uluhe" burrow and B-22, both in Enclosure B. In 2016, after it first appeared that Hawaiian petrels had stopped landing to prospect and visit potential nesting burrows during the period when the mixed recorded sequences were playing, the call playback sequence was apparently returned to species-specific calls being broadcast in the two respective enclosures, and indeed Hawaiian petrels were observed on the ground, briefly, in 2017. As our data and observations indicate, the quality and character of the recorded call playback sequences are very important. Prior to July 2019, we thought it problematic to expect both species to establish equally successful nesting colonies intermixed or in close proximity given the more aggressive behavior exhibited by Newell's shearwaters. Newell's shearwaters have responded favorably to audio playback of the species' recorded calls, and as indicated by the camera data, may, at times, fiercely protect a chosen nest site (Figure 10).

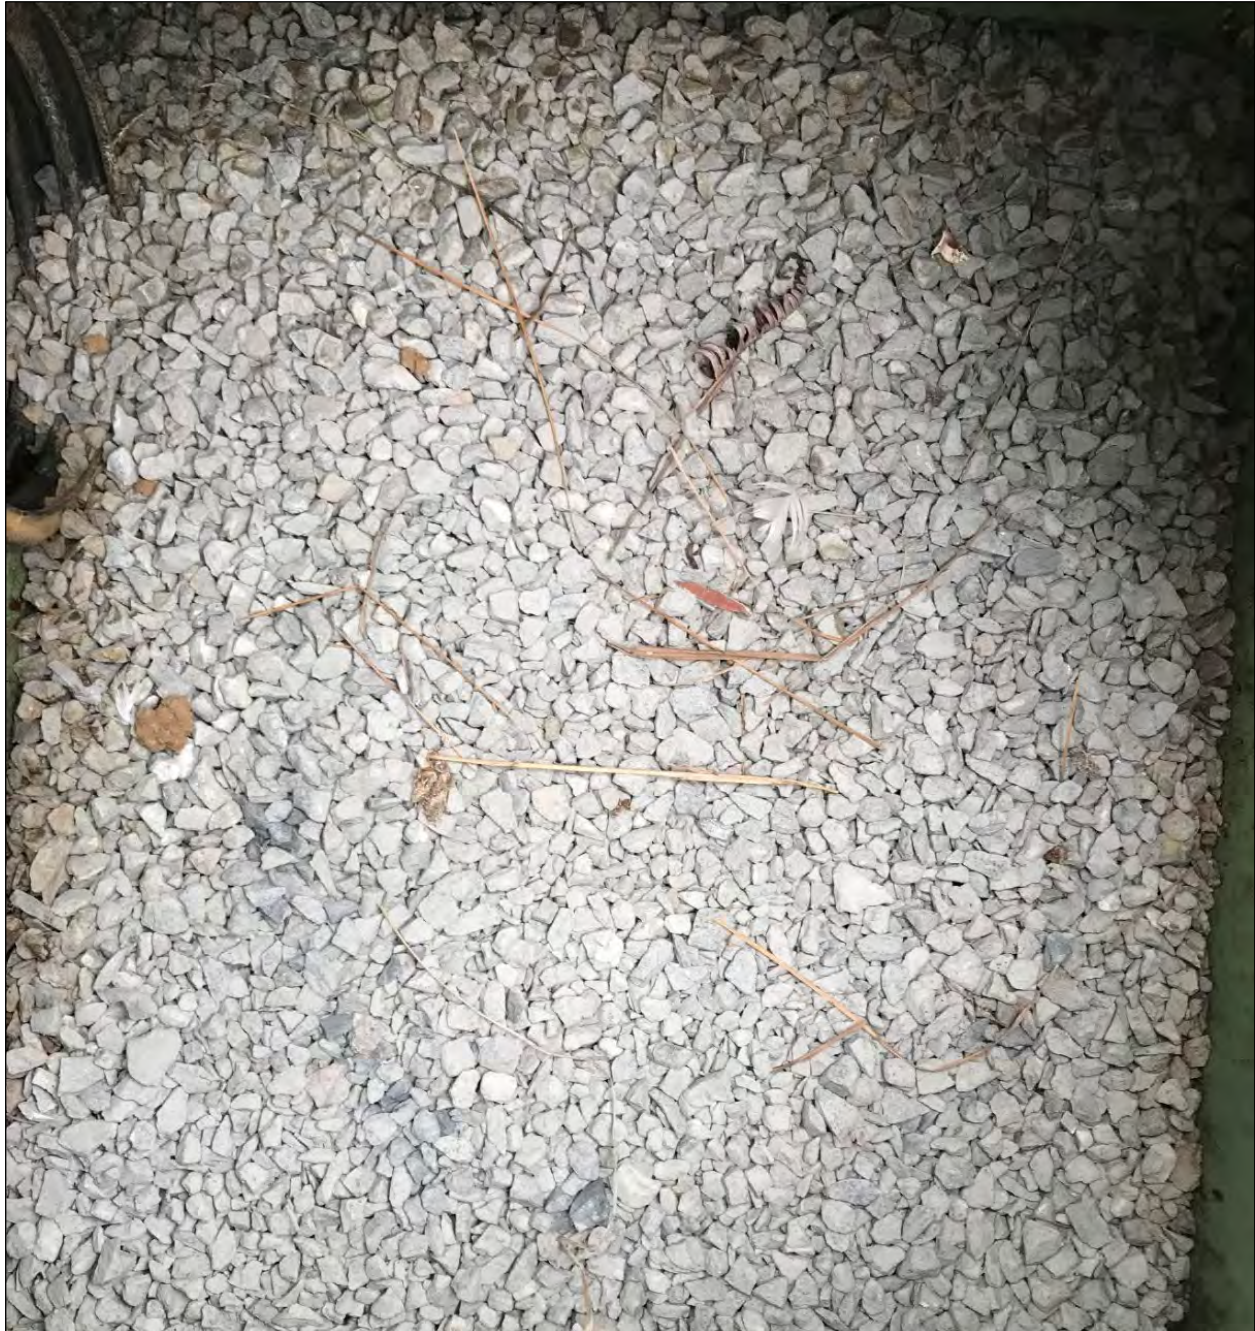
**Nest Box A-11 Contents on October 10, 2019 Consisted of Sparse Nesting Material with Little Evidence of Activity Inside the Nest Box by Shearwaters**
