# **Kaheawa Wind Project II Habitat Conservation Plan FY 2020 Annual Report**

September 2020

**Incidental Take License ITL-15 / Incidental Take Permit TE27260A-1**

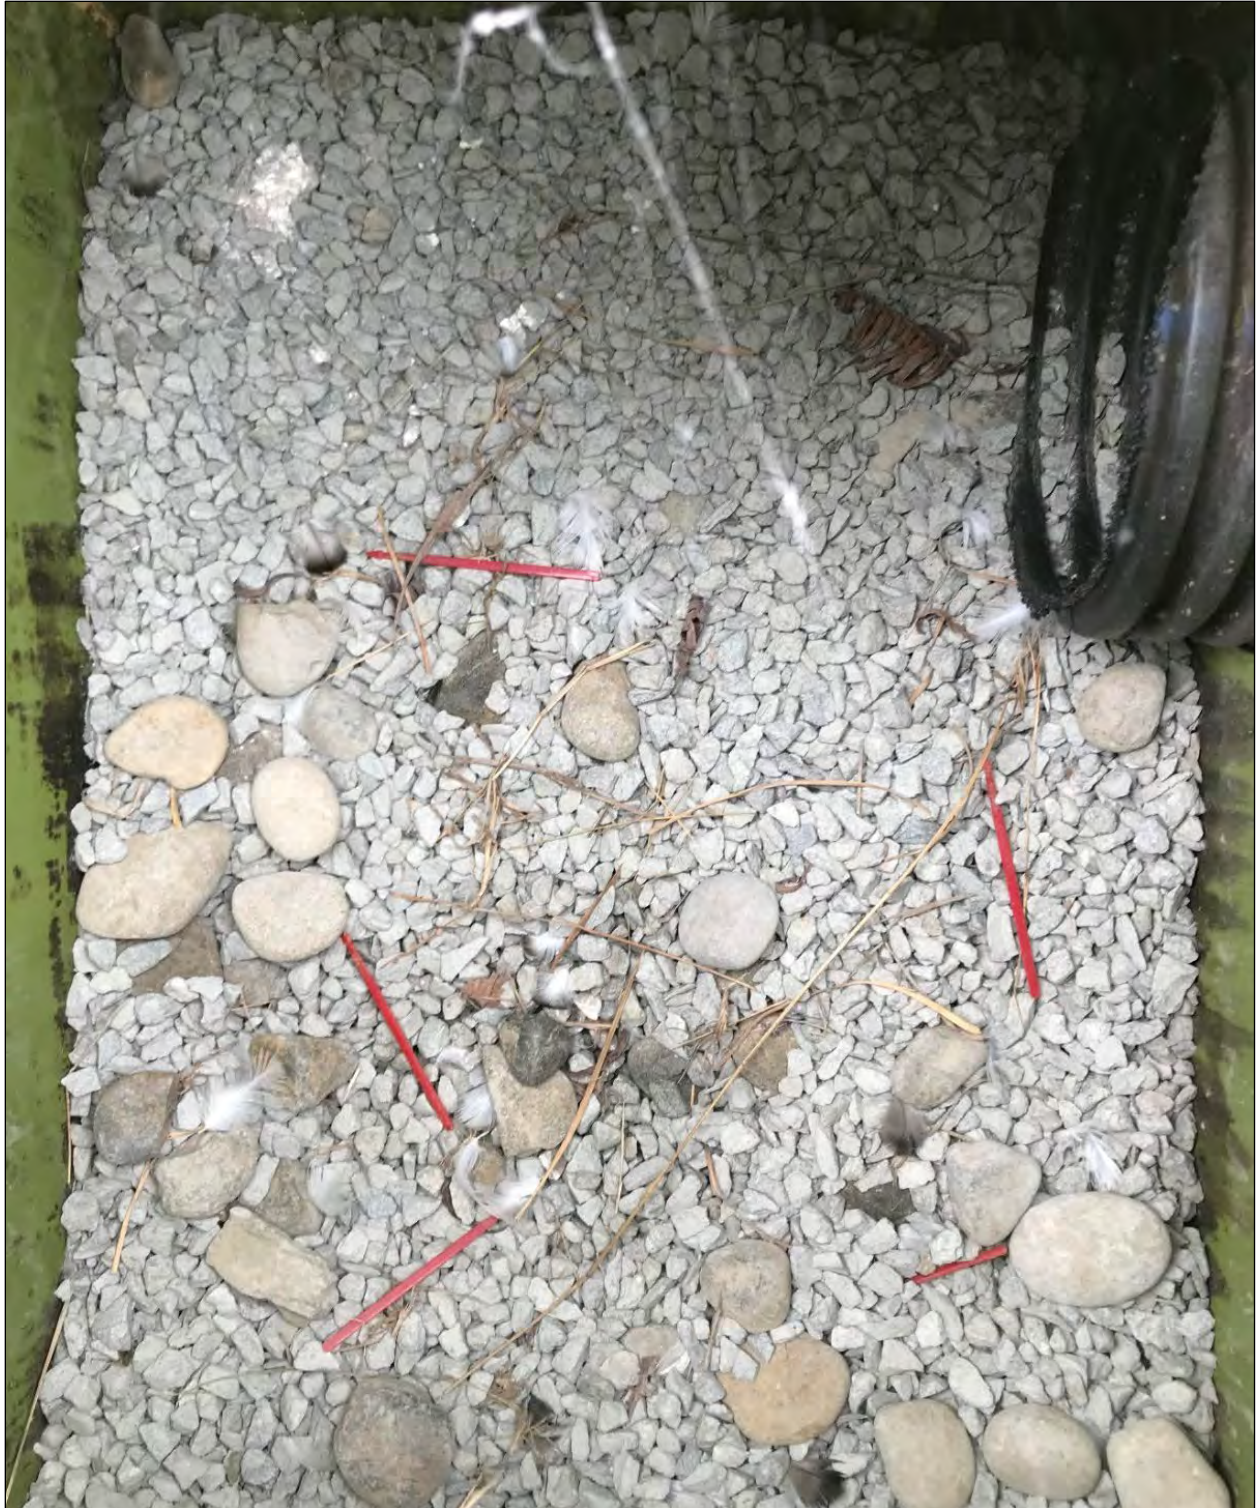
**Nest Box A-12 Contents on October 10, 2019 Consisted of a Small Amount of Nesting Material, Feathers, and Dried Guano. No Eggshell, Membrane, or Down was Found**

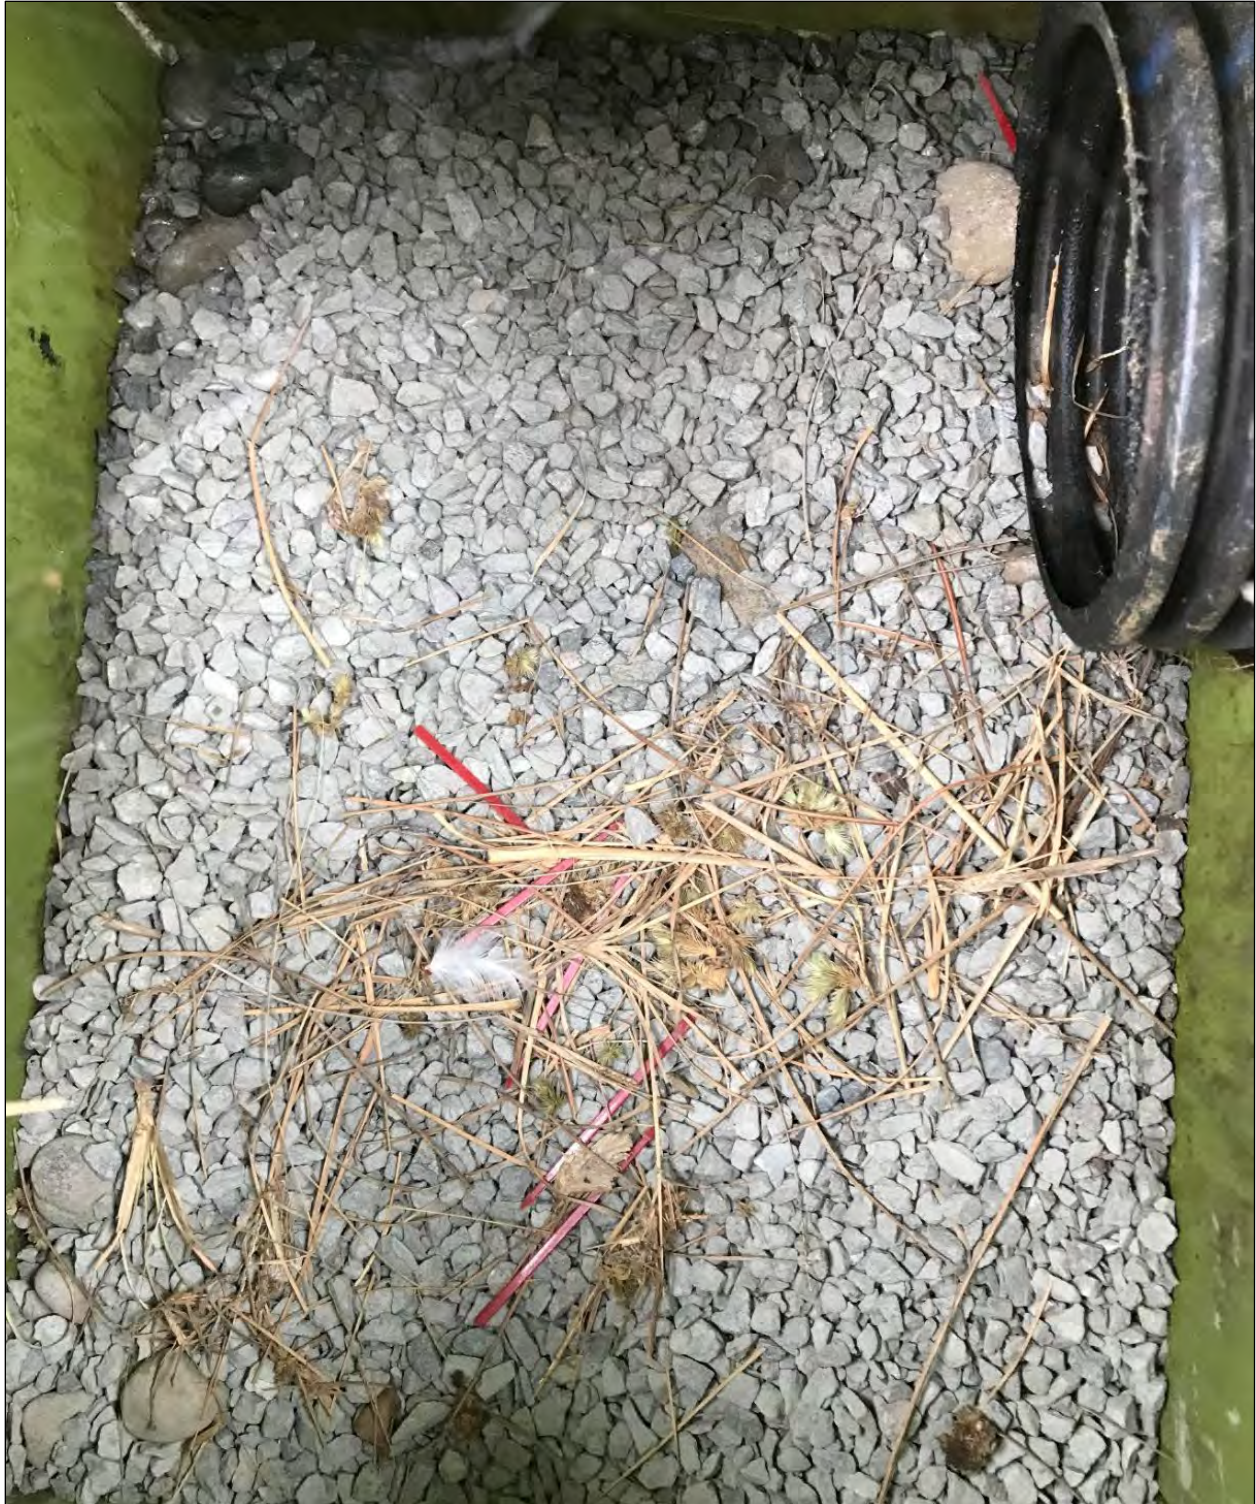
Nest box A-13 contents on October 10, 2019 consisted of nesting material and feathers. No eggshell, membrane, or down was found.

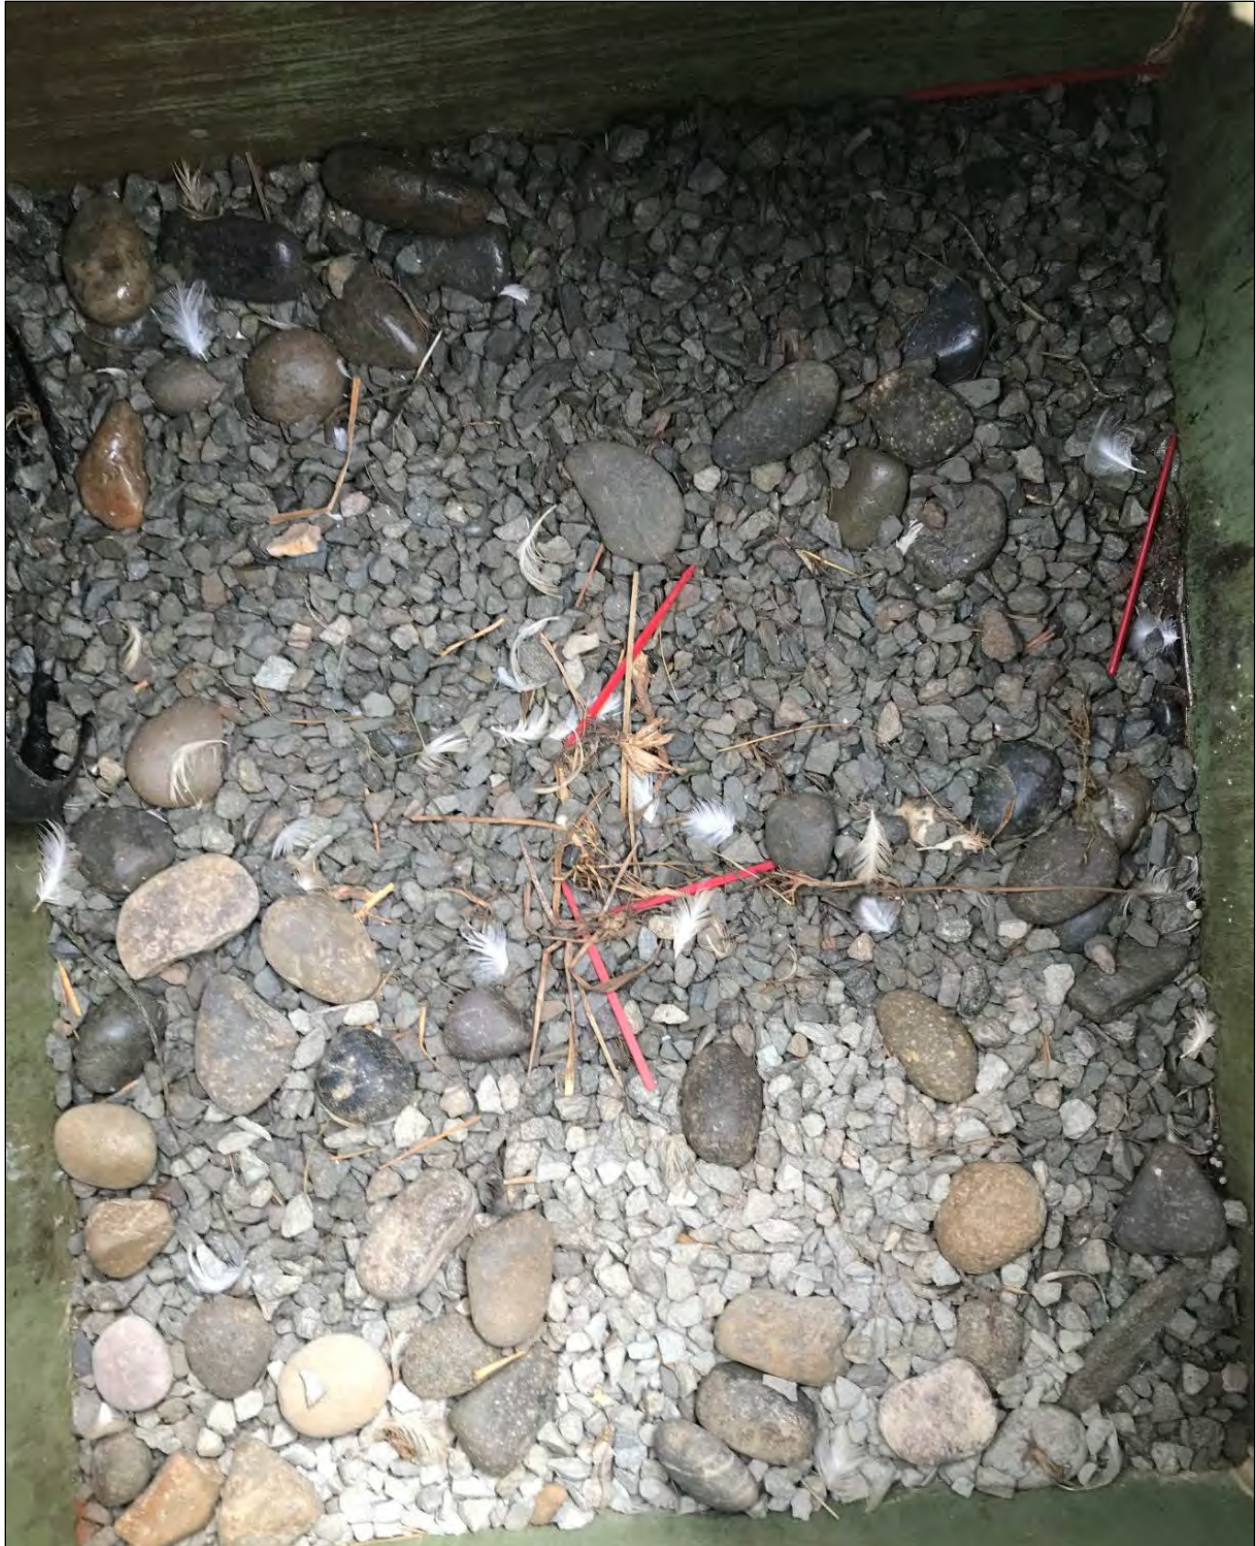
**Nest Box A-14 Contents on October 10, 2019 Consisted of a Small Amount of Nesting Material and Feathers. No Eggshell, Membrane, or Down was Found**

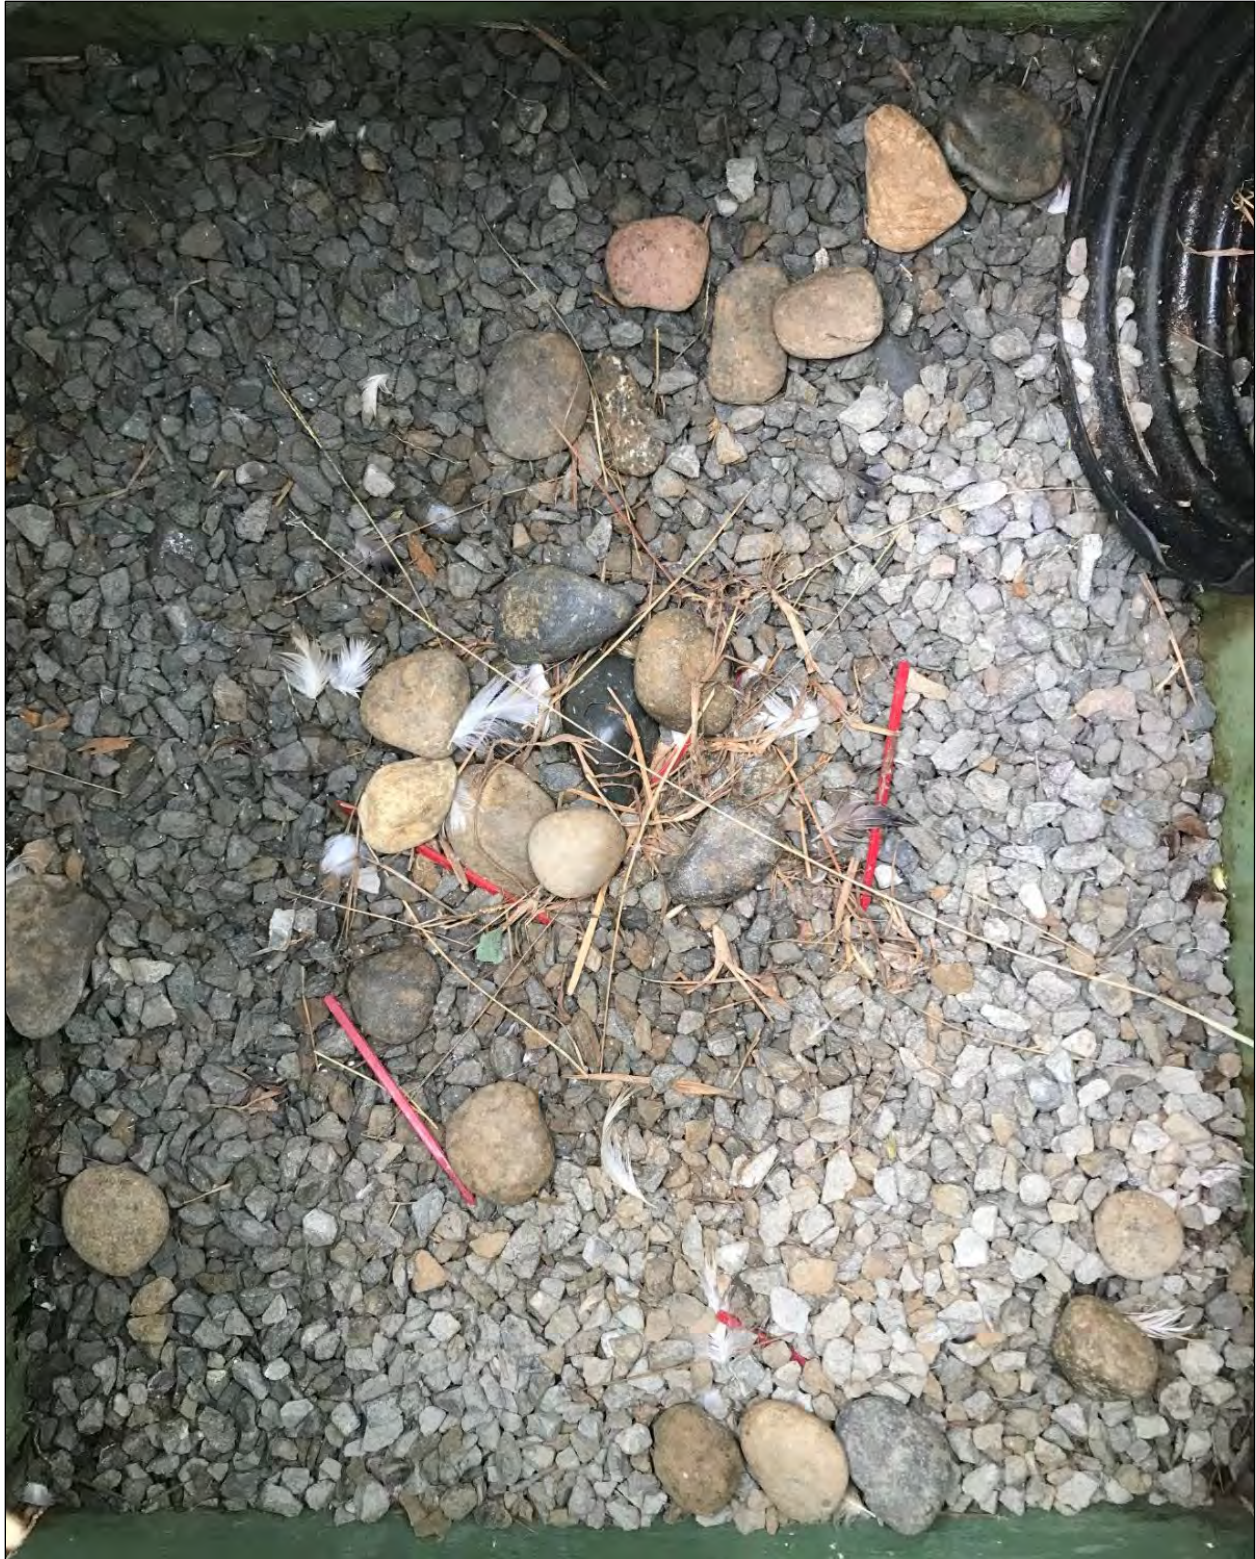
**Nest Box A-18 Contents on October 10, 2019 Consisted of a Small Amount of Nesting Material and Feathers. Some Larger Stones were Excavated and Moved to the Center of the Nest by the Birds. No Eggshell, Membrane, or Down was Found**

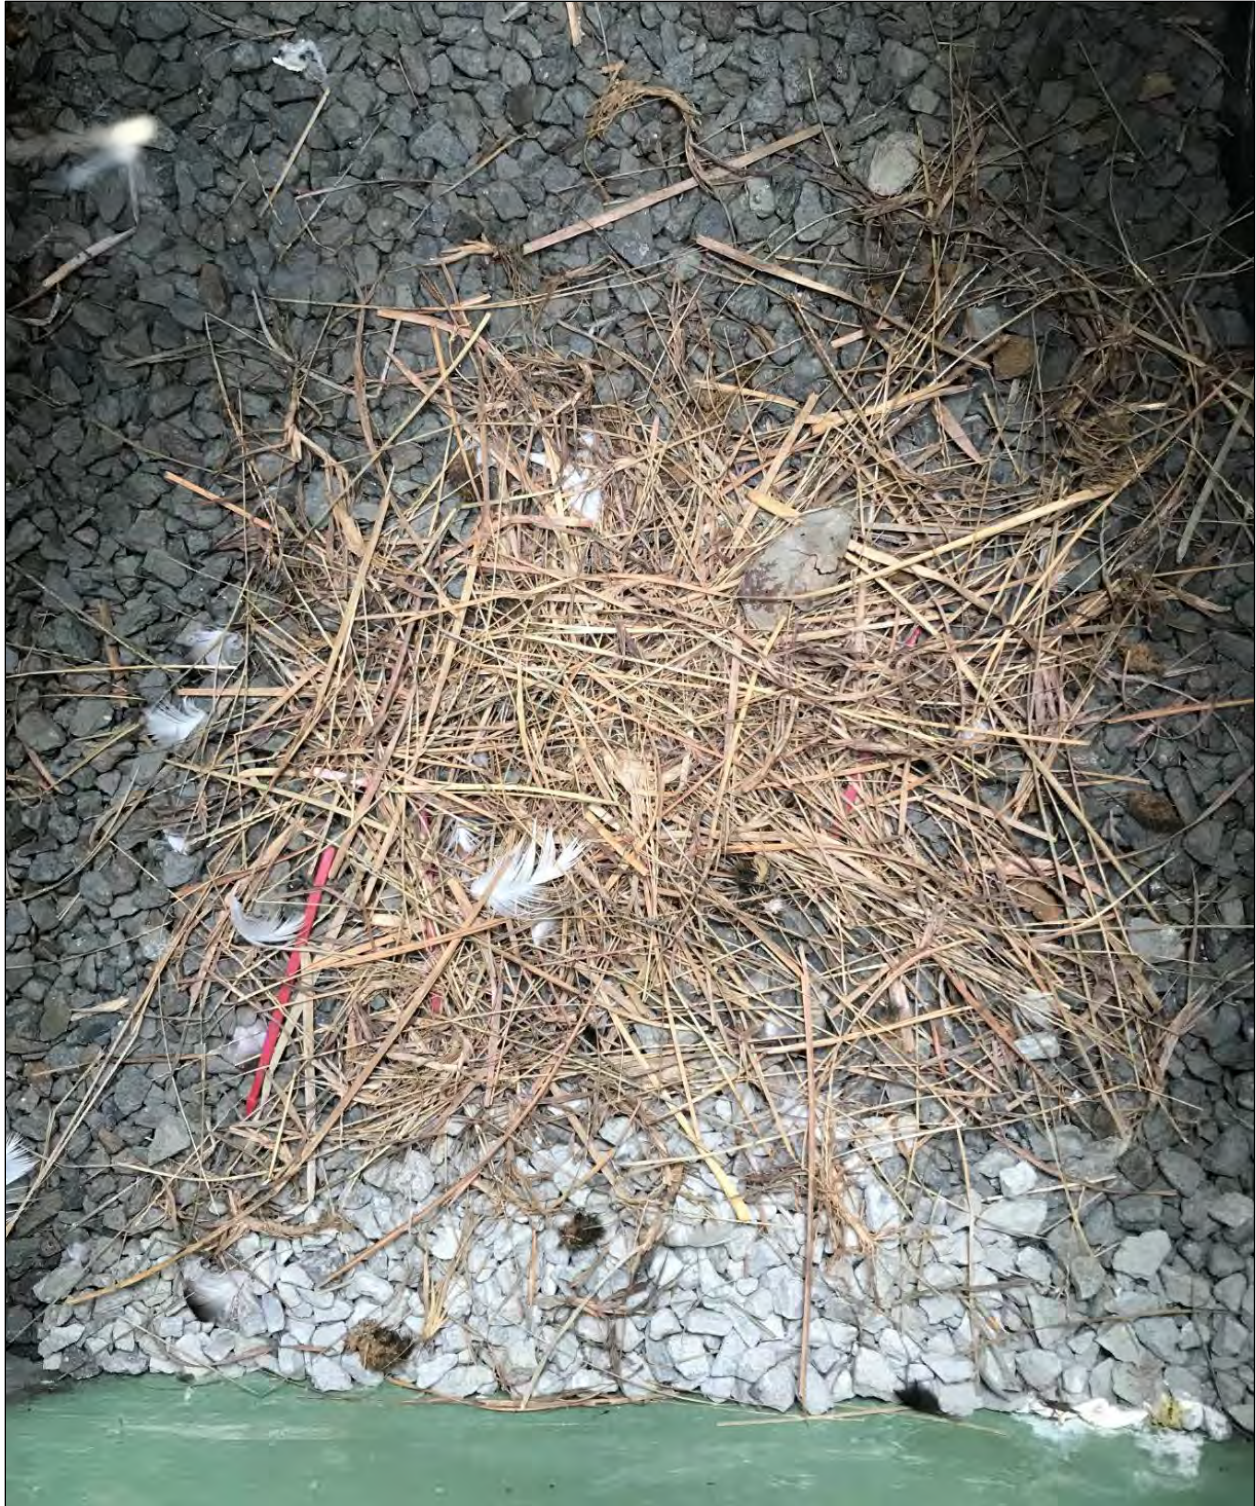
**Nest Box A-20 Contents on October 10, 2019 Consisted of Copious Nesting Material and Some Feathers. No Eggshell, Membrane, or Down was Found**

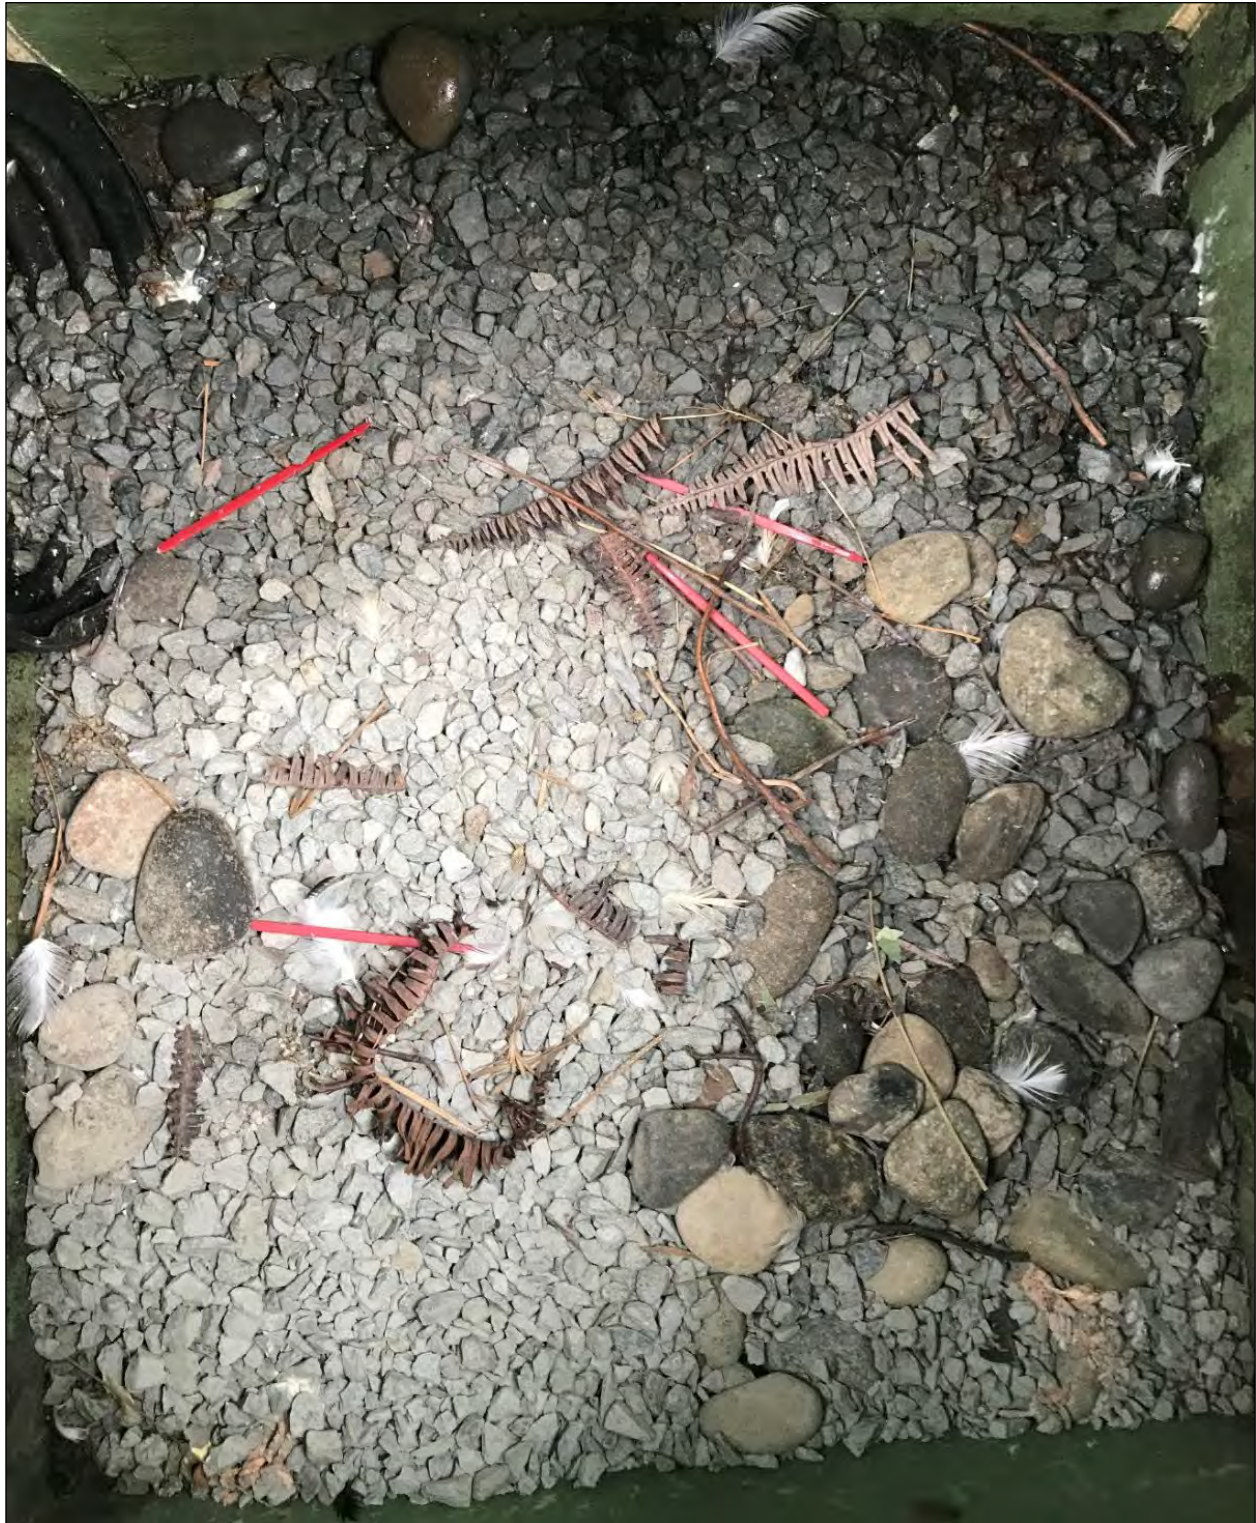
Nest Box A-21 Contents on October 10, 2019 Consisted of a Small Amount of Nesting Material, Some Feathers, and Guano. No Eggshell, Membrane, or Down was Found.

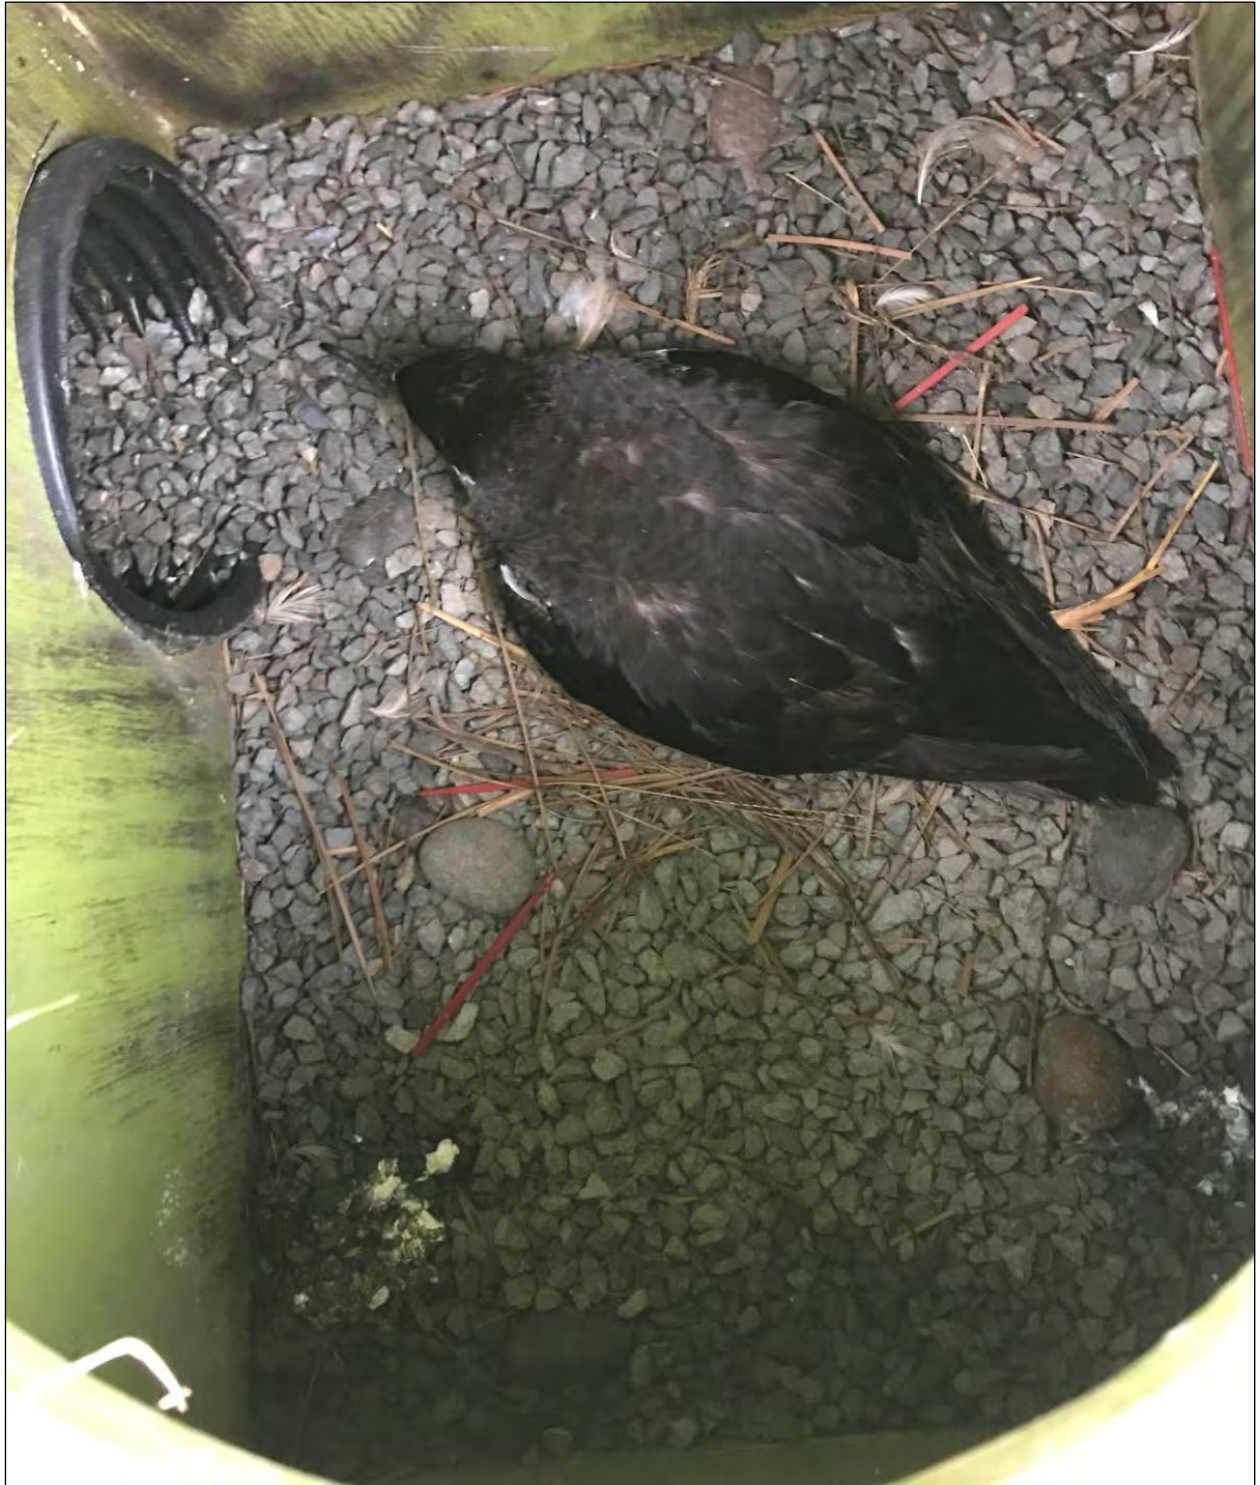
Newell's Shearwater Chick was Discovered in Nest Box A-22 on October 14, 2019. The Nest Box also Contained a Small Amount of Nesting Material, Some Feathers, Guano, and Sparse Down. No Eggshell or Membrane was Found

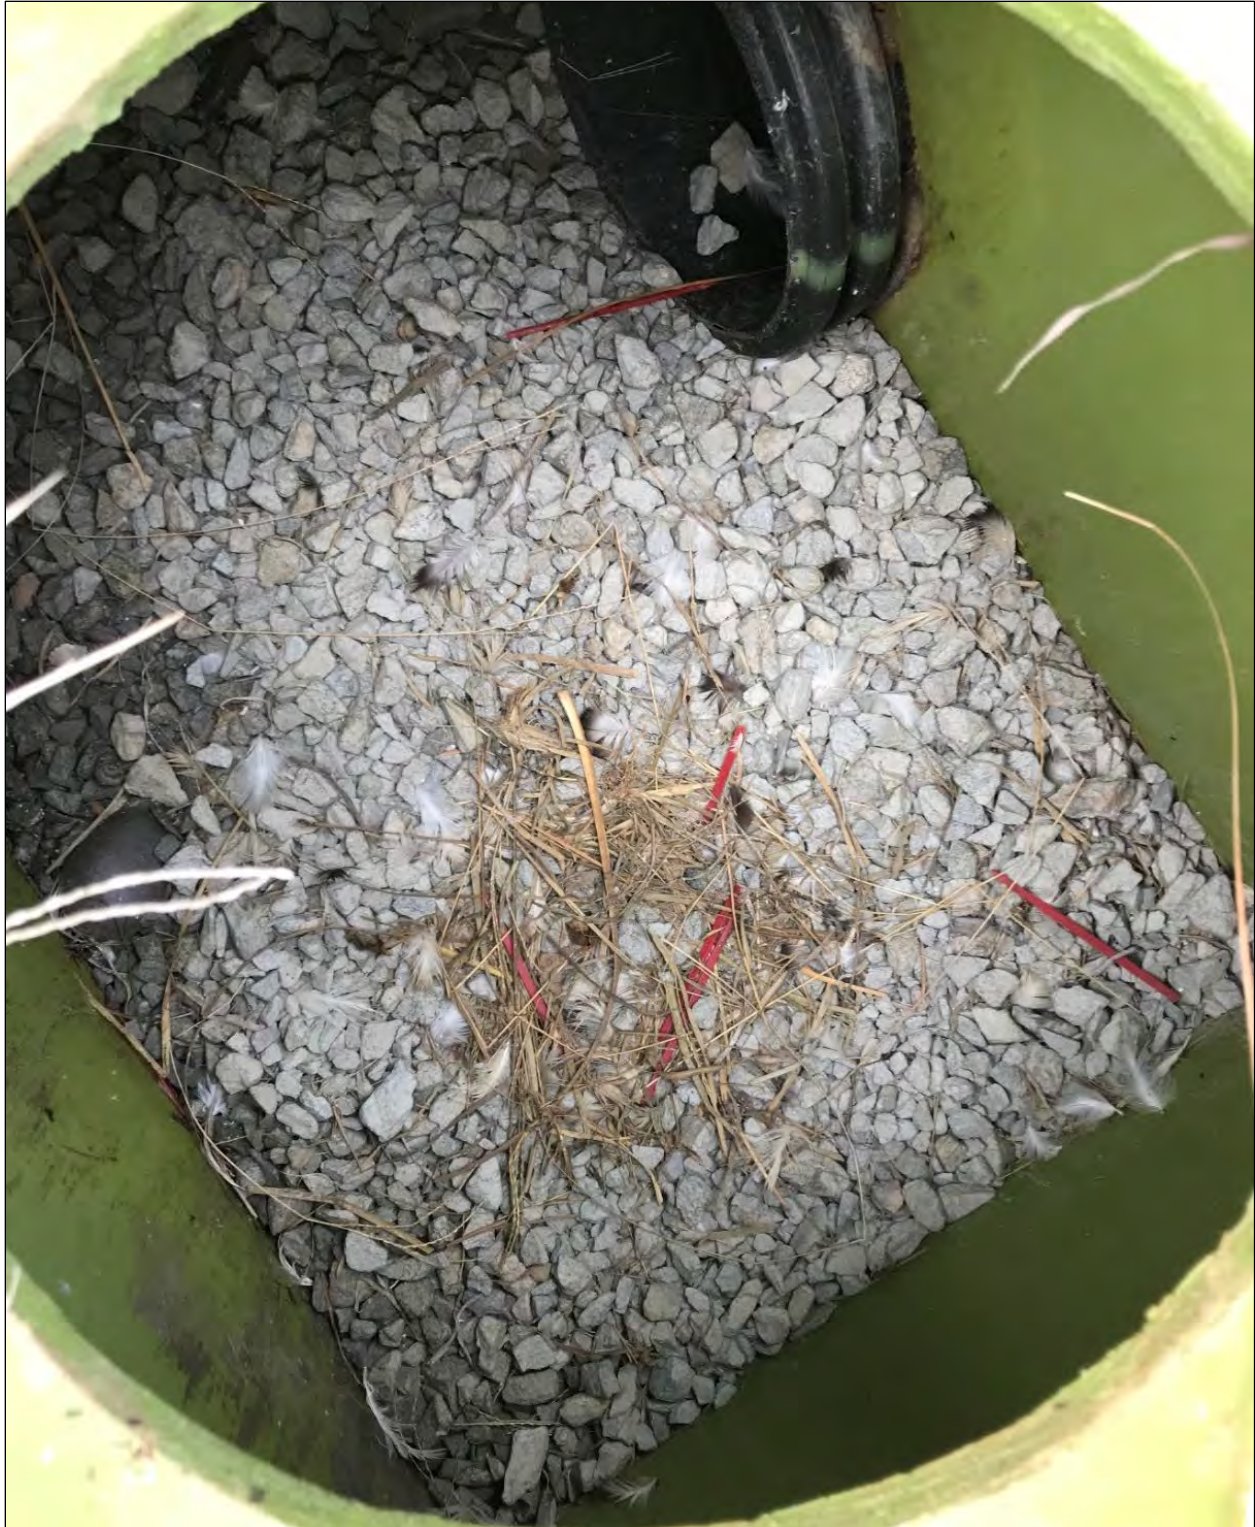
Nest Box A-24 Contents on October 10, 2019 Consisted of Nesting Material and Feathers. No Eggshell, Membrane, or Down was Found

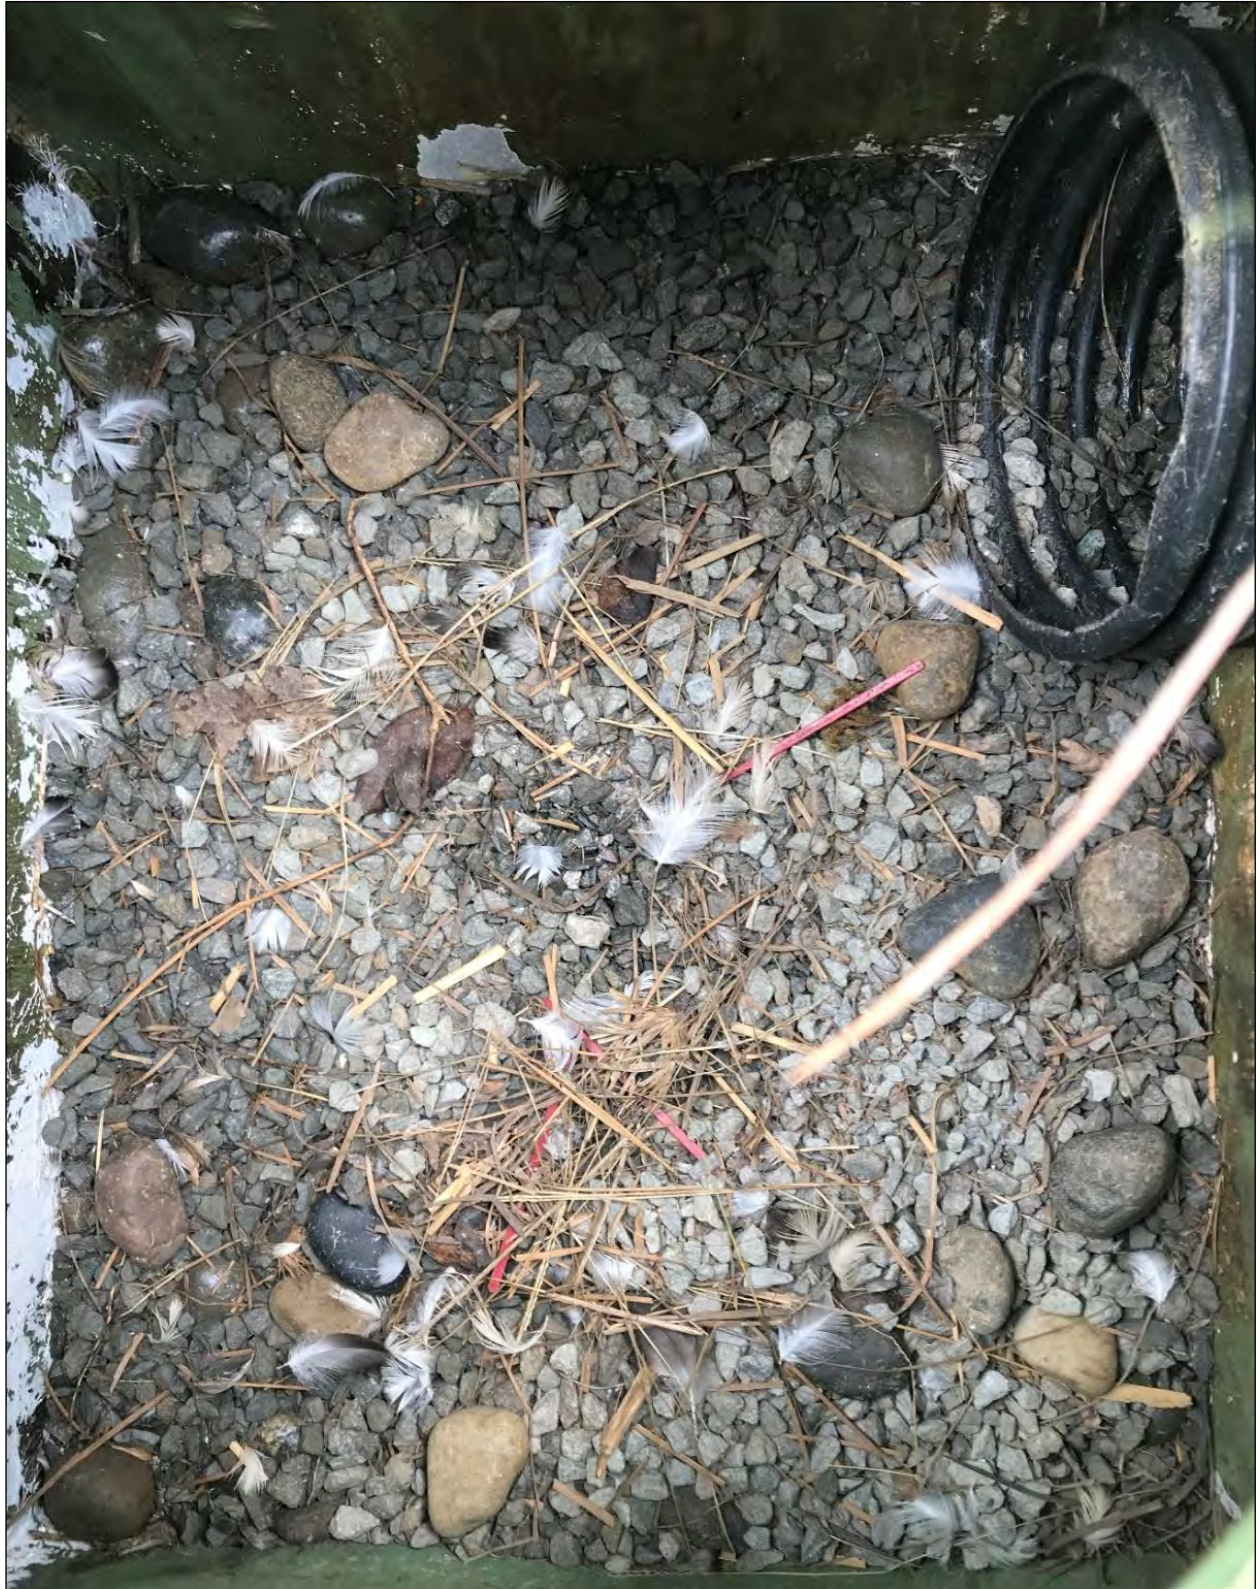
**Nest Box A-25 Contents on October 10, 2019 Consisted of Nesting Material, Feathers, and Few Small Down-Like Feathers. No Eggshell or Membrane was Found**

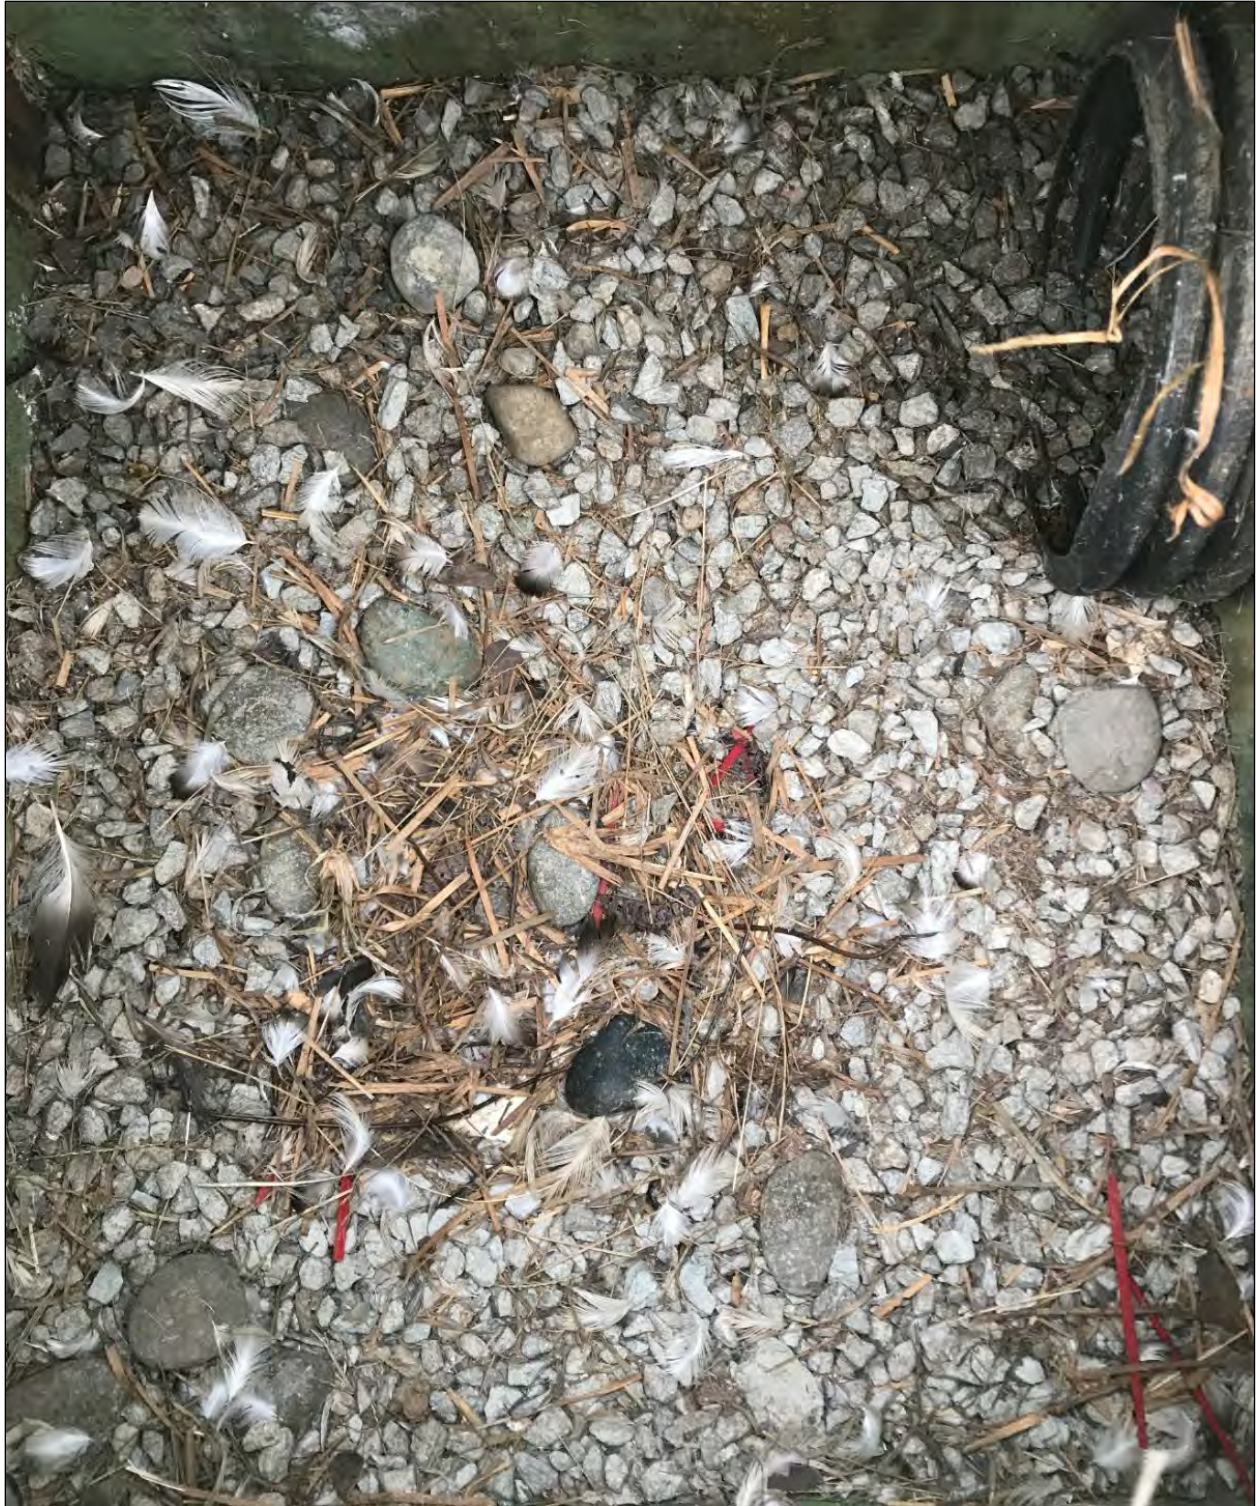
Nest Box A-26 Contents on October 14, 2019 Consisted of Nesting Material, Feathers, Down, Eggshell Fragments, and Membrane

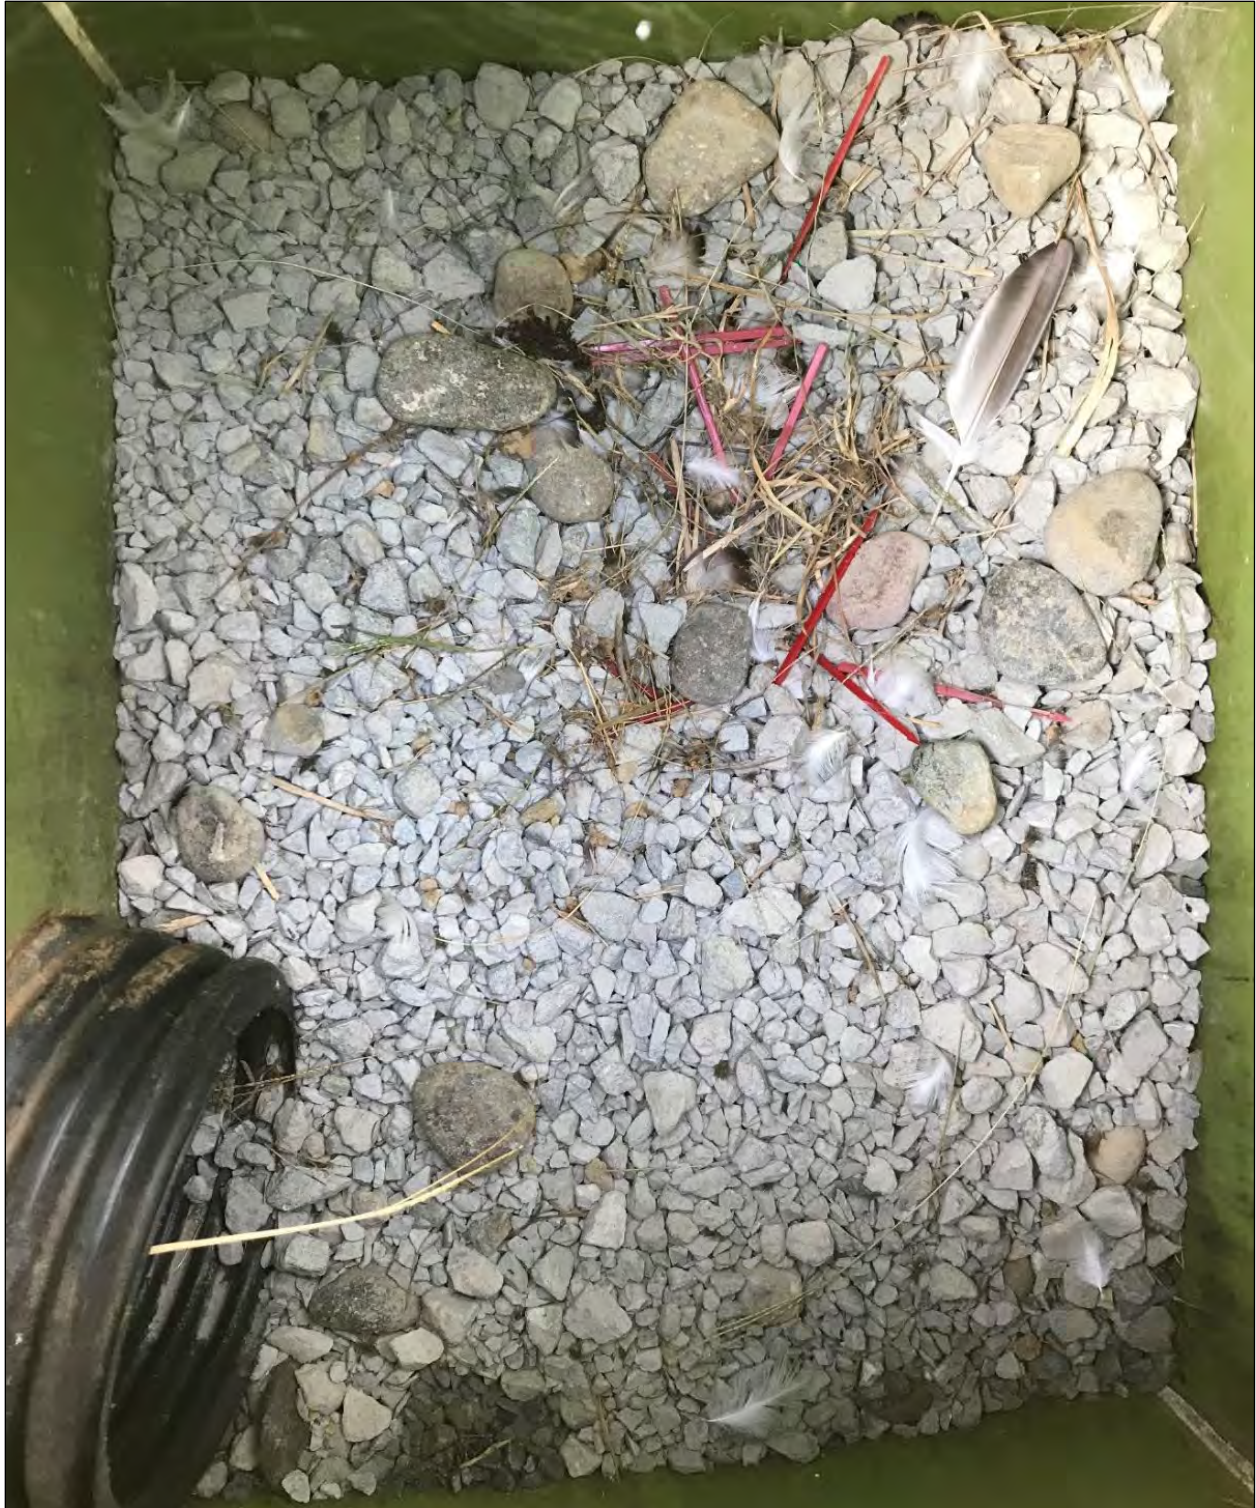
Nest Box A-42 Contents on October 10, 2019 Consisted of Nesting Material and Feathers. No Eggshell, Membrane, or Down was Found
