# **Kaheawa Wind Project II Habitat Conservation Plan FY 2020 Annual Report**

September 2020

**Incidental Take License ITL-15 / Incidental Take Permit TE27260A-1**

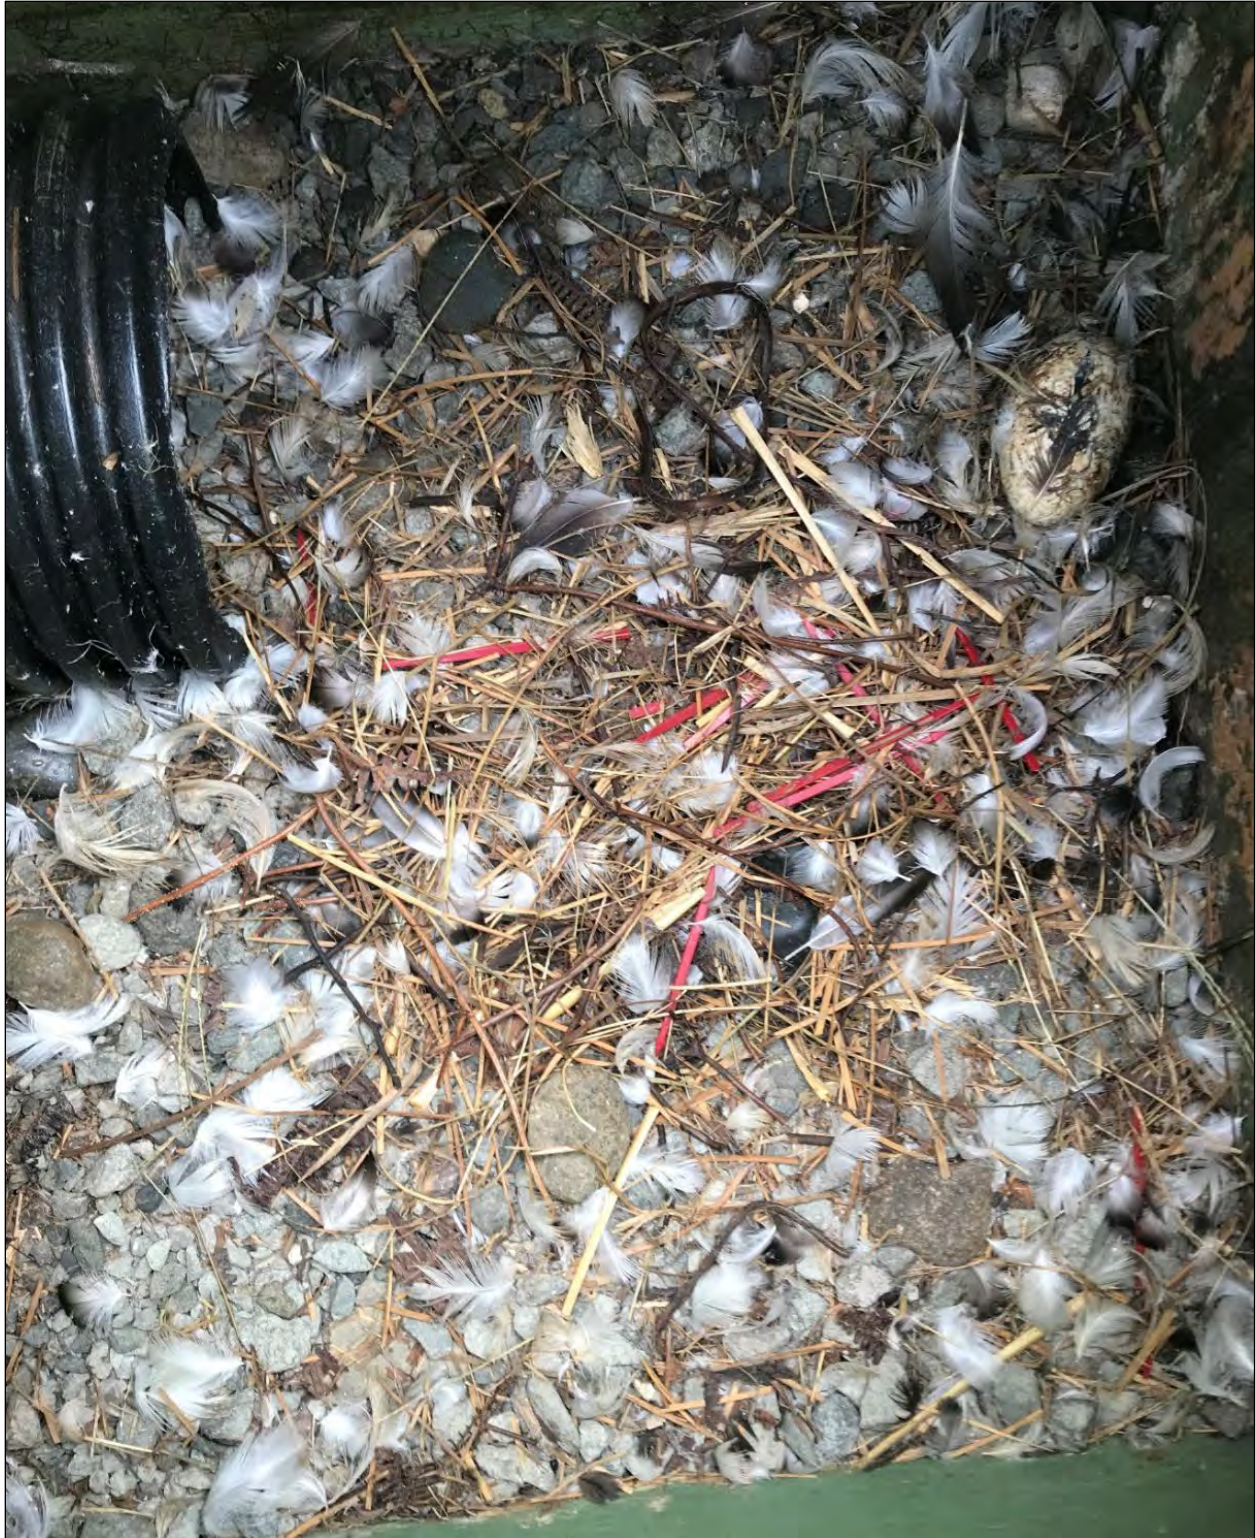
**Nest Box A-43 Contents on October 10, 2019 Consisted of Copious Nesting Material, Feathers, a Complete Intact Egg, Eggshell Fragments from a Second Egg, and Down Scattered throughout the Nest Bowl**

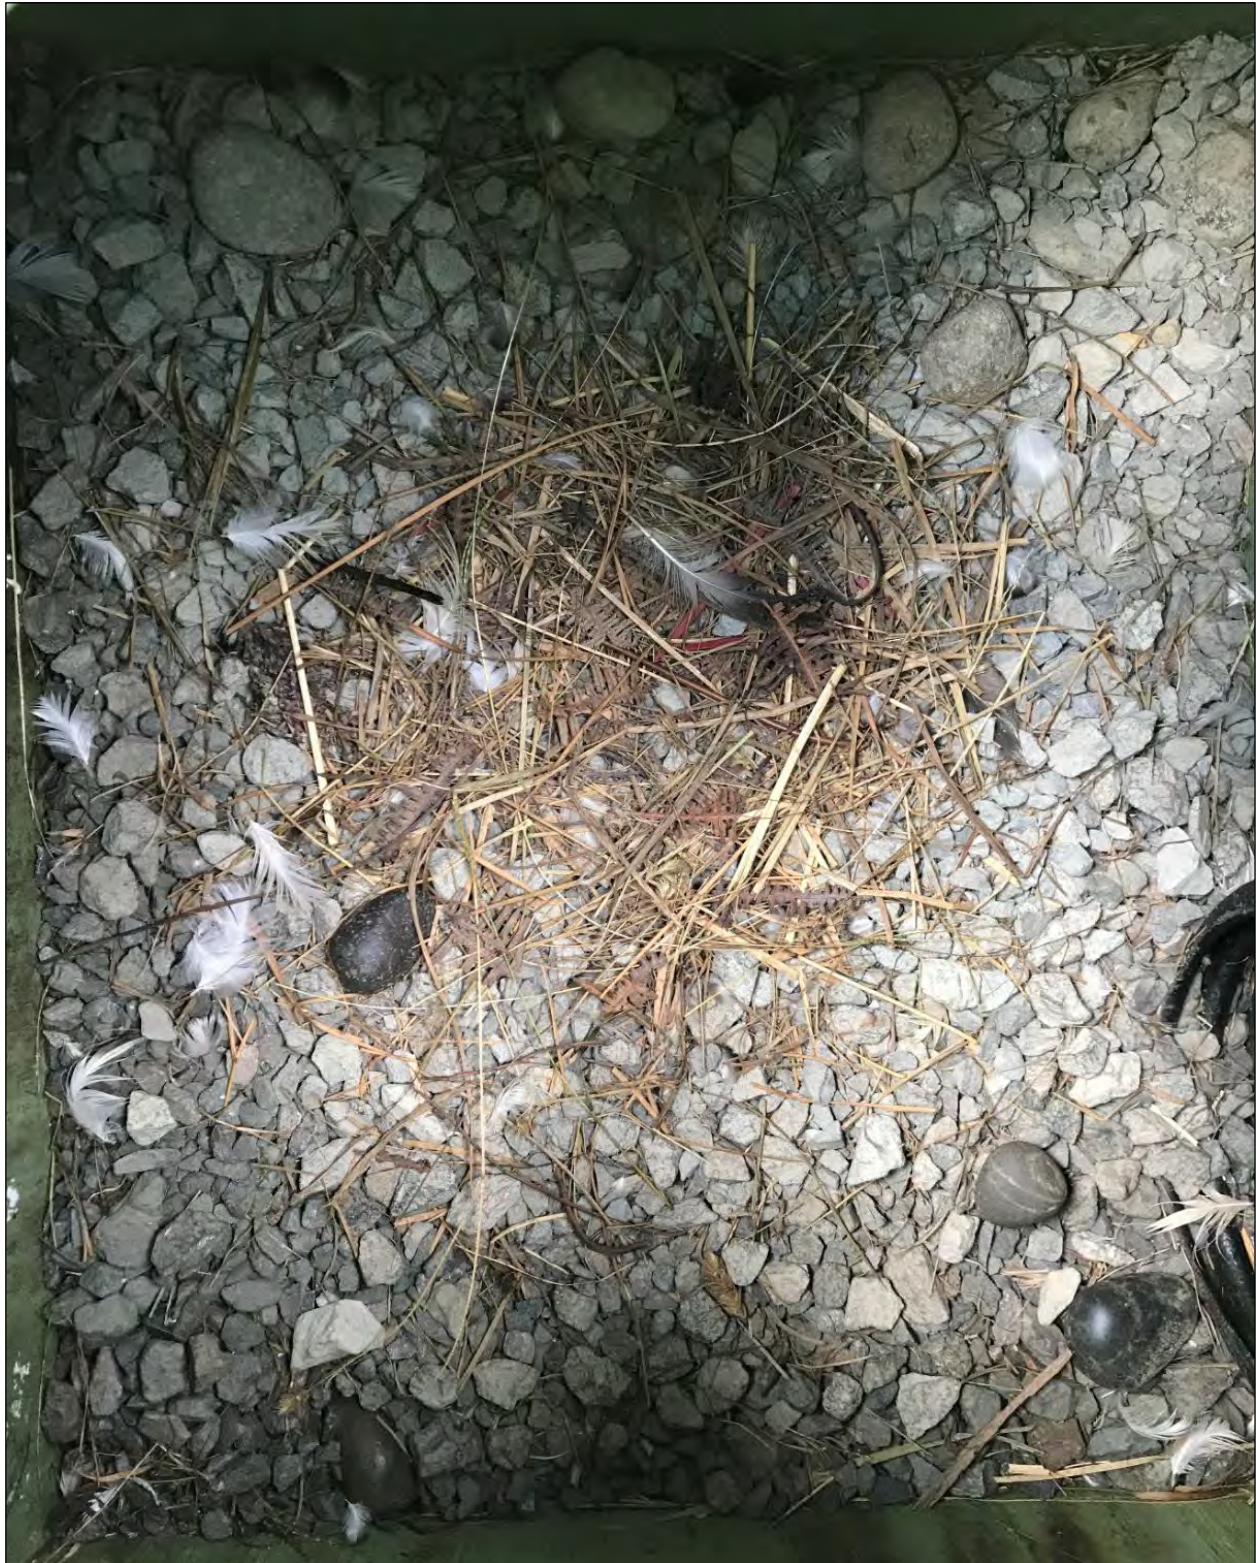
**Nest Box A-48 Contents on October 10, 2019 Consisted of Nesting Material and Feathers. No Eggshell, Membrane, or Down was Found**

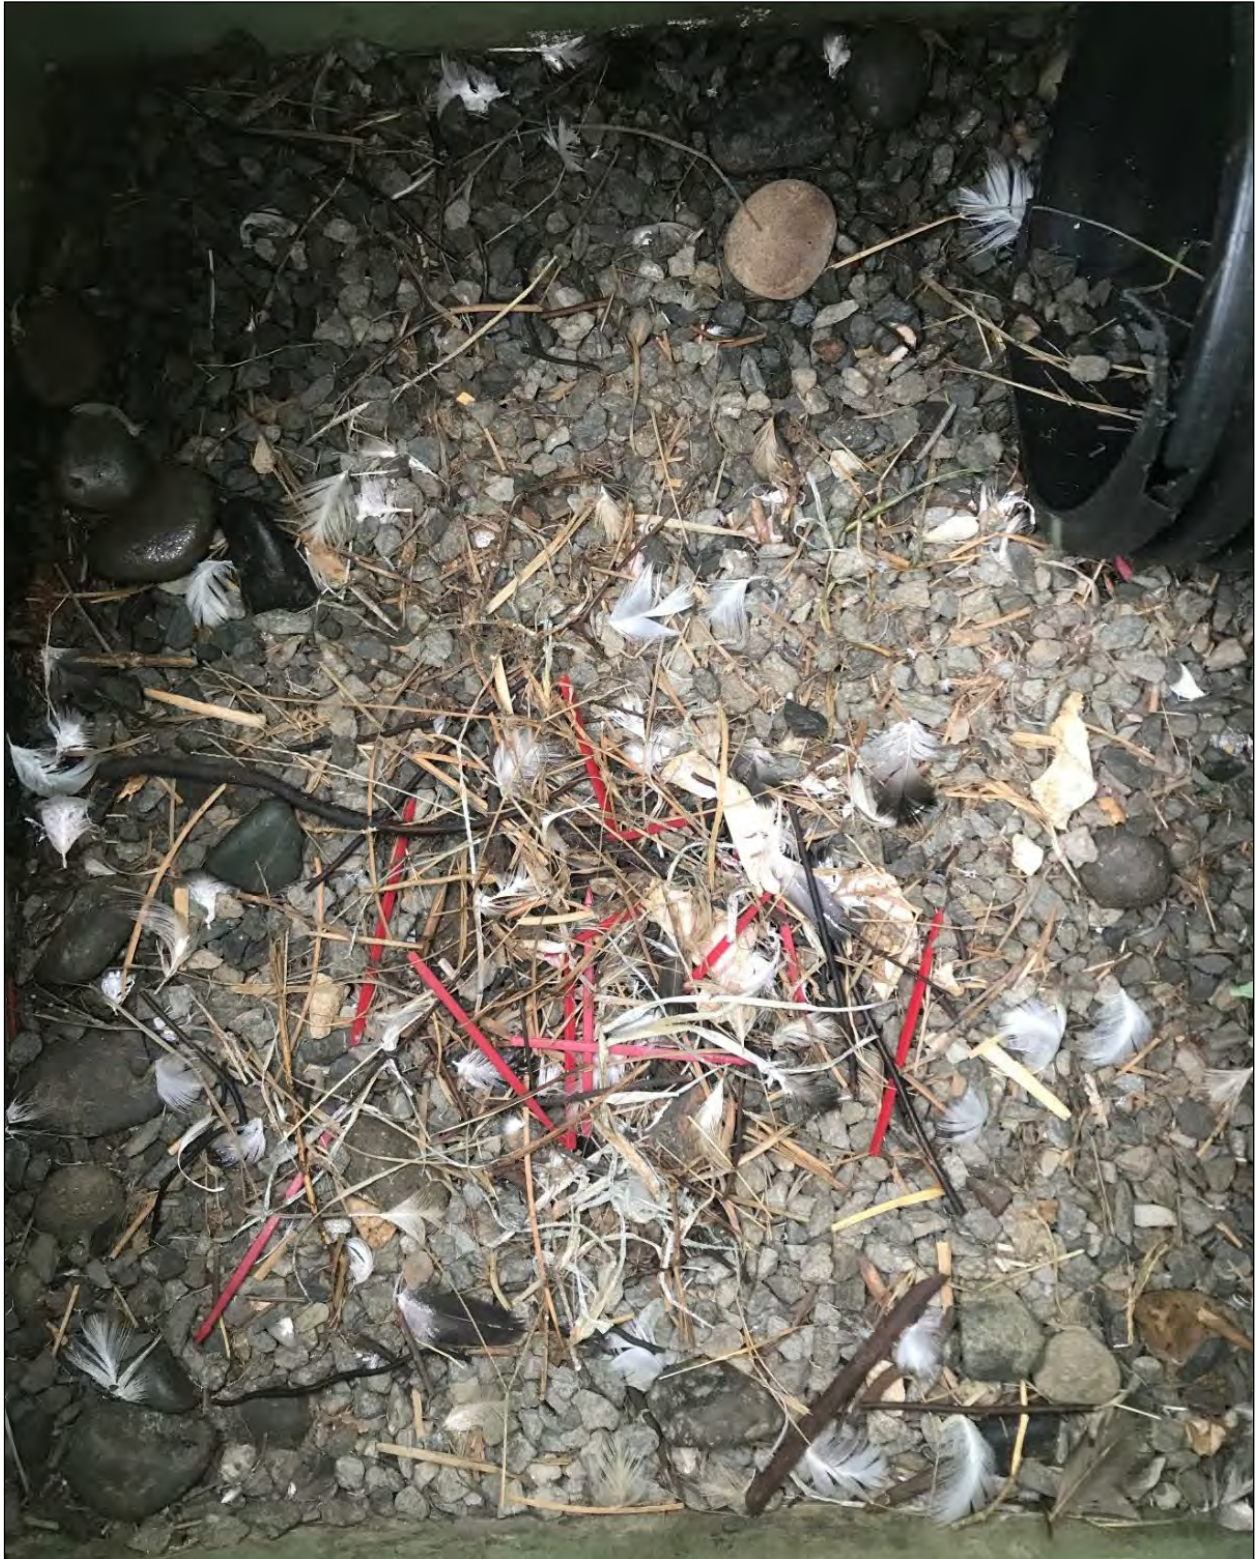
Nest Box B-22 Contents on October 11, 2019 Consisted of Nesting Material, Feathers, Down, and Eggshell Membrane

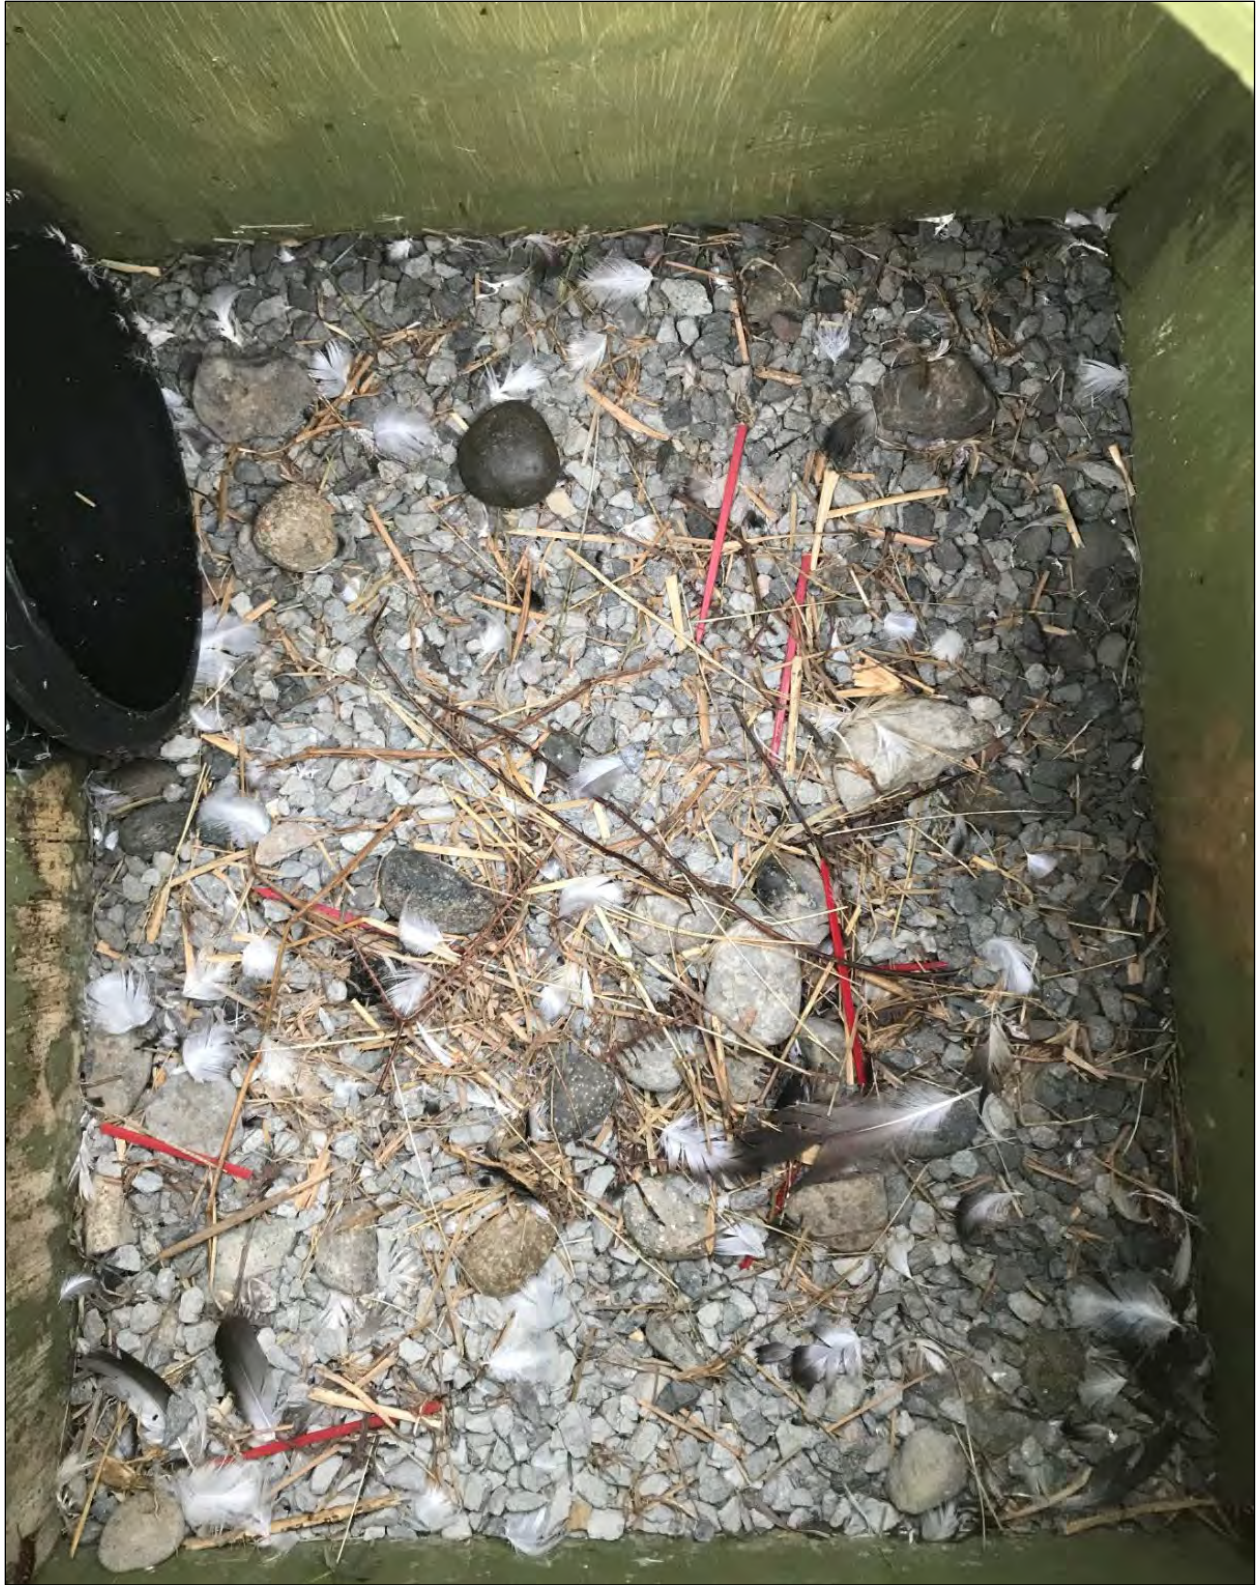
**Nest Box B-50 Contents on October 11, 2019 Consisted of Nesting Material, Feathers, and Down. No Eggshell or Membrane was Found**

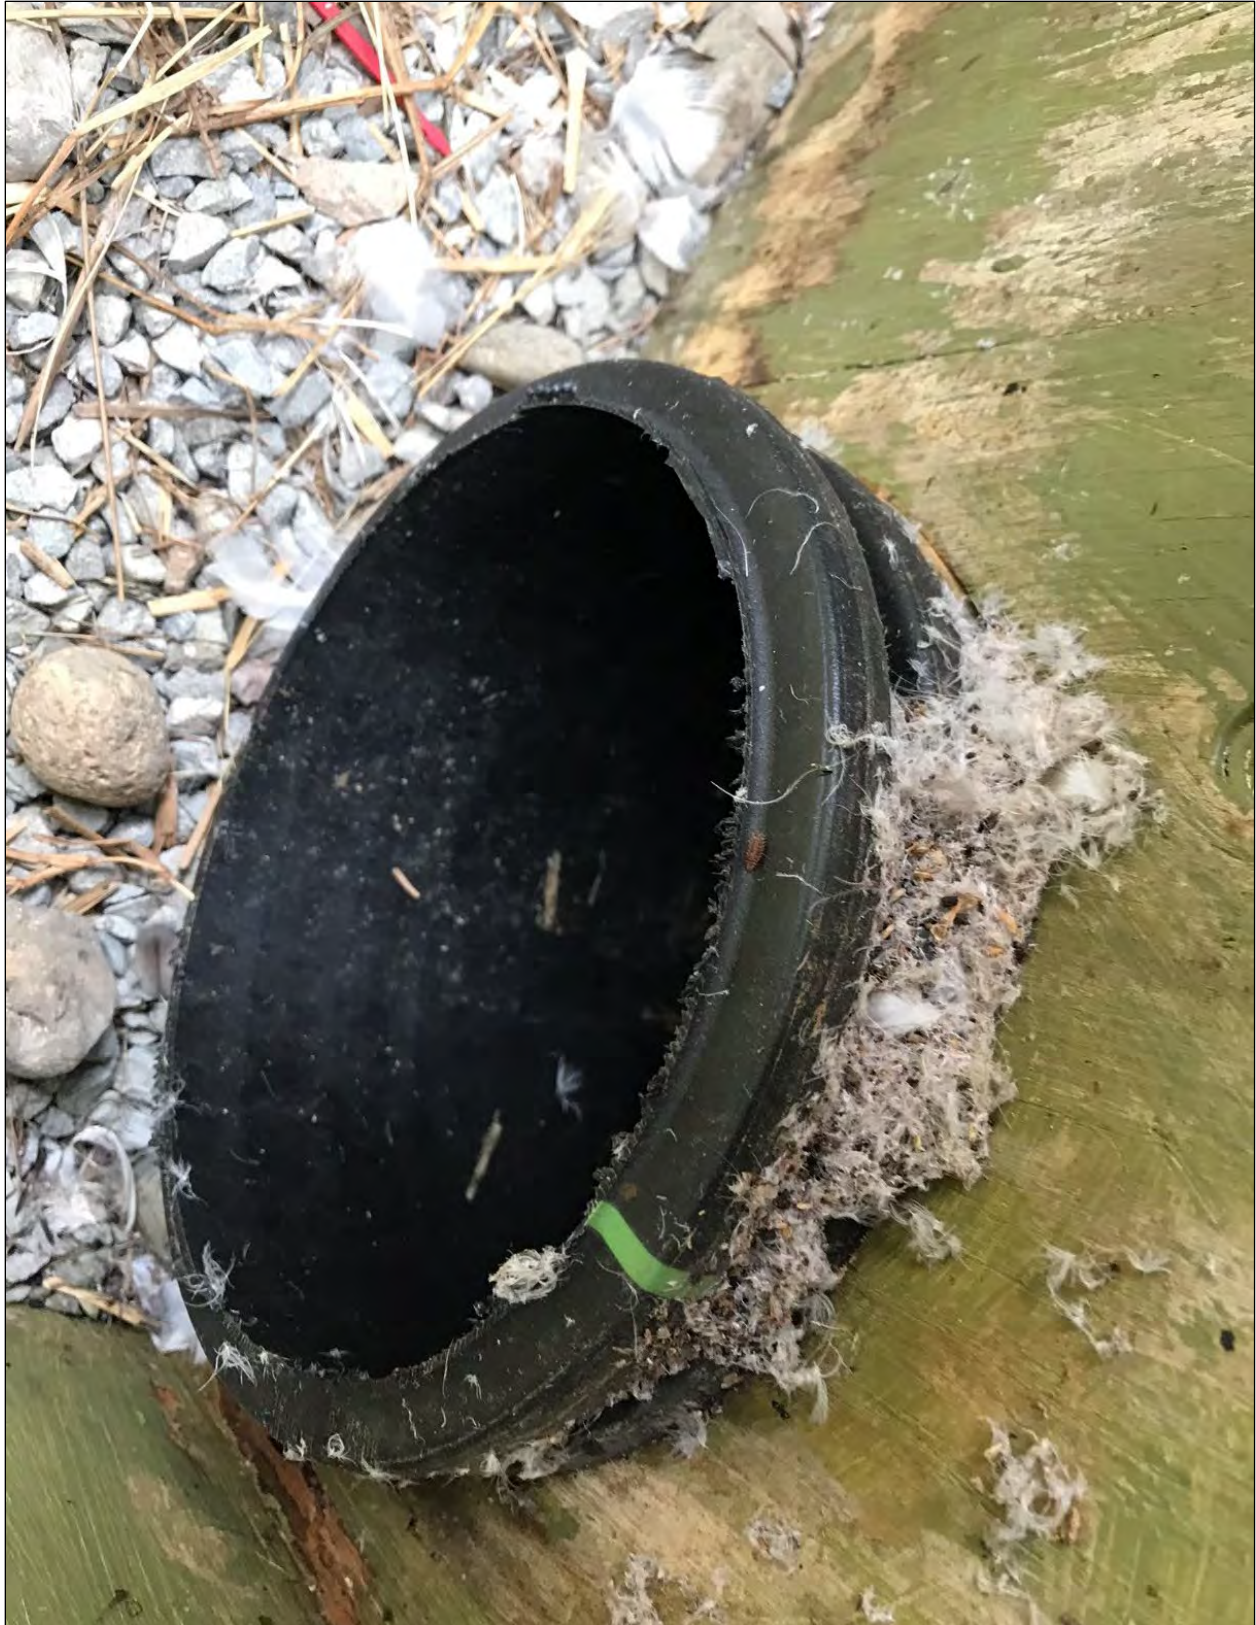
Nest B-50 Entrance Passageway Margin Inside the Nest Box Encrusted in Down on October 16, 2019
