**KSHCP Participant Annual Report - Base Form**

Reporting Year	2023	Participant Name	State of Hawaii, Department of Transportation			For participants with multiple facilities, indicate here the total number of facilities for which Base Forms have been produced. Complete the Information Required to be Reported on each Base Form.	3

**KSHCP 2023 - Addendum Sheet 3, Take Calculations, Lihue Airport**

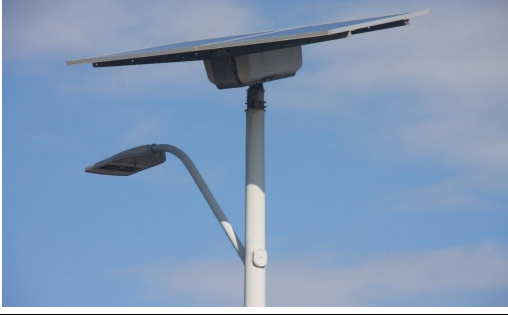
New public parking lot lights, installed in 2022, are LED and contain full cut-off fixtures. No further upgrades in 2023.
		KSHCP 6.6.1.2

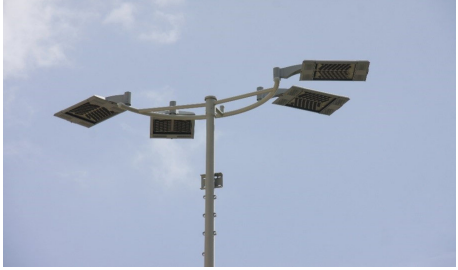
Full cut-off LED light fixtures installed in 2020, part of facility-wide Phase 3 upgrades planned for completion during 2020-2025 at Lihue Airport. These upgrades are substantively complete and no further installations were made in 2023.
		KSHCP 6.6.1.2

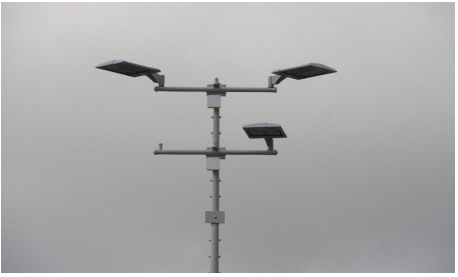
Full cut-off LED light fixtures installed in 2020, part of facility-wide Phase 3 upgrades planned for completion during 2020-2025 at Lihue Airport. These upgrades are substantively complete and no further installations were made in 2023.
		KSHCP 6.6.1.2

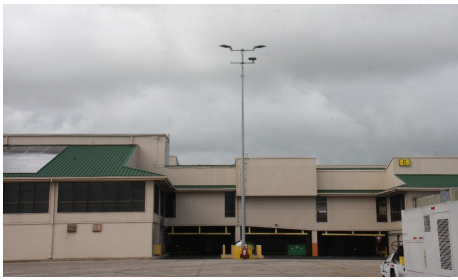
Full cut-off LED light fixtures installed in 2020, mounted on tall masts along the main terminal ramp adjacent to Gate 6 at Lihue Airport. These upgrades are substantively complete and no further installations were made in 2023.

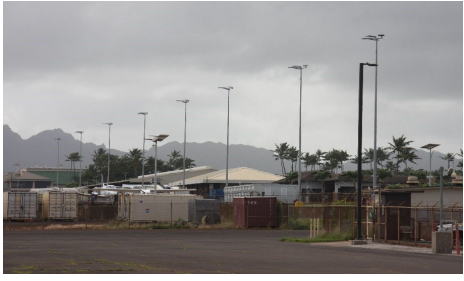
High mast lights used to illuminate the cargo ramp apron at Lihue Airport were upgraded to full cut-off LED fixtures in 2020. These upgrades are substantively complete and no further installations were made in 2023.
		KSHCP 6.6.1.2

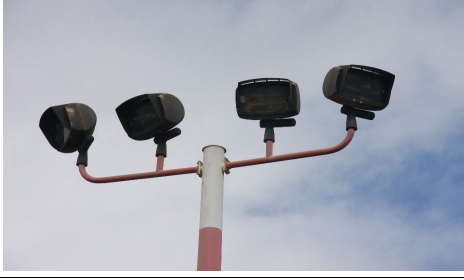
High pressure sodium lamps, like those pictured here, remain in use mostly on the north ramp.
		KSHCP 6.6.1.2

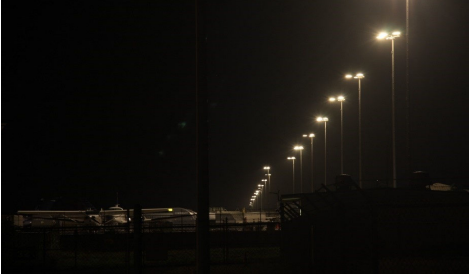
High mast lights installed in 2020 equipped with LED full cut off heads illuminate the main commercial ramp, cargo ramp, commuter terminal and portions of the general aviation-north ramp at Lihue Airport. These upgrades are substantively complete and no further installations were made in 2023. See Appendix 3 for additional nighttime photos of lighting at Lihue Airport in 2023.

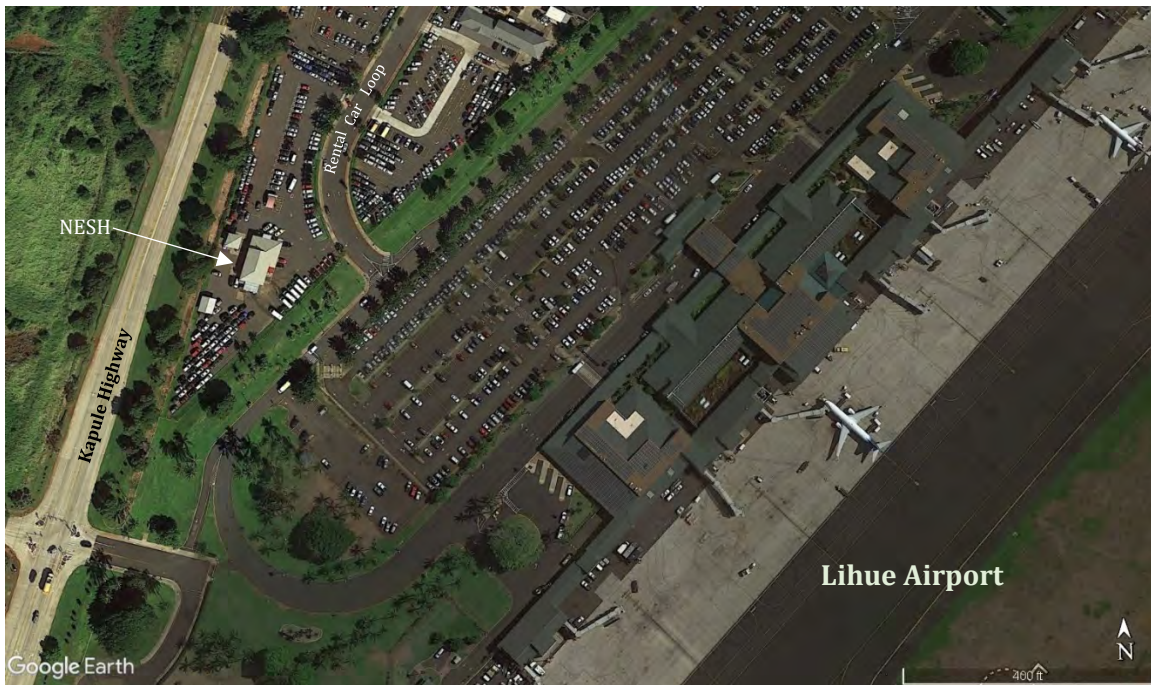
Wide view of the western end of Lihue Airport. The Newell's shearwater was discovered in one of the several rental car facilities that are adjacent to Kapule Highway

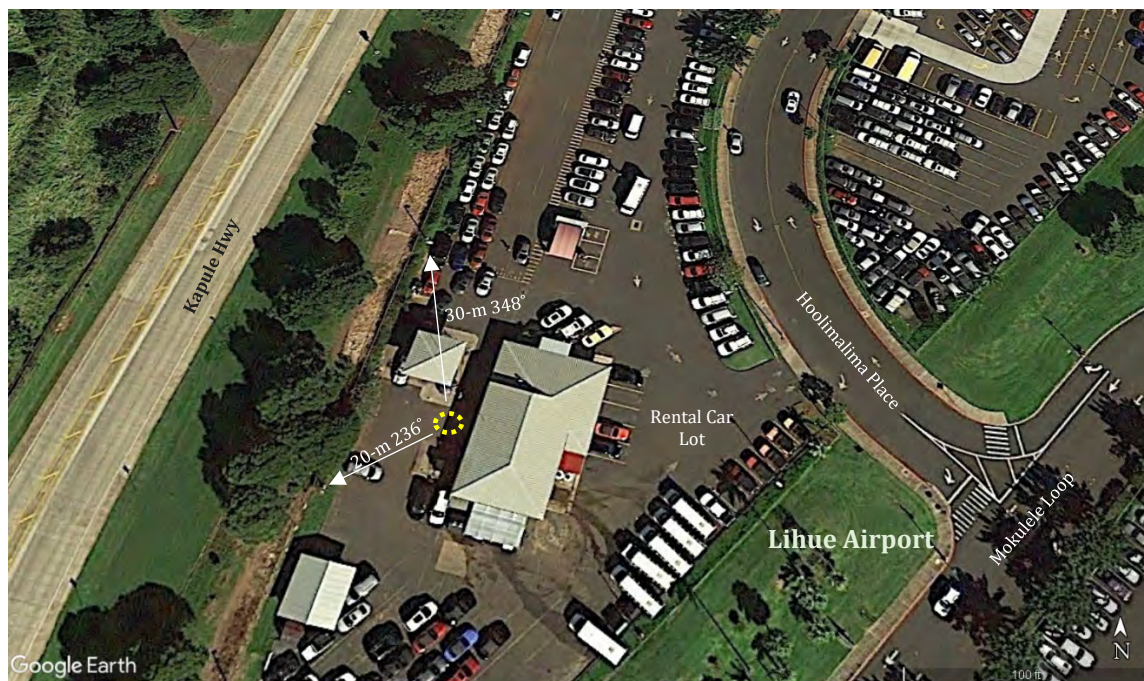
Light attraction disorientation likely contributed to the grounding; no observed injuries reported by the Avis employee or USDA-Wildlife Services.

The dashed oval in the image above gives the location where the Newell's shearwater was found by rental car agency staff at Lihue Airport; nearest service area lights were about 20 and 30 meters away.

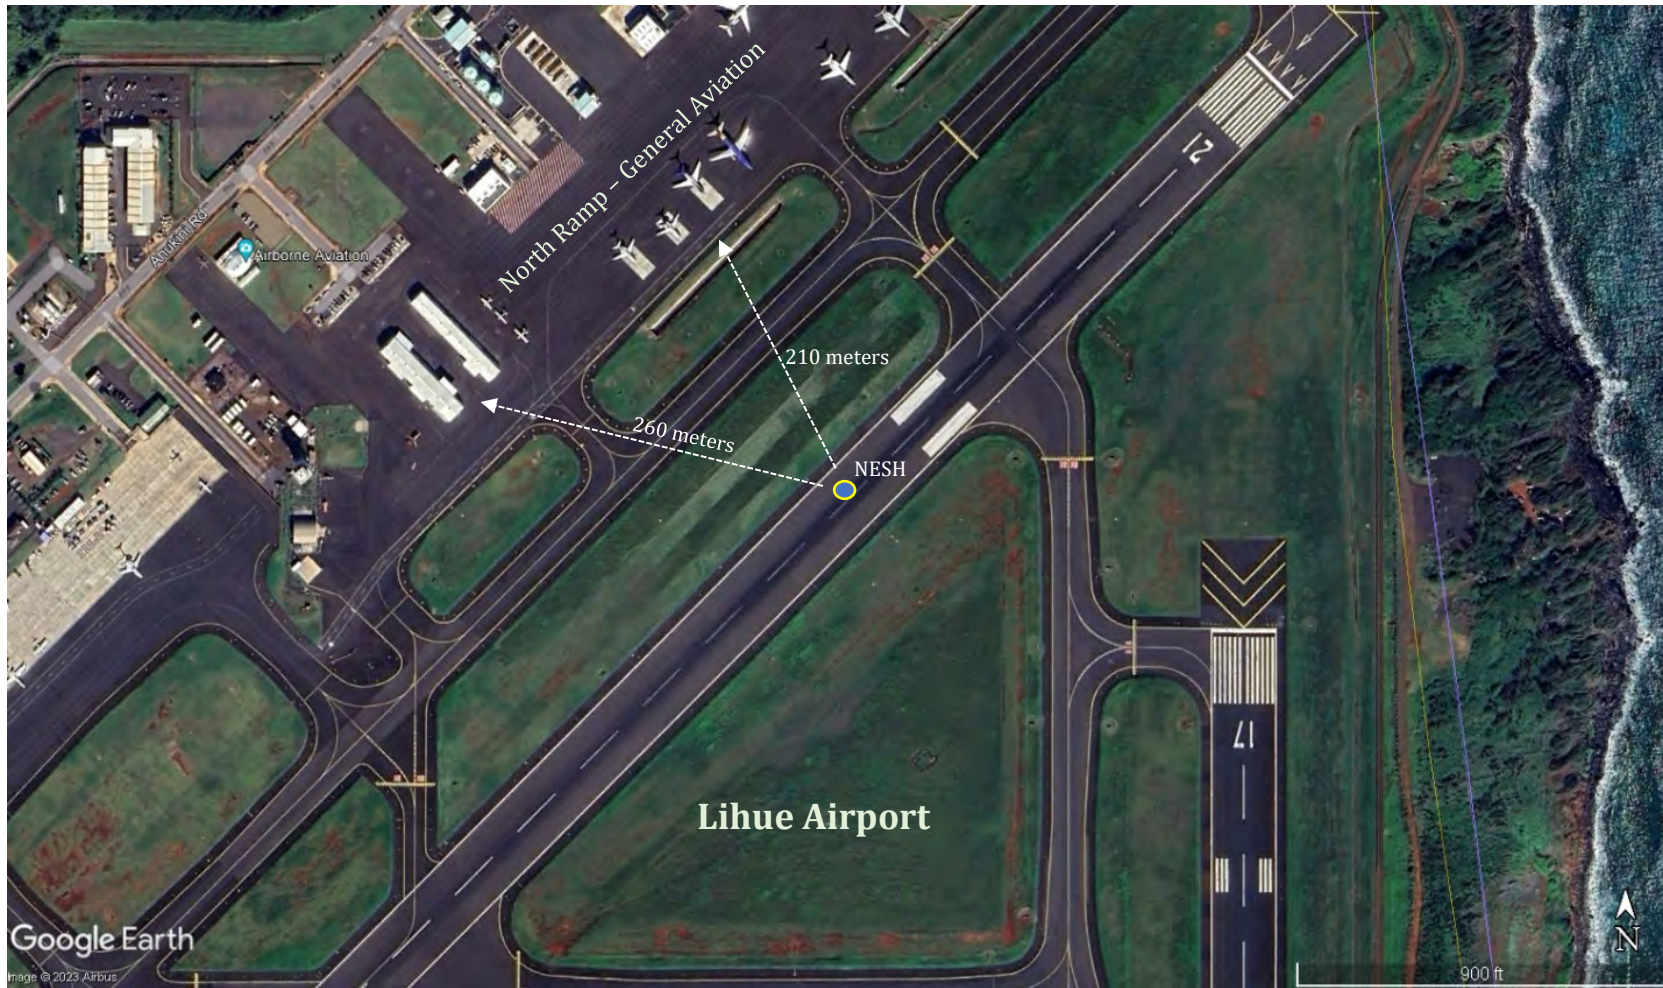
Found alive, no injuries were reported.

Location where a Newell's shearwater (NESH) was discovered by a USDA Wildlife Services biologist at Lihue Airport on October 17, 2023

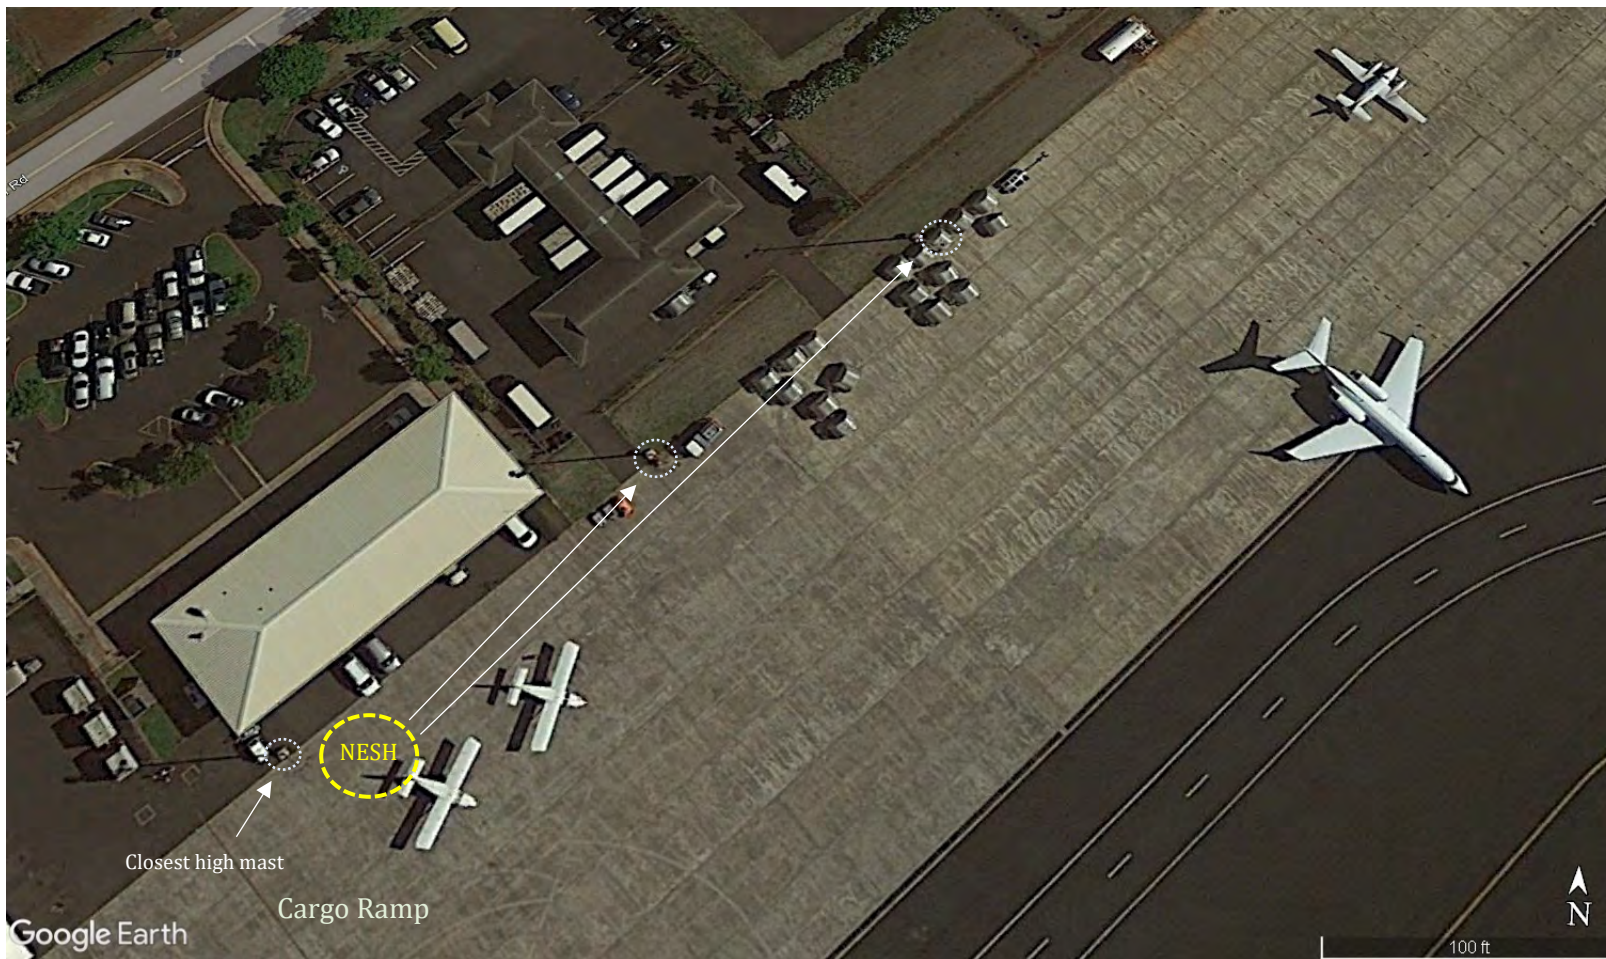
Specific layout features in the vicinity where a grounded Newell's shearwater was discovered by USDA-Wildlife Services during routine wildlife and seabird surveillance and monitoring at Lihue Airport on October 25, 2023.

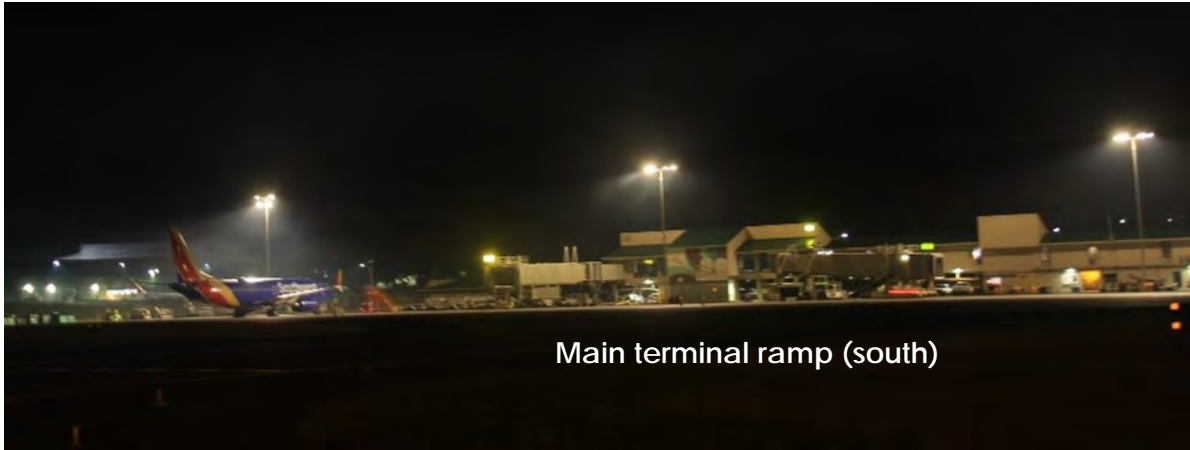
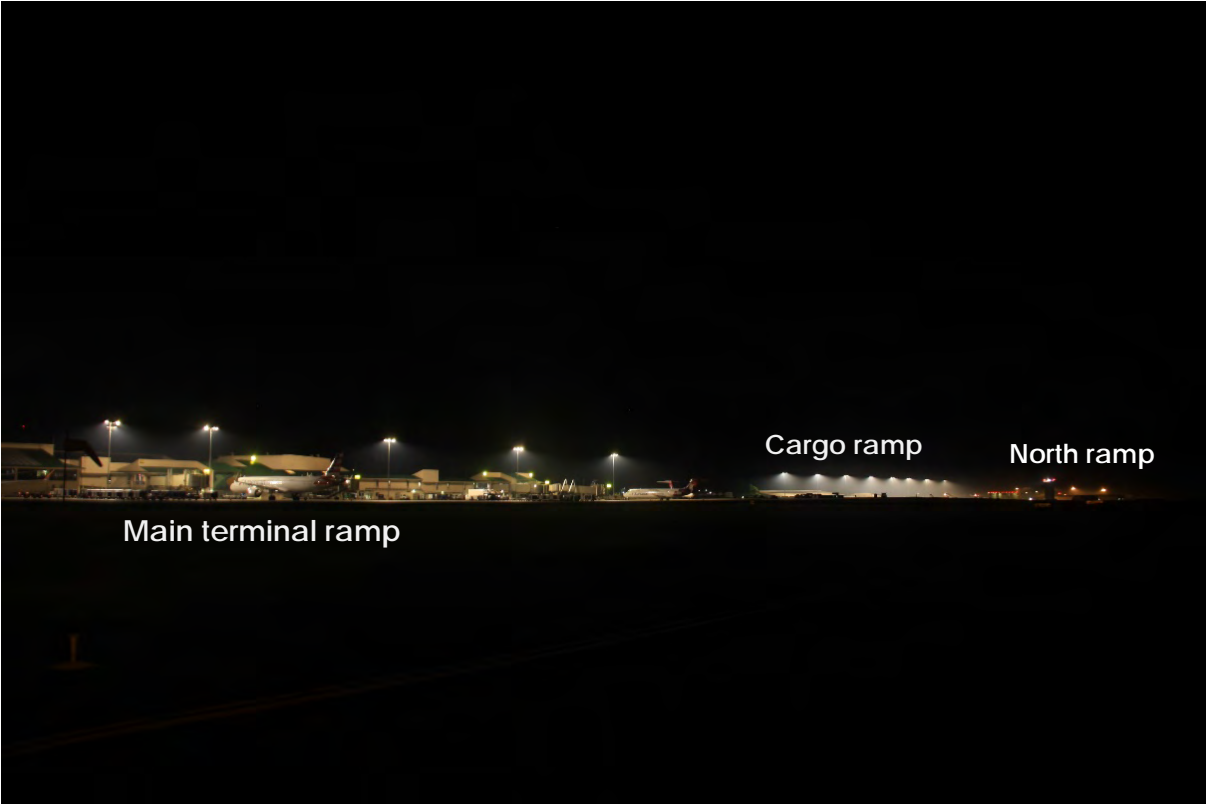
Main terminal ramp (south)

Aircraft and lighting infrastructure along the main terminal ramp (above), cargo and north ramps (below) at Lihue Airport during normal operational conditions.

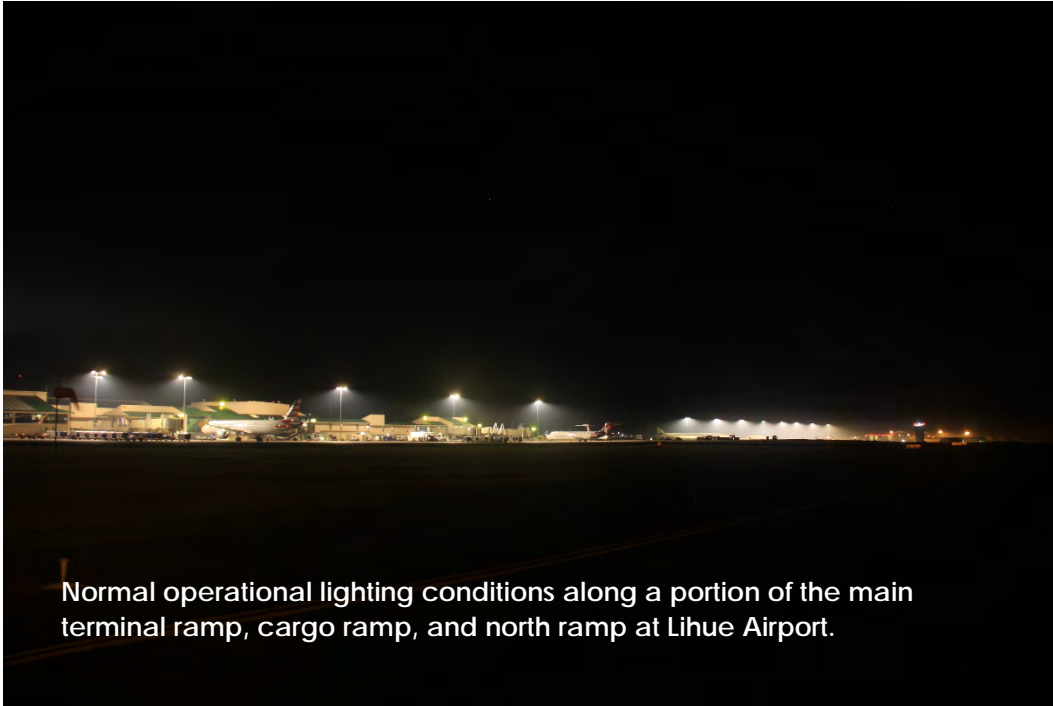
Normal operational lighting conditions along a portion of the main terminal ramp, cargo ramp, and north ramp at Lihue Airport.

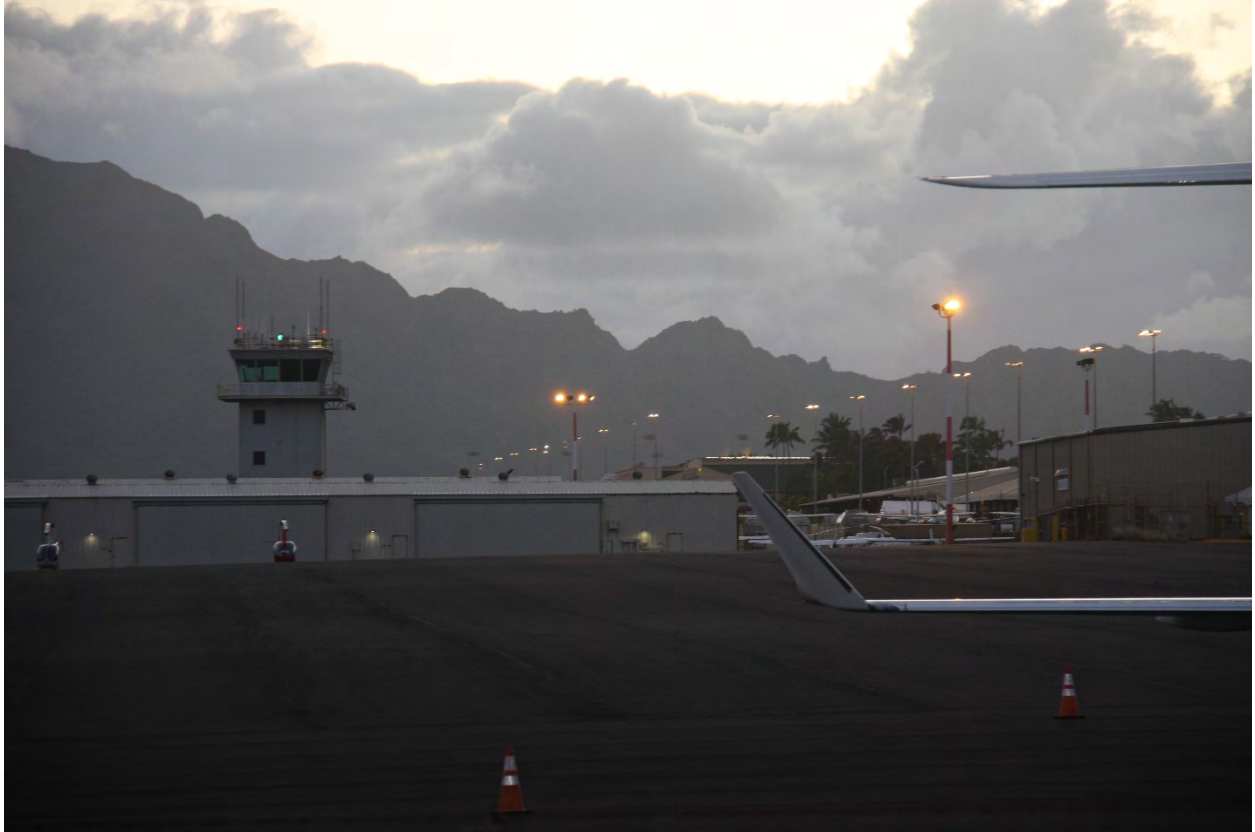
View from the North ramp looking south along the Cargo and Main Terminal sections of the airfield at Lihue Airport.
