STATE OF HAWAII  
DEPARTMENT OF LAND AND NATURAL RESOURCES  
Land Division  
Honolulu, Hawaii 96813

Grant of Term, Non-Exclusive Easement to Steven Robert Campbell and Deana Darlene Campbell, Trustees, Campbell Family Trust dated April 15, 1993, for Concrete Seawall Purposes; Issuance of Management Right-of-Entry; Assess Administrative Cost of \$500, Halakaa, Lahaina, Maui, Tax Map Key: (2) 4-6-003:Seaward of 007.

SUBJECT: Encroachment MA-15-5, Lahaina, Maui, Hawaii, Tax Map Key  
(2) 4-6-003:007

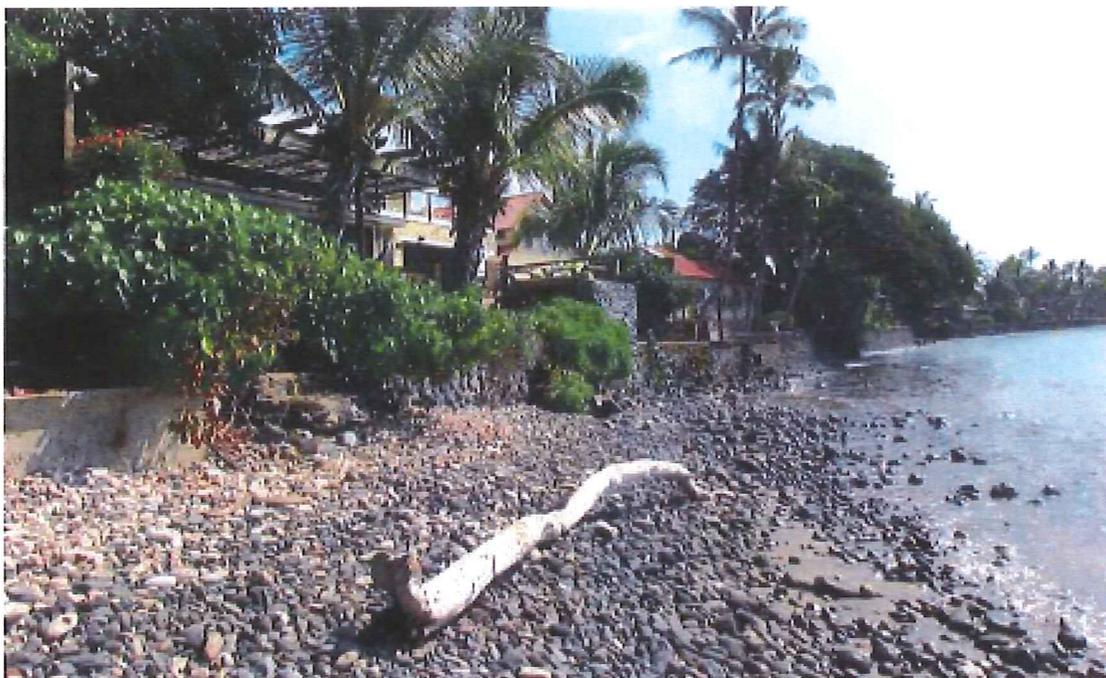
**Figure 1. Looking south along the coastline from the subject property.**

interconnected coastal structures that stretch almost 1,000 feet in length (Figure 1). The subject property seawall is buried within the coastal plain on the northwest end and exposed in the beach face at the southeast end, where it abuts the neighbor's structure (Figure 2).

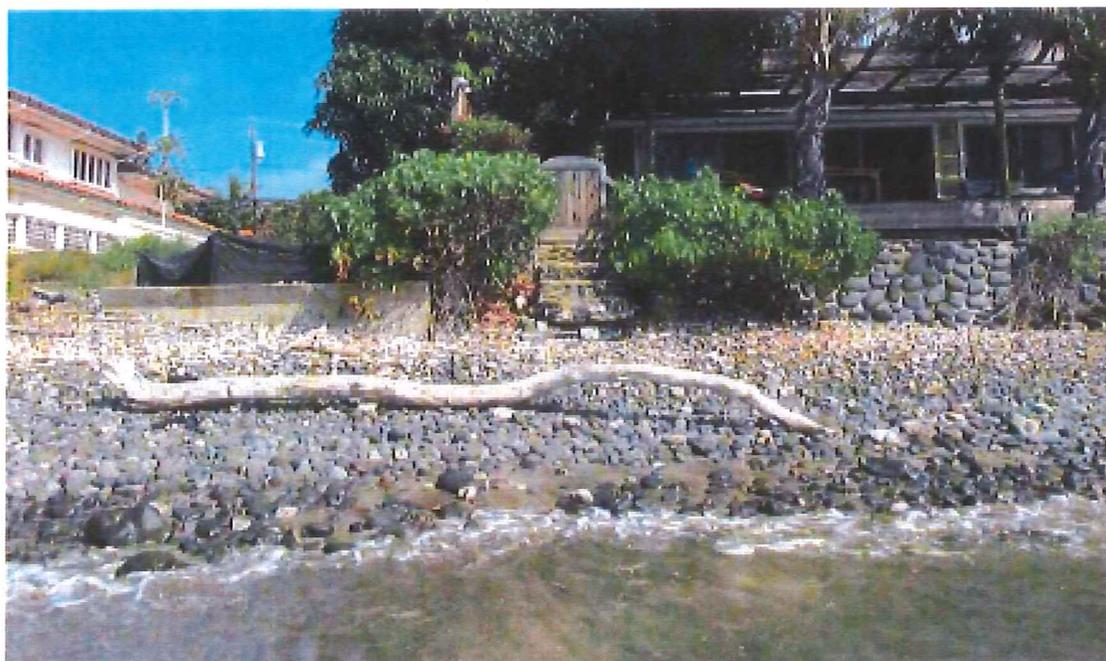
**Figure 2. Subject property and southern neighbor. Both shoreline structures abut, and the faces of each are exposed above the deflated beach face.**

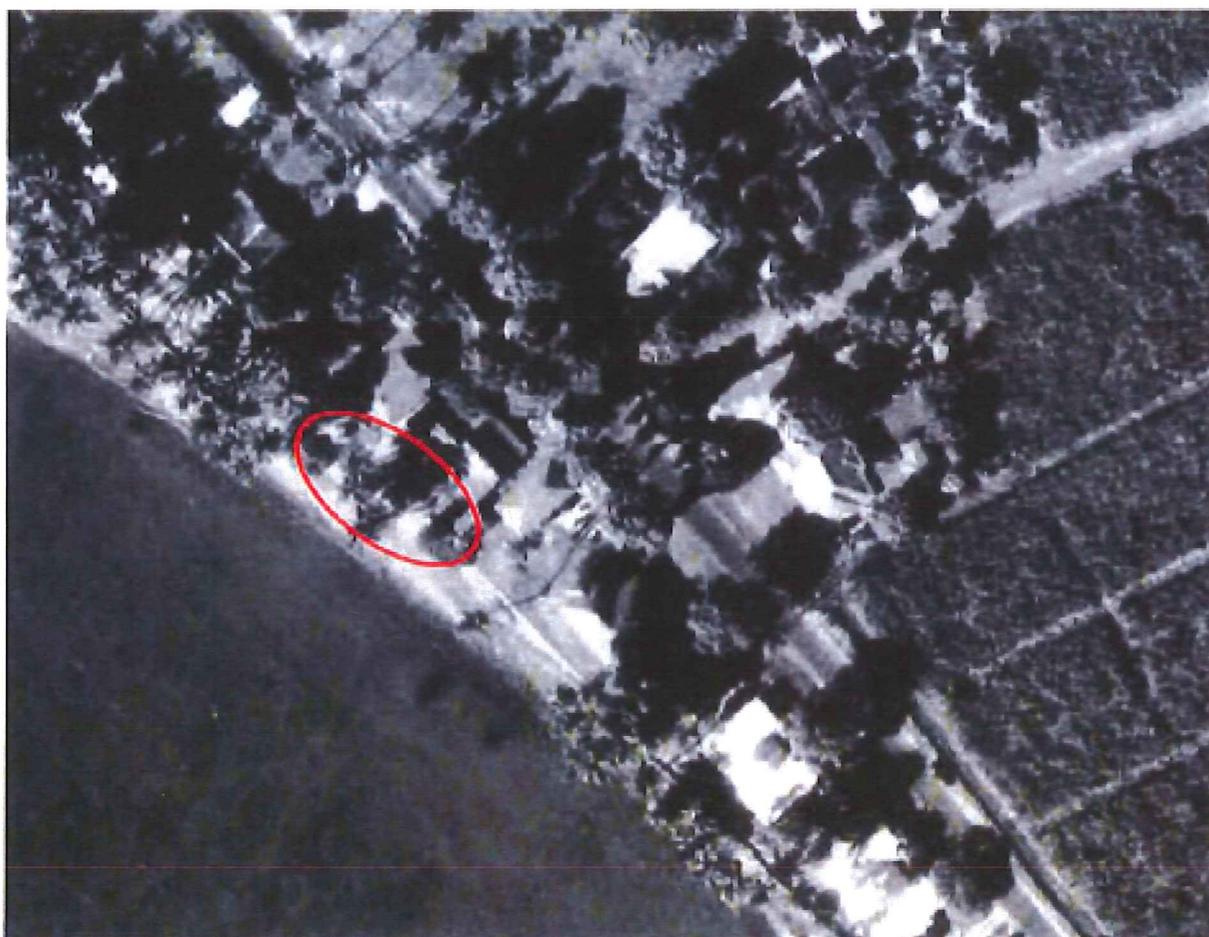
**Figure 3. 1949 aerial photograph. Linear feature fronting the southern neighbor's property identified by the red oval. There are linear features within the shadows that are in-line with the walls to the south, and in similar location to the current structure.**

The southern neighbor's shoreline structure appears to be non-conforming, based on review of historic aerial photographs. There is a linear feature on the shoreline in 1949 on the seaward side of the southern neighbor's parcel (Figure 3). The linear feature in the shadow of the trees is located along the seaward neighbor's property. The 1960 aerial image (Figure 4) also shows an extension of the linear features from the south and possibly as far north as the subject property, as shown on the photograph below. The linear feature identified in both of these images is in line with the neighboring structure to the south. The southern neighbor's wall, itself, appears to be built out of native stones (Figure 5), in similar fashion to the walls farther south (Figure 6). The southern neighbor's wall appears to be non-conforming to the Conservation District rules based on these observations. Based on the aerial photographs, it is unclear if the subject property's seawall is also non-conforming, due to foliage cover in the images.

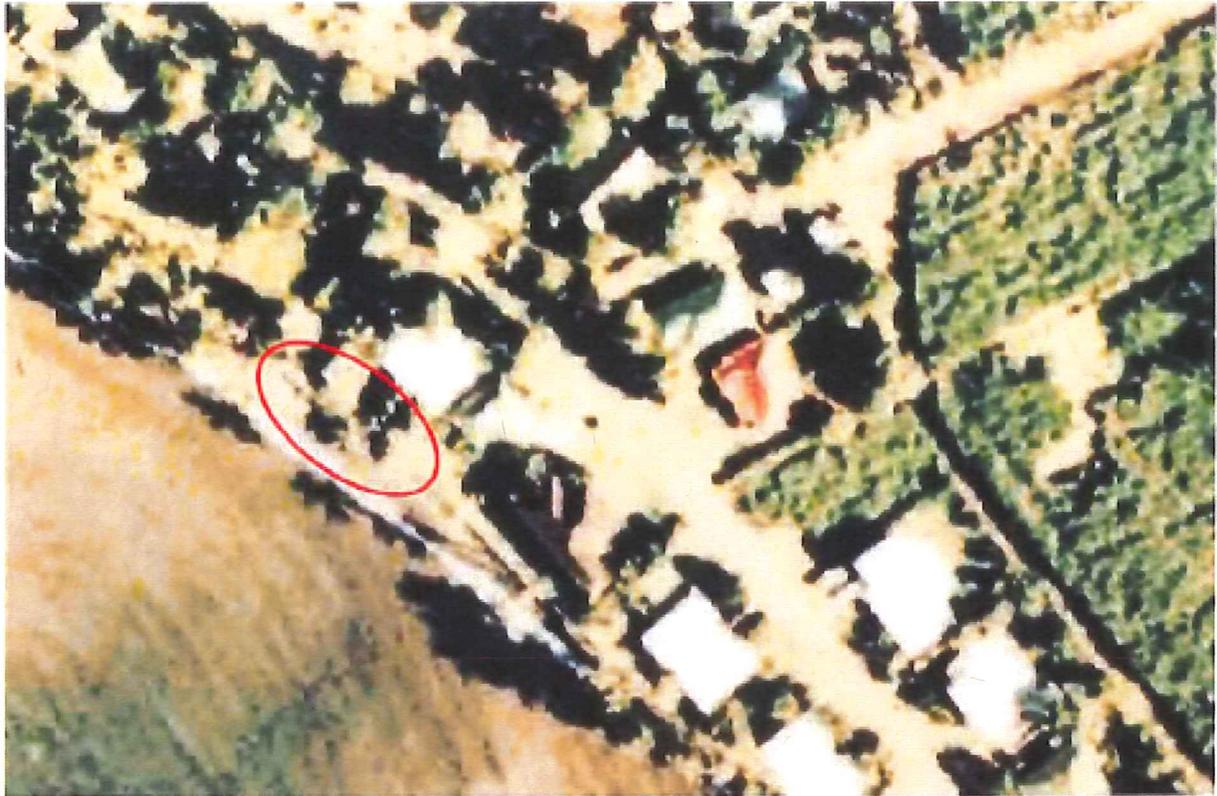
**Figure 4.** 1960 aerial photograph. Linear feature fronting the southern neighbor's property, and possibly the subject property, identified by the red oval.

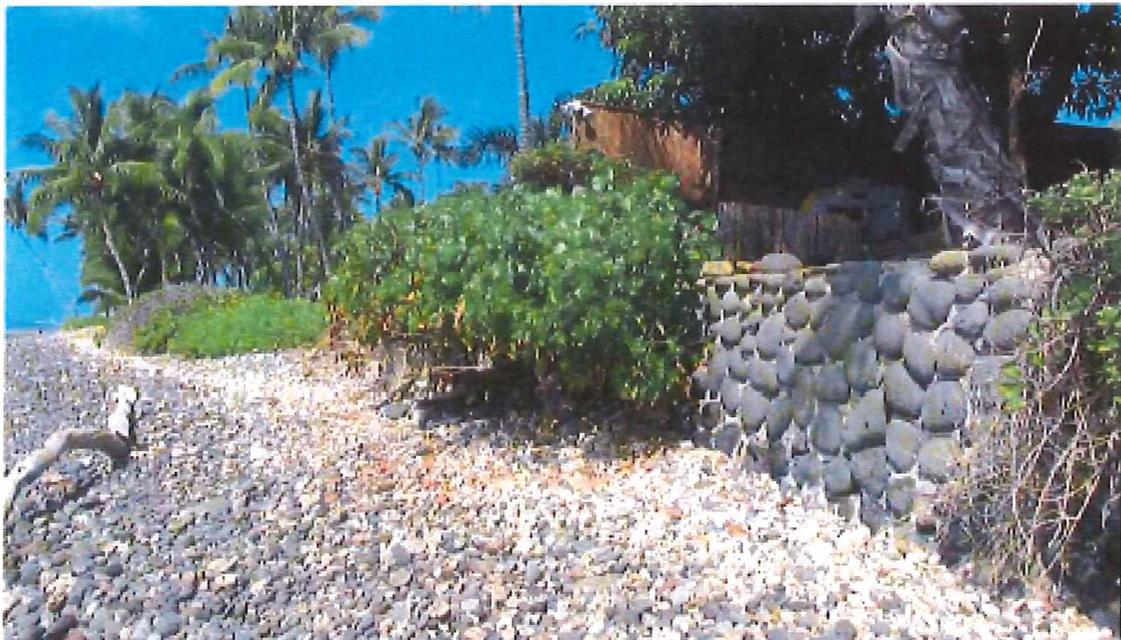
**Figure 5.** Southern neighbor's wall built out of native rocks.

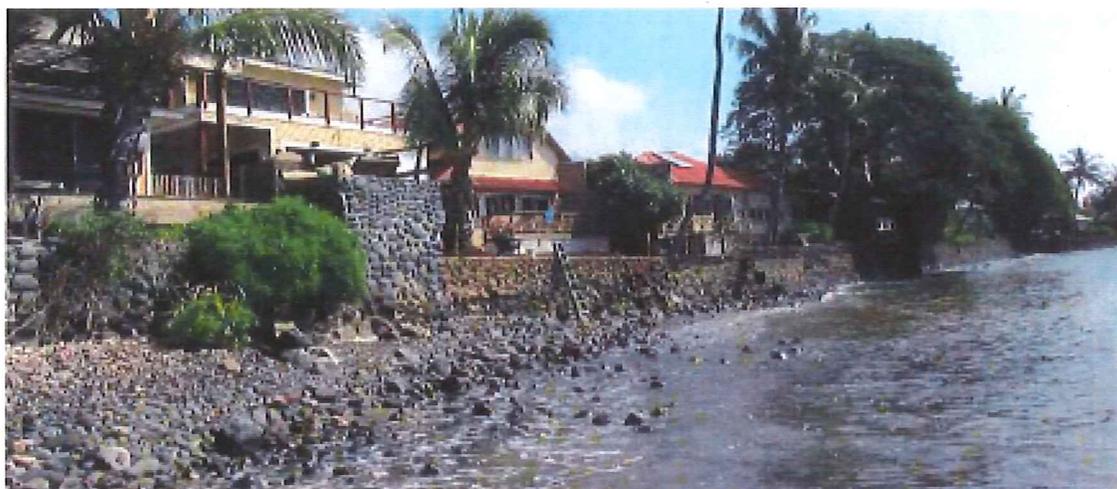
**Figure 7. The walls abutting the southern neighbor are built of similar materials.**

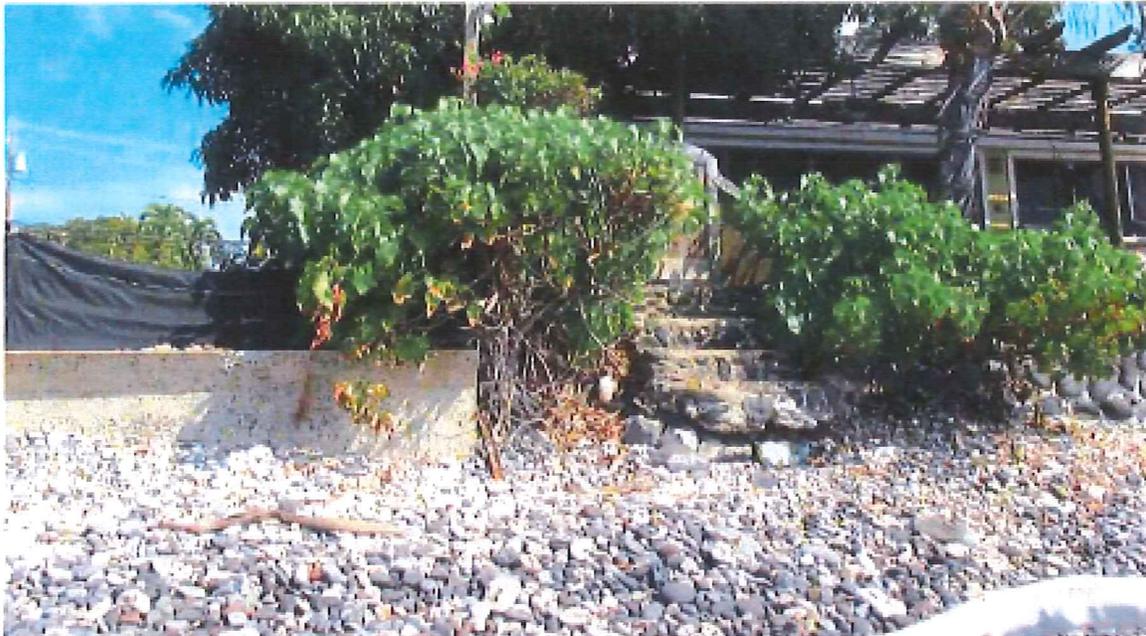
**Figure 8. The subject property wall and southern neighbor wall are abutting.**

The request in this letter, and the data within the letter, are focused on potential impacts to the southern neighbor's seawall and residence, which may result from a requirement to remove the existing seawall along the subject property's shoreline. The southern neighbor's wall is likely non-conforming, and is abutting the subject property's seawall (Figure 8). The subject property's seawall protects the neighbor's wall from flanking. The wall on the common boundary between the two parcels is a landscaping feature with a shallow footing, not an engineered return wall.

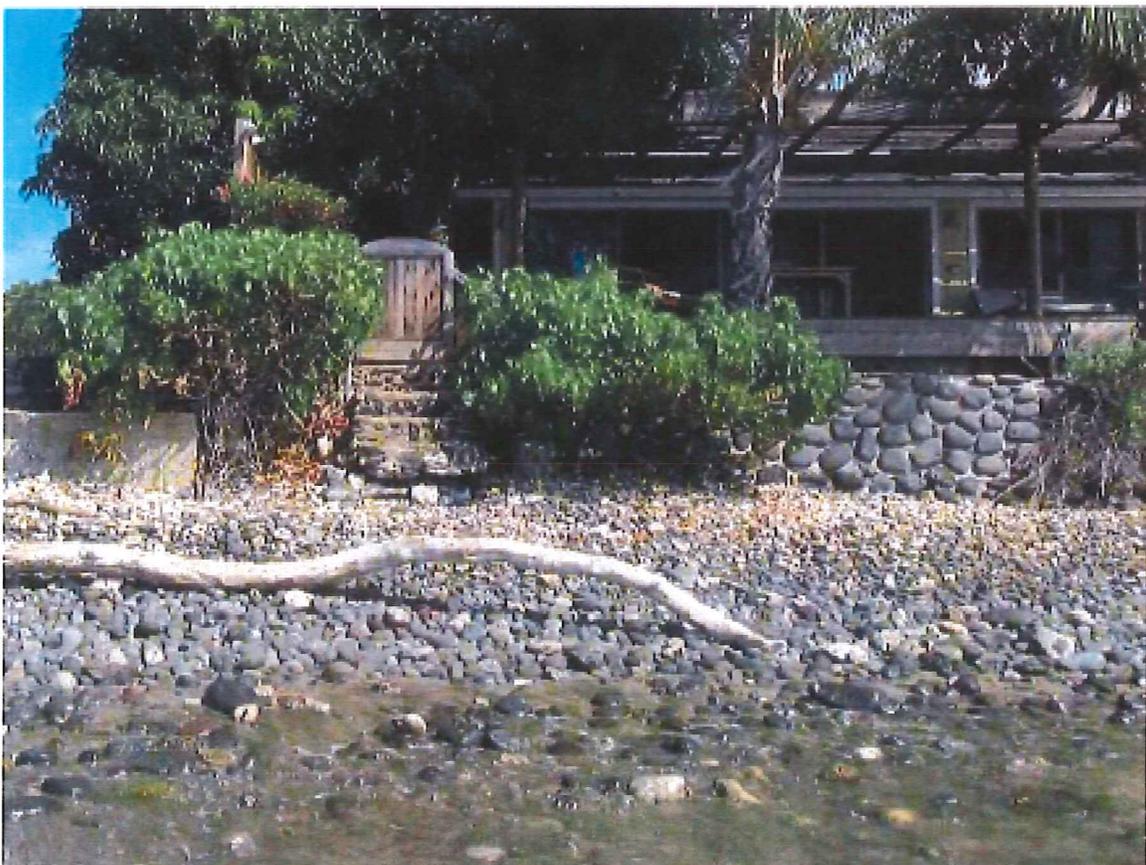
**Figure 9. The southern neighbor's residence is less than 15 feet from the seawall.**

The southern neighbor's home is less than 15 feet from the seawall (Figure 9). There is an active debris line at the face of the wall, and a wet/dry line from quiescent conditions (January 16, 2015) that is nearly at the wall's face. Both the subject property and the southern neighbor seawalls are regularly impacted by littoral processes.

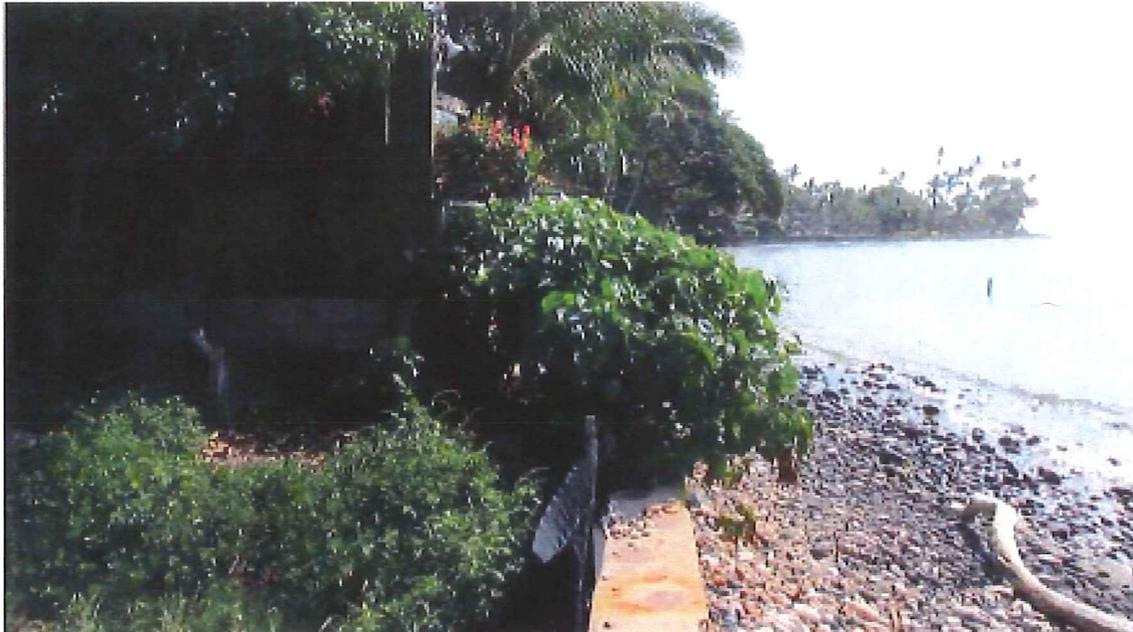
**Figure 10. The deflated cobble beach and backshore elevations have a vertical offset at the south end of the seawall and at the neighbor's seawall. The side wall is a landscaping feature, not an engineered return wall.**

There is a vertical offset between the backshore lawn area and the beach on the seaward face of the subject property's and southern neighbor's seawalls (Figure 10). This vertical offset, or discontinuous slope, will likely result in erosion during normal wave conditions. This is a common outcome when over-steepened slopes equilibrate to active beach conditions. Initial erosion could expose the north end of the neighbor's seawall and the north side of the neighbor's lawn to littoral processes, including erosion.

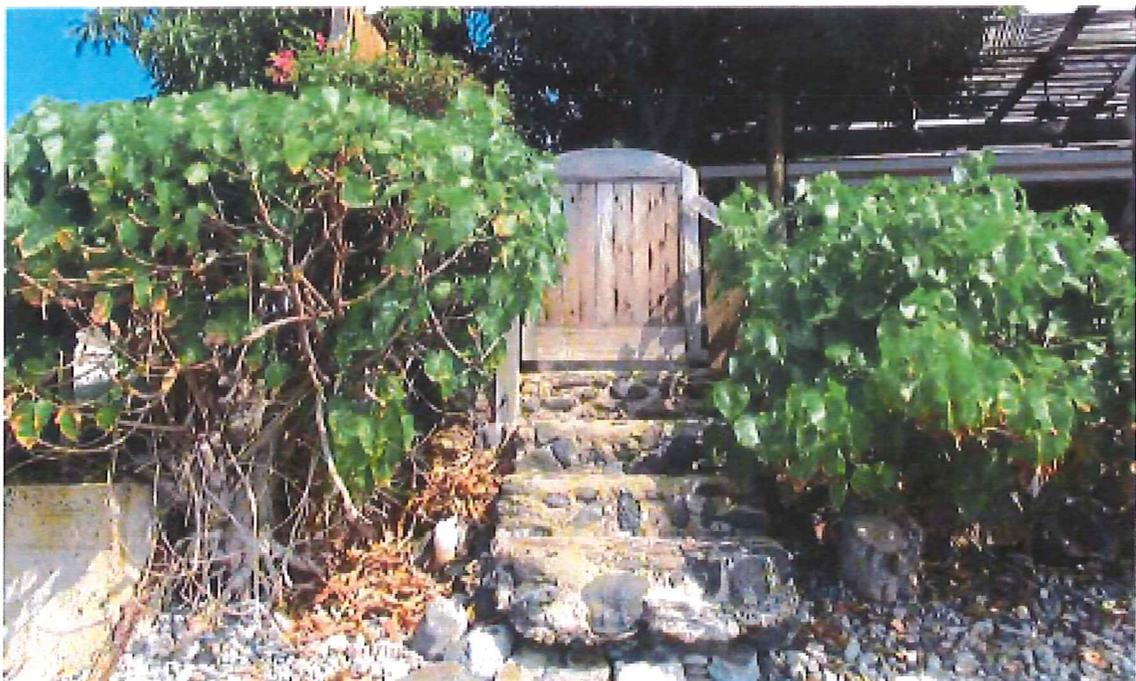
**Figure 11. The subject property stairs are currently undermined, and are exposed to ongoing littoral processes.**

The stairs on the southern neighbor's wall are already undermined due to beach deflation and other ongoing littoral processes (Figure 11), signifying active and continuous erosion on the coastline. This is also detailed in the Coastal Geology Group erosion data for the properties.

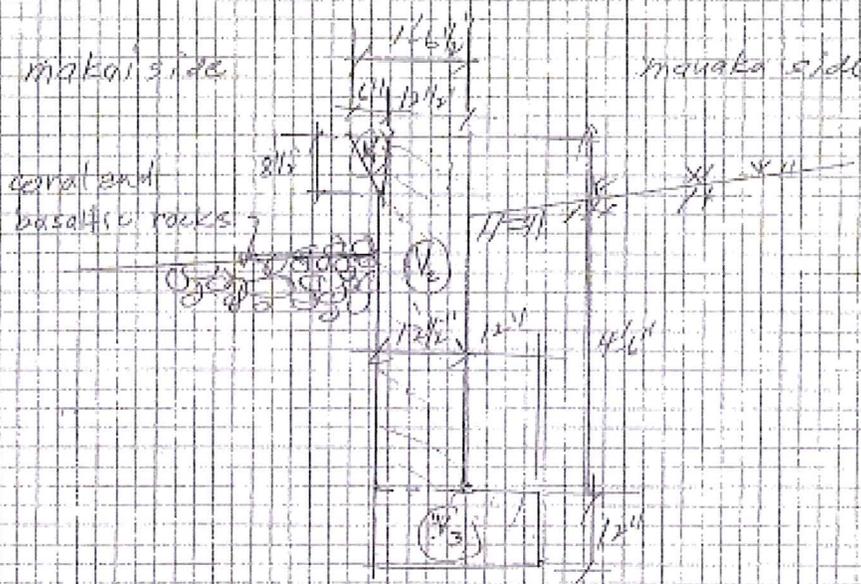
FIGURE NO. 3

Cementitious seawall located @  
Lahaina, Maui, Hawaii

SEAWALL SECTION

Approx. height 12.57' + 4'  
order  
DEC 18  
OKA 11

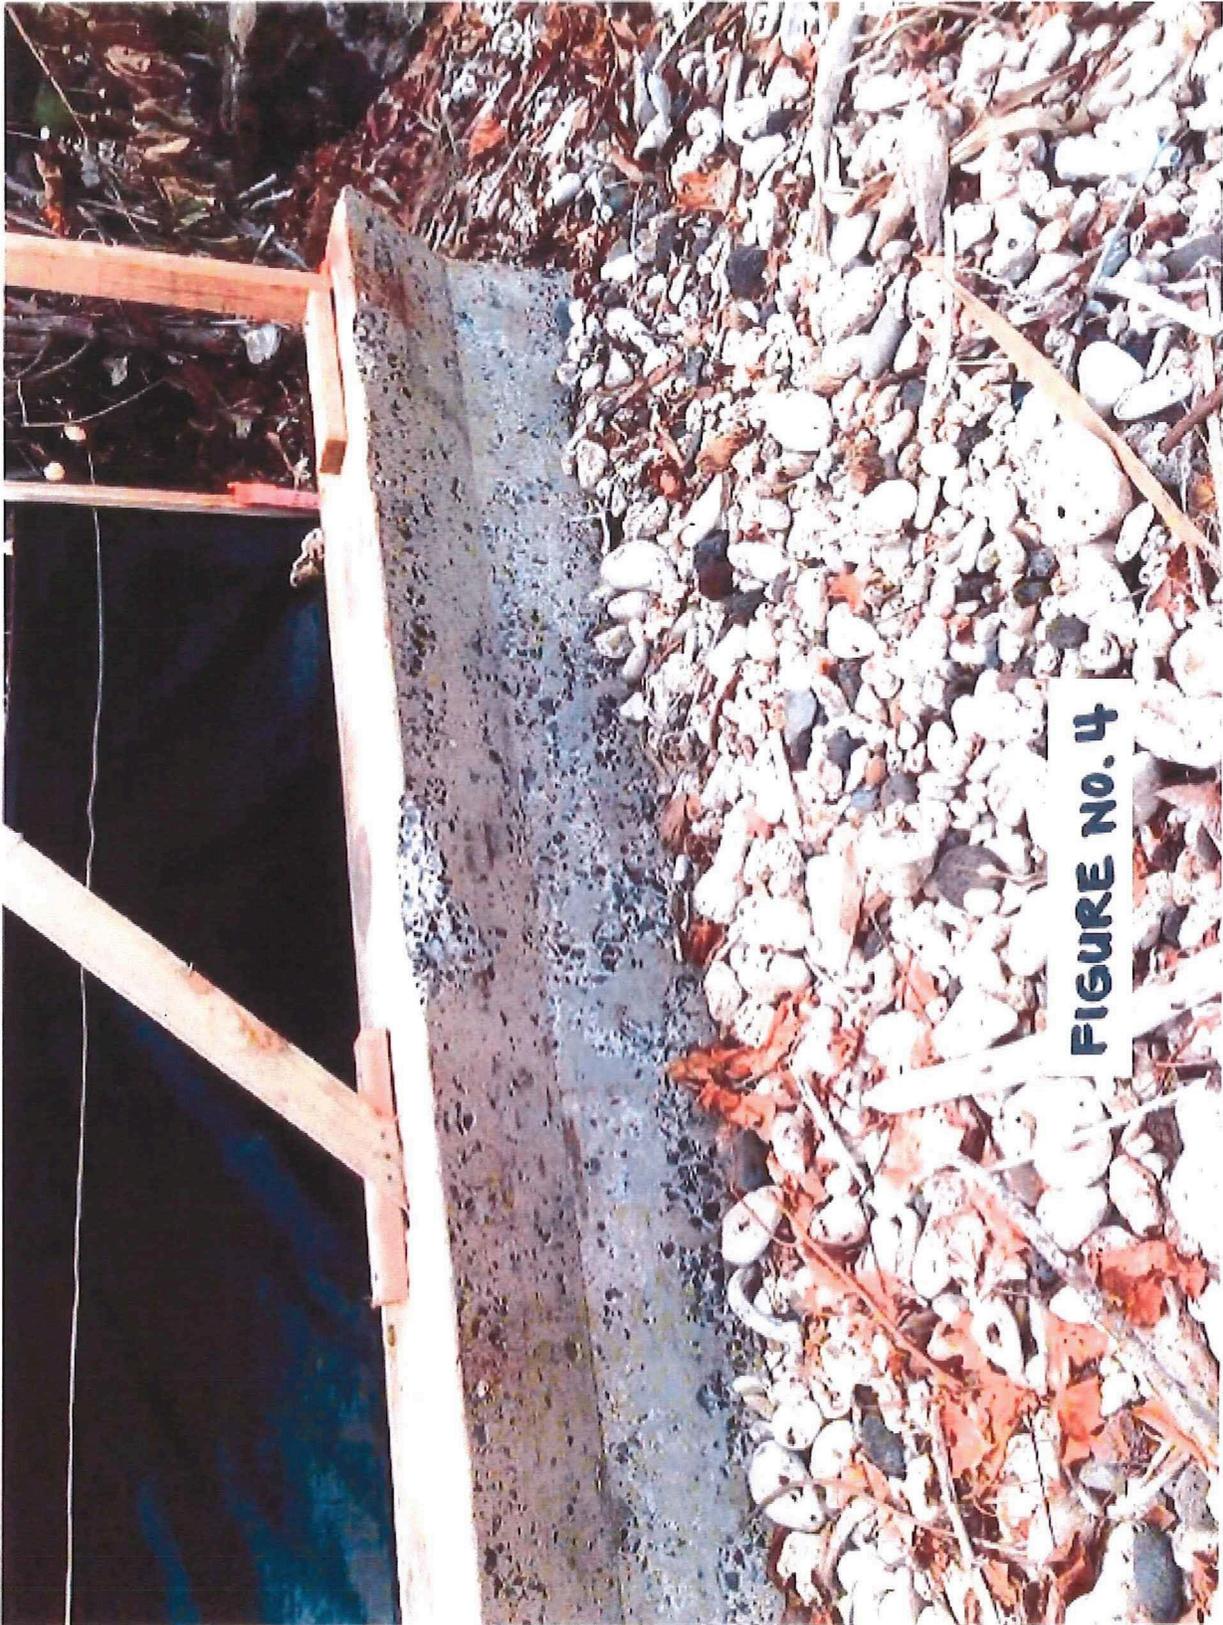
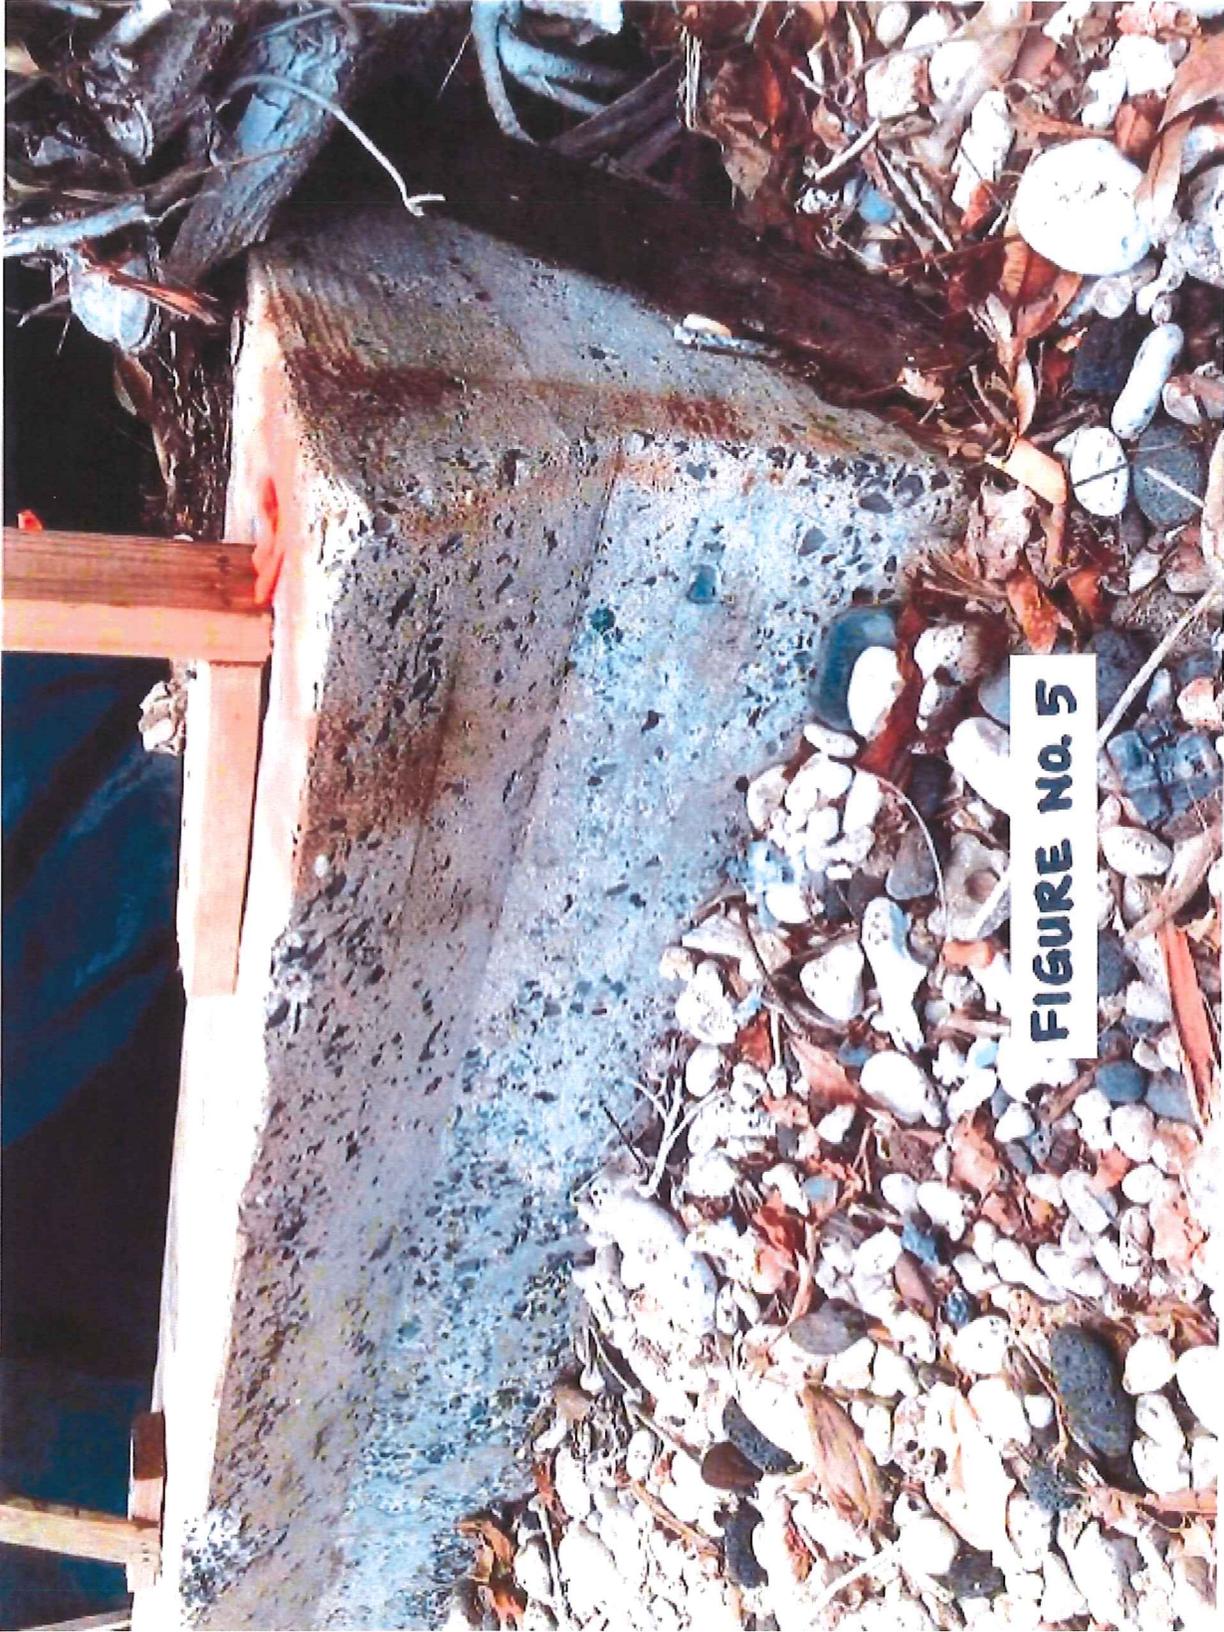
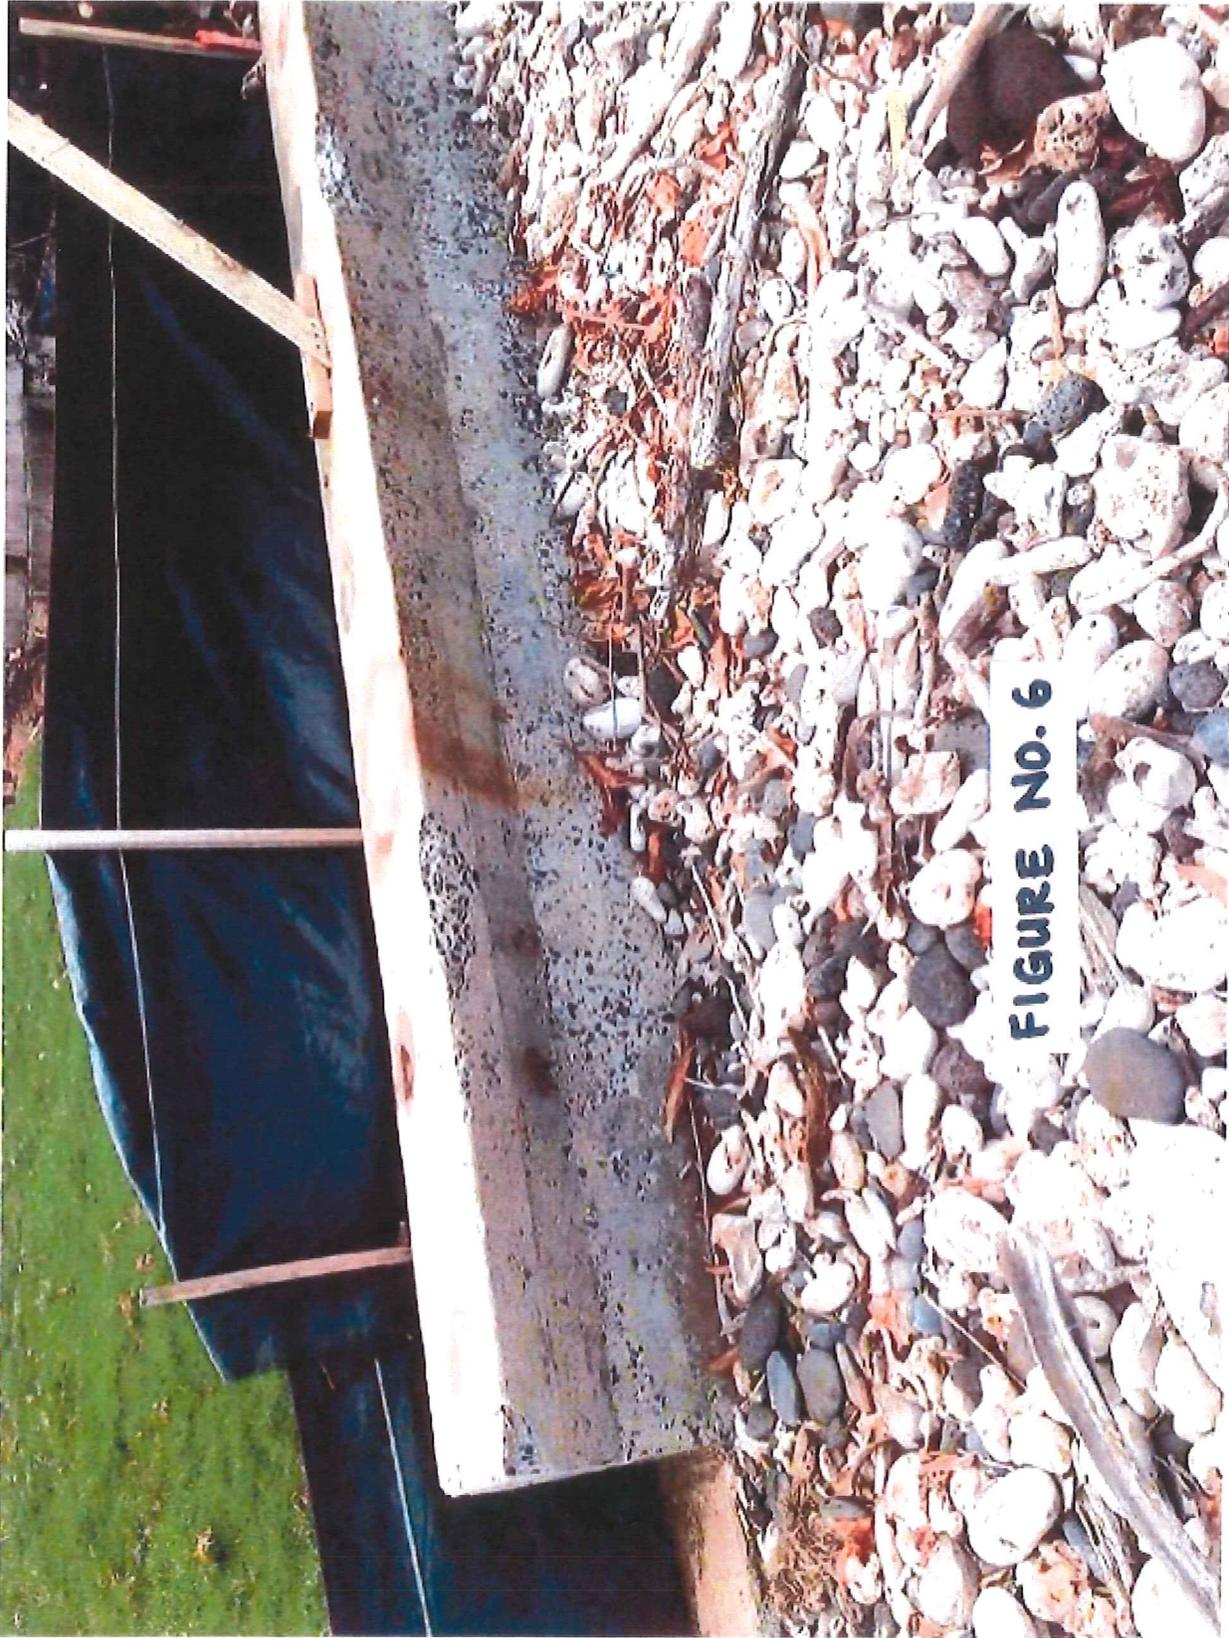
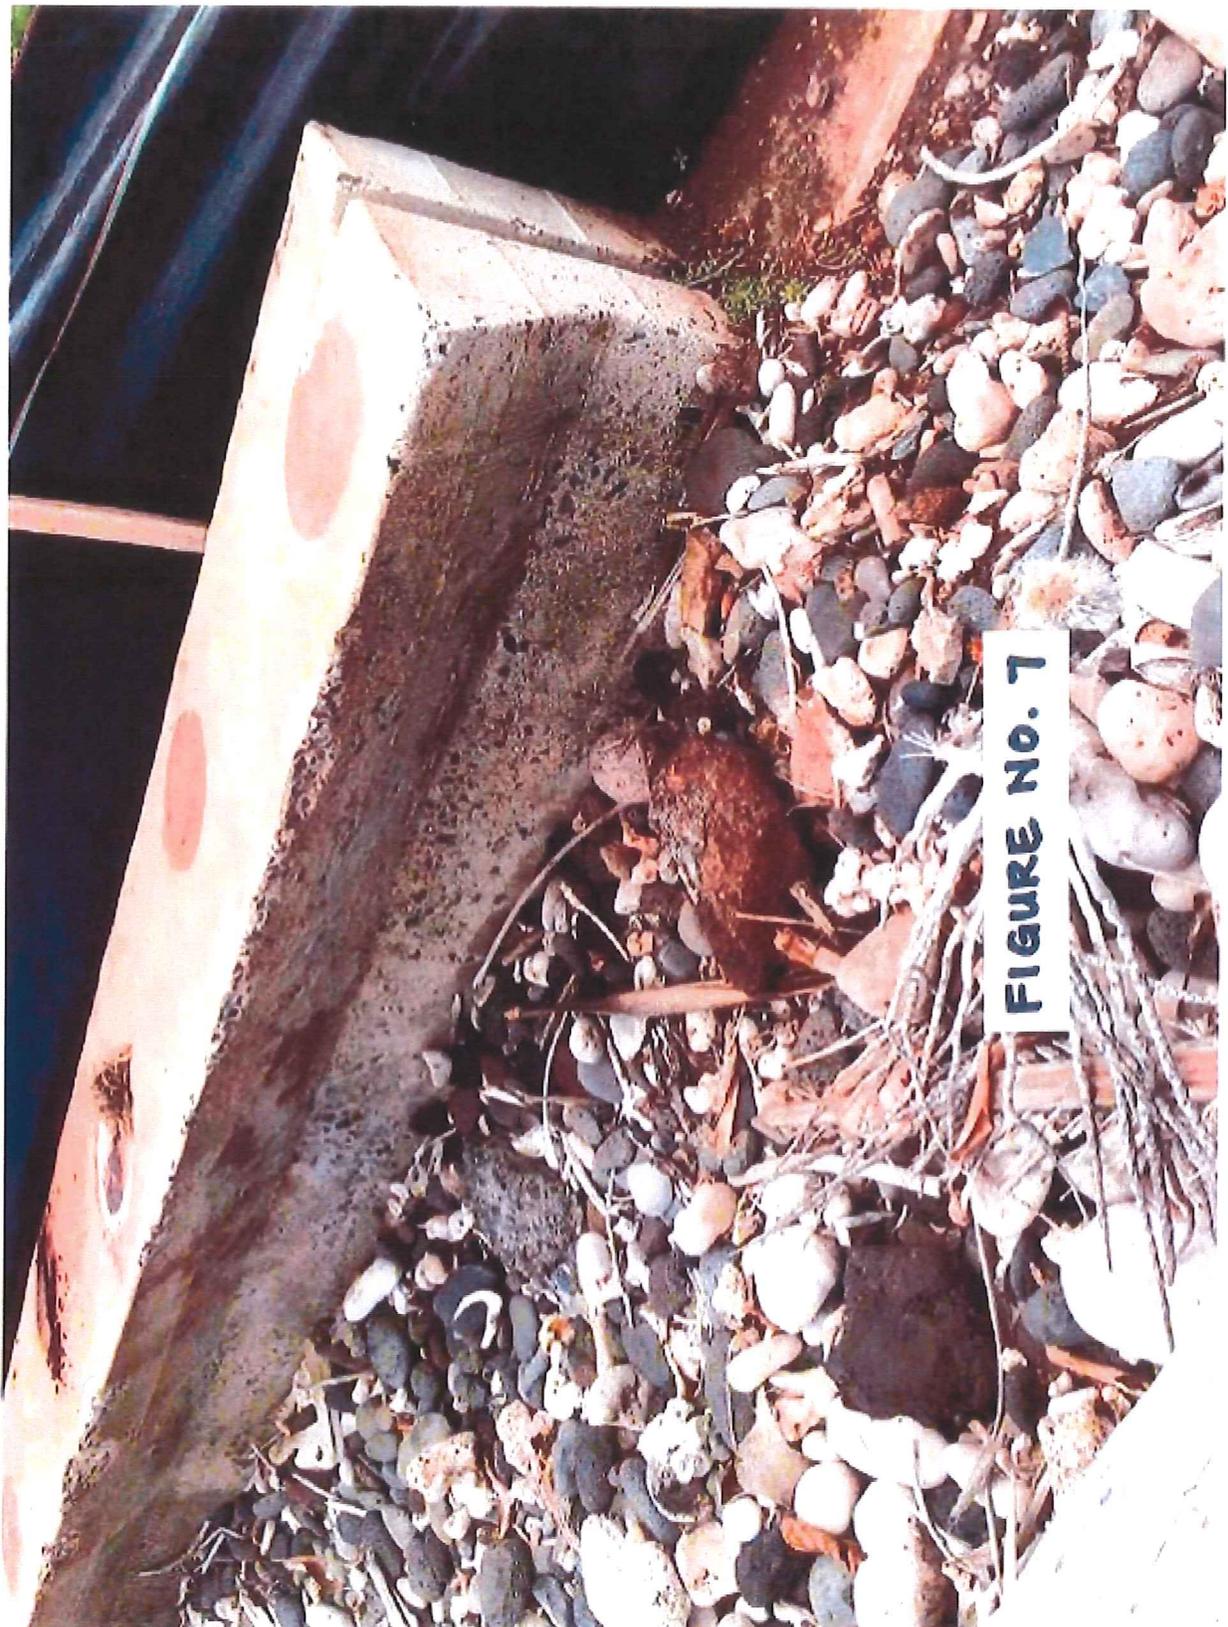
These concrete chips and abrasion were cause from years of exposure to the seasonal high ocean wave conditions and the seawall has been battered and impacted by the rocks. This deteriorations is similar to having a mechanical chipping gun hammer chipping and trying to penetrate and remove the concrete. The impacting and battering from the abrasive ocean wave actions together with the hard rocks have been occurring for a long period of time during the seasonal high surf. See photos, Figures No. 4, 5, 6, & 7.

4. The seaward (makai) face of the wall shows visual deterioration due to ocean wave actions that carries the hard abrasive materials such as coral and basaltic rocks toward the seawall. These hard materials are impacting and battering against the exposed seaward facing wall surfaces. The fast moving ocean waves during high surf seasons carrying the rocks are still impacting and battering the concrete face and causing chips and abrasion on the concrete surfaces thru out (See attached photos, Figures 4, 5, 6, & 7 ). Also, note that the many coral and basaltic rocks fronting the seaward (makai) face were brought to the shore by severe seasonal high ocean wave conditions.

5. The rear (mauka side) surface of the concrete seawall shows no signs of impact or deterioration due to protection from the earth backfill. The mauka side of the wall is not impacted by the severe ocean wave carrying rocks. See photo, Figure No. 8. The rear surface is in good conditions.
6. As a professional structural engineer, it is in my opinion, from the above information received including affidavits, survey map, photos, visual site inspection, and engineering evaluation that the concrete seawall was built in December 1959.
