PSF No.: 16KD-104

Cancellation of Governor's Executive Order No. 1715 and Reset Aside to the County of Kauai for Public Purposes; Issuance of Management Right of Entry to County of Kauai, Kapaa, Kawaihau (Puna), Kauai, Tax Map Key: (4) 4-5-015: 005.

Final
Environmental Condition
of Property
Kapa'a Armory, Kaua'i

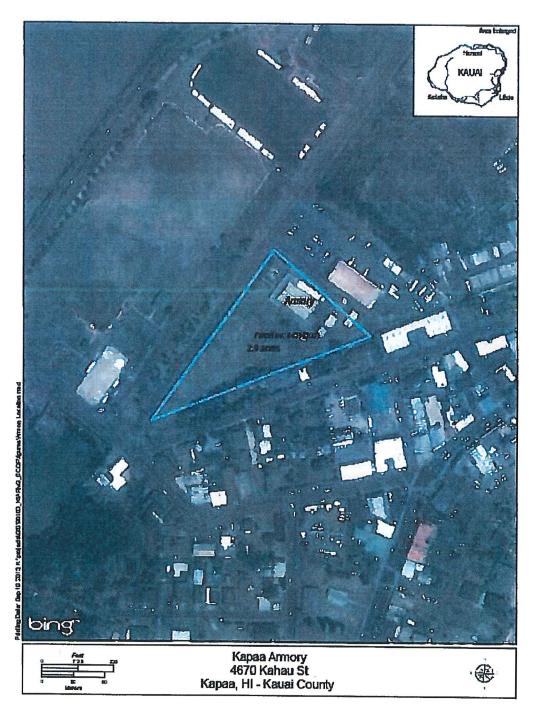
Figure 2-1. General Site Map

The property is improved with two permanent structures, and two temporary trailers are located immediately southeast of the armory. The permanent structures include the Armory building and the POL shed. The Armory building is eligible for the National Register of Historic Places (HIARNG 2009). Two Federal Emergency Management Agency (FEMA) trailers reportedly stocked with emergency supplies are also stored on the property.

The Kapa'a Armory is a one-story building (approximately 8,100 square feet) and was constructed in 1957 of a steel frame and hollow tile block (Hawai'i Army National Guard, 2009), slab-on-grade construction. The medium-pitch gable roof was partially replaced following Hurricane Iniki in 1992 (pers.comm., Daligdig 2013). The only extant ancillary structure, the POL shed (approximately 350 square feet), was built in 1963 of concrete block and a corrugated metal gable roof (Hawai'i Army National Guard, 2009).
