**SUBJECT:** Enforcement Action against the Edwin C. Olson Trust No. 2. Alteration of historic properties during the course of land alteration activities without a permit. Amaulu Camp Cemetery. Pu'u'e'o Ahupua'a, South Hilo, Island of Hawai'i. **TMK:** (3) 2-6-008:028

### FIELD REPORT: Documentation of Potential Violations at TMK (3) 2-6-008:028

INVESTIGATION # 16-870 HA	District East Hawaii	Lead Investigator Shishido, Edwin	Report Status In Progress	Key Report <input checked="" type="checkbox"/> Yes <input type="checkbox"/> No
Date/Time Reported 05/03/2016 12:30PM	Location South Hilo	Classification HP : Possible 6E Violations	Connecting Reports

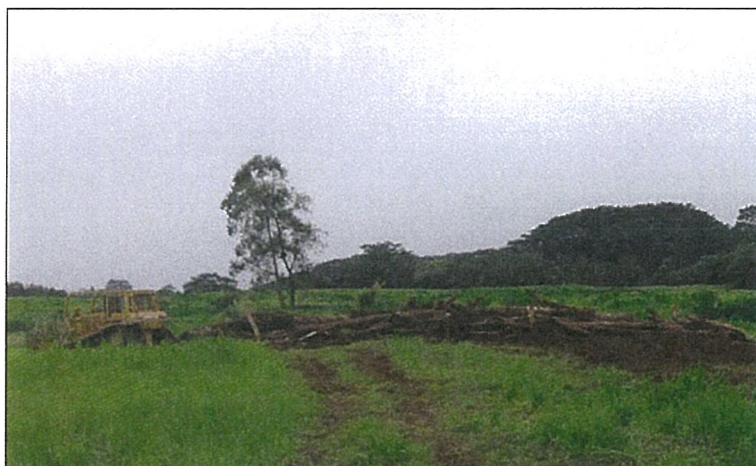
Nāleimaile observed that the area had been impacted by the removal of large trees, some of which could have been present near the cemetery area (Figure 2). Aerial photos from Google Earth (Google Earth 2013) (Figure 1) show the canopy of trees that was present on the parcel in the area of the cemetery, but many of the trees seen in the aerial photo have now been removed indicating that these trees have since been removed.

Figure 2: Large trees and bulldozer in the vicinity of the cemetery.

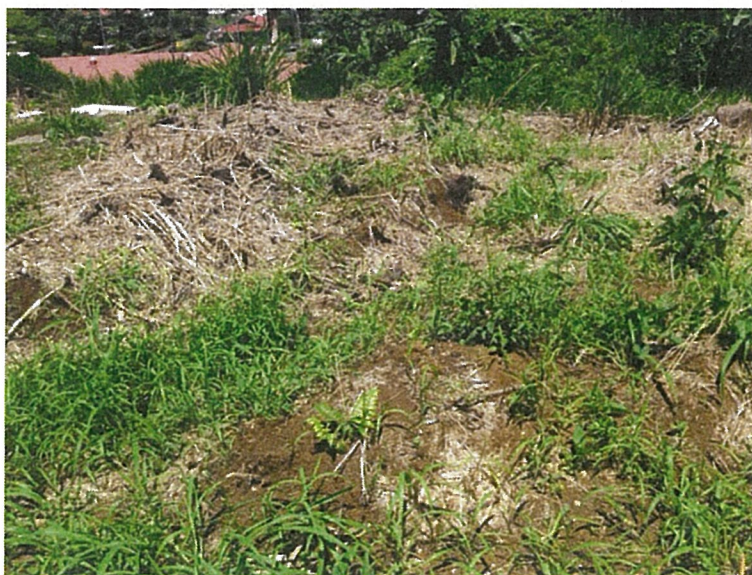
Naleimaile observed that impacts to the cemetery had clearly been done via mechanical means (Figure 3). Nāleimaile conducted a limited pedestrian survey of the cemetery to examine the extent of the cemetery area and the extent of land clearing activities within the cemetery. Upon completion of the site visit, it appeared that there was evidence of a potential violation pursuant to Chapter 6E-11(c). Naleimaile then attempted to contact the County of Hawaii to report the findings and make them aware of the possible violation.

Figure 3: Tracks consistent with heavy machinery.

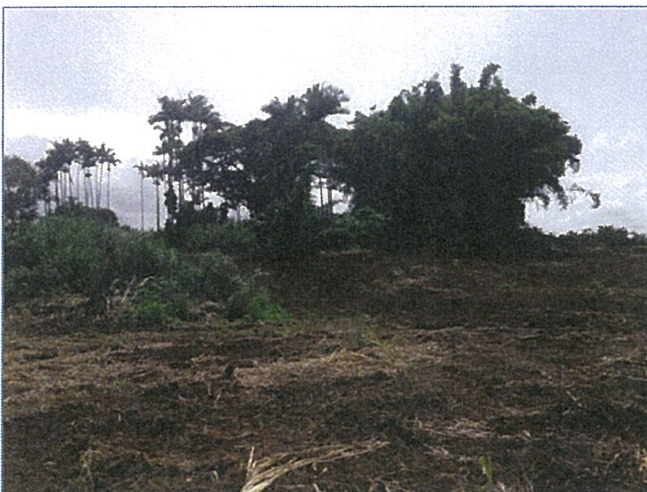
On September 9, 2016, Mr. Nāleimaile was notified by SCS archaeologist Mr. Escott that he was informed by Mr. Cross that land clearing activities has occurred in an area adjacent to the cemetery (Figure 4) and that an undocumented grave marker had been disturbed. Mr. Nāleimaile (SHPD) conducted a third site visit on September 12, 2016 with DOCARE (Officer Edwin Shishido) to assess the most recent unpermitted work that occurred in this area. During the site visit Mr. John Cross arrived on site and went on to explain that the work in the recently impacted area was approved by the landowner, Mr. Ed Olson. It was confirmed during this site visit that a previously undocumented grave site was impacted by the clearing. On a fourth site visit on September 16, 2016, which included Dr. Susan A. Lebo

Figure 4: Recent impacted area (September 9, 2016)

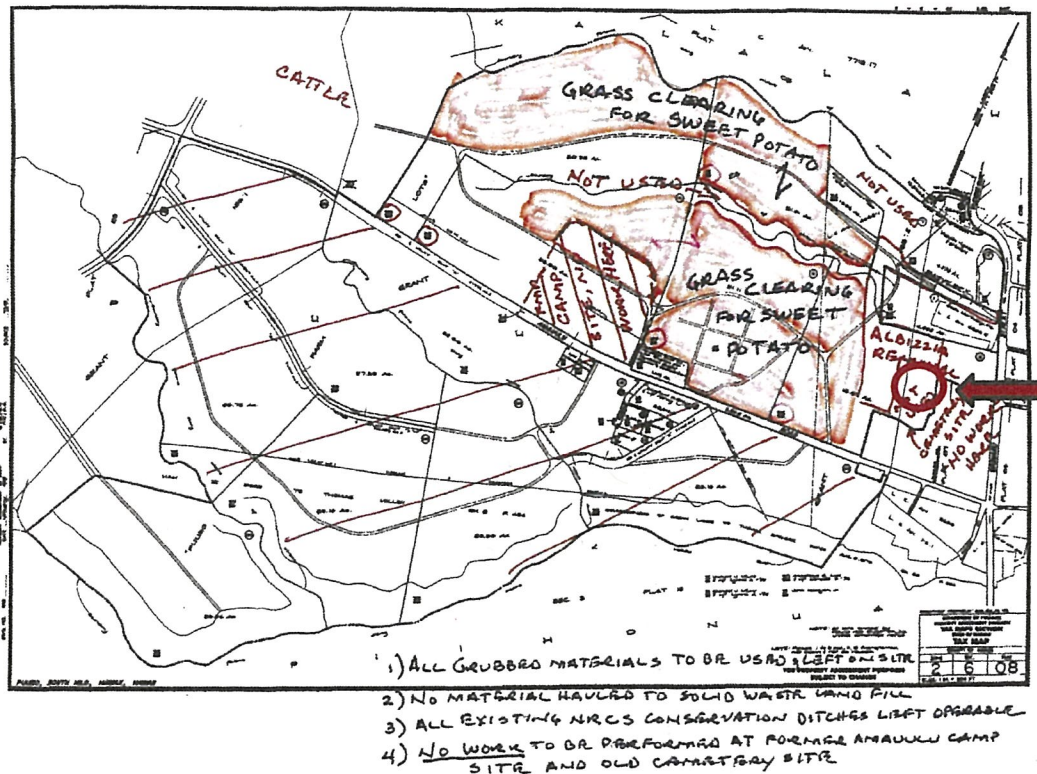
Map 1: TMK map with area of proposed impacts. The red arrow indicates the approximate location of the area most recently impacted. The map designates this area as an area on no work.

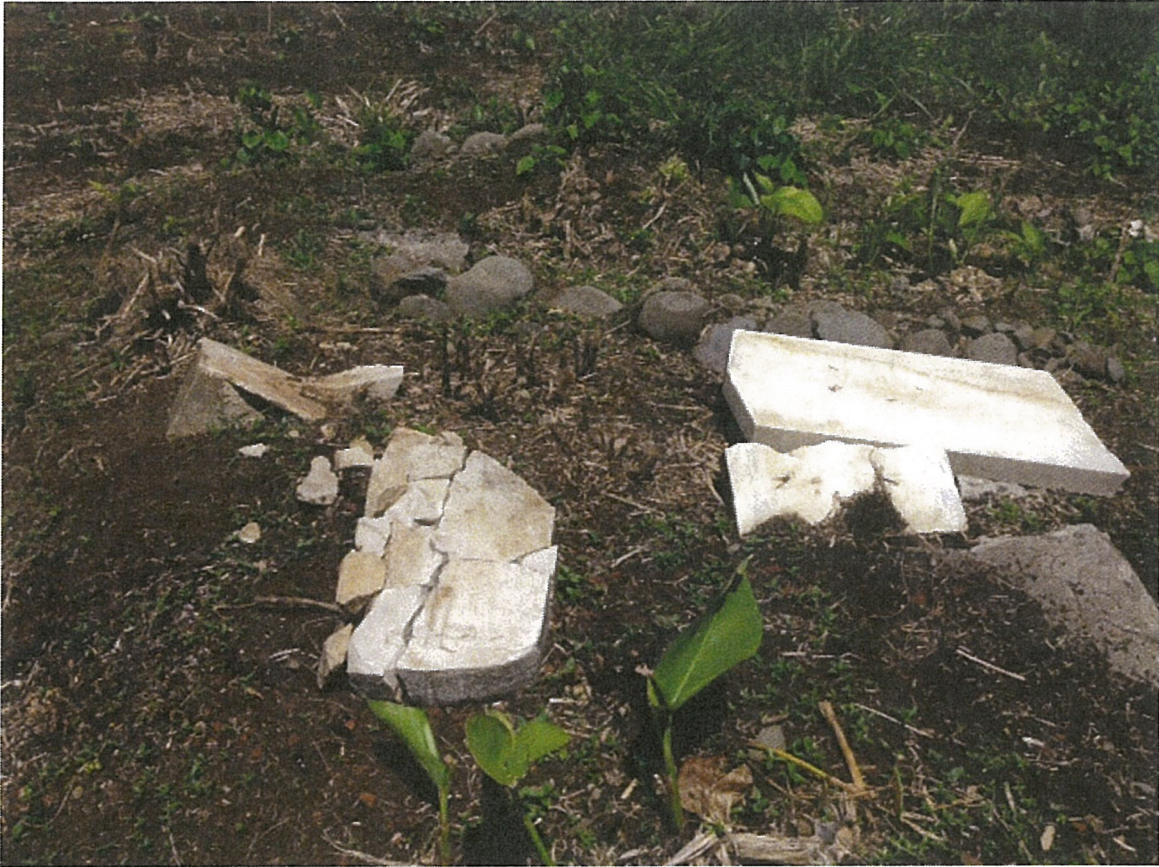
Apparent HRS 6E-11(c) Violation #1: Impact to Burial Site

1. Damage to the headstones found in the eastern portion of the cemetery. It is apparent that the headstones were damaged or altered during recent land clearing activities. The observable alterations are the obvious cracks and breaks that are, in the professional judgment of SHPD staff, recent and are inconsistent with long term exposure to the elements. In the professional judgement of SHPD staff the alterations to the headstones are the result of recent land clearing activities and are inconsistent with alterations caused by a bull on the loose over 65 years ago as suggested. This impact constitutes an alteration and destruction of a portion of burial sites. See, Exhibit A, Figure 5.

Figure 5: Historic headstones with recent breaks

This photograph depicts what is believed to be very recent damage to the headstones found in the eastern portion of the cemetery. It is apparent that the conditions of the headstones were altered during recent land clearing activities. The observable alterations are the obvious cracks and breaks that appear to be recent and not consistent with long term exposure to the elements. The alterations to the headstones are likely the result of recent land clearing activities and not consistent with alterations caused by a loose bull over 65 years ago. This impact constitutes an alteration and destruction of a portion of the site.

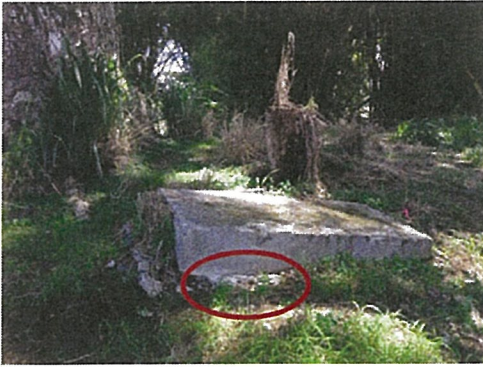
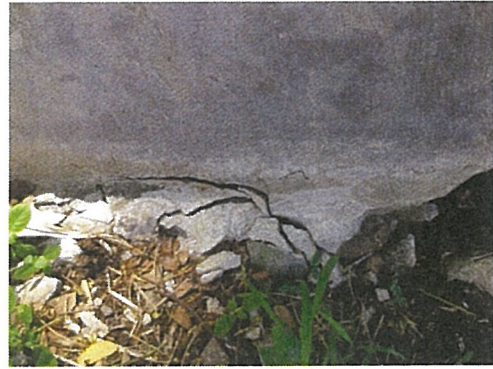
Apparent HRS §6E-11(c) Violation #2: Impact to Large Crypt

2. Damage to the large crypt located southwest of the previously described violation. While the crypt appears to be impacted by the presence of roots from the large tree that is in the vicinity of the burial site, it is likely that the damage shown in Exhibit A, Figure 6 occurred recently when the nearby tree was cut down. As in the previous violation, the cracks appear to be more recent than something done prior to the current owners' recent activities in the cemetery area. This impact constitutes an alteration and destruction of a portion of the historic property. See Exhibit A, Figures 6 & 7.

Figure 6: Large Crypt Feature with damaged area outlined

Figure 7: Close-up of Damage to Crypt

These photographs show the large crypt located southwest of the previously described violation. While the crypt appears to be impacted by the presence of roots from the large tree that is in the vicinity of the burial site, it is likely that the damage shown in figure 6 occurred recently when the nearby tree was cut down. Again as in the previous violation, the cracks appear to be more recent than something done prior to the current owners' recent activities in the cemetery area. This impact constitutes an alteration and destruction of a portion of the site.

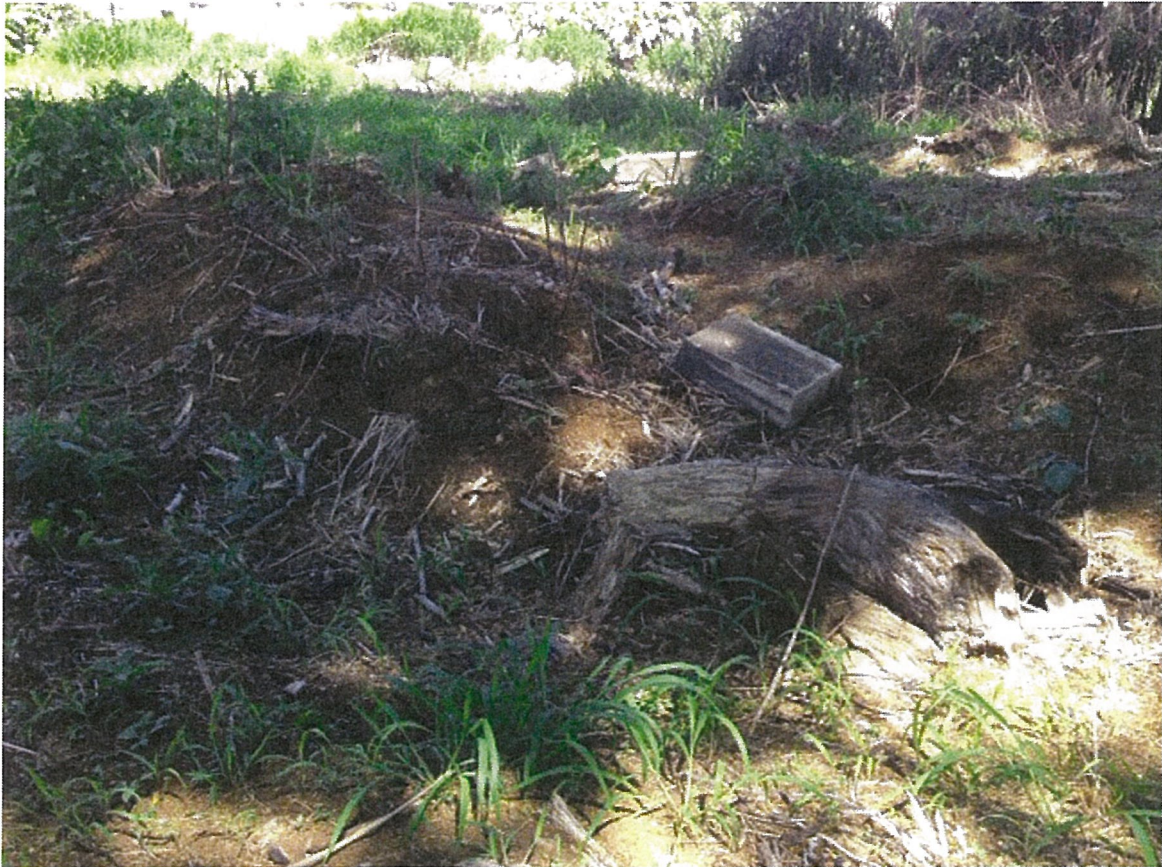
Apparent HRS §6E-11(c) Violation #3: Disturbance of Headstone

3. Damage to the burial site as a result of recent disturbance to an area adjacent to present headstone. The deep cuts in the dirt have been made very recently and the original location of headstone can no longer be ascertained. This impact constitutes an alteration and destruction of a portion of a historic property. See Exhibit A, Figure 8.

Figure 8: Disturbance of Headstone due to grubbing

This photograph depicts recent disturbance to an area where the headstone is. The deep cuts in the dirt appear to have been made recently and where the actual location of where the headstone once was, is unknown. This impact constitutes an alteration and destruction of a portion of the site.

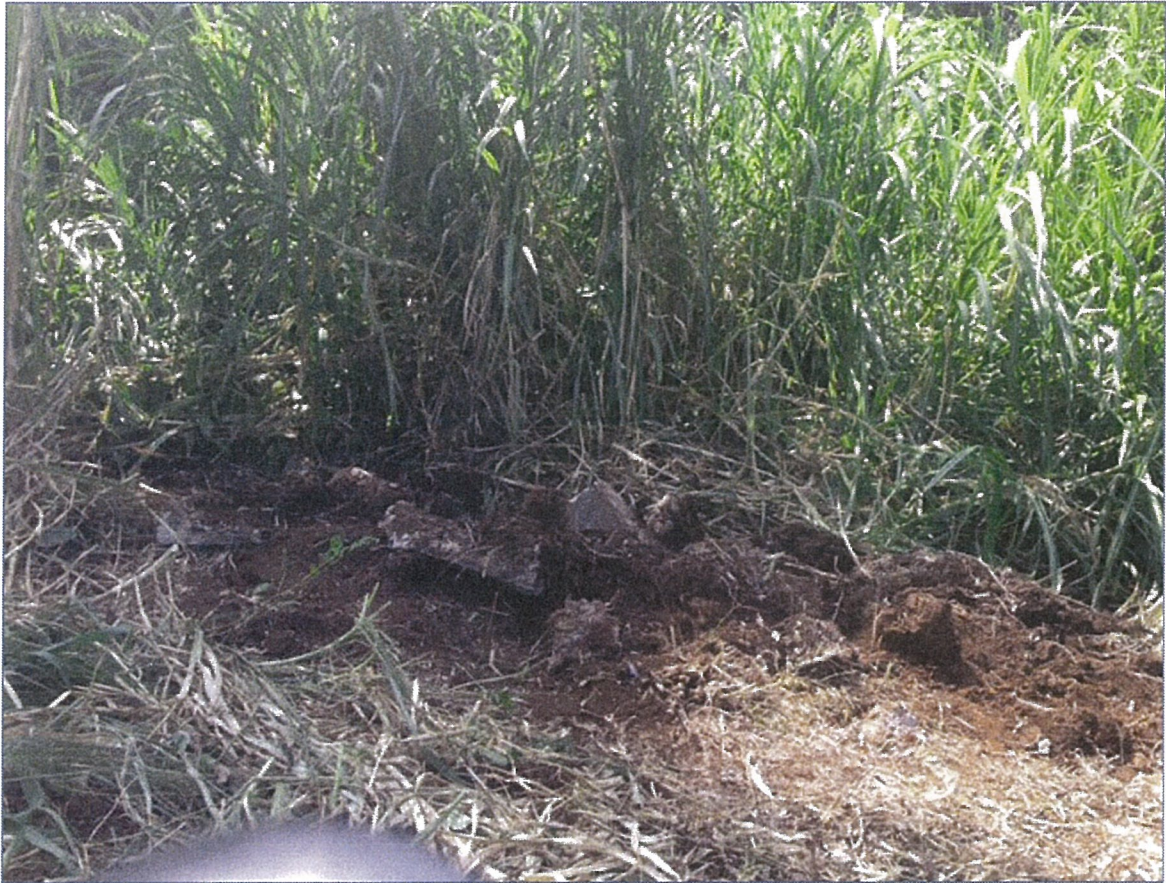
Apparent HRS §6E-11(c) Violation #4: Additional Disturbance from Recent Land Clearing

4. Damage to a previously unidentified burial site caused by the most recent land clearing activities. The grave marker had not been identified in the ongoing archaeological inventory survey. The presence of this grave marker was buried and obscured by 5-6 foot tall overgrowth of grasses. The presence of this grave marker significantly extends the boundaries of the cemetery from previous estimates of its extent. While the grave marker was previously unidentified and obscured due to overgrowth, the work that uncovered and damaged the grave marker in this area occurred after the issuance of the stop work order by the County. See Exhibit A, Figure 9. This area was also designated as an area of no work as indicated in a grubbing plan provided by Mr. Cross.

Figure 9: Most recent disturbance of grave marker due to unpermitted land clearing

This photo depicts the damage caused by the most recent land clearing activities that caused extensive damage to a previously unidentified grave marker. The grave marker had not been identified in the ongoing archaeological inventory survey. The presence of this grave marker was buried and obscured by 5-6 foot tall overgrowth of grasses. The presence of this grave marker significantly extends the boundaries of the cemetery from previous estimates of the extent of the cemetery. While unidentified and obscured due to overgrowth, additional work in the area continued to be under the stop work order from the County of Hawaii. This area was also designated as an area of no work as indicated in a grubbing plan provided by Mr. Cross.

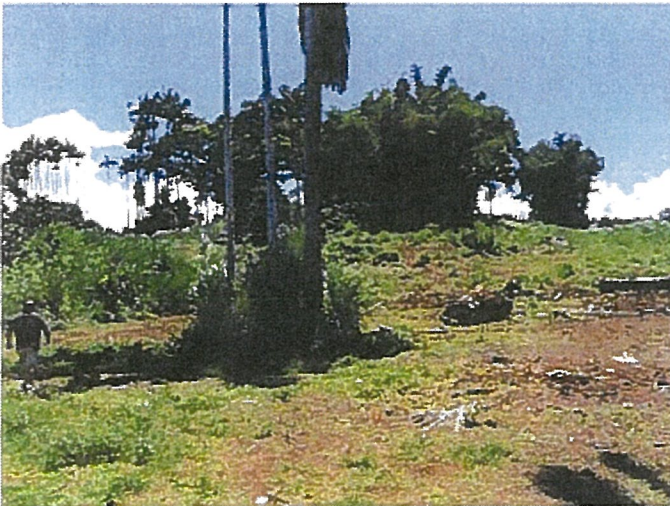
**1** Depicts grubbed land, hill where graves located.

Note : Photo taken facing NW direction. Location of cemetery is in and around the bamboo stand.

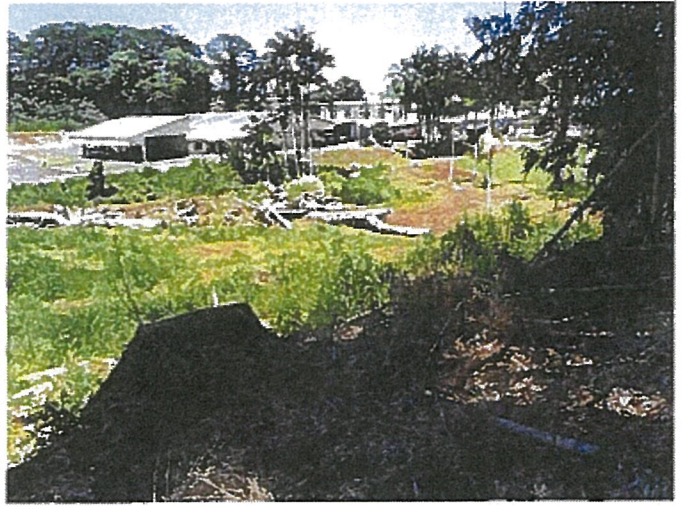
**2** Depicts grubbed area facing NE.

Note : Bulldozed trees and top soil pushed towards Dodo Mortuary Building.

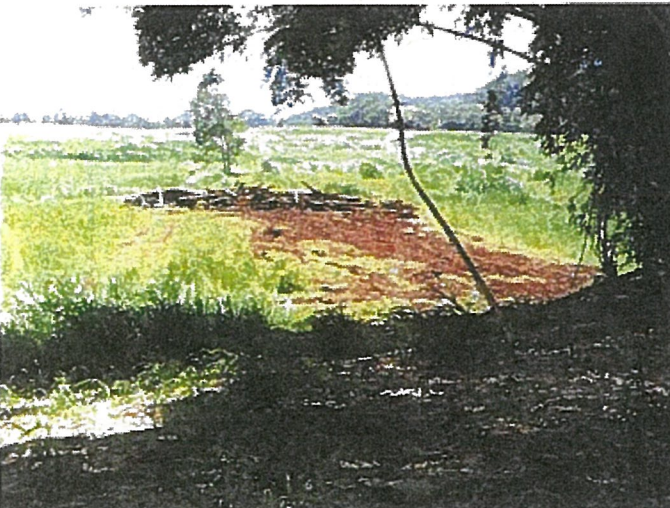
**3** Depicts pushed trees and soil away from bamboo,

Note : Grubbed trees and topsoil pushed away from bamboo stand.  
Note that exposed soil recently bulldozed.

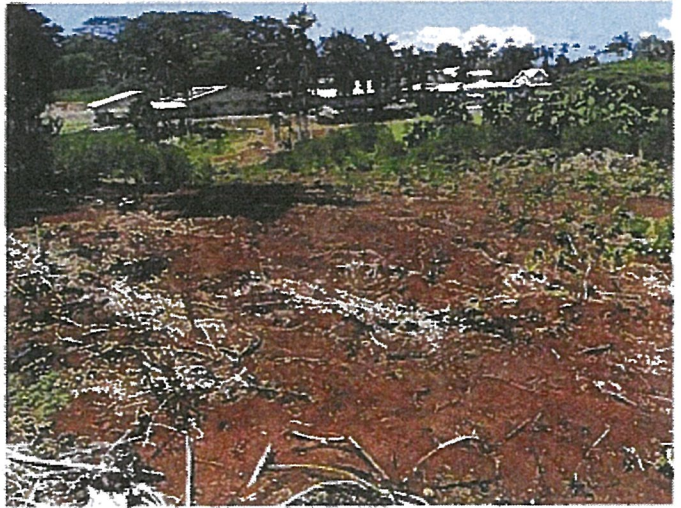
**4** Depicts recently grubbed land facing NE.

Note : Signs of topsoil recently grubbed. Newly sprouting greenery.

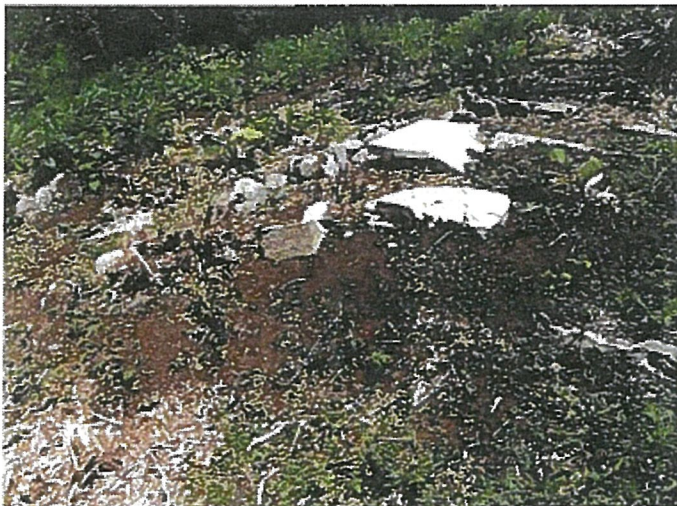
**5** Depicts photo of an area with damaged gravesite.

Note : Recently damaged cement stone and grubbed soil. Note newly sprouting weeds in close proximity to grave.

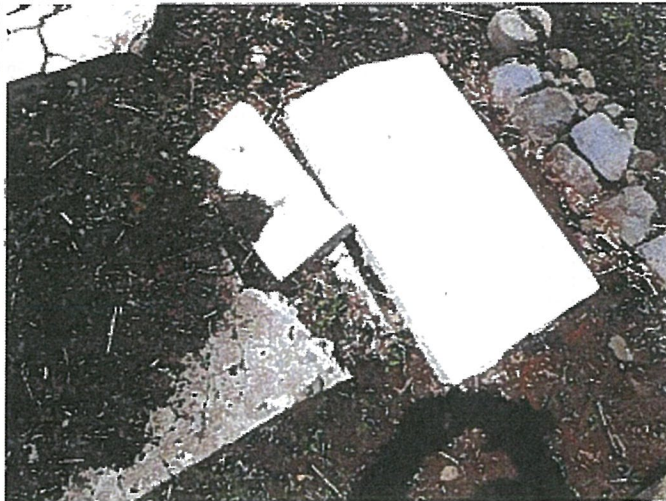
**6** Depicts damaged gravesite headstone.

Note : Down headstone. Name on stone HAKAU AKAI 1849-1891.

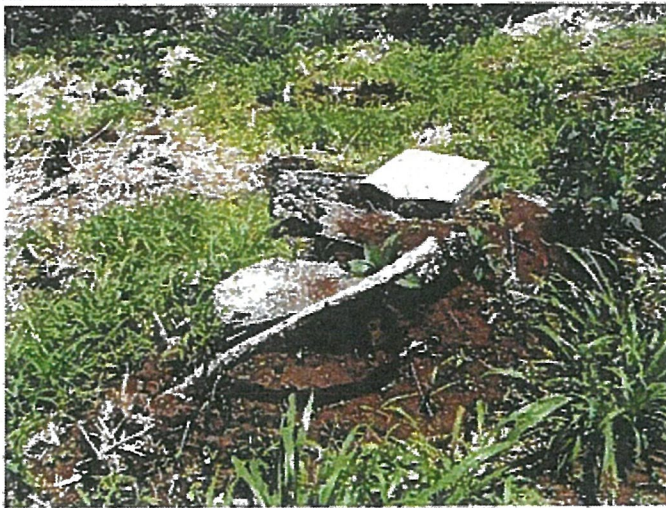
**8** Depicts photo of recently damaged gravesite.

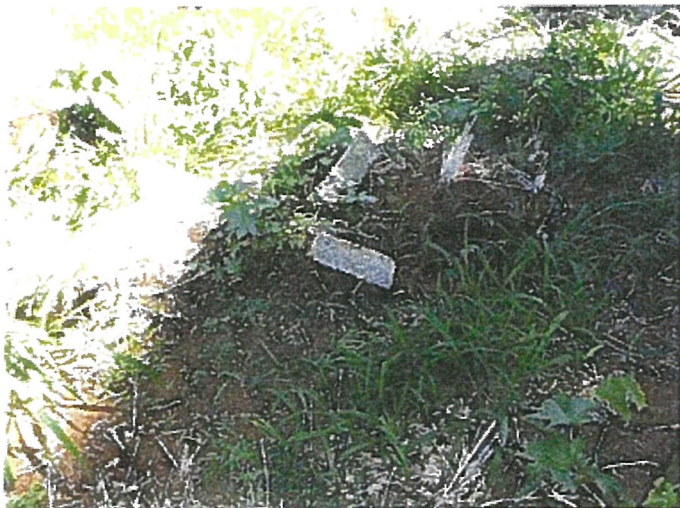
**9** Depicts recently disturbed cement gravesite.

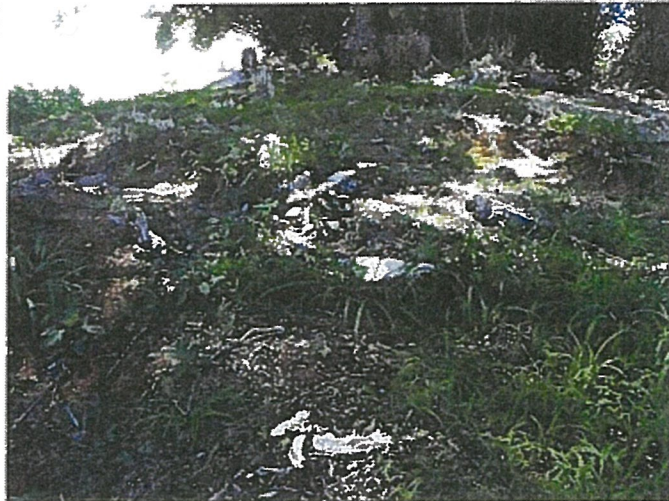
**10** Depicts numerous unearthed cement gravesite.

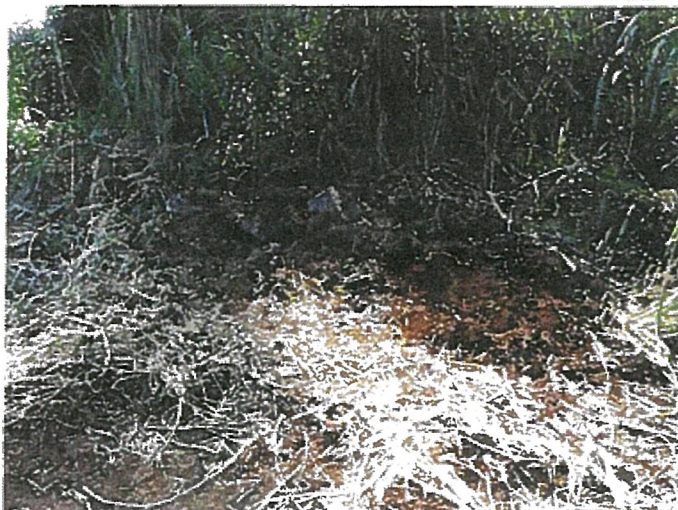
3 Depicts view of recent damaged grave site.

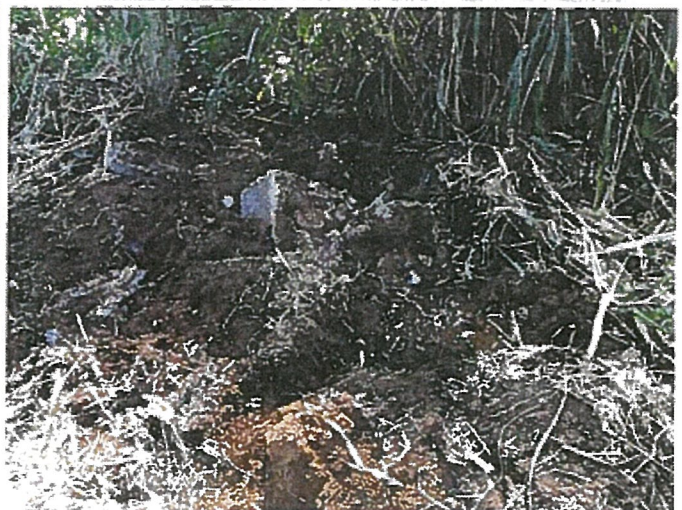
4 Depicts close up view of recently damaged grave site.

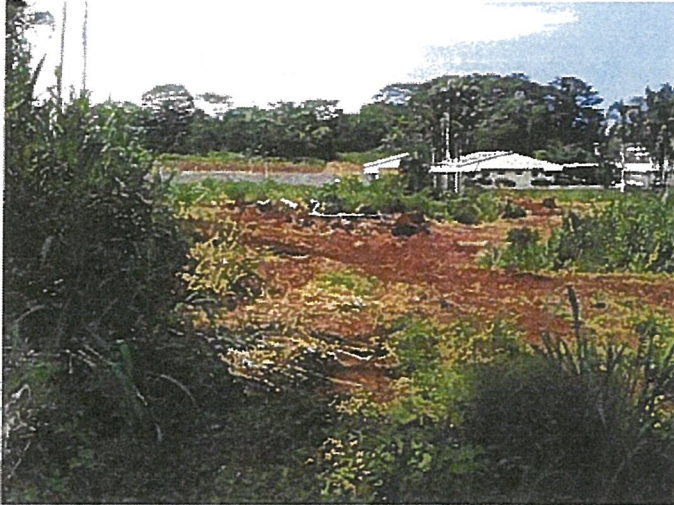
**5** Depicts view of recent grubbing activity.

Note: damaged grave site is in the weeds to the bushes on the left in the tall weeds in this photo.

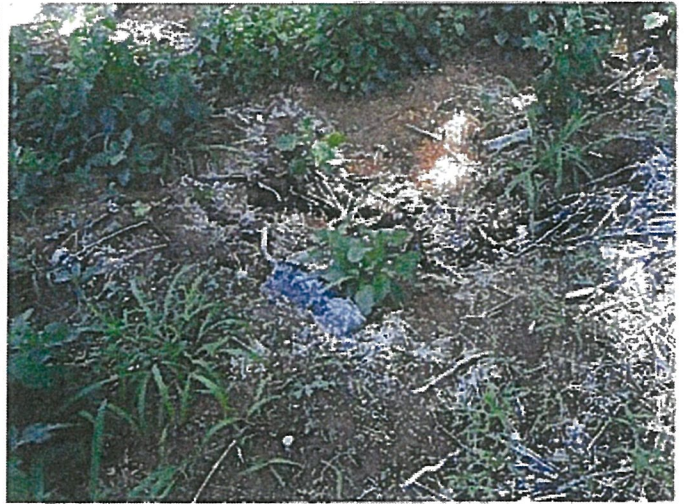
18 Depicts photo of recently disturbed gravesite.

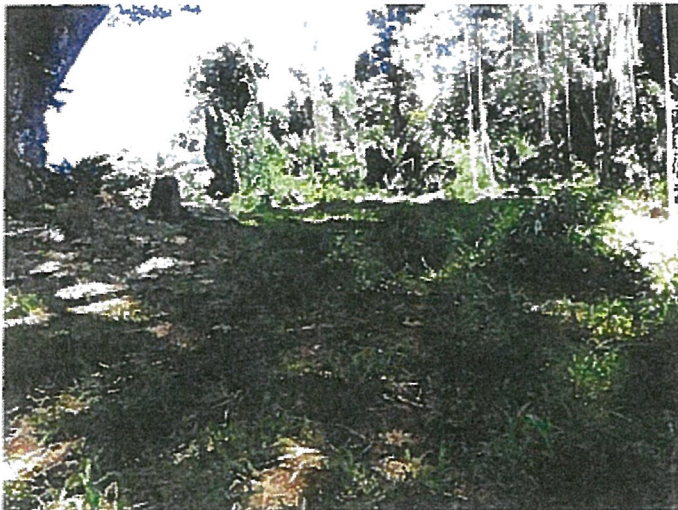
19 Depicts area where heavy machinery went through.
