SUBJECT: Enforcement Action against the Edwin C. Olson Trust No. 2. Alteration of historic properties during the course of land alteration activities without a permit. Amauulu Camp Cemetery. Pu'u'e'o Ahupua'a, South Hilo, Island of Hawai'i. **TMK:** (3) 2-6-008:028

SUMMARY: This Notice of Violation requests the Board find that the Edwin C. Olson Trust No. 2 violated Hawaii Revised Statutes § 6E-11(c) by altering historic properties without a County approved grading and grubbing permit, and requests that the Board assess an administrative fine pursuant to Hawaii Revised Statutes §6E-11(f).

FIELD REPORT: Documentation of Potential Violations at TMK (3) 2-6-008:028

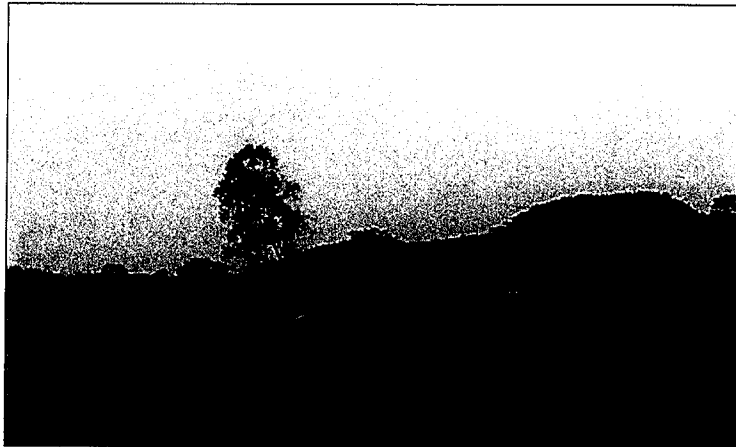
Figure 2: Large trees and bulldozer in the vicinity of the cemetery.

Nāleimaile observed that the area had been impacted by the removal of large trees, some of which could have been present near the cemetery area (Figure 2). Aerial photos from Google Earth (Google Earth 2013) (Figure 1) show the canopy of trees that was present on the parcel in the area of the cemetery, but many of the trees seen in the aerial photo have now been removed indicating that these trees have since been removed.

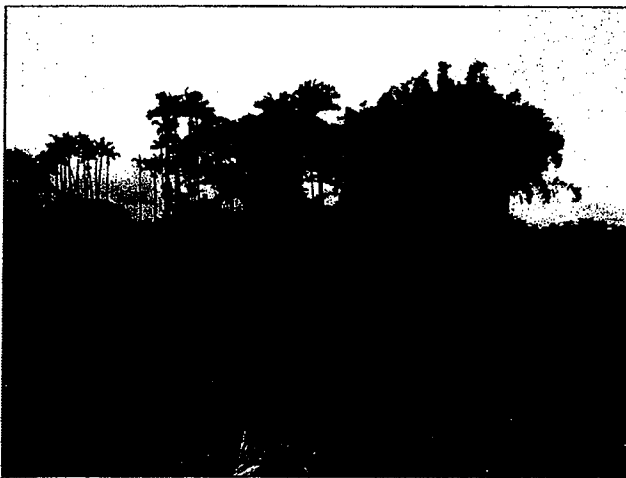
Figure 4: Recent impacted area (September 9, 2016)

On September 9, 2016, Mr. Nāleimaile was notified by SCS archaeologist Mr. Escott that he was informed by Mr. Cross that land clearing activities has occurred in an area adjacent to the cemetery (Figure 4) and that an undocumented grave marker had been disturbed. Mr. Nāleimaile (SHPD) conducted a third site visit on September 12, 2016 with DOCARE (Officer Edwin Shishido) to assess the most recent unpermitted work that occurred in this area. During the site visit Mr. John Cross arrived on site and went on to explain that the work in the recently impacted area was approved by the landowner, Mr. Ed Olson. It was confirmed during this site visit that a previously undocumented grave site was impacted by the clearing. On a fourth site visit on September 16, 2016, which included Dr. Susan A. Lebo

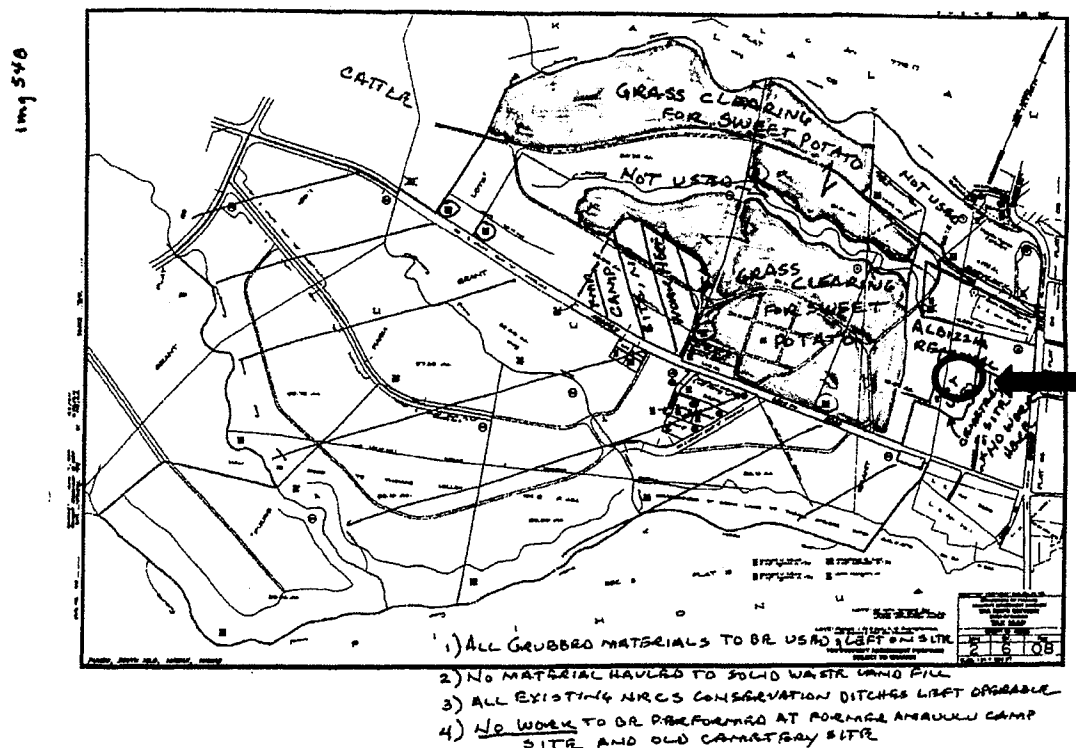
Map 1: TMK map with area of proposed impacts. The red arrow indicates the approximate location of the area most recently impacted. The map designates this area as an area on no work.

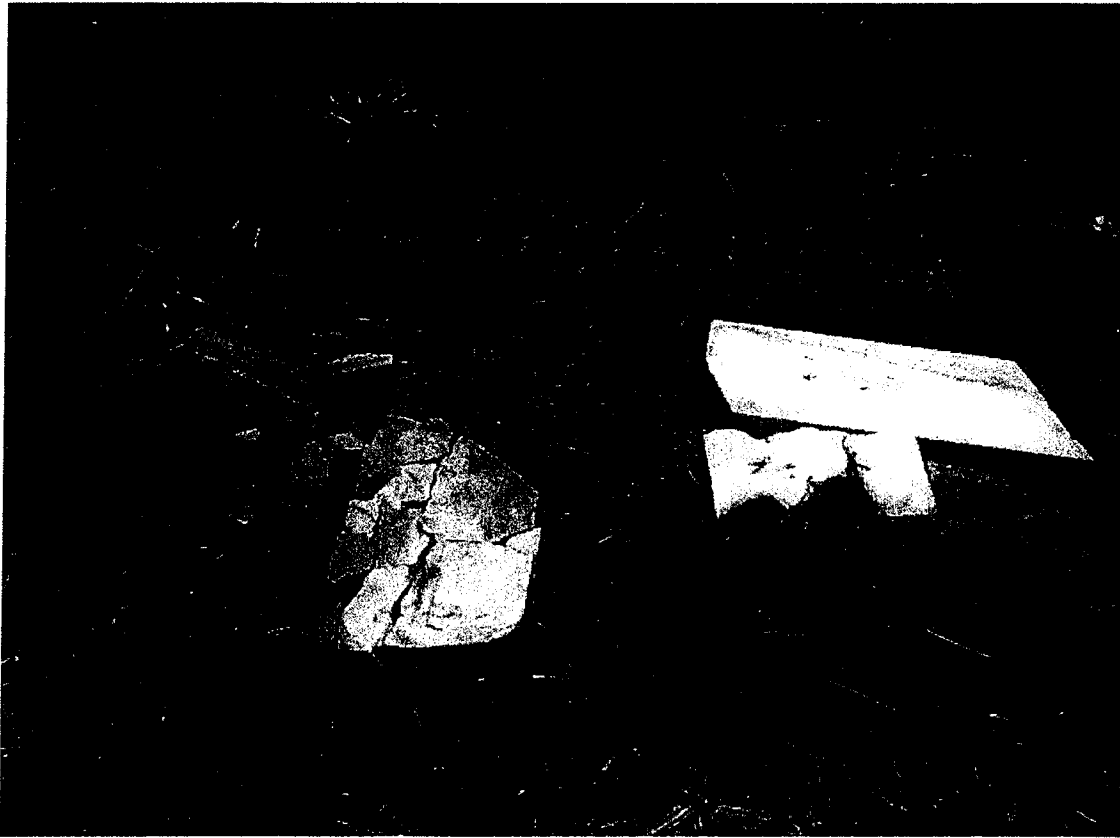
Figure 5: Historic headstones with recent breaks

1. Damage to the headstones found in the eastern portion of the cemetery. It is apparent that the headstones were damaged or altered during recent land clearing activities. The observable alterations are the obvious cracks and breaks that are, in the professional judgment of SHPD staff, recent and are inconsistent with long term exposure to the elements. In the professional judgement of SHPD staff the alterations to the headstones are the result of recent land clearing activities and are inconsistent with alterations caused by a bull on the loose over 65 years ago as suggested. This impact constitutes an alteration and destruction of a portion of burial sites. See Exhibit A, Figure 5.

This photograph depicts what is believed to be very recent damage to the headstones found in the eastern portion of the cemetery. It is apparent that the conditions of the headstones were altered during recent land clearing activities. The observable alterations are the obvious cracks and breaks that appear to be recent and not consistent with long term exposure to the elements. The alterations to the headstones are likely the result of recent land clearing activities and not consistent with alterations caused by a loose bull over 65 years ago. This impact constitutes an alteration and destruction of a portion of the site.

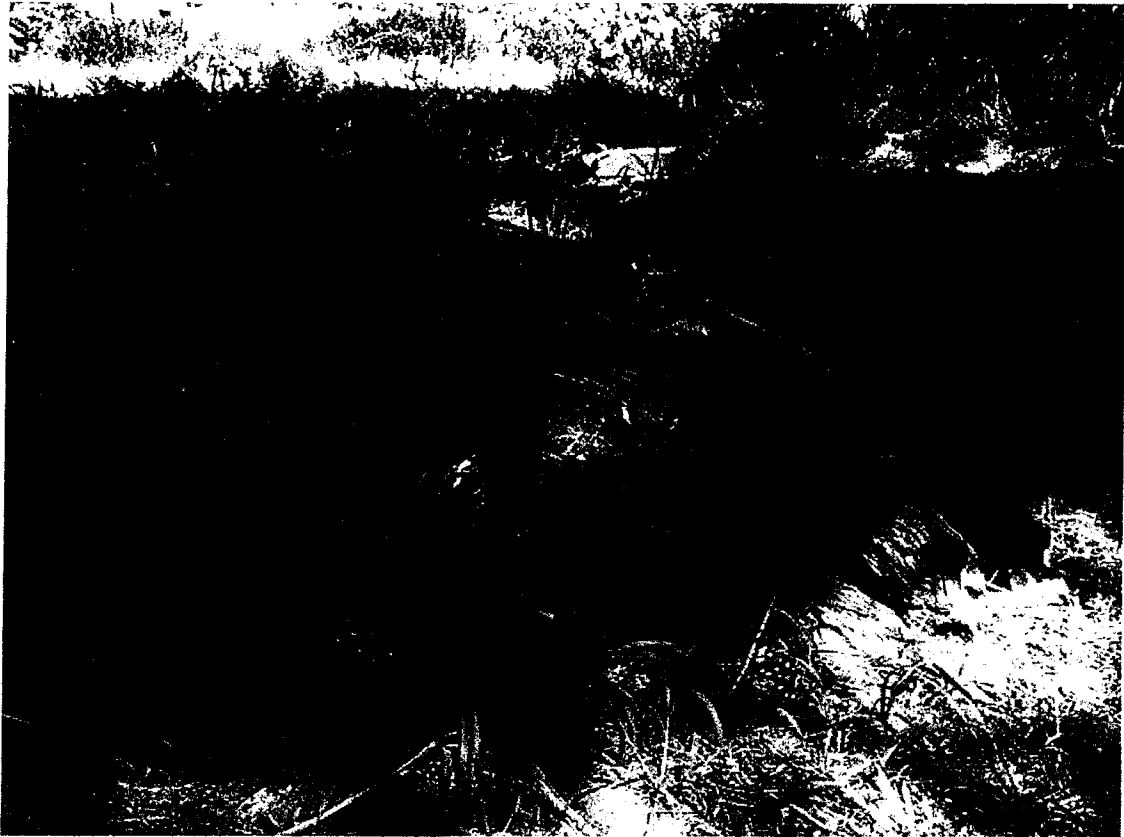
Figure 8: Disturbance of Headstone due to grubbing

3. Damage to the burial site as a result of recent disturbance to an area adjacent to present headstone. The deep cuts in the dirt have been made very recently and the original location of headstone can no longer be ascertained. This impact constitutes an alteration and destruction of a portion of a historic property. See Exhibit A, Figure 8.

This photograph depicts recent disturbance to an area where the headstone is. The deep cuts in the dirt appear to have been made recently and where the actual location of where the headstone once was, is unknown. This impact constitutes an alteration and destruction of a portion of the site.

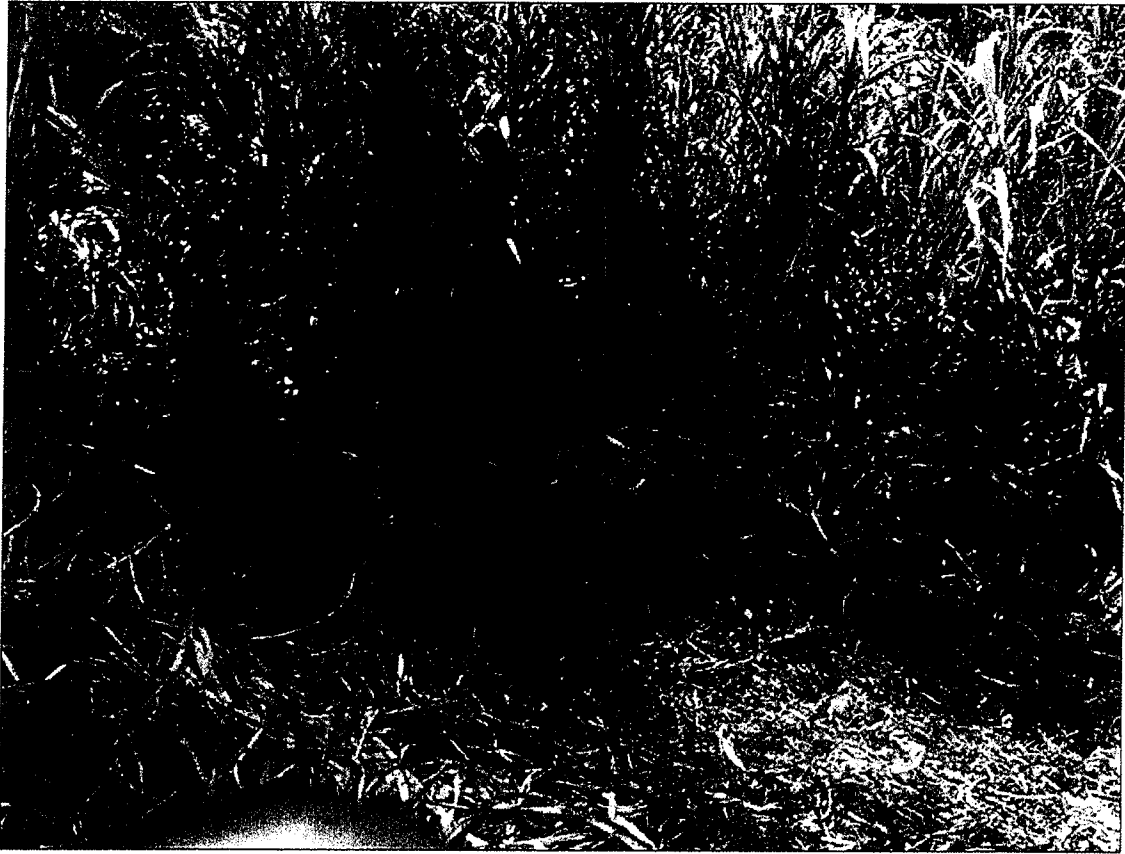
Figure 9: Most recent disturbance of grave marker due to unpermitted land clearing

4. Damage to a previously unidentified burial site caused by the most recent land clearing activities. The grave marker had not been identified in the ongoing archaeological inventory survey. The presence of this grave marker was buried and obscured by 5-6 foot tall overgrowth of grasses. The presence of this grave marker significantly extends the boundaries of the cemetery from previous estimates of its extent. While the grave marker was previously unidentified and obscured due to overgrowth, the work that uncovered and damaged the grave marker in this area occurred after the issuance of the stop work order by the County. See Exhibit A, Figure 9. This area was also designated as an area of no work as indicated in a grubbing plan provided by Mr. Cross.

This photo depicts the damage caused by the most recent land clearing activities that caused extensive damage to a previously unidentified grave marker. The grave marker had not been identified in the ongoing archaeological inventory survey. The presence of this grave marker was buried and obscured by 5-6 foot tall overgrowth of grasses. The presence of this grave marker significantly extends the boundaries of the cemetery from previous estimates of the extent of the cemetery. While unidentified and obscured due to overgrowth, additional work in the area continued to be under the stop work order from the County of Hawaii. This area was also designated as an area of no work as indicated in a grubbing plan provided by Mr. Cross.

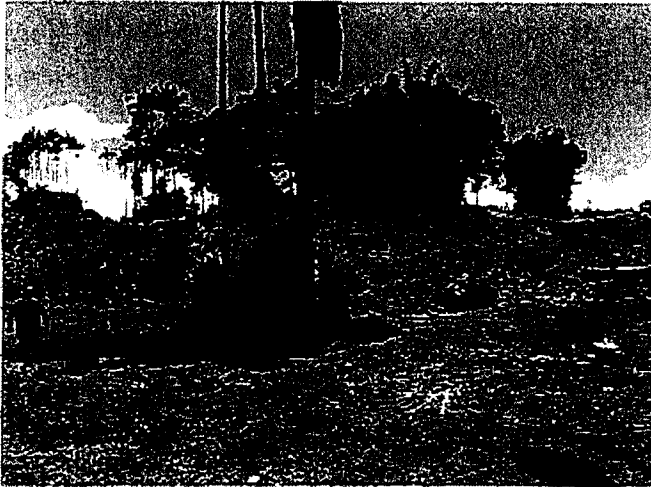
1 Depicts grubbed land, hill where graves located.

Note : Photo taken facing NW direction. Location of cemetery is in and around the bamboo stand.

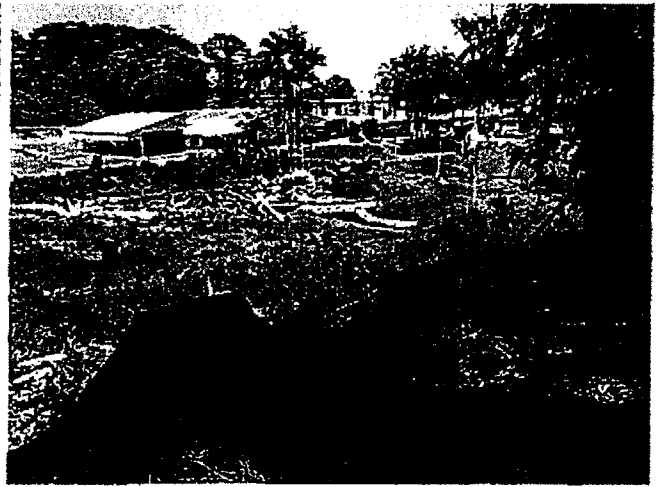
2 Depicts grubbed area facing NE.

Note : Bulldozed trees and top soil pushed towards Dodo Mortuary Building.

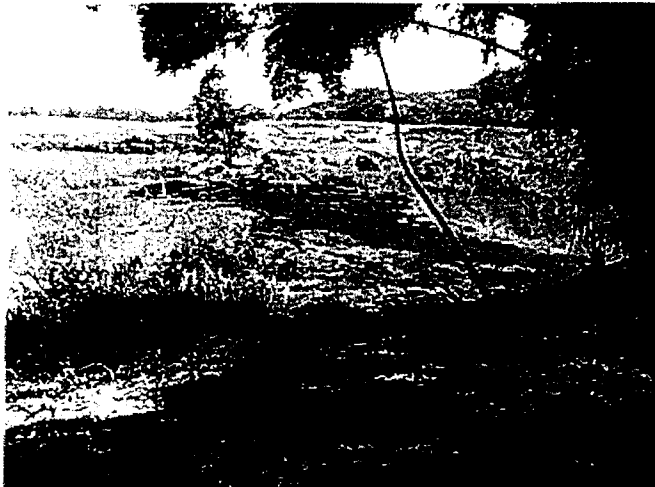
3 Depicts pushed trees and soil away from bamboo,

Note : Grubbed trees and topsoil pushed away from bamboo stand. Note that exposed soil recently bulldozed.

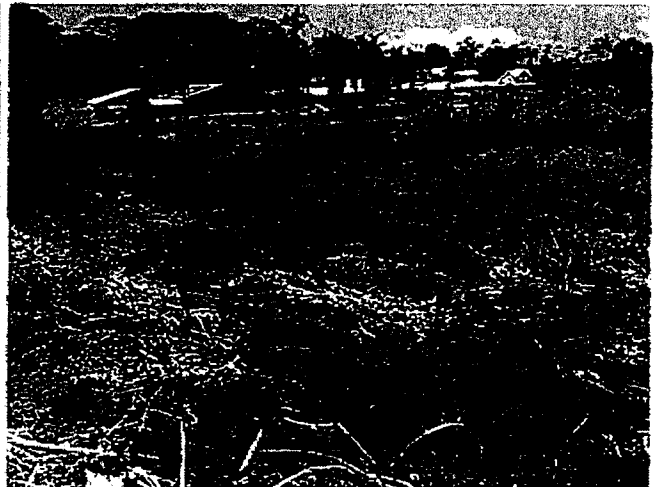
4 Depicts recently grubbed land facing NE.

Note : Signs of topsoil recently grubbed. Newly sprouting greenery.

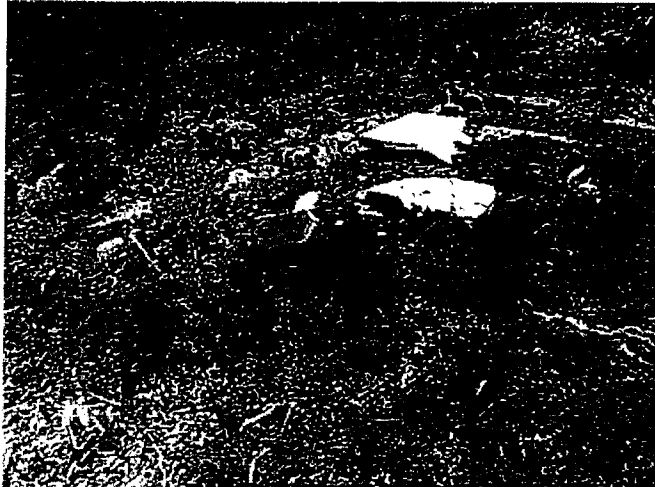
5 Depicts photo of an area with damaged gravesite.

Note : Recently damaged cement stone and grubbed soil. Note newly sprouting weeds in close proximity to grave.

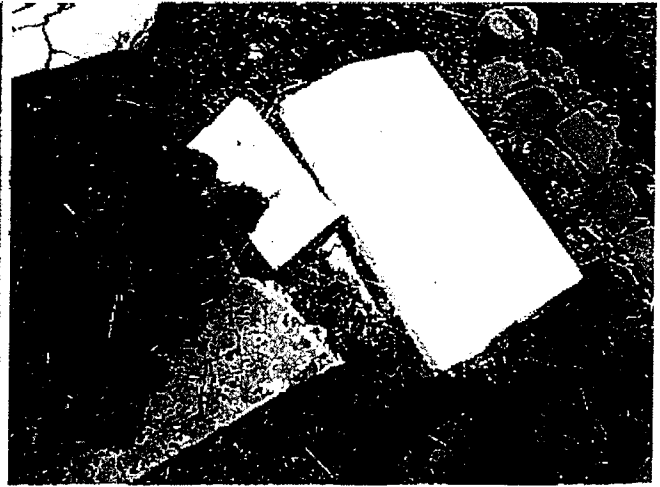
6 Depicts damaged gravesite headstone.

Note : Down headstone. Name on stone HAKAU AKAI 1849-1891.

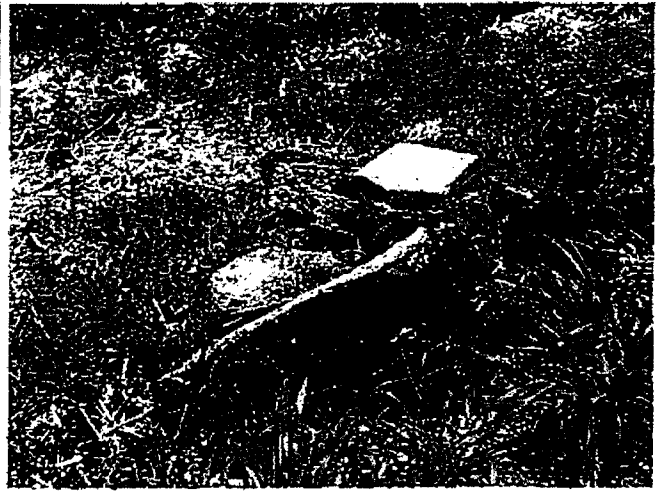
8 Depicts photo of recently damaged gravesite.

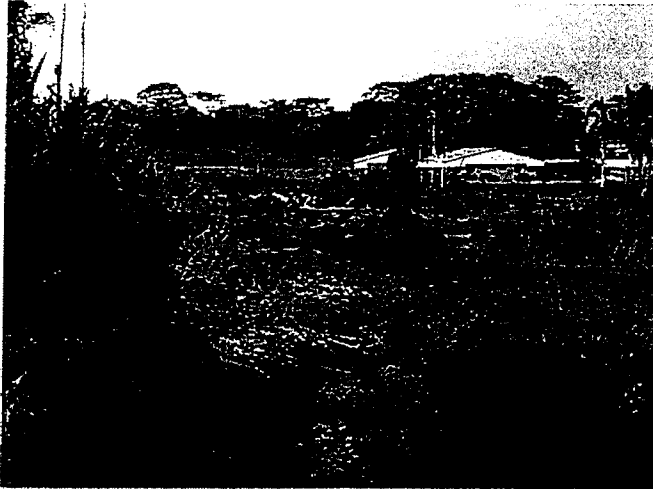
5 Depicts view of recent grubbing activity.

Note: damaged grave site is in the weeds to the bushes on the left in the tall weeds in this photo.
