Amend Prior Board Action of September 22, 2017, Item D-7, *Grant of Term, Non-Exclusive Easement to Seaview 2004, Inc. for Resolution of Encroaching Seawall Purposes, Spreckelsville, Wailuku, Maui, Tax Map Key: (2) 3-8-002: seaward of 001.*

The purpose of amending the Board's September 22, 2017 action is to increase the area of the easement from 1,128 square feet, more or less, to 2,206 square feet, more or less.

Grant of Term, Non-Exclusive Easement to Seaview 2004, Inc. for Resolution of Encroaching Seawall Purposes, Spreckelsville, Wailuku, Maui, Tax Map Key: (2) 3-8-002: seaward of 001.

NON-EXCLUSIVE SEAWALL EASEMENT

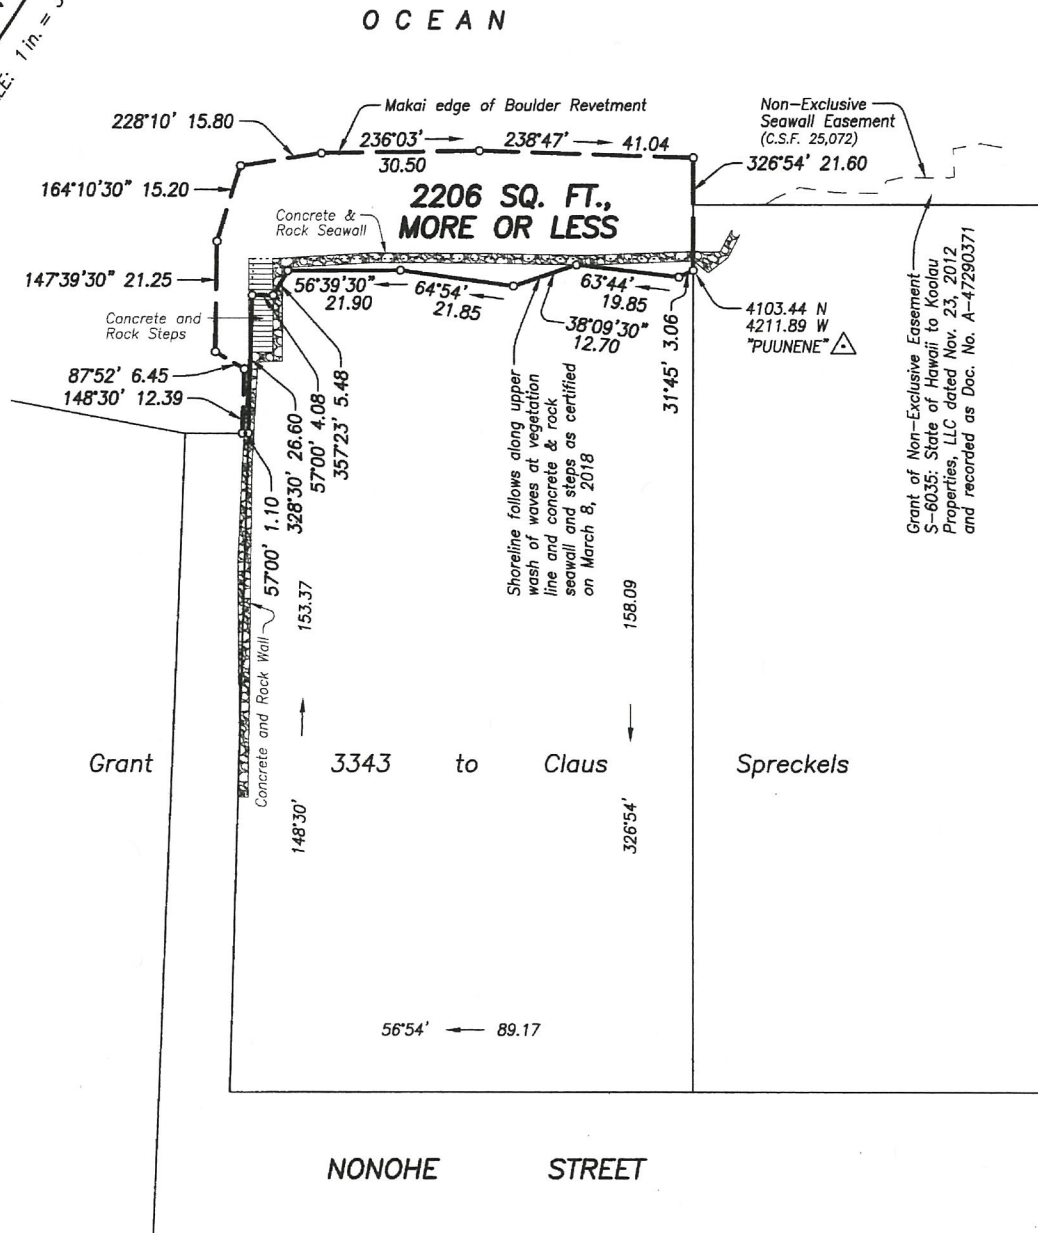
C.S.F. NO. 25,680

21.60 feet along the makai edge of boulder revetment
and Grant 3343 to Claus Spreckels to the
point of beginning and containing an
AREA OF 2206 SQUARE FEET, MORE
OR LESS.

NON-EXCLUSIVE SEAWALL EASEMENT

Spreckelsville, Wailuku, Maui, Hawaii

Scale: 1 inch = 30 feet

Beginning on the shoreline as certified on March 8, 2018 at the southeast corner of this easement and on the northwesterly boundary Grant 3343 to Claus Spreckels, the coordinates of said point of beginning referred to Government Survey Triangulation Station "PUUNENE" being 4103.44 feet North and 4211.89 feet West, thence running by azimuths measured clockwise from True South:-
