SUBJECT: Settlement of Enforcement Action against the Edwin C. Olson Trust No.2 during the course of land altering activities without a permit. Amauulu Camp Cemetery, Pu'u'e'o Ahupua'a, South Hilo, Island of Hawai'i. **TMK:** (3) 2-6-008:028.

FIELD REPORT: Documentation of Potential Violations at TMK (3) 2-6-008:028

EXHIBIT D

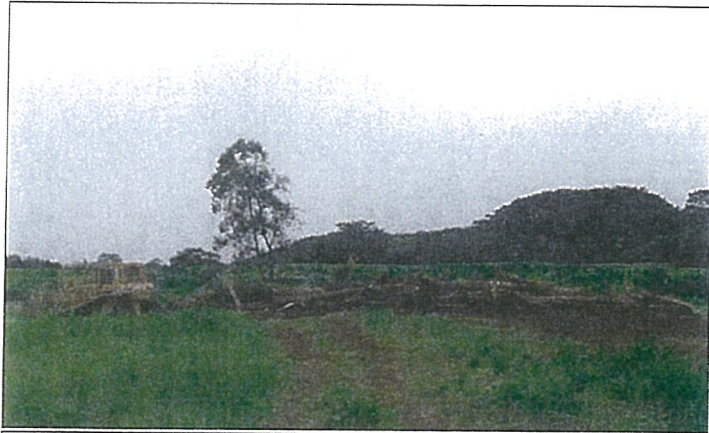
Nāleimaile observed that the area had been impacted by the removal of large trees, some of which could have been present near the cemetery area (Figure 2). Aerial photos from Google Earth (Google Earth 2013) (Figure 1) show the canopy of trees that was present on the parcel in the area of the cemetery, but many of the trees seen in the aerial photo have now been removed indicating that these trees have since been removed.

Figure 2: Large trees and bulldozer in the vicinity of the cemetery.

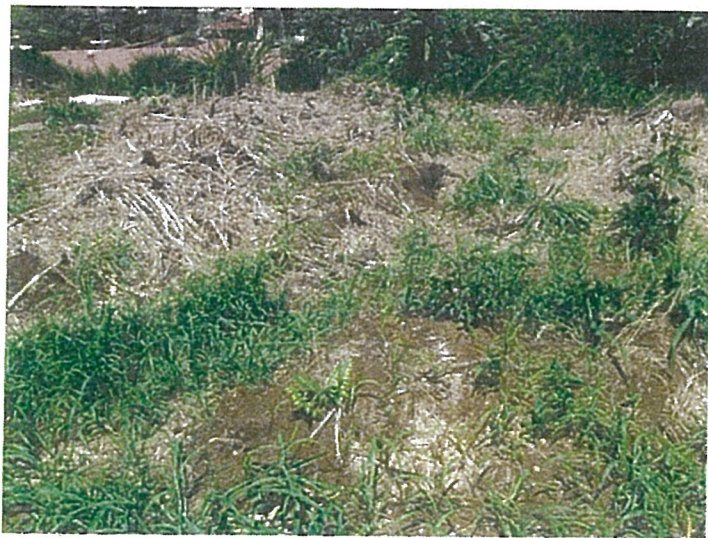
Naleimaile observed that impacts to the cemetery had clearly been done via mechanical means (Figure 3). Nāleimaile conducted a limited pedestrian survey of the cemetery to examine the extent of the cemetery area and the extent of land clearing activities within the cemetery. Upon completion of the site visit, it appeared that there was evidence of a potential violation pursuant to Chapter 6E-11(c). Naleimaile then attempted to contact the County of Hawaii to report the findings and make them aware of the possible violation.

Figure 3: Tracks consistent with heavy machinery.

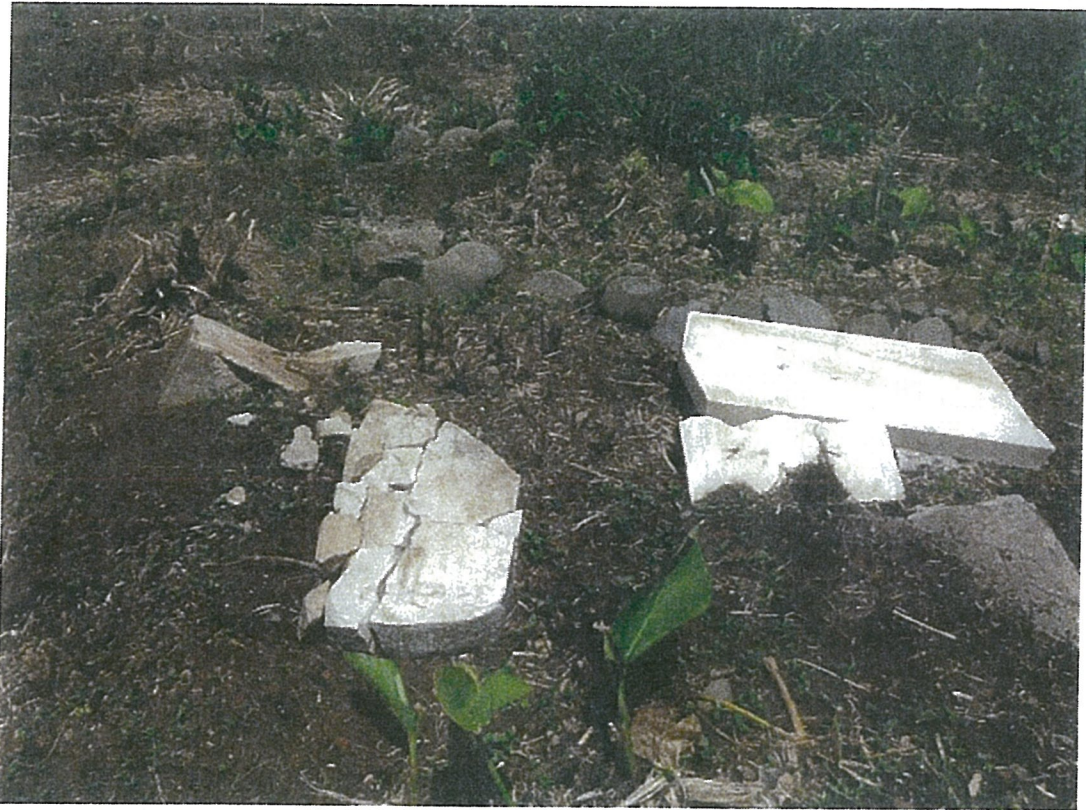
Apparent HRS 6E-11(c) Violation #1: Impact to Burial Site

1. Damage to the headstones found in the eastern portion of the cemetery. It is apparent that the headstones were damaged or altered during recent land clearing activities. The observable alterations are the obvious cracks and breaks that are, in the professional judgment of SHPD staff, recent and are inconsistent with long term exposure to the elements. In the professional judgement of SHPD staff the alterations to the headstones are the result of recent land clearing activities and are inconsistent with alterations caused by a bull on the loose over 65 years ago as suggested. This impact constitutes an alteration and destruction of a portion of burial sites. See Exhibit A, Figure 5.

1. Damage to the two headstones found in the eastern portion of the cemetery. This impact constitutes an alteration, damage, and destruction of a portion of the burial sites. See Exhibit A, Figure 5.
2. Damage to the large crypt located southwest of the previously described violation. This impact constitutes an alteration, alteration, and destruction of a portion of a burial site. See Exhibit A, Figures 6 & 7.

Figure 5: Historic headstones with recent breaks

This photograph depicts what is believed to be very recent damage to the headstones found in the eastern portion of the cemetery. It is apparent that the conditions of the headstones were altered during recent land clearing activities. The observable alterations are the obvious cracks and breaks that appear to be recent and not consistent with long term exposure to the elements. The alterations to the headstones are likely the result of recent land clearing activities and not consistent with alterations caused by a loose bull over 65 years ago. This impact constitutes an alteration and destruction of a portion of the site.

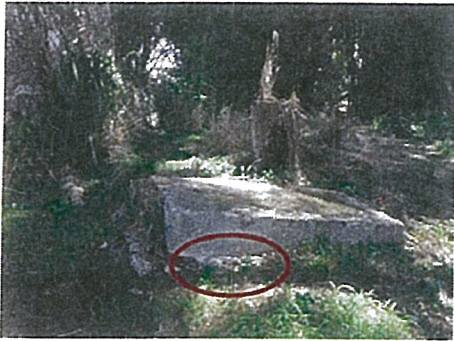
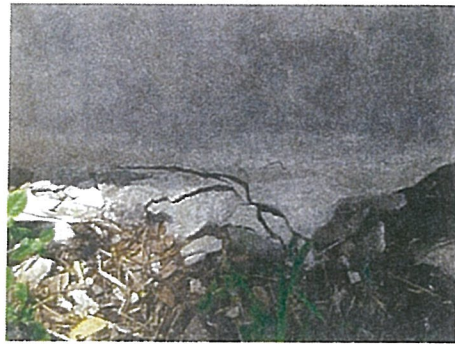
Apparent HRS §6E-11(c) Violation #2: Impact to Large Crypt

2. Damage to the large crypt located southwest of the previously described violation. While the crypt appears to be impacted by the presence of roots from the large tree that is in the vicinity of the burial site, it is likely that the damage shown in Exhibit A, Figure 6 occurred recently when the nearby tree was cut down. As in the previous violation, the cracks appear to be more recent than something done prior to the current owners' recent activities in the cemetery area. This impact constitutes an alteration and destruction of a portion of the historic property. See Exhibit A, Figures 6 & 7.

Figure 6: Large Crypt Feature with damaged area outlined

Figure 7: Close-up of Damage to Crypt

These photographs show the large crypt located southwest of the previously described violation. While the crypt appears to be impacted by the presence of roots from the large tree that is in the vicinity of the burial site, it is likely that the damage shown in figure 6 occurred recently when the nearby tree was cut down. Again as in the previous violation, the cracks appear to be more recent than something done prior to the current owners' recent activities in the cemetery area. This impact constitutes an alteration and destruction of a portion of the site.

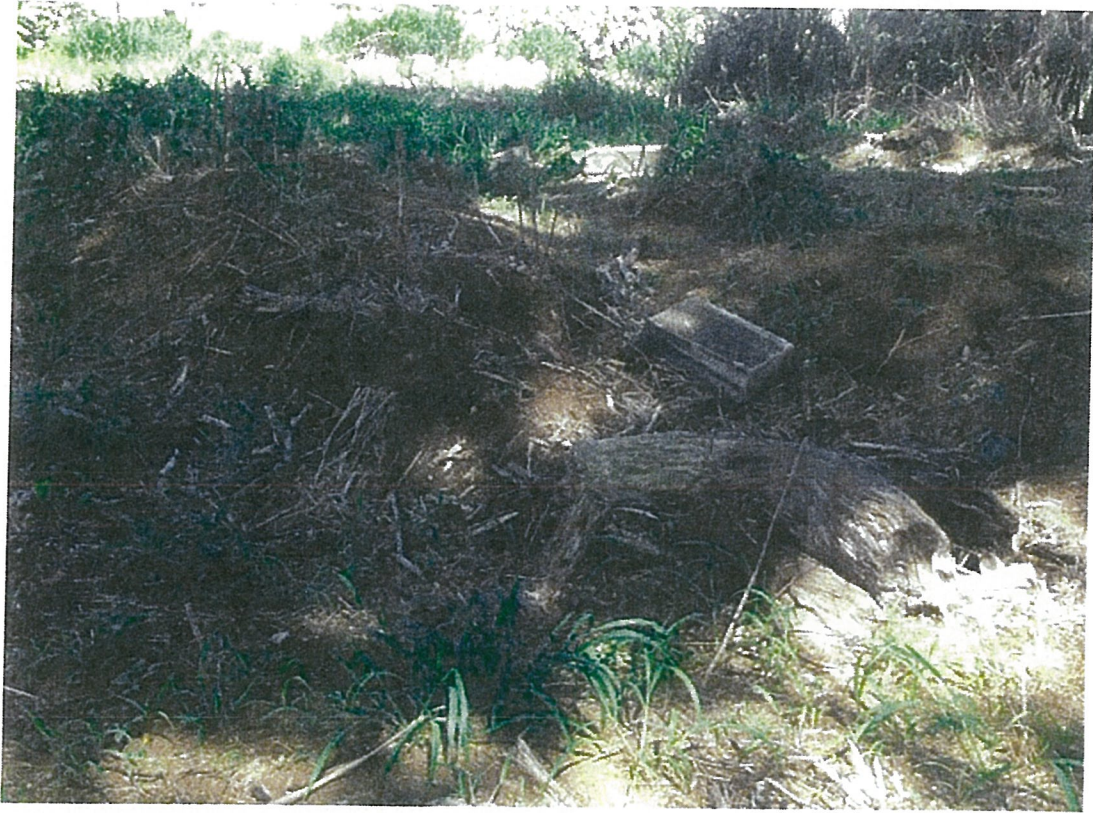
Apparent HRS §6E-11(c) Violation #3: Disturbance of Headstone

3. Damage to the burial site as a result of recent disturbance to an area adjacent to present headstone. The deep cuts in the dirt have been made very recently and the original location of headstone can no longer be ascertained. This impact constitutes an alteration and destruction of a portion of a historic property. See Exhibit A, Figure 8.

3. Damage to the burial site as a result of recent disturbance to an area adjacent to present headstone. This impact constitutes an alteration and destruction of a portion of the historic Amauulu Cemetery. See Exhibit A, Figure 8.
4. Damage to a previously unidentified burial site caused by the most recent land clearing activities. See Exhibit A, Figure 9. This area was also designated as an area of no work as indicated in a grubbing plan provided by Mr. Cross.
6. Additional clearing activities conducted within the historic Amauulu Cemetery resulted in further alteration or damage to the cemetery as a whole.

Figure 8: Disturbance of Headstone due to grubbing

This photograph depicts recent disturbance to an area where the headstone is. The deep cuts in the dirt appear to have been made recently and where the actual location of where the headstone once was, is unknown. This impact constitutes an alteration and destruction of a portion of the site.

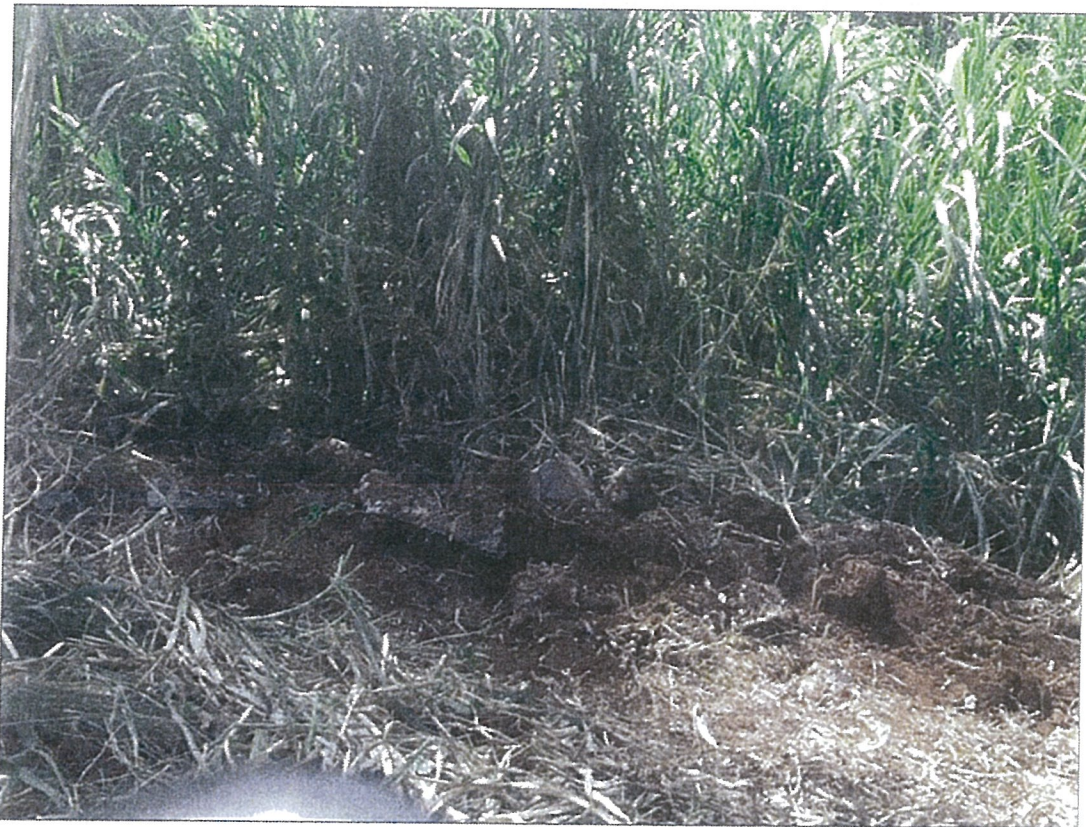
Apparent HRS §6E-11(c) Violation #4: Additional Disturbance from Recent Land Clearing

4. Damage to a previously unidentified burial site caused by the most recent land clearing activities. The grave marker had not been identified in the ongoing archaeological inventory survey. The presence of this grave marker was buried and obscured by 5-6 foot tall overgrowth of grasses. The presence of this grave marker significantly extends the boundaries of the cemetery from previous estimates of its extent. While the grave marker was previously unidentified and obscured due to overgrowth, the work that uncovered and damaged the grave marker in this area occurred after the issuance of the stop work order by the County. See Exhibit A, Figure 9. This area was also designated as an area of no work as indicated in a grubbing plan provided by Mr. Cross.

Figure 9: Most recent disturbance of grave marker due to unpermitted land clearing

This photo depicts the damage caused by the most recent land clearing activities that caused extensive damage to a previously unidentified grave marker. The grave marker had not been identified in the ongoing archaeological inventory survey. The presence of this grave marker was buried and obscured by 5-6 foot tall overgrowth of grasses. The presence of this grave marker significantly extends the boundaries of the cemetery from previous estimates of the extent of the cemetery. While unidentified and obscured due to overgrowth, additional work in the area continued to be under the stop work order from the County of Hawaii. This area was also designated as an area of no work as indicated in a grubbing plan provided by Mr. Cross.

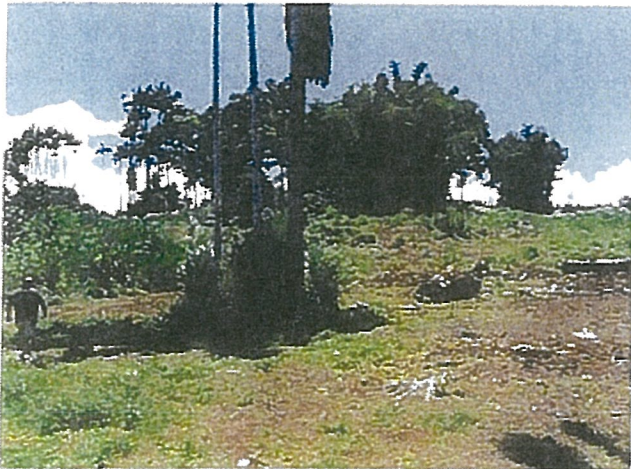
1 Depicts grubbed land, hill where graves located.

Note : Photo taken facing NW direction. Location of cemetery is in and around the bamboo stand.

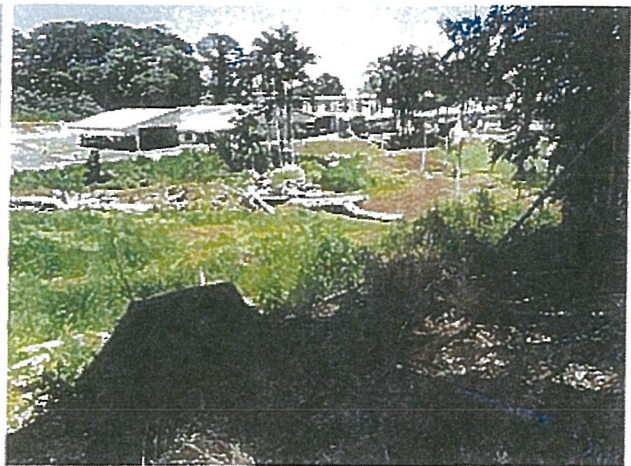
2 Depicts grubbed area facing NE.

Note : Bulldozed trees and top soil pushed towards Dodo Mortuary Building.

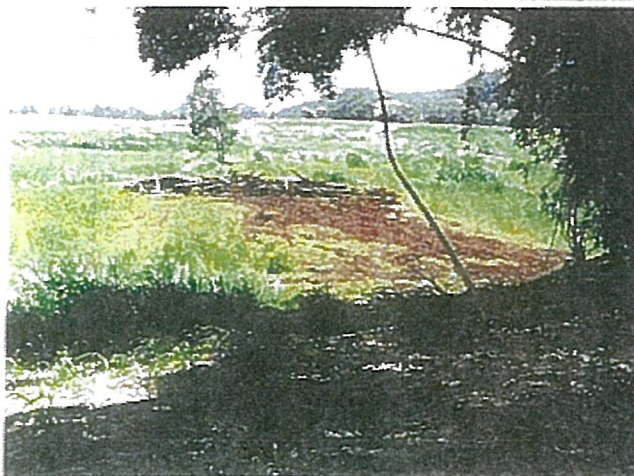
3 Depicts pushed trees and soil away from bamboo,

Note : Grubbed trees and topsoil pushed away from bamboo stand.
Note that exposed soil recently bulldozed.

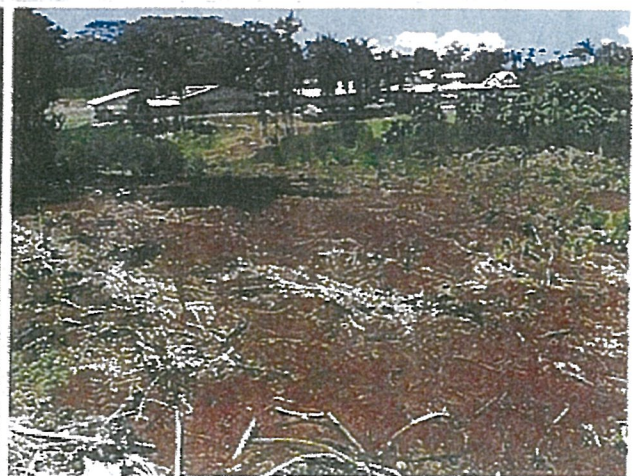
4 Depicts recently grubbed land facing NE.

Note : Signs of topsoil recently grubbed. Newly sprouting greenery.

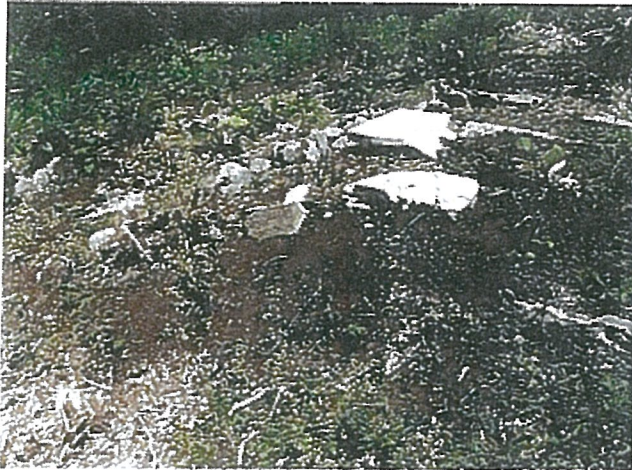
5 Depicts photo of an area with damaged gravesite.

Note : Recently damaged cement stone and grubbed soil. Note newly sprouting weeds in close proximity to grave.

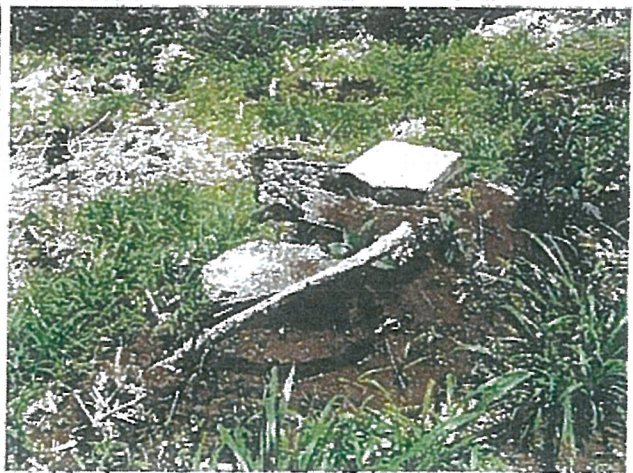
8 Depicts photo of recently damaged gravesite.

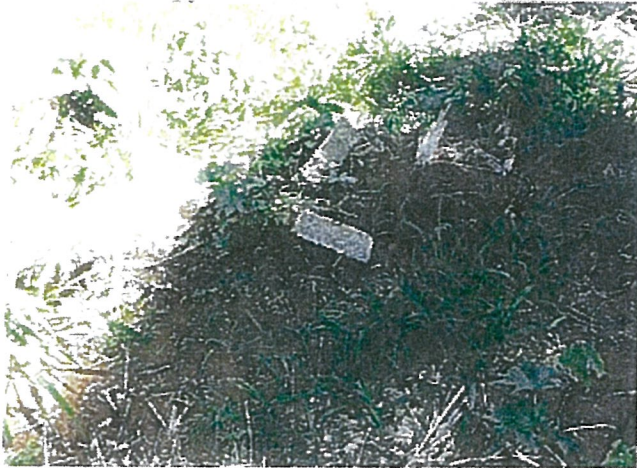
9 Depicts recently disturbed cement gravesite.

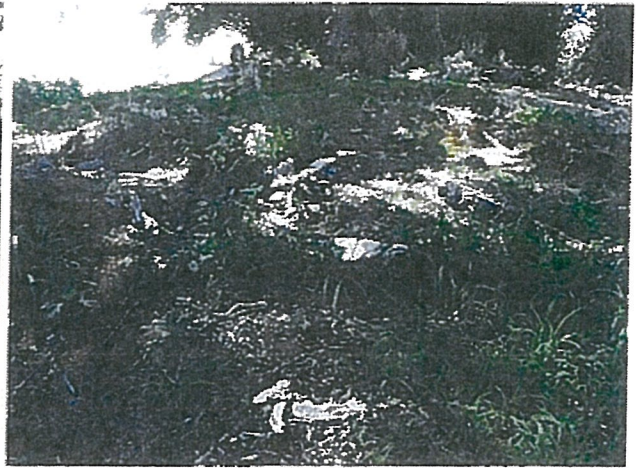
10 Depicts numerous unearthed cement gravesite.

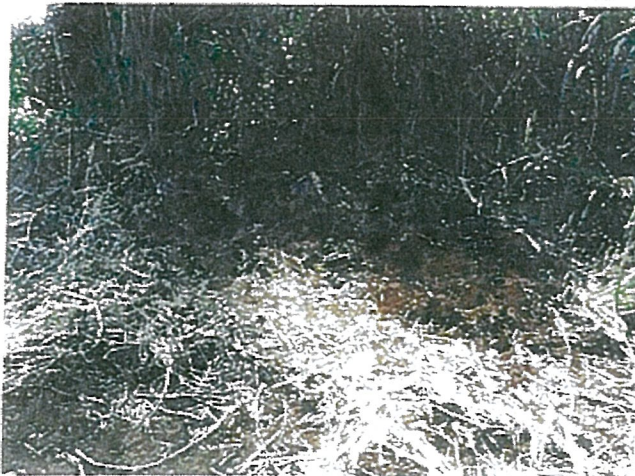
3 Depicts view of recent damaged grave site.

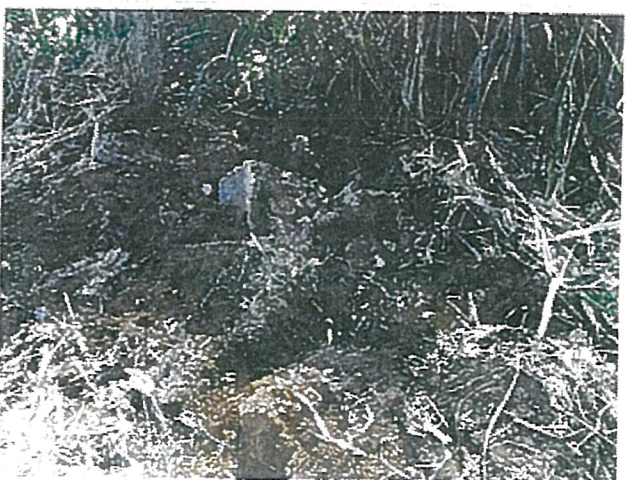
4 Depicts close up view of recently damaged grave site.

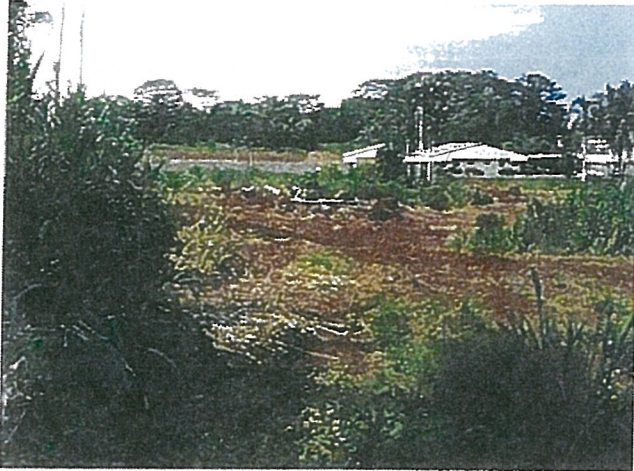
5 Depicts view of recent grubbing activity.

Note: damaged grave site is in the weeds to the bushes on the left in the tall weeds in this photo.

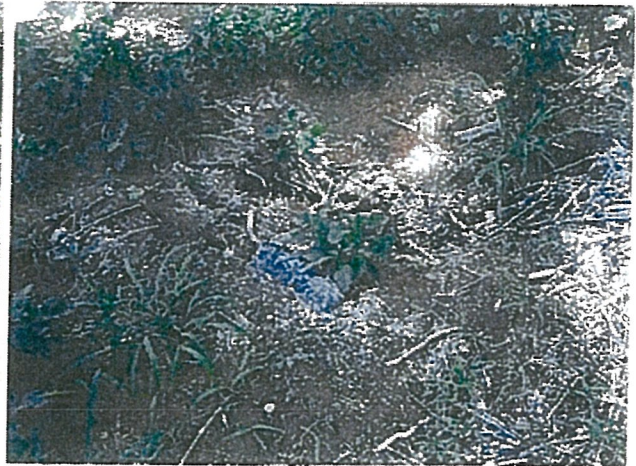
18 Depicts photo of recently disturbed gravesite.

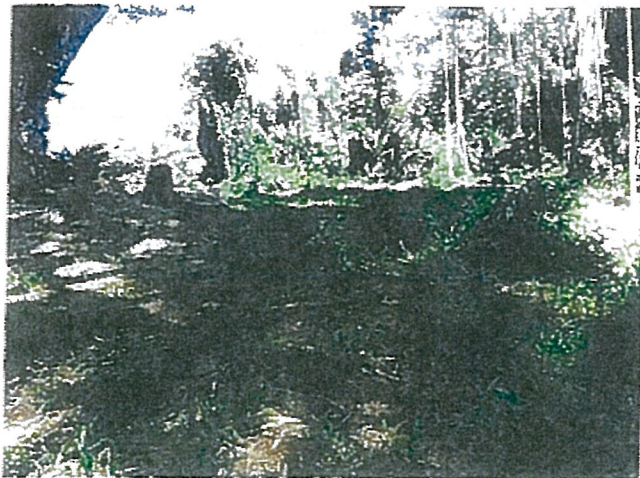
19 Depicts area where heavy machinery went through.
