**STATE OF HAWAII**  
**DEPARTMENT OF LAND AND NATURAL RESOURCES**  
**OFFICE OF CONSERVATION AND COASTAL LANDS**  
**Honolulu, Hawai'i**

**REGARDING:** Conservation District Enforcement Case, OA 20-41  
**Regarding an** Alleged Unauthorized Structure Located Along the  
Shoreline Within the Conservation District at Portlock Beach  
Maunalua Bay, Oahu

**LOCATION:** Honolulu, Oahu  
**TAX MAP KEY:** (1) 3-9-002:003 (Wells Trust) and (1) 3-9-002:029 (Beach Ohana)

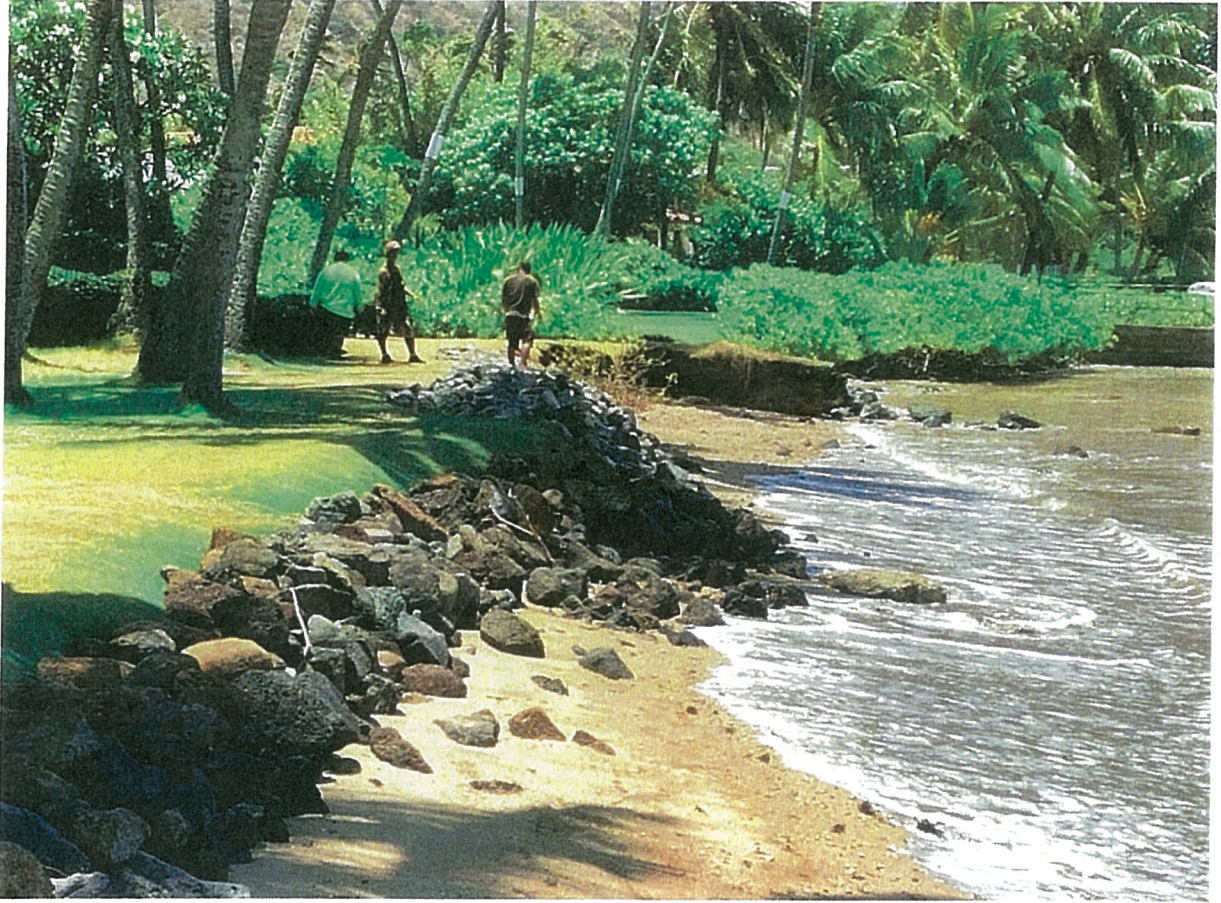
*Figure 4 - Rocks Actively Being Placed Along Scarp Located Seaward of Residential Parcel and Located on and Seaward of Subject Beach Reserve Parcel, Facing Southeast*

5. The Landowner shall remove the shoreline protection structure in its entirety within 90 days of the order of the Board;
6. That in the event of failure of the landowners to comply with any order herein, the landowner shall be fined an additional \$15,000.00 per day until the order is complied with; and

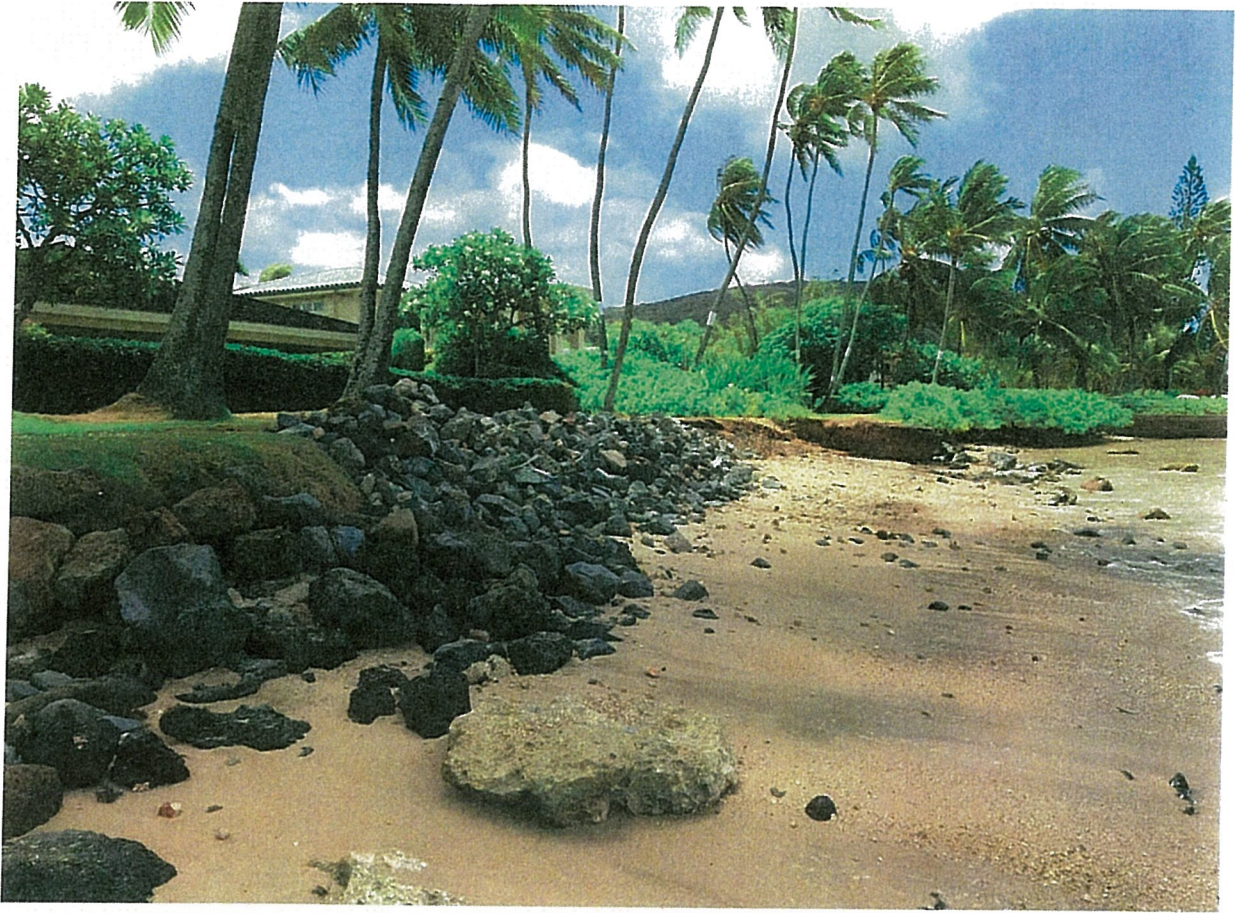
*Figure 5 - Completed Revetment Placed Along Scarp Seaward of Residential Parcel and Located on and Seaward of Subject Beach Reserve Parcel, Facing Southeast*

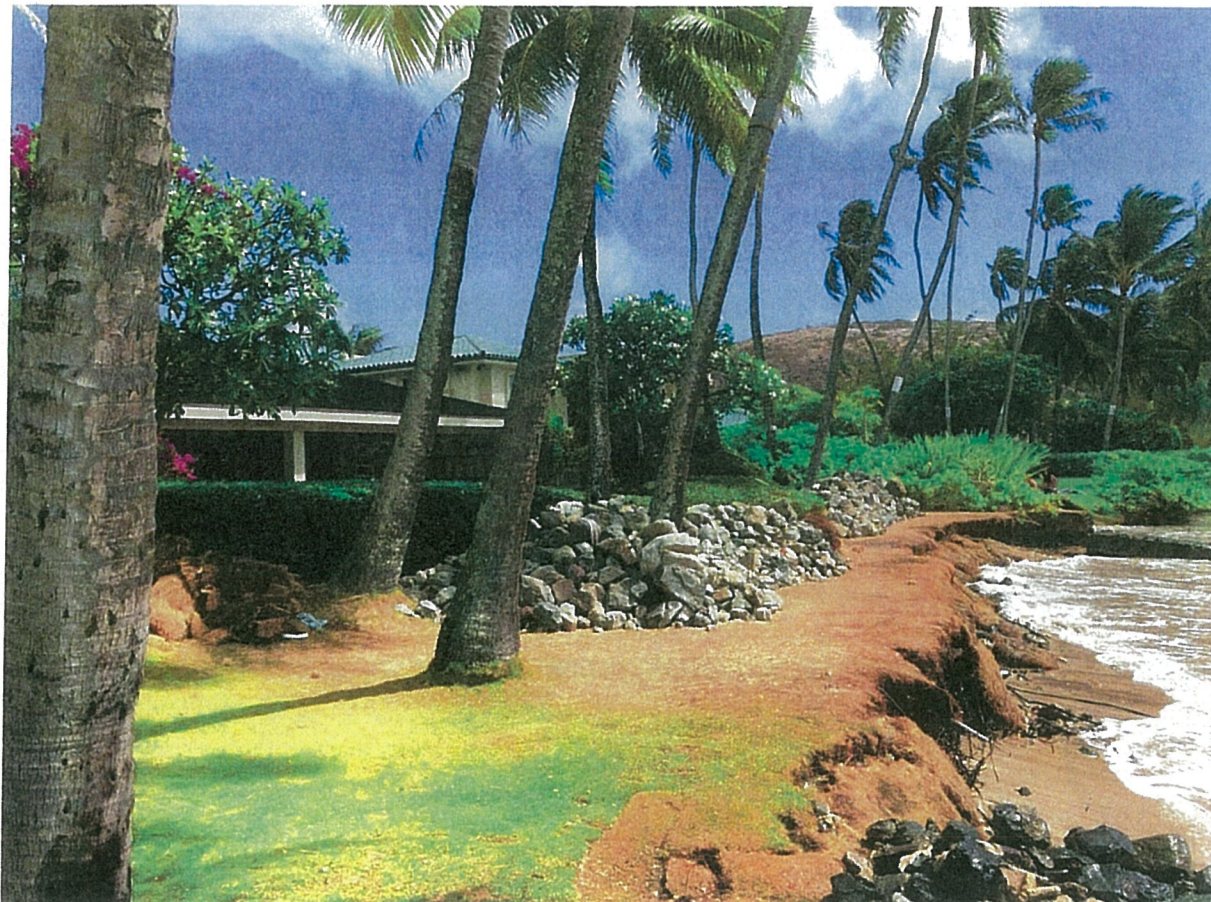
*Figure 6-  
Rocks Removed and Placed Landward of Scarp, Groin Installed*

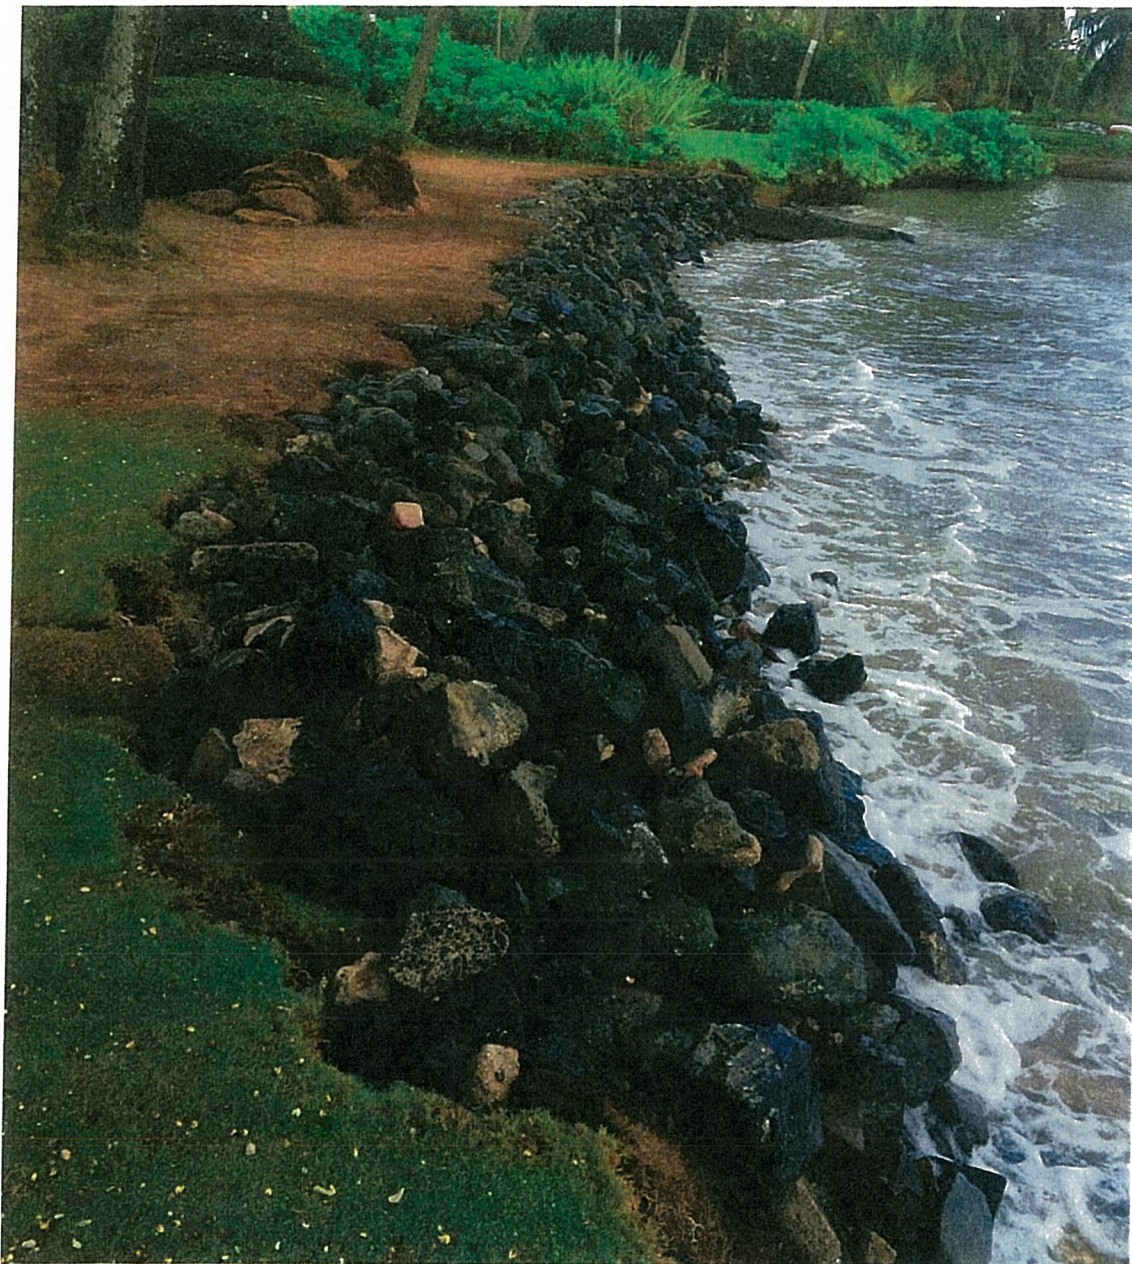
Staff from the Office of Conservation and Coastal Lands visited the subject property on multiple occasions, including on July 21, July 23, September 26, and October 12. On July 21, 2020 OCCL staff reported observing what appeared to be work done in the shoreline area that included the placement of a large quantity of rocks and boulders, as well as objects (i.e. PVC irrigation tubing) projecting out of the erosion scarp into the sandy beach area. *(Figure 3)*. On July 23, 2020 OCCL staff reported observing work actively being done to install a rock revetment along the erosion scarp using previously staged rocks and boulders *(Figure 4)*. On July 28, 2020 OCCL staff reported that all staged rocks had been installed along the scarp in the form of a completed rock revetment. *(Figure 5)*. On September 26, 2020 OCCL staff reported that rocks from the rock revetment had been removed and placed landward of the scarp and that a cement groin feature had been installed on the eastern end of the subject beach area *(Figure 6)*. On October 12, 2020 OCCL staff reported that rocks had been reinstalled along scarp to form a completed rock revetment *(Figure 7)*.

*Figure 7-  
Rocks Placed Along Scarp for the Second Time, Completing the  
Rock Revetment and Groin*
