**REQUEST AUTHORIZATION FOR THE CHAIRPERSON TO ISSUE FINES, TO
EXTEND THE NOTICE OF DEFICIENCY DEADLINES, AND MAKE A FINDING OF
VIOLATIONS SUFFICIENT TO SUPPORT SPECIFIED FINES ON THE OWNERS IF
EXTENDED DEADLINES ARE MISSED FOR
UKUMEHAME RESERVOIRS (MA-0140) REMOVAL**

WAIKAPU, MAUI

Regarding: Dam Safety Enforcement Action on Ukumehame Reservoirs (MA-0140) for Failure to Comply with Notice of Deficiency, February 18, 2020

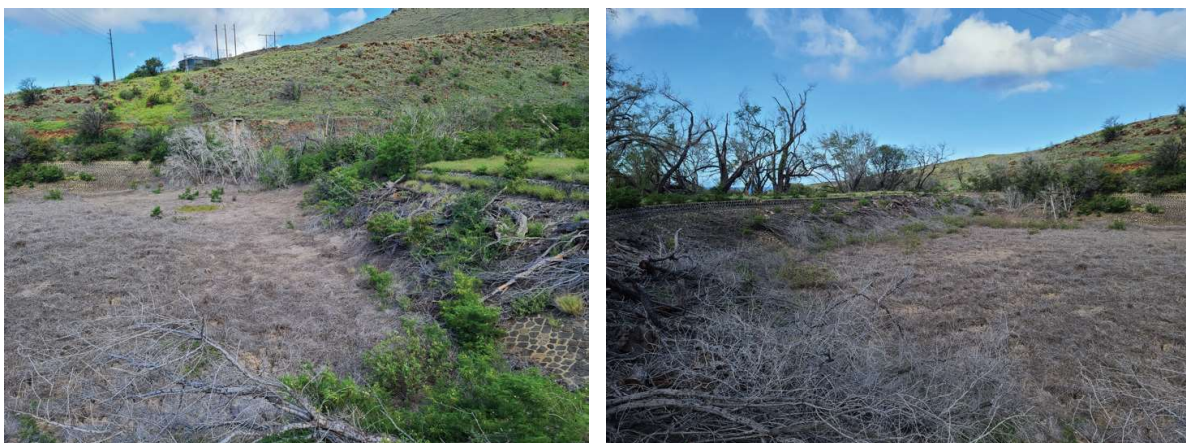
Construction:	Earthen embankment dams with rock lined reservoir
Dam No. 2 Height:	21 ft high
Volume:	18 acre-ft (6 million gallons)
Dam No. 3 Height:	29 ft high
Volume:	26 acre-ft (8.9 million gallons)

Figure 2. Ukumehame Reservoirs No. 2 (left) and No. 3 (right). (2021)

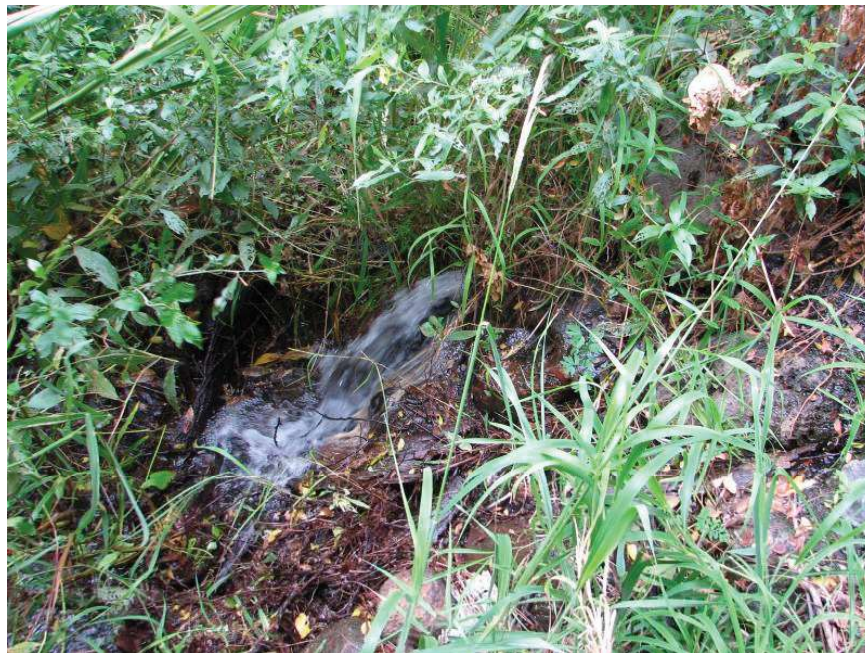
1. A significant seepage area on the downstream slope and crest, which could progress to an internal erosion failure.

1. A large flowing seep (estimated 30-50 gallons per minute), on the downstream slope of the dam from Reservoir 3 (figure 3). If allowed to persist, the seep could develop into a more serious problem and eventually cause a piping failure of the dam.
2. The spillways for both Reservoir Nos. 2 and 3 are undersized to handle a Probable Maximum Flood (PMF) of 15,161 cfs from Ukumehame Gulch. The Reservoirs would be overtopped during a PMF storm event.

Figure 3. Seepage at the downstream face of Reservoir 3.

June 20, 2008, DNLR sent a letter directing the owner to immediately reduce the water level in Reservoir No.3 until the seep on the downstream slope stopped. The owner lowered the water level in the reservoir, and in a letter (April 13, 2009) notified the DLNR that Gannett Fleming had been retained to study the seepage and provide recommendations. In the April 2009 Condition Assessment Report performed by

DLNR worked with the owner and their consultant on the approval of a dam safety permit to remove the structure. A dam safety permit was approved by the DLNR Land Board and issued on November 14, 2017. (See the approved Dam Safety Permit No. 77 in Attachment C.) Subsequent to the issuing the permit, DLNR dam safety staff is not aware of any further action to initiate the construction of the removal work.
