Re: Statement of Position – The Albert Trust
Hearing: July 28, 2023
Proposed DLNR Enforcement Action

Damage Assessment

Field Investigation Report
Initial Field Assessment 2/21/2023
Final Assessment 3/7/2023
Final Report Completed 4/20/2023

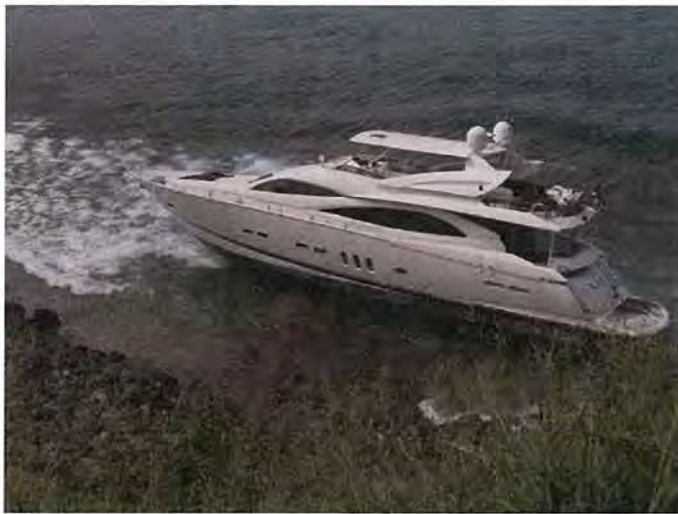
The Vessel “Nakoa” shown grounded on the rocky shoreline and leaking diesel fuel.

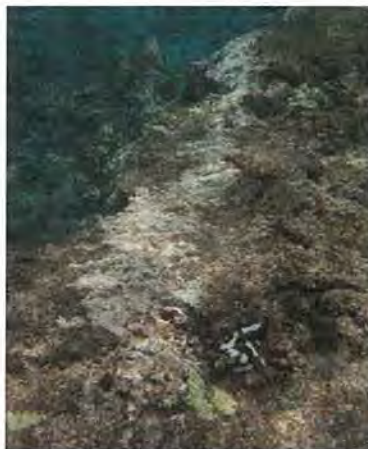
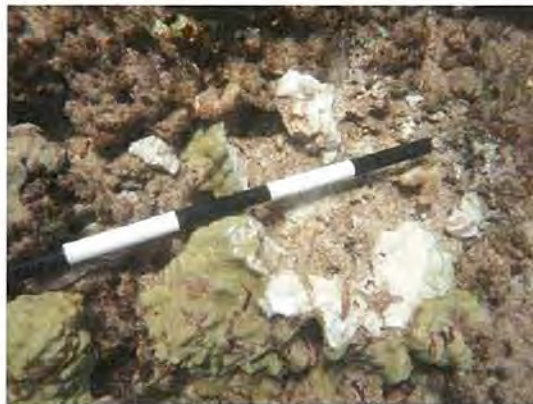
Examples of damage to live rock habitat and corals from the grounding and salvage operations.

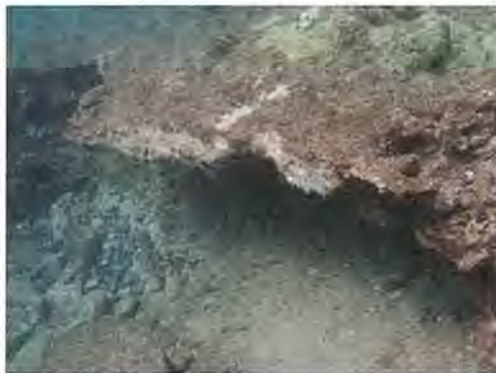
The initial grounding incident resulted in a patchy impact scar extending 85 meters by 2 meters from a northwestern direction (170 square meters). Of this total 170 square meters of disturbed habitat, 35.5 square meters of clearly damaged high rugosity live rock habitat was specifically documented and photographed (Figures 1 & 2). In addition, there were 18 coral colonies directly damaged or destroyed during this grounding. All damaged coral colonies were individually documented during the initial grounding inspection and consisted of 8 colonies of *Pocillopora meandrina* (“cauliflower coral”) and 10 colonies of *Porites lobata* (“lobe coral”).

Figure 1: Photograph of an underwater shelf habitat broken off from impacts during the grounding of the vessel “Nakoa”.

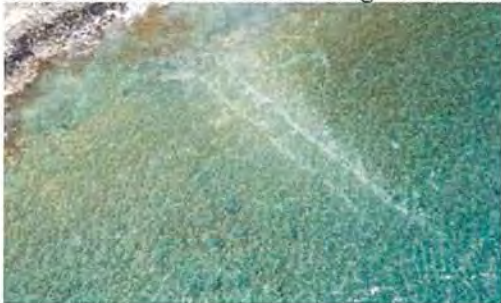
The final salvage removal operation that was conducted on Sunday, March 5, 2023, resulted in a scar to the substrate that extended an additional 75 meters in a westerly direction from where the vessel was stranded. The initial 15 meters of this salvage scar consisted of two deep trench-like scars that were about 5 meters apart and were each 1 meter wide (Figures 4 & 5). This was followed by a smaller impacted area for the next 60 meters that was limited to about 2 meters of width and extended out to a final depth of 10 feet. Within the deeper habitat, the damage was patchy and mostly composed of damage to individual coral colonies. The combined hard bottom live rock substrate impacted by this salvage scar was 195 square meters. There were significant impacts to living coral colonies all along this total salvage scar area, but the most significant impact to the live rock habitat was along the two scars that each extended 15 m x 1 m (30 square meters). Coral colonies impacted included 77 colonies of *Pocillopora meandrina* ("cauliflower coral") and 24 colonies of *Porites lobata* ("lobe coral") for a total of 101 impacted coral colonies within the salvage scar.

Figure 4: Aerial Photograph showing the two parallel salvage scars leading offshore from grounding site. (photo by: Mark Deakos)

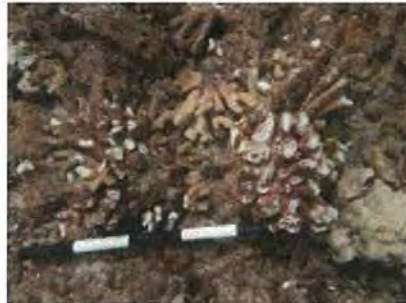
Figure 5: Underwater photograph showing coral damage along the salvage scar.
