Subject: Enforcement Action against Jim Jones, Noelani Yacht Charters, LLC, Kevin S. Albert, Kimberly L. Albert, and the Albert Revocable Trust for Stony Coral and Live Rock Damage resulting from the *Nakoa* grounding incident on February 20, 2023 outside of the Honolua-Mokulē‘ia Bay Marine Life Conservation District, island of Maui.

Nakoa Vessel Grounding, Lipoa Point
Maui Damage Assessment
Field Investigative Report
April 20, 2023

Field Investigation Report
Initial Field Assessment 2/21/2023
Final Assessment 3/7/2023
Final Report Completed 4/20/2023

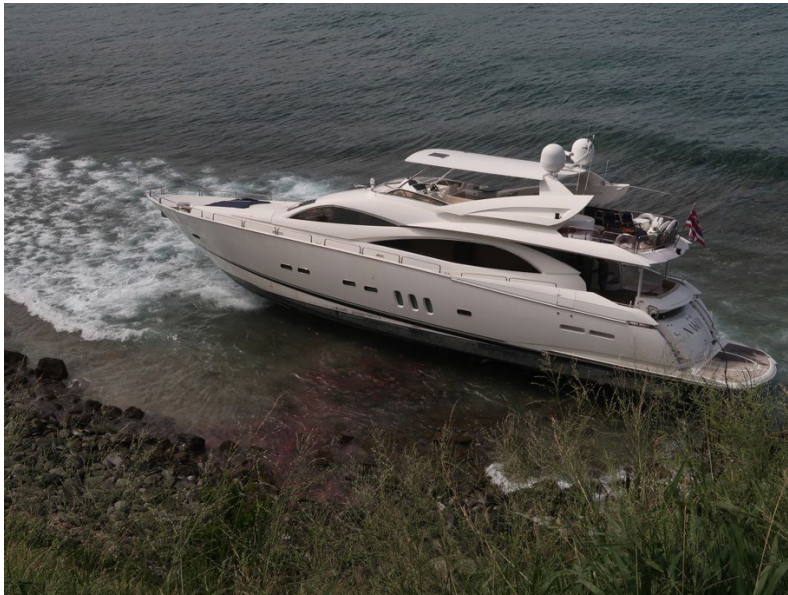
The Vessel “Nakoa” shown grounded on the rocky shoreline and leaking diesel fuel.

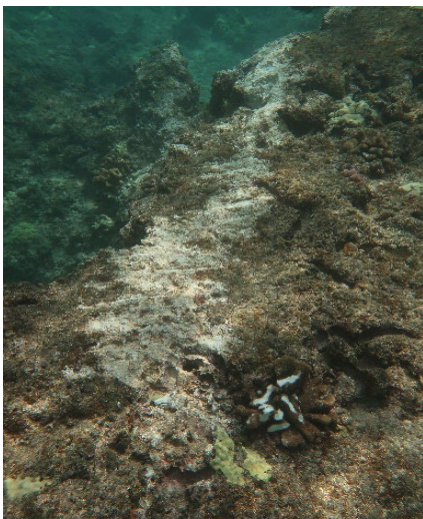
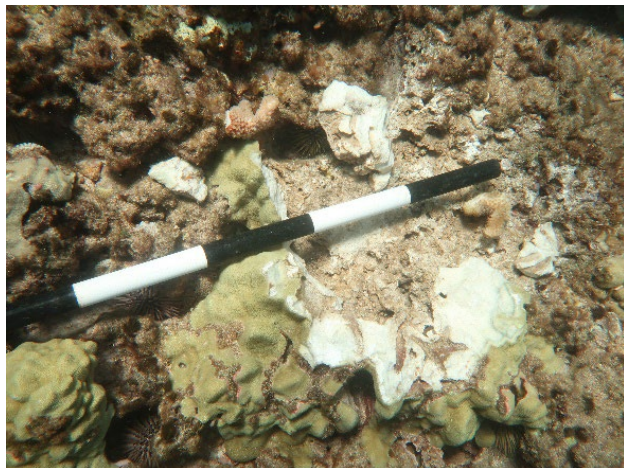
Examples of damage to live rock habitat and corals from the grounding and salvage operations.

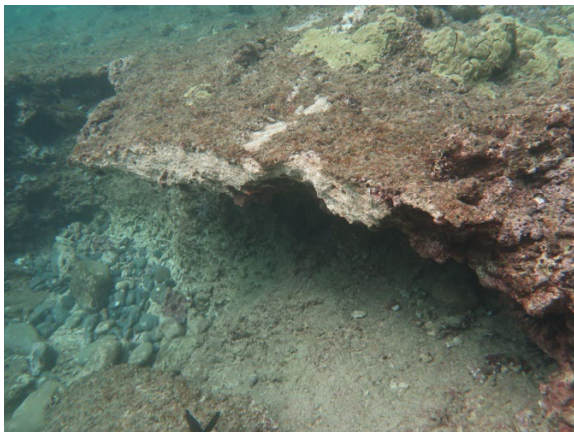
The initial grounding incident resulted in a patchy impact scar extending 85 meters by 2 meters from a northwestern direction (170 square meters). Of this total 170 square meters of disturbed habitat, 35.5 square meters of clearly damaged high rugosity live rock habitat was specifically documented and photographed (Figures 1 & 2). In addition, there were 18 coral colonies directly damaged or destroyed during this grounding. All damaged coral colonies were individually documented during the initial grounding inspection and consisted of 8 colonies of *Pocillopora meandrina* (“cauliflower coral”) and 10 colonies of *Porites lobata* (“lobe coral”).

Figure 1: Photograph of an underwater shelf habitat broken off from impacts during the grounding of the vessel “Nakoa”.

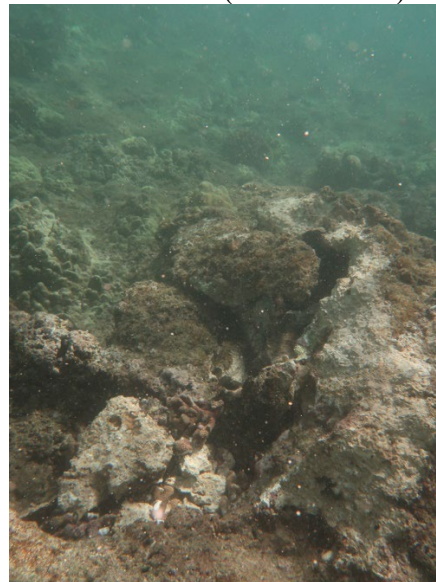
Figure 2: Photograph showing a section of structured habitat Smashed by the grounding event.

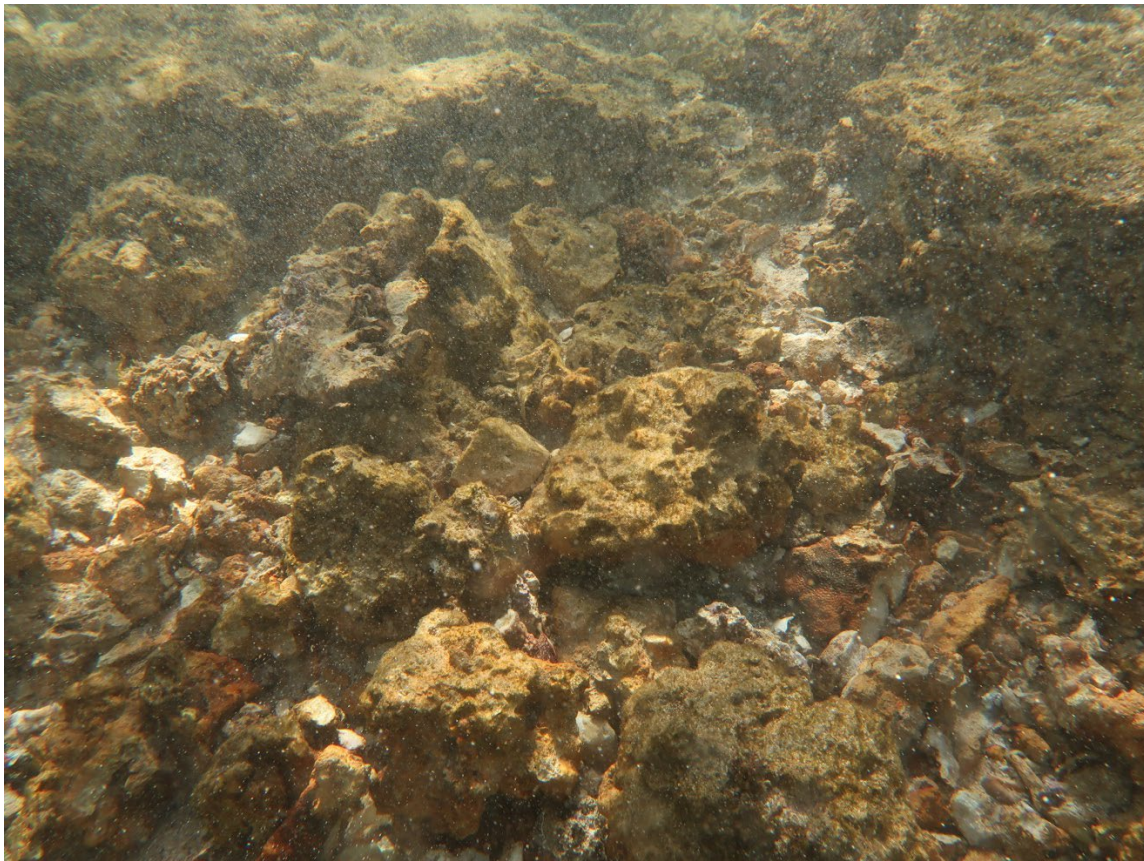
The vessel then remained grounded in extremely shallow water along a basalt boulder shoreline for 14 days while salvage efforts were planned and the pollutants were removed. This area where the vessel remained stranded was composed of flat carbonate pavement and basalt boulder habitat in a high wave energy environment. In this area, a total of 1,575 square meters of live rock habitat was scarred, smashed and/or disturbed (45m long by 35 m wide) (Figure 3). There

were very few live coral colonies found in this area and the substrate was covered mostly by turf algae.

Figure 3: Underwater photograph showing the damage to hard bottom substrate at the location where the Nakoa was grounded for 6 days.

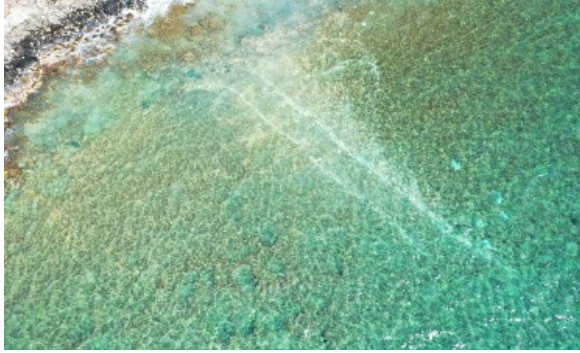
The final salvage removal operation that was conducted on Sunday, March 5, 2023, resulted in a scar to the substrate that extended an additional 75 meters in a westerly direction from where the vessel was stranded. The initial 15 meters of this salvage scar consisted of two deep trench-like scars that were about 5 meters apart and were each 1 meter wide (Figures 4 & 5). This was followed by a smaller impacted area for the next 60 meters that was limited to about 2 meters of width and extended out to a final depth of 10 feet. Within the deeper habitat, the damage was patchy and mostly composed of damage to individual coral colonies. The combined hard bottom live rock substrate impacted by this salvage scar was 195 square meters. There were significant impacts to living coral colonies all along this total salvage scar area, but the most significant impact to the live rock habitat was along the two scars that each extended 15 m x 1 m (30 square meters). Coral colonies impacted included 77 colonies of *Pocillopora meandrina* (“cauliflower coral”) and 24 colonies of *Porites lobata* (“lobe coral”) for a total of 101 impacted coral colonies within the salvage scar.

Figure 4: Aerial Photograph showing the two parallel salvage scars leading offshore from site. (photo by: Mark Deakos)

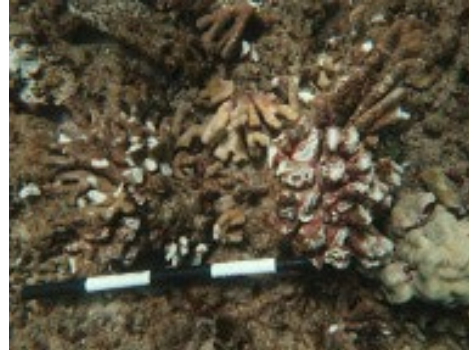
Figure 5: Underwater photograph showing coral damage along the grounding salvage scar.
