Consent to Assign General Lease No. S-4275, Denny’s Repair & Service, Inc., Assignor, to Garden Island Marine LLC, Assignee; Approval of 10-year Term Extension of General Lease No. S-4275, Hanapepe, Waimea (Kona), Kauai, Hawaii; Tax Map Key: (4) 1-9-005:009.

Re: Conduct Inspections of Leased Properties as Identified, and Provide Building Condition Reports with Photos and an Assessment of the Conditions of Existing Improvements, Including Identifying and Deficiencies and Recommended Repair and Maintenance

Pursuant to your request Herbert Chock & Associates, Inc. dba HCA Consulting Group International ("HCA") performed a site inspection of the property and building conditions for the property located at 4545 Kona Road, Hanapēpē, Kaua'i, Hawai'i. We are pleased to submit this report of an assessment of the conditions of existing improvements, including identifying any deficiencies and recommended repair and maintenance.

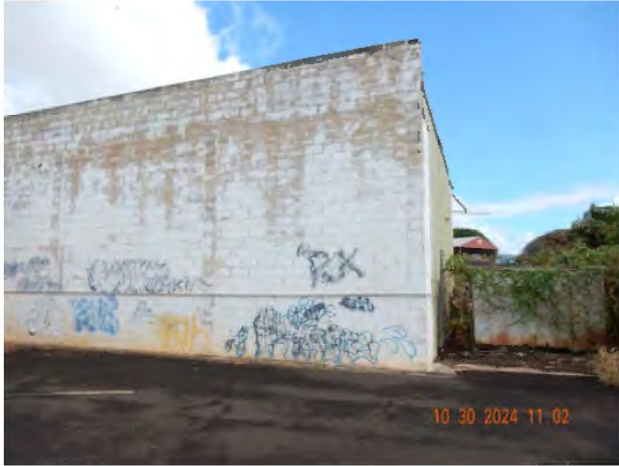
Figure 11. Perimeter (DSCN3700).

Figures 20 & Figure 21. Existing west / south-west CMU wall of auto repair shop with faded paint and graffiti (DSCN3699 & DSCN3700).

The north, west / south-west and south side concrete masonry unit ("CMU") walls of the auto repair shop should be re-painted to remove the graffiti, provide a clean surface and protect / seal the CMU.

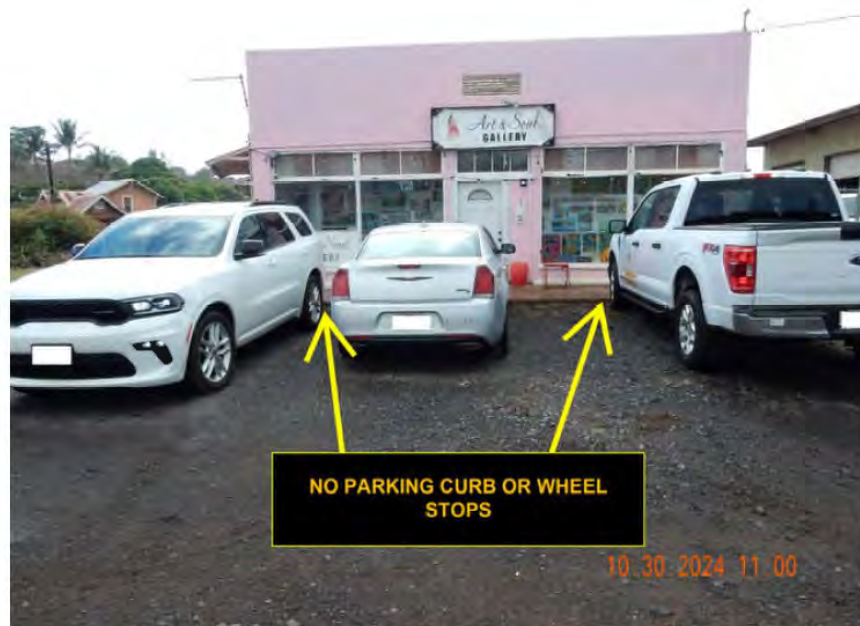
HCA observed that the parking lots are gravel and parking stall markings to distinguish parking allocations would not work, but the installation of either curbs or wheel stops around the property where vehicles could park, would help protect the buildings.

Figure 16. No parking stall markings or wheel stops in front of the art gallery (DSCN3687).

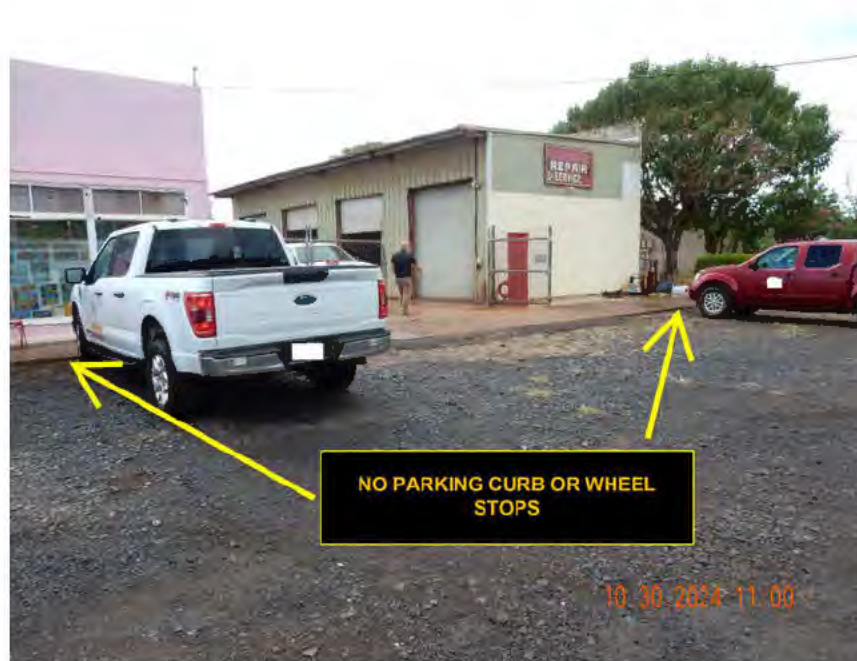
Figure 17. No parking stall markings or wheel stops in front of the art gallery or auto repair shop (DSCN3688).

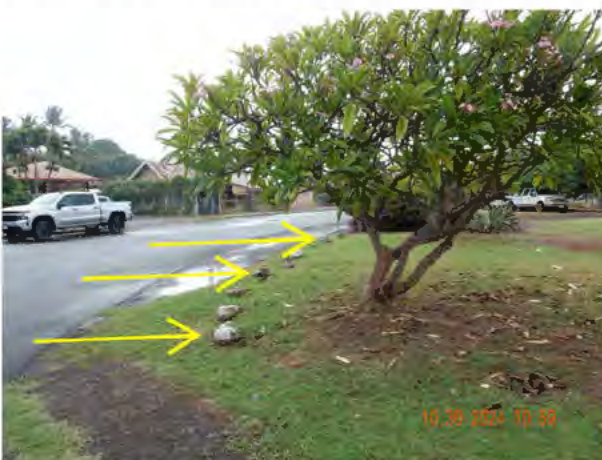
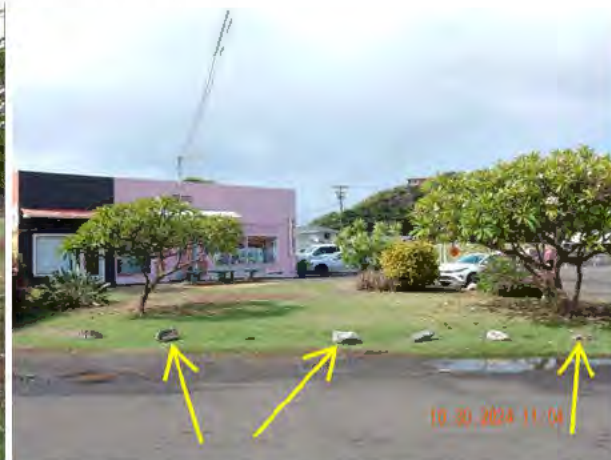
Figures 18 & Figure 19. Property perimeter painted stones (DSCN3680 & DSCN3714).

It was observed that street lighting around the property is very limited. The existing white painted stones along the property line on Kona Road and ē Road should be re-painted with white florescent paint to provide a clear a clear property border for vehicles of the property line and from driving through the landscaping.

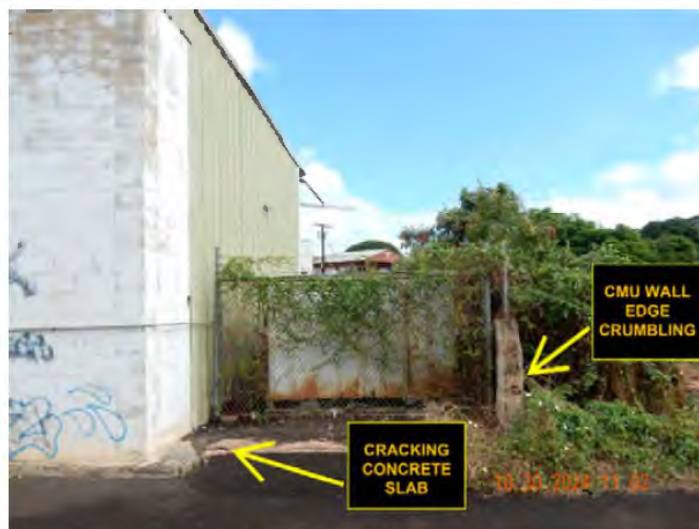
Figure 22. Locations of cracked concrete slab and crumbling CMU wall (DSCN3701).

The south-west concrete slab next to the graffiti CMU wall is cracking and should be repaired. The CMU wall edge at the south side of the property is crumbling and should be repaired to prevent further crumbling and loss of the chain-link fence on top of the CMU wall.

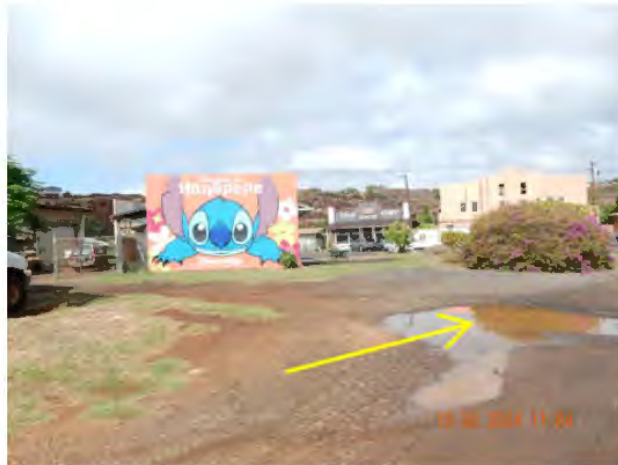
Figure 23. Low lying areas of property (DSCN3711).

Low lying areas of the property should be filled in to prevent potential trip and falls by pedestrians (future legal cases) and breeding ground for mosquitoes and other insects.

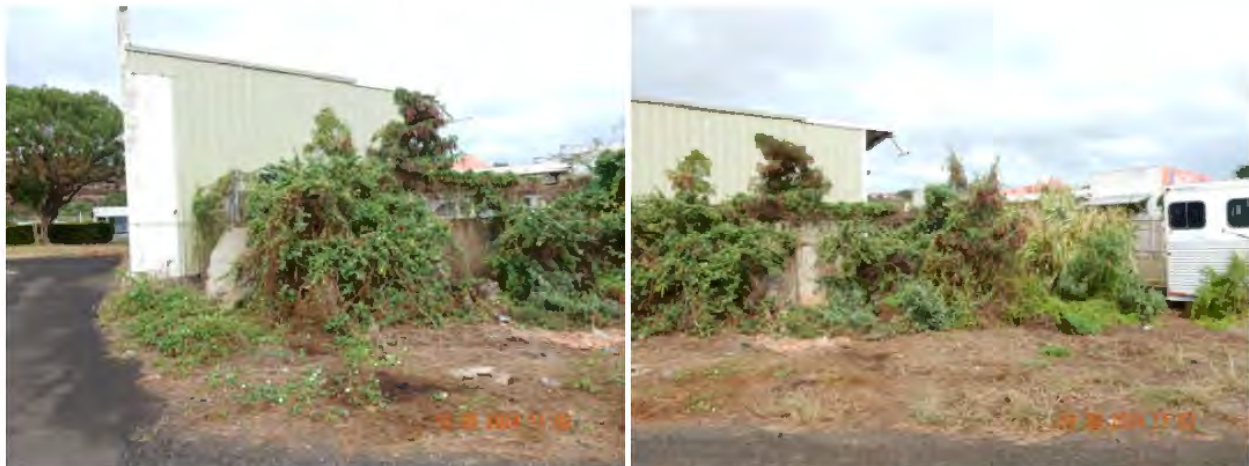
Figures 24 & 25. Overgrown landscaping (DSCN3703 & DSCN3704).

Better landscape demarcation lines between grass and roads. The overgrown trees / bushes and weeds on the south side of the property should be removed to prevent any potential damage to the south side CMU wall.

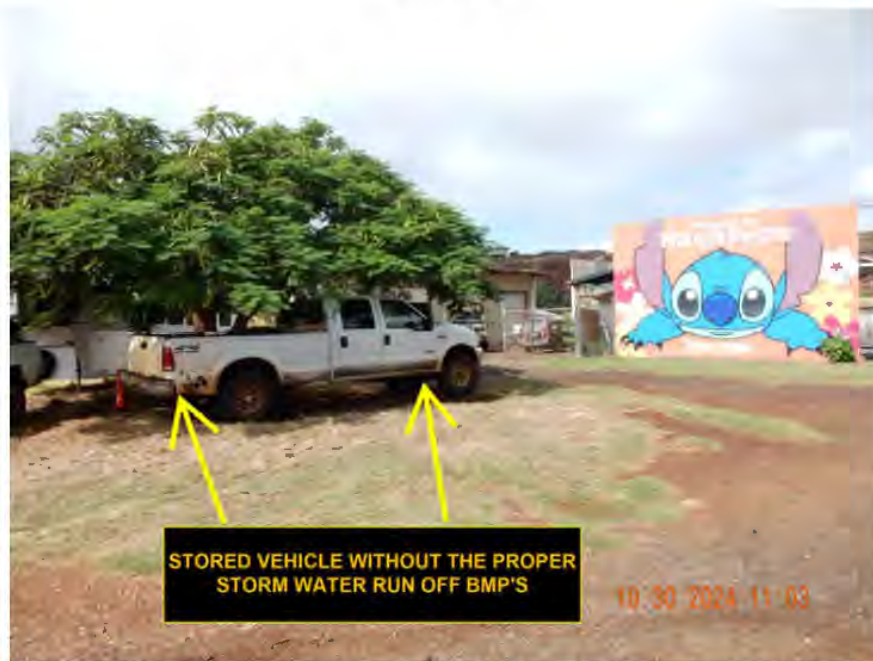
Figure 26. Stored vehicles without the proper storm water run-off BMP's (DSCN3710).

under the vehicle(s) to capture any leaking fuel, oil or other fluids dripping from the vehicle. Leaking vehicle fluids on the bare ground are potential storm water run-off pollutants which could travel to the ocean via island waterways. Storm water run-off is a potential fine from the Department of Health, Clean Water Branch.

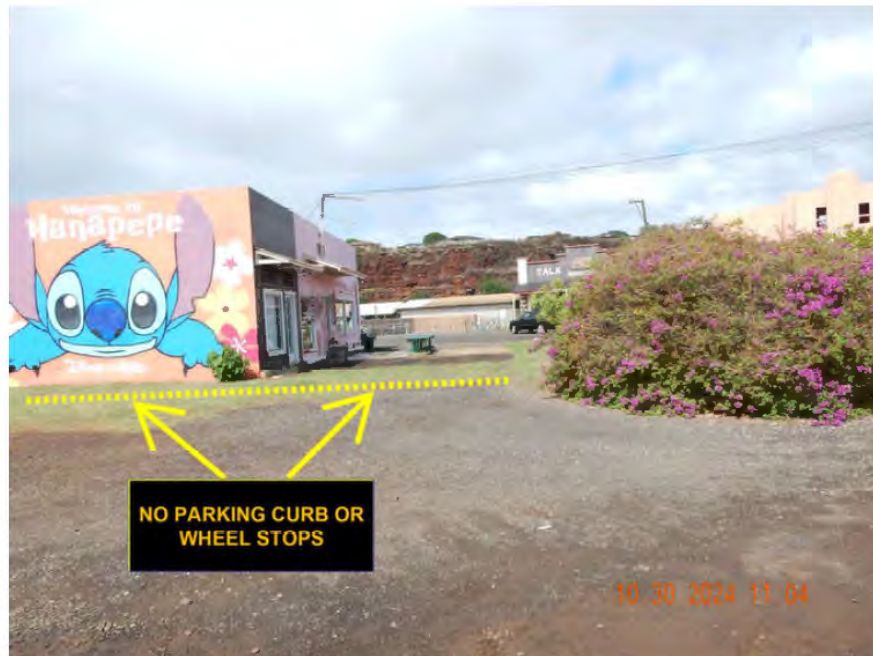
HCA observed that the gravel areas in front, side and back of the building do not have either curbs or wheel stops to prevent vehicles from damaging the building. HCA was informed that on Friday nights Hanapēpē has outdoor music and events which attract large crowds and parking around the building is very likely. Per the repair proposal (discussed below) vehicle damage to the building exterior walls has occurred. Installation of curbs or wheel stops would help protect the building.

Figure 27. No parking curb or wheel stops (DSCN3712).

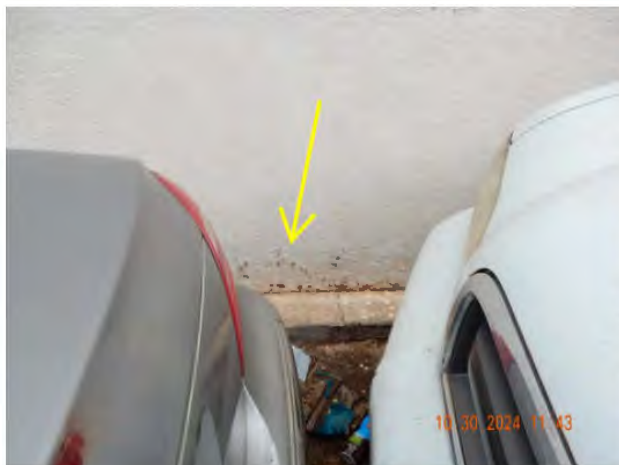
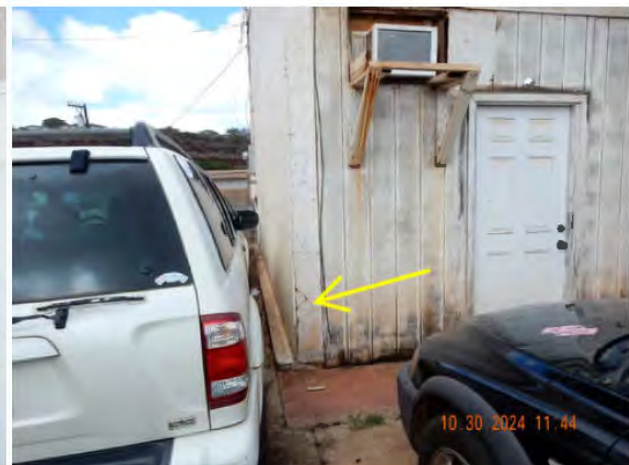
Figure 28. Exterior wall stucco (DSCN3884). Figure 29. Exterior wall stucco (DSCN3881).

HCA observed that the building's exterior wall stucco finish is crumbling. Repairs or replacement of crumbling stucco should be made especially at the base of the wall where water penetration could occur.

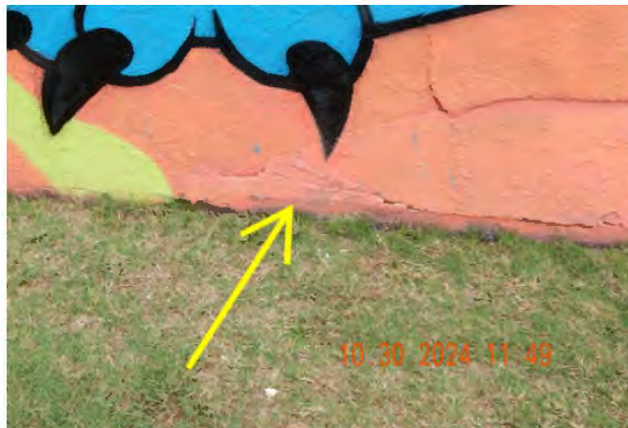
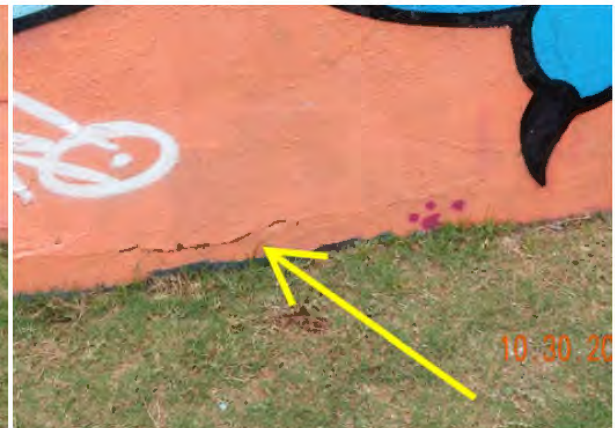
Figure 32. Exterior wall stucco (DSCN3927). Figure 33. Exterior wall stucco (DSCN3930).

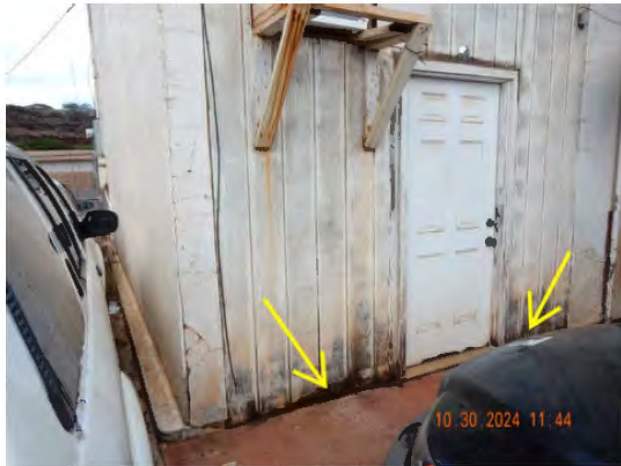
HCA also observed dry rot and termite damage to the exterior walls and windows which should be repaired or replaced.

Figure 34. Exterior wood wall (DSCN3887).

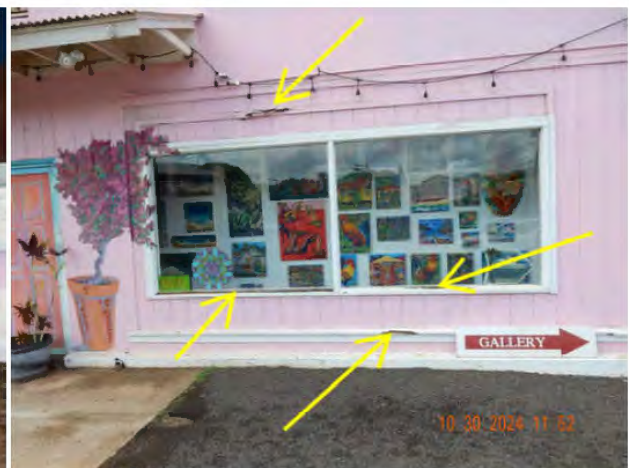
Figure 39. Exterior wood wall (DSCN3952).

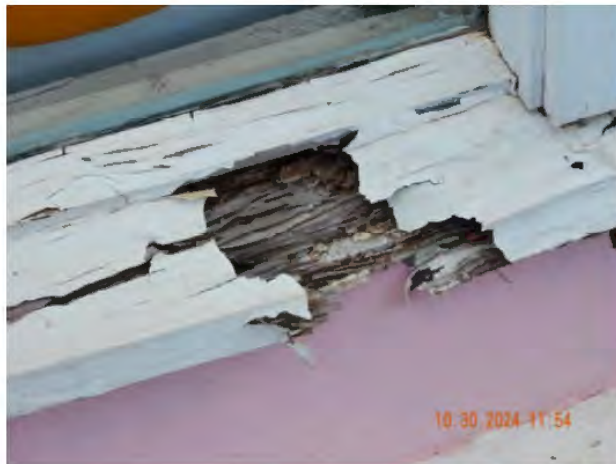
Figure 42. Termite damage to window seal, typical (DSCN3971).

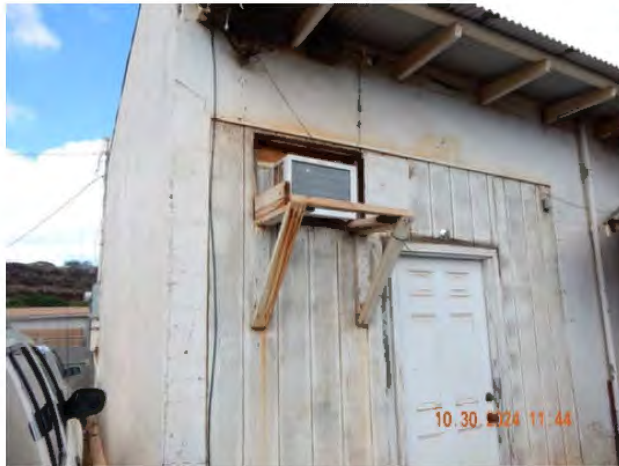
Figure 43. Exterior painting (DSCN3888).

HCA also observed that the entire building exterior should be cleaned up and painted after all needed repairs / replacements have taken place.

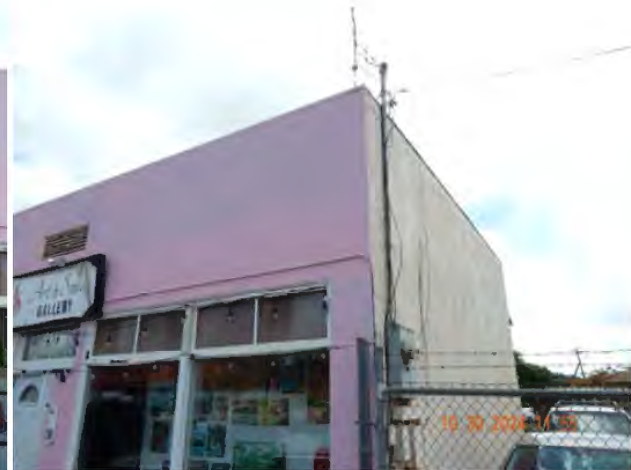
Figure 50. Exterior painting (DSCN3973).

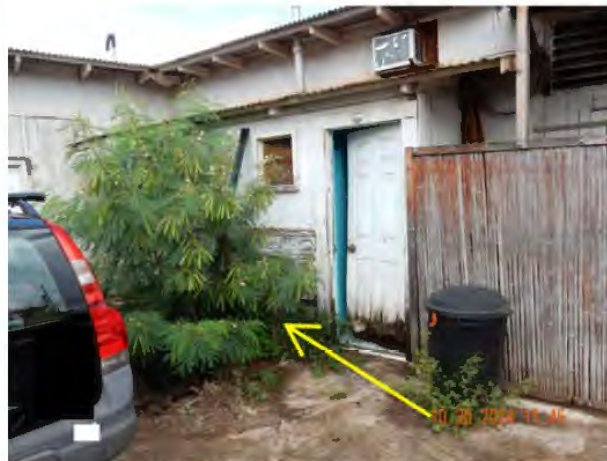
Figure 51. Overgrown bushes and weeds (DSCN3898).

The overgrown trees / bushes and weeds on the south-west side of the property should be removed or trimmed.

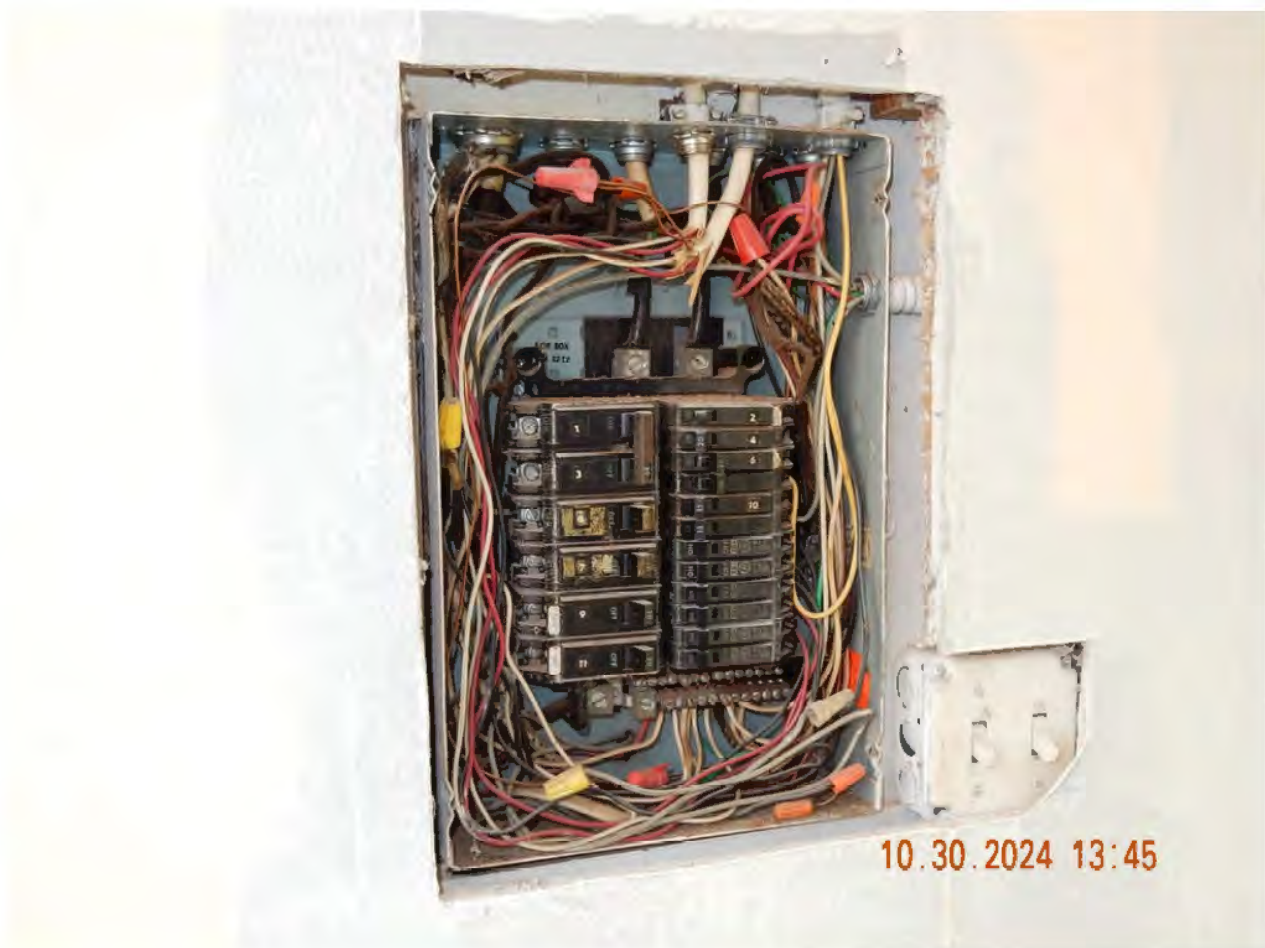
HCA found the electrical panel box on the south side wall. HCA removed the electrical panel cover and found several concerns including but not limited to wire nuts inside the electrical panel:

Figure 52. Electrical panel in Building #1, south wall (DSCN4079).

- Positive (Red & Black) wires individually capped (top, bottom and left)
- This panel appears to be undersized. Circuits have been replaced and or abandoned. The ground bar is completely filled (which mean the capped circuits noted above were never removed from the bar), the new circuits are capped to one another and not properly grounded.

HCA does not believe there is a fire hazard, but there is definitely an electrical shock hazard. If there are other electrical panel boxes within Building #1, HCA recommends they also be reviewed by a licensed electrician for any potential issues.

HCA recommends that a licensed electrician review the electrical panel, remove the existing panel and upgrade it with a properly sized panel. In addition, any circuits that have been abandoned need to be removed from the panel box and each of the switches or outlets on these circuits removed and blank covers provided at these locations.

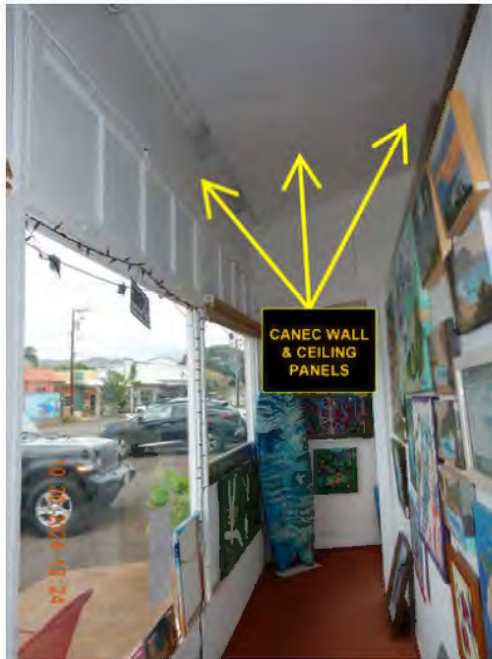
As a word of caution, HCA observed that many of the interior walls and the ceiling are Canec⁴ panels. Please observe caution when disturbing these panels and follow Hawaii State Department of Health guidelines.

Figures 53 & 54. Canec wall & ceiling panels (DSCN3997 & DSCN4025).

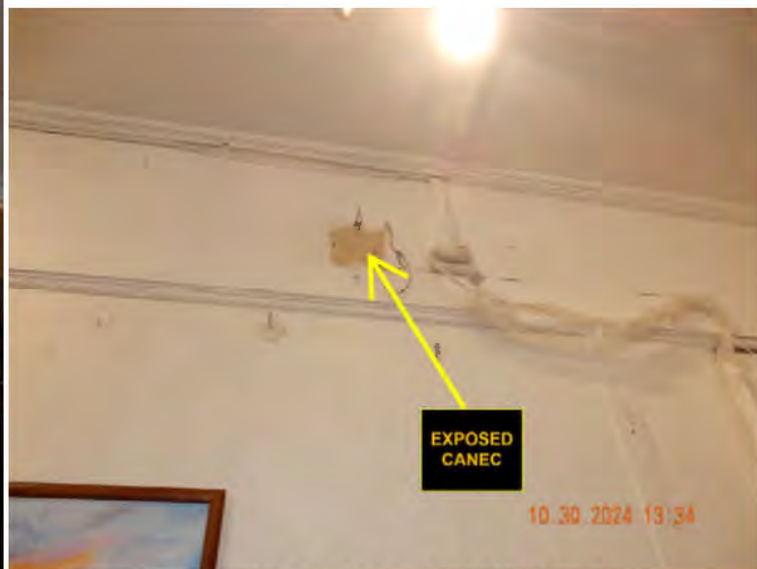
Figure 55 & 56. Canec wall & ceiling panels (DSCN4038 & DSCN4058).

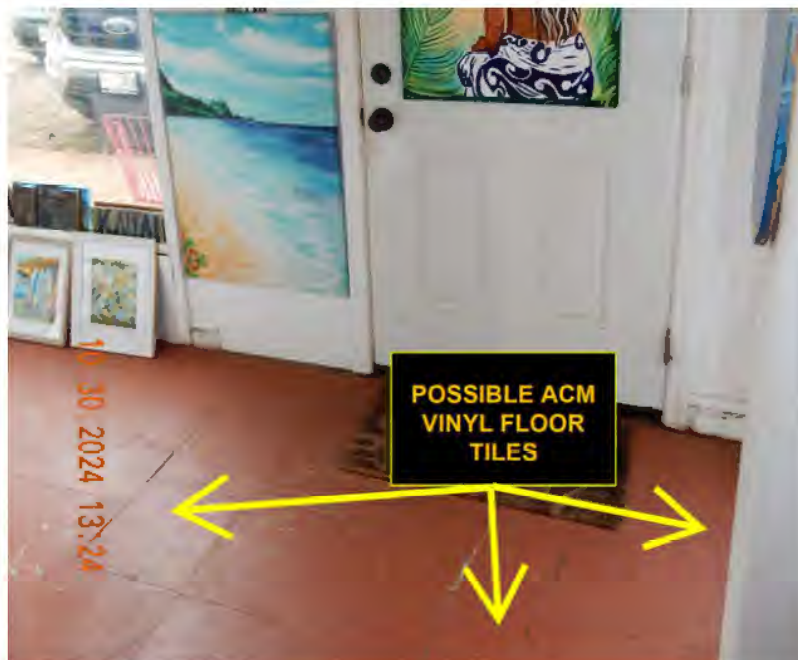
HCA also observed that the painted vinyl flooring tiles are very old and may include asbestos-containing material (“ACM”) – this may also include the adhesive below the tile.

Research on the property shows that the building was constructed in 1950 when ACM vinyl floor tiles and adhesive were commonly used. ACM vinyl floor tiles are considered non-friable asbestos, meaning it cannot be damaged by the human hand. This does not mean the possible ACM vinyl floor tiles in Building #1 are safe to demolish without the necessary precautions. If the ACM vinyl flooring is ever to be disturbed, it is recommended that a professional, licensed, environmental firm should be hired to inspect and test the vinyl tiles and adhesive prior to planned work.

Figure 57. Possible ACM vinyl floor tiles (DSCN3994 Close Up).

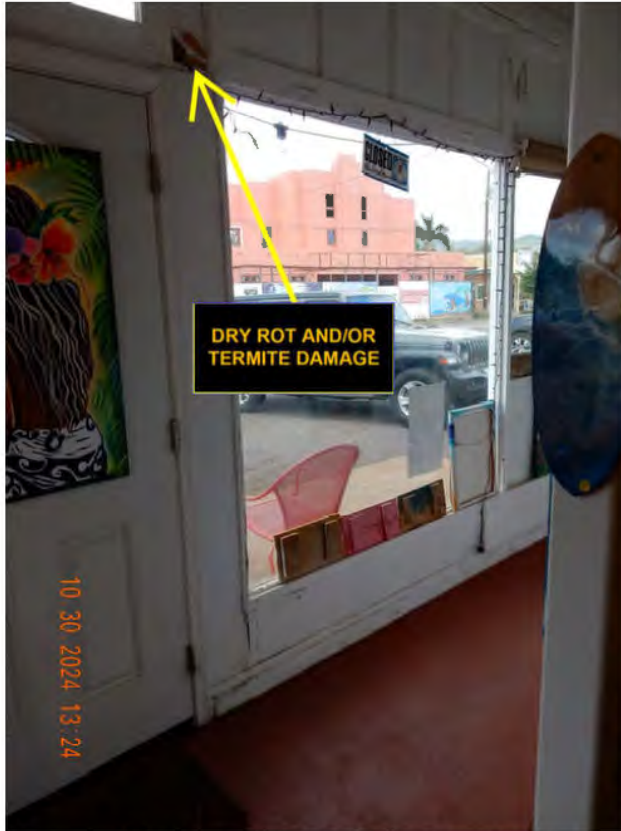
HCA observed dry rot and/or termite damage to interior wood elements. Repair or replacement of damaged wood elements along with a termite treatment program is recommended.

Figures 58 & 59. Dry rot and/or termite damage (DSCN3996 & DSCN4002).

HCA also recommends that the entire building be tented and fumigated on a regular maintenance schedule to help prevent further termite deterioration of the building.

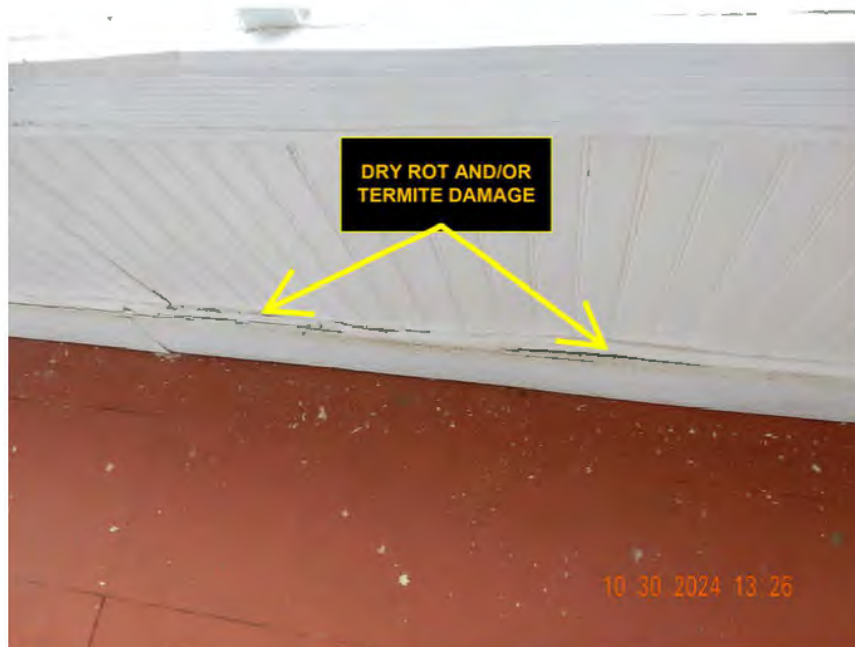
Figure 60. Dry rot and/or termite damage (DSCN4010).

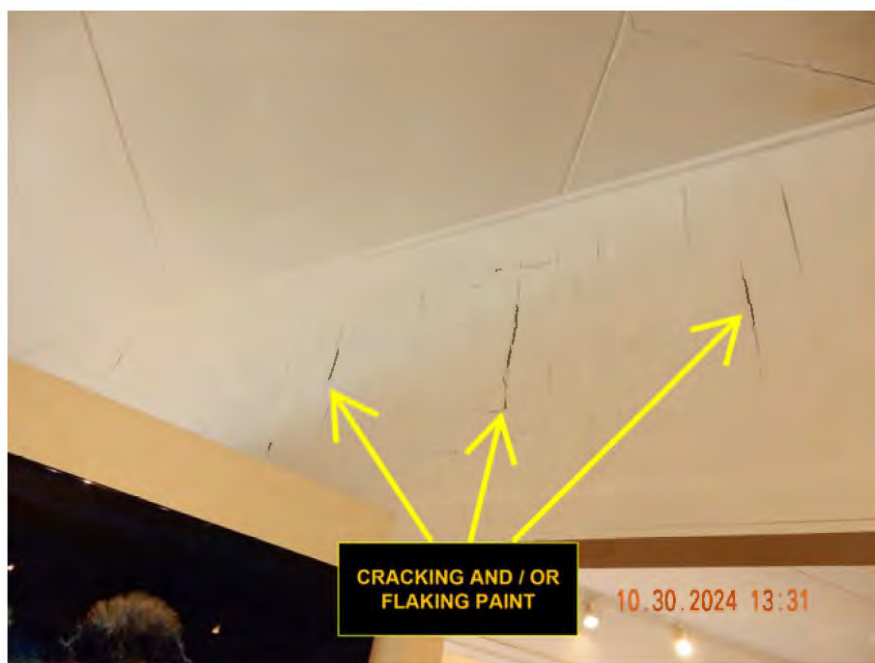
HCA observed several areas of wall where the paint is cracking and flaking off. The building may have original paint from 1950, which may contain lead, another hazardous material that should be properly contained if disturbed.

Figure 63. Cracking and / or flaking interior paint (DSCN4041).

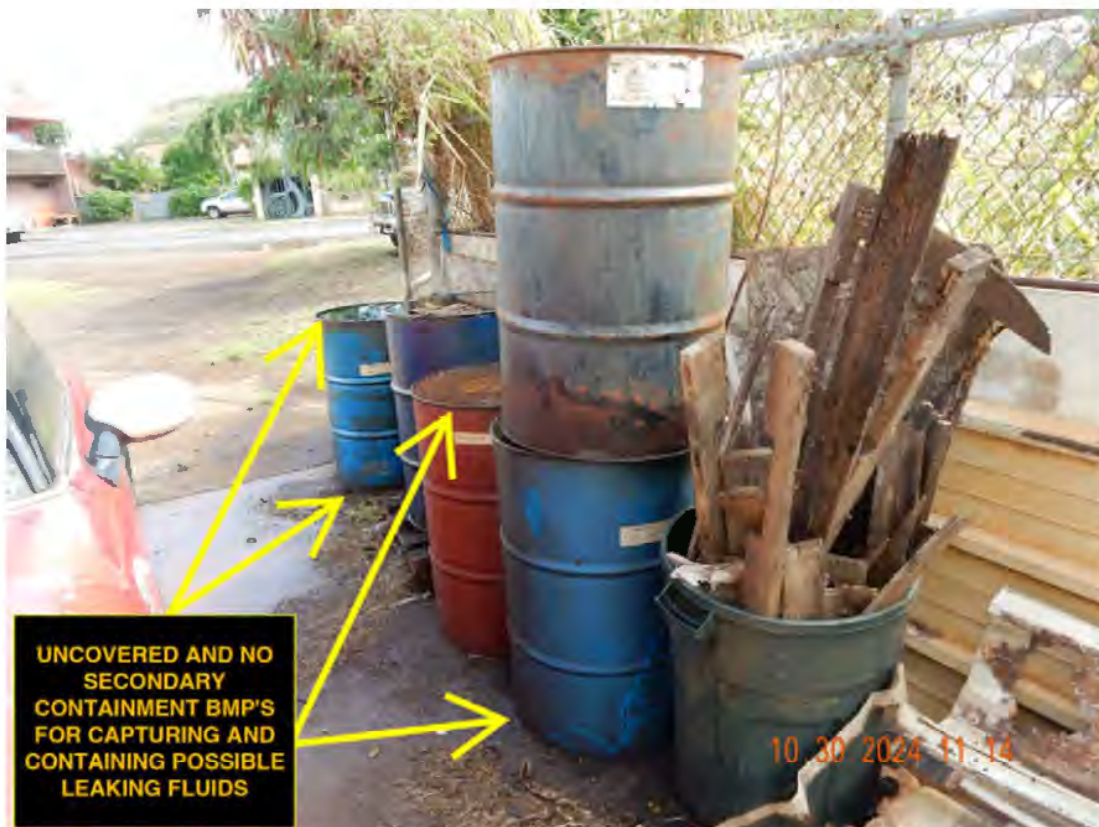
HCA observed steel drums stored at the south side and plastic drums on the north side of Building #2, uncovered and no secondary containment BMP's for capturing and containing leaking fluids, such as oil and fuel. Tapping on the drums indicated to HCA that

Figure 64. Uncovered and no secondary containment BMP's for capturing and containing possible leaking fluids (DSCN3741).

these drums were full. Oil sheens mixed with rain water were observed on the top of the drums. It is recommended that the drums be covered and placed in secondary containment to capture and contain any possible leaking fluids that could be exposed to the ground and become storm water runoff pollutants. Storm water can pick up pollutants that wash off or dissolve in water from materials that are exposed to rain or runoff flowing through the storage area. Pollutants in storm water runoff may flow directly into streams and coastal waters leading to a fine for either the Lessee and/or Lessor from the County of Kaua'i and/or the State Department of Health, Clean Water Branch.

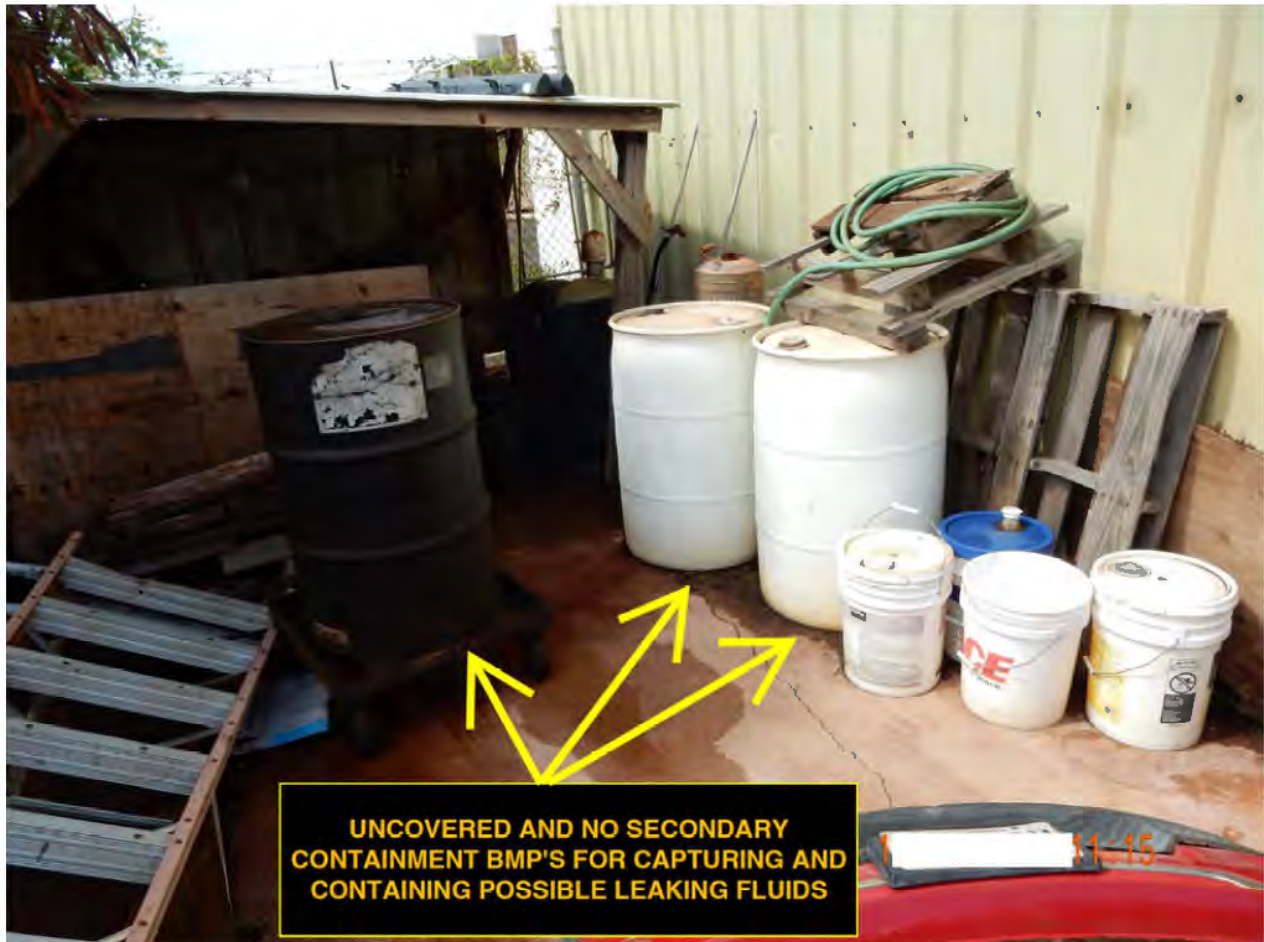
Figure 65. Uncovered and no secondary containment BMP's for capturing and containing possible leaking fluids (DSCN3747).

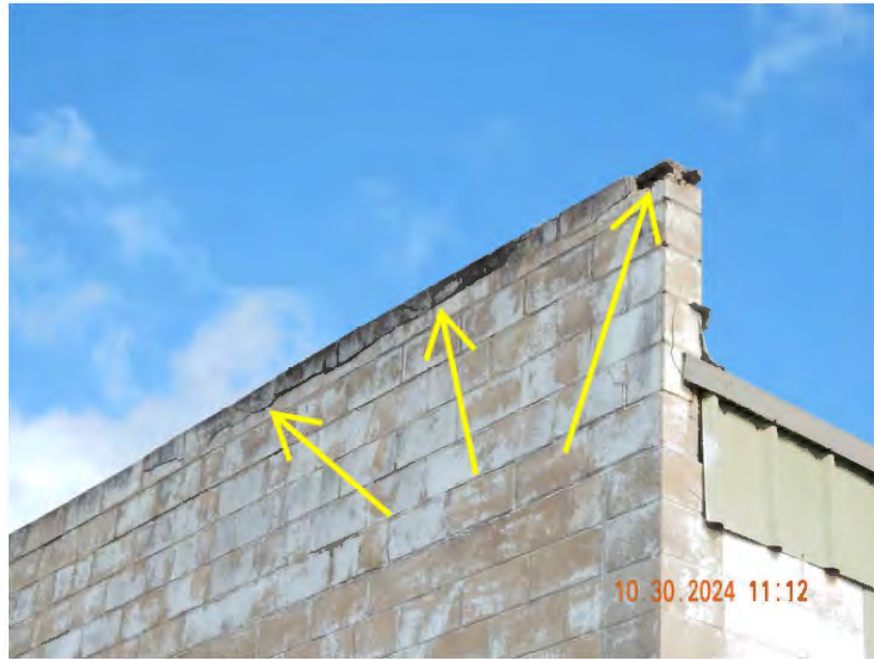
HCA observed that the top of the south-west CMU wall has cracked and partially crumbled away. HCA recommends that the top or CMU cap be repaired to prevent a falling hazard and to protect the CMU wall.

Figure 66. Cracked and crumbling CMU wall top (DSCN3735).

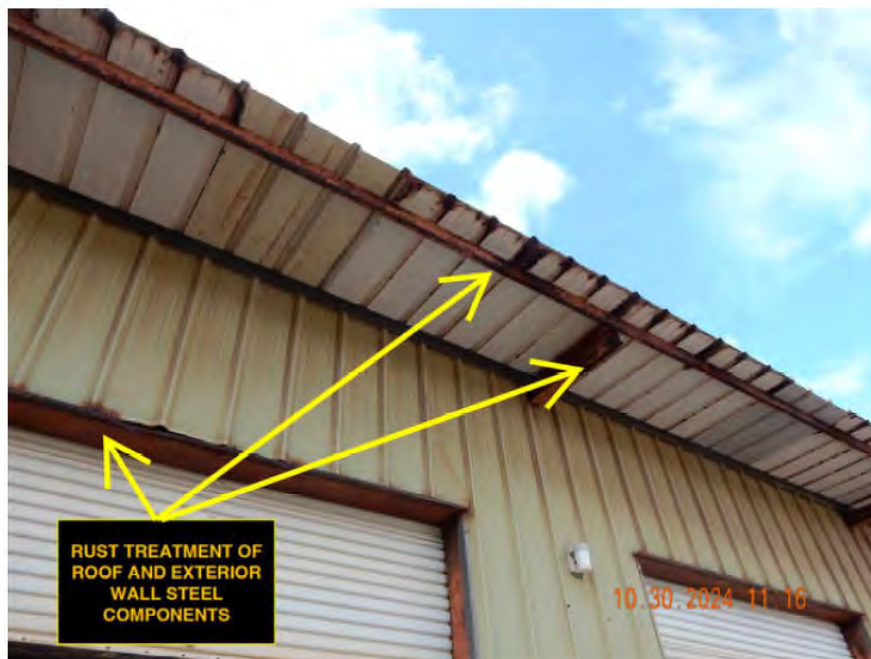
HCA observed that the majority of steel roof and exterior wall components are rusting and should be treated to preserve the life of the roof and walls.

Figure 67. Rusting roof and exterior wall steel components (DSCN3757).

Recommend setup of routine rust treatment program for all exterior building components.

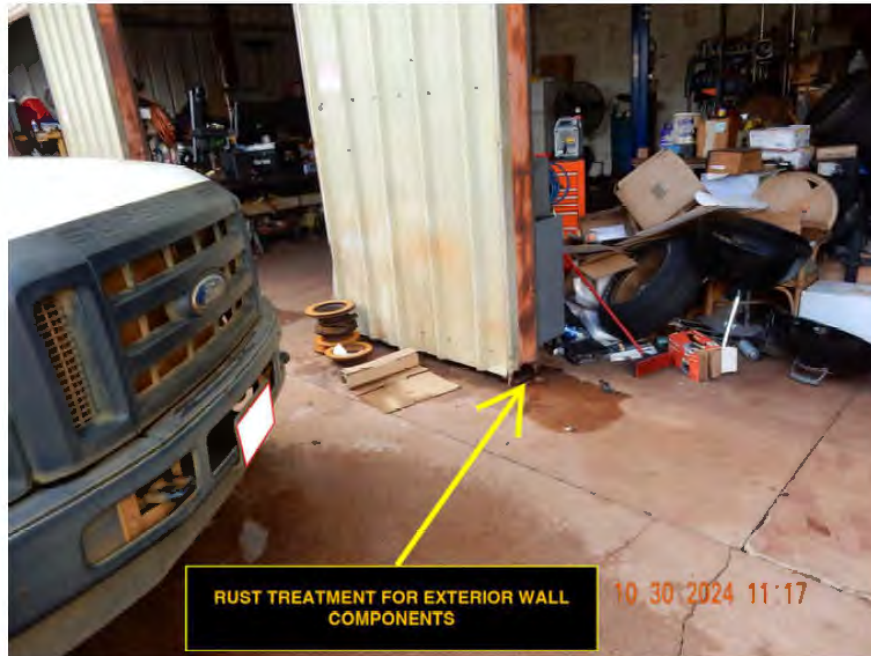
Figure 68. Rusting exterior wall steel components (DSCN3760).

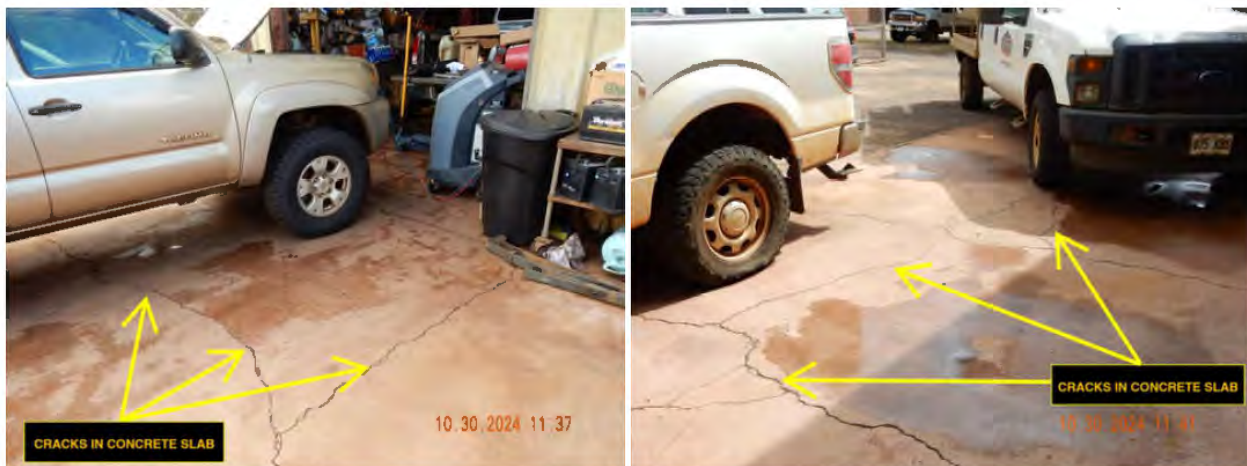
HCA observed that the concrete slab between Building #1 and Building #2 has numerous cracks. Recommend that the cracks be filled in to prevent motor vehicle fluids from leaching into the ground and becoming a possible storm water runoff pollutant.

Figure 69 & 70. Cracks in concrete slab (DSCN3856 & DSCN3871).

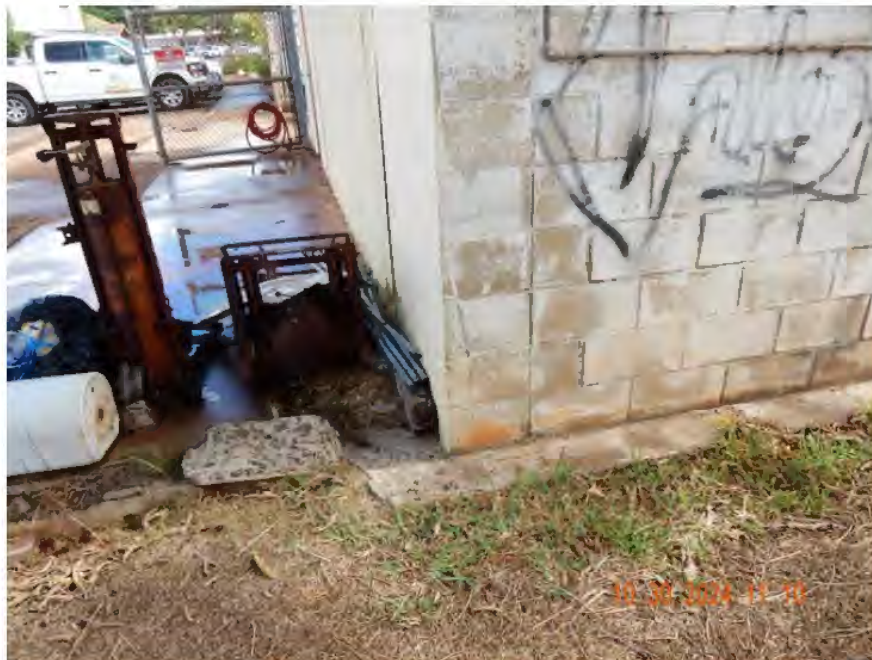
Figure 71. Unwanted materials around building (DSCN3726).

Recommend that all outside stored fluid drums / containers, etc. be continuously checked for coverage and leaks. Make sure all stored fluid drums / containers have secondary containment. Review County of Kauaʻi storm water run-off policies to protect the property and the environment. Unwanted materials around the building should be routinely removed from the property to help prevent damage to concrete slab and building. And recommend routine rust treatment and/or replacement of exterior roof and wall rusted materials.

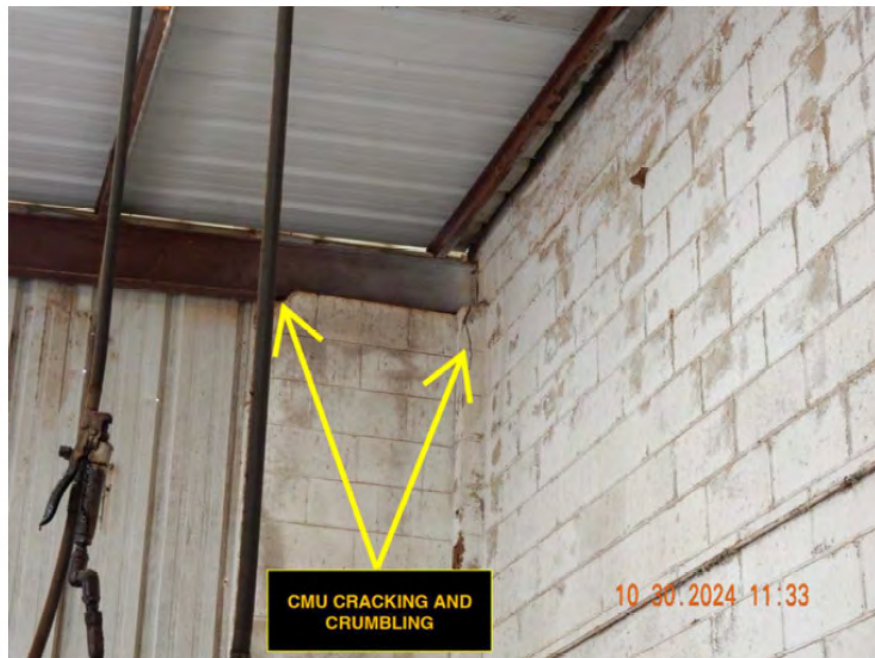
HCA observed interior CMU cracking and crumbling where the end of a structural I-beam sits. HCA recommends that the CMU be repaired to prevent further cracking and crumbling and to prevent a possible structural issue in the future.

Figure 72. CMU cracking and crumbling at a structural point (DSCN3828).

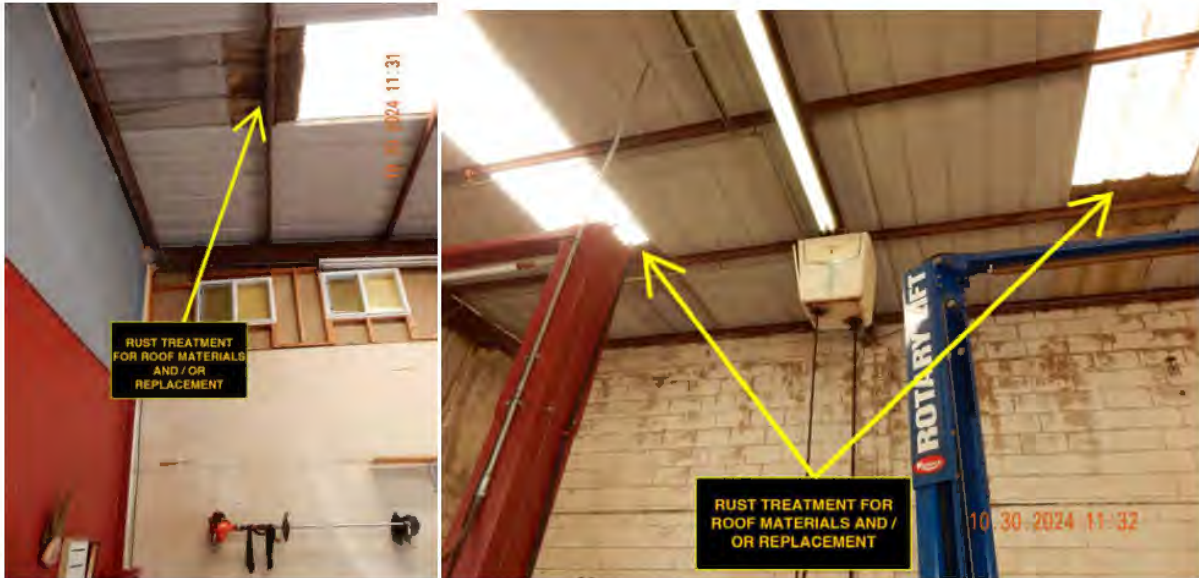
HCA observed that several roof panels next to sky lights are rusted and should be either rust treated and/or replace.

Figure 73 & 74. Rusted roof panels (DSCN3815 & DSCN3824).

Recommend routine rust treatment and/or replacement of interior roof and wall rusted materials.
