PSF No.: 24MD-103
Maui

Grant of Term, Non-Exclusive Easement, Immediate Right-of-Entry and Revocable Permit to Association of Apartment Owners of Paki Maui for Seawall, Stairs, and Metal Railing; Grant of 60-Day Right-of-Entry to Association of Apartment Owners of Paki Maui for Removal of Unauthorized Stairs, Wailuku, Maui, Tax Map Key: (2) 4-4-001: seaward of 050 and 051.

Sea Engineering, Inc.

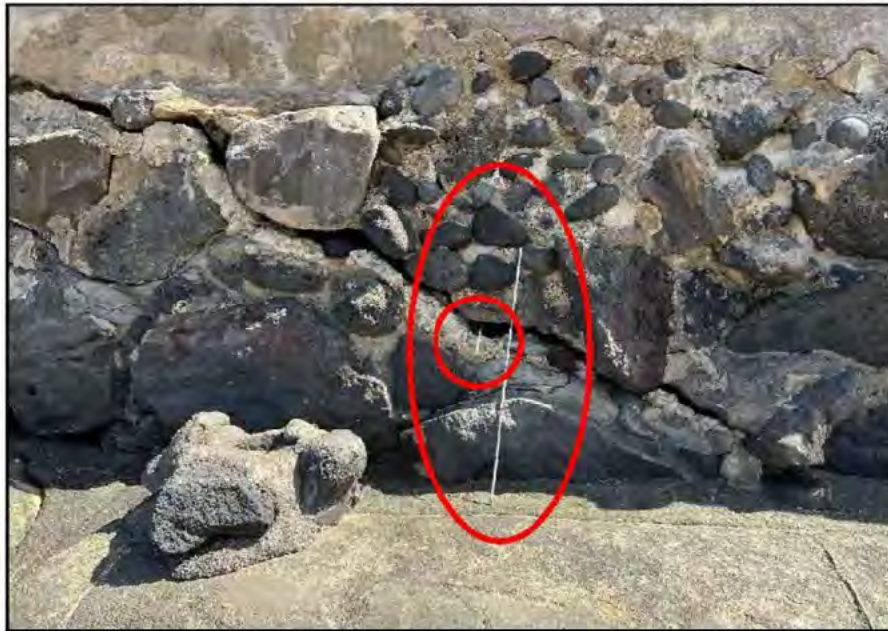
Figure 7. Diagonal crack in wall above concrete/mortar bags, 3-foot survey rods (circled in red) one inserted into crack to an approximate depth of 2 feet

- The south stairway appears to have settled and was closed for use at the time of the site visit (Figure 6).
- Diagonal and horizontal cracks were observed in the wall with downward sagging of the top of the wall (Figure 7). Horizontal and diagonal cracking and separations in the wall appear to be due to settlement due to lack of support at the toe of the wall due to scouring of the sand and undermining of the wall.

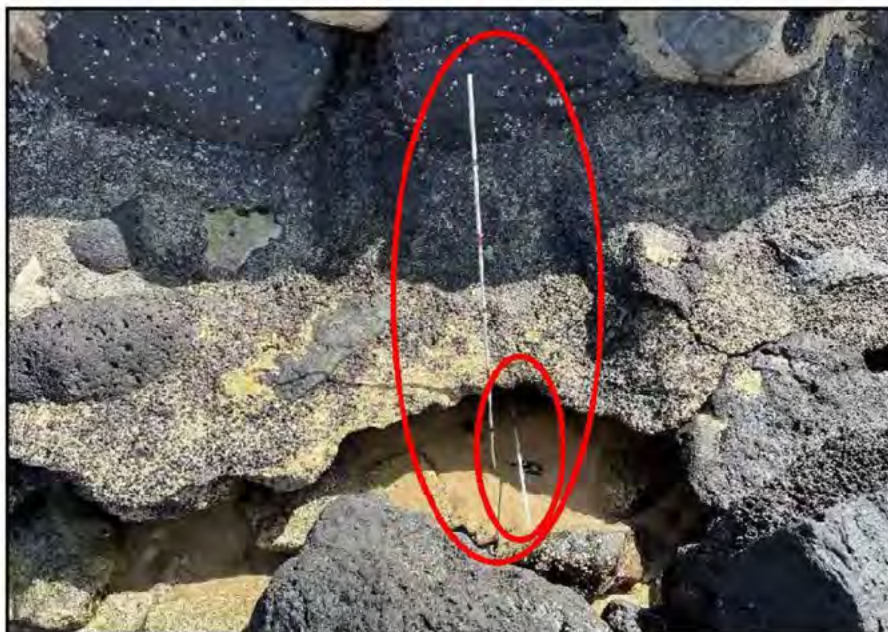
Figure 8. North section of wall undermining, 3-foot survey rods (circled in red)

- The north section of the wall is undermined. Probe measurements indicate that the undermining extends up to 3ft inshore of the seawall in some locations with a maximum undermined height of about 1 ft (Figure 8 and Figure 9). At one location, a soft foam was observed behind the CRM wall with a 3-foot survey probe (Figure 10).

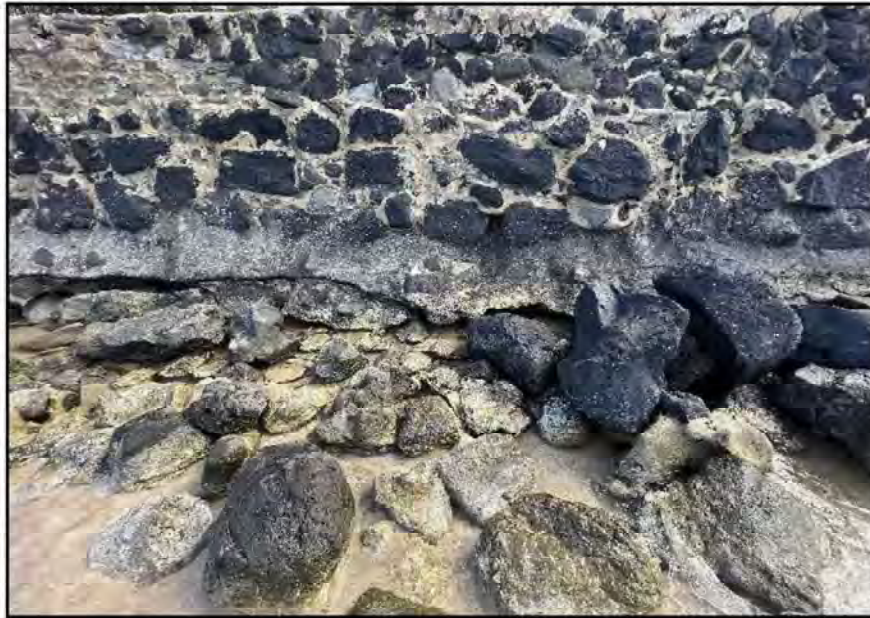
Figure 11. Stones at the base of the wall with various stages of mortar and grout conditions

- Some of the stones at the base of the wall have broken off and displaced down and outward onto the shoreline seaward of the seawall (Figure 11).
- Portions of the wall mortar and grout appear to have been repaired more than once and some is abraded (Figure 11). Missing and abraded mortar appears to be due to abrasion from wave action.

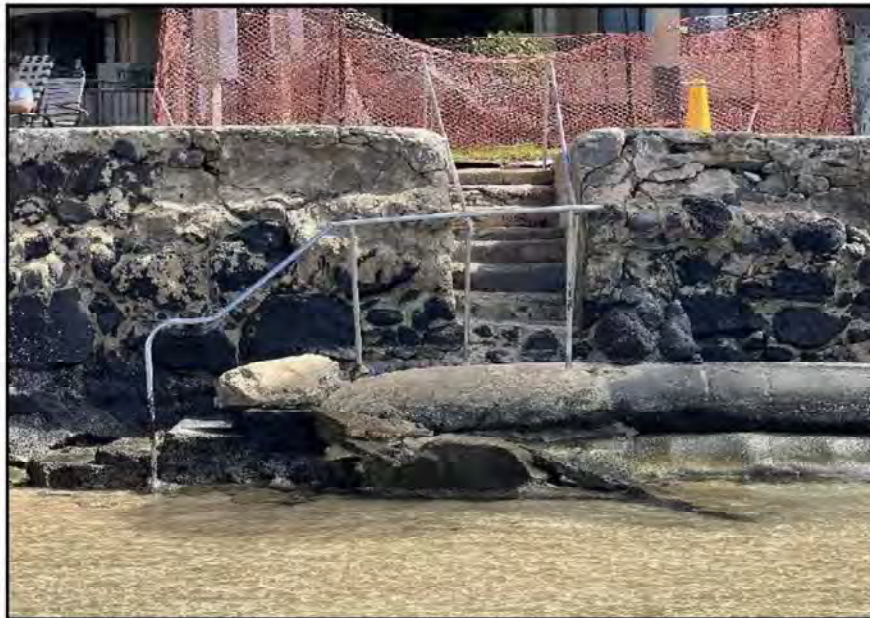
Figure 12. Concrete/mortar bags located on the north end with undermining at the toe

- The concrete/mortar bags located on the north end show signs of undermining at the toe at least 1 to 2 feet with a height of a few inches (Figure 12).

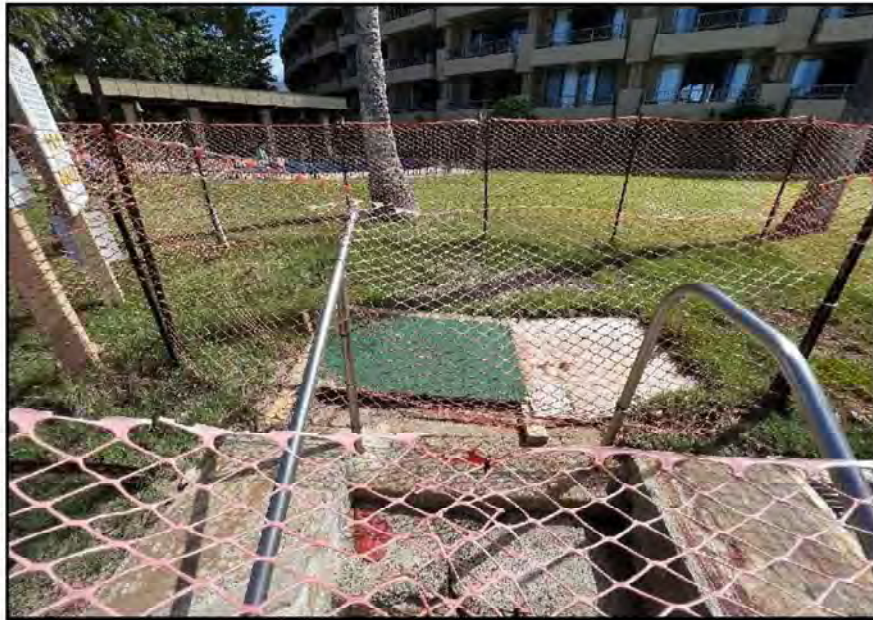
Figure 13. Covered sinkhole at top of north stairway

- Sinkholes are present at two locations landward of the seawall on the northern section of the wall. Access to these locations was restricted with temporary fencing and covered with plywood at the time of the site visit (Figure 13 and Figure 14). Sinkhole formation appears to be due to the undermining and resulting leaching out of soil and sand below the base of the undermined wall.
