Mutual Early Cancellation of One-Year Holdover of General Lease No. S-4310, Alumside Products, Inc., Lessee, for Industrial Purposes, Hilo Industrial Development, Pohaku Street Section, Waiakea, South Hilo, Hawaii, Tax Map Key: (3) 2-2-058:031.

GLS-4310 ALUMSIDE PRODUCTS, INC. – PRE-EXIT INSPECTION PHOTOS 3/12/2025

**GLS-4310 ALUMSIDE PRODUCTS, INC. – FINAL INSPECTION PHOTOS 10/31/2025**

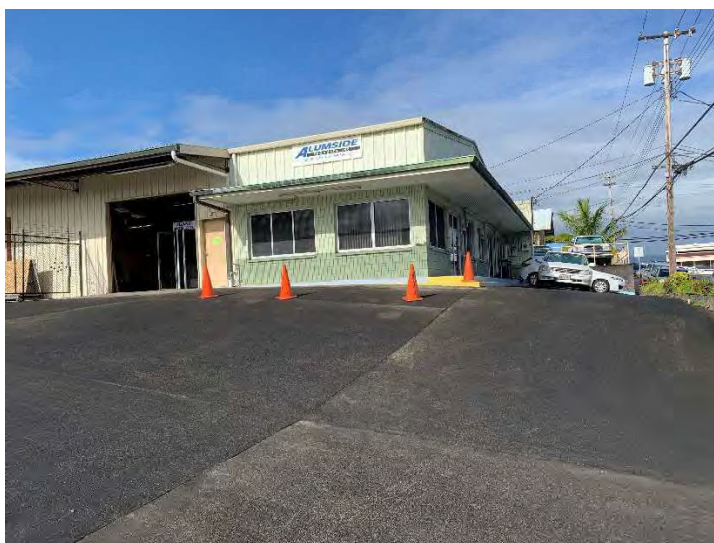
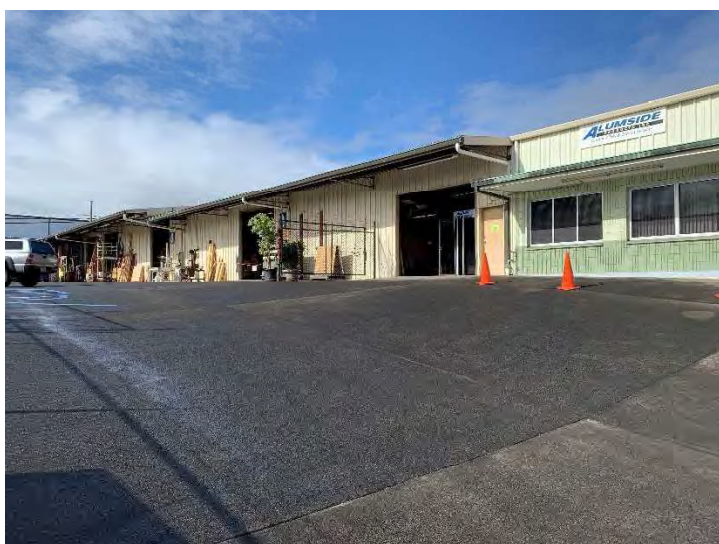
VIEW SHOWING LENGTH OF BUILDING WITH ALL 5 BAY DOORS AND PARKING/LOADING AREA.

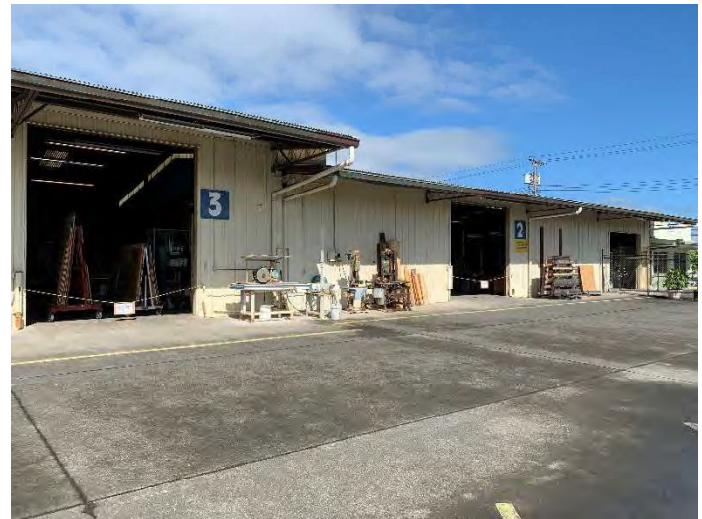
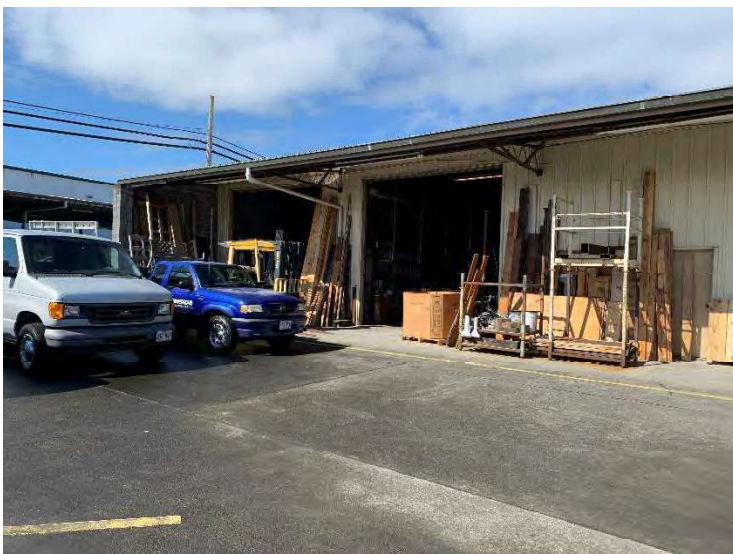
LAST TWO BAY DOORS SHOWING THE  
END OF THE ADDITION.

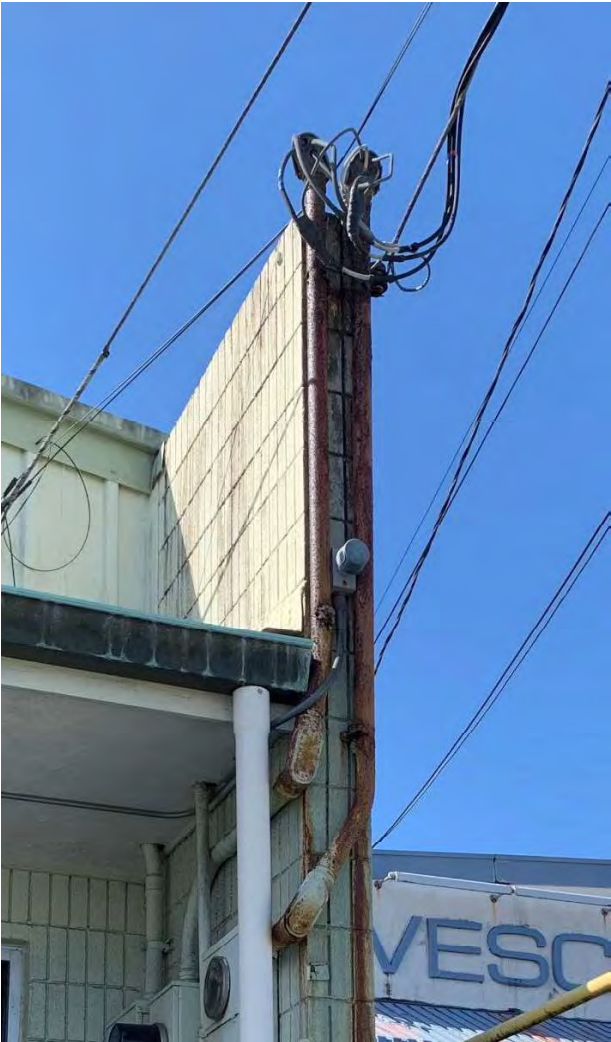
| ITEM | SATISFACTORY? | | | COMMENTS/NOTES |
|---|---|---|---|---|
| Electrical | | | | The HELCO electrical service mast is in very poor condition and will need to be replaced. |

The electrical service mast is very badly rusted. HELCO will be contacted to determine if the mast needs immediate replacement or if it can wait.

CORRODED ELECTRIC SERVICE MASTHEAD

| ITEM | SATISFACTORY? | | | COMMENTS/NOTES |
|---|---|---|---|---|
| <p>Other:</p> <p>Property is in excellent condition. Recommend putting out for auction as soon as possible.</p> <p>Note: Electrical weather-head will need to be replaced in the near future – however, HELCO says OK for now.</p> | | | | |

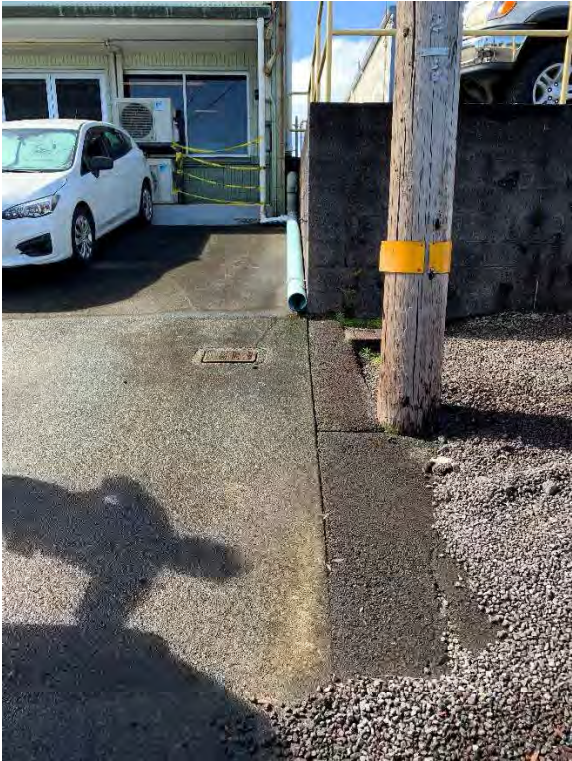
| ITEM | SATISFACTORY? | | | COMMENTS/NOTES |
|---|---|---|---|---|
| Roof Drainage | | | | On west side of property is a 6" pvc pipe that collects water from half of the roof and half of the neighboring building's roof (also State land). This drain line directs the water out to the street preventing water intrusion into this property. |

SHARED ROOF DRAINAGE TO STREET

In this section of the Kanoelehua industrial lots, the properties are stair-stepped down the natural grade of the land where the property on one side is higher in elevation and the property on the other side is lower in elevation. This can result in water drainage problems such as flooding, erosion and seepage through concrete walls. To address the problem, this property and the property above have utilized a shared 6" drainage pipe to collect roof runoff and direct the flow downslope to the lower elevation roadway. This method does not pose drainage problems for other properties in the area and seems to be a good solution.

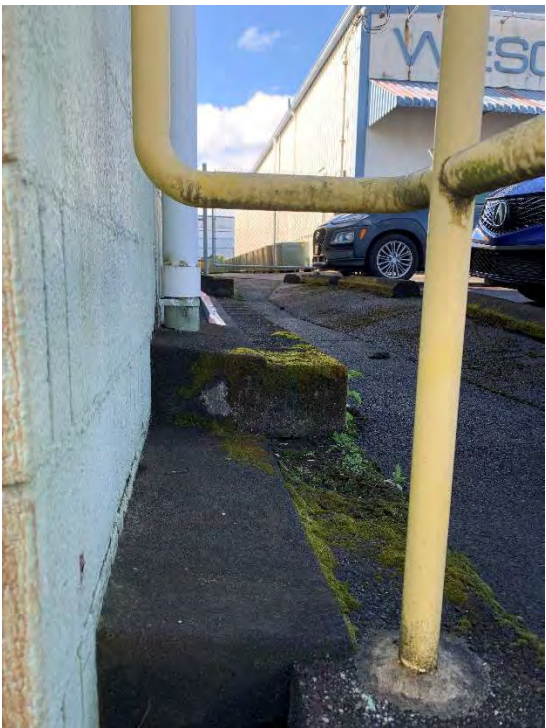
PROPERTY BOUNDARY BETWEEN PARCELS. DOWNSPOUTS FROM BOTH BUILDINGS TIE INTO THE ONE DRAIN CONDUIT.

NOTE THE HEIGHT DIFFERENCE BETWEEN PROPERTIES. WITHOUT SHARED DRAIN WATER WOULD TEND TO SEEP THROUGH CMU WALL OF SUBJECT DOWNSLOPE PROPERTY.

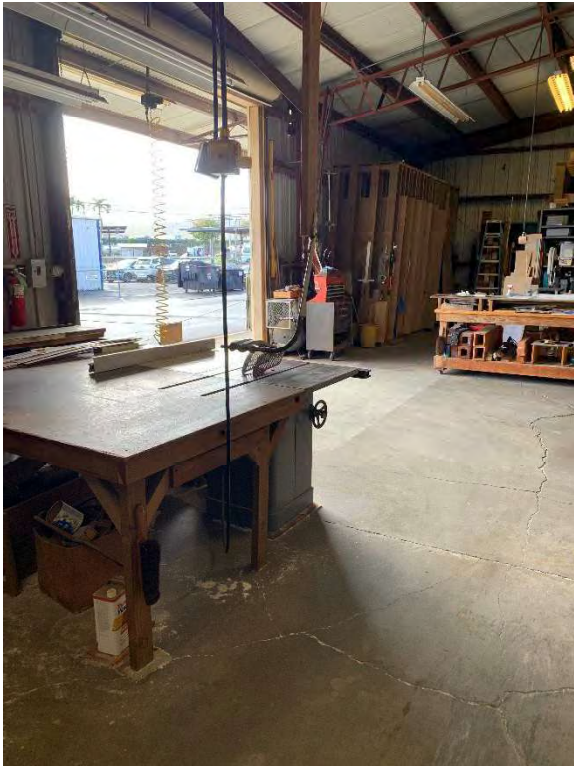
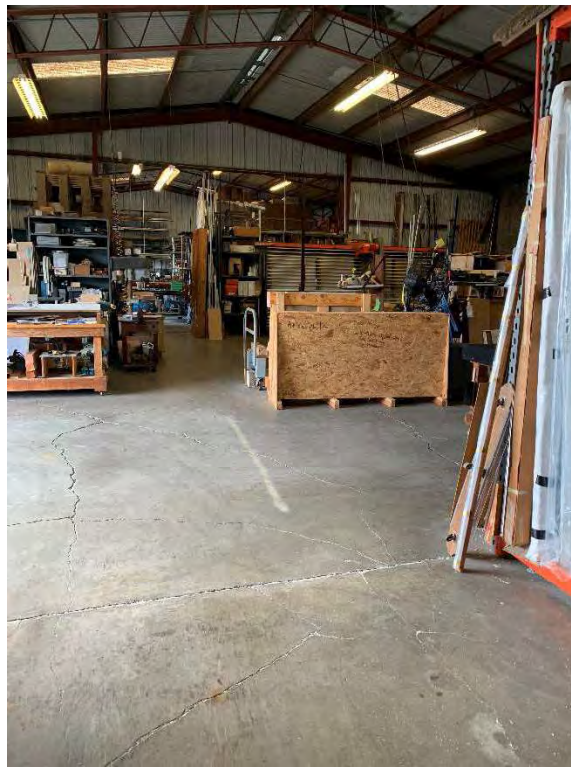
| ITEM | SATISFACTORY? | | | COMMENTS/NOTES |
|---|---|---|---|---|
| Warehouse floor | | | | There are large stress cracks in the warehouse concrete floor from loaded forklift use. The cracks do not appear to extend to the building foundation and are not buckling or separating. |

The cracks in the warehouse floor appear to be from heavily loaded forklift traffic. The lessee is a window and screen manufacturer and moves a lot of heavy glass and windows in and out of the warehouse. The cracks are restricted to the area inside one of the entrance bay doors. The floor is level and no buckling or collapsing was noted in or around the cracks. Appears stable and not effecting the structure of the building.

VIEW OF BACK OF ORIGINAL WAREHOUSE. NOTE STRESS CRACKS IN FLOOR. WALL IN BACKGROUND IS END OF ORIGINAL WAREHOUSE

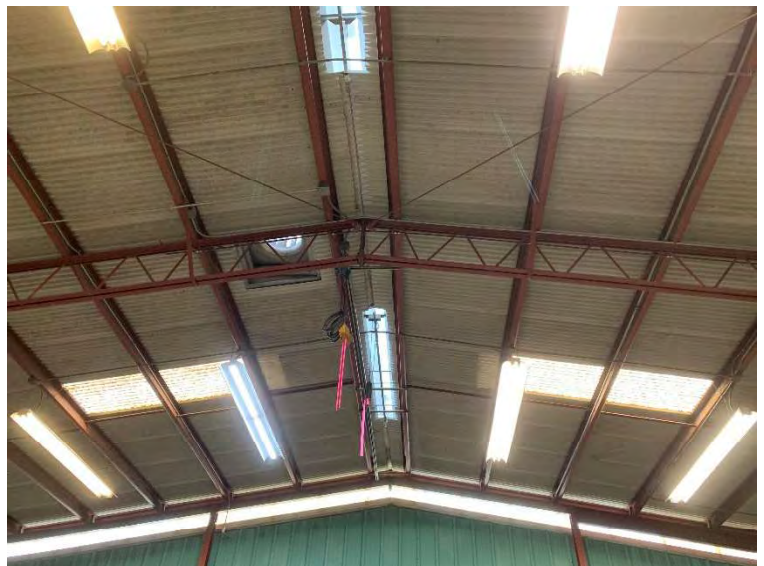
TYPICAL ROOF  
SECTION SHOWING  
GOOD CONDITION
