# Manta Ray Viewing Boating Operations and Safety Assessment

*Prepared for the Hawaii Coral Reef Initiative Research  
Program (HCRI-RP) on September 6th, 2015*

**by Marine Science Consulting LLC**

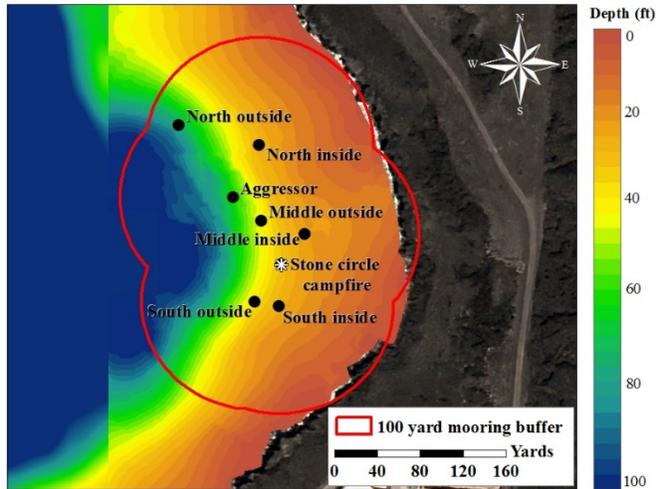
Figure 8. Map of the Makako Bay manta viewing site and the day-use mooring locations – both official and unofficial. The red outline indicates the 100 yard perimeter surrounding the official day-use moorings.

At Makako Bay, seven moorings with subsurface floats are used on a nightly basis (Figure 8, Table 1). Five are anchored using double pins, one (north inside) is anchored with a single pin, and one (north outside) is secured to a large boulder via chains (Figure 9). The north outside mooring is not a U.S. Army Corp of Engineers (USACE) permitted mooring. These moorings are located in close proximity and surround the circle of rocks known as the stone circle “campfire” where scuba divers place lights and sit on the seafloor to view manta rays (Figure 8). The campfire is the primary manta ray viewing site for scuba divers in Makako Bay.

Given the number of vessels compared to available moorings, at least 2-3 vessels simultaneously use each mooring on a nightly basis. The boats are attached end-to-end (“daisy chained”) to each other. Given that the number of vessels observed at Makako Bay during this study was well short of its peak activity, the number of vessels per mooring likely increases on busier days. Due to the limited number of moorings and space constraints, vessels also commonly anchor nearby (within 100 yards of the moorings). Some vessels, particularly smaller boats arriving after dark, do not moor or anchor but “live boat” throughout the duration of the night. These boats typically drop-off and pick-up snorkelers near the campfire and wait offshore in the interim.

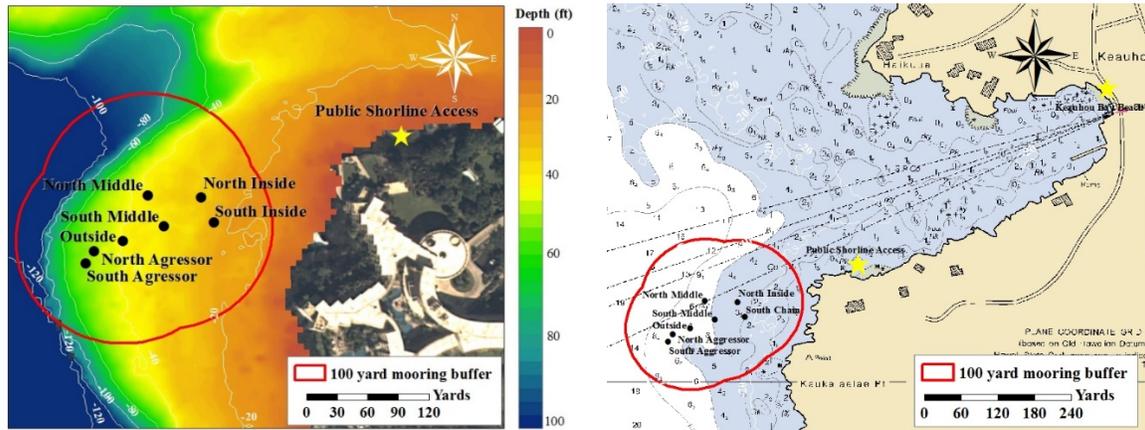
At Keauhou Bay, there are seven moorings but only four have subsurface floats. Three are anchored using double pins, one (inside north) is anchored with a single pin, and three (Aggressor north, Aggressor south, south chain) are anchored to large boulder via chains (Figure 10, Table 1). The three chain moorings do not have subsurface floats and are not USACE permitted moorings. Additionally, the south chain mooring is not secure and consists of a chain loosely looped over a boulder (Figure 11). The

Keauhou moorings are located in close proximity to the boat channel which is actively used throughout the day and night by vessels not associated with the manta ray viewing operations.

accident to occur due to **(a)** and **(b)**, especially on the busiest days. Additionally, the spatial proximity of the Keauhou manta viewing site to an active boat channel increases the likelihood of an accident ([Figure 10](#)).

During the night-time observation periods, unrelated vessels exiting and entering the Keauhou harbor at high speed avoided the manta ray viewing area where most moored/anchored vessels were well lit. This behavior contrast to day-time activity when vessels commonly transit over the day-use moorings at high speed when entering & exiting the Keauhou boat harbor. However, on one night multiple groups of swimmers associated with lighted rafts were observed following manta rays well into the boat channel (north of the North Middle mooring) as defined by the NOAA nautical chart ([Figure 10](#)).
