Kuualii Fishpond Tsunami Damage Restoration

Anaehoomalu Bay, Waikoloa, South Kohala, Hawaii

Revision 1

October 2015

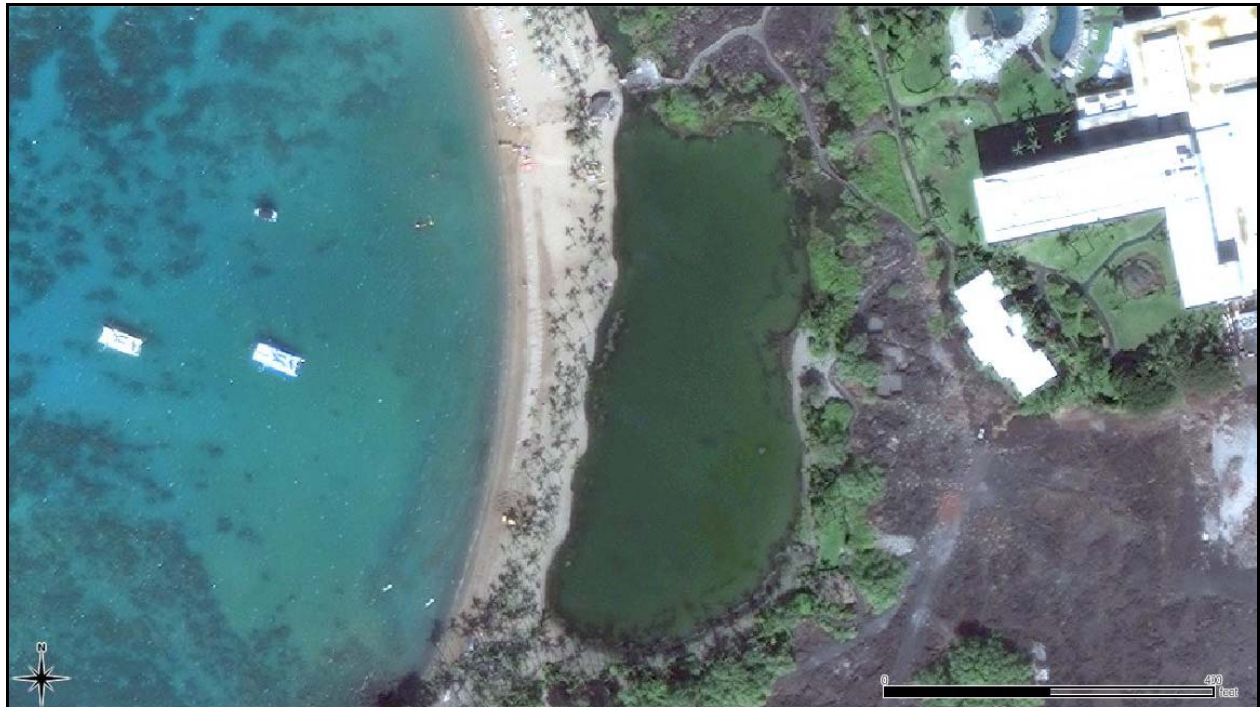
Figure 1-4 Satellite Image of Waikoloa Beach, 10 November, 2010

The pre-tsunami beach size and configuration has been estimated using the November 10, 2010 satellite image (Figure 1-4). Overlaying this on the post-tsunami topographic survey an estimated 9,000 cubic yards (cy) of sand was removed from the beach during creation of the breach and other tsunami damage. The majority of beach sand loss due to the tsunami occurred in the immediate vicinity of the breach; however sand loss lowered the beach crest elevation about 1-foot along virtually the entire length of the beach.

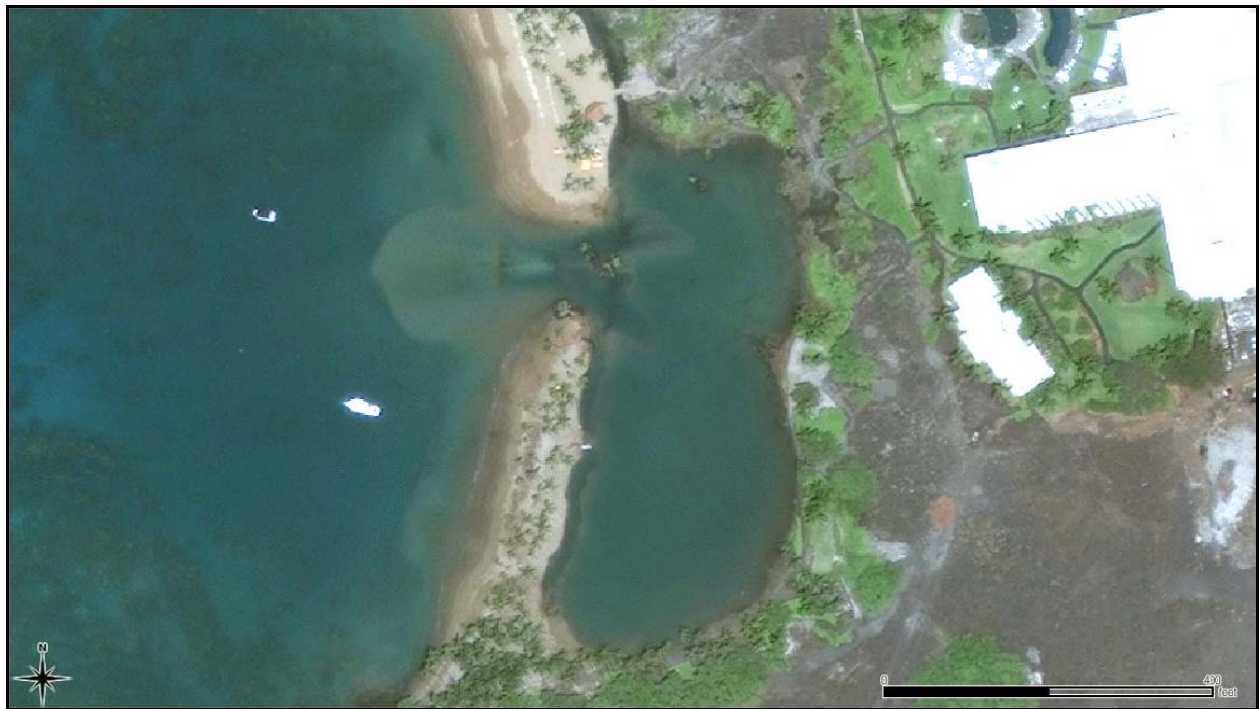
Figure 1-5 Satellite Image of Waikoloa Beach, 11 March, 2011

As shown on Figure 1-5, the tsunami created a wide breach all the way through the beach and the rock fishpond wall. Sand was both pushed into the pond on both sides of the breach, and moved directly offshore to form a mound immediately seaward of the breach. A survey made on March 21, three weeks after the tsunami, showed the breach to be about 100 feet wide at the mean lower low water (mllw) elevation. A detailed site topographic survey on April 12, 2011 showed the breach to be about 160 feet wide. The post-tsunami beach condition based on the April topographic survey is shown on Figure 2-1. During the three month period required to obtain all the necessary approvals for the emergency repair of the breach, wave action continued to enlarge the breach and scour sand from the remaining beach on both sides and move it into the pond. By the time the emergency repair was accomplished in the first week of August the breach was about 200 feet wide. The damage due to the immediate effects of the tsunami combined with the continuing damage during the permit phase of the emergency breach repair, resulted in the beach being significantly lower in elevation and narrower than it was pre-tsunami. The beach crest is presently about +3 feet mean lower low water (mllw). [Note: all elevations are referenced to the mllw datum.] The beach width above mean higher high water (mhhw) is presently about 50 to 70 feet along the southern half and 80 to 100 feet at the north end.

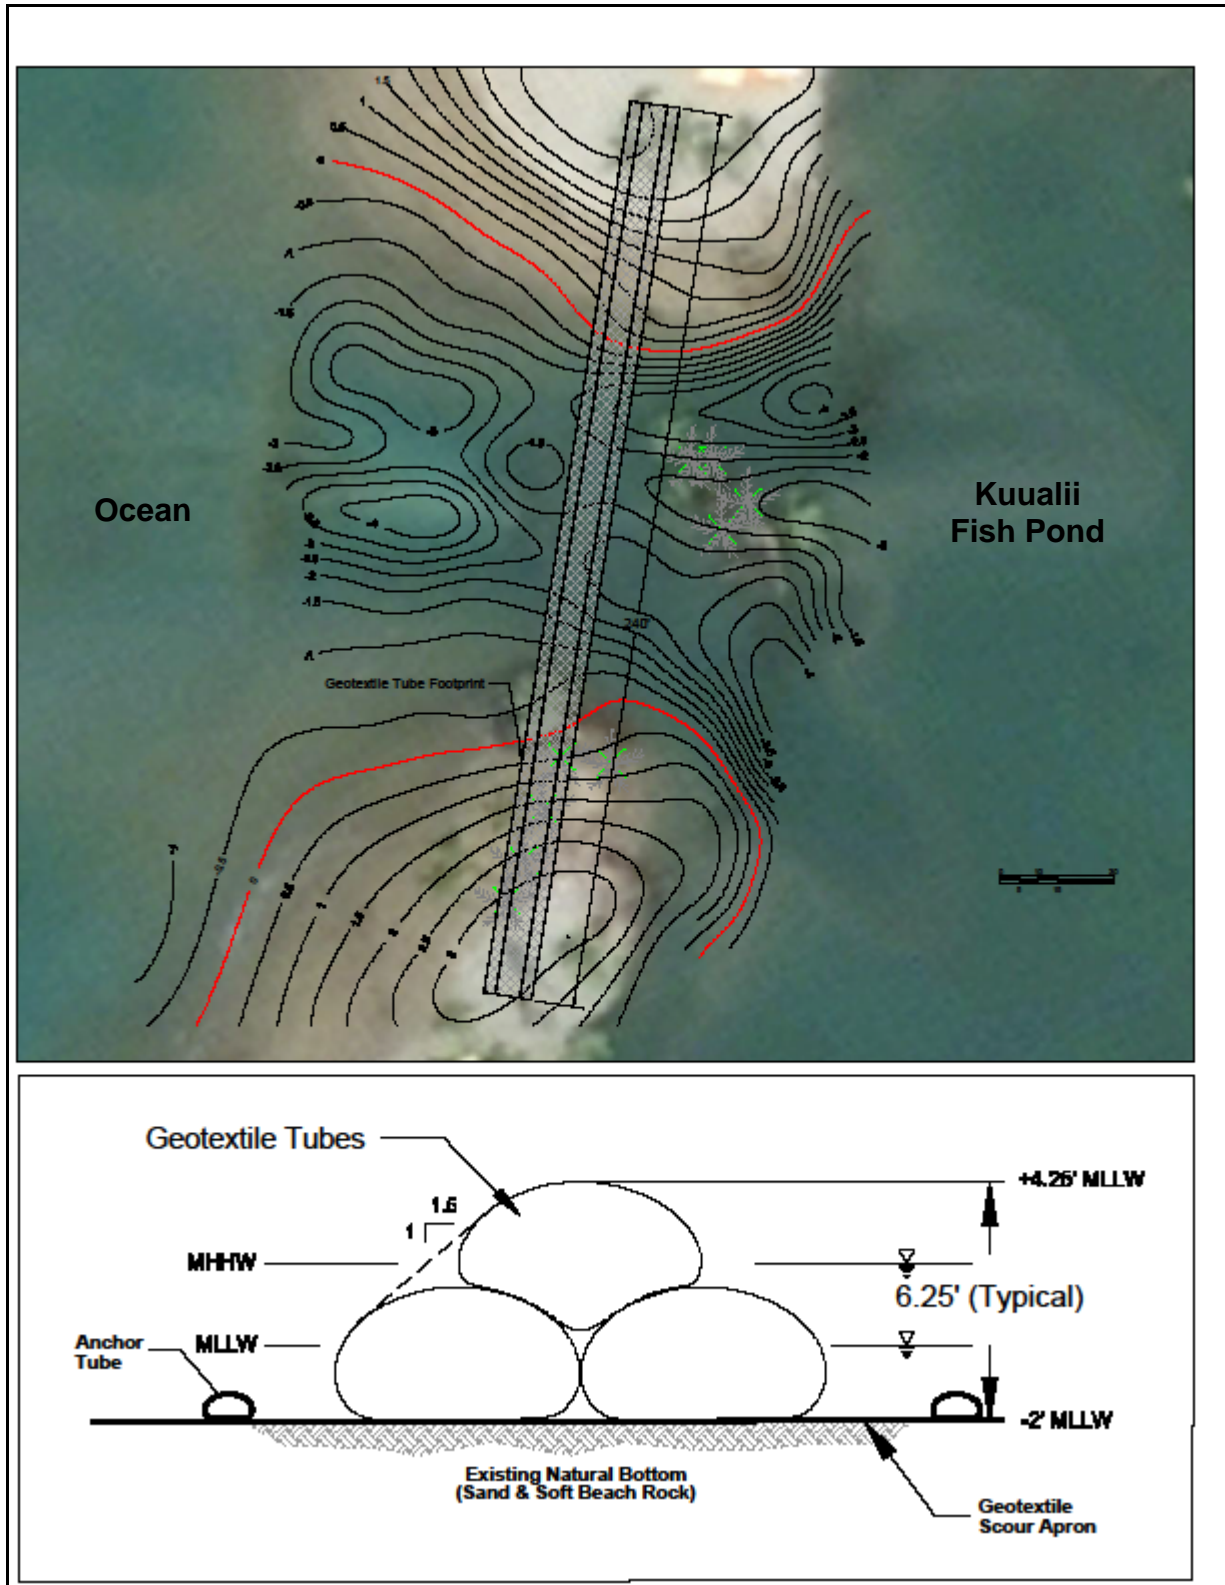
Figure 1-8 Plan View and Cross Section of Emergency Repairs

The gap in the beach resulted in continuing sand infill into the pond by wave action. Various permits issued by the County, State and U.S. Army Corps of Engineers (USACE) during development of the resort require the maintenance and preservation of the pond, and thus a request for emergency repair of the beach was made by the WBA to the County Planning Department, the State Department of Land and Natural Resources (DLNR), and the USACE on March 28. After the final necessary approval was granted on July 7, repair work was initiated on July 25, and completed on August 3. The temporary emergency repair plan consisted of installing sand filled geotextile tubes to close the gap in the beach. The completed emergency repair work is shown on Figure 1-7. Plan and section views of the repair plan are shown on Figure 1-8. During the three month period required to obtain all the necessary approvals for the emergency repair work, wave action continued to enlarge the breach in the beach, scour sand from the remaining beach on both sides of the breach, and move sand into the fishpond. Consequently, when emergency repair work was finally able to start, the damage to the beach was considerably greater than it had been immediately after the tsunami. This resulted in the need for geotextile tubes with a total length of 240 feet to completely close the gap.

Emergency repairs used sand which had been pushed into the pond on either side of the breach to both fill the tubes and anchor them by creating a minor beach berm on their mauka side. Currently there are six (6) 120 foot long by 15 foot circumference sand filled tubes placed across the breach section to form a 240-foot-long barrier, stacked in a two tubes on the bottom and one on top configuration. Mauka of the tubes is an approximately 25 foot wide sand berm separating them from Kuualii fishpond. The post-emergency repair beach configuration is shown on Figure 2-2.

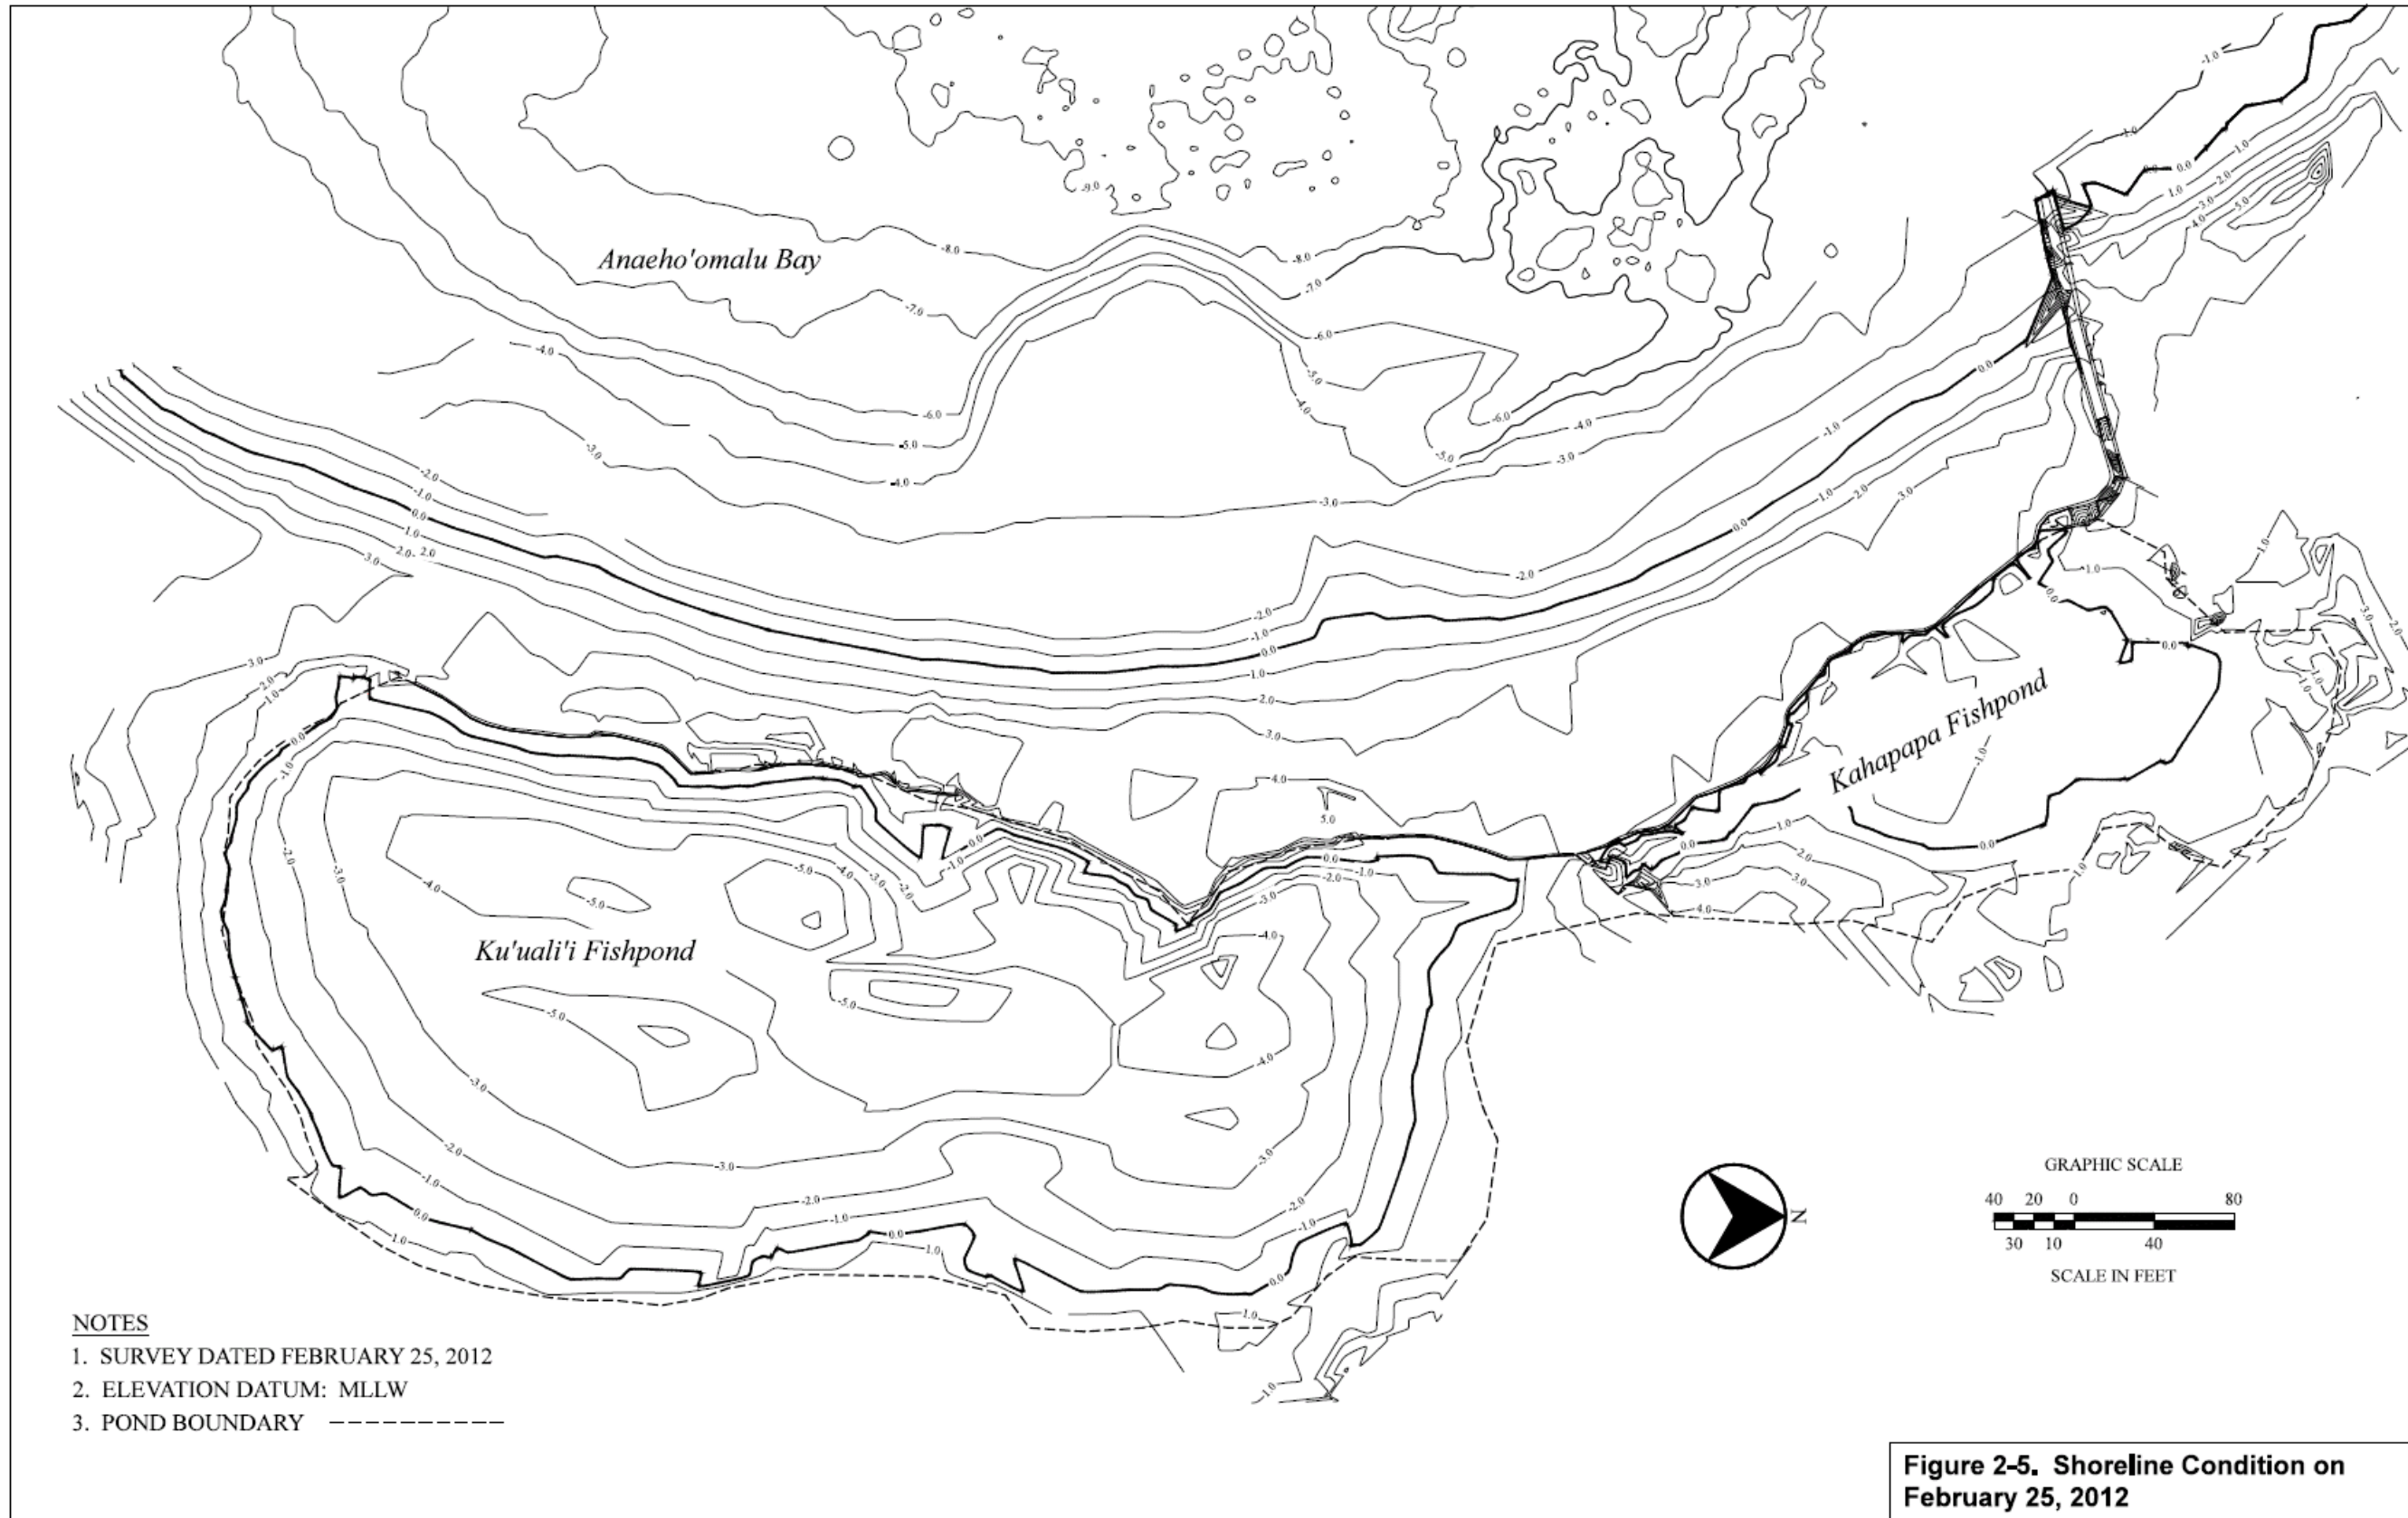
Figure 2-5 Shoreline Condition on February 25, 2012

The emergency repairs removed much of the sand in-fill from the pond in the vicinity of the breach to fill the geotubes, however an estimated 800 cy of sand remains to be removed and could be placed on the beach.

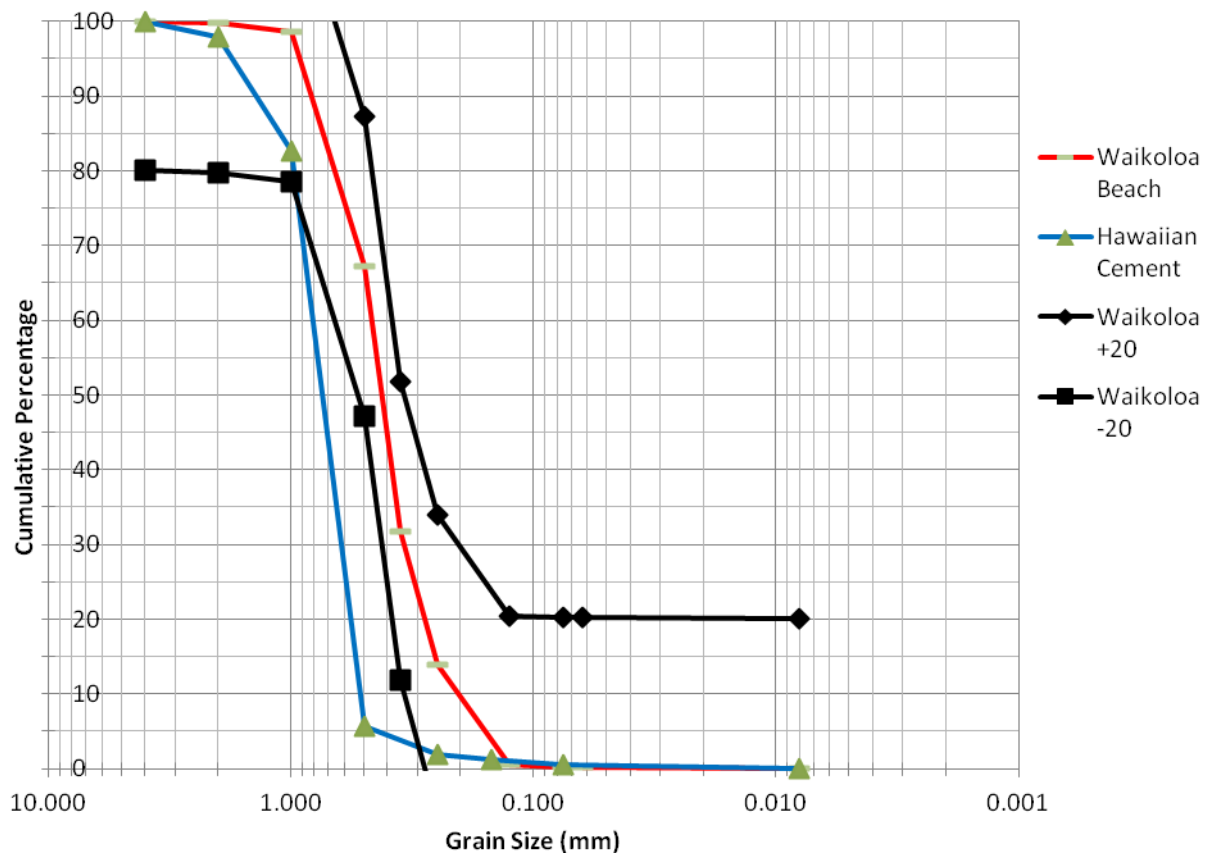
Figure 3-5 Grain size distributions for Waikoloa beach and Haleiwa sand (Hawaiian Cement) samples

The grain size distribution, by weight, comparison shows that the existing beach sand is finer than the proposed beach fill sand. The difference is greater than 20% in the coarse to medium grain sizes. Though this sediment will be placed higher on the beach profile, in the subaerial region, the purpose of the beach restoration project is to stabilize the dune and provide overwash protection to the fishpond. The slightly larger grain size of the fill sand (predominantly coarse grain size), compared to the mostly medium grain sized existing sand, will provide this additional stability without sacrificing either beach performance or aesthetics.

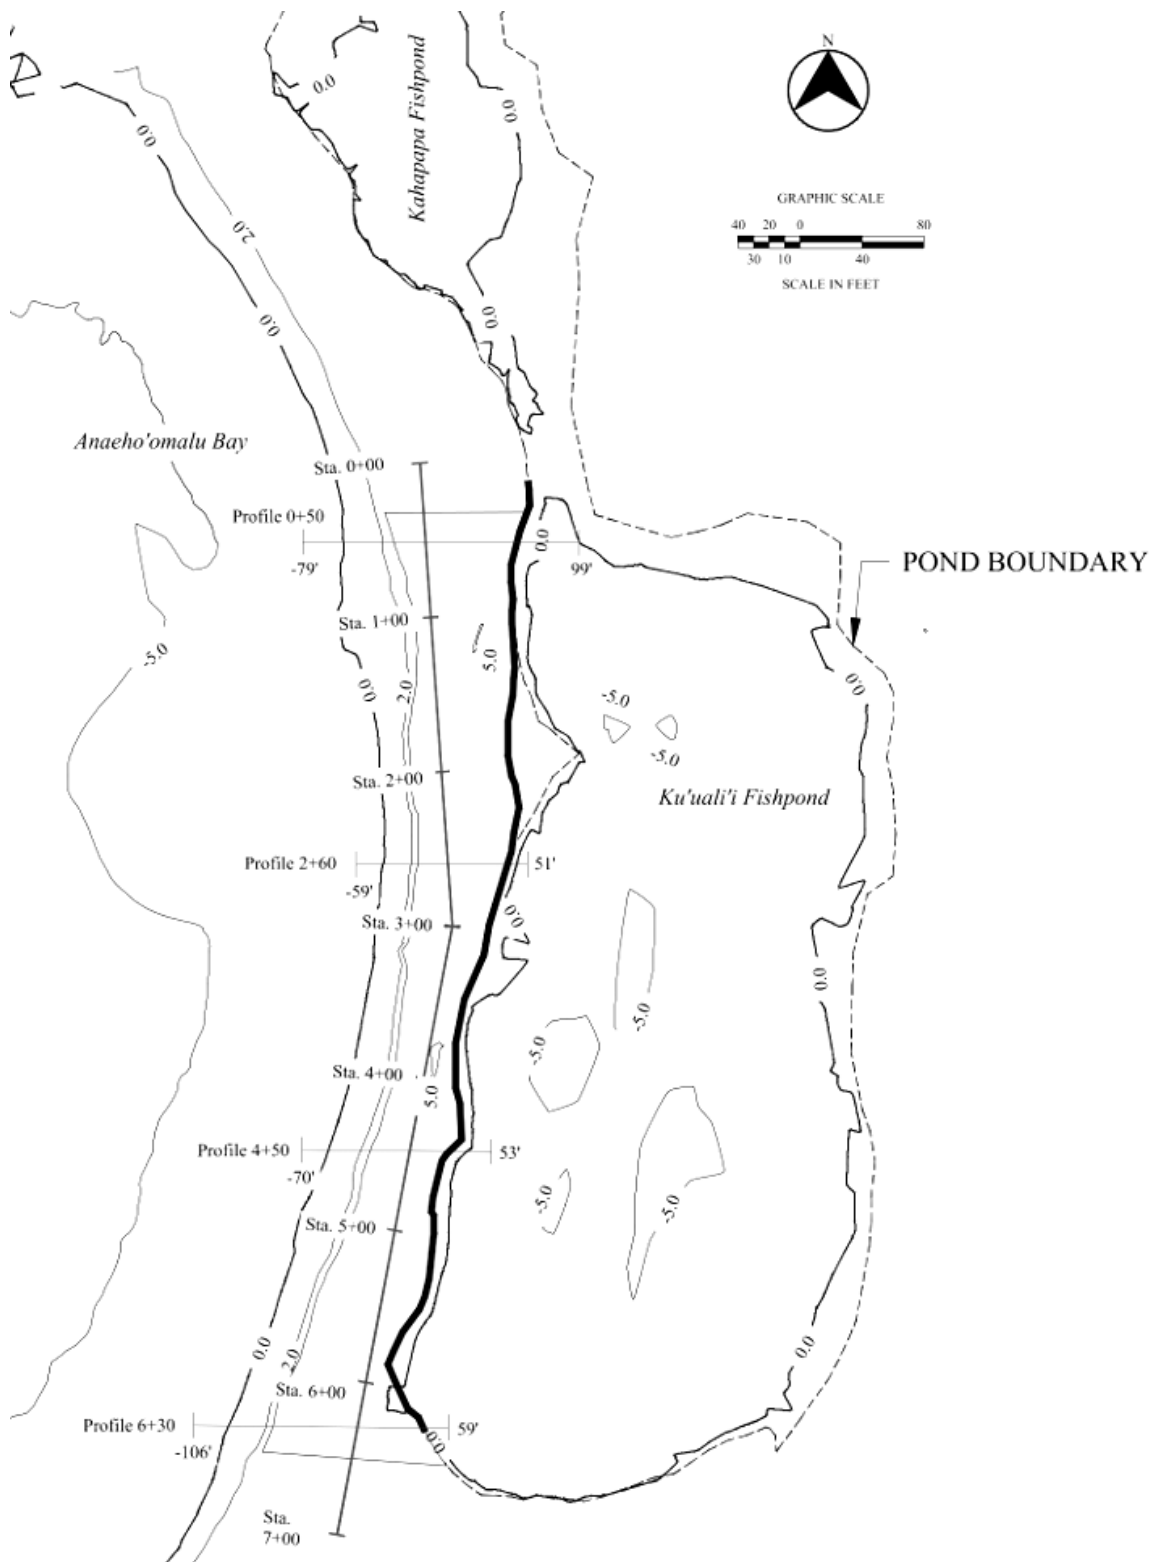
Figure 3-6 Project area map showing profile locations

Beach berm restoration will cover a total area of **37,200** square feet, or **0.85** acres. The entire project area is within TMK (3) 6-9-007:011. Locations of representative beach profiles are shown in Figure 3-6. Representative beach profiles are shown in Figure 3-7.

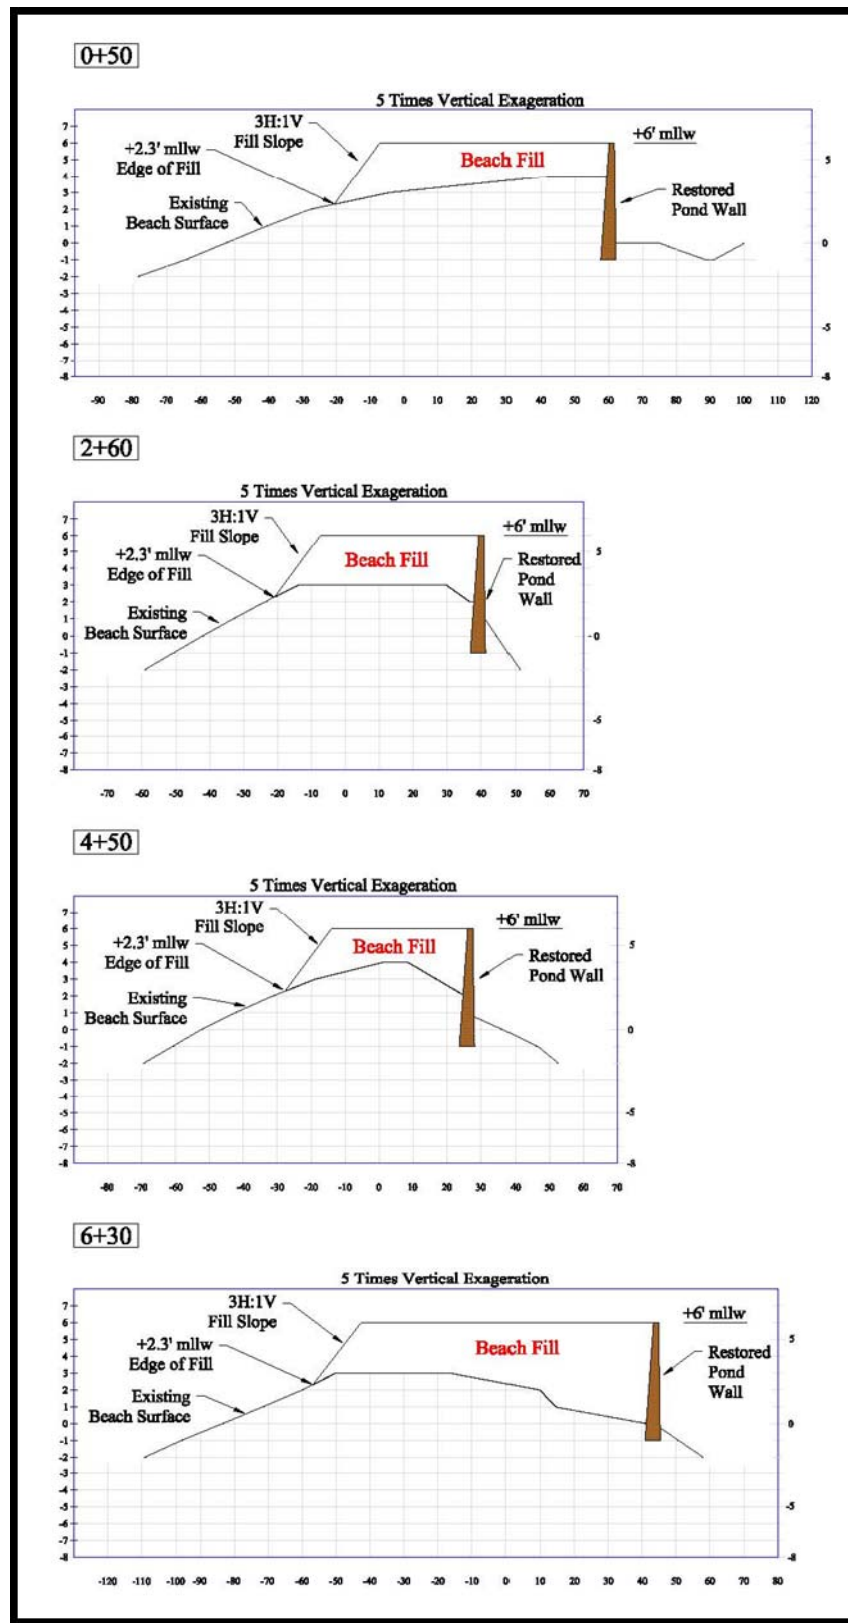
Figure 3-7 Berm restoration profiles showing existing and finished ground elevations

Centerline length down the berm, in the area of the beach restoration, is **approximately 620 feet**. Average berm width in the restoration **area is 65 feet**.
