Tantalus-Round Top Drive Corridor Management Plan

Honolulu Ahupua'a, O'ahu, Hawai'i

Prepared By:
Planning Solutions, Inc.

December 2019

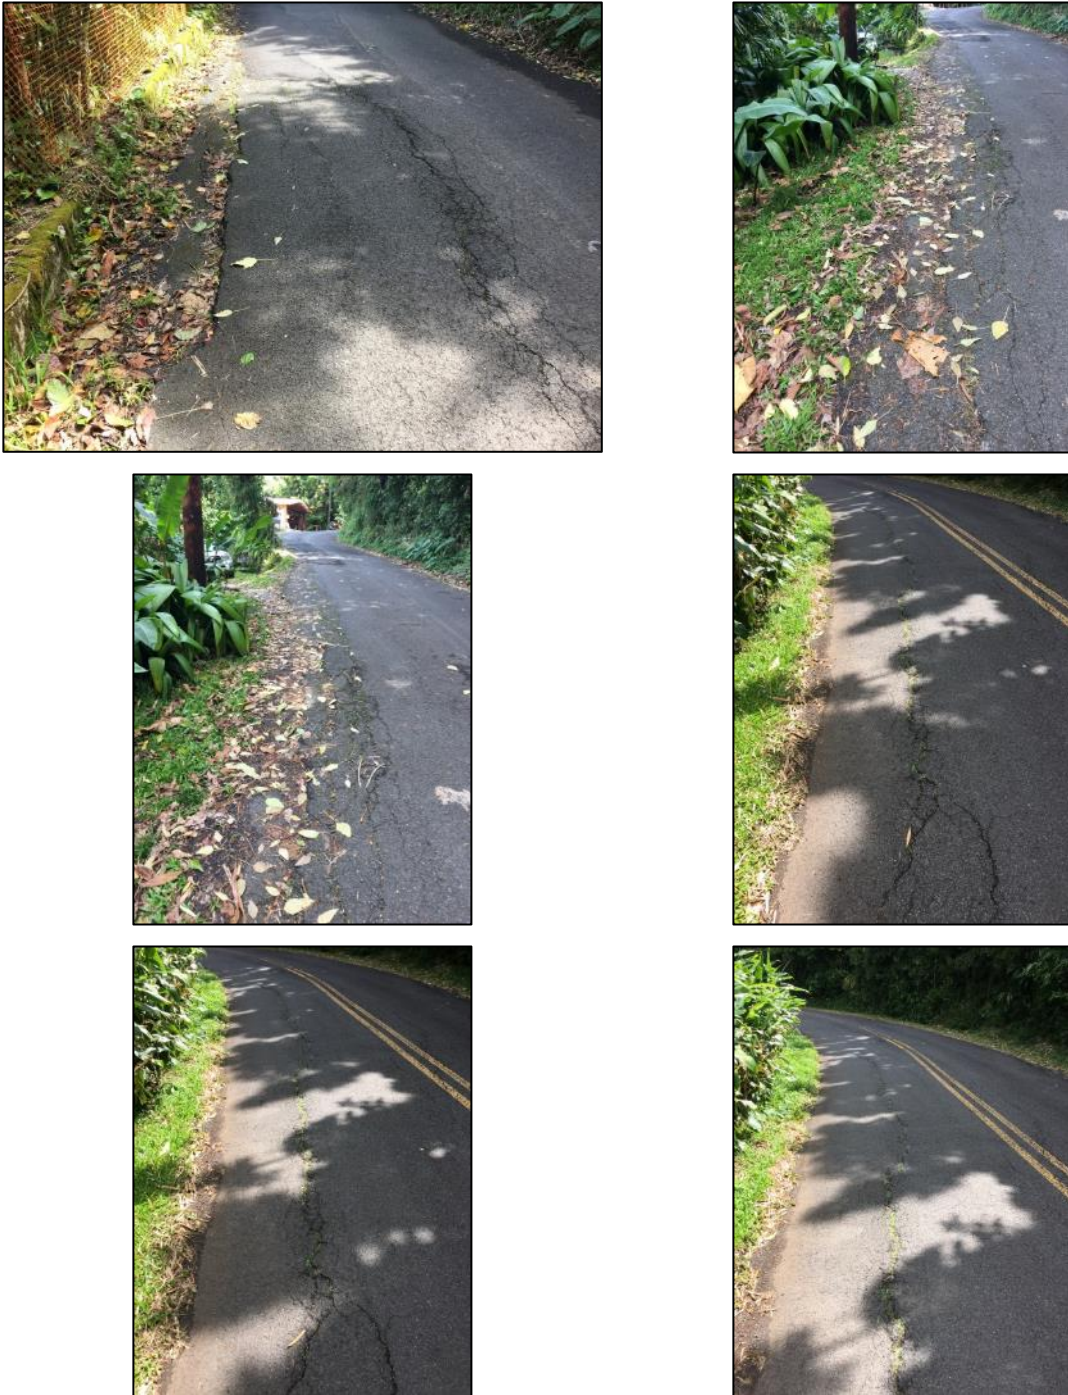
Figure 3.8 Subsidence Between 4110 Round Top Drive and Forest Ridge Way

- Several areas along a roughly 1,400-foot-long stretch of Round Top Drive between 4110 Round Top Drive and just above its intersection with Forest Ridge Way. Figure 3.8 provides photographs of existing conditions in this area.

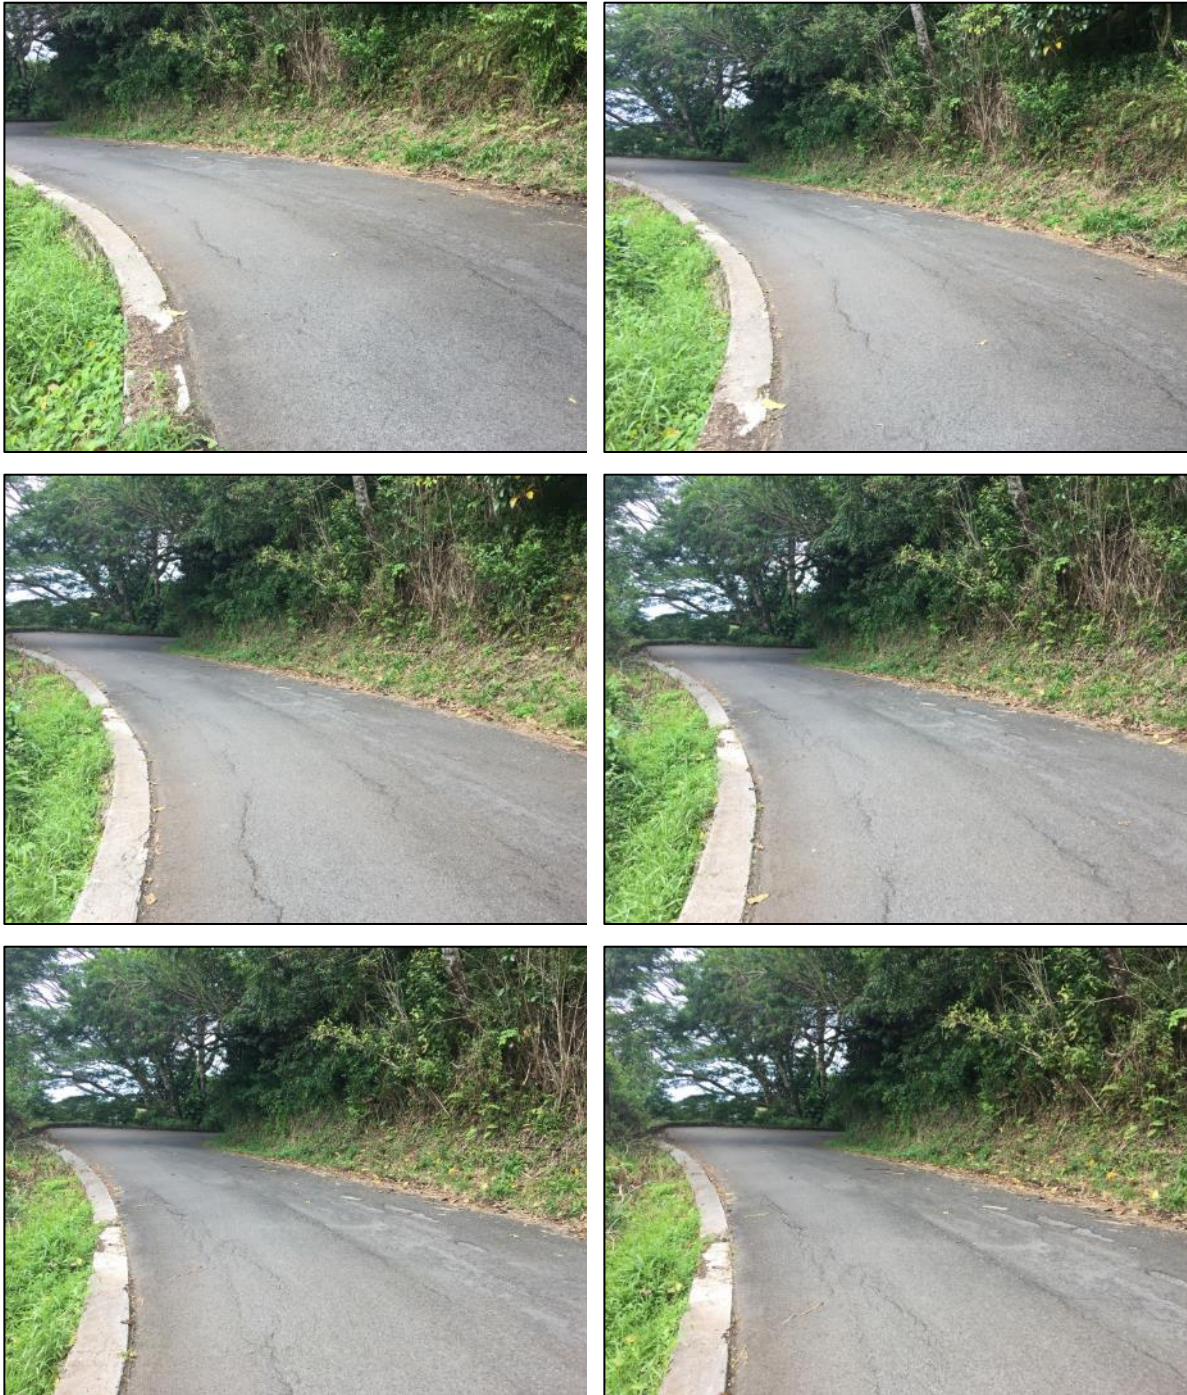
Figure 3.9 Subsidence between 3811 Tantalus Drive and Pu‘u ‘Ōhi‘a Trailhead

- Portions of the roadway along the steep southern side of Pu‘u ‘Ōhi‘a starting a short distance above 3811 Tantalus Drive and extending to the vehicle parking area opposite the base of the Pu‘u ‘Ōhi‘a Trail. Figure 3.9 provides photographs of existing conditions in this area.

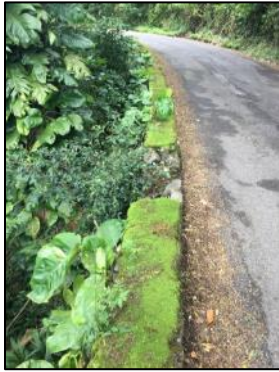
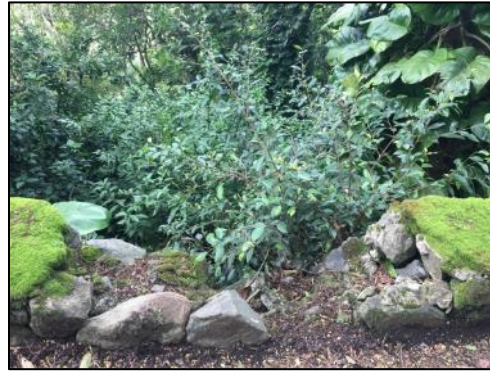
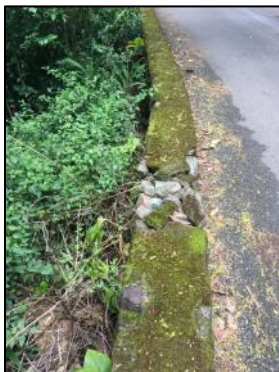
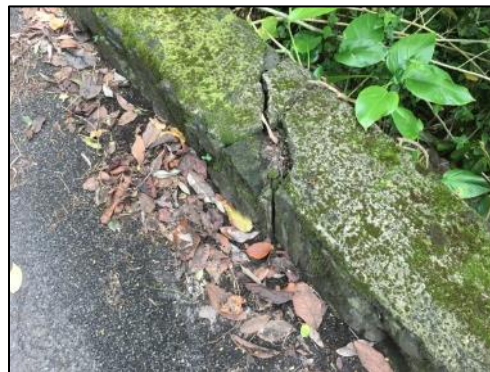
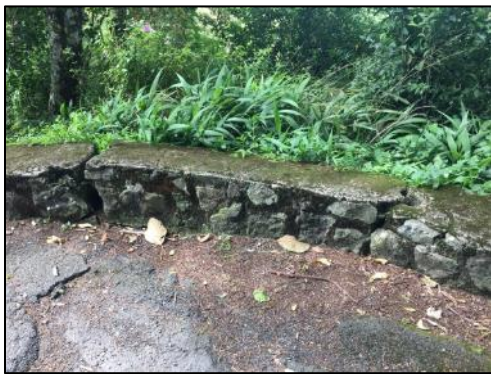
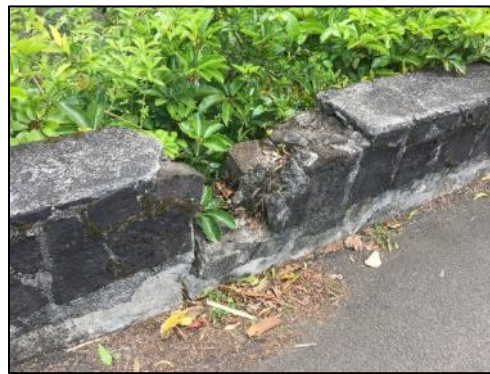
Figure 3.11 Deterioration of Retaining Walls between the Hogsback and the Pu‘u ‘Ōhi‘a Trailhead

Portions of the TRTD ROW rely on retaining walls to provide structural support to the roadway. Visual inspections of the TRTD ROW have revealed multiple instances where these retaining walls are exhibiting signs of vehicular damage, cracking, and crumbling as a result of weathering. Over time, these conditions can result in the loss of the retaining structures and ultimately of the roadway itself. Many of the most severe instances of these breakdowns are located in the area between the Hogsback and the Pu'u 'Ōhi'a Trailhead. Examples of these conditions are provided in Figure 3.11 below.

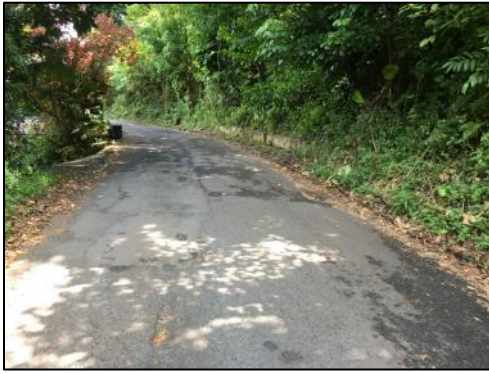
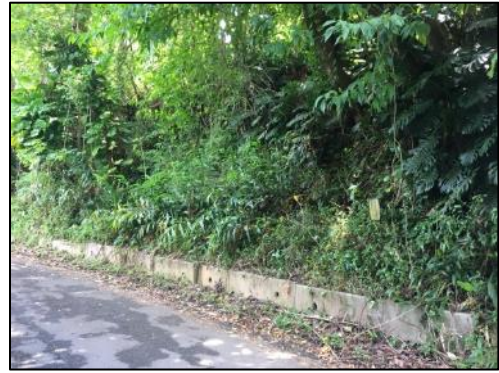
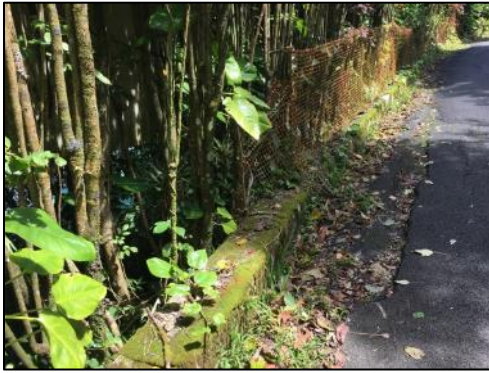
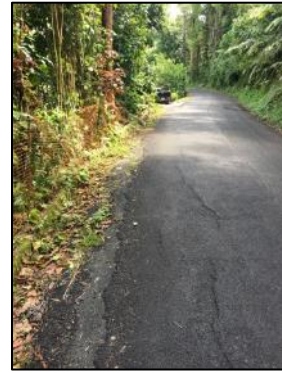
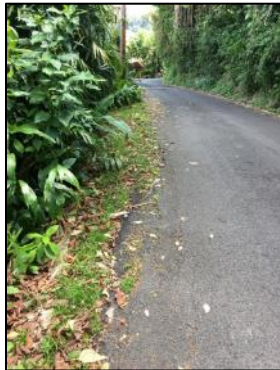
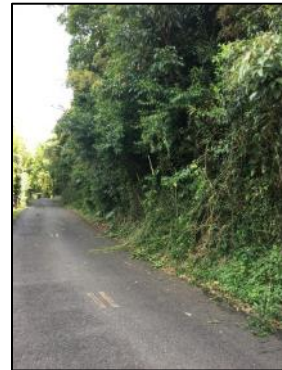
Figure 3.14 Embankment Issues between 4110 Round Top Dr. and Forest Ridge Way

- A roughly 1,200-foot-long stretch of Round Top Drive starting approximately 300 feet below its intersection with Forest Ridge Way. This area has experienced more than one substantial landslide and has had some remedial work conducted there. The existing condition of embankments in this area is shown in Figure 3.14; the first two photos in the figure show some of the previous reinforcement up the cut slope.

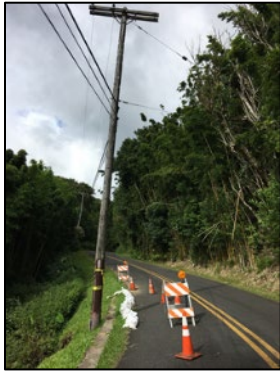
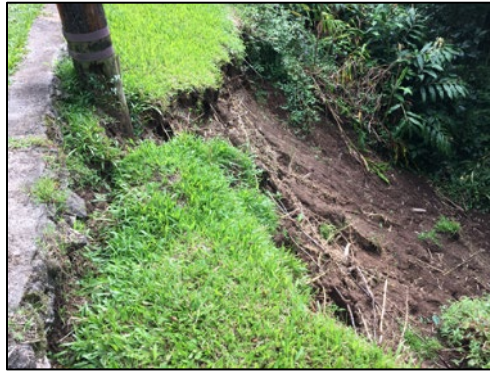
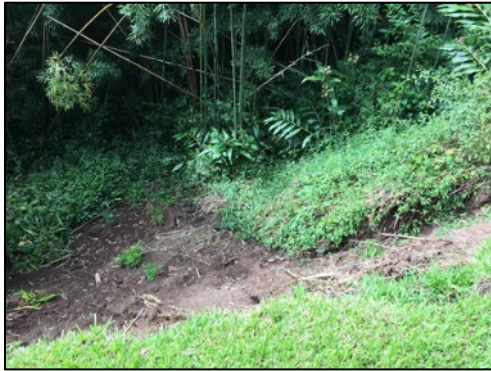
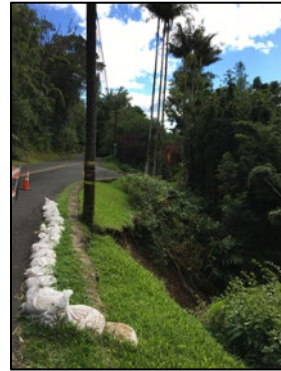
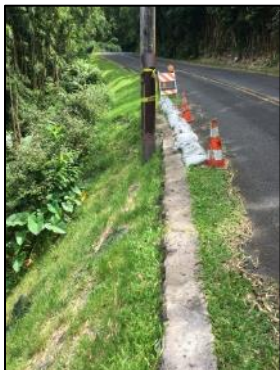
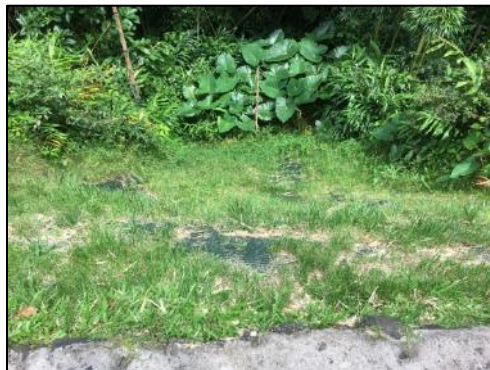
Figure 3.15 Embankment Issues above Forest Ridge Way

- The fill (i.e., downslope) embankment directly above the intersection of Round Top Drive and Forest Ridge Way where a recent landslide has occurred. Figure 3.15 depicts the original condition of the landslide in November 2017 and the temporary remediation with geotextile fabric as of May 2018.

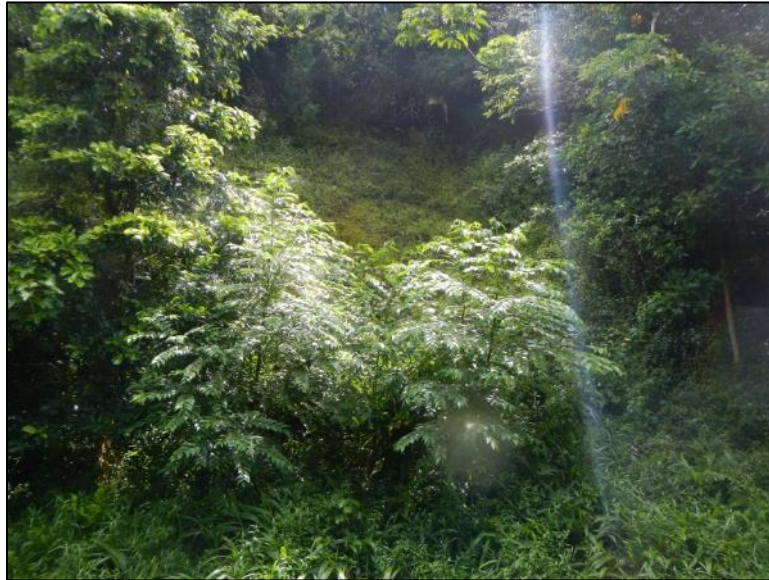
Figure 3.16 Embankment Issues between 3811 Tantalus Drive and Pu‘u ‘Ōhi‘a Trailhead

- Portions of the roadway along the steep southern side of Pu‘u ‘Ōhi‘a starting a short distance above 3811 Tantalus Drive and extending to the vehicle parking area opposite the base of the Pu‘u ‘Ōhi‘a Trail. The existing condition of embankments in this area is shown in Figure 3.16.

Site of a previous landslide with reestablished ruderal vegetation in the foreground.

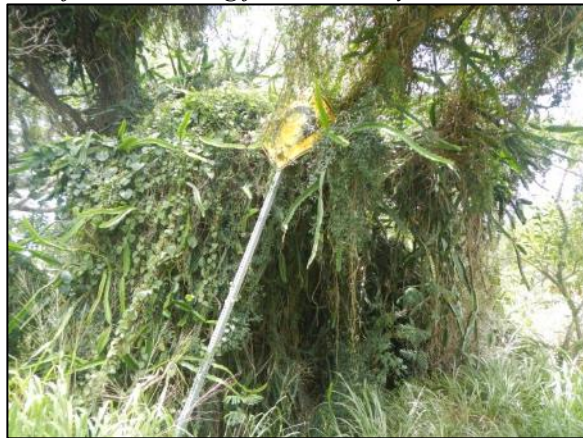
Sign obscured by vegetation

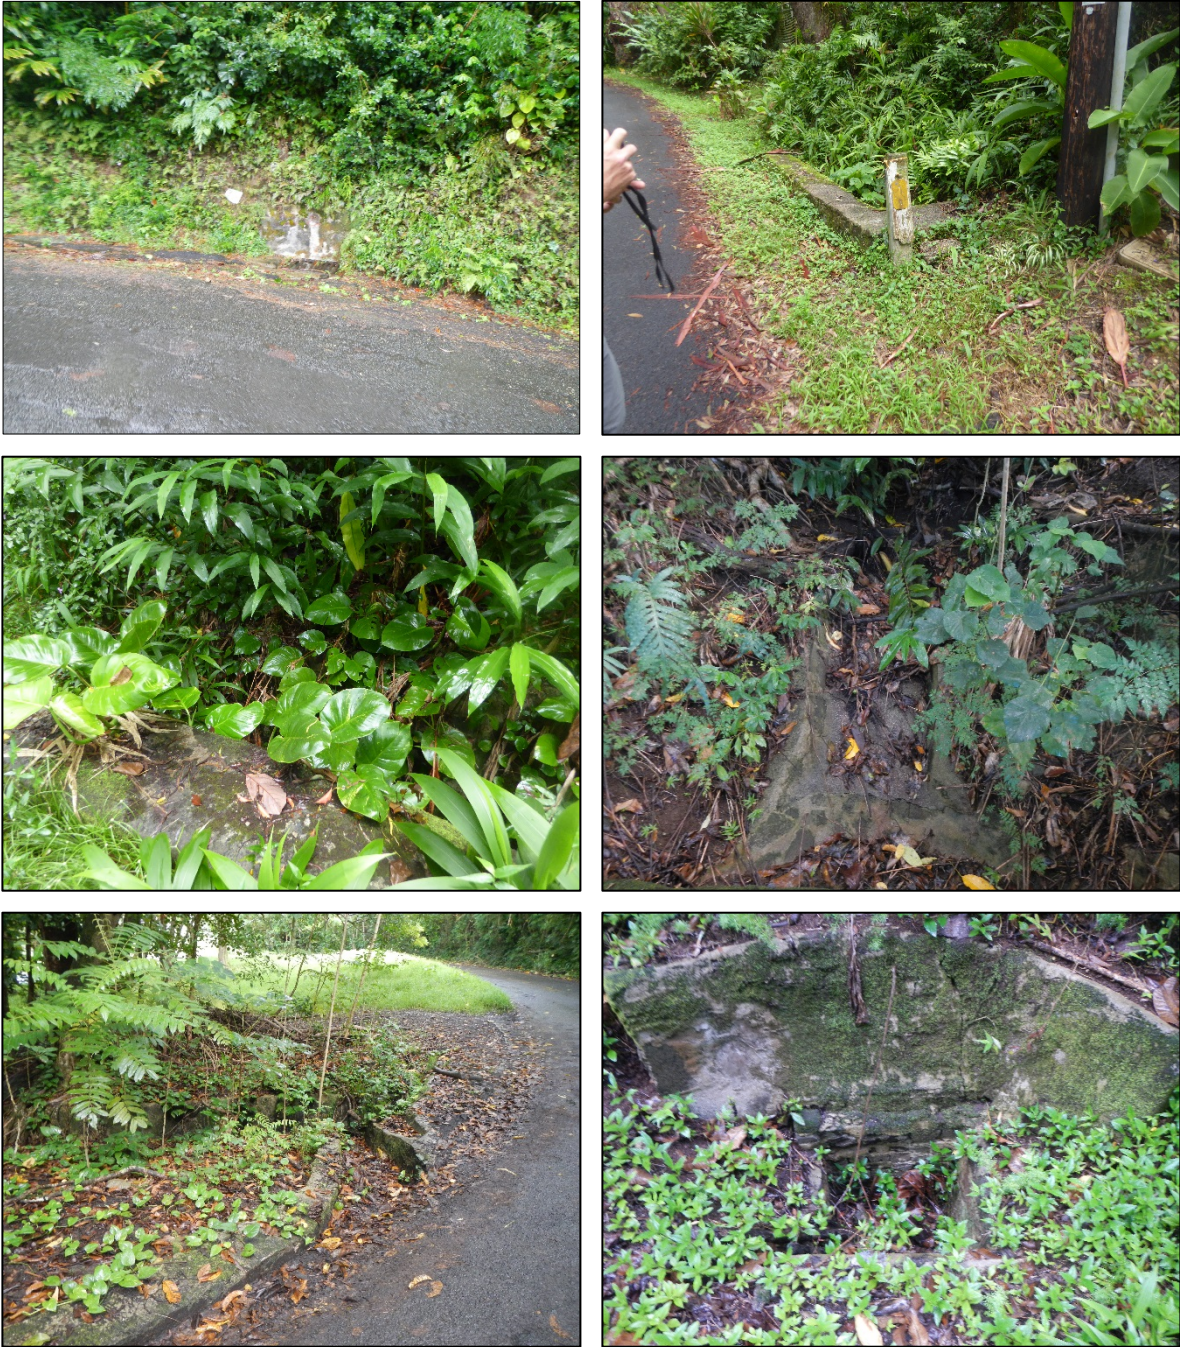
Figure 3.21 Typical Drainage Structures Along the TRTD Corridor

- Weathered, worn, damaged, and clogged drain inlets, culverts, and outlet structures;
- Drain inlets higher than adjacent grades, due to repeated resurfacing of the roadway without reference to the pattern of drainage;
- Drain swales bypassing and/or redirecting storm water runoff away from and/or around drain inlets;
- Roadway grades at, or near, the top of the adjacent walls which once served to contain storm water runoff within the roadway;
- Damaged and/or deteriorated rockwork retaining walls; and
- Erosion along the shoulders and at discharge locations where runoff leaves the roadway.

Based on these observations, there appear to be isolated drainage issues at various locations along the corridor related to excess storm water runoff entering the roadway. In some instances, this water may pond on the roadway and cause damage to the asphalt cement (AC) pavement there (see Section 3.2.2). In general, excess storm water runoff which is not captured by functional drainage structures and which, instead accumulates on the roadway is attributable to a combination of causes; these include: (i) age-related deterioration of the drainage structures; (ii) lack of maintenance; (iii) repaving work conducted without reference to storm water drainage; (iv) inadequate drainage collection and conveyance systems including drain inlets, roadside swales, and culverts; and (v) additional development within the watershed, including renovation, addition, and related improvements to private property along the TRTD corridor. See Figure 3.21 for photographs of drainage structures at points along the TRTD corridor.

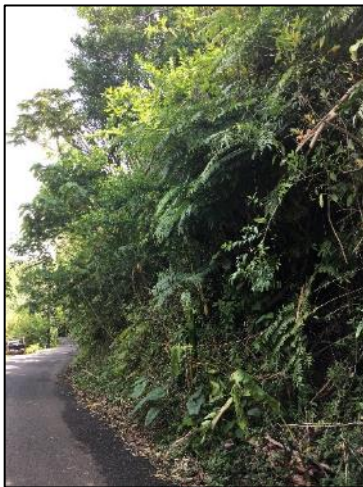
Rapidly growing invasive plants species, including guinea grass (*Megathyrsus maximus*), several species of bamboo (*Poaceae spp.*), haole koa (*Leucaena leucocephala*), yellow ginger (*Hedychium flavescens*), and white ginger (*Hedychium coronarium*) grow along the road shoulder and, as the plants develop their foliage, narrowing the travelway as it spreads. To avoid having their vehicles struck and damaged by the foliage, drivers deviate towards the centerline, deteriorating the striping and reflectors, and posing a hazard of collision with oncoming traffic.

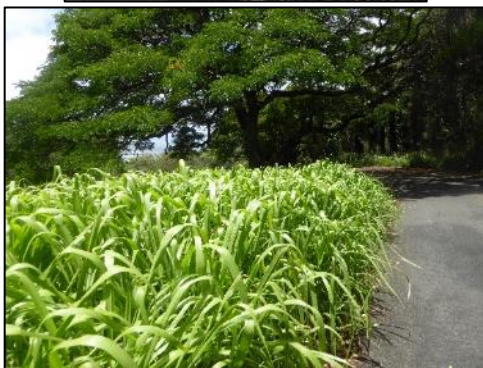
Thick vegetation growing on the nose of tight hairpins or other curves in the road can reduce or completely obstruct site distances.

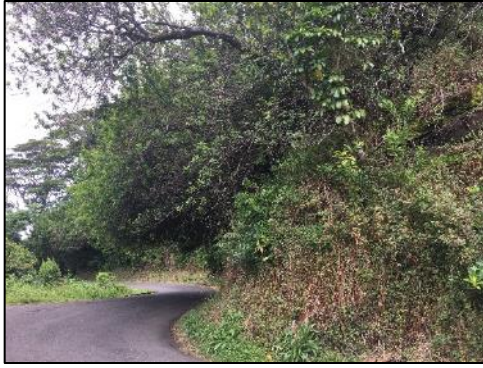
Overhanging vegetation, such as banyan (*Ficus benghalensis*) and hau (*Hibiscus tiliaceus*) can strike taller vehicles (e.g., Department of Environmental Services (ENV) refuse collection trucks) and deposit vegetable matter onto the roadway, reducing traction.

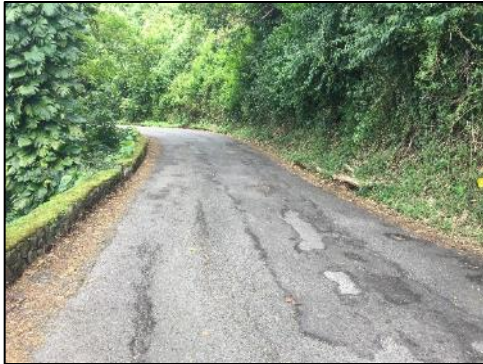
Vegetation on the shoulder, when not properly maintained, can make it difficult or impossible for pedestrians to get out of the way of oncoming vehicles. This situation is particularly noticeable in areas such as the stretch of Tantalus Drive between Telephone Road and the Mānoa Cliffs Trailhead.

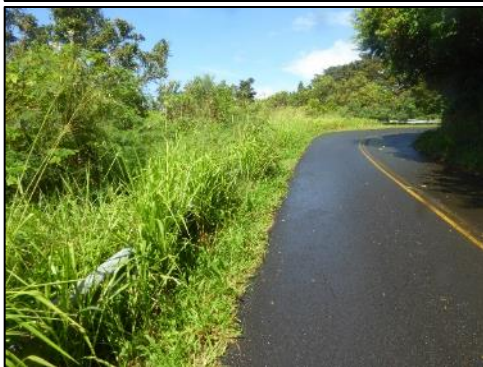
Unchecked vegetation on the shoulder can make existing walls and safety barriers difficult or impossible to see, posing a collision hazard to vehicles.

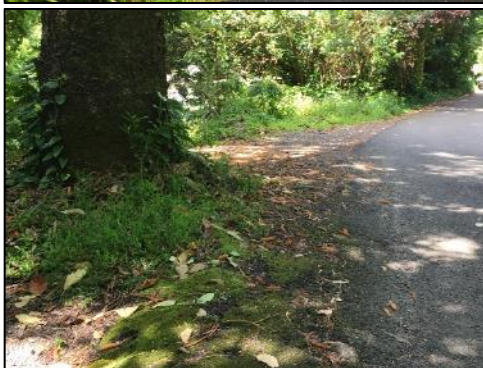
Uplift of the roadway caused by root structures from adjacent trees can disrupt the integrity of the road's surface.

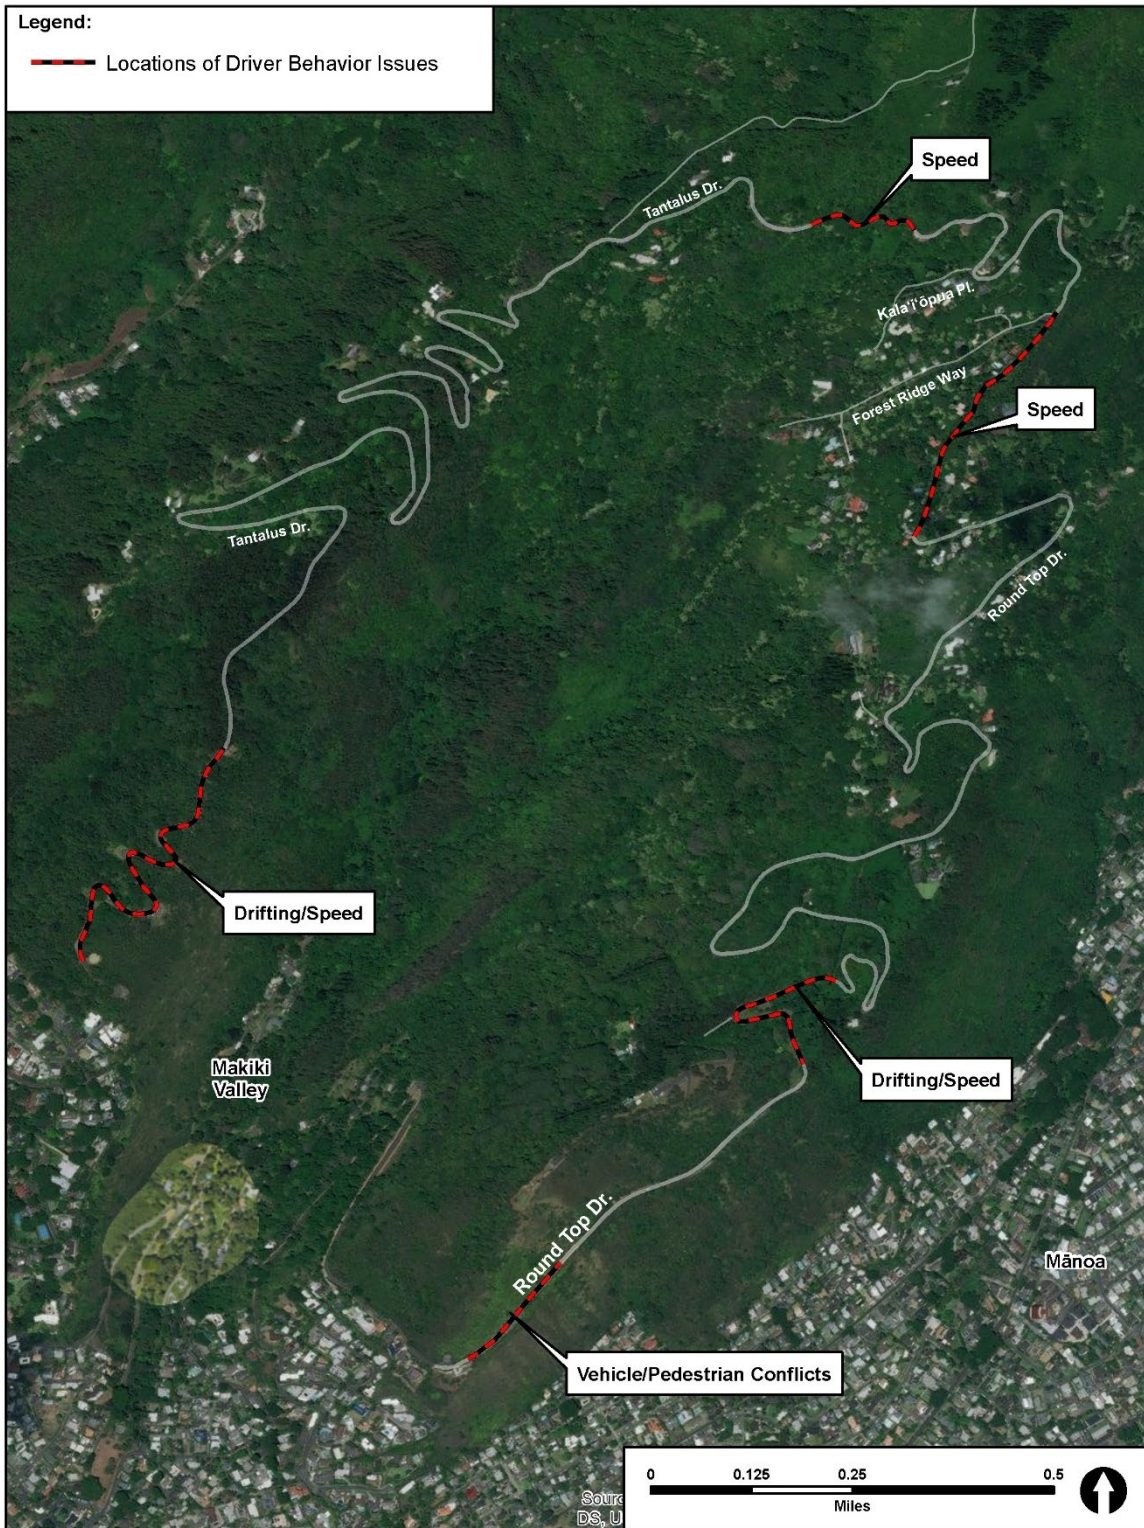
Figure 3.24 Locations of Known Driver-Behavior Issues

While a complete traffic study was outside the scope of this TRTD-CMP, there are specific problem areas and problem times along the corridor which could be made subject to targeted interventions that could result in incremental improvements. Selected locations, where specific behaviors have been observed over the years, are identified in Figure 3.17. Chapter 4 provides recommendations which may be employed individually or collectively to address and manage these behaviors.

- Figure 3.24 on page 3-40 shows locations of known driver-behaviors issues. The strip of road just up the road from the pu'u ohia trail head (Gills residence) extending up to Forest Ridge Way is also an area for speeding that creates noise for everyone in the valley. Although I haven't heard or seen people speeding recently (probably because the road conditions are so poor), in the past there have been some weeks when cars or motorcycles speed up that road every night, sometimes several times a night.

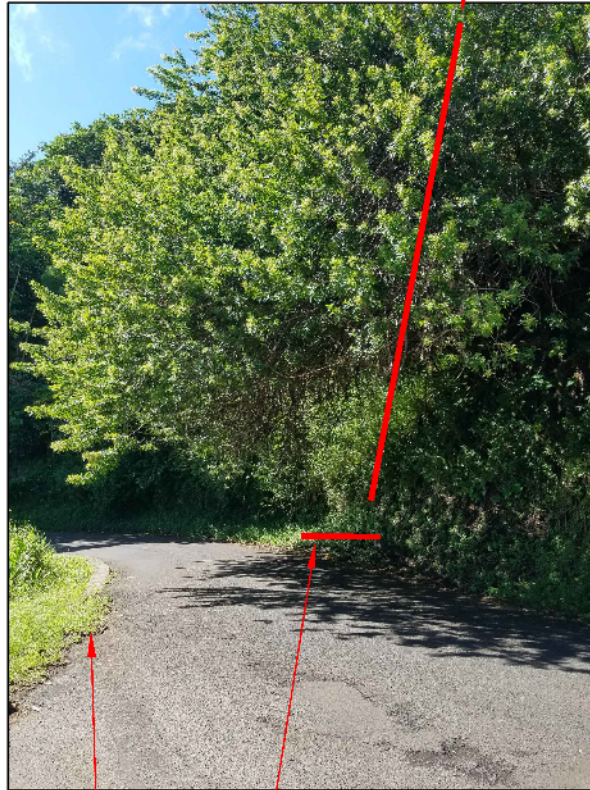
Figure 4.34 T16 Vegetation Management Recommendations D

Note: According to the Turnout map (page 3-42), this looks to be T17. But under Vegetation Management Recommendations D it appears to be part of a series of turnouts along the upper end of **T16** (Figure 4.34).

Remove or prune under canopy branches that are or will enter the 17' min. vertical clear space in the LMZ and create a better vehicular sight lines at this curve in the roadway. If tree cannot be removed without causing potential erosion on slope, heavily prune so the direction of branching is upward and as tight to the face of slope as possible.

Foreground bunch grasses and weedy material should be trimmed to 6"-12" and not allowed to exceed 30" in height.

Remove any vegetative growth that has spread on top of the asphalt or concrete pavement. The edge of pavement should be clearly visible from the roadway.
