Sugar Cove Berm Maintenance Effort 6-Month Interim Report

Sugar Cove, Sprecklesville, Maui, Hawaii

July 2018

Job No. 25411

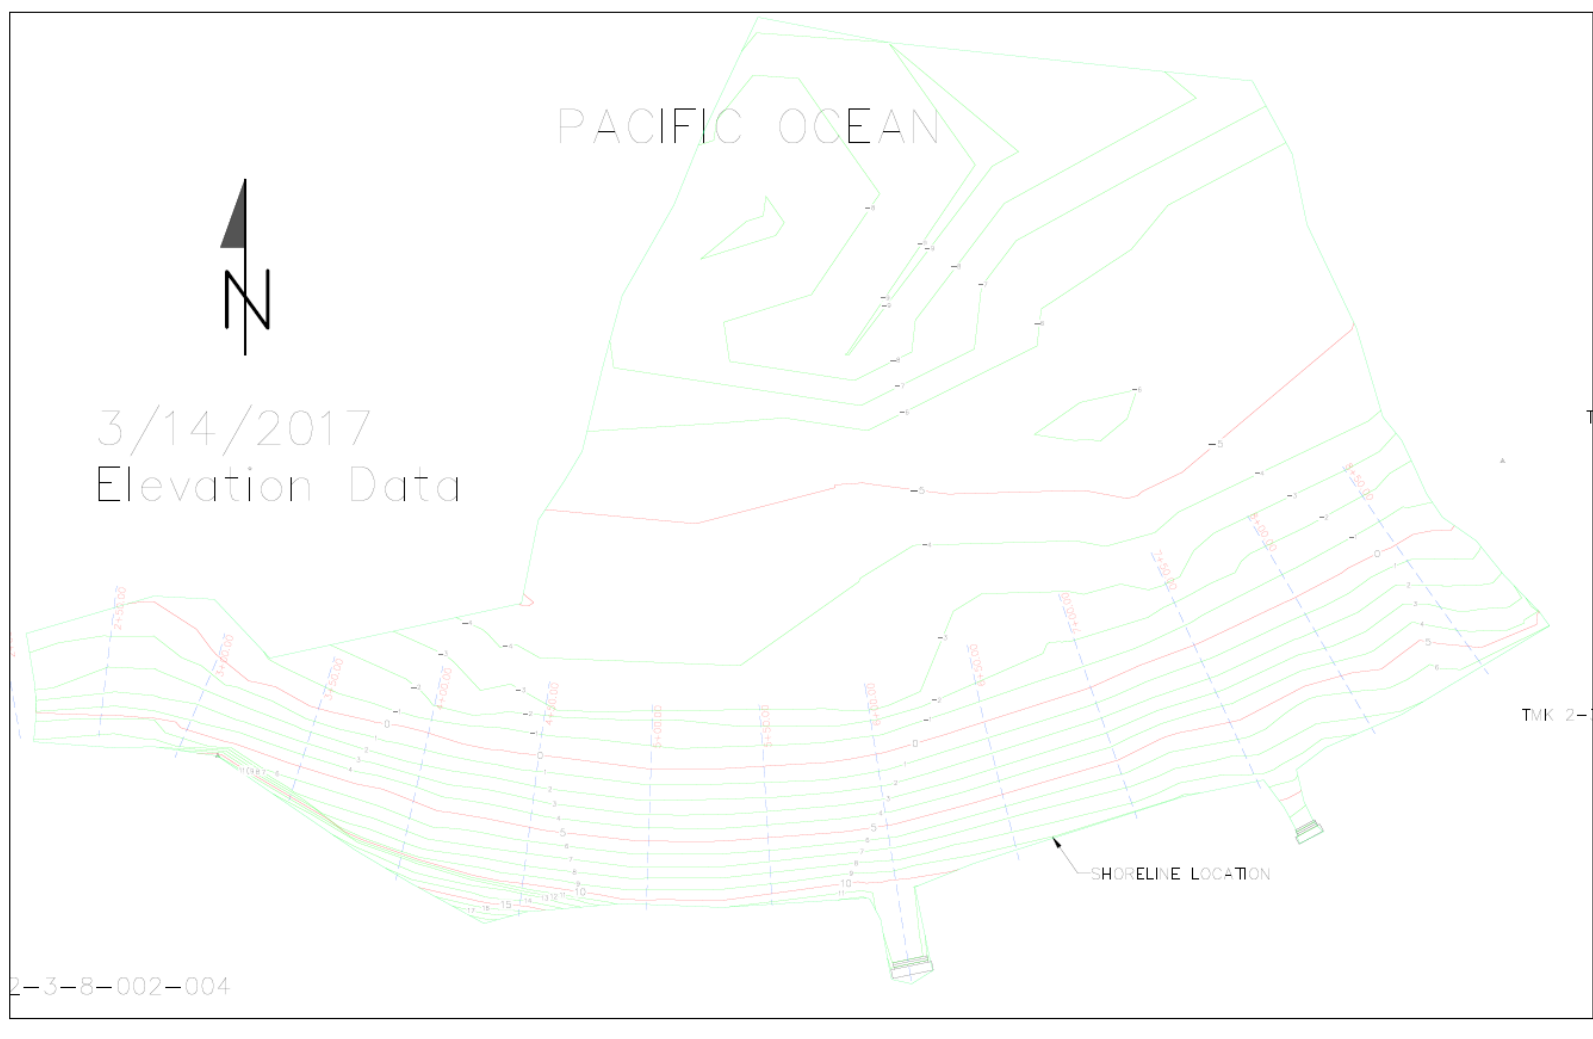
The public sand beach at Sugar Cove is composed primarily of beach quality fill sand placed on the shoreline by the Association. The current beach sits atop and makai of the Hayashi seawall, built in 1993. The cusped beach shape (Figure 1-4) forms a wide curve between the natural western headland and the shoreline armoring headland on the eastern side.

Figure 1-4 Existing topography and bathymetry at the project site, March 14, 2017 (LMSL datum).

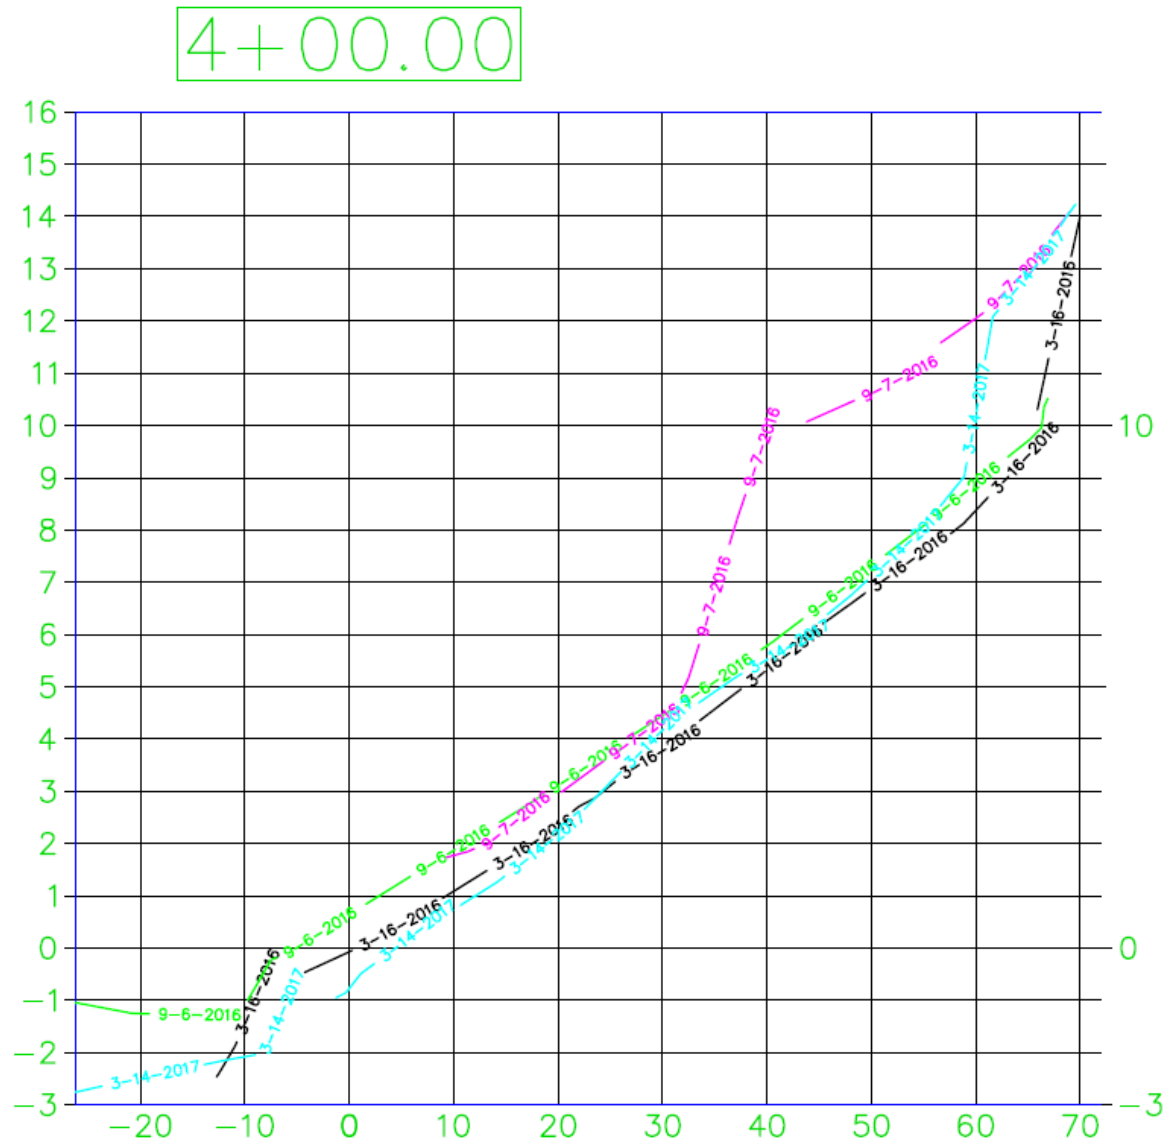
The most recent topographic survey, March 14, 2017, showed the average berm height as +11 ft. The beach width is approximately 105 ft at Transect 5. Beach profiles are included in this document. Profile 4+00 (Figure 1-5) is near Transect 7; Profile 6+00 (Figure 1-6) is near Transect 5; and Profile 7+50 (Figure 1-7) is near Transect 3.

Figure 1-5 Existing profile in cyan at the project site, March 14, 2017 (Transects 7 is approximately the same location as Profile 4+00, LMSL Datum). In pink is the beach profile six months earlier just after the last maintenance effort.

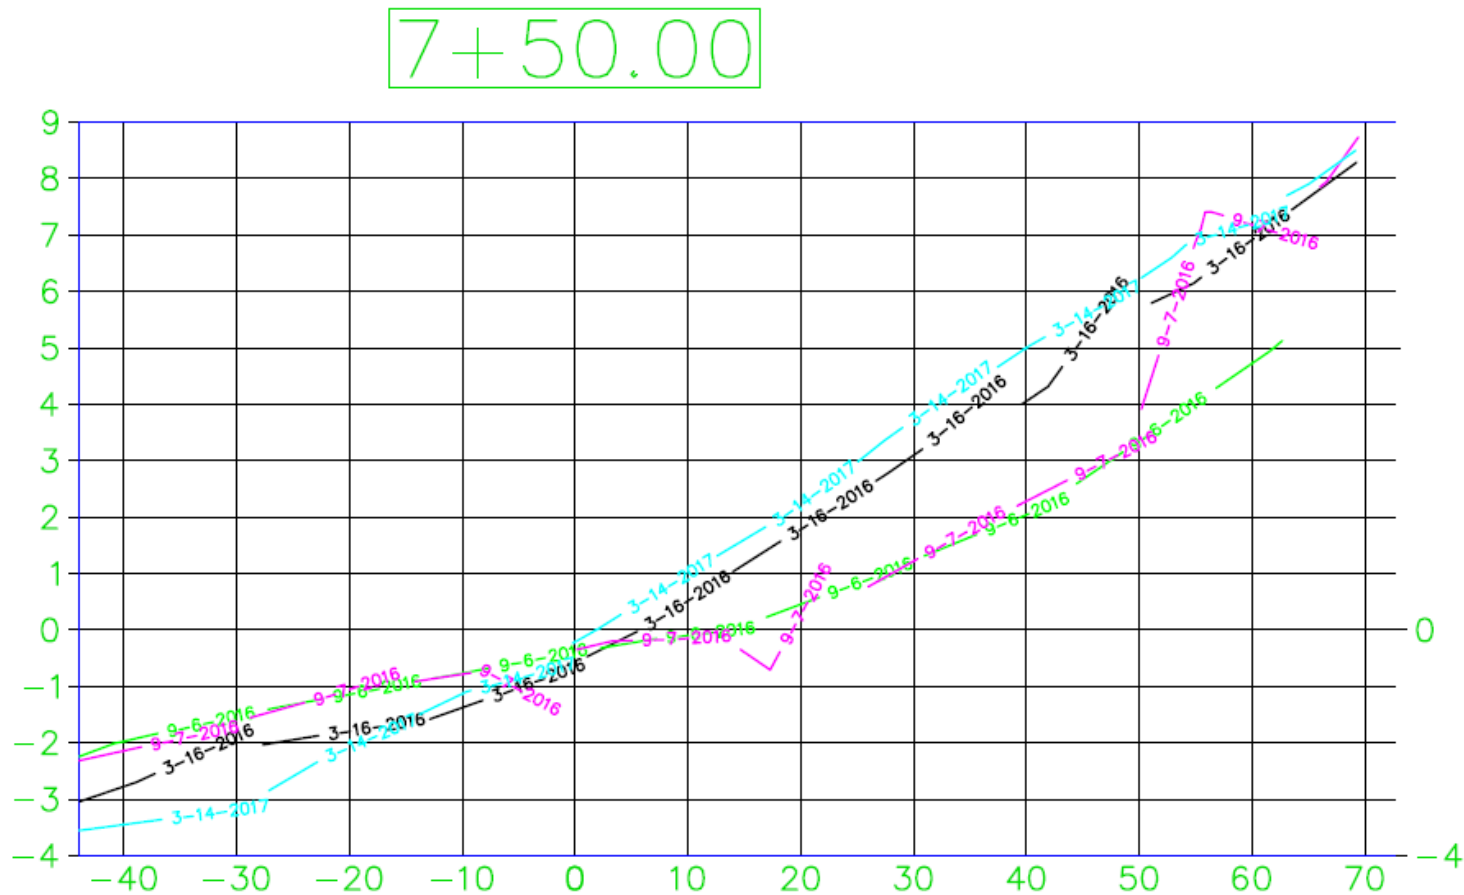
Figure 1-7 Existing profile in cyan at the project site, March 14, 2017 (Transects 3 is approximately the same location as Profile 7+50, LMSL Datum). In pink is the beach profile six months earlier just after the last maintenance effort.

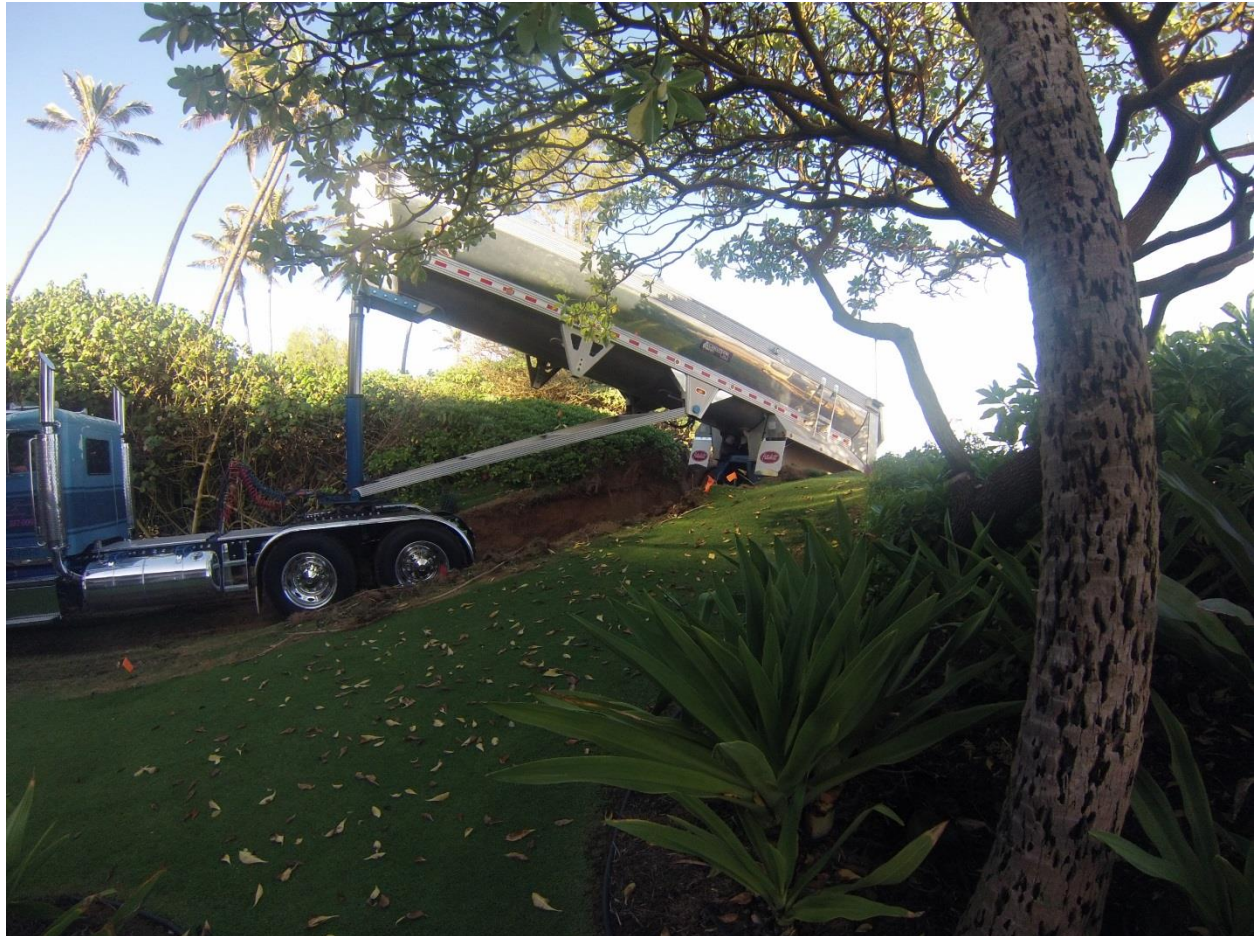
Delivery Method: Tavares Trucking utilized four vehicles to maintain a consistent delivery pace. Morning and afternoon delivery speeds were negatively impacted by local traffic issues. Truck delivery of sand to the berm was at the west end of the embayment, through the Sugar Cove property to the public beach. A small gap was cut into the sand bank (Figure 4-1) allowing the trucks to deliver sand directly to the berm. Truck delivery of sand to the County of Maui beach access utilized a smaller truck and delivered sand directly to the beach access from the street (Figure 4-2).

Figure 4-1 Dump truck delivering sand to the west end of the cove for placement on the berm (Maintenance #1).

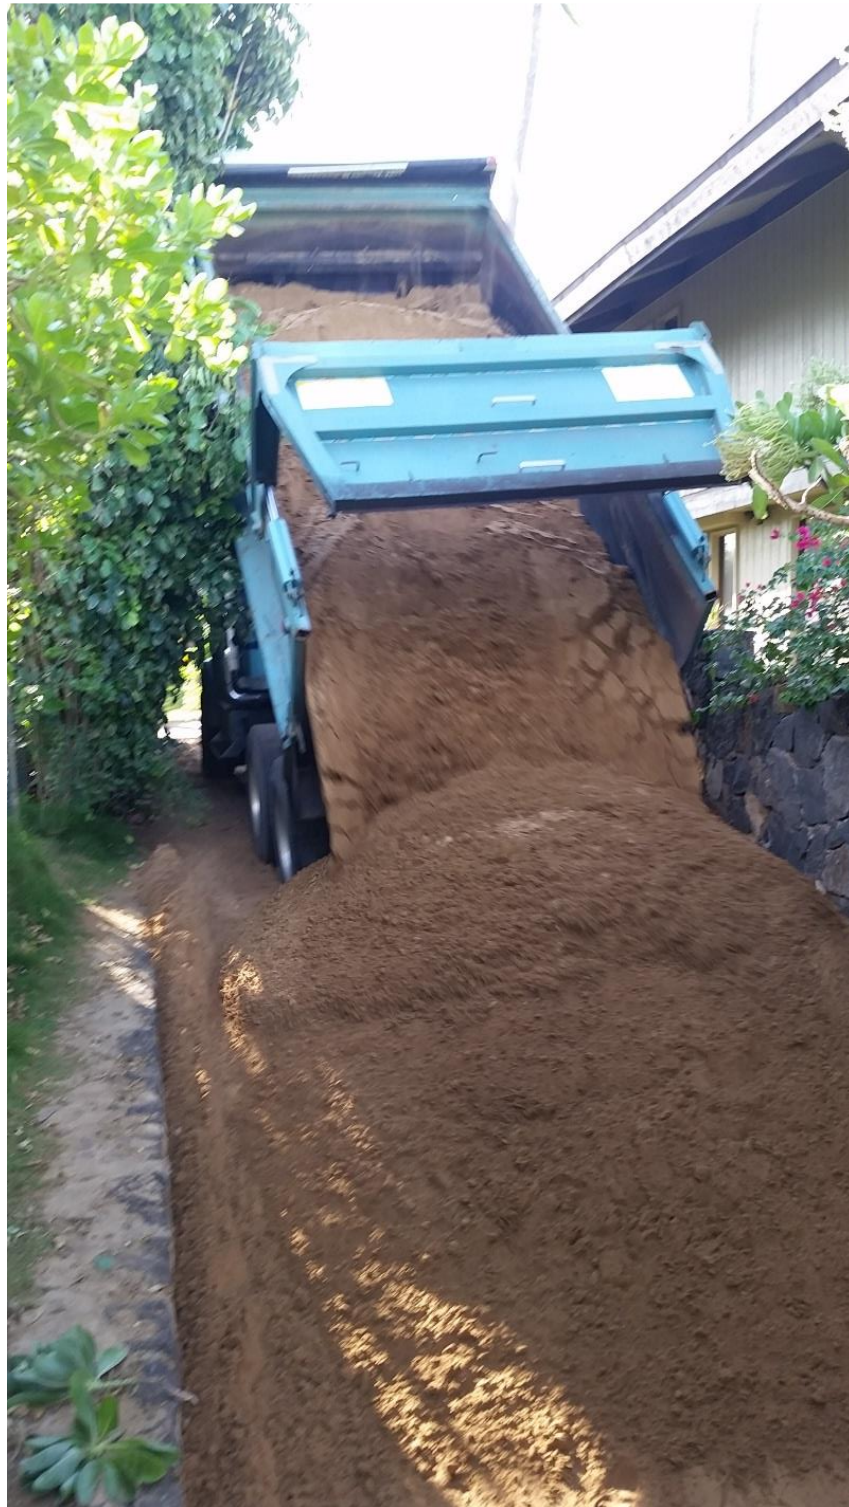
Figure 4-2 Smaller dump truck delivering sand to the County of Maui beach access path (Maintenance #1).

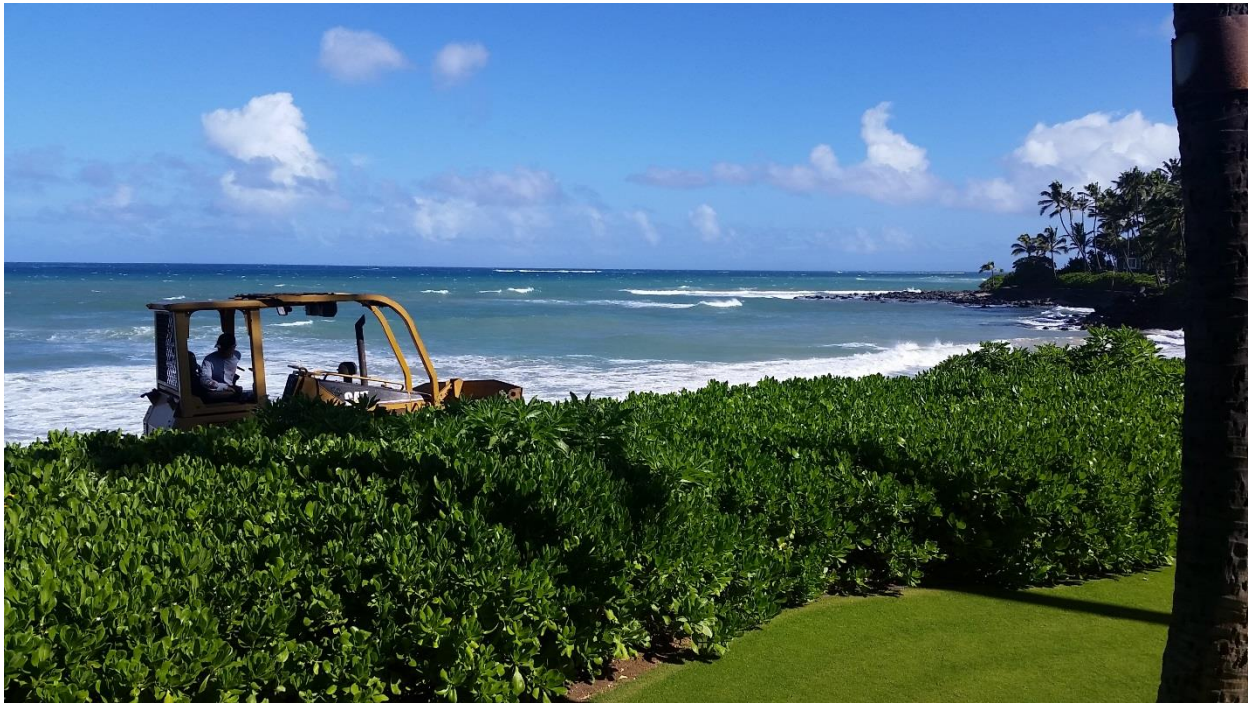
Placement: A single operator, contracted by Tavares Trucking, used a Caterpillar D4G bulldozer (Figure 4-3) to move sand along the berm and shape the new sand bank (Figure 4-4). Sand pushing and grading were completed from west to east along the berm. All sand moving and grading was conducted on the berm, makai of the shoreline vegetation and well inland from mean higher high water. The maintenance sand berm abutted the boulders and sand bank on the mauka side and extended from the west end of the property to Transect 3. The low elevation of the existing berm prevented placement of the maintenance sand between Transect 3 and the County of Maui beach access path (Figure 4-5). Sand placed within the County of Maui beach access was brought in from the street and pushed down the beach access by the Caterpillar operator.

Figure 4-3 Bulldozer spreading sand along the berm (Maintenance #1).

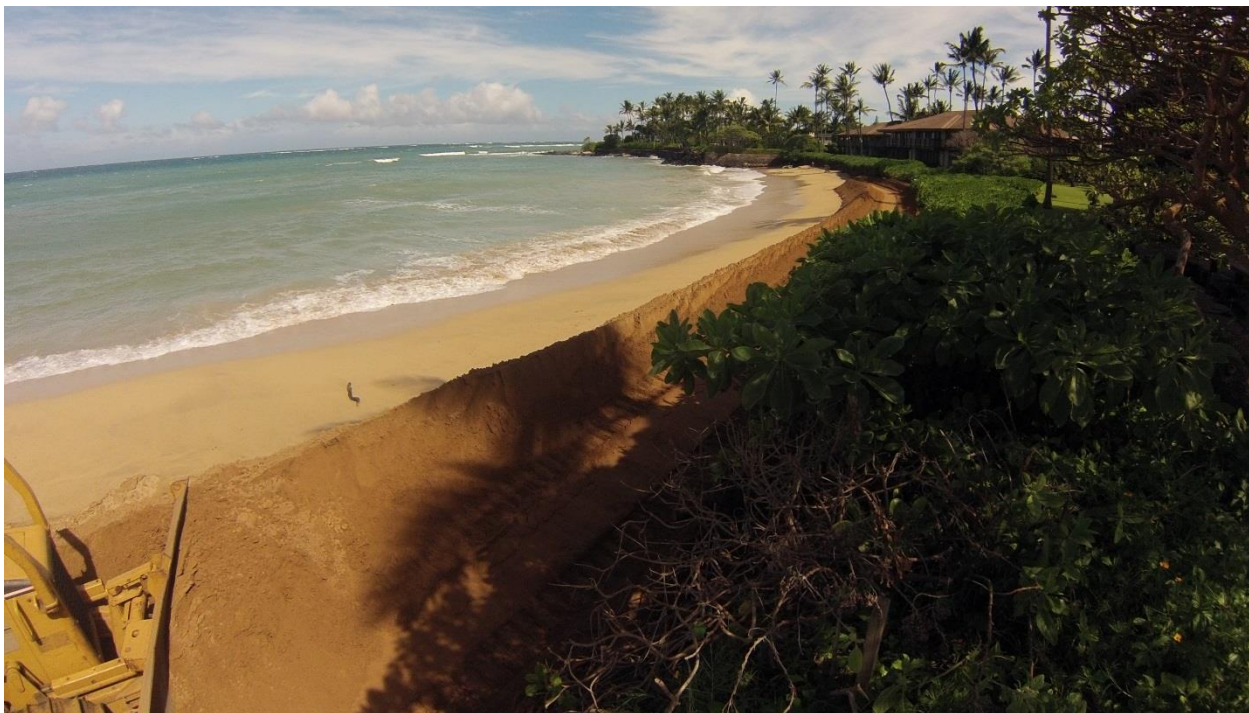
Figure 4-4 Sand grading on the berm (Maintenance #1).

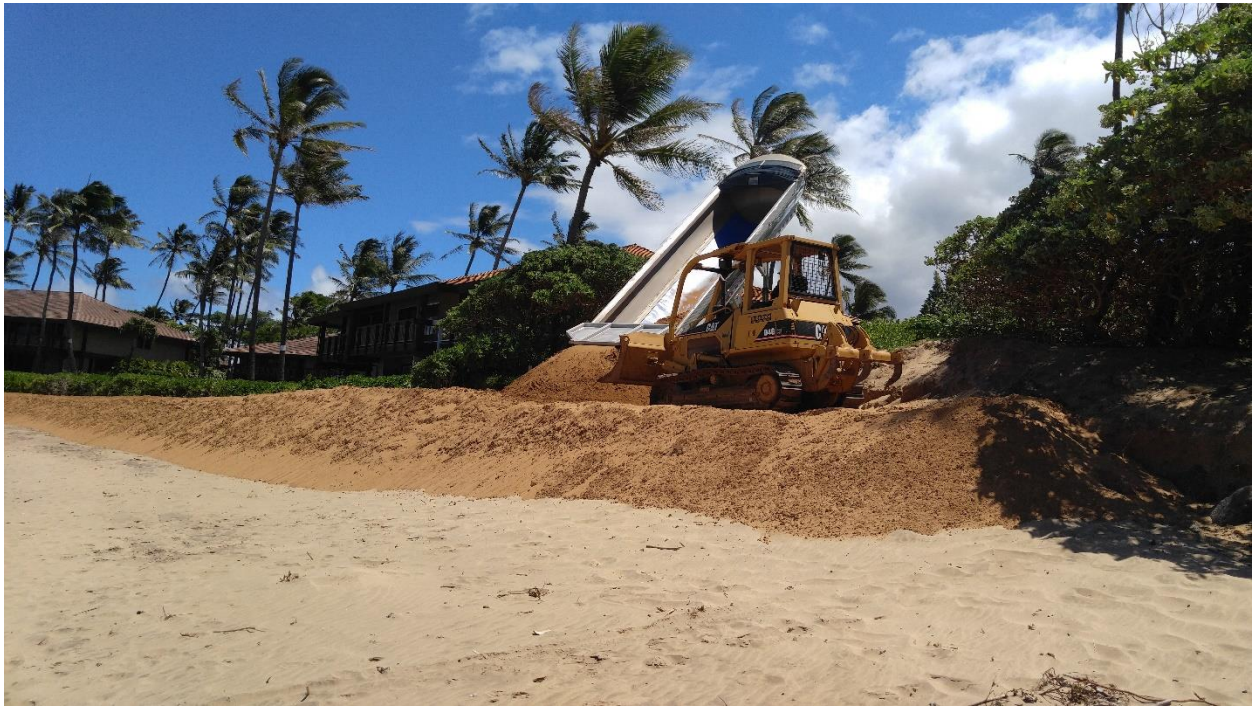
Figure 5-1 Dump truck delivering sand to the west end of the cove for placement on the berm (Maintenance #2).

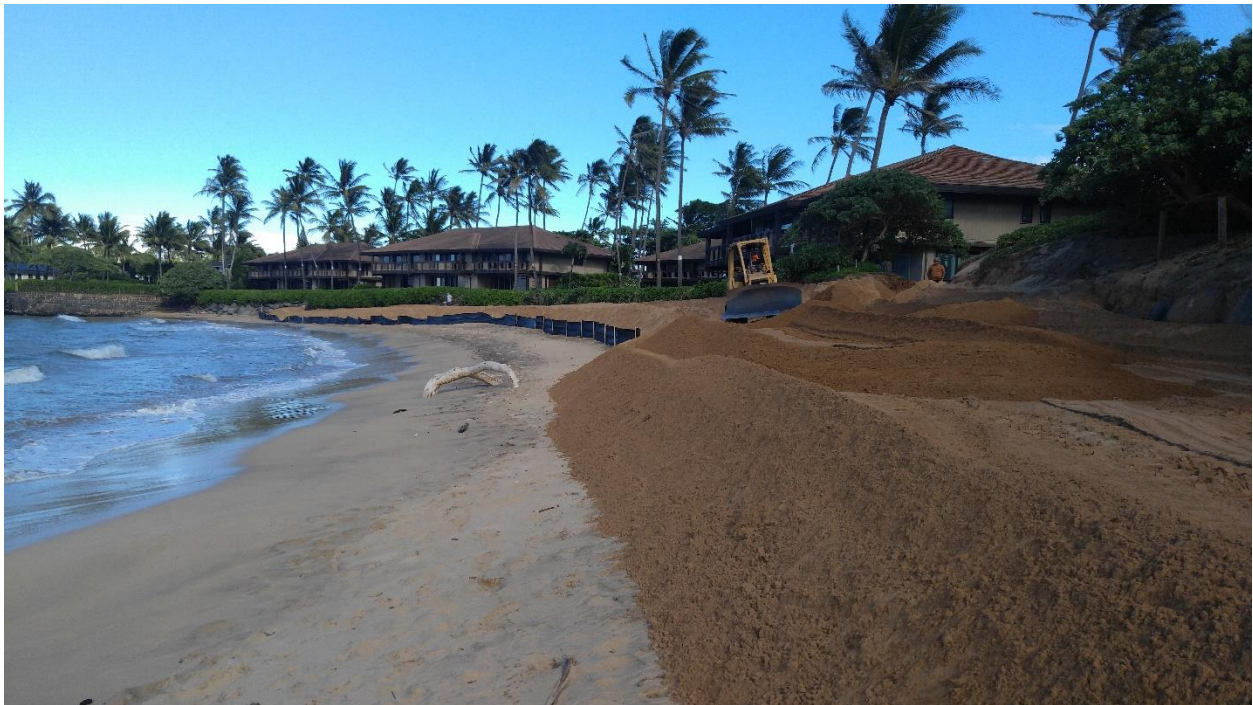
Placement: A single operator, contracted by Tavares Trucking, used a Caterpillar D4G bulldozer (Figure 5-2) to move sand along the berm and shape the new sand bank. Sand pushing and grading were completed from west to east along the berm. All sand moving and grading was conducted on the berm, makai of the shoreline vegetation and well inland from mean higher high water. The maintenance sand berm abutted the boulders and sand bank on the mauka side, and extended from the west end of the property to Transect 3 where the erosion was too severe for the bulldozer to spread sand without entering the water (Figure 5-3). No sand was added to the access path because it was still full. Too much sand on the path would make it too steep of a slope.

Figure 5-2 Bulldozer spreading sand along the berm (Maintenance #2).

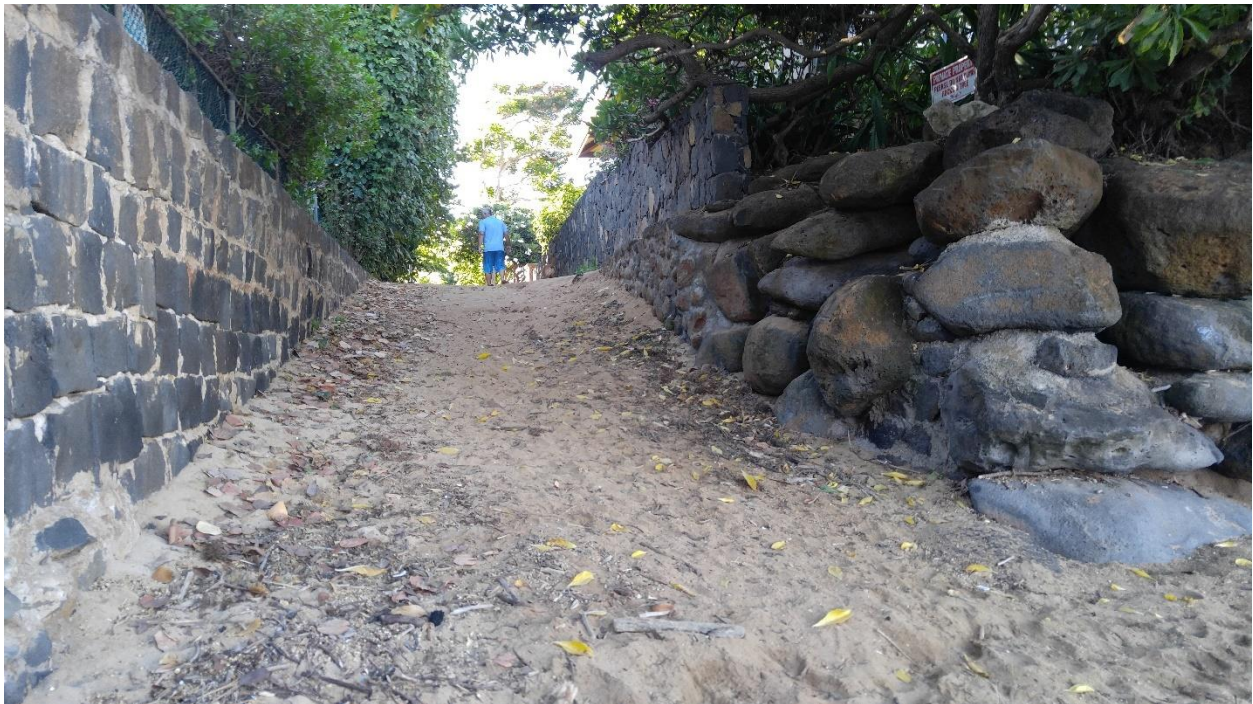
Figure 5-6 County of Maui beach access path during sand placement (Maintenance #2).

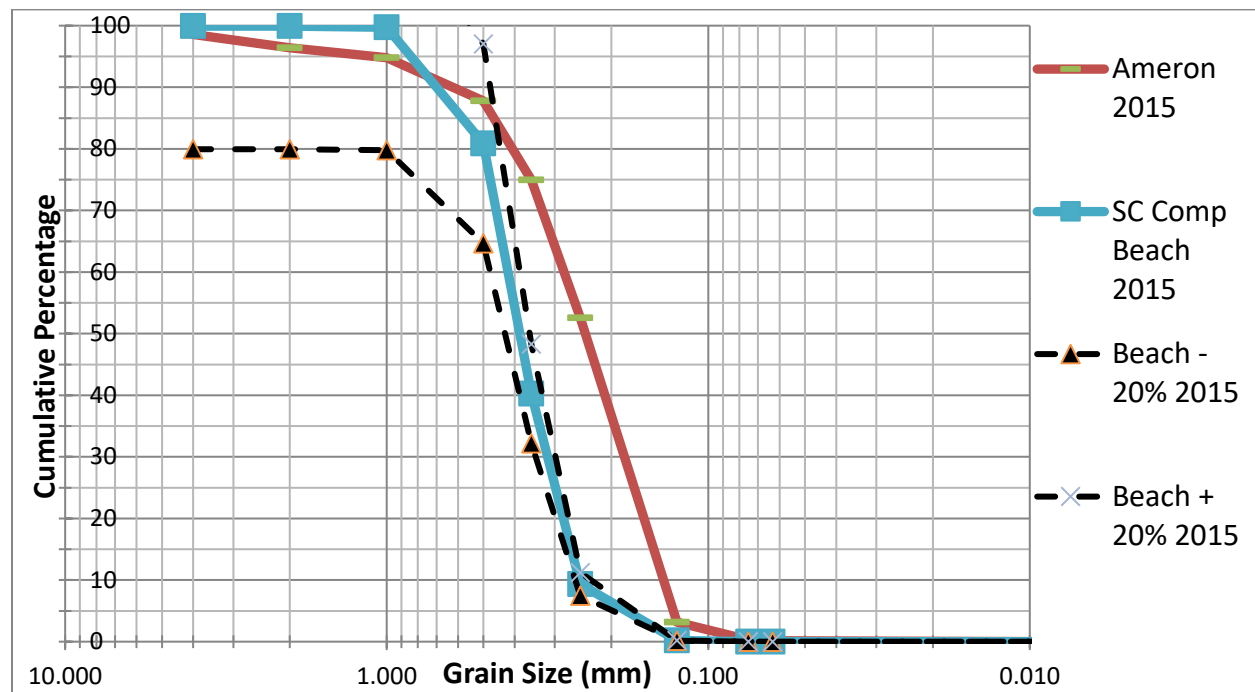
This sand is light reddish brown in color and has a median grain size of 0.28 mm. 97.9% of the material is within the range of sand grain size, and 2.1% is silt size. This material is dominantly marine carbonate sediment in origin. The berm fill sand did not fit entirely within the +/- 20% brackets around the composite existing beach sand sample (Figure 7-3). This may be a result of variation in the sieve sizes used for analysis of the sand samples. Regardless, the berm fill sample was finer in nature than the existing beach sand.

Figure 7-3 Grain size distribution for composite beach sample, the +/- 20% thresholds and the berm fill sand sample (Maintenance #1).

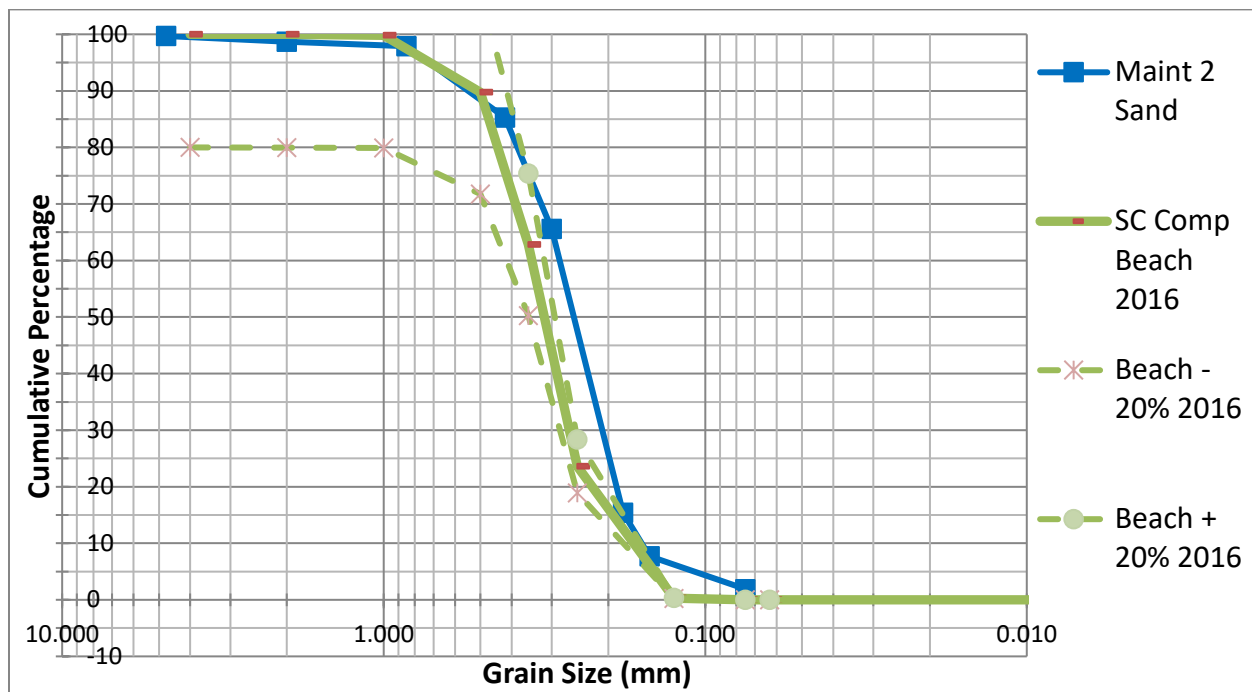
Ameron Inland Dune Sand was utilized again for maintenance effort #2 in 2016. The berm fill sand did not fit entirely within the +/- 20% brackets around the composite existing beach sand sample (Figure 7-5). This may be a result of variation in the sieve sizes used for analysis of the sand samples. Regardless, the berm fill sample was finer in nature than the existing beach sand.

Figure 7-5 Grain size distribution for composite beach sample, the +/- 20% thresholds and the berm fill sand sample (Maintenance #2).

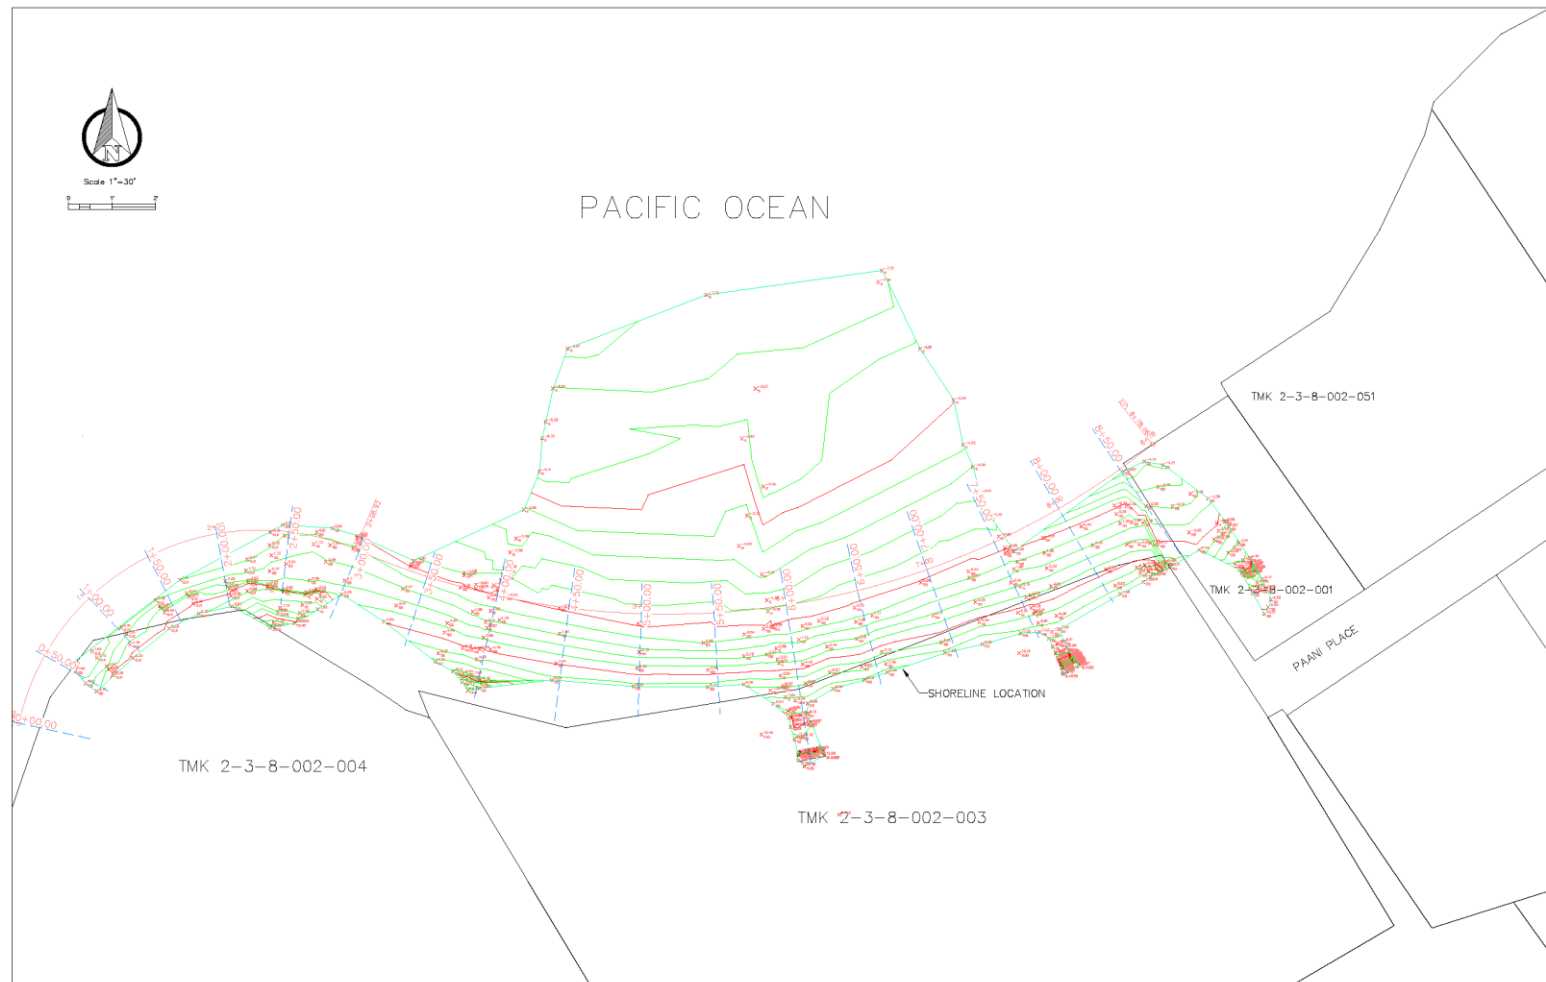
Figure 7-24 November 09, 2015 conditions prior to initiating berm maintenance #1.

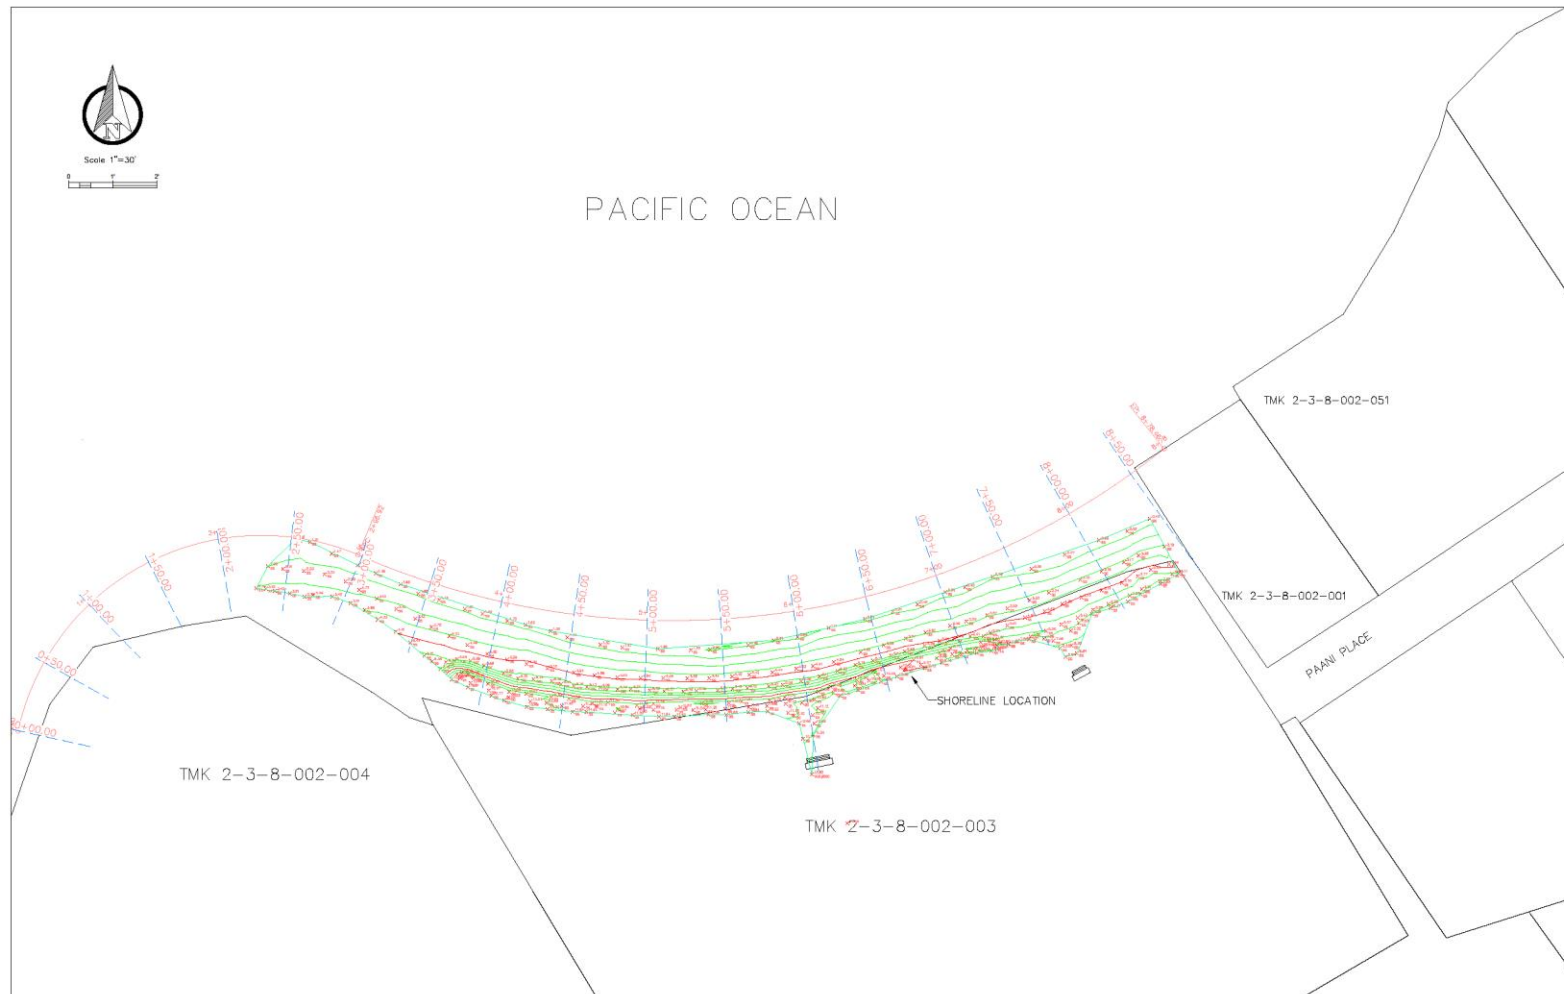
Figure 7-25 November 10, 2015 conditions immediately following berm maintenance #1.

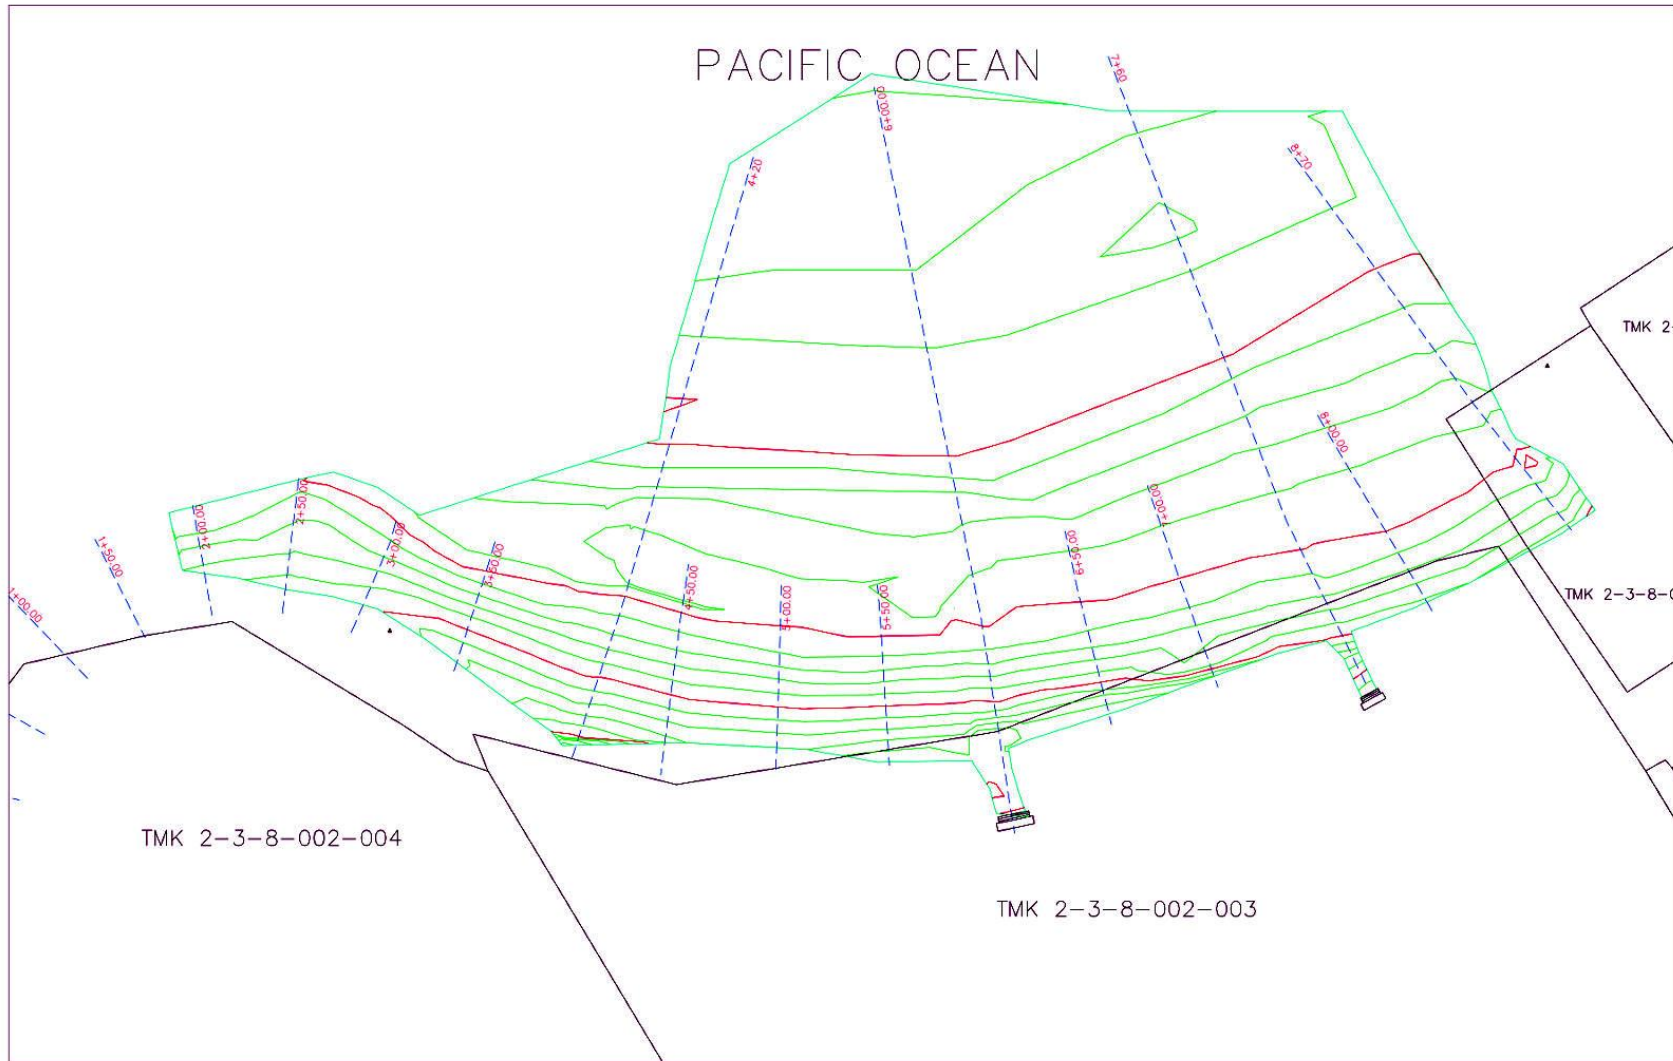
Figure 7-35 September 06, 2016 conditions prior to initiating berm maintenance #2.
