MEMORANDUM

PROJECT: Kauai Kailani Beach Restoration (Project No. 201752)

SUBJECT: Preliminary Completion Report for Category II Small-Scale Beach Nourishment Seaward of Kauai Kailani Condominiums at 4-856 Kūhiō Highway, Kapa'a, Kaua'i, TMK: (4) 4-3-009:041

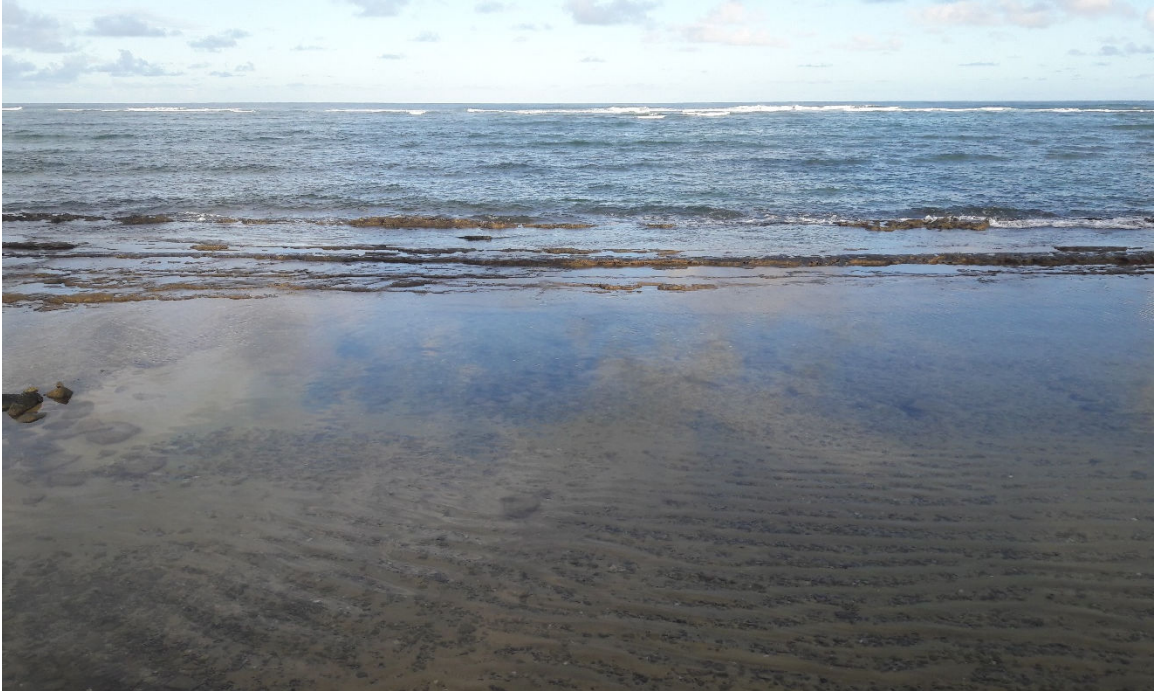
Figure 2. Photograph taken before construction, on October 31, 2018, showing typical nearshore conditions, facing east

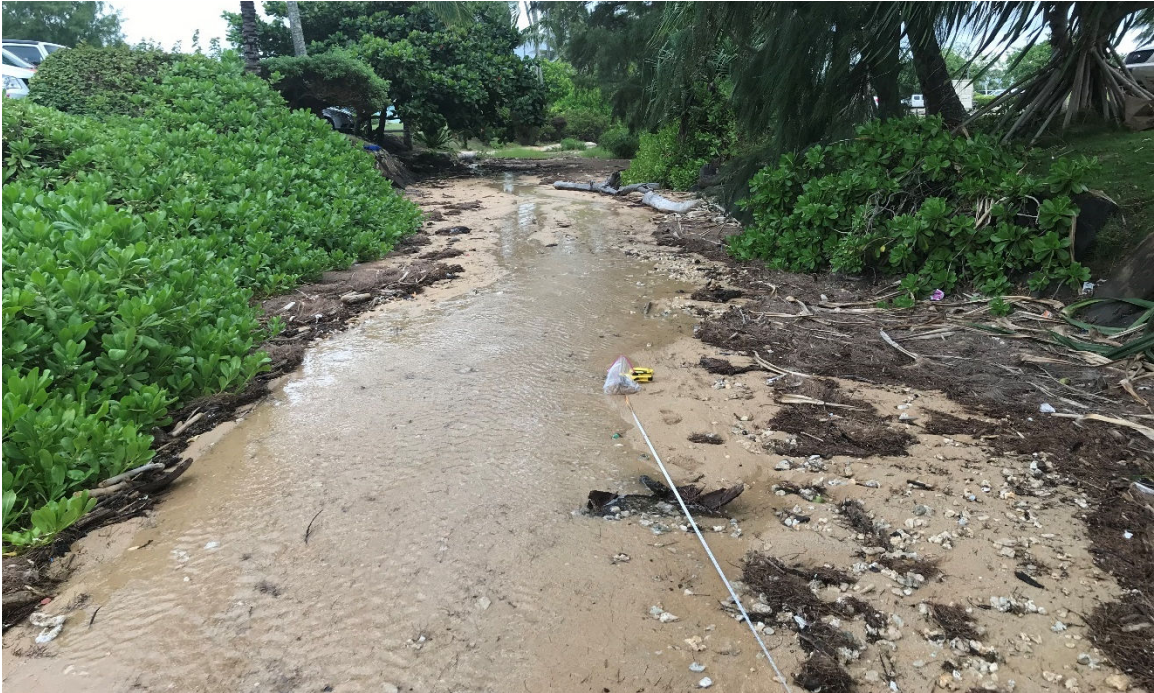
Figure 5. Photograph taken before construction, on August 1, 2018, showing Waipouli Drainage Canal, facing west

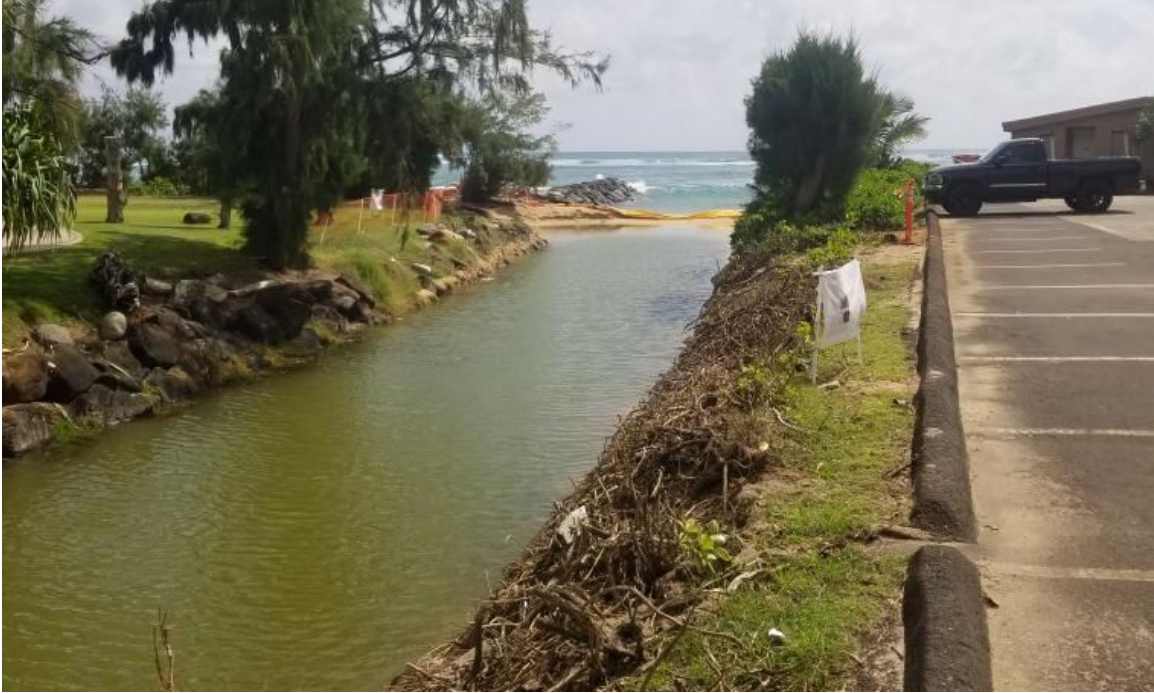
Figure 9. Photograph taken during construction, on February 16, 2023, showing the dredged Waipouli Drainage Canal, facing east

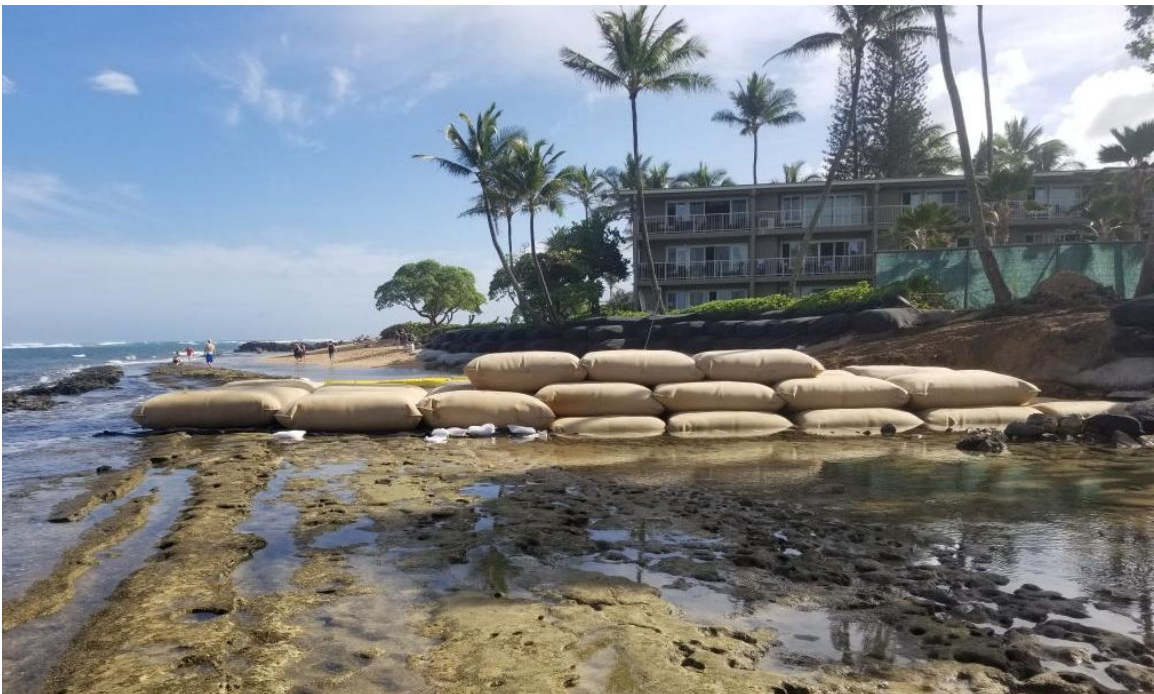
Figure 10. Photograph taken during construction, on March 31, 2023, showing installation of the sandbag groin during low tide, facing south

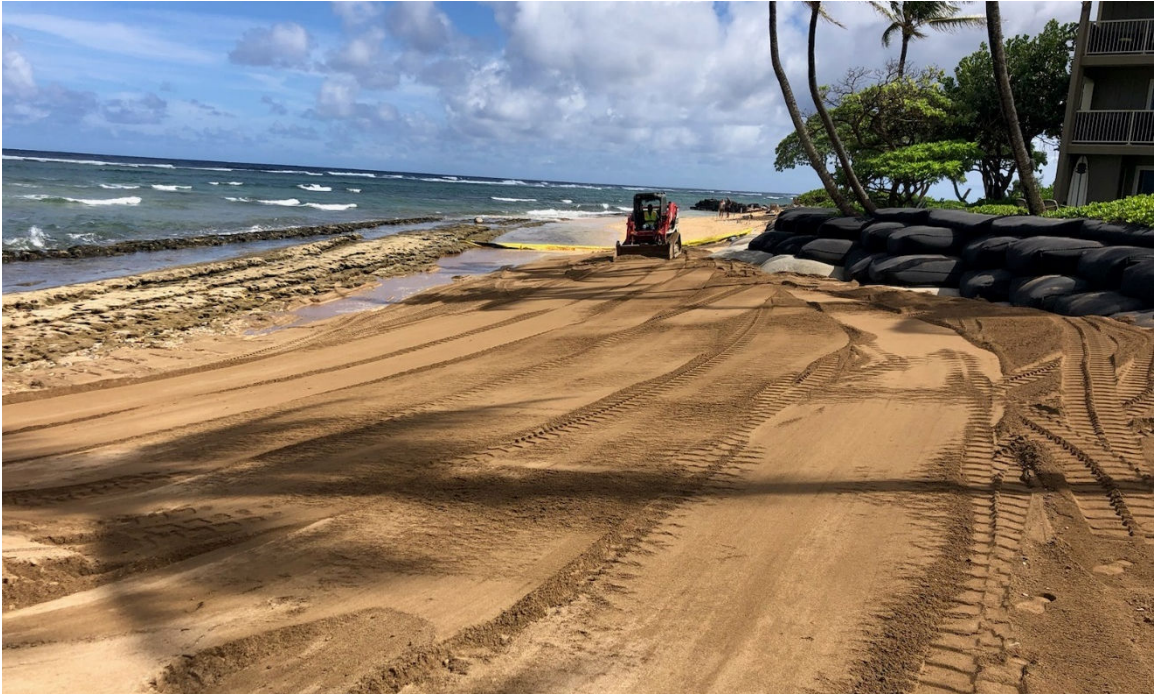
Figure 11. Photograph taken during construction, on April 10, 2023, showing placement of beach nourishment during low tide, with silt curtain BMP in place, facing south

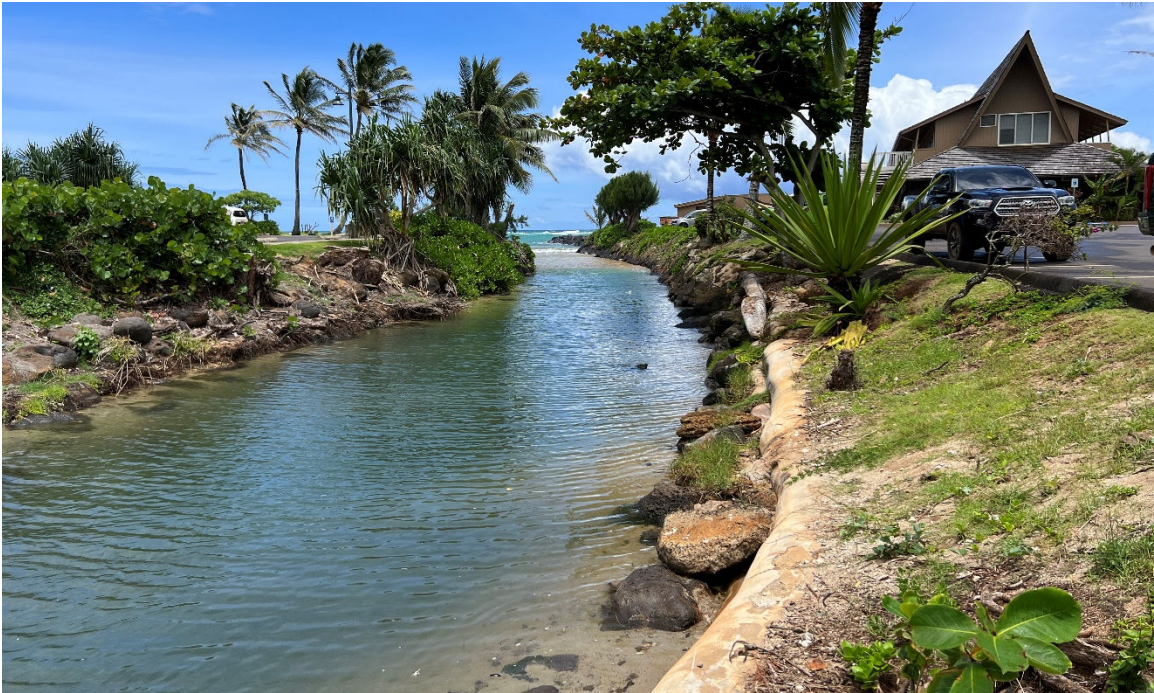
Figure 12. Photograph taken during construction, on May 17, 2023, showing the dredged Waipouli Drainage Canal, facing east

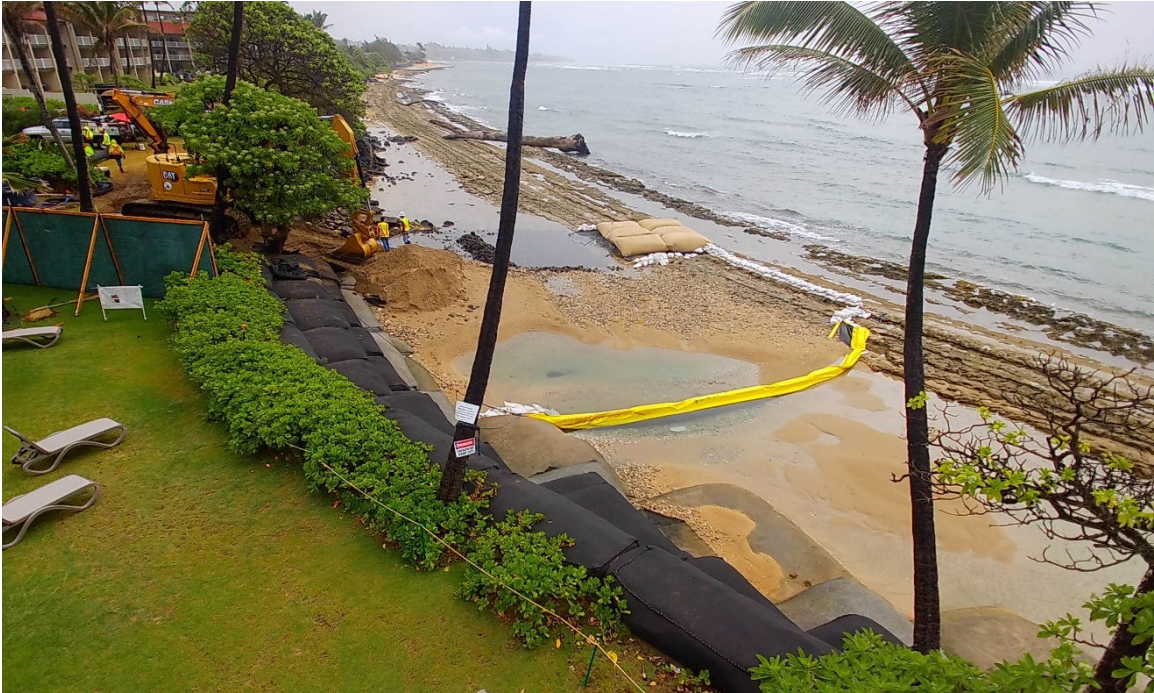
Figure 22. Photograph taken on March 23, 2023, at 9:33 AM, during project construction

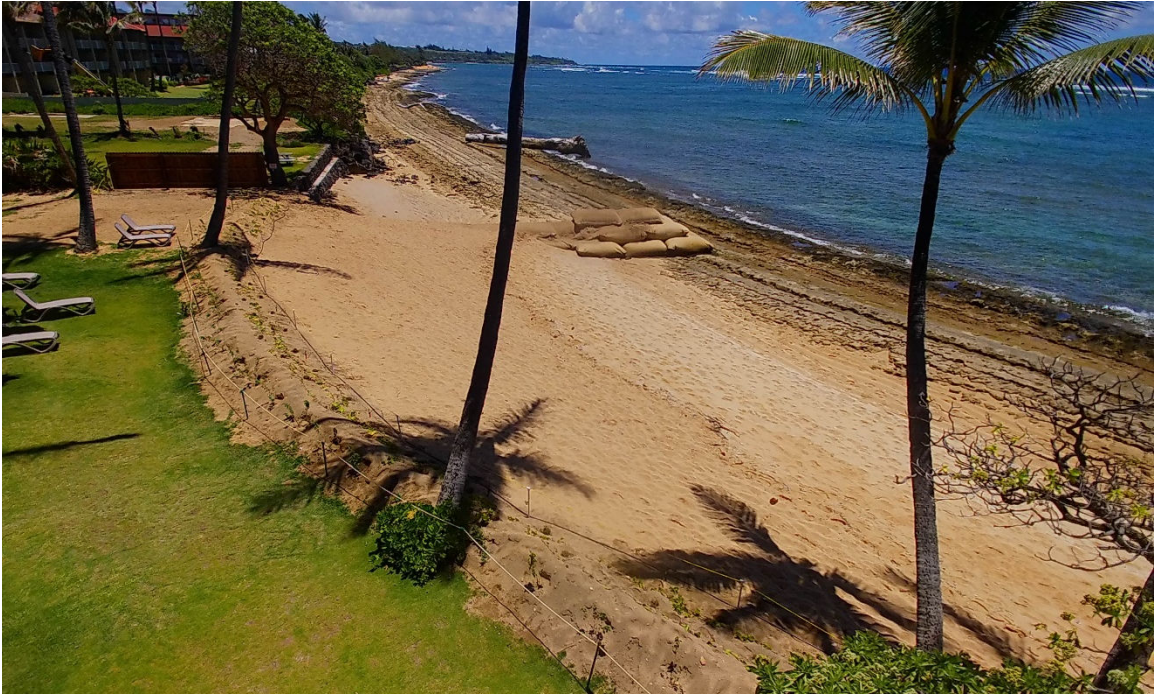
Figure 23. Photograph taken on June 6, 2023, at 12:05 PM, after sand fill and groin placement
