Sugar Cove Berm Maintenance Effort #6 Monitoring

Sugar Cove, Spreckelsville, Maui, Hawaii

March 2025

Sea Engineering, Inc.
504 N. Nimitz Hwy
Honolulu, HI 96817

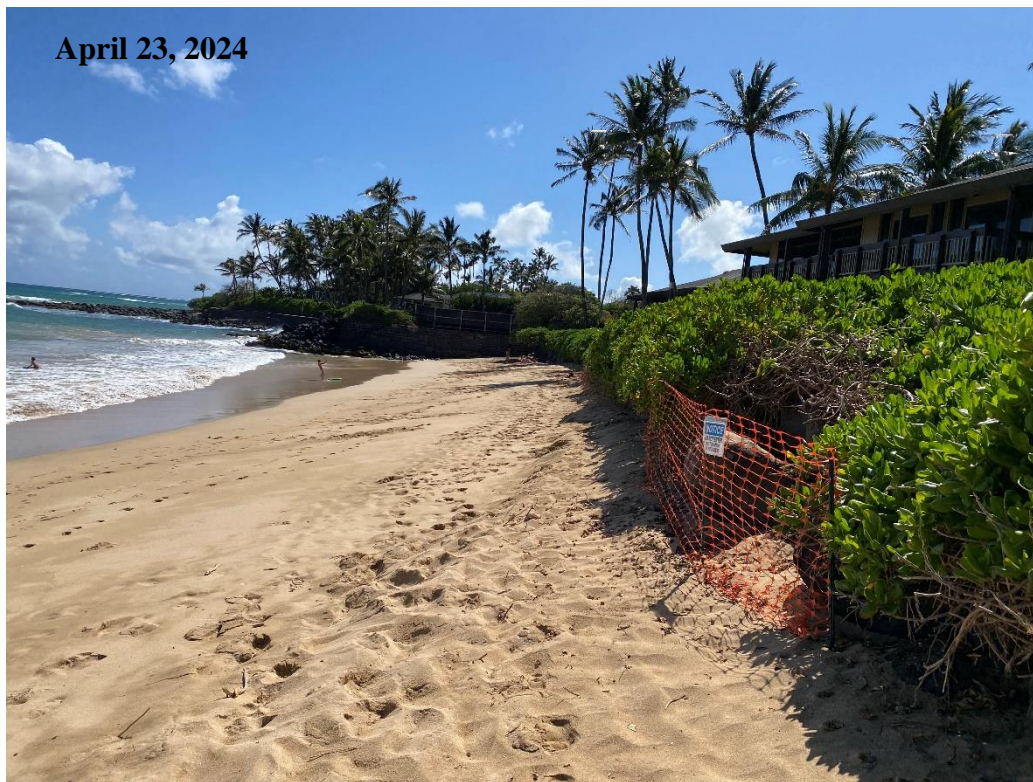
The restored beach has a stable berm between the active berm crest and the seawall's backstop (Figure 1-8, and Figure 1-9). The County beach access at the east end of the beach has a sand slope leading inland. The full expanse of the restored beach and berm area is a public resource. Since the last maintenance effort in April 2024, the beach at Sugar Cove has stayed relatively stable at the western end but has deflated at the eastern end resulting in net erosion.

Figure 1-8. Looking east along the beach, from near the middle of the maintenance area

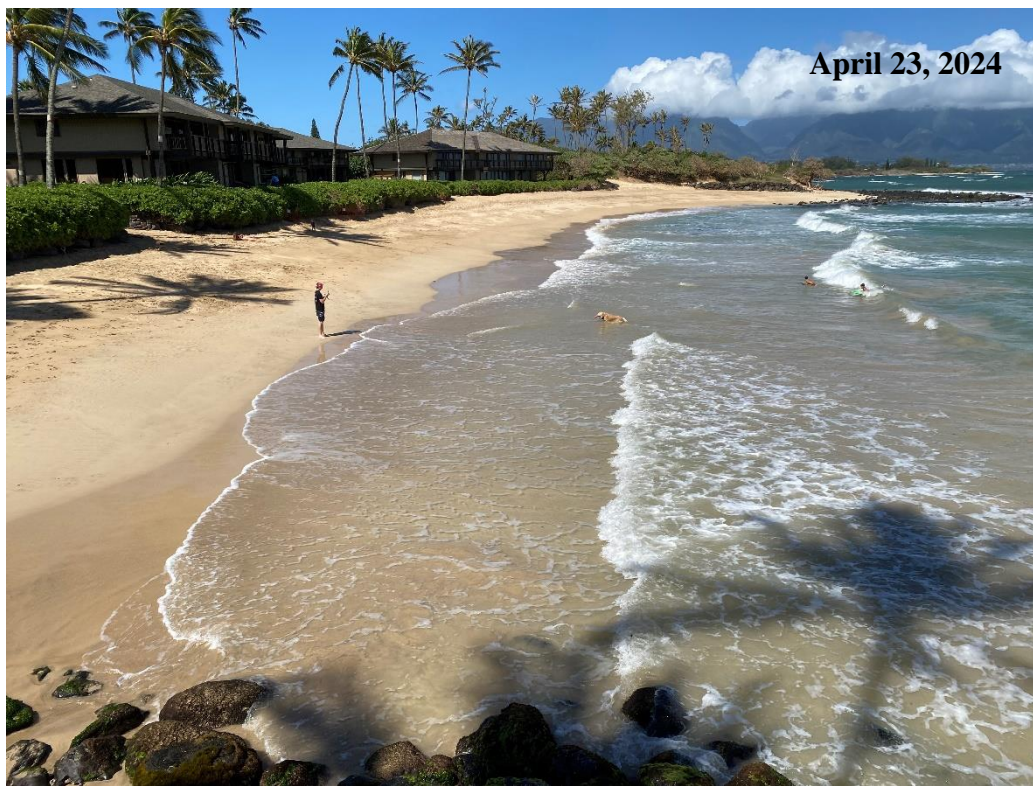
Figure 1-9. Looking west along the beach, from near the eastern end of the maintenance area

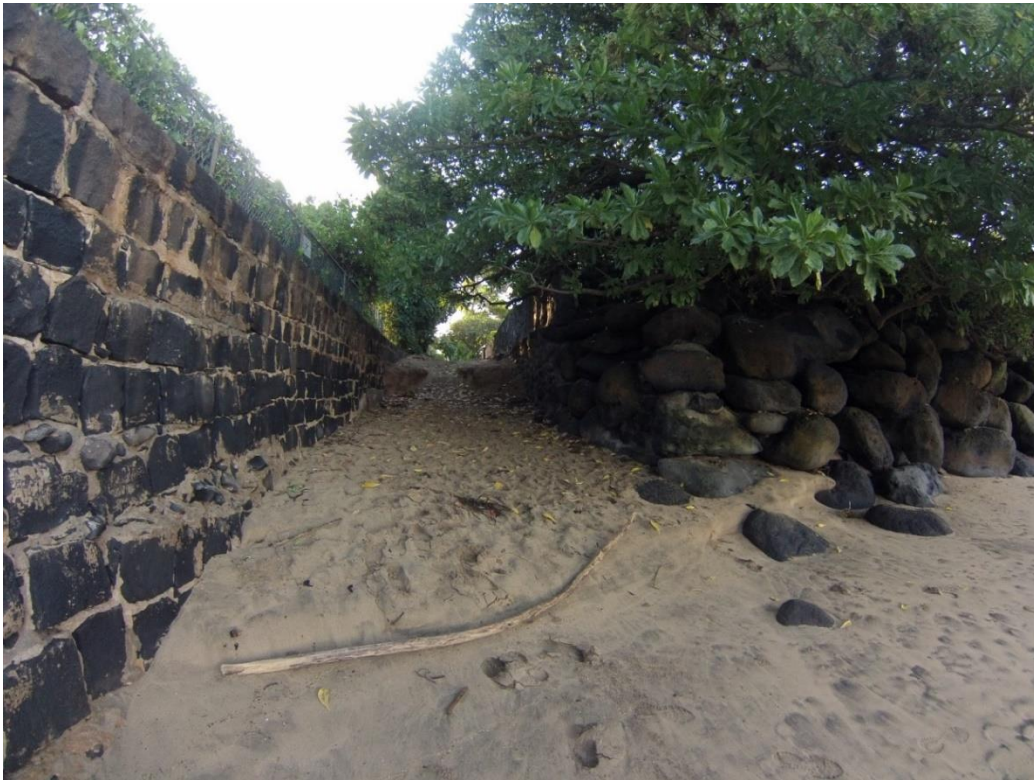
Figure 4-8. County of Maui beach access path prior to sand placement (Maintenance #1)

The makai face of the material was graded to as gentle a slope as was possible, given the already deflated and narrow beach profile. 60 ton of sand was placed in the County of Maui beach access to cover the pre-existing irregular grade (Figure 4-8), including a 3-foot-tall ledge (Figure 4-9). The final grade in the access was a smooth slope from the top of the access path to the beach berm (Figure 4-10).

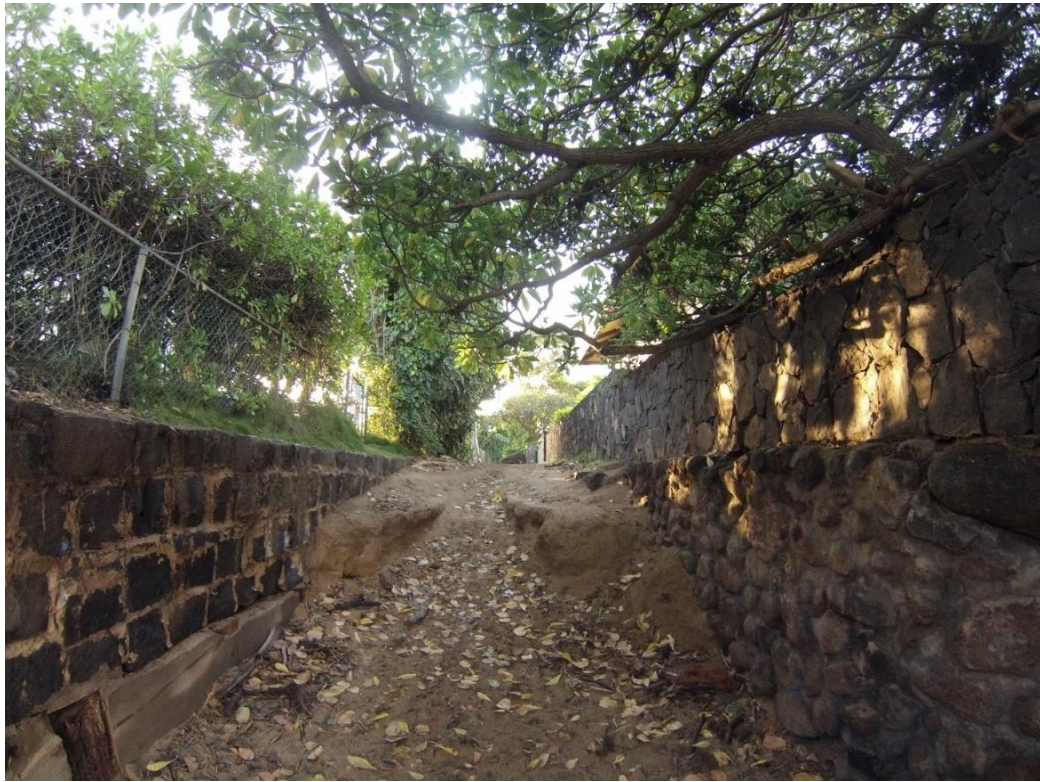
Figure 4-9. Three-foot scarp in County of Maui beach access path (Maintenance #1)

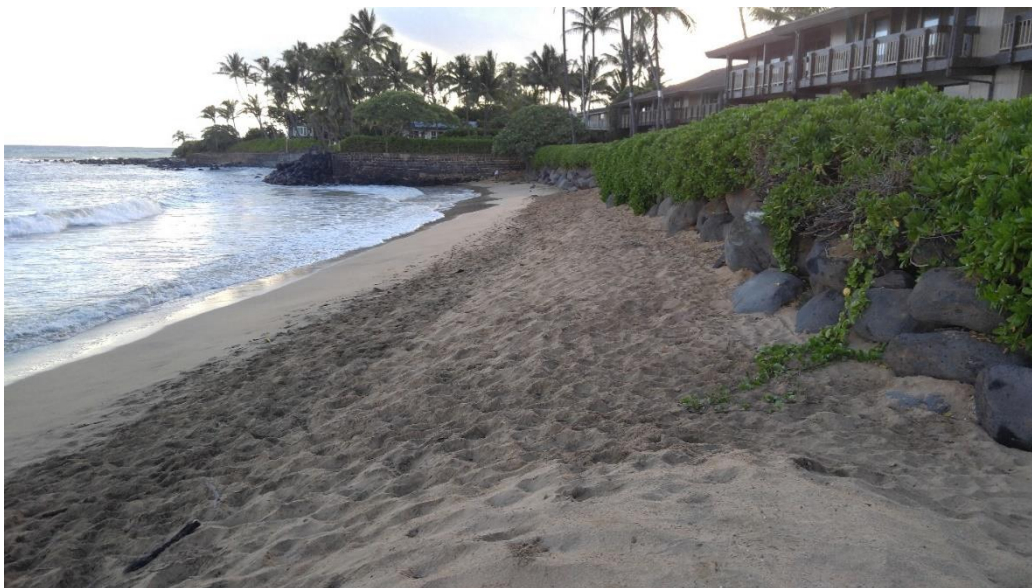
Figure 5-4. Beach condition prior to placement on September 6, 2016 (Maintenance #2)

Final Grade: The upper portion of the berm maintenance sand was placed atop the low elevation berm (Figure 5-4) on the beach profile and was graded to a nearly horizontal plane (Figure 5-5). The makai face of the material was graded to as gentle a slope as was possible, given the already deflated and narrow beach profile.

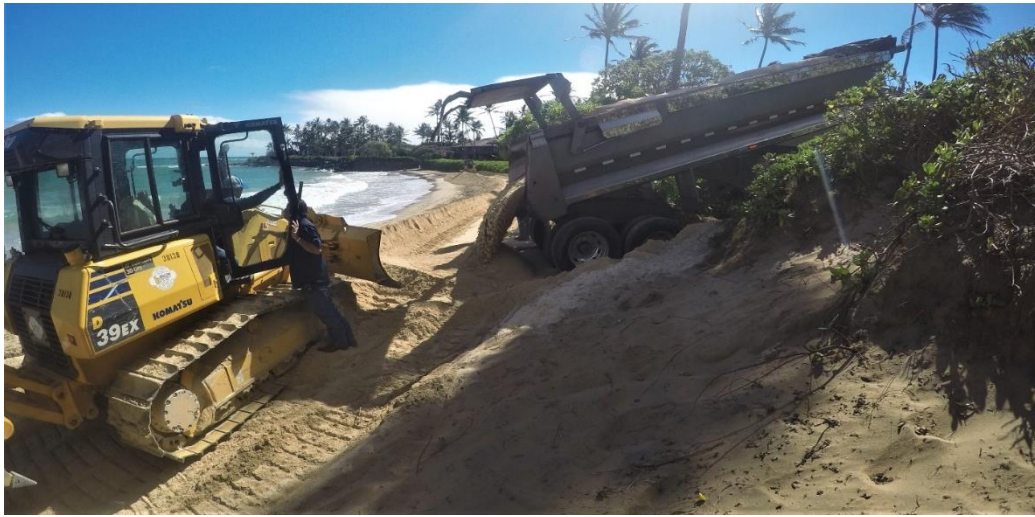
Figure 7-1. Dump truck delivering sand to the west end of the cove for placement on the berm (Maintenance #4)

Delivery Method: The sand was first shipped from Oahu to Maui on a barge. Several delays with the barge and weather resulted in a 5-day delay of arrival to Maui. The Pacific Aggregate sand was located on the barge for the duration of the delay. The sand arrived on September 28, 2021. From Kahului Harbor, Gomes Trucking and Tavares Trucking utilized vehicles to maintain a consistent delivery pace of about 12 trucks per hour for a total of about 60 truckloads between 1000 and 1700. Truck delivery of sand to the berm was at the west end of the embayment, through the Sugar Cove property to the public beach. A small gap was cut into the sand bank (Figure 7-1) allowing the trucks to deliver sand directly to the berm.

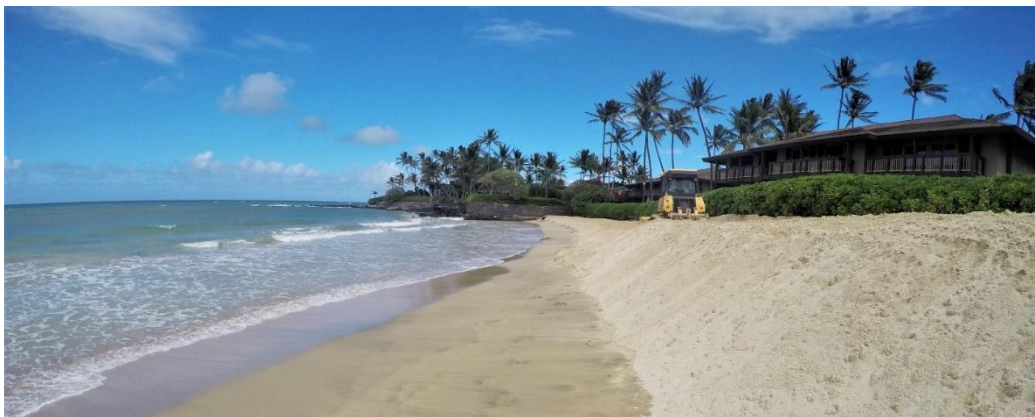
Figure 7-3. Graded sand with finished makai slope ending near the public access at the eastern neighbor's seawall (Maintenance #4)

Final Grade: The upper portion of the berm maintenance sand was placed atop the low elevation berm (Figure 7-3) on the beach profile and was graded to a nearly horizontal plane (Figure 7-4). The makai face of the material was graded to as gentle a slope as was possible, given the already deflated and narrow beach profile.

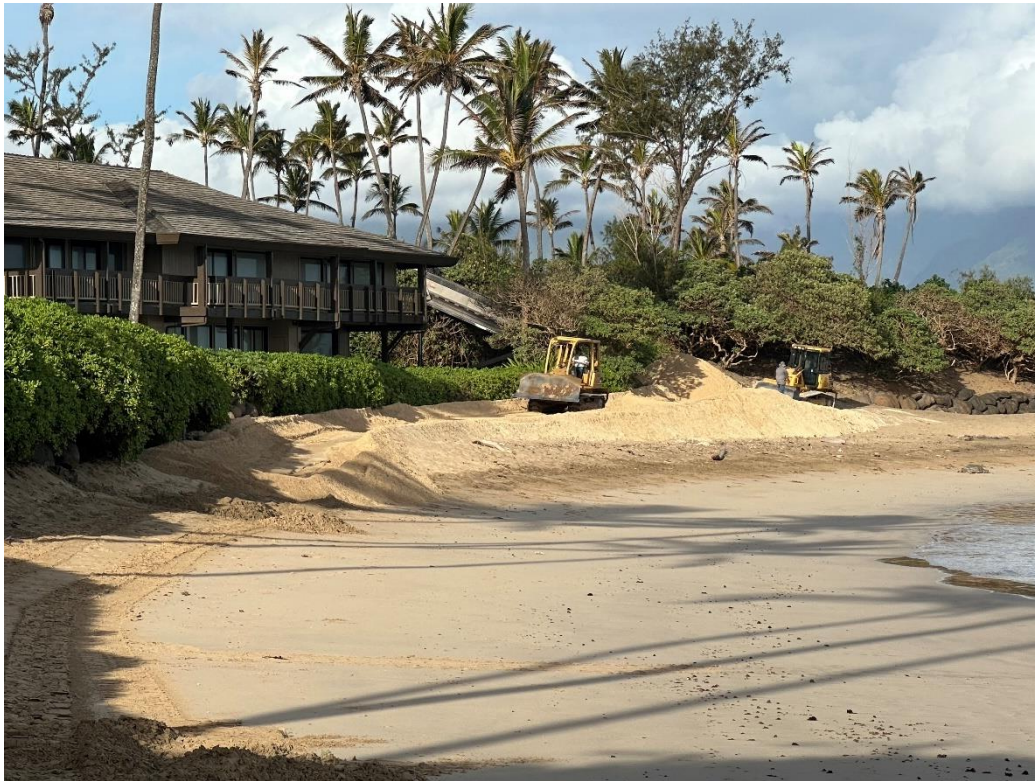
Figure 8-1. Dump truck delivering sand to the west end of the cove for placement and bulldozers spreading sand on the berm (Maintenance #5)

Delivery Method: From a stockpile site, Gomes Trucking and Tavares Trucking utilized vehicles to maintain a consistent delivery pace of about 12 trucks per hour for a total of about 60 truckloads between 1000 and 1700. Truck delivery of sand to the berm was at the west end of the embayment, through the Sugar Cove property to the public beach. A small gap was cut into the sand bank (Figure 8-1) allowing the trucks to deliver sand directly to the berm.

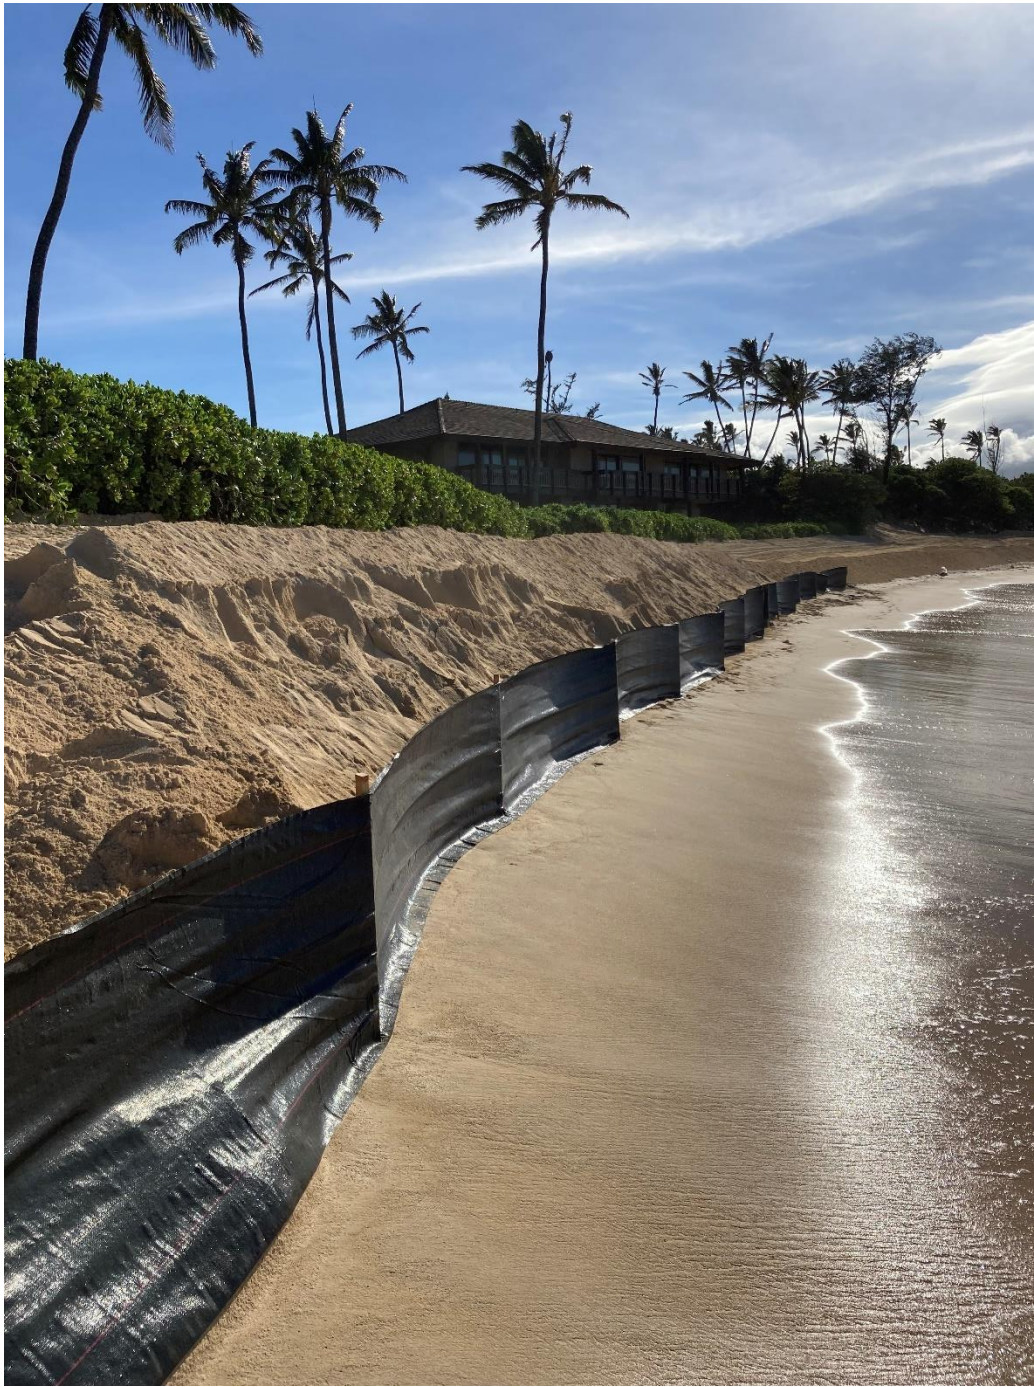
Figure 8-2. Beach and berm condition after placement on September 12, 2023 (Maintenance #5)

Final Grade: The upper portion of the berm maintenance sand was placed atop the low elevation berm (Figure 8-2) on the beach profile and was graded to a nearly horizontal plane (Figure 8-3). The makai face of the material was graded to as gentle a slope as was possible, given the already deflated and narrow beach profile.

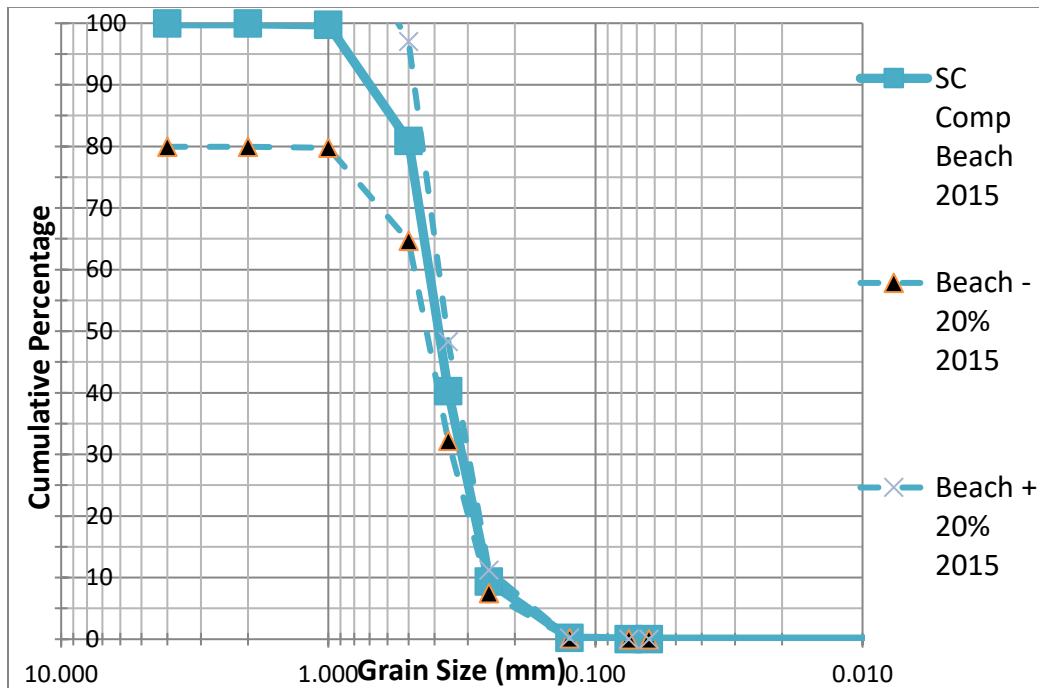
Figure 10-1. Grain size distribution for beach sand samples, composite beach sample, and the $\pm 20\%$ thresholds (Pre-Maintenance #1)

Figure 10-1 is a graph of the sand samples collected prior to the first maintenance effort. These samples were collected within the swash zone, at the wet/dry line, on the upper beach face, and from the berm near the stairwell at the center of the project area's shoreline. The composite sample is a combination of all four of these samples. Also shown on the graph are the $\pm 20\%$ thresholds for the composite beach sand sample. The composite sample of beach sand grains is normally sorted material within the range of coarse (1 mm) to very fine (0.125 mm) sand. The composite sample's median grain size is within the medium sand range, just smaller than 0.4 mm in diameter.

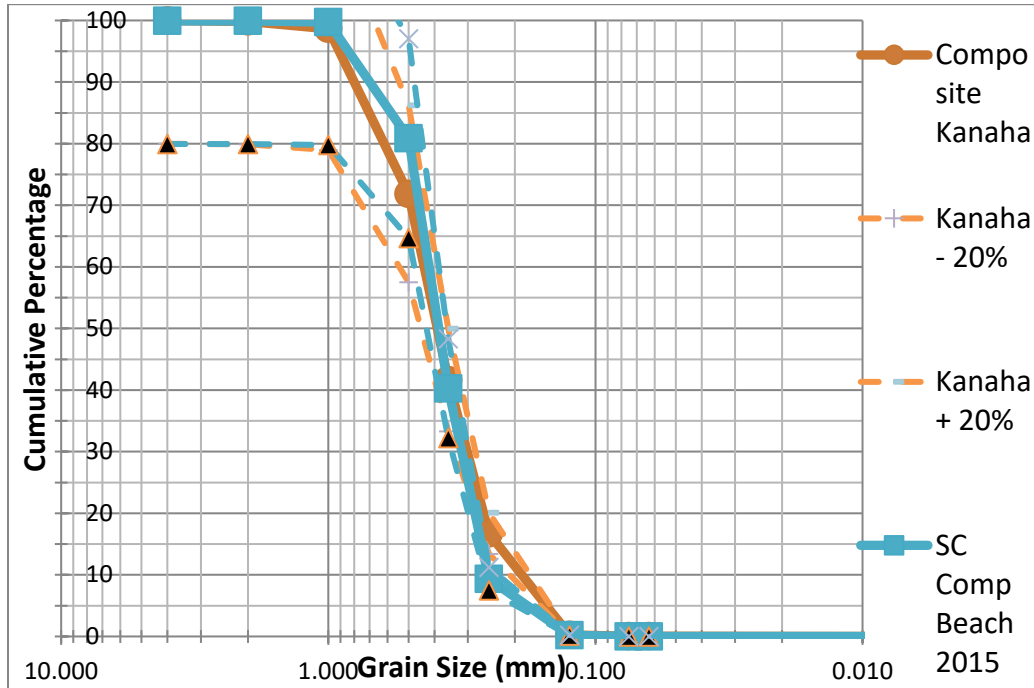
Figure 10-2. Grain size distribution for beach sand samples for Sugar Cove and Kanaha Beach, composite beach sample, and the +/- 20% thresholds (Pre-Maintenance #1)

Figure 10-2 depicts the grain size fraction relationship between Sugar Cove's restored beach and Kanaha Beach, which is a native beach that is also located within Spartan Reef. The composite sample from Kanaha Beach fits within the $\pm 20\%$ ranges of Sugar Cove's composite beach sand and is overlapping for median grain size. The similarity between the two samples further highlights the success of previous restoration efforts at Sugar Cove.

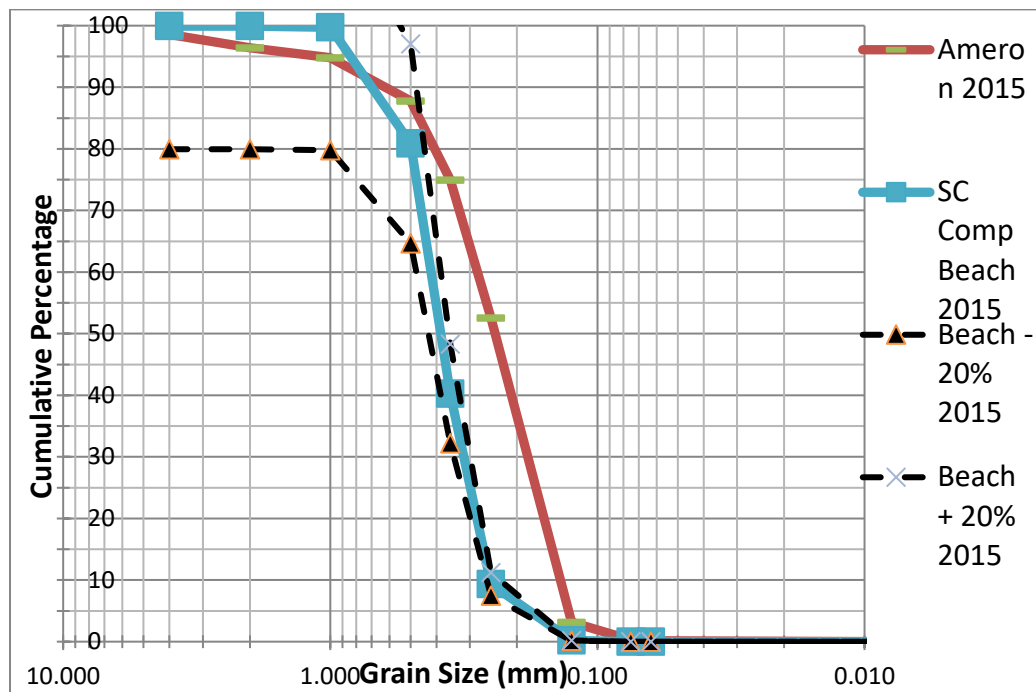
Figure 10-3. Grain size distribution for composite beach sample, the +/- 20% thresholds and the berm fill sand sample (Maintenance #1)

This sand is light reddish brown in color and has a median grain size of 0.28 mm. 97.9% of the material is within the range of sand grain size, and 2.1% is silt size. This material is dominantly marine carbonate sediment in origin. The berm fill sand did not fit entirely within the +/- 20% brackets around the composite existing beach sand sample (Figure 10-3). This may be a result of variation in the sieve sizes used for analysis of the sand samples. Regardless, the berm fill sample was finer in nature than the existing beach sand.

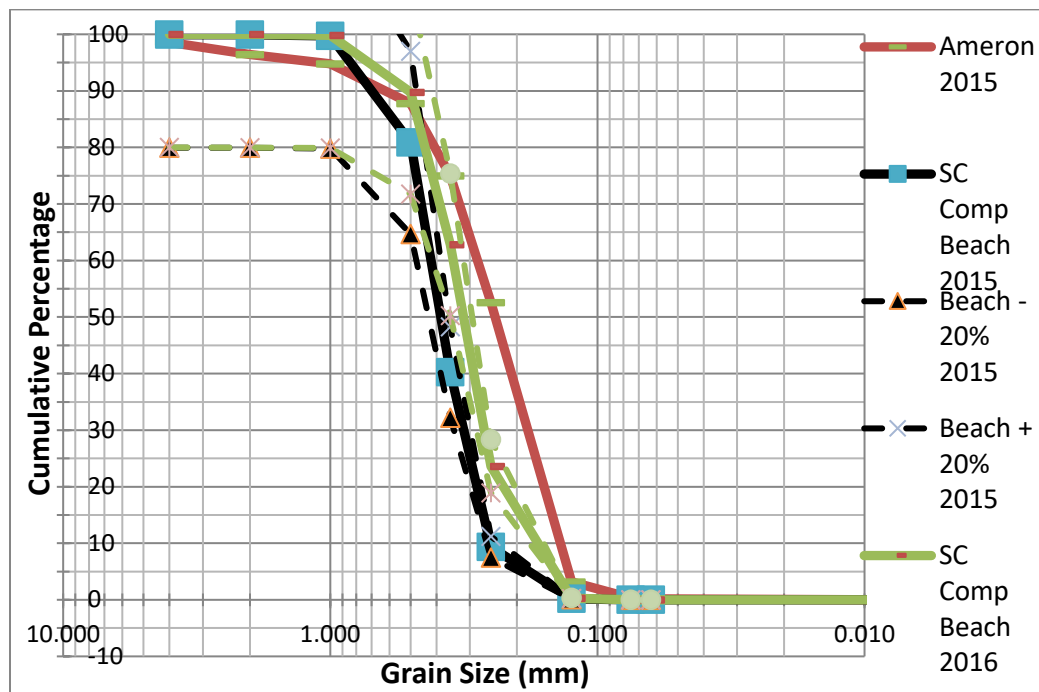
Figure 10-4. Grain size distribution for pre-maintenance and post-maintenance composite Sugar Cove beach samples, and the +/- 20% thresholds (Pre and post-maintenance #1)

Figure 10-4 is a graph of the grain size distribution from the sand samples after maintenance #1 and before maintenance #2 (SC Comp Beach 2016). These samples were collected within the swash zone, at the wet/dry line, on the upper beach face, and from the berm near the stairwell at the center of the project area's shoreline. The composite sample is a combination of all four of these samples. Also shown on the graph are the +/- 20% thresholds for the composite beach sand sample.

The composite sample of beach sand grains is normally sorted material within the range of coarse (1 mm) to very fine (0.125 mm) sand. The composite sample's median grain size is within the medium sand range, just smaller than 0.4 mm in diameter.

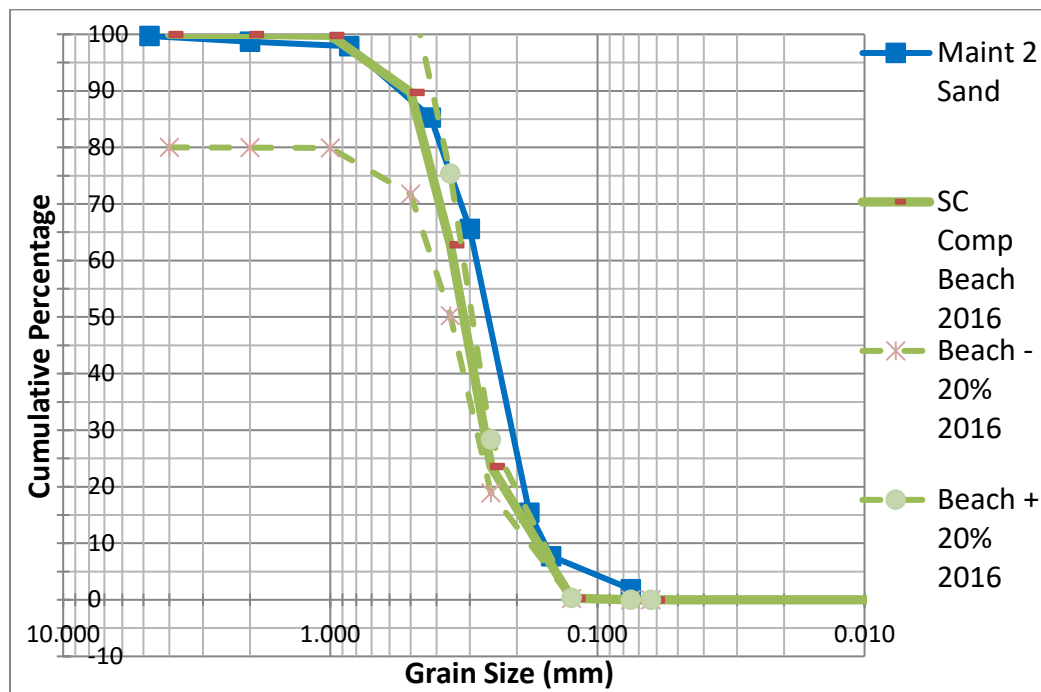
Ameron Inland Dune Sand was utilized again for maintenance effort #2 in 2016. The berm fill sand did not fit entirely within the +/- 20% brackets around the composite existing beach sand sample (Figure 10-5). This may be a result of variation in the sieve sizes used for analysis of the sand samples. Regardless, the berm fill sample was finer in nature than the existing beach sand.

Figure 10-5. Grain size distribution for composite beach sample, the +/- 20% thresholds and the berm fill sand sample (Maintenance #2)

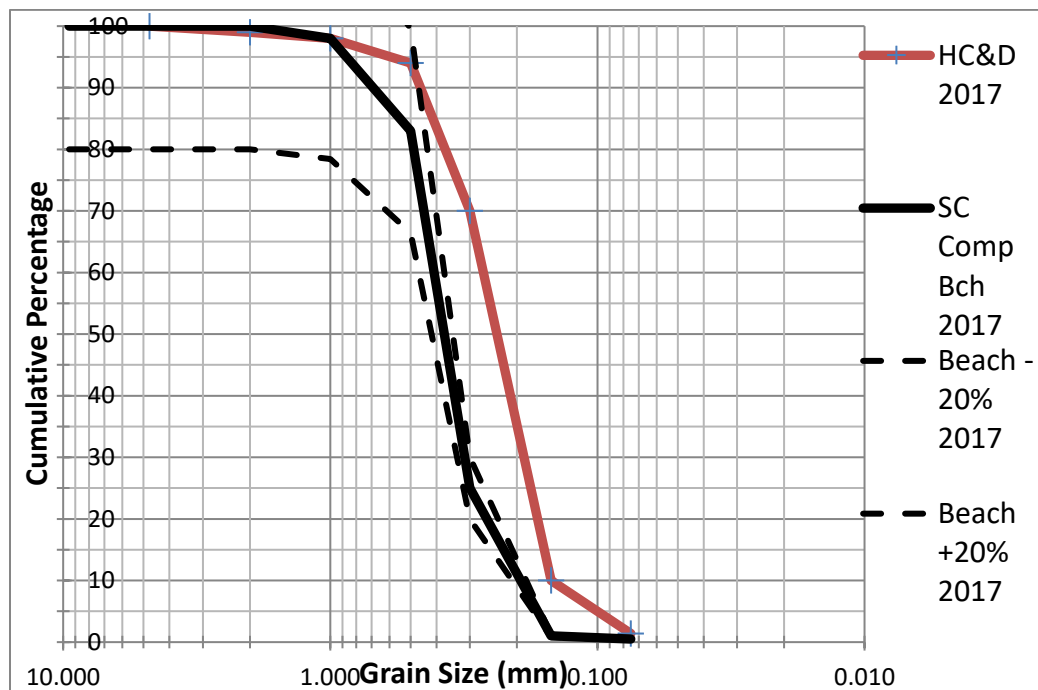
Figure 10-7 is the post-maintenance #2 sand distribution and the Ameron (HC&D) sand source that would have been used for maintenance #3. The composite sample of beach sand grains is normally sorted material within the range of coarse (1 mm) to very fine (0.125 mm) sand. The composite sample's median grain size is within the medium sand range, just smaller than 0.4 mm in diameter.

Figure 10-7. Grain size distribution for composite Sugar Cove beach samples, and the +/- 20% thresholds for the pre-maintenance sample (Post-maintenance #2, Pre-maintenance #3 that did not occur)

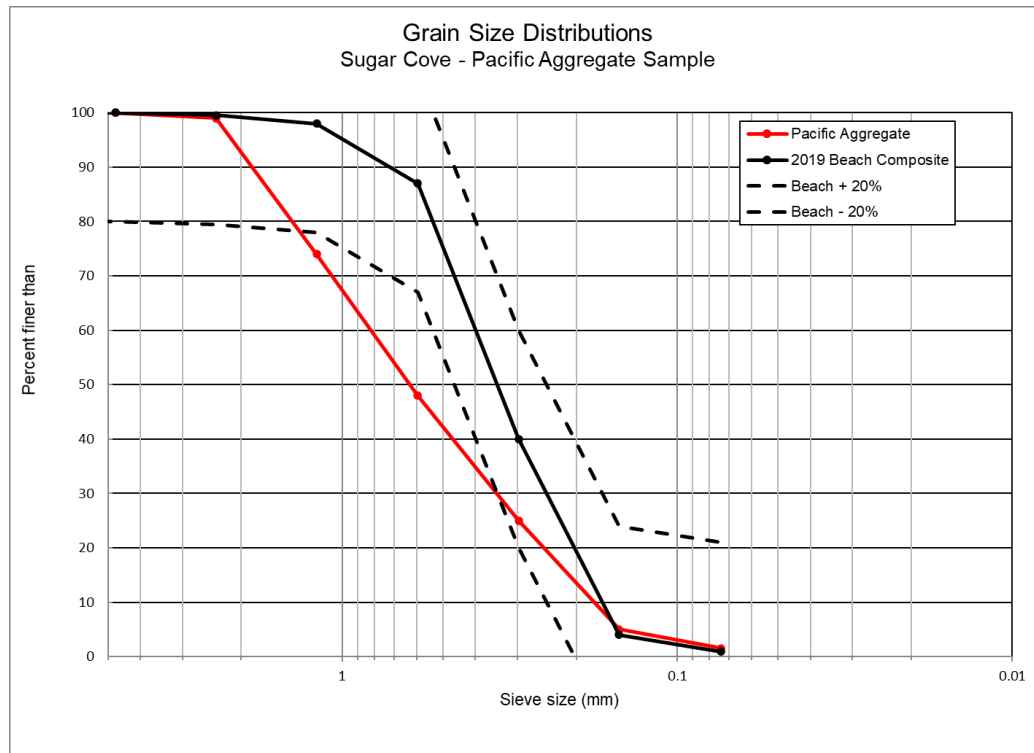
Pacific Aggregate LLC “Natural Sand Blended” was utilized for maintenance effort #3 in 2020. The berm fill sand did not fit entirely within the $\pm 20\%$ brackets around the composite existing beach sand sample (Figure 10-5). The berm fill sample was coarser in nature than the existing beach sand.

Figure 10-9. Grain size distribution for composite beach sample, the $\pm 20\%$ thresholds and the berm fill sand sample (Maintenance #3).

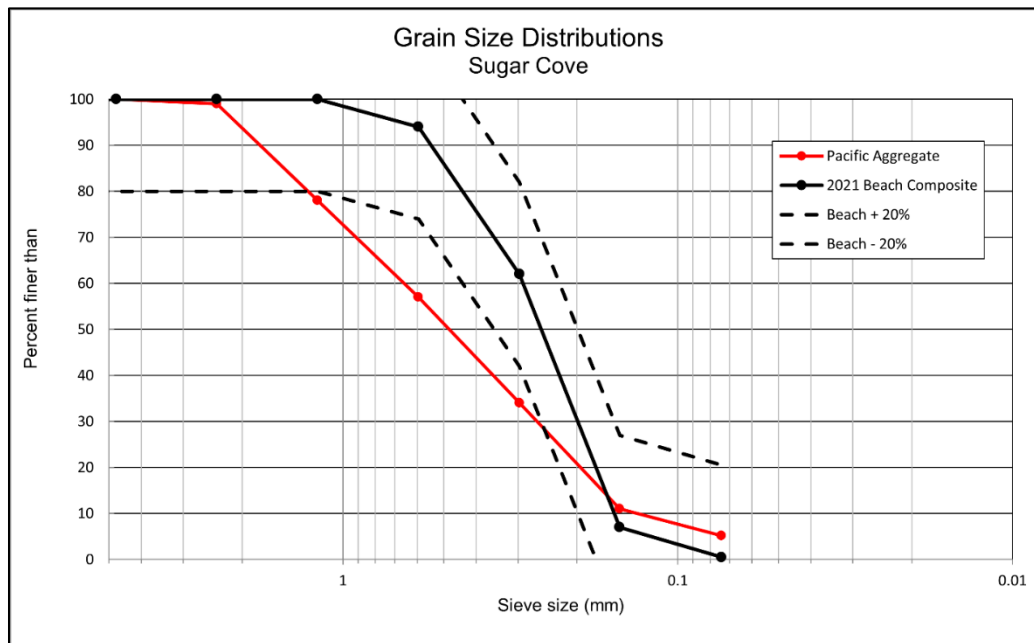
Pacific Aggregate LLC “Natural Sand Blended” was utilized for maintenance effort #4 in 2021. The berm fill sand did not fit entirely within the +/- 20% brackets around the composite existing beach sand sample (Figure 10-12). The berm fill sample was coarser in nature than the existing beach sand. Sand samples prior to the maintenance effort, from the stockpile on Oahu, were similar to the 2020 samples. Grain size analysis results presented below are from hand samples collected during the maintenance effort.

Figure 10-12. Grain size distribution for composite beach sample, the +/- 20% thresholds and the berm fill sand sample (Maintenance #4)

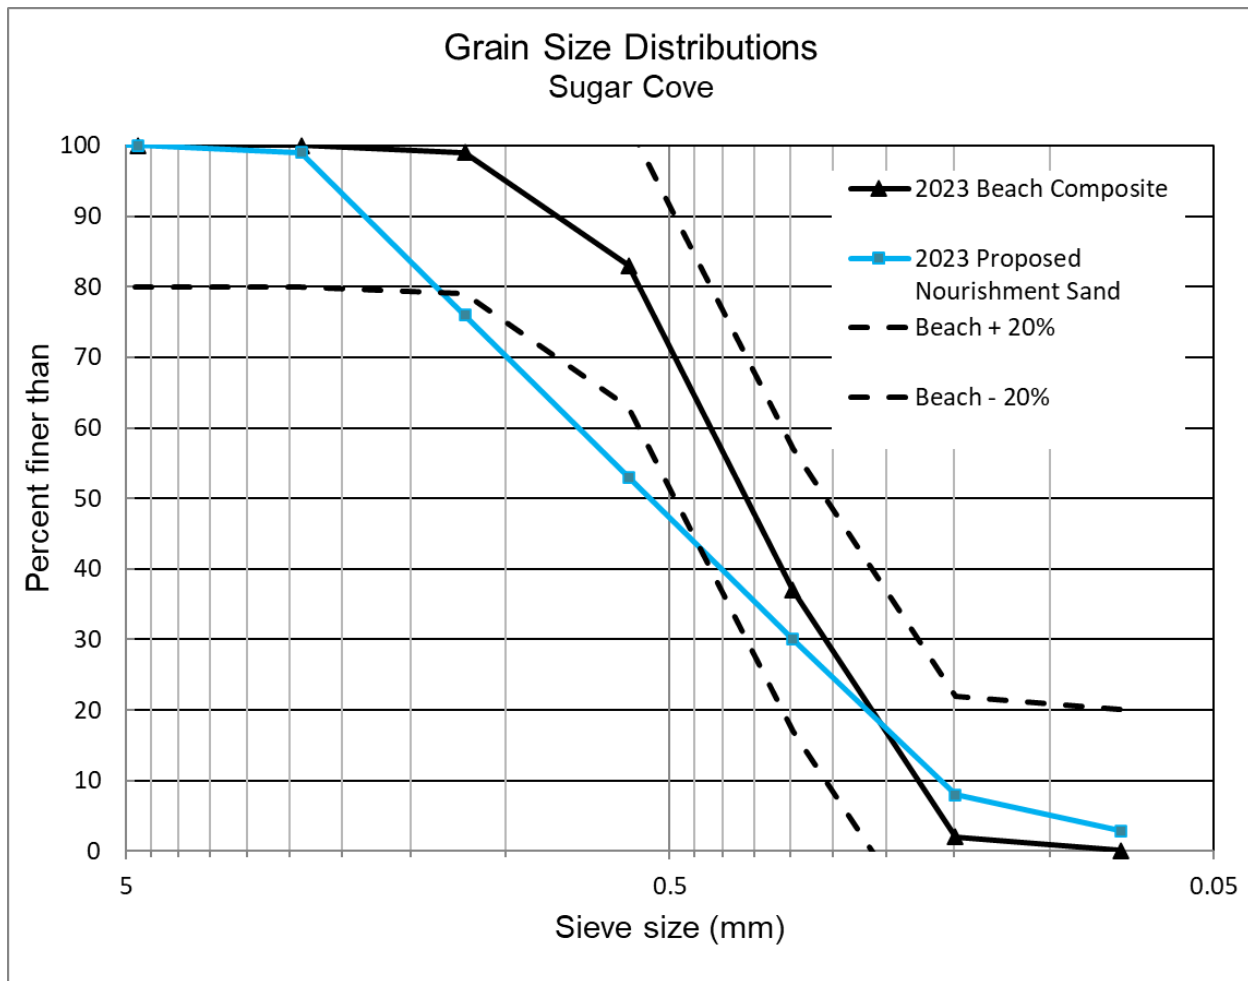
Pacific Aggregate LLC “Natural Sand Blended” was utilized for maintenance effort #5 in 2023. The berm fill sand did not fit entirely within the +/- 20% brackets around the composite existing beach sand sample (Figure 10-12). The berm fill sample was coarser in nature than the existing beach sand. Sand samples prior to the maintenance effort, from the stockpile on Oahu, were similar to the 2021 samples.

Figure 10-14. Grain size distribution for composite beach sample, the +/- 20% thresholds and the berm fill sand sample (Maintenance #5)

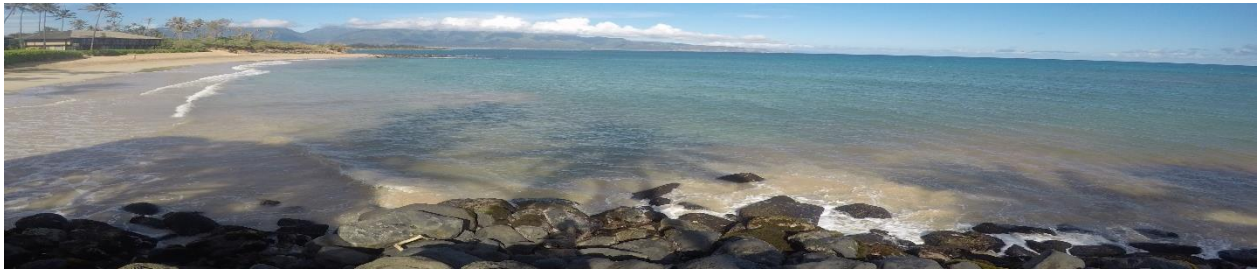
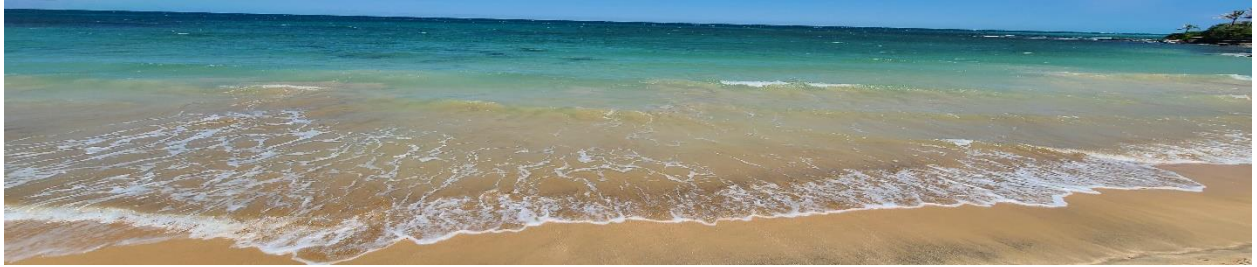
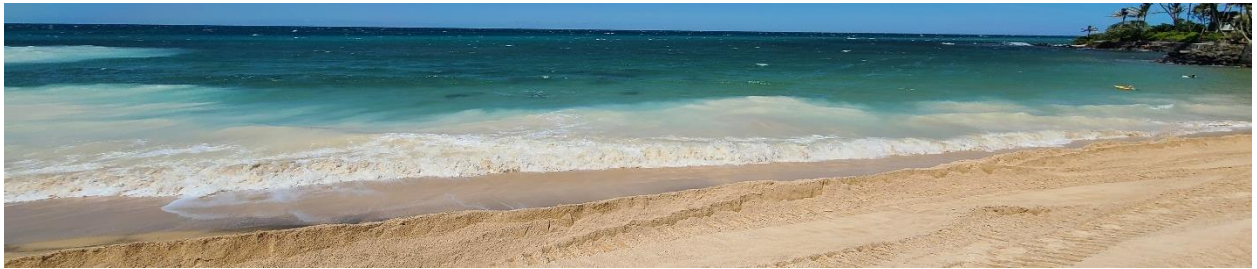
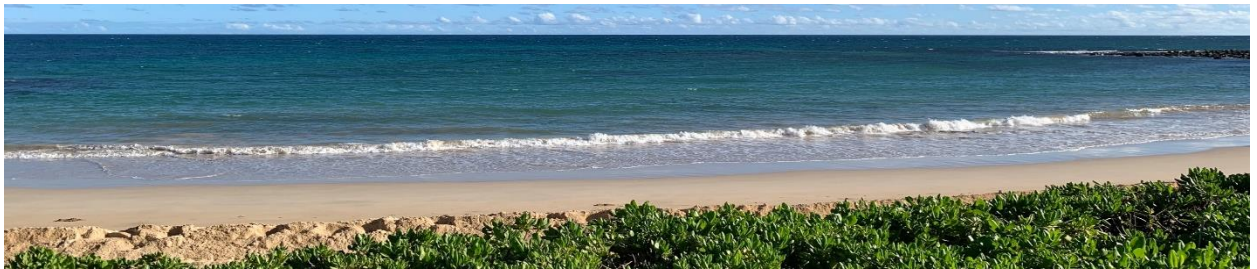
Visual observations for water quality were collected periodically before, during, and after completion of the berm maintenance effort. Water quality in the nearshore, or between the shoreline and the reef crest offshore, varied significantly along the shoreline. After the initial placement, fines were observed in the nearshore, however, offshore conditions beyond the reef crest appeared to be ubiquitous (Figure 10-20-Figure 10-22, Table 10-5). Offshore water quality was noticeably clearer directly offshore of the reef crest. Observations of the nearshore waters at Sugar Cove, Baldwin Beach, and Laulea (the western cove abutting Sugar Cove) are presented in Table 10-5.

For maintenance #3, Sprecklesville was the most turbid every recorded since 2015 when this project began. This is likely due to the erosion occurring there. Baldwin Beach was also found to have a high turbidity. Sugar Cove had a small amount of turbidity that is comparable to what has been observed during previous site visits.

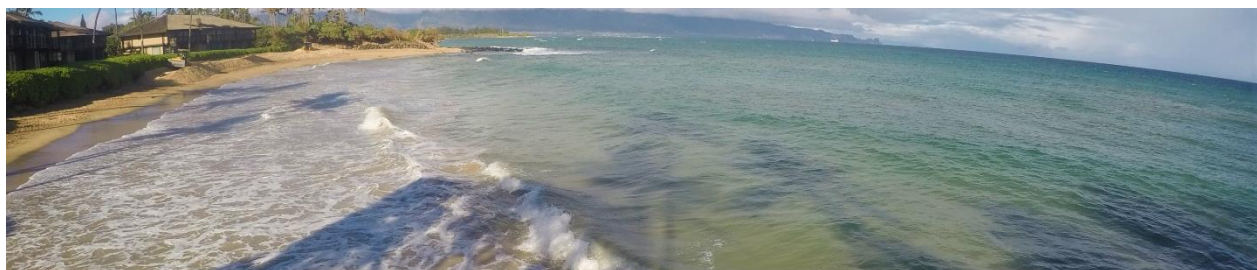
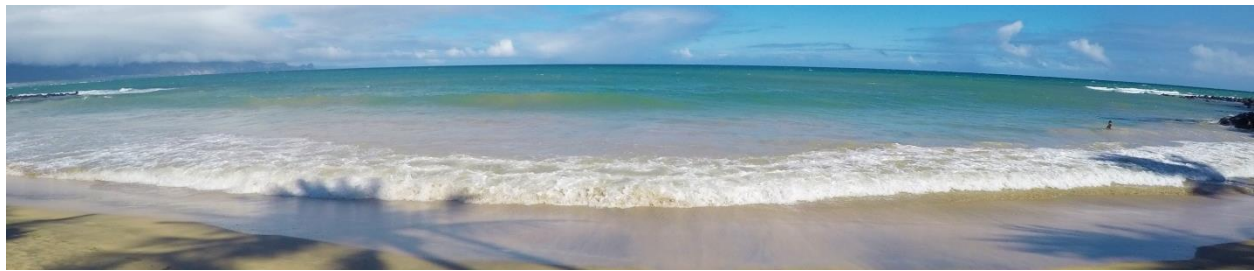
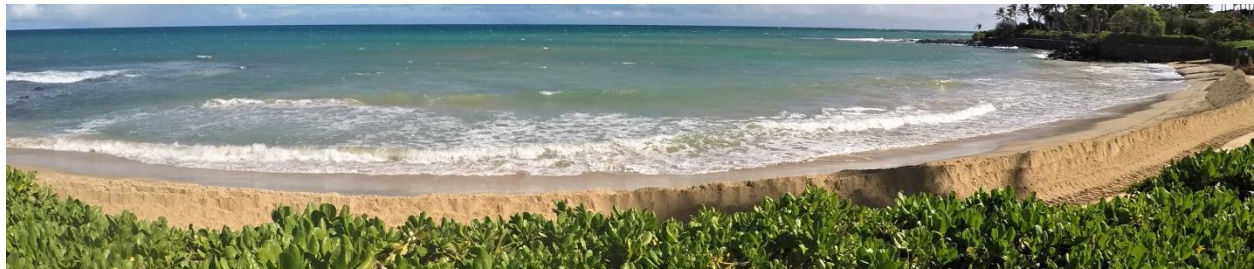
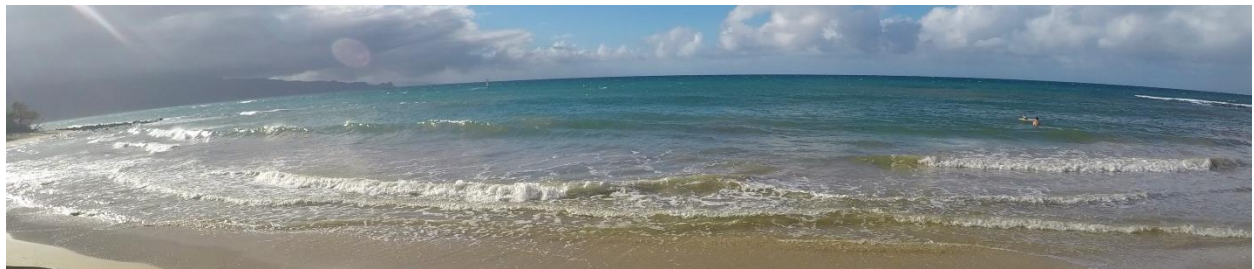
Visual observations for water quality were collected periodically before, during, and after completion of the berm maintenance effort. Water quality in the nearshore, or between the shoreline and the reef crest offshore, varied significantly along the shoreline. After the initial placement, fines were observed in the nearshore, however, offshore conditions beyond the reef crest appeared to be ubiquitous (Figure 10-27 to Figure 10-30, Table 10-11). Offshore water quality was noticeably clearer directly offshore of the reef crest. Observations of the nearshore waters at Sugar Cove, Baldwin Beach, and Laulea (the western cove abutting Sugar Cove) are presented in Table 10-11.

For maintenance #4, all sites were noted as average turbidity in respect to the previous maintenance project records. Baldwin Beach had the most turbid water quality at the project site.

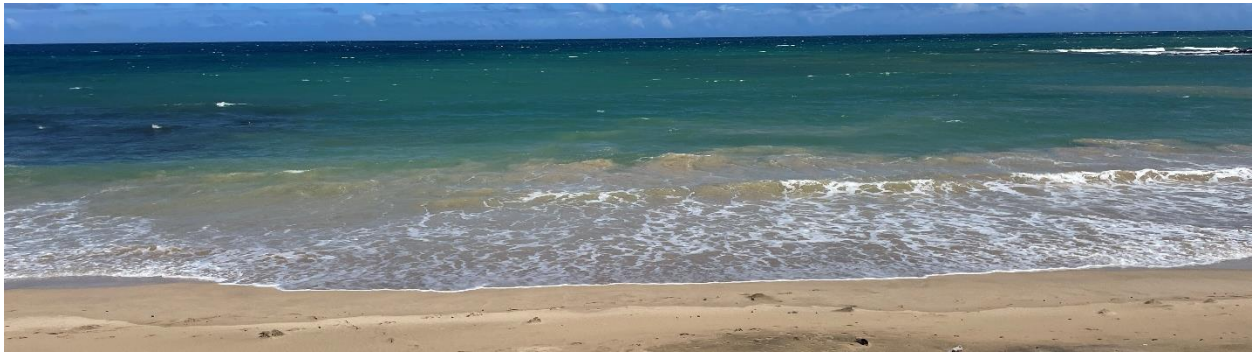
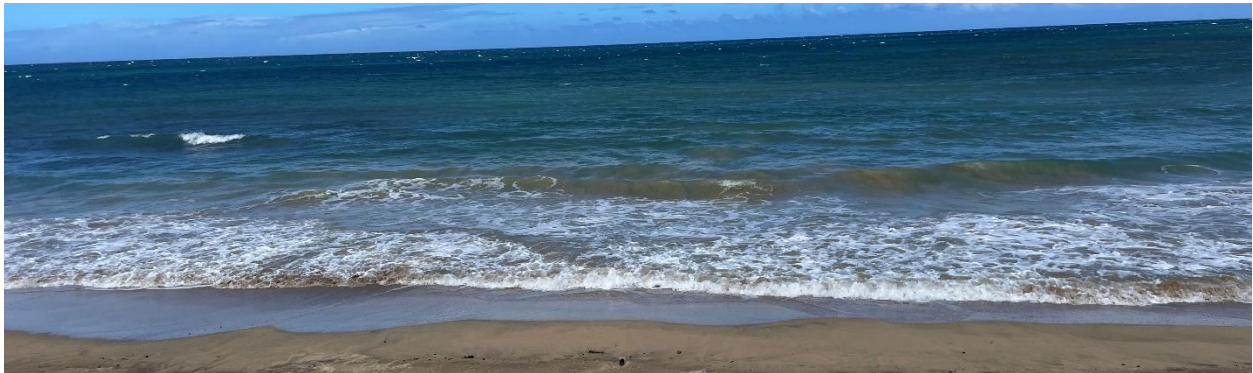
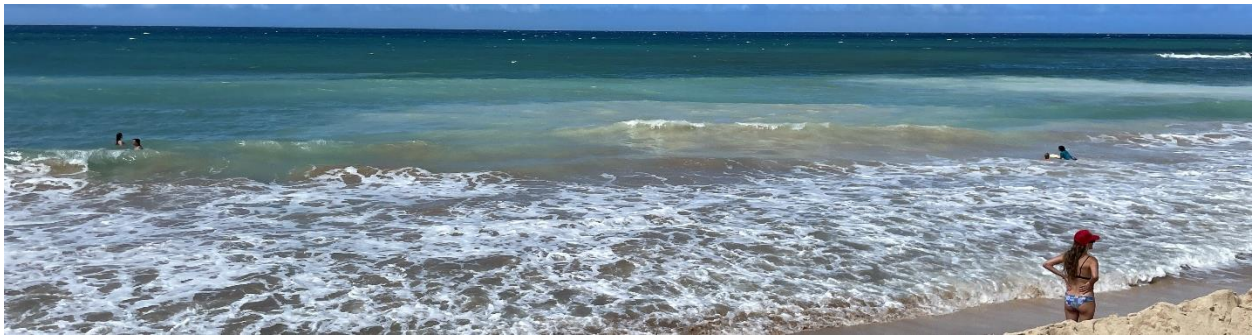
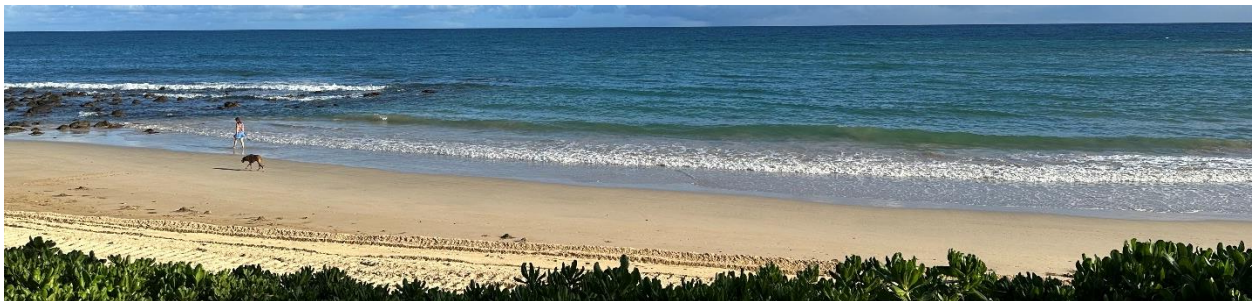
Visual observations for water quality were collected periodically before, during, and after completion of the berm maintenance effort. Water quality in the nearshore, or between the shoreline and the reef crest offshore, varied significantly along the shoreline. After the initial placement, fines were observed in the nearshore, however, offshore conditions beyond the reef crest appeared to be ubiquitous (Figure 10-35 through Figure 10-38). Offshore water quality was noticeably clearer directly offshore of the reef crest.

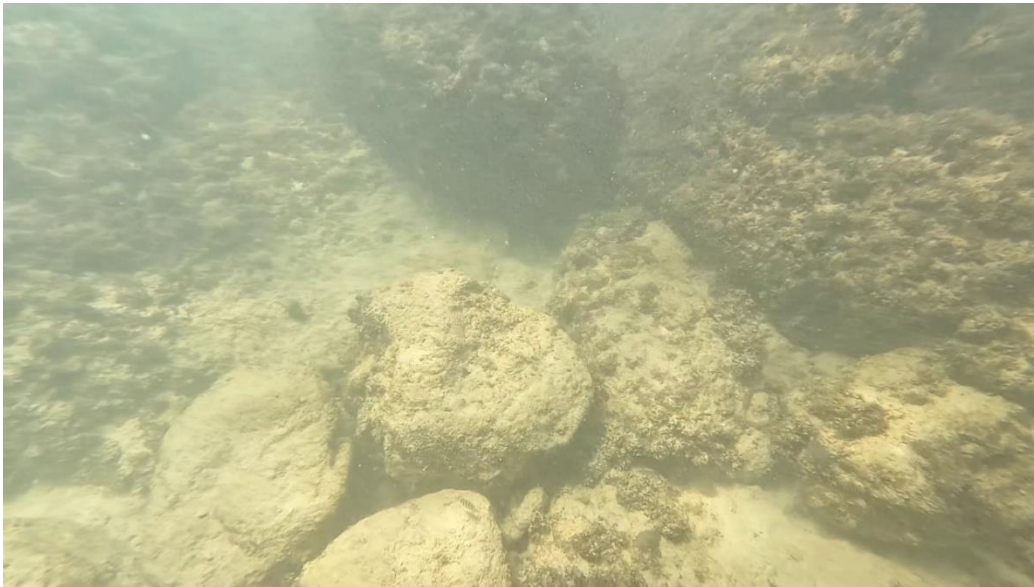
The nearshore area is comprised of a sand field with scattered rocks in the middle of the cove. Sand ripples indicate that the sand is subject to wave orbital motion and that the grain sizes remaining are well-sorted and large enough to remain stable on the seafloor (Figure 10-46). Rocky pavement and boulders extend offshore of the western headland and eastern shoreline armoring units.

Figure 10-46. Sand substrate observed in the nearshore region of the middle of the cove
