Sugar Cove Berm Maintenance Effort #6 Monitoring

Sugar Cove, Spreckelsville, Maui, Hawaii

March 2025

Sea Engineering, Inc.
504 N. Nimitz Hwy
Honolulu, HI 96817

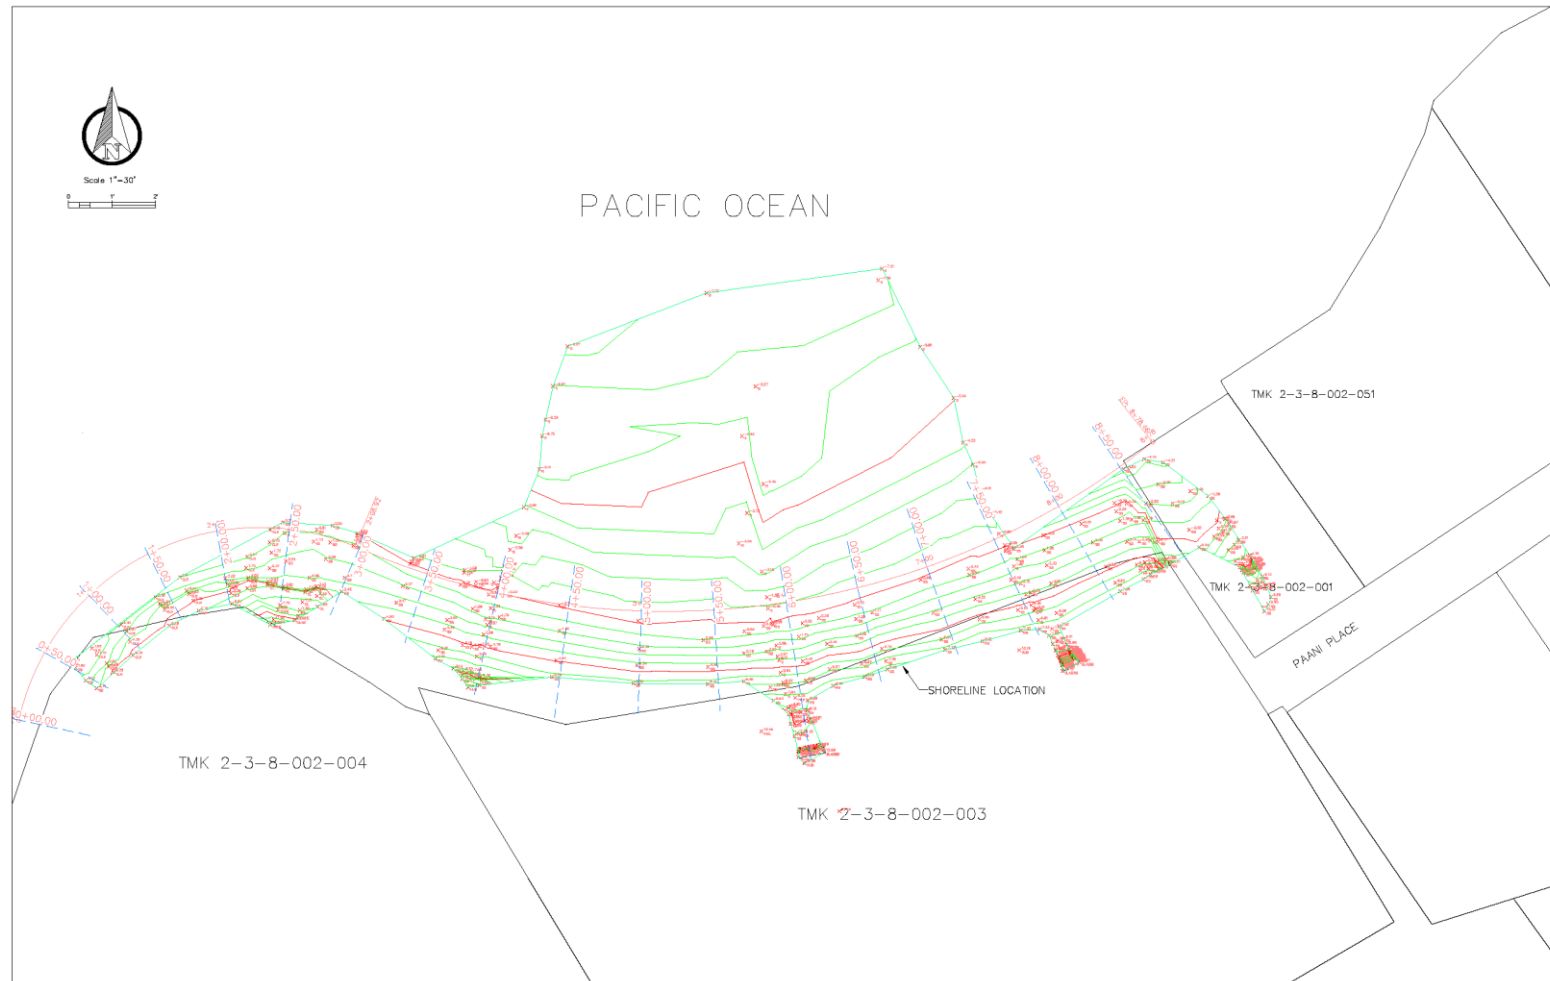
Figure 10-49. November 09, 2015 topography prior to initiating berm maintenance #1

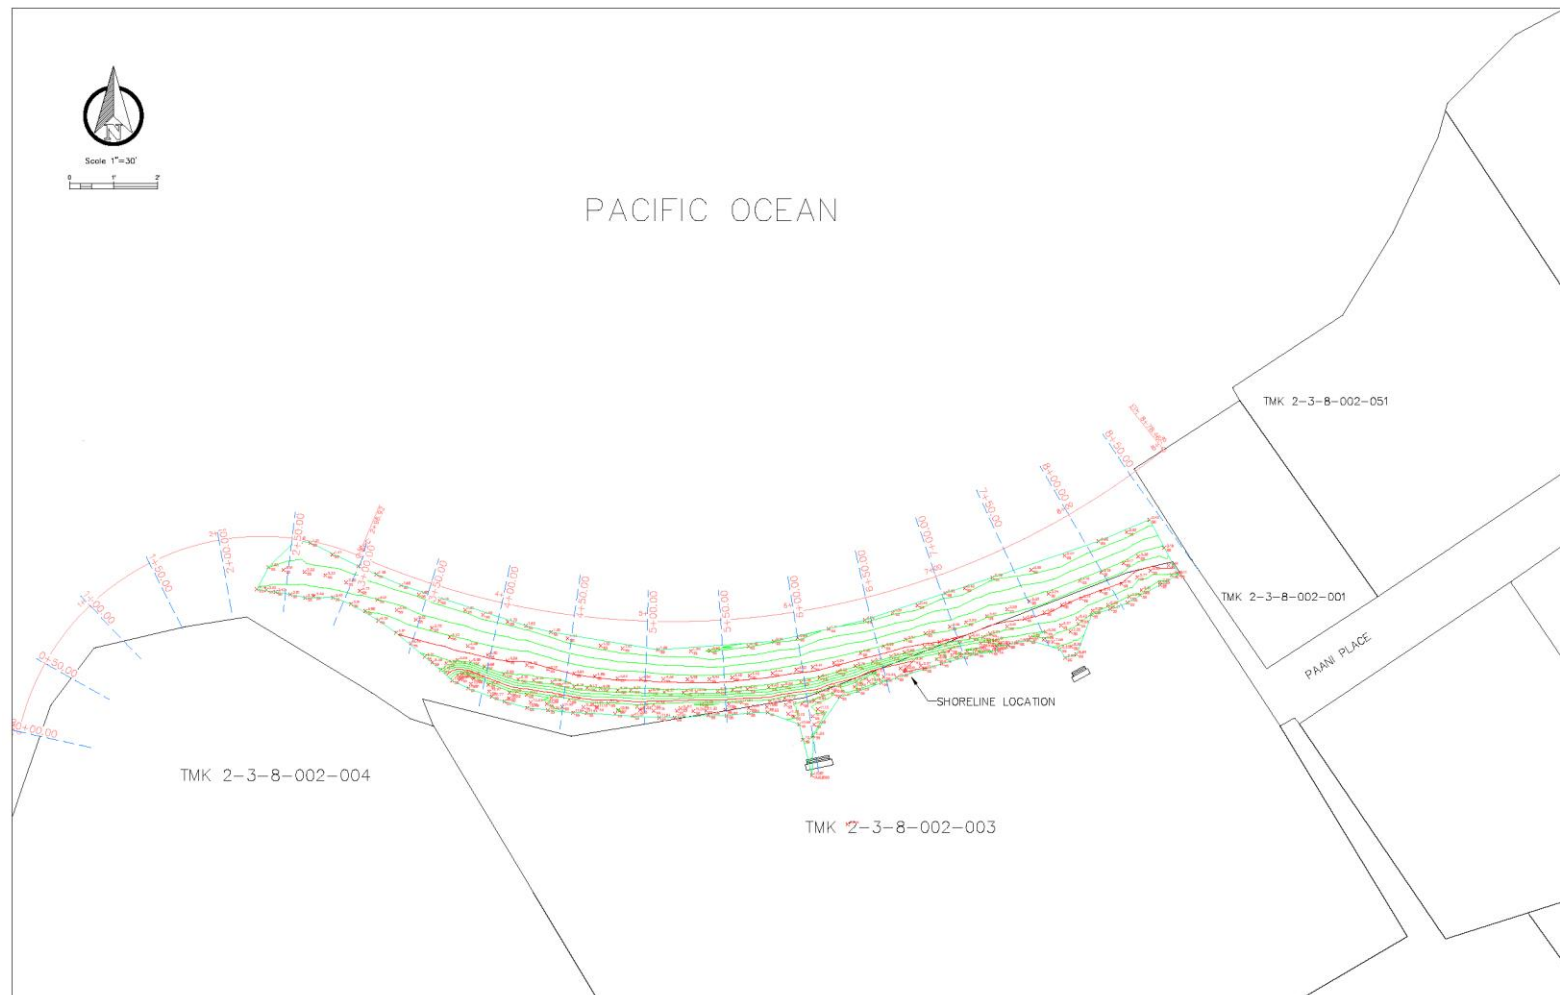
Figure 10-50. November 10, 2015 topography immediately following berm maintenance #1

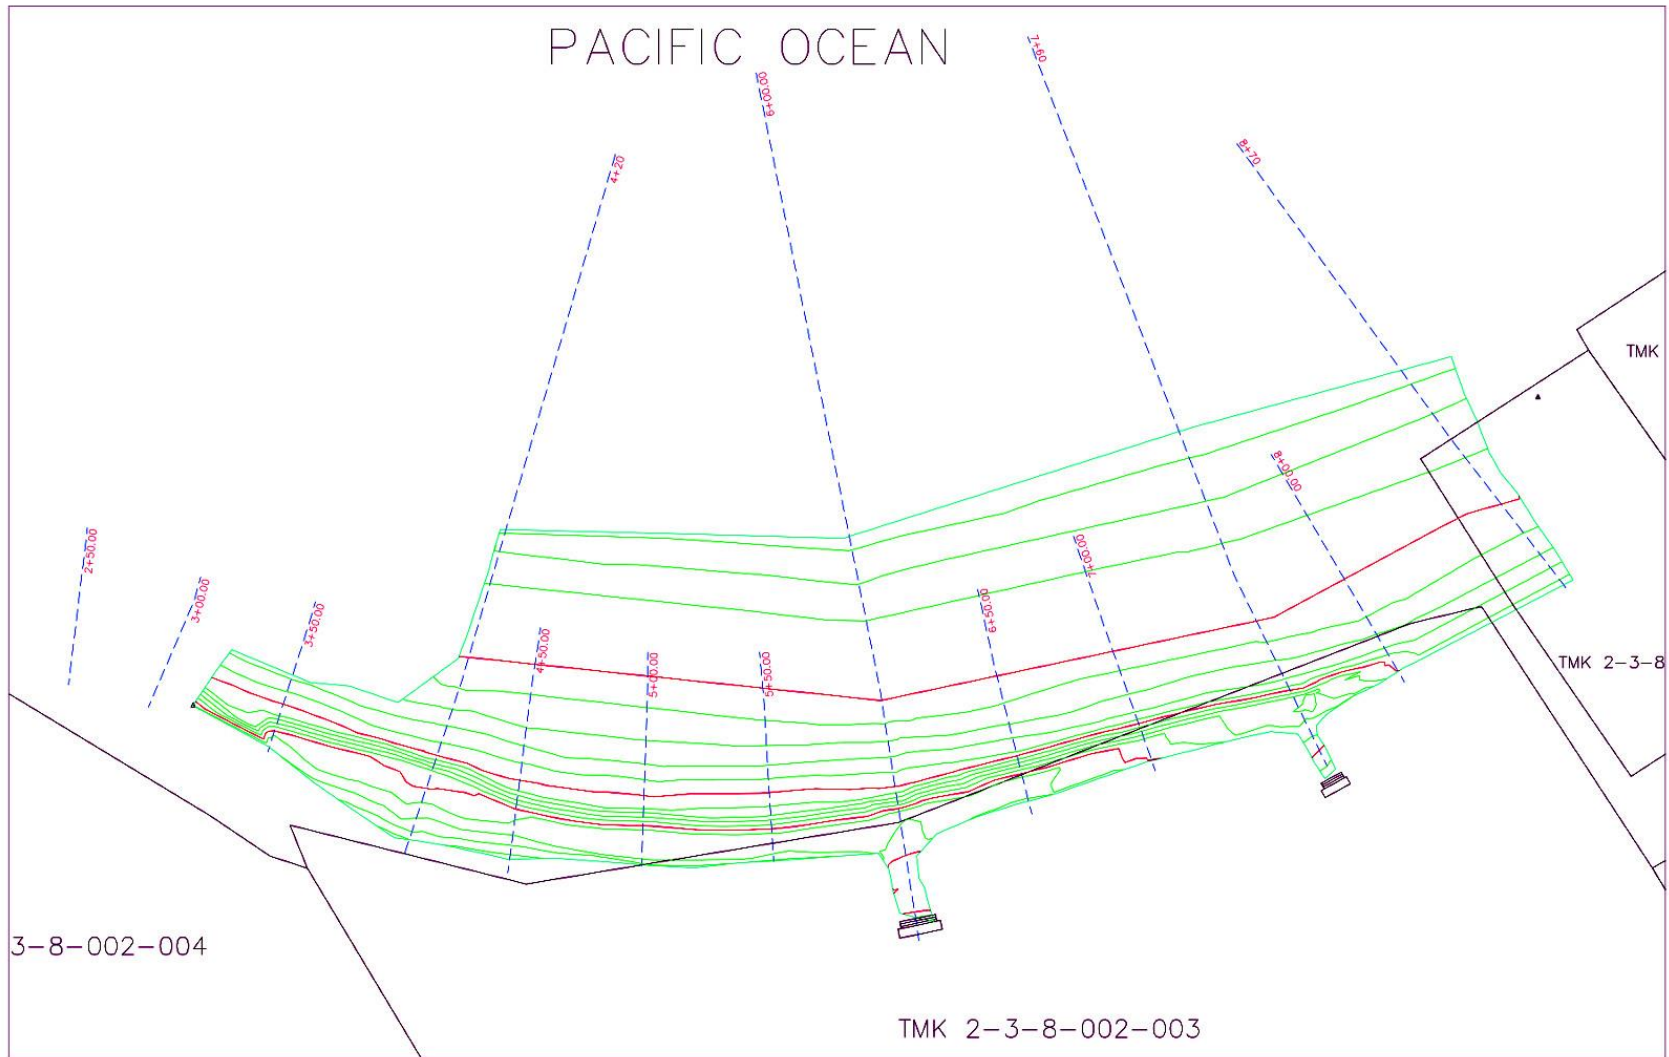
Figure 10-61. September 7, 2016 topography immediately following berm maintenance #2

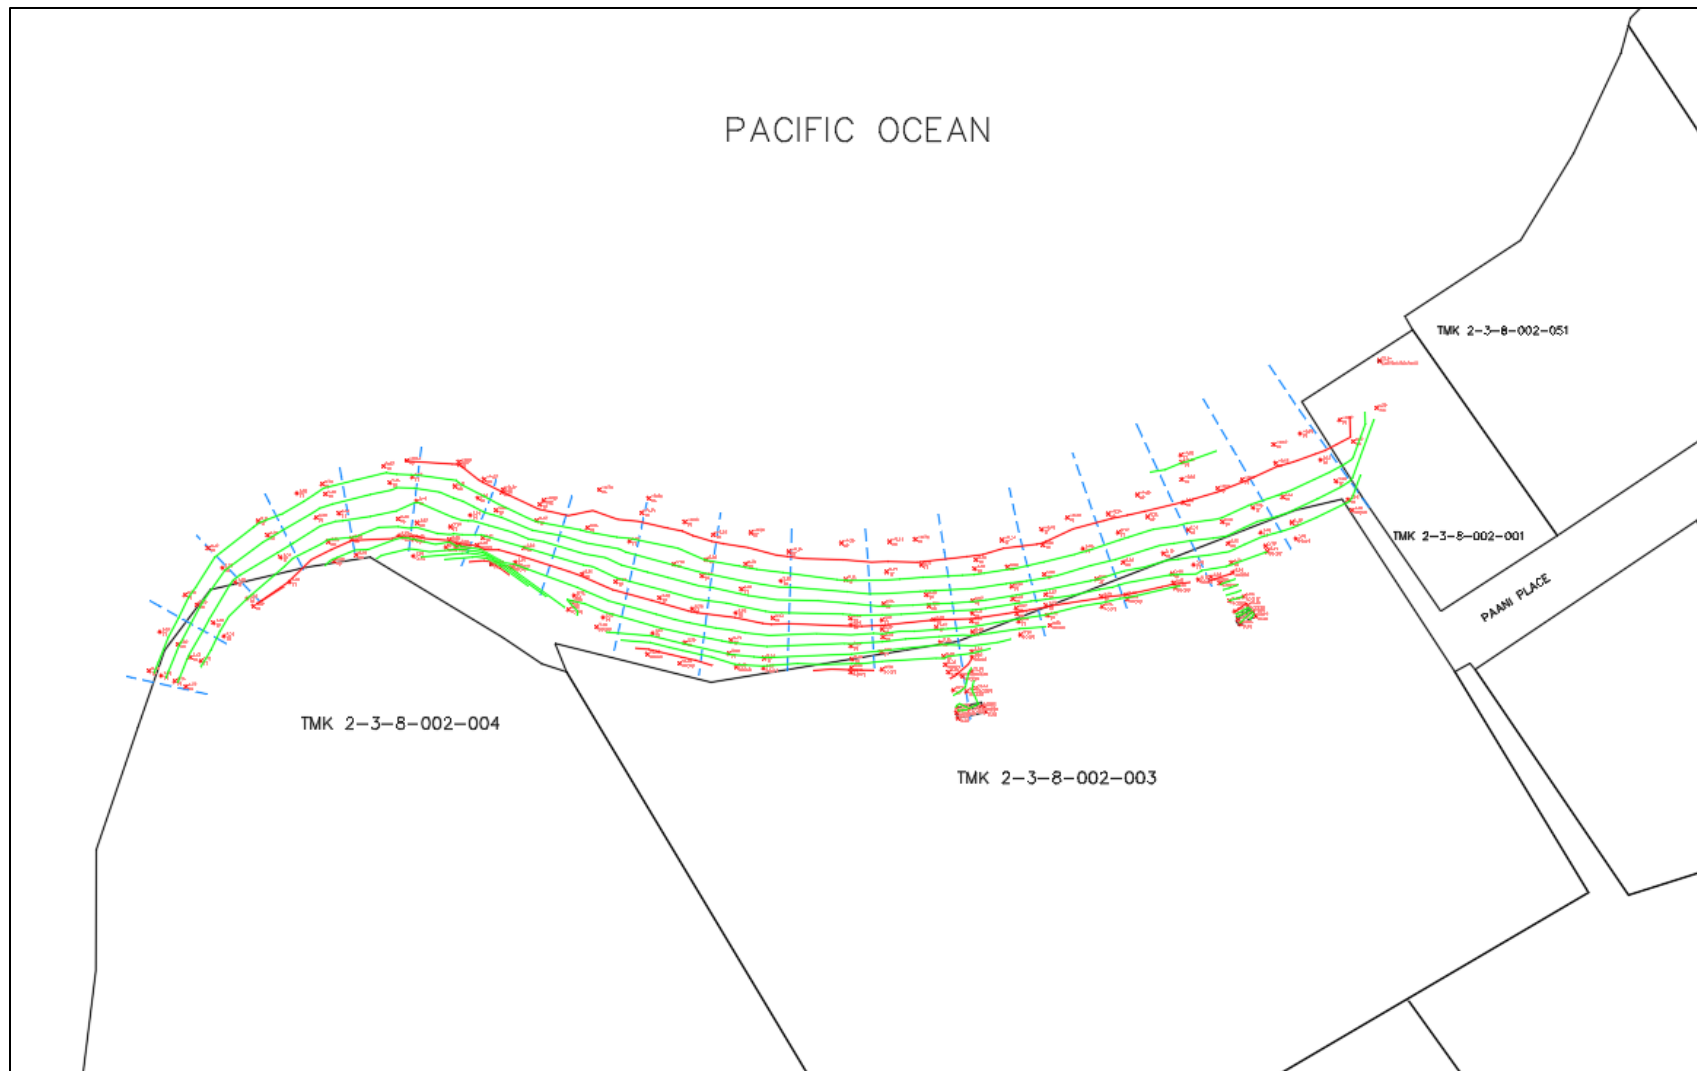
Figure 10-71. September 15, 2020 topography prior to initiating berm maintenance #3

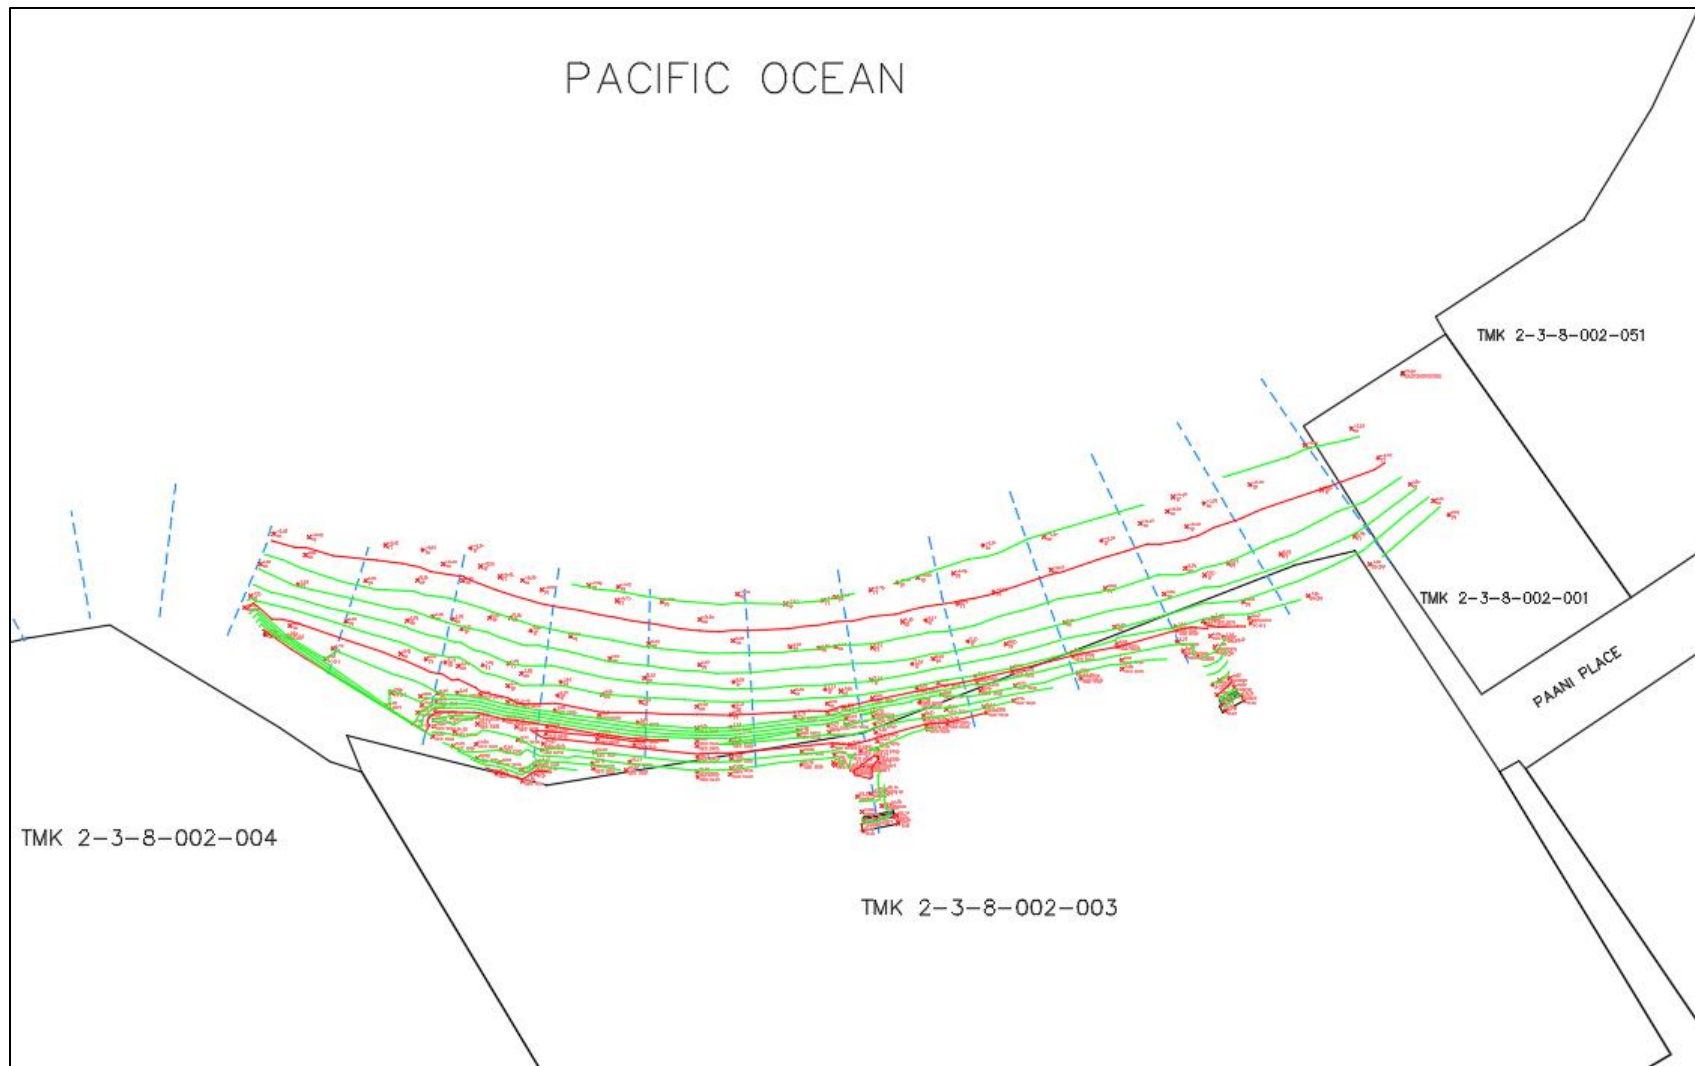
Figure 10-72. September 18, 2020 topography immediately following berm maintenance #3

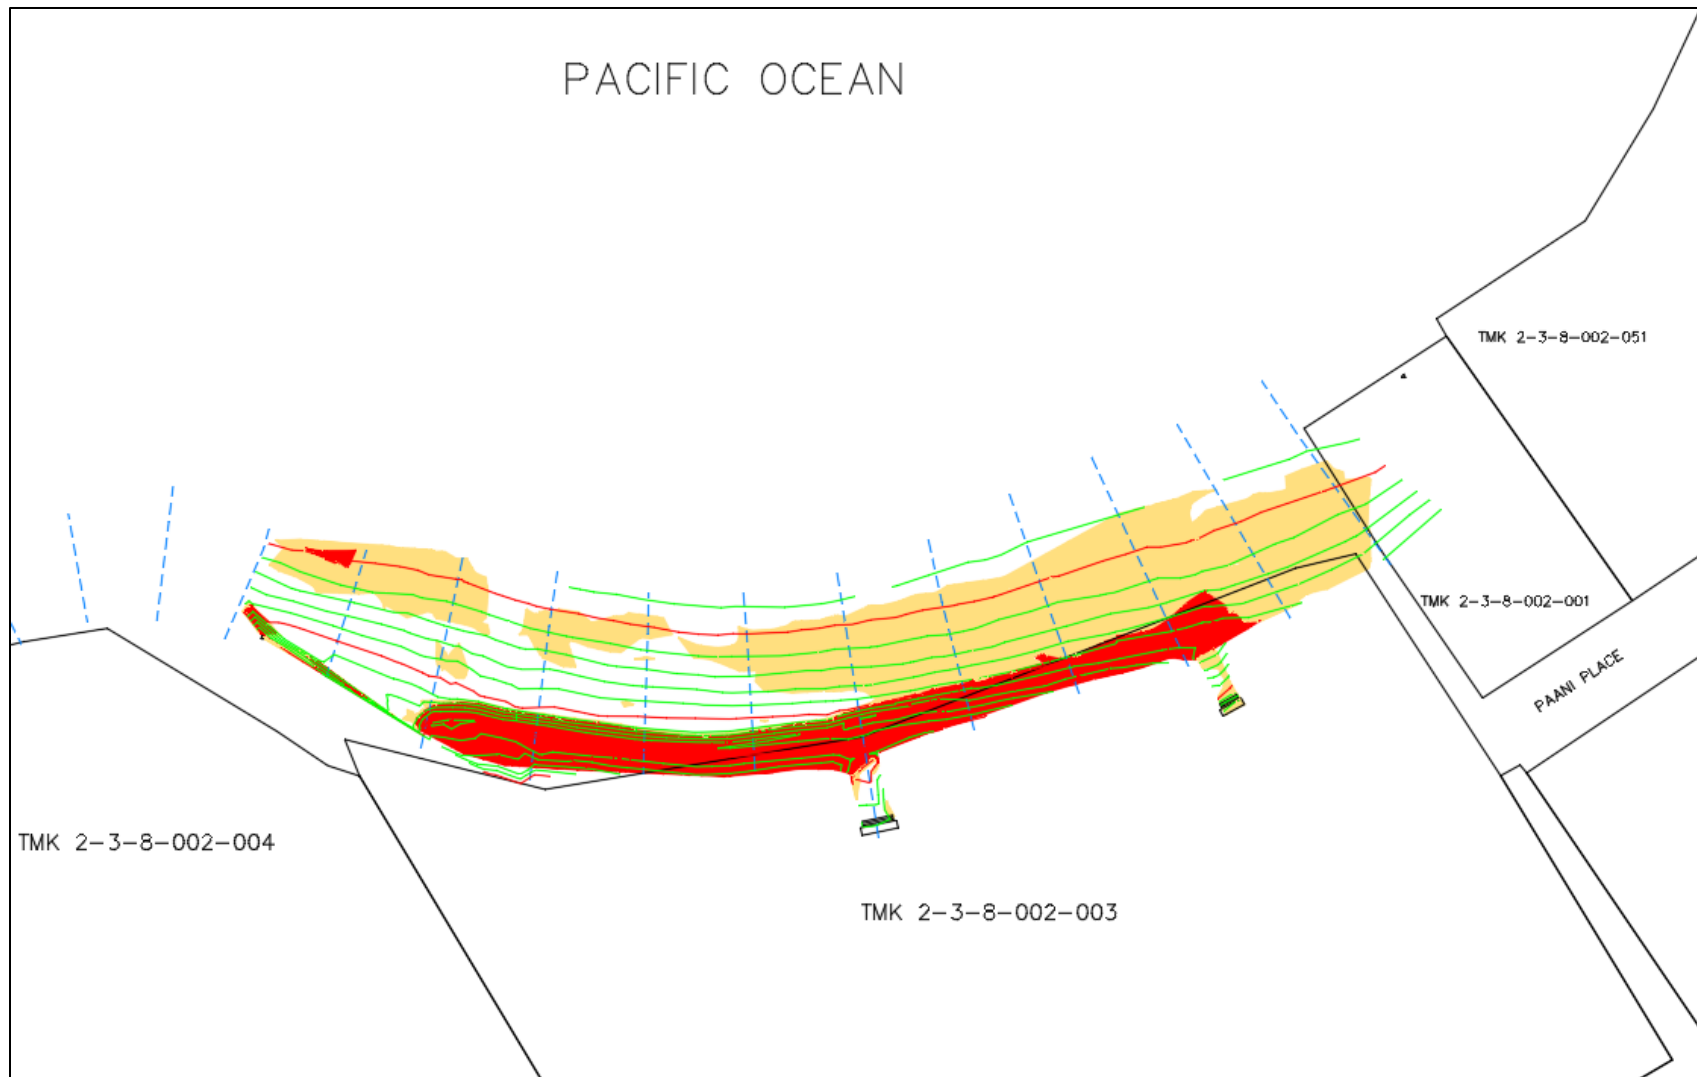
Figure 10-73. Comparison of September 15 and 18, 2020 topography showing where sand was placed during berm maintenance #3 in red
