SUBJECT: PETITION TO REMOVE HISTORIC PROPERTY "FALLS OF CLYDE"
FROM HAWAII REGISTER OF HISTORIC PLACES PER HAR §13-198-10(1)

THE FOUR-MASTED IRON SHIP *FALLS OF CLYDE*: EVALUATION OF LOSS OF INTEGRITY AND RECOMMENDATION FOR DELISTING FROM THE NATIONAL REGISTER OF HISTORIC PLACES

James P. Delgado, Ph.D.

May 10, 2023

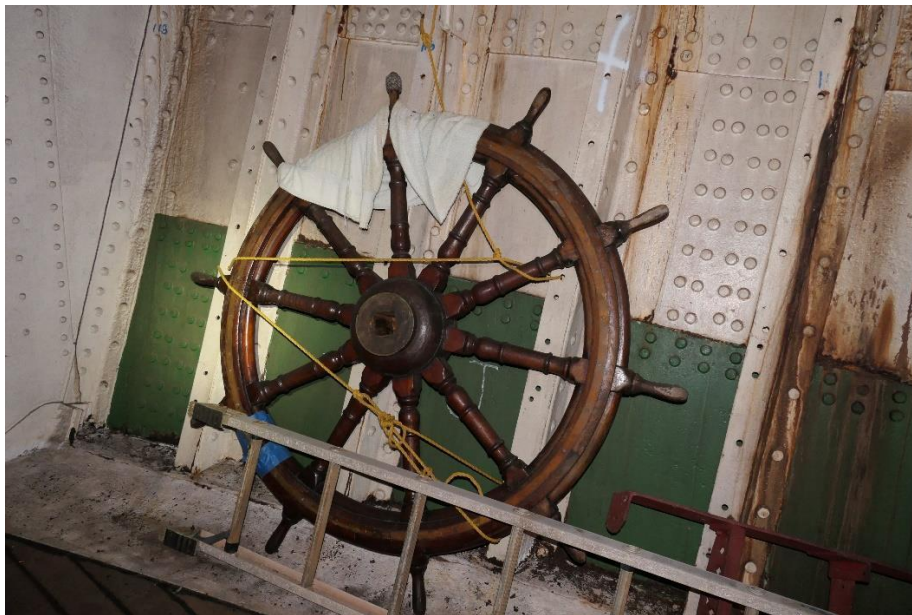
Figure 22: The ship's wheel in the pump room, 2023 (Joseph Lombardi).

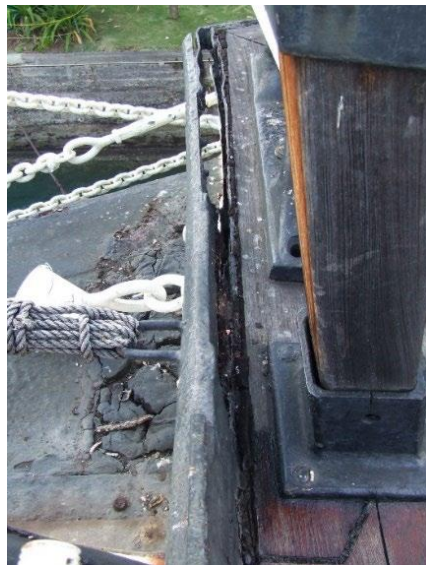
The forward wrought iron margin of the deck is badly corroded and provides support for the guy wires of the bowsprit. This will give way shortly with catastrophic failure of bowsprit to follow.

Leading edge of forecastle deck showing massive corrosion.

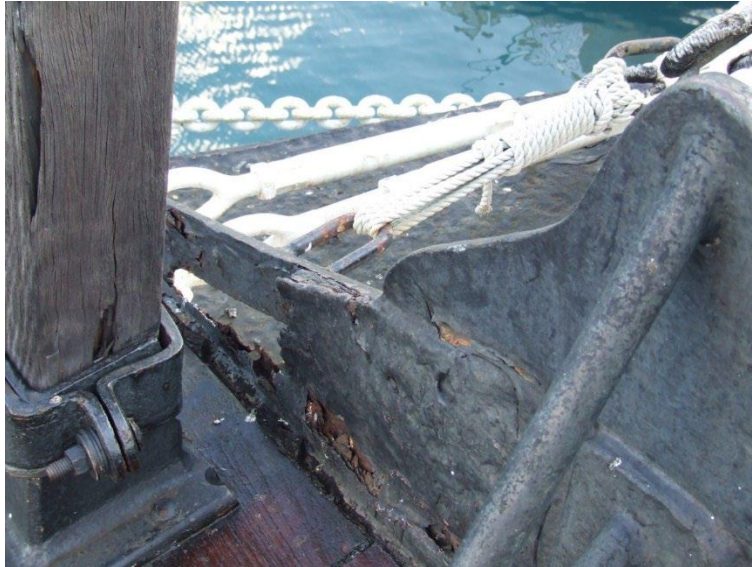
**Corrosion of the deck and margin plates is evident in this picture.
Notice eyebolt supporting bowsprit guywire lacings.**

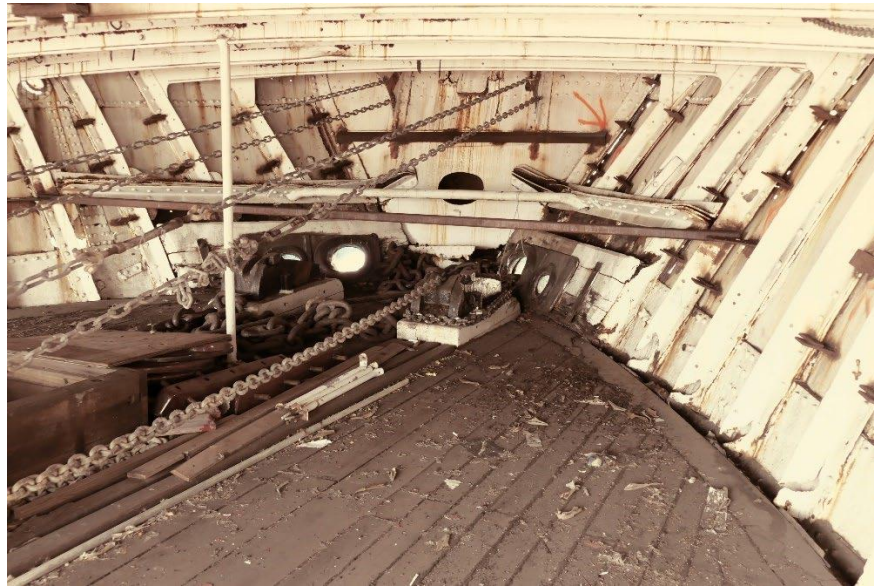
Forecastle showing chains and transverse steel bars supporting collision bulkhead and shell plating to transverse frames.

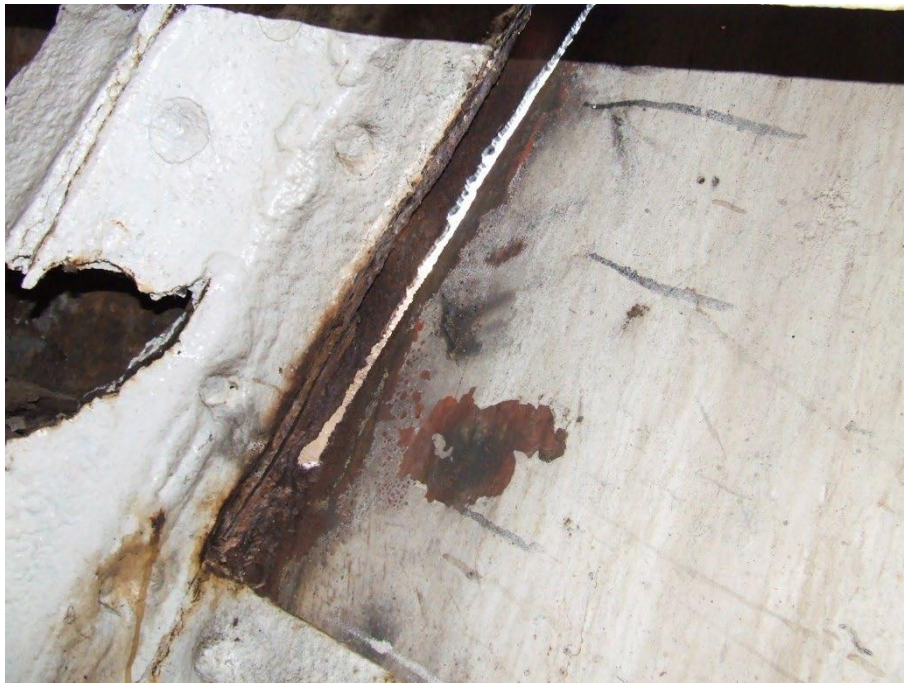
Wasted transverse frame/rivets and separated shell plating to starboard.

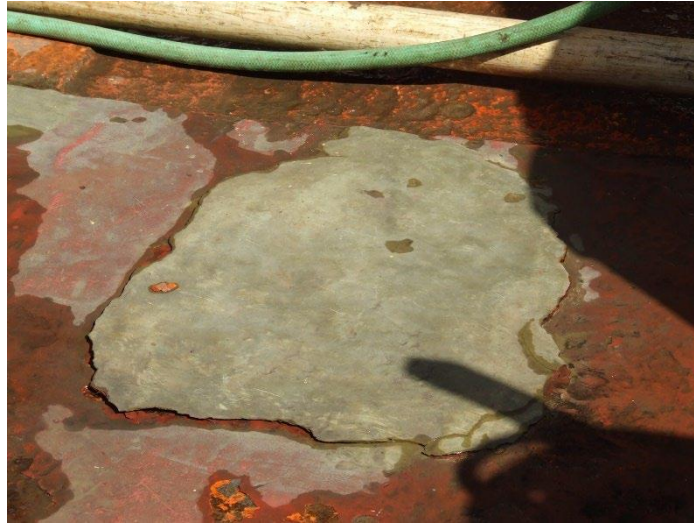
Epoxy patches made to maindeck plating have failed. These areas require new inserts or steel doubler plates. They are a possible danger to personnel.

RED HAND epoxy patches that have failed on maindeck.

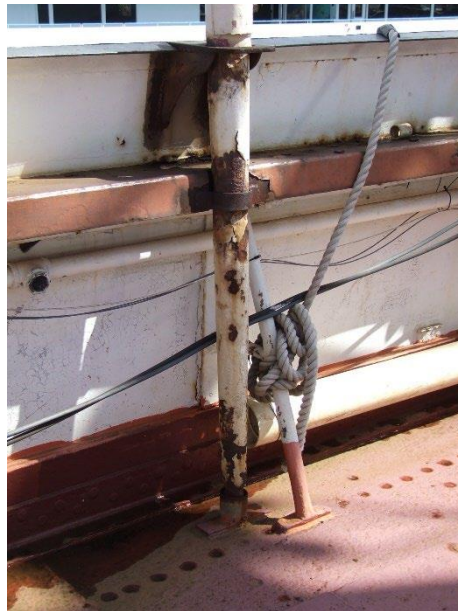
The davit utilized to support the accommodation brow to port (since removed) has a rotted base and is in danger of carrying away.

Wasted base of davit that previously supported the accommodation brow to port.

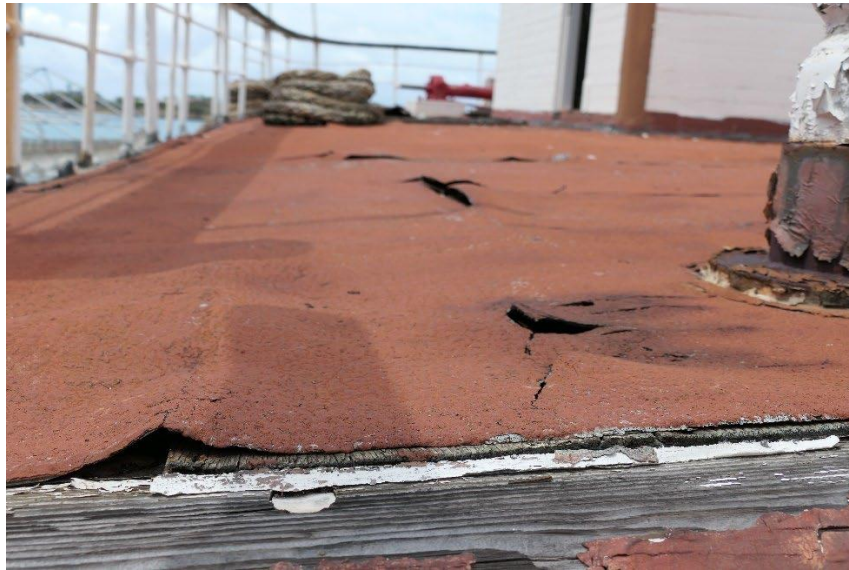
The fiberglass sheathed fir deck has failed with rotted plywood substrate throughout.

De-laminated sheathing on poop deck.

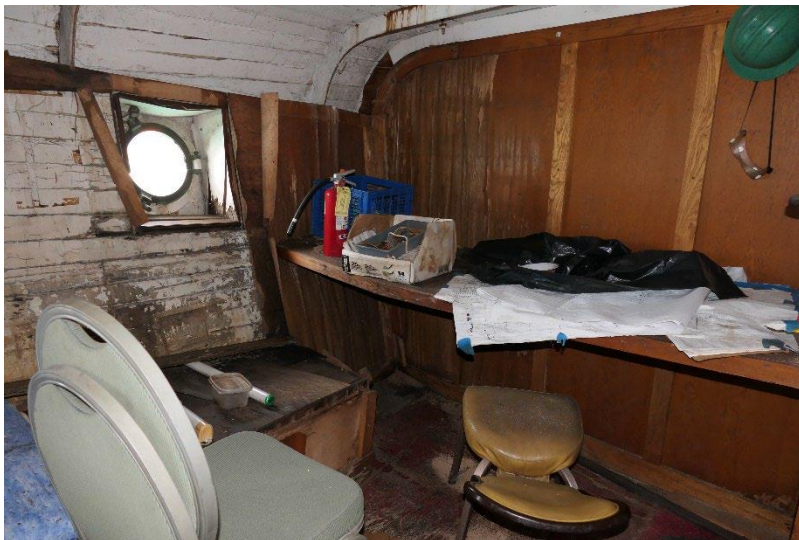
Heavily mildewed hull sheathing with rainwater coming through deck.

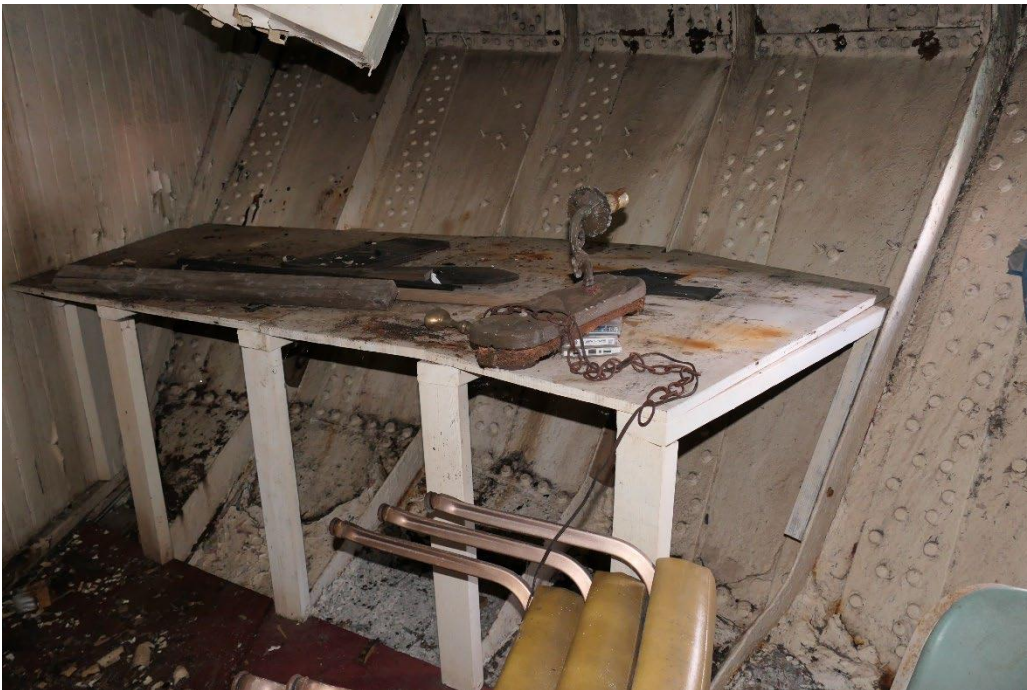
Small cabin to port at the counter showing overhead sagging down at top of photo and poorly maintained inner hull facing.

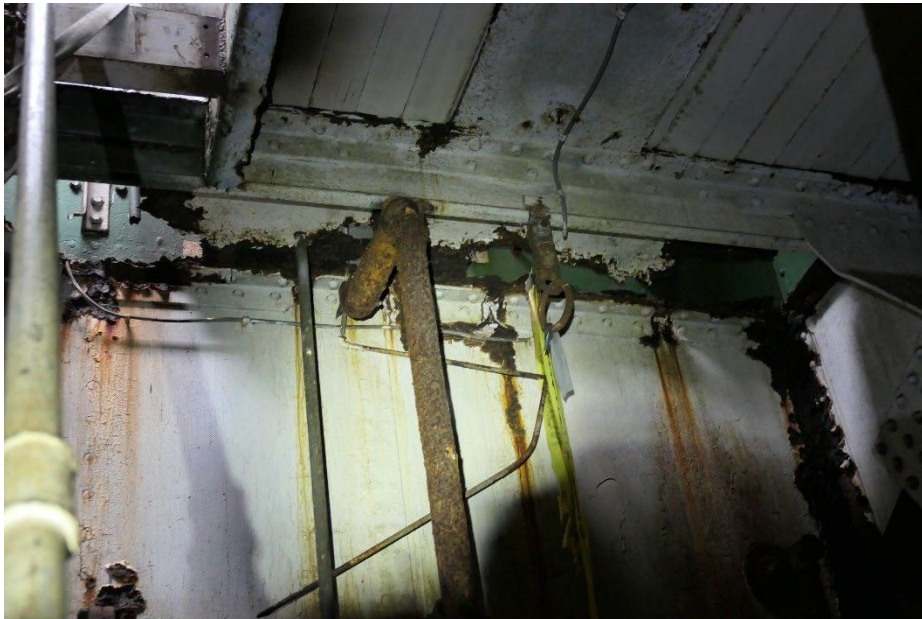
Rotted deck and scantlings at aft end of upper pump room to starboard.

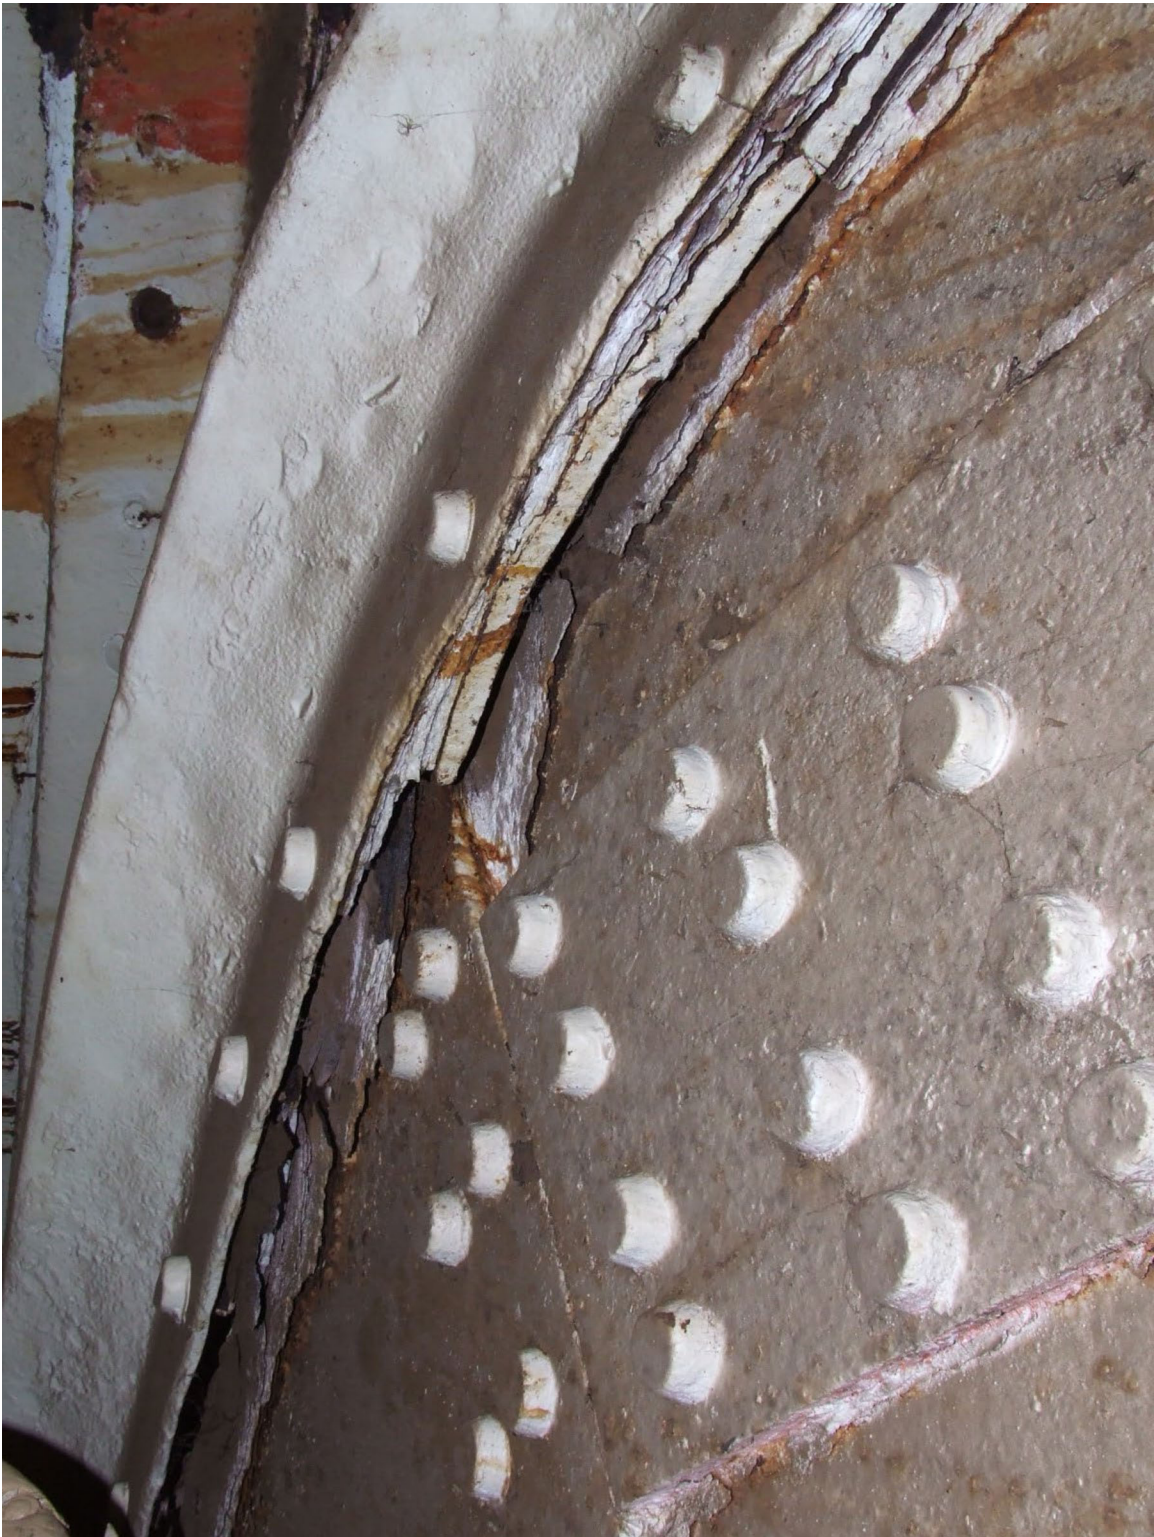
Shell plating detached from transverse frame in Aft Storeroom.

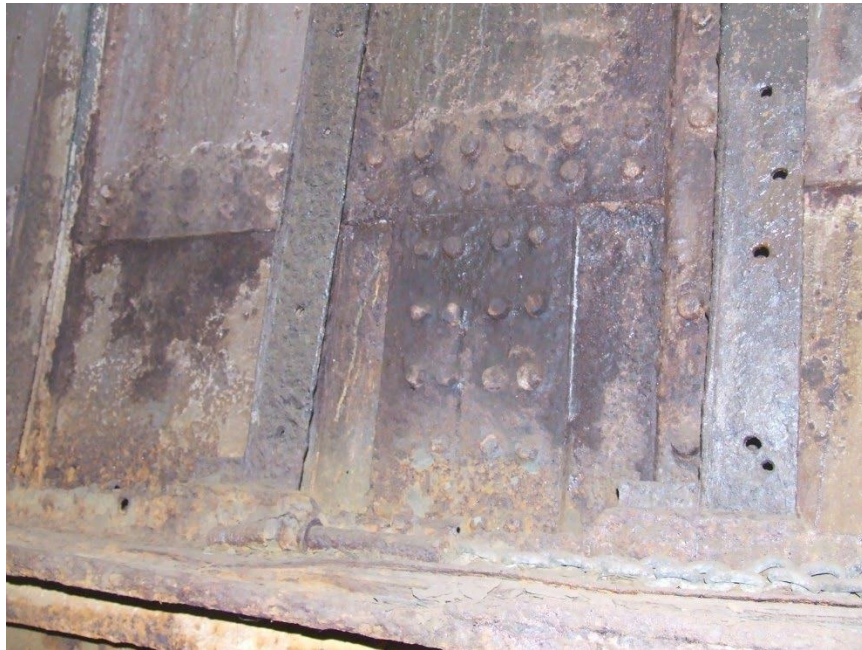
Wasted or non-existent rivets on transverse framing in Pump Room, port side looking aft.

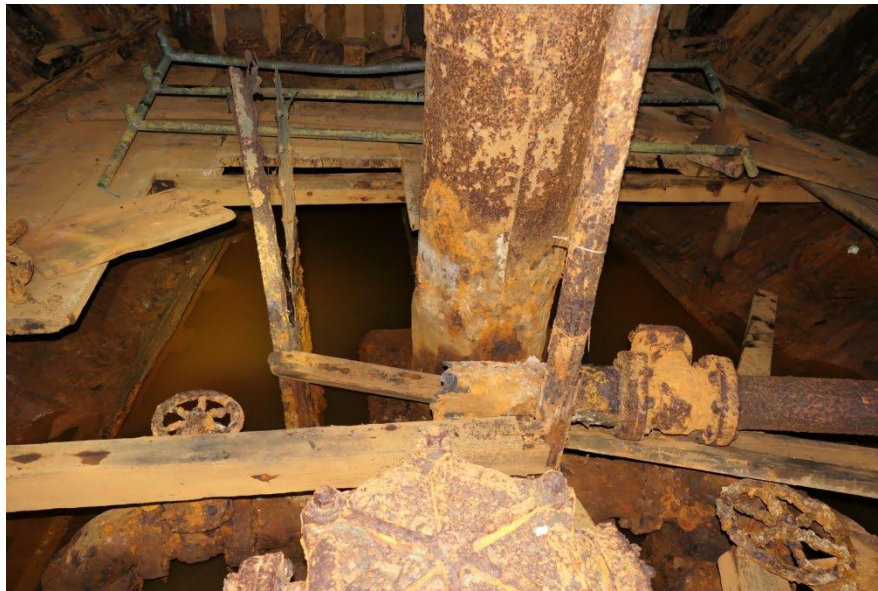
Base of foremast in Pump Room, Heavily scaled.

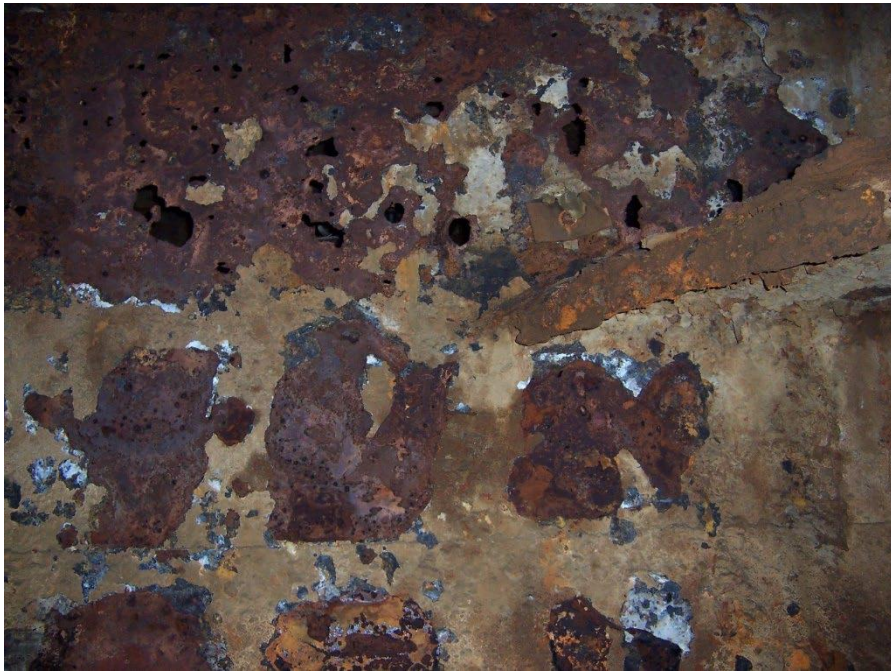
The forward bulkhead is holed in Tank #1 port. The forward bulkhead to Tank #1 starboard will be shortly as there are numerous pinholes. The forward bulkhead is in an unsafe way and could collapse due to heavy weight of the Boiler Room.

Wasted bulkhead in Tank #1.

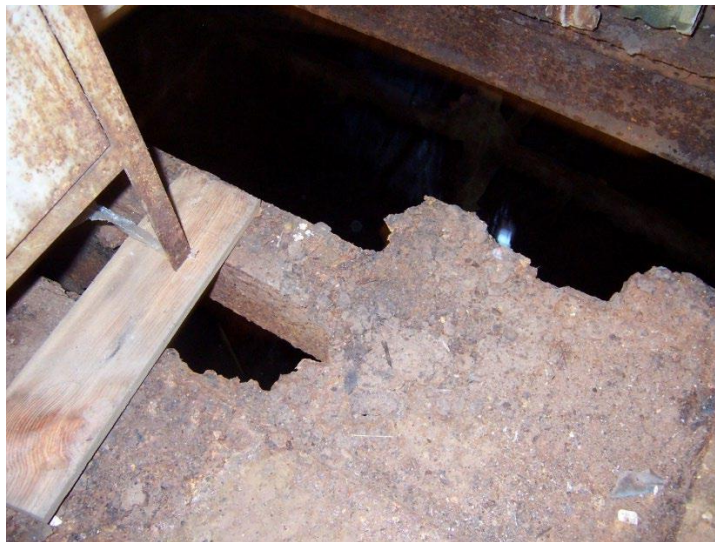
Wasted intermediate platform in Tank #2 port.

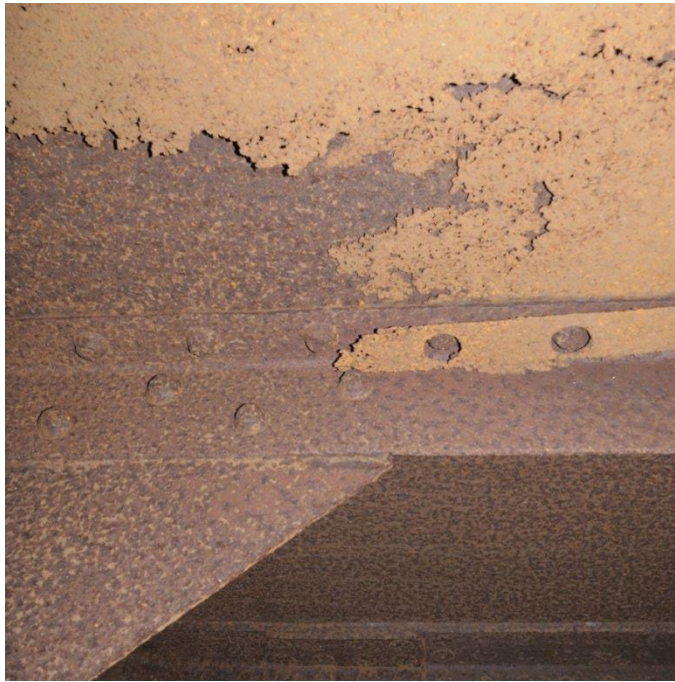
Overhead plate scaling in Tank #3 starboard..

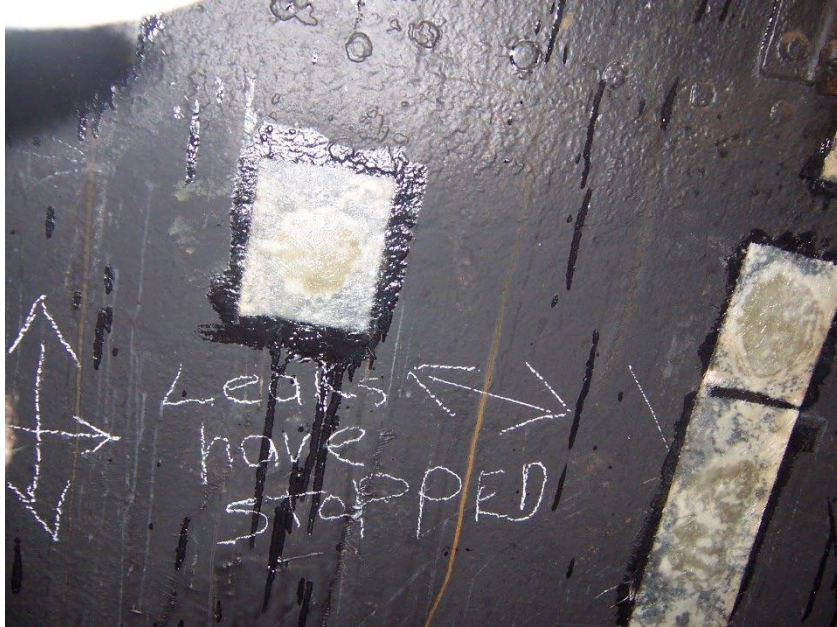
Re-patched holes in bulkheads in Tank #4 port.

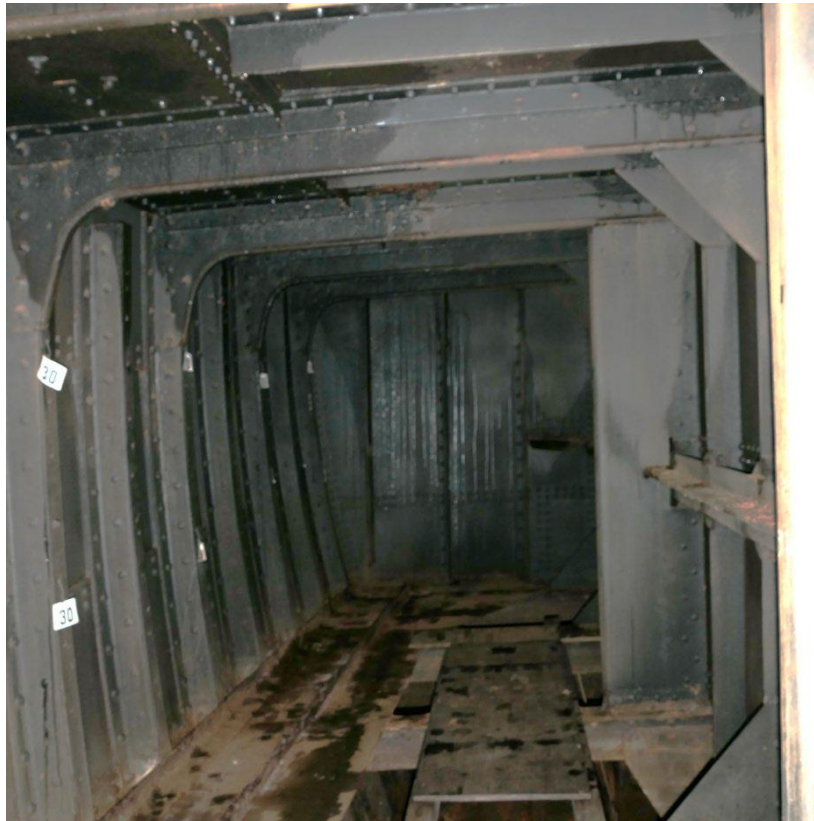
Tank #4 Port, looking forward.

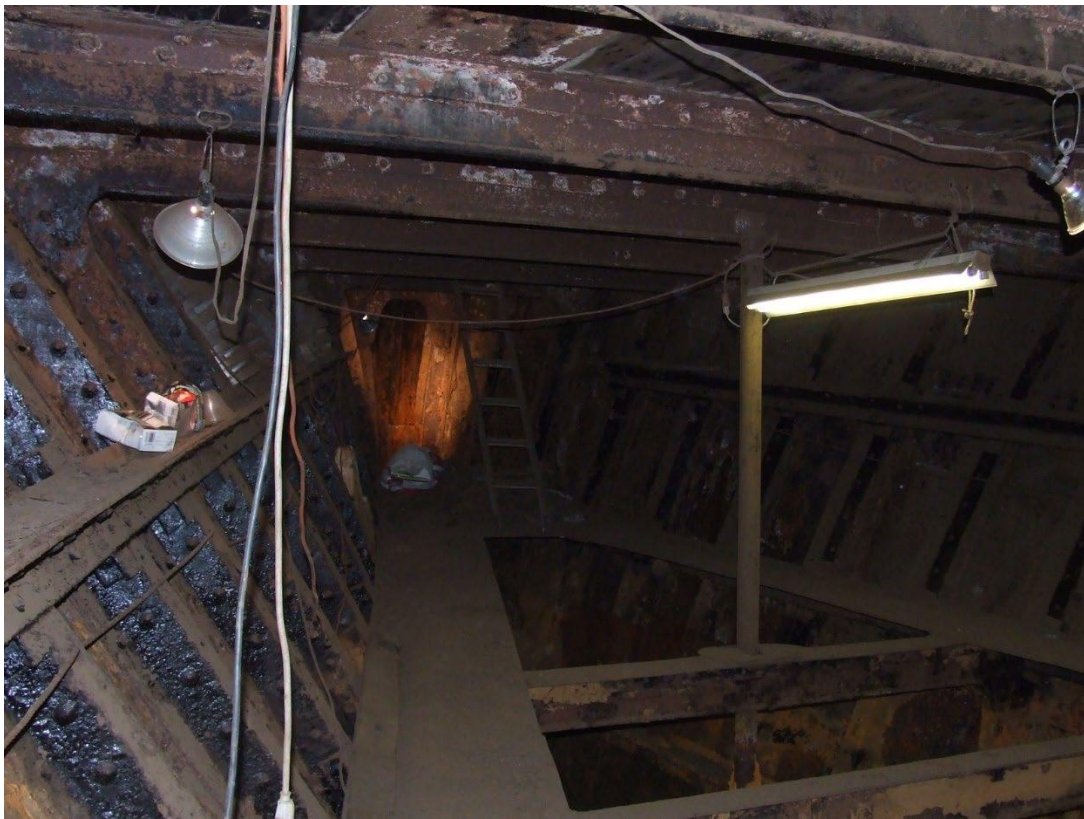
Lazerette, seen from forward part of space near bulkhead, looking back to starboard toward stern casting.

This space is in total disrepair with totally wasted and/or broken transverse frames. Many rivet seams missing rivets; much wastage/scale of remaining rivets.

The stern casting is in very poor condition with major degradation and waste apparent.

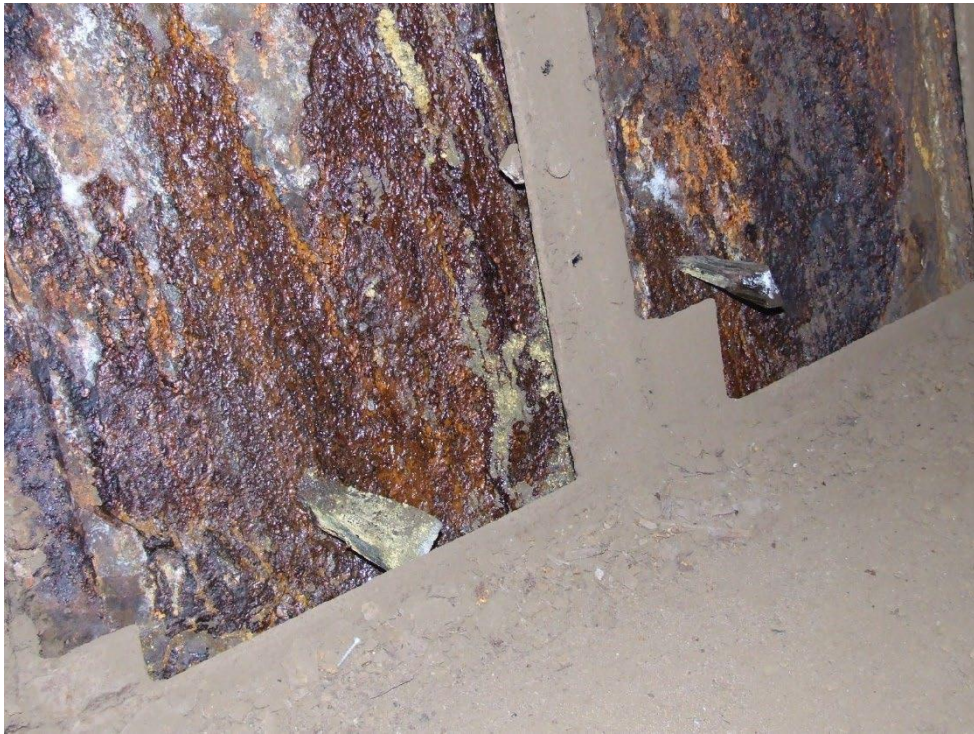
More wasted plating with wooden plugs. Notice separation of shell plating from frames.

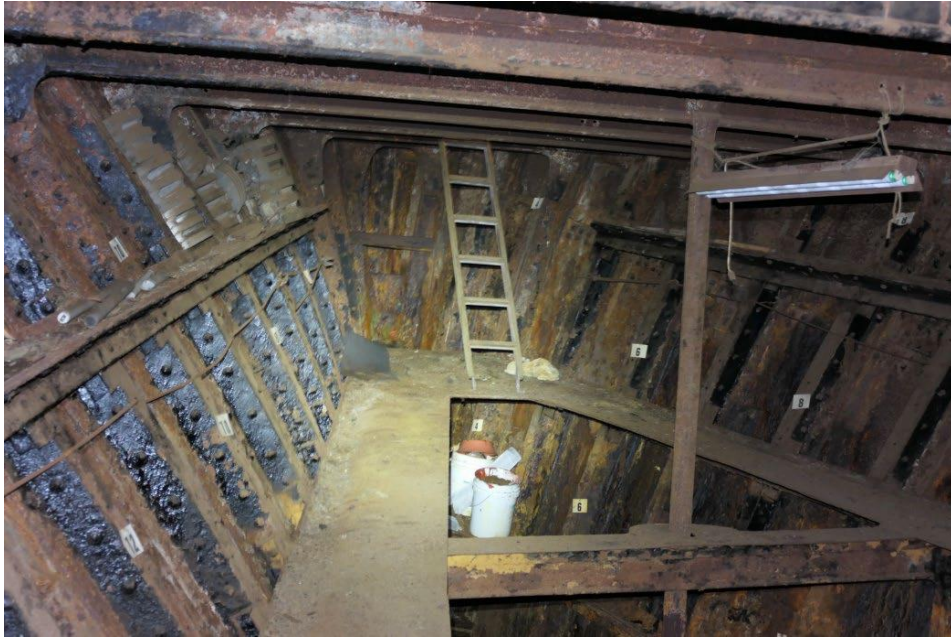
Intermediate level Aft Peak Tank.

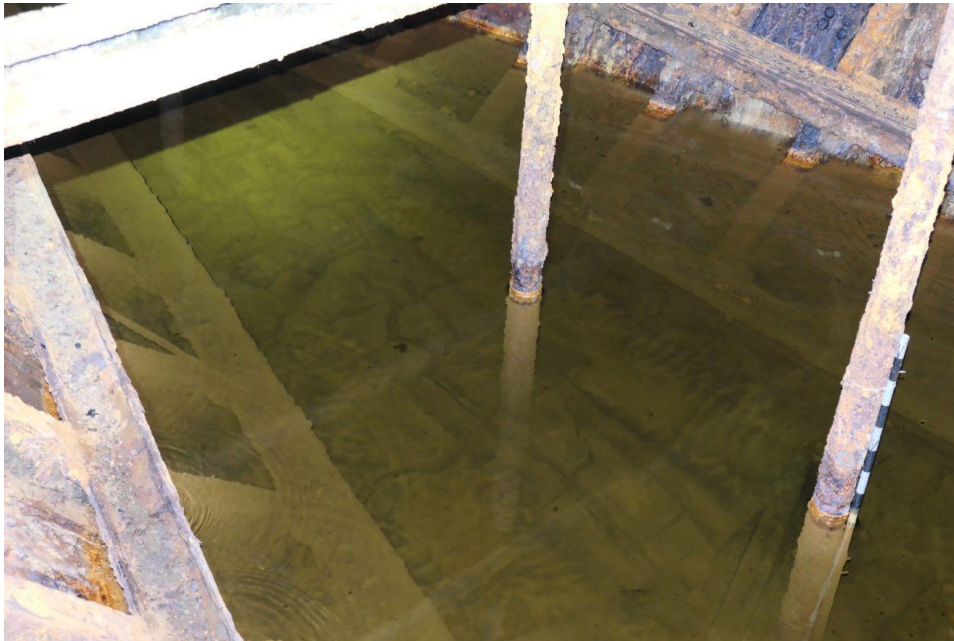
Flooded lower flat of Aft Peak Tank.
