# STATE OF HAWAII DEPARTMENT OF LAND AND NATURAL RESOURCES

Subject: Enforcement Action against TWOL, LLC for Stony Coral and Live Rock

Damage Resulting from the October 10, 2017 CFV *Pacific Paradise* Grounding within the Waikiki-Diamond Head Shoreline Fisheries

# CFV *Pacific Paradise* Injury Report Waikīkī – Diamond Head Fisheries Management Area, October 10<sup>th</sup>, 2017 – December 7<sup>th</sup>, 2017

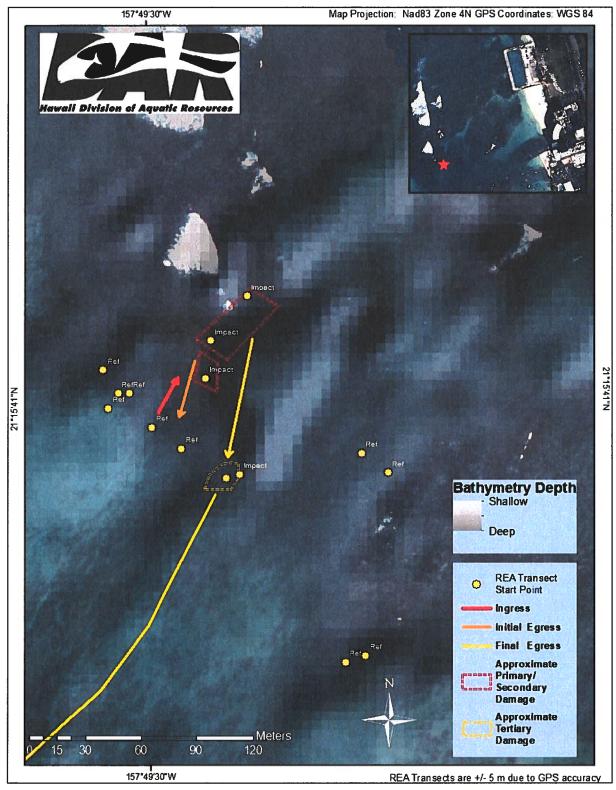
Reference sites are unimpacted areas adjacent to the impact site that demonstrate the pregrounding condition of the reef, with similar substrate and depth. Reference site starting locations for the primary/secondary impacts were pre-selected using ArcGIS NCCOS (National Centers for Coastal Ocean Science) bathymetry habitat mapping data to identify depths between the impact and reference sites. In the field, transects were laid out by following similar isobathymetric depths as the start point. Reference sites directly north and west of the primary/secondary impact site were ruled out due to shallow depths and turbulent waters created by the surf break. Areas to the north and east of the primary/secondary impact were not considered because they consisted mostly of deeper sand habitat which did not represent the grounding site. The surrounding area of the tertiary impact site had uniform depth and substrate so the reference sites were determined by using a standardized 25 fin kicks north of the impact site (Figure 11).

Figure 11. Bathymetry data layer used to identify similar habitat for determining reference survey locations. (Impact = vessel impact events, Ref = reference sites).
