BLNR Hearing K-1 Punaluu/ Johnson

Written testimony Aug 13, 2021

PUNALU'U EMERGENCY SHORELINE PROTECTION

SPA: OA-13-55 EP: OA-20-8

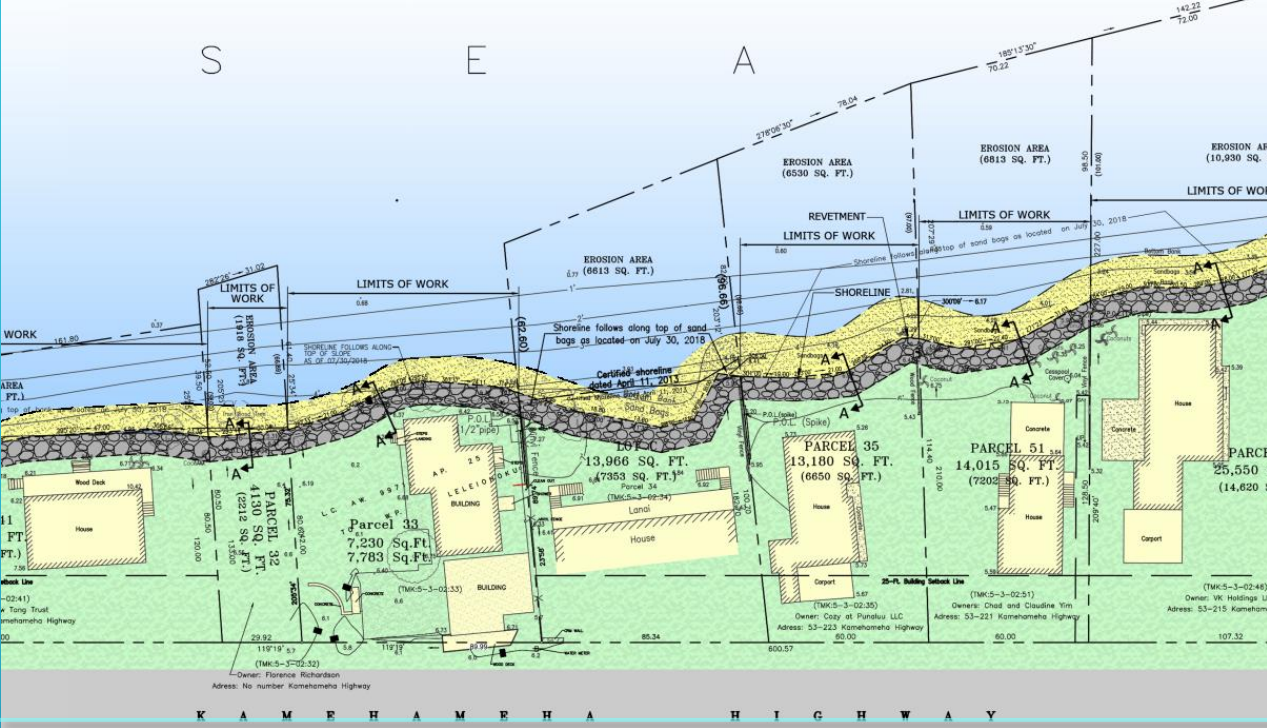
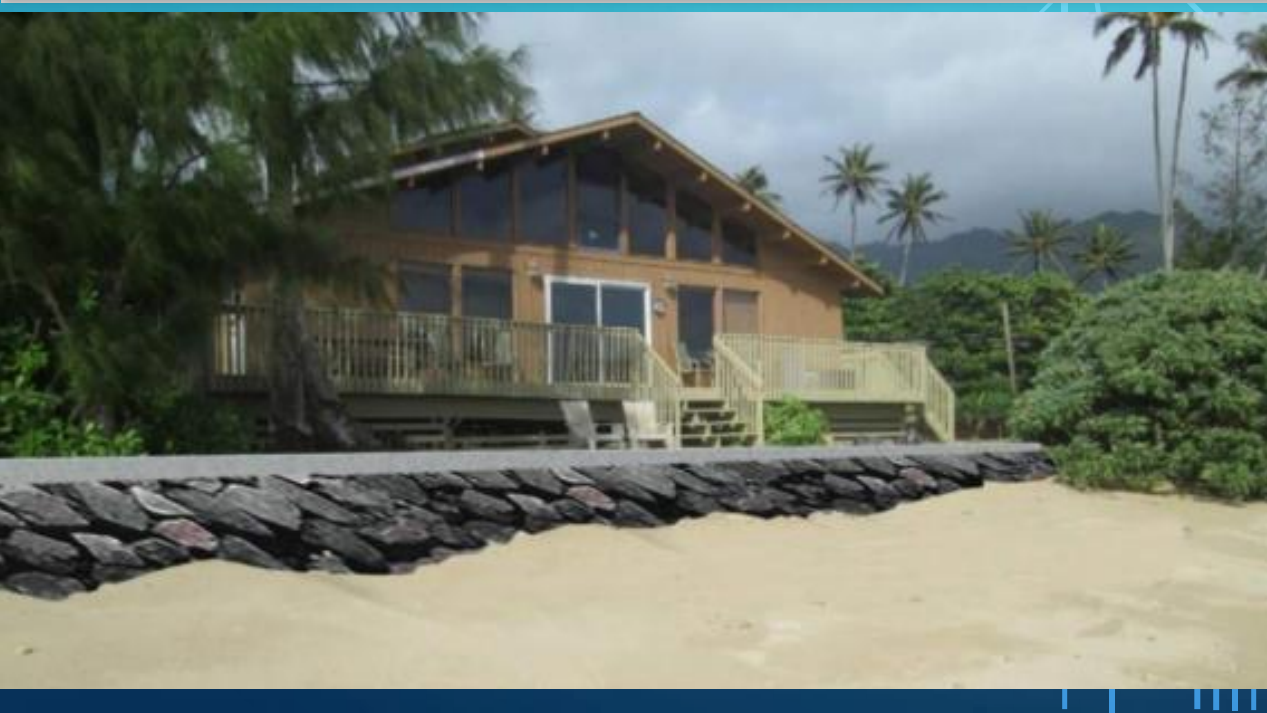
- May 2013 - DLNR SPA OA-13-55 sandbag structure (Johnson)
- Oct 2013 - Modifications approved for 5-year term, Expired May 2018
- History of erosion threat to 7 adjoining properties up to Punalu'u Beach Park
- Endless Headache for DLNR OCCL 20+ years of individual owner problems
- Recommended seeking an acceptable long-term solution through joint project

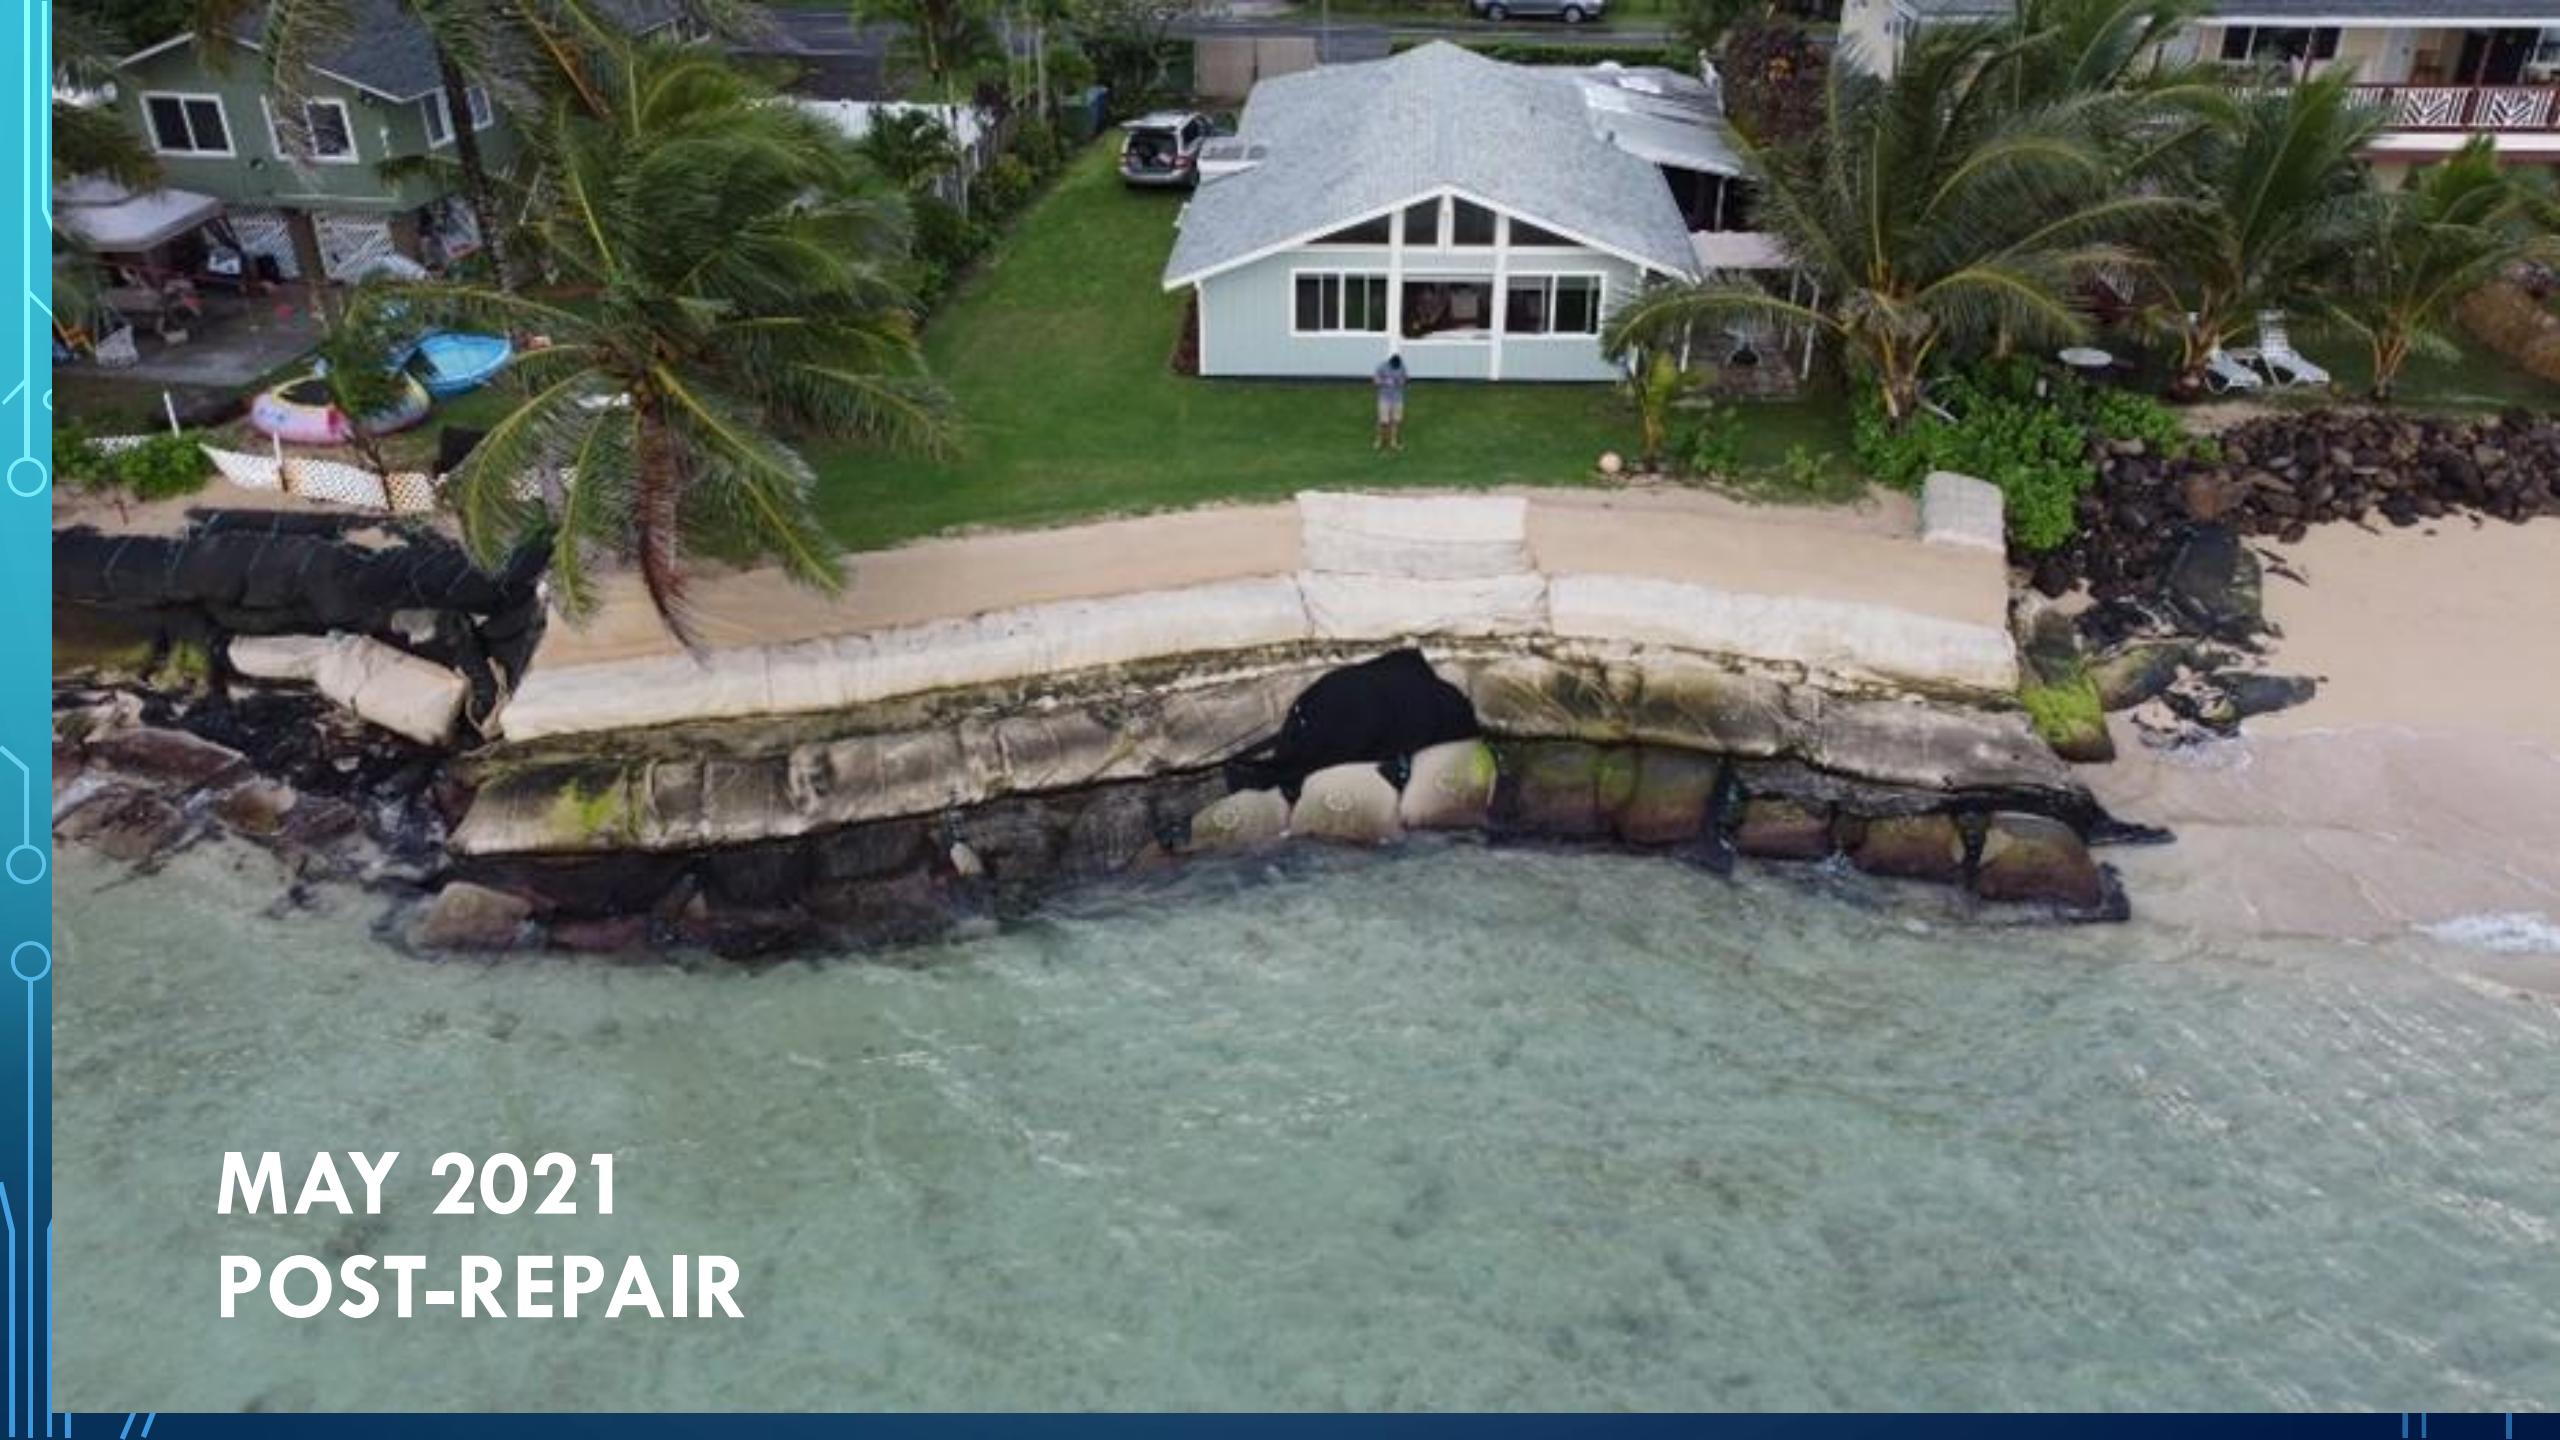
- FAILING STRUCTURE**
- DEFLATED SANDBAGS**
- DEBRIS IN NEARSHORE AREA**
- POOR LATERAL ACCESS**

- + SAME STRUCTURE FOOTPRINT**
- + REMOVED NEARSHORE REMNANTS**
- + IMPROVED LATERAL ACCESS ACROSS
2ND ROW OF SANDBAGS**
