STATE OF HAWAII
DEPARTMENT OF LAND AND NATURAL RESOURCES
Division of Aquatic Resources
Honolulu, Hawaii 96813

Subject: Enforcement Action against John Joseph Barry III and Avalanche Adventures Corp. for Alleged Stony Coral and Live Rock Damage Resulting from the May 28, 2021 *Avalanche* Anchoring Incident Within the Waters of the Kaloko-Honokōhau Fish Replenishment Area / Netting Restricted Area, Hawai'i Island.

Incident Report: DAR, DOBOR, DOCARE, NPS response to report of coral damage due to vessel anchoring within the Kaloko-Honokōhau National Historic Park

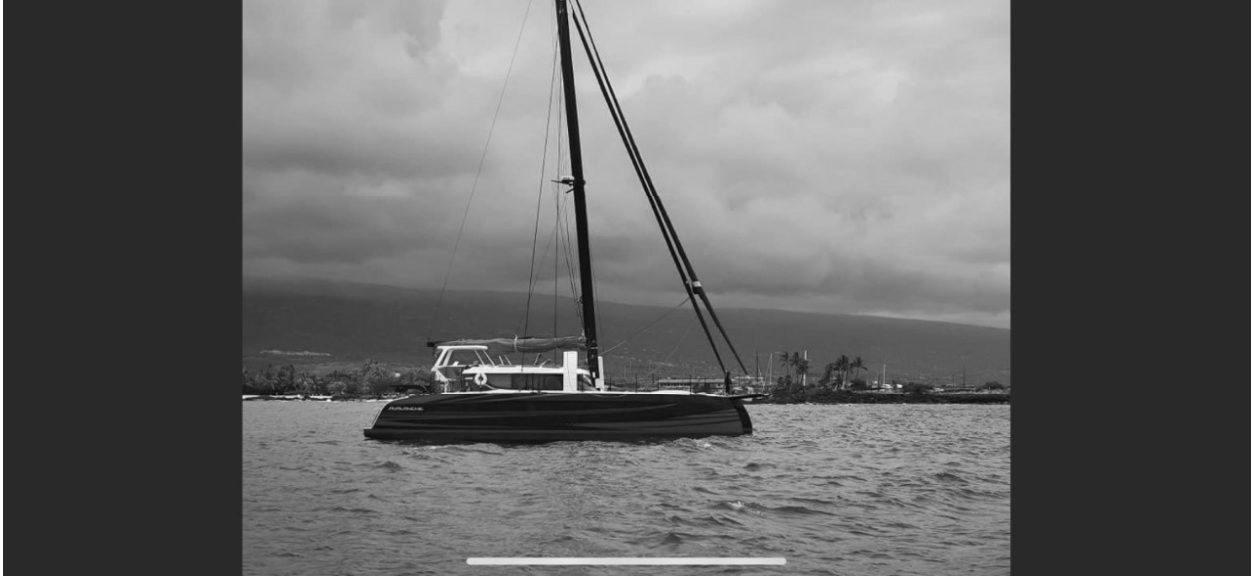
On May 28, 2021 at approximately 1330, DAR Kona was forwarded a report on social media regarding a vessel outside of Honokōhau Harbor anchored on top of live coral (Figure 1). From the images, it was clear that, while the anchor itself was in a patch of sand (Figure 2), much of the anchor chain was draped across live coral (Figure 3). DAR staff recommended to the reporting individual that they submit the incident and photos to the DLNR Tip line or DLNRTip app. Soon after, Nikki Smith (DAR Aquatic Biologist) received a call from Tania Taitano with the Honokōhau Division of Boating and Ocean Recreation (DOBOR) office reporting the anchor damage to DAR and requesting someone from the DAR Kona office assist with response. DAR Aquatic Biologist Chris Teague then contacted Taitano and went into the DOBOR office to discuss further.

Figure 1: Image of vessel posted to social media.

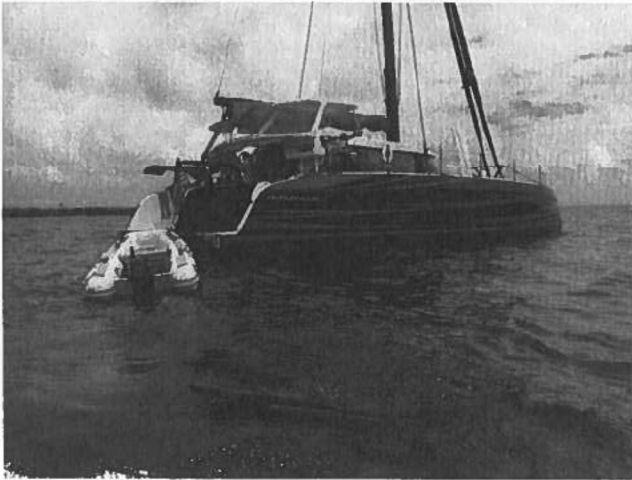
#1) Photo of "AVALANCHE" vessel anchored just outside of Honokohau Small Boat Harbor.
