CONSERVATION DISTRICT USE APPLICATION (CDUA)

PROJECT NAME Diamond Head Breakwater Safety Project

Conservation District Subzone: Protective

Project Address: Submerged lands makai of 4055 Papu Circle, Honolulu, HI 96816

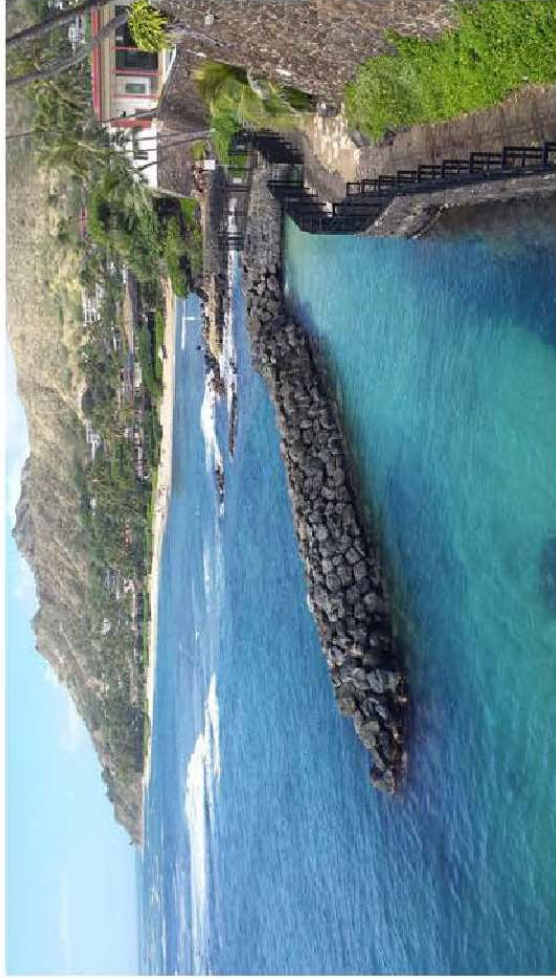
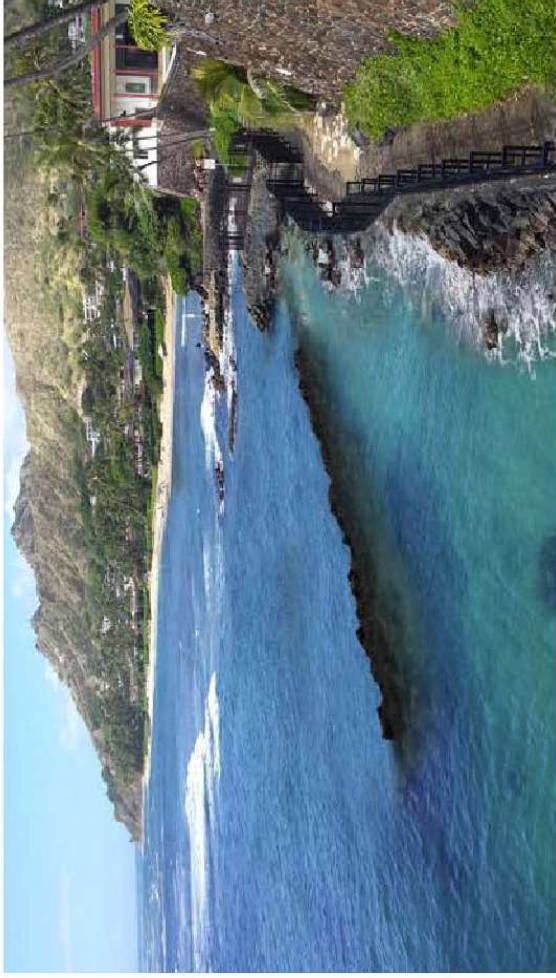
Current View of Diamond Head Breakwater from Balcony

Simulated View After Breakwater Dismantling

The Diamond Head Breakwater is proposed to be dismantled by removing all of the boulders except for the last row of boulders which are situated on the ocean floor. The row of boulders on the ocean floor would remain because they are partially buried by sand accumulation; and this would reduce turbidity effects from dismantling activities. It is estimated that approximately 500 cubic yards of boulders would be removed from the breakwater. The structurally sound portions of what remains of the natural volcanic dike underneath the breakwater would be untouched. Broken or loose pieces from remaining sections of the dike would be removed to prevent further deterioration from wave activity that may create potential hazards from dislodged pieces. No blasting and/or excavation of the natural dike is proposed. While the dike's condition is unknown, what remains is anticipated to be deteriorated and lower in height compared to the existing breakwater. It is anticipated that remnants of the dike likely vary in height from mean sea level (MSL) to approximately 3 feet above MSL. By removing the breakwater, the direct connection between the public access path to the dike would no longer exist upon completion of the project thus reducing the convenience, attraction, thrill of jumping, and the potential for injuries. In addition, the existing drainage pipe situated within the breakwater would also be removed and disposed of, thus eliminating the hazard of persons trying to swim through it. Exhibit 7 includes a typical section view of the boulder removal around the dike, and the removal of the drainage pipe section of the breakwater while Exhibit 8 shows visual simulations of before and after dismantling the Diamond Head Breakwater and re-naturalizing the shoreline.

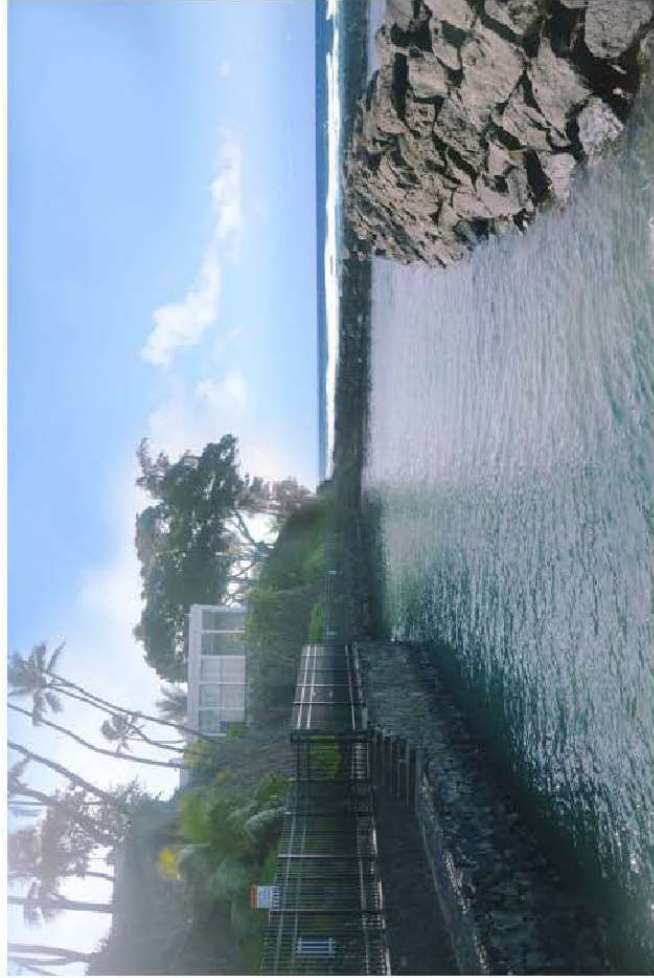
Current View of Breakwater and Basin

Simulated View After Breakwater Dismantling

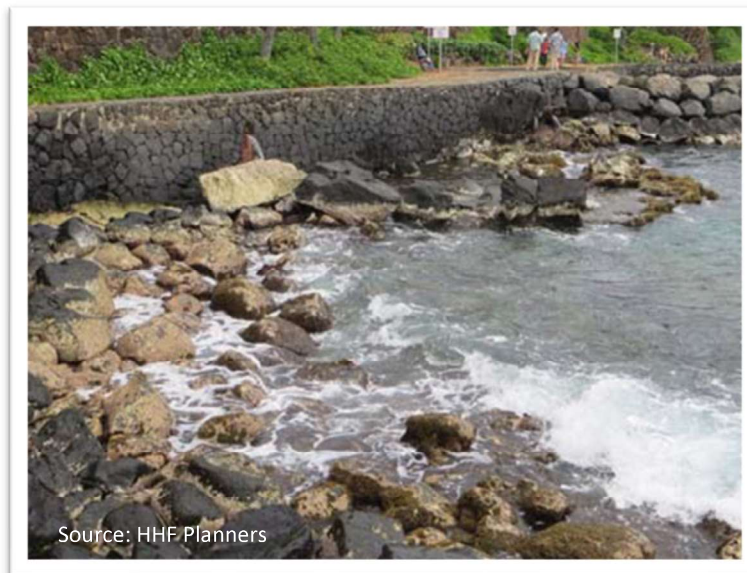
PHOTO 6: Shoreline Conditions Northwest of Breakwater

After dismantling the breakwater, the boulders would be placed along the face of, and makai of, the existing DDFIA seawall for the length of the entire basin in order to mimic the natural shoreline conditions as observed northwest of the existing breakwater (Photo 6). By doing so, the State hopes to create a condition that would deter the risky behavior of people jumping from the seawall into the basin.

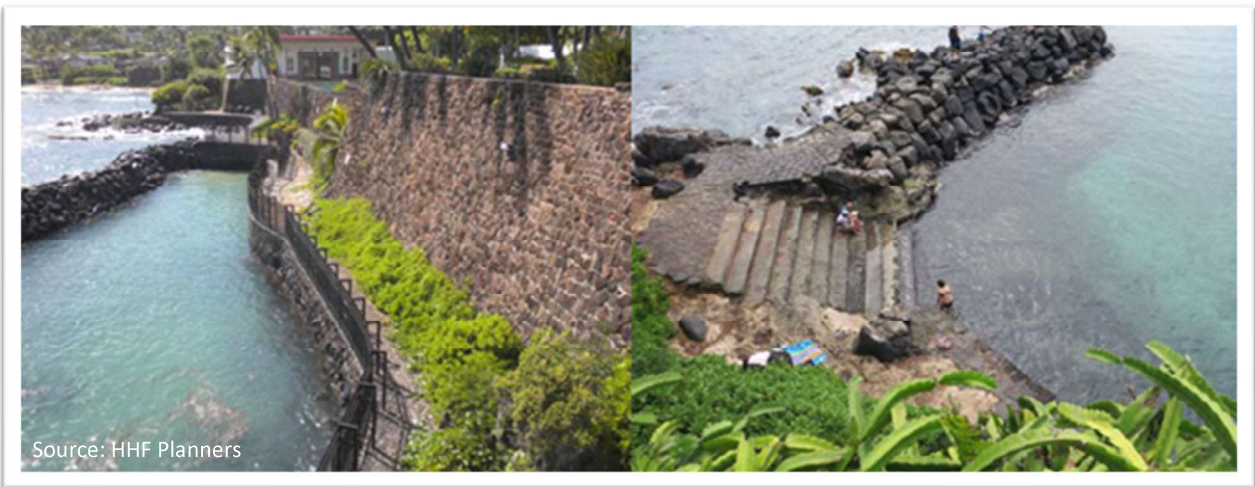
PHOTOS 7 & 8:

**PUBLIC WALKWAY PROVIDING
LATERAL ACCESS**

**CONCRETE STEPS AT KOKOHEAD BREAKWATER
PROVIDES ACCESS TO FORMER BOAT BASIN**

Access to the site is provided via an unimproved path accessible from Ka'alāwai Beach which travels east toward the project site, ending in a coral shelf terminating at the start of the boat basin seawall. The basin seawall includes a shoreline walkway providing the public with lateral access along the shoreline fronting the Shangri La property. This walkway is visible in Photo 7. Concrete steps are present at the mauka end of the Koko Head Breakwater, allowing public access to basin waters from the shoreline walkway. Photo 8 shows the location of these steps. East of the Koko Head breakwater is a rocky shoreline fronting several residential estates. The shoreline in this area is accessible, but unimproved and extends further east for a short distance. There is no convenient shoreline access further east.

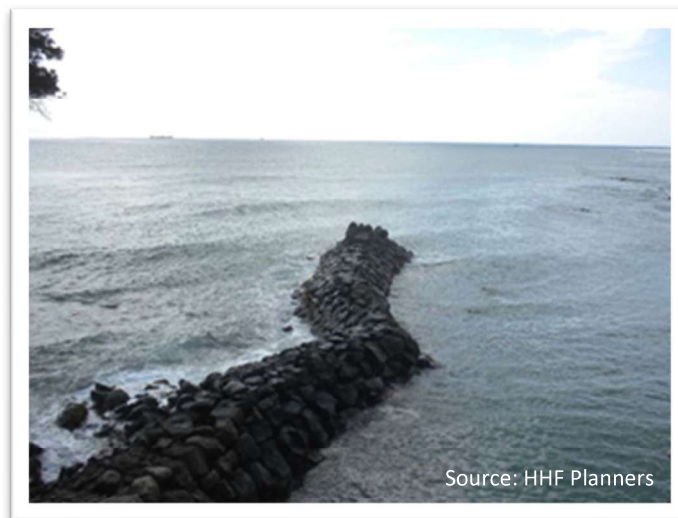
PHOTO 9: KOKOHEAD BREAKWATER

Koko Head Breakwater: The Koko Head Breakwater was also constructed in 1938 and extends seaward in a southwest direction from the eastern end of the property (see Photo 9). This breakwater provides protection from southern swells and is oriented generally north to south. The breakwater is approximately 175 feet long and constructed similar to the Diamond Head Breakwater using boulders stacked in a pyramidal orientation without concrete or mortar. Boulders comprising the breakwater average about 55 inches in diameter and are stacked four courses high on the mauka end and seven to eight courses high on the makai end. The breakwater terminates on the makai end with a raised platform and low rock wall.

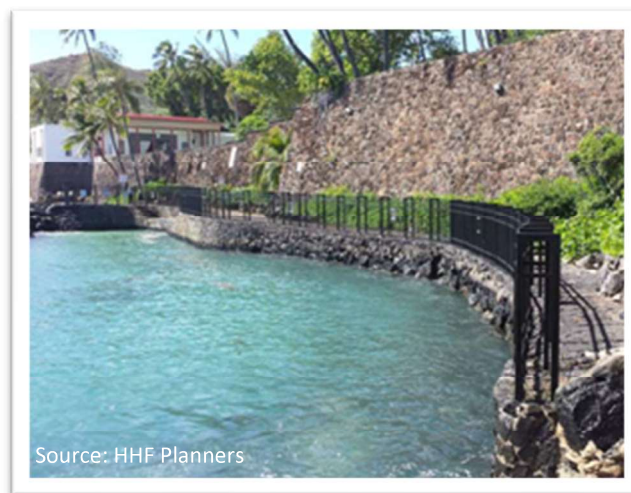
PHOTO 12: EXISTING SEAWALL AND PUBLIC SHORELINE WALKWAY

Shangri La Seawall: Along the Shangri La shoreline, the boat basin has a stone seawall with a stone walkway surface (public shoreline walkway) that provides public lateral access along the shoreline. In 2014, a 6-foot high aluminum fence was installed along the public shoreline walkway at the edge of the seawall (see Photo 12). Two sets of concrete steps are present at the Diamond Head end leading to a lower section of the seawall where access to a vessel berth was formerly located (refer back to Figure 10 – Existing Site Plan). A tall reinforced concrete retaining wall with lava rock veneer separates the residential portion of the property from the public lateral access along the seawall. This retaining wall increases in height as it nears Shangri La’s main house, and ranges from approximately 13 feet to 40 feet tall.

Along the shoreline, the seawall with stone walkway forms the inland (mauka) edge of the basin and is approximately 260 feet in length measured from the Diamond Head Breakwater (southbound) to the concrete stairs at the Koko Head Breakwater. The seawall varies in height from about 9 feet above MSL at the Diamond Head Breakwater, to 7.5 feet above MSL east of the stairs serving the vessel berthing area, and then gradually decreasing to 5.5 feet above MSL at the steps at the Koko Head Breakwater. The lower section of the seawall formerly used for access to the vessel berthing area is about 5 feet above MSL. Note that a 6-foot high aluminum fence was installed in May 2014 along the public shoreline walkway at the edge of seawall as an initiative to increase public safety and maintain public access.

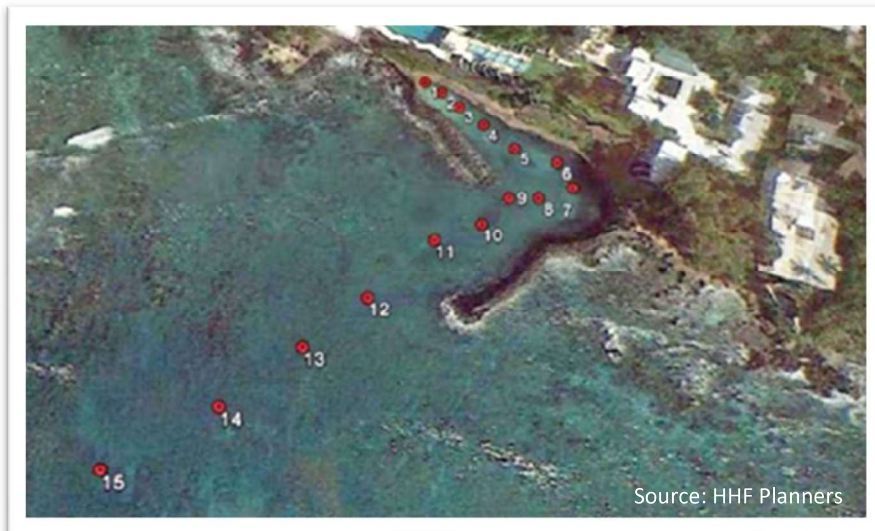
PHOTO 14: WATER QUALITY SAMPLING TRANSECT SURVEY LOCATIONS

Water Quality: A water quality survey was conducted in 2014 in the former boat basin, the entrance channel, and nearby offshore area to assess the impact of the project on project site water quality. Water samples were collected at 15 locations along a sampling transect starting at the point of discharge at the drainage pipe within the Diamond Head Breakwater, then extending approximately 500 feet offshore in an area deemed to be beyond the influence of land activities (see Photo 14). Water quality parameters evaluated included the 10 specific water quality criteria designated for open coastal waters under the State Department of Health's (DOH) Water Quality Standards (Chapter 11-54, HAR). In addition, orthophosphate phosphorus (PO₄₃-) and silica (Si) were reported because these parameters are indicators of biological activity and the degree of groundwater mixing. This survey is discussed in detail in the Final EA.

Survey results indicate that the detectable groundwater input at the shoreline results in nutrient and salinity gradients in the semi-enclosed boat basin. As a result, nutrient concentrations in the basin exceed State DOH water quality standards. The main factor promoting nutrient concentrations observed is the presence of the Diamond Head Breakwater that shelters the basin from wave mixing. Breakwater dismantling is anticipated to result in increased nearshore mixing because the comparatively lower height of the volcanic dike will allow more overwash and increased water mixing. As a result, the magnitude of detectable nutrients should dissipate. Basin water quality would be beneficially impacted because the elevation of nutrients would be reduced and no longer exceed State DOH water quality standards.

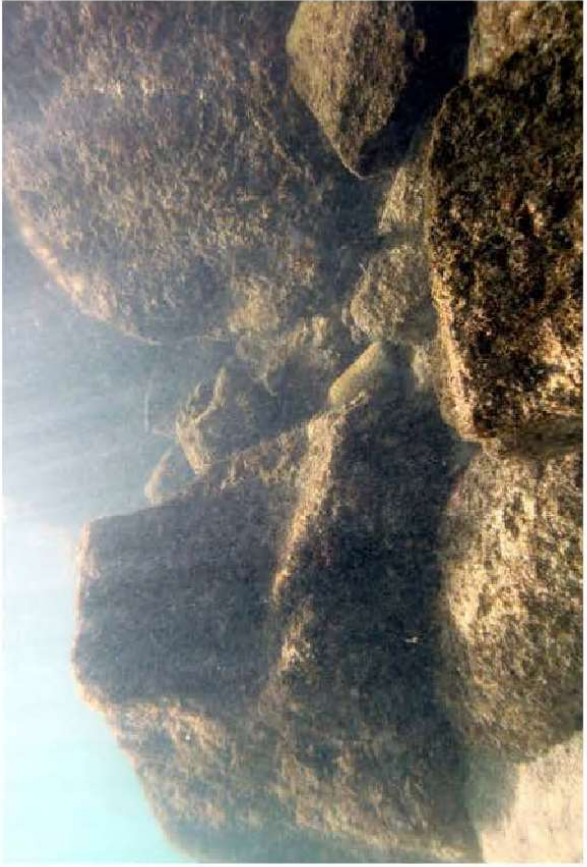
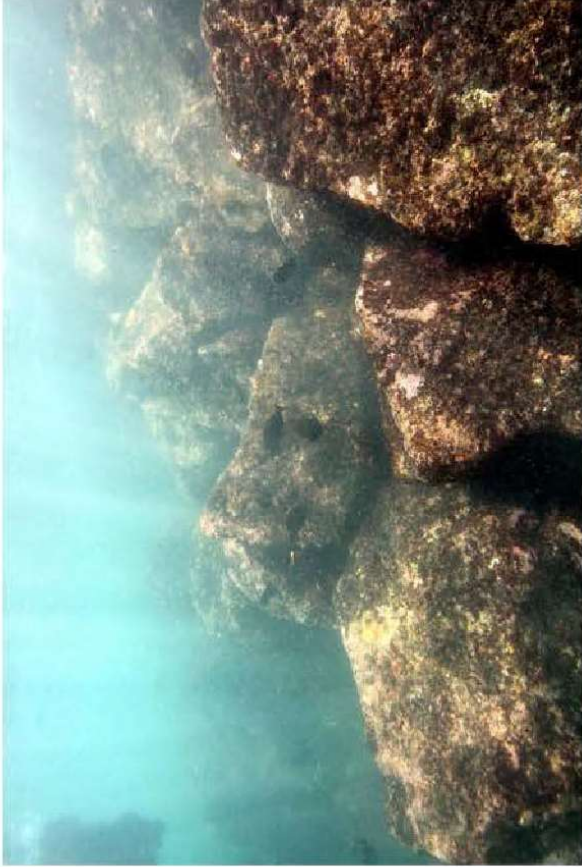
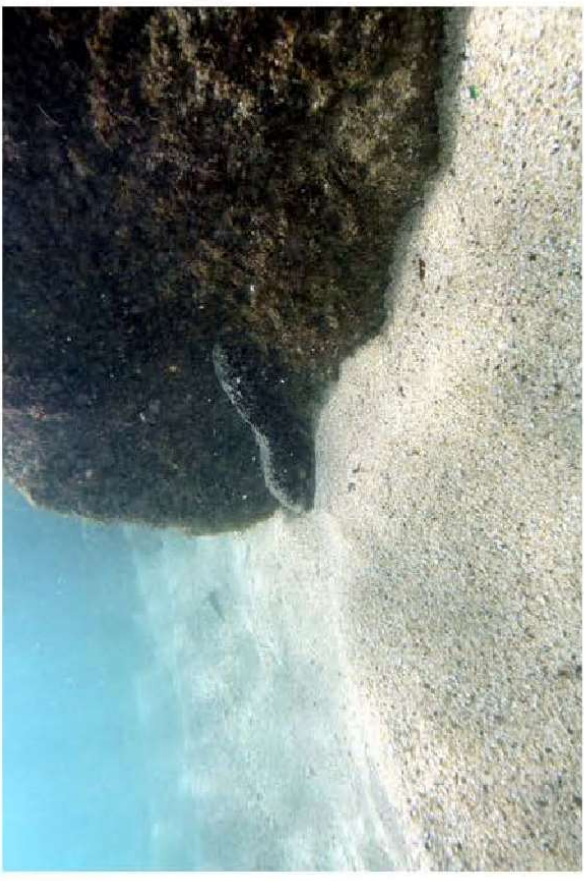
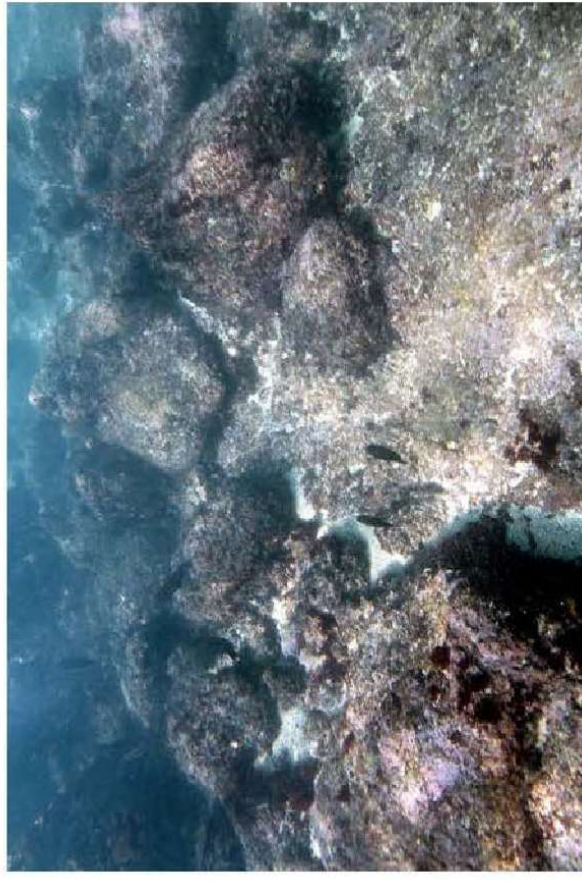
PHOTOGRAPHS OF SUBSTRATUM WITHIN & OUTSIDE OF BASIN

Typical view of Diamond Head Breakwater boulders inside of boat basin (November 2015).

Boulders on the seaward outer face of the Diamond Head Breakwater (November 2015).

Boulders and coarse white sand covering the basin floor (November 2015).

Within the inner entrance channel, corals were sporadic, occurring primarily as lobate forms of *Porites* growing on the reef platform (see Exhibit 15). No living corals were observed during the multiple surveys of the outer face of the boulders forming the Diamond Head Breakwater. Therefore, there are presently no living corals on the boulders comprising the breakwater that are planned to be dismantled.

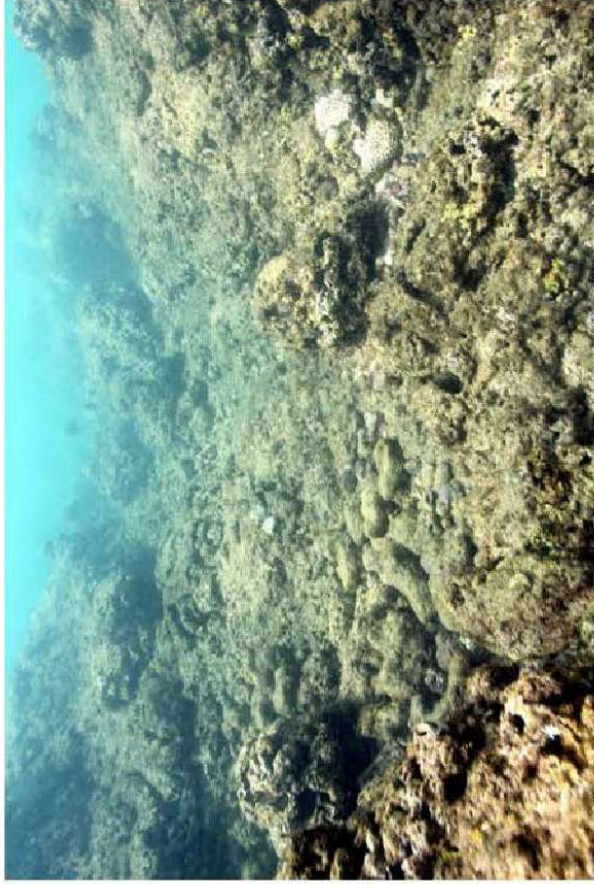
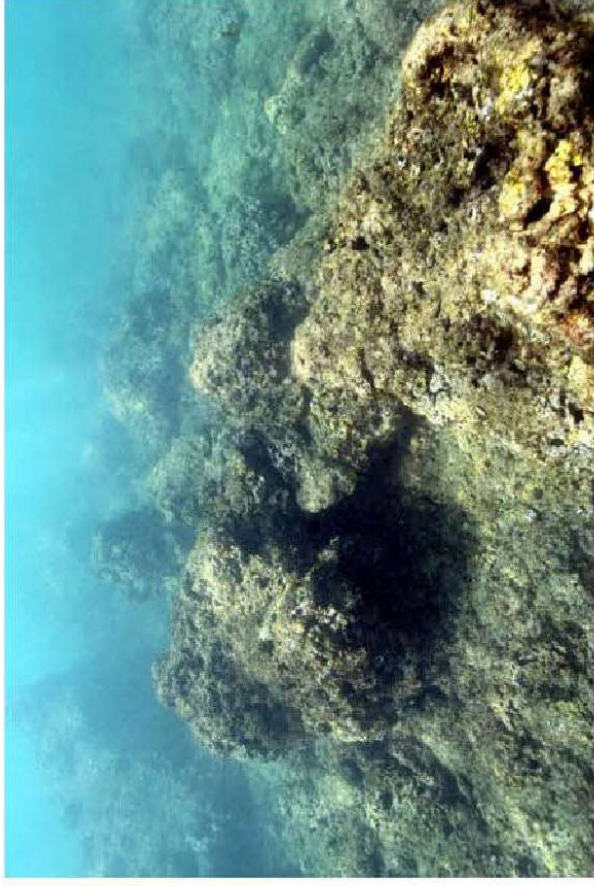
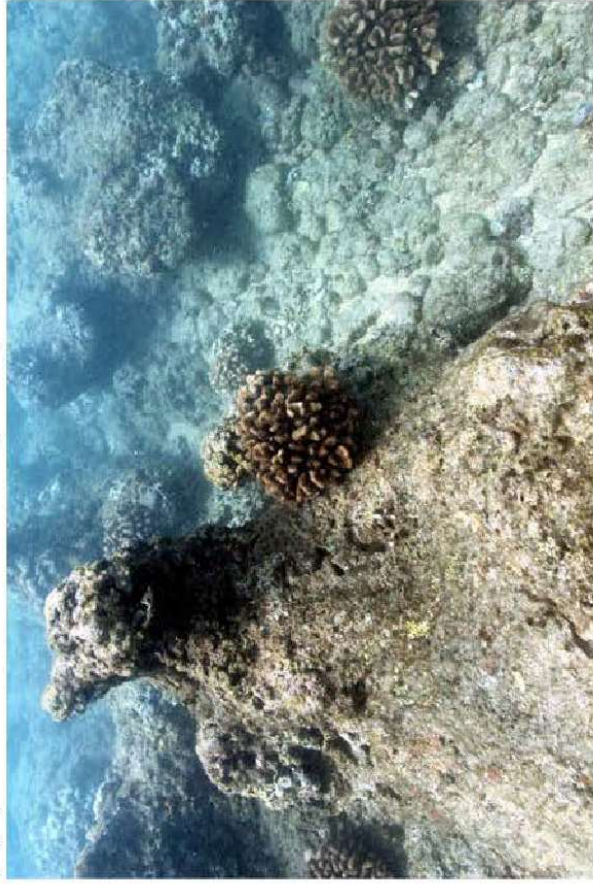
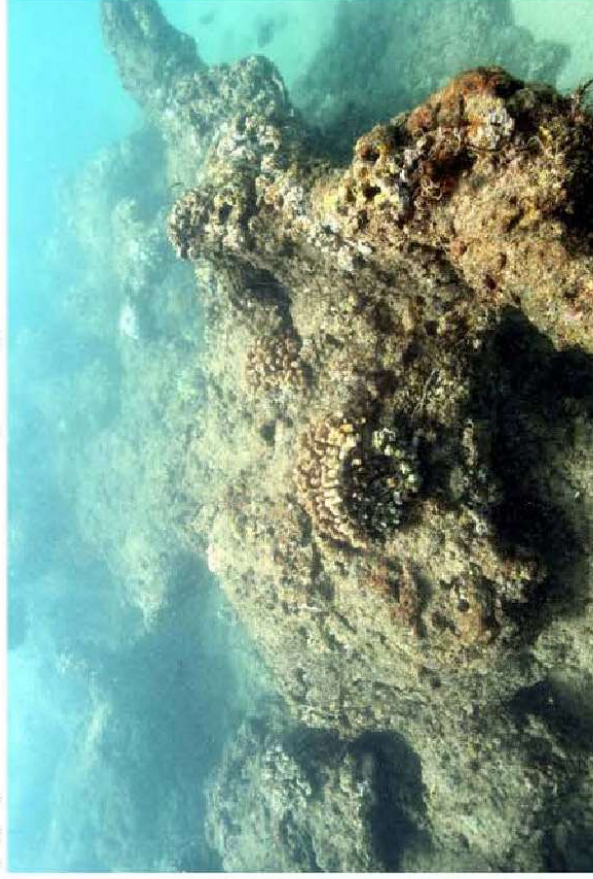
PHOTOGRAPHS OF SUBSTRATUM OUTSIDE OF BREAKWATER

View of outer reef structure seaward of Diamond Head Breakwater (highly eroded fossil reef structures present).

View of farthest outer reef structure seaward of Diamond Head Breakwater showing highly eroded fossil reef structures with scattered colonies of the hemispherical branching coral *Pocillopora meandrina*.

The outer reef seaward of the breakwaters consists of an eroded fossil reef platform. Biotic colonization of the platform was limited, and likely the result of annual events of large waves that exceed the physiological and structural tolerance of most corals. Extending approximately 20 feet seaward from the breakwater boulders, this area of the reef was essentially devoid of living corals.

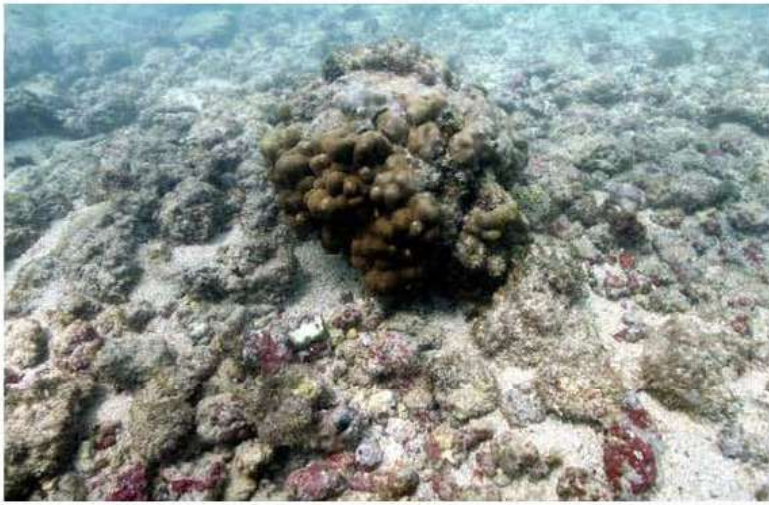
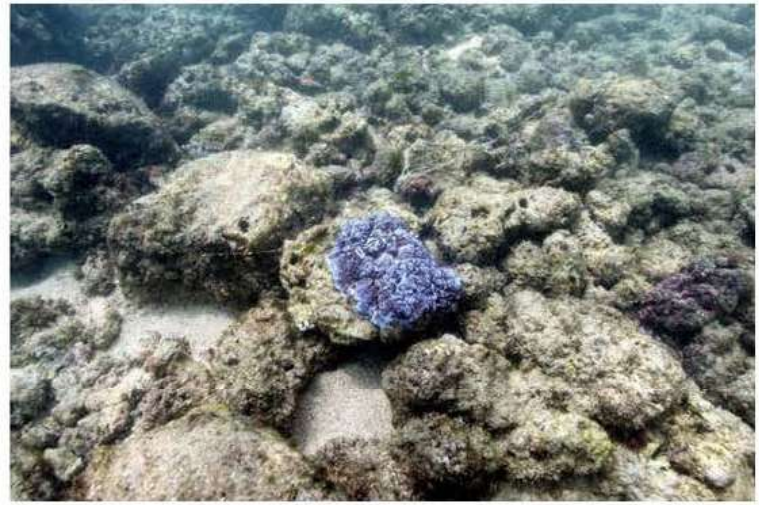
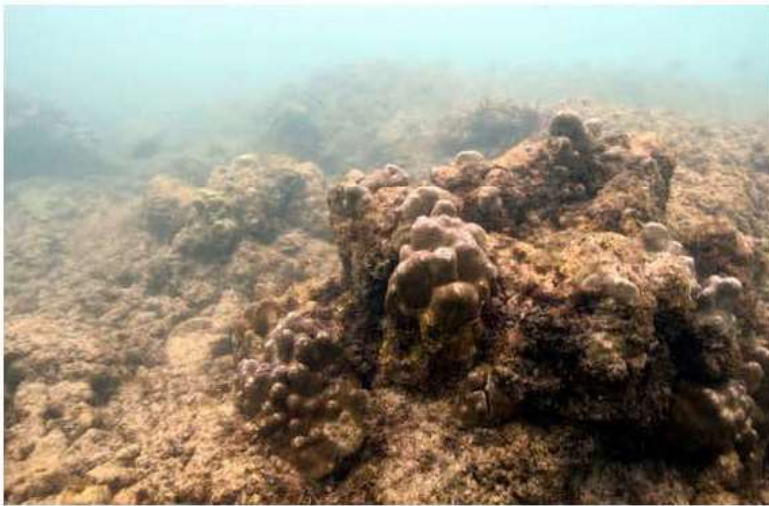
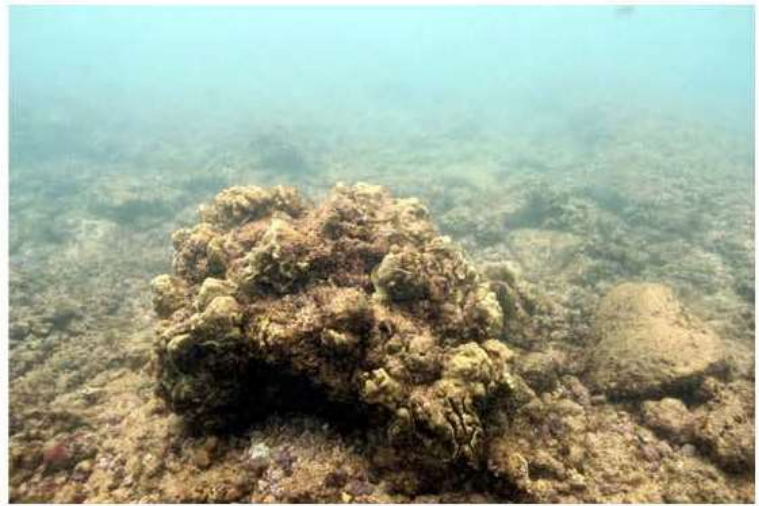
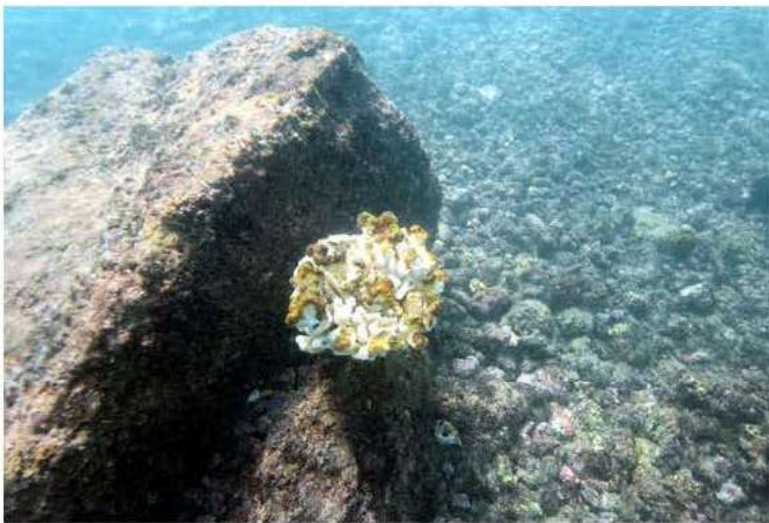
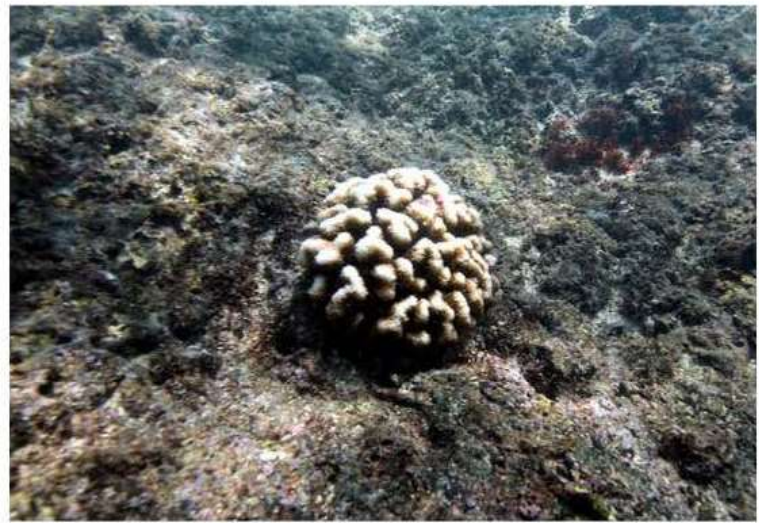
Hemispherical colony of *Porites lutea* located at inner channel of basin near breakwater.

Encrusting colony of *Montipora flabellata* located at inner channel of basin near breakwater.

Fragmented colonies of *Porites lutea* located on outer channel floor seaward of breakwater.

Encrusting colony of *Porites lobata* on eroded limestone on reef surface seaward of breakwater.

Colony of bleached *Pocillopora meandrina* growing on outer reef surface.

Colony of *Pocillopora meandrina* growing on outer reef surface.

Beyond this distance, sporadic living colonies occur, primarily consisting of the genera *Porites* and *Pocillopora* (refer to Figure 15). Most of the colonies of *Porites* were flat encrustations or patches of living tissue interspersed between areas of dead limestone.

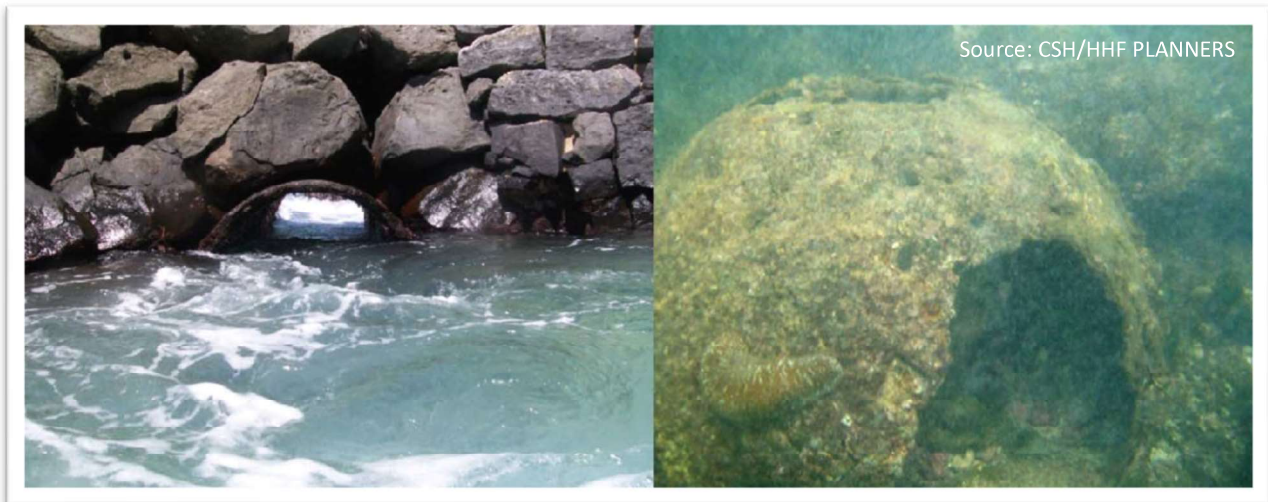
PHOTOS 18 & 19:

**FEATURE 8
DRAINAGE CULVERT**

**FEATURE 10
BUOY**

Feature 8 (Drainage Culvert). Directly adjacent to Feature 7 is an exposed concrete culvert pipe (see Photo 18). The concrete pipe is approximately 48 inches in diameter and runs entirely through the Diamond Head Breakwater.
