STATE OF HAWAII
DEPARTMENT OF LAND AND NATURAL RESOURCES
Engineering Division
Honolulu, Hawaii 96813

**Request Approval of Variance for Keaīwa Reservoir (HA-0049) of Hawaii
Administrative Rules Section 13-190.1-21(b)(2), and allow more than 5 feet of Water depth
to remain in the Breached Dam**

Dam Owner: Edmund C. Olson Trust No. II
P.O. Box 280
Pahala, HI 96777

Location: Middle & Lower Moaula Camp, Pahala, Hawai'i County

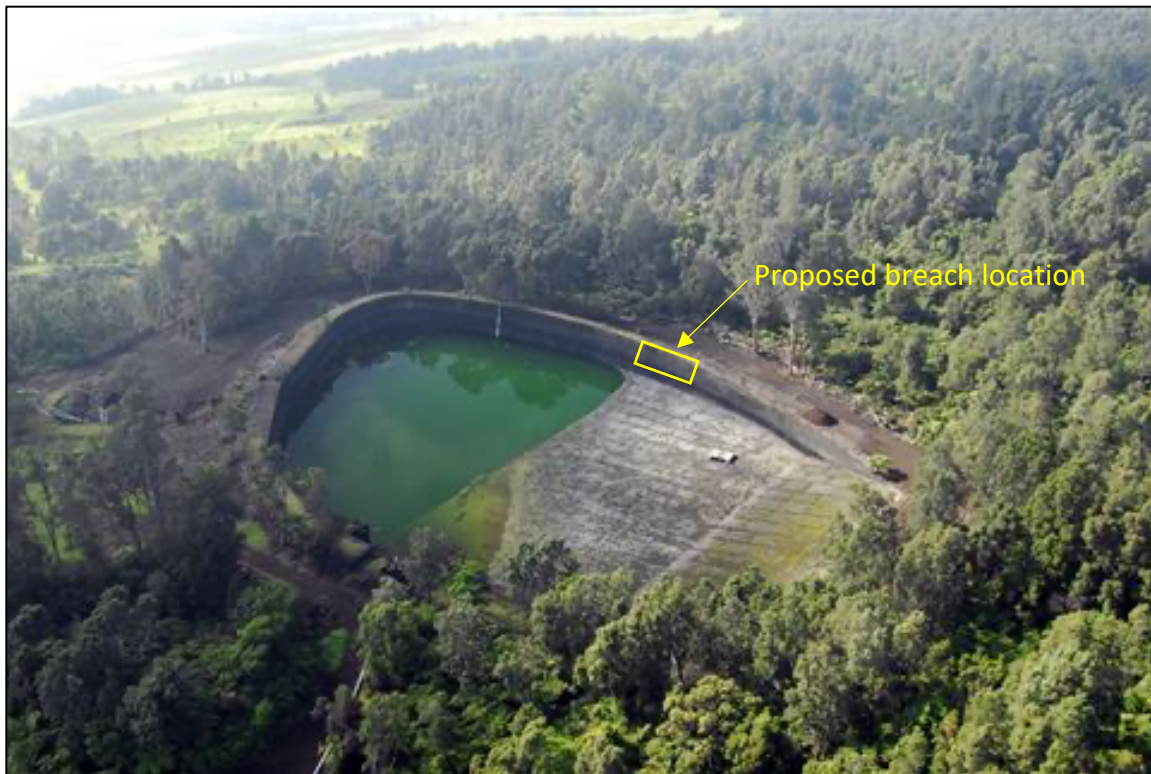
Figure 1. Keaīwa Reservoir (2011).

The Keaīwa Reservoir is located in Pahala on the island of Hawai'i. (See Figure 1 for aerial photo.) The structure receives water from the Ka'ala'ala and Noguchi Tunnels and is used for agricultural irrigation purposes for local farmers. The dam was constructed in 1920 and has a concrete lined earth embankment with a concrete parapet wall extension on the crest. This dam is 32 feet high and has the capacity to impound 48 acre-feet (16 million gallons), though it

The Trust is proposing to deregulate the Keaīwa Reservoir by breaching a portion of the embankment (see Figure 1) to lower the effective dam height and storage volume. For the reservoir to be removed from DLNR regulatory oversight, it must fall below a volume and depth threshold as defined in the HAR. The chart in Figure 2 shows the volume and dam height thresholds as defined by the Department, as well as the new planned dam height and volume.

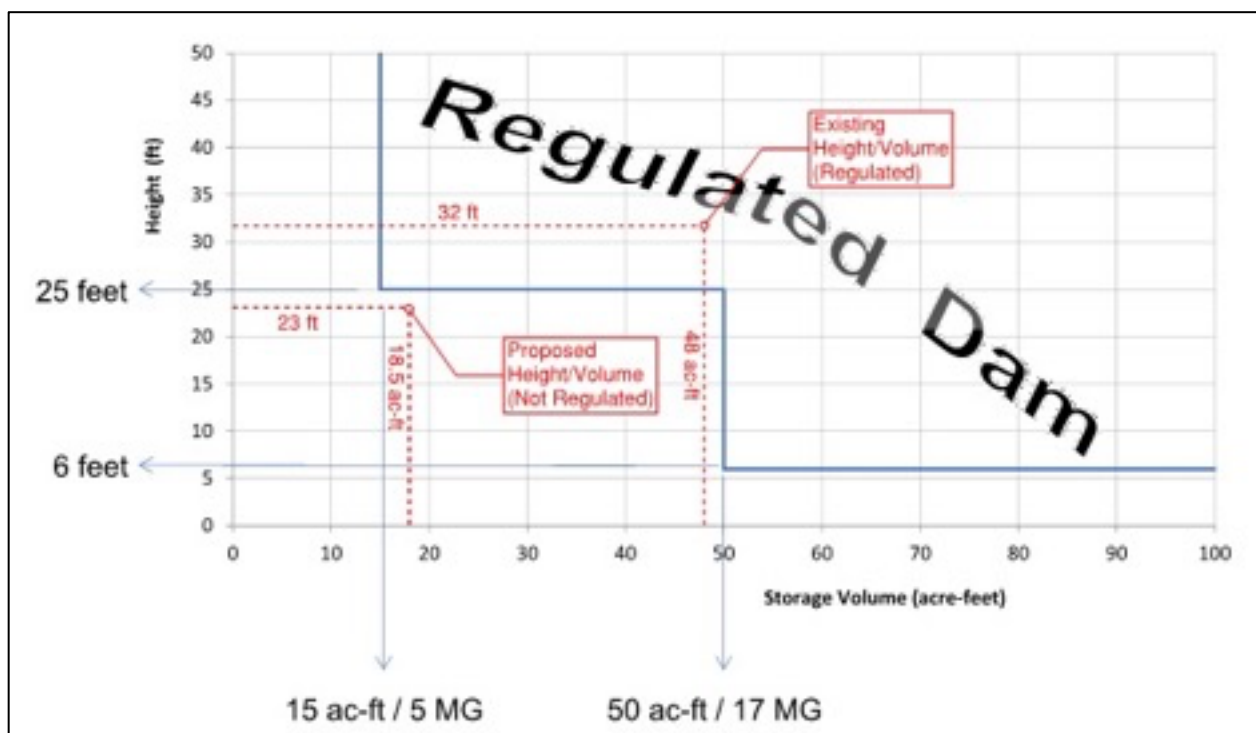
Figure 2. Jurisdictional size limits for dam regulation.

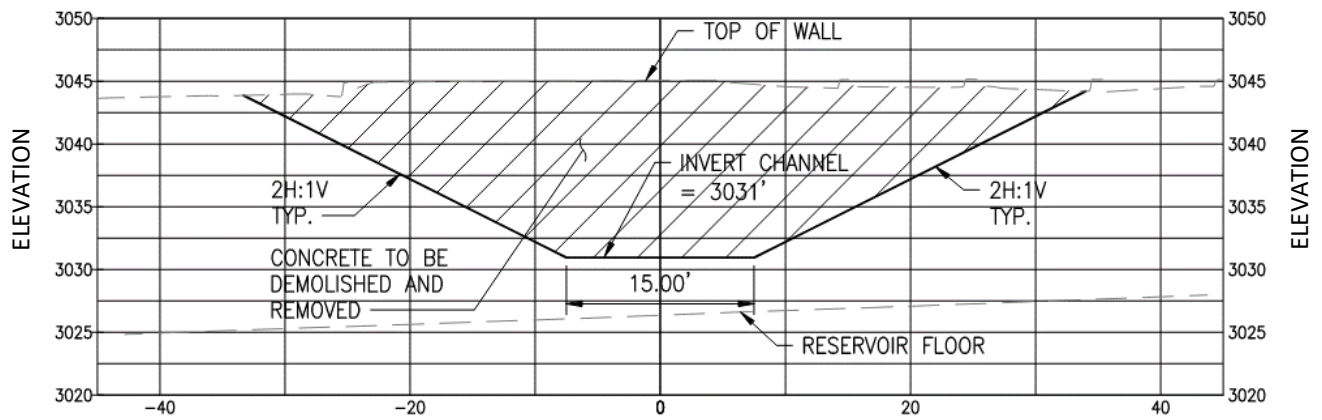
Figure 3. Typical section of proposed dam breach.

The Owner is proposing to modify the dam by creating a trapezoidal shaped channel through a portion of the southwest embankment wall (see Figure 3), which will lower the effective height and storage capacity of the dam. The intent is to partially remove the dam to bring it below the jurisdictional thresholds. The effective height of the dam structure will be reduced from 32-ft to 23-ft and the storage volume is greatly reduced from 48 acre-ft (16 million gallons) to 18.5 acre-ft (6 million gallons). The engineered breach is conservatively designed, having several times the capacity to pass a Probable Maximum Flood (PMF) event.

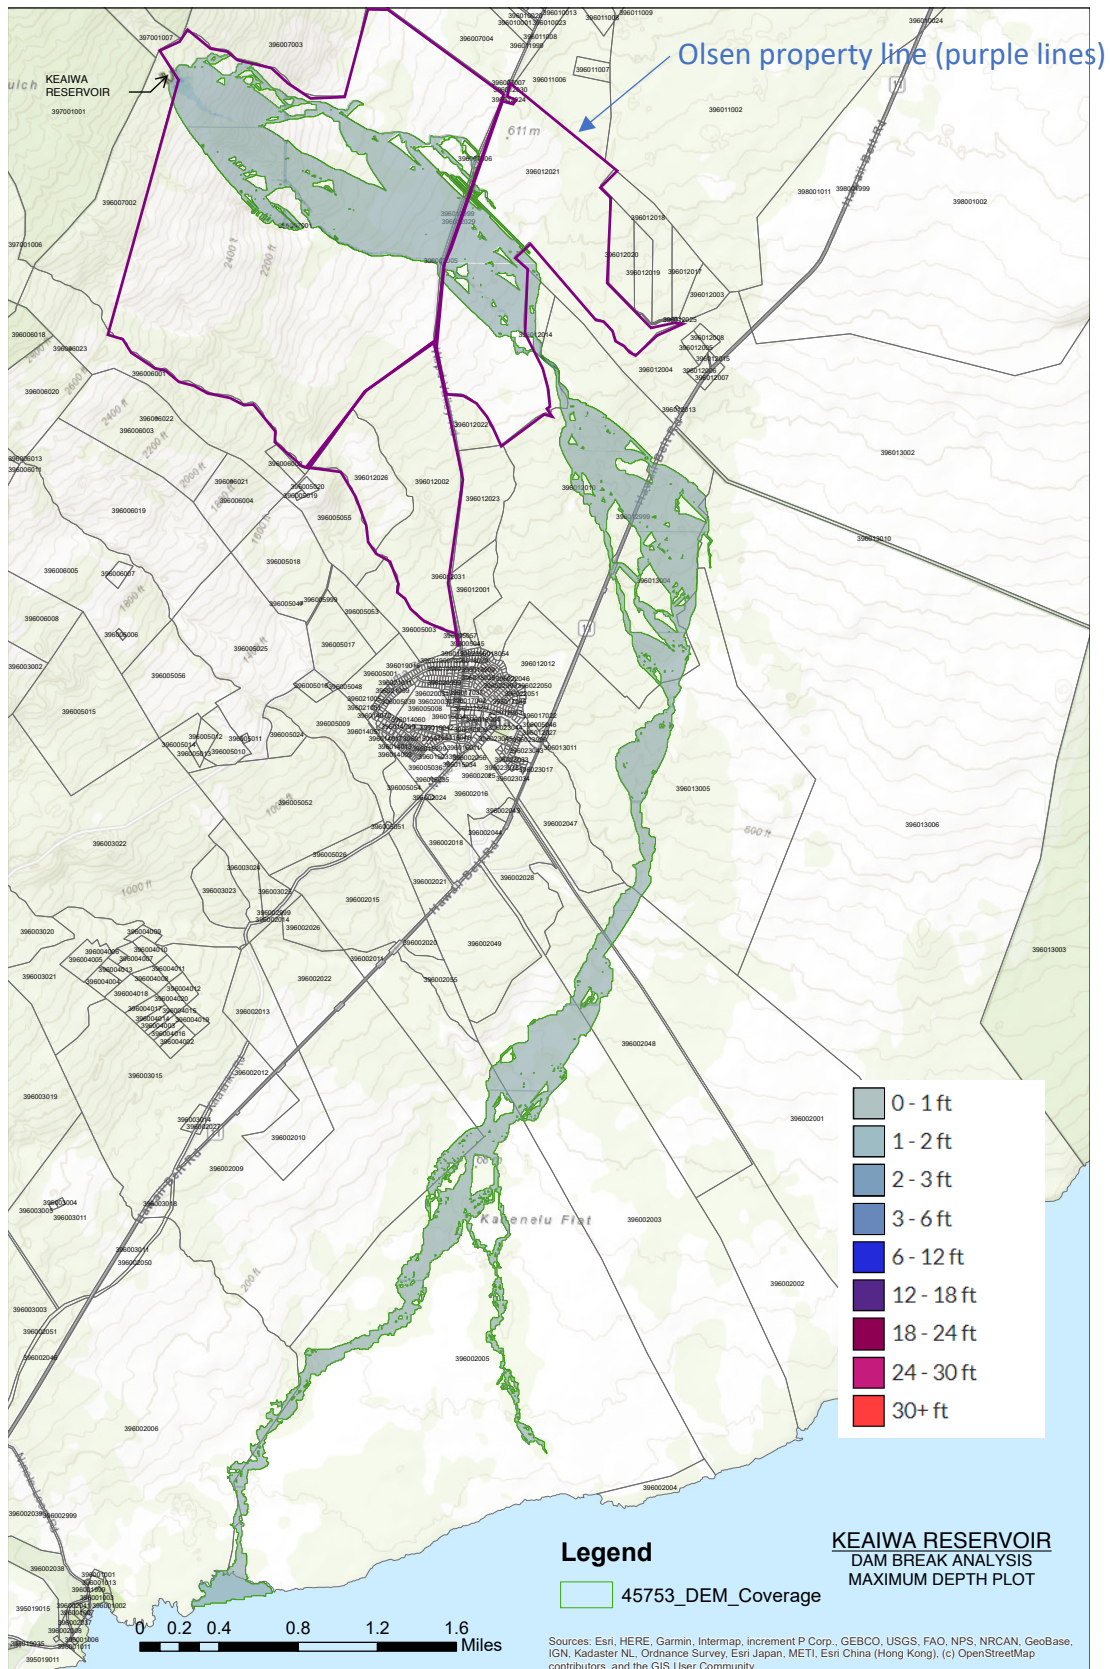
Figure 4. Dam breach inundation map, maximum depth plot.

A dam breach (failure) analysis was performed with the reduced reservoir storage volume and determined the modified dam's failure would generate a peak water flow rate of 1 foot per second at a depth of 1-2 feet and is primarily contained within existing drainageways. The flow route is displayed on the inundation map maximum depth and maximum velocity plots on Figures 4 and 5, respectively. With the modified dam holding close to three times less water in the reservoir, the downstream flow is greatly reduced.

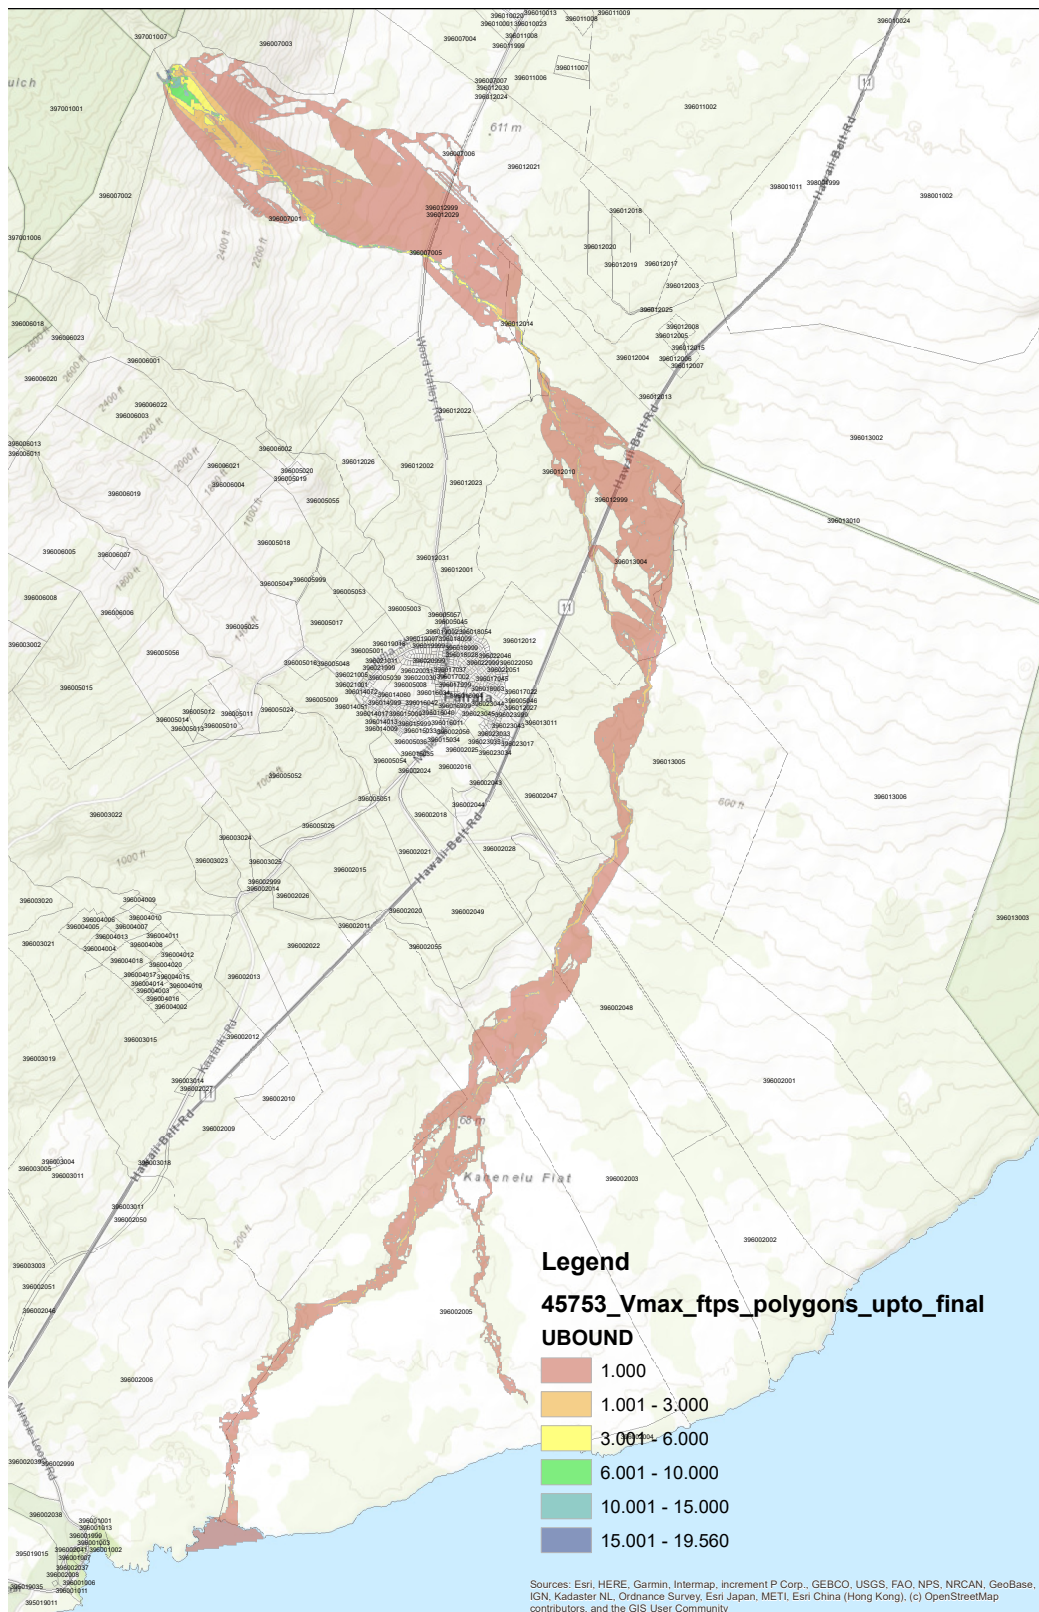
Figure 5. Dam breach inundation map, maximum velocity plot.
