TO:	Brian J. Neilson
	DAR Administrator
FROM:	Troy Sakihara, Aquatic Biologist
CC:	Brian Kanenaka, Program Manager Ryan Okano, Program Manager David Sakoda, Program Manager
SUBJECT:	Pahe'ehe'e Stream Inspection

Pahe'ehe'e Stream Trip Report Honomu, Hawaii Island

DAR Visual Survey Conducted in Pahe'ehe'e Stream on the Island of Hawaii

For Surveys Conducted on 09/10/20

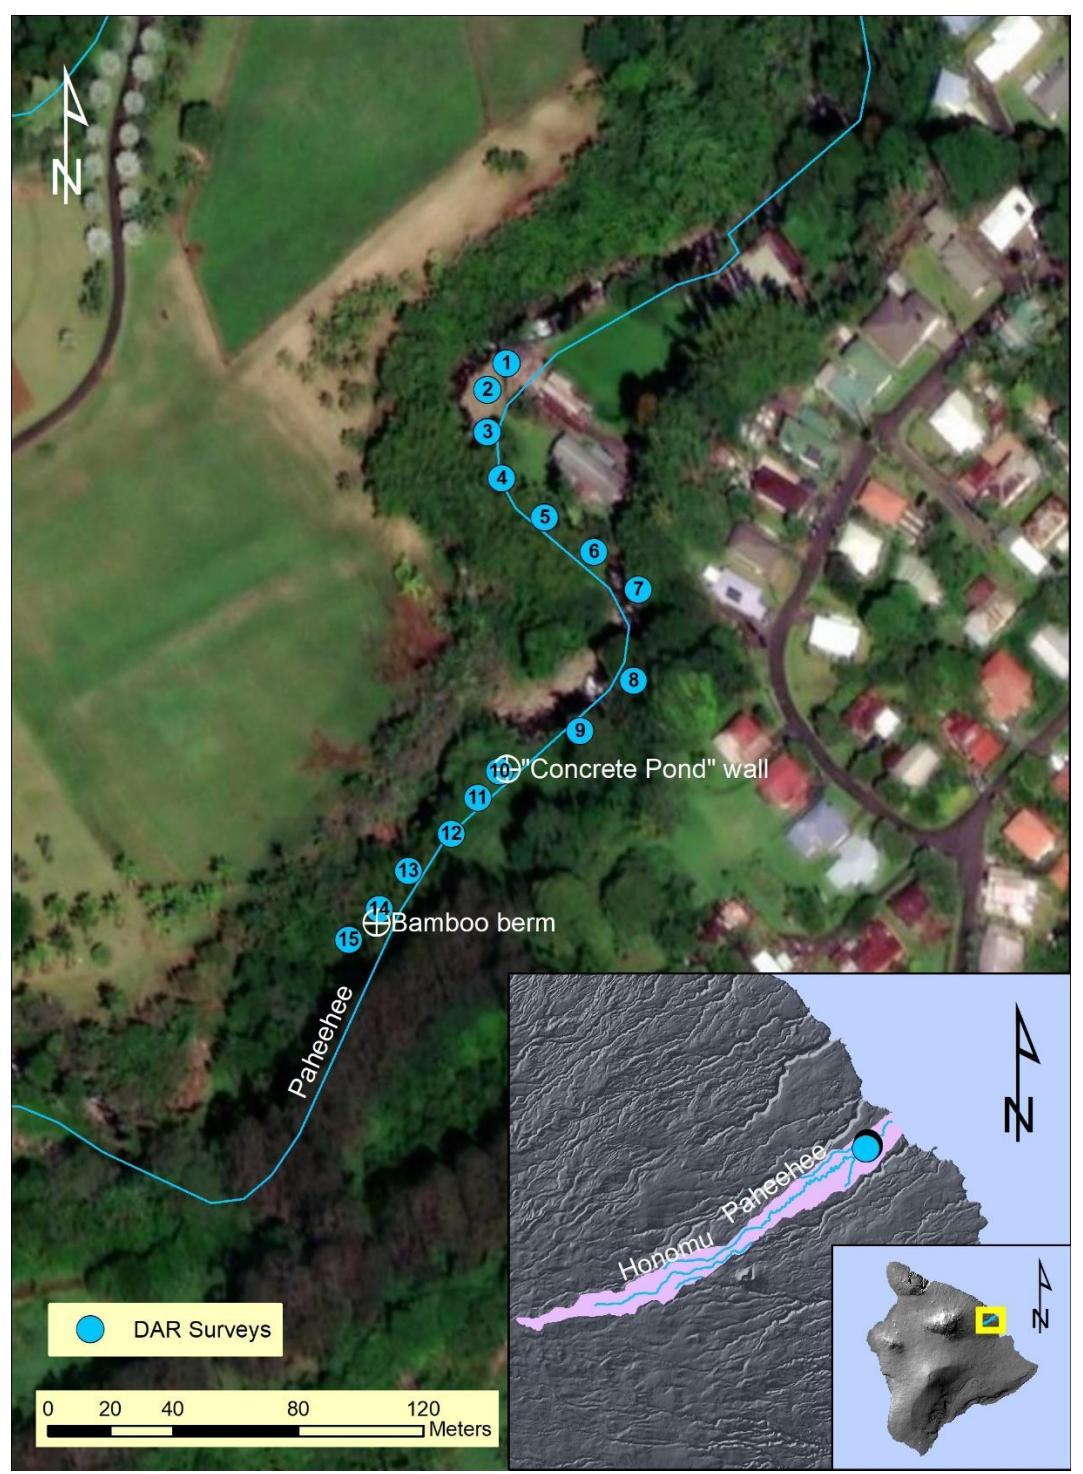
Figure 1. Map of stream surveys conducted in Pahe'ehe'e Stream, Hawaii Island on September 10, 2020.

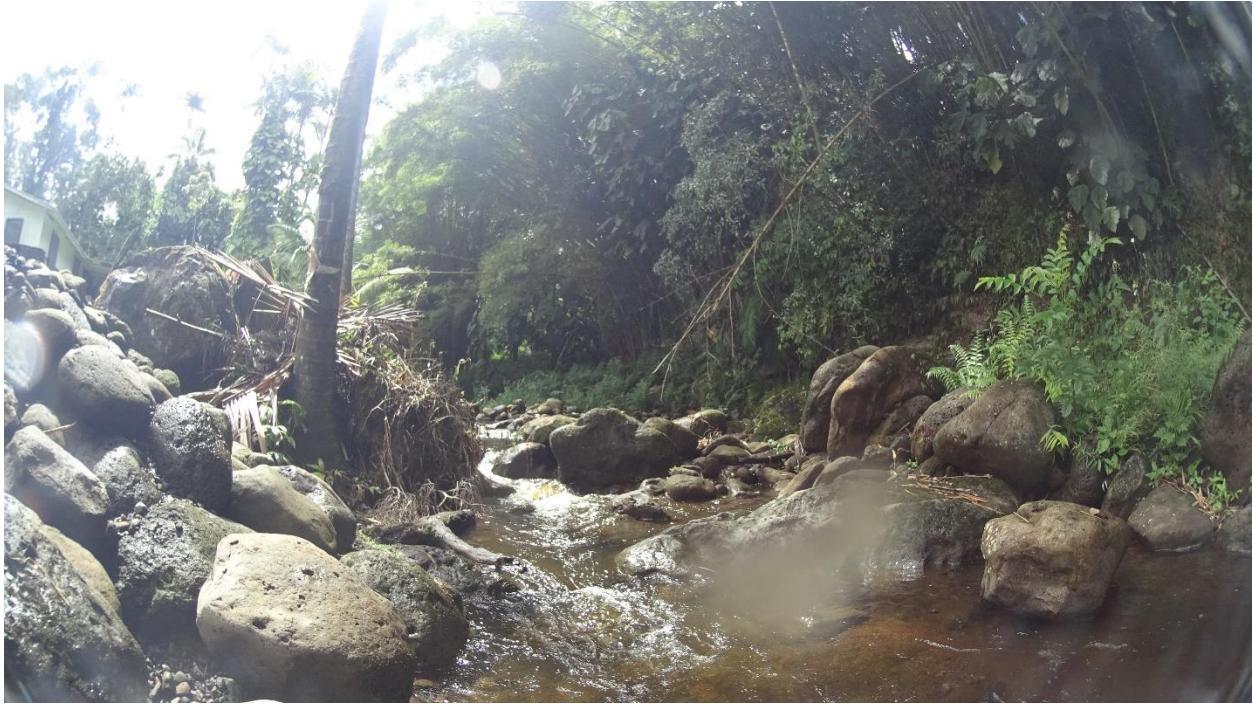
Four stream habitat types, run, riffle, cascading pool and pool, were recorded across 15 survey stations (Table 1). The stream habitat consisted almost entirely of natural boulder and cobble (Figure 2), except for a concrete weir running across the stream width immediately below survey station 10 (Figure 1 and 3). Overall, stream flow, visibility and observed habitat conditions were considered typical of streams in East Hawaii.

Figure 2. Photo of Pahe'e he'e Stream facing upstream near survey station 4, taken on September 10, 2020.

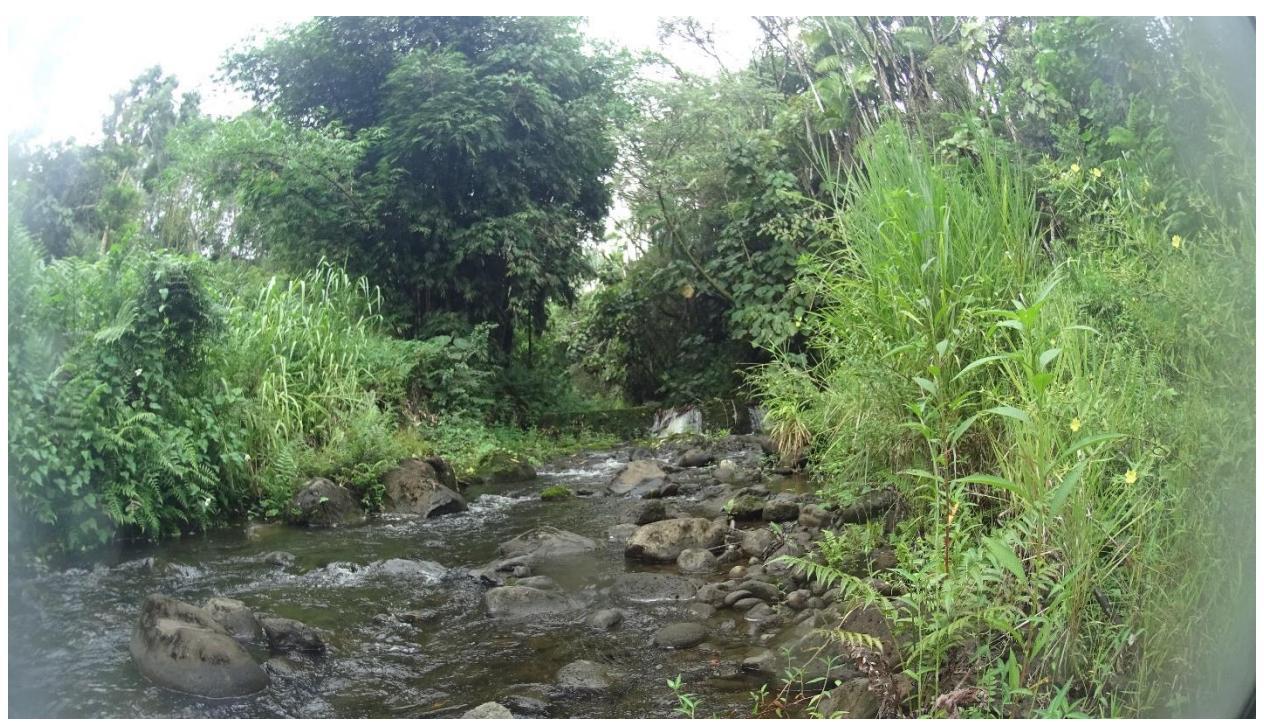
Figure 3. Photo of Pahe'e he'e Stream and concrete weir, facing upstream near survey station 9, taken on September 10, 2020.

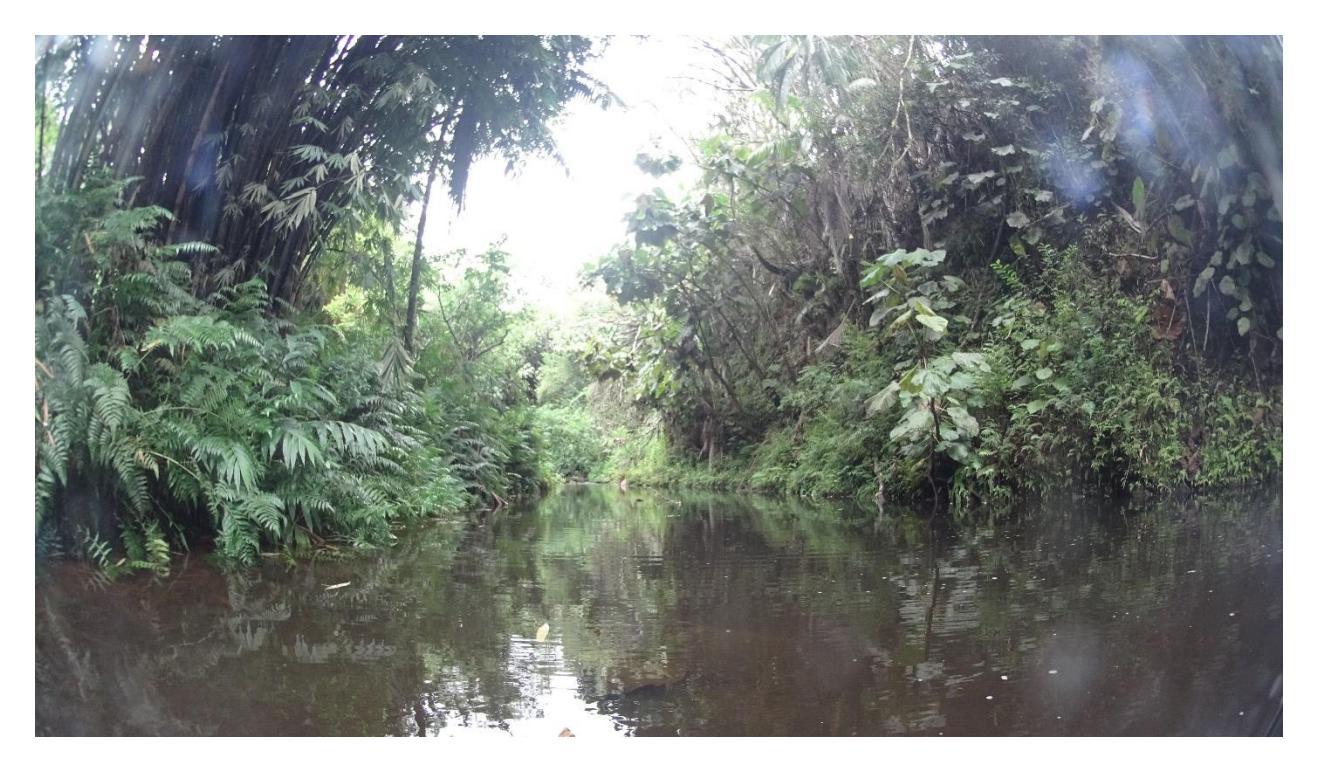
It is important to note that the habitat conditions within "concrete pond" and above the "bamboo berm" were very similar (Figure 4 and 5), consisting of shallow, calm water with a thick layer of sediment and decaying organic matter (leaf litter and branches), which is preferred and ideal habitat for *M. lar*. As expected, *M. lar* was prevalent and in relatively higher densities above the

"bamboo berm". In contrast, having no M. lar observed in "concrete pond" is considered highly unusual and atypical of biological compositions found in these types of stream habitat in Hawaii. This was also verified by a resident in the area that regularly observed prawns in abundance in "concrete pond" prior to the animal kill incident on July 13, 2020 (K. Masaoka pers. comm.). These observations indicate that some significant and unnatural form of disturbance occurred somewhere below the "bamboo berm" and above "Concrete Pond", which extirpated M. lar in "concrete pond", and impacted the biological community downstream as indicated by lower M. lar densities at survey stations 1 through 9. Also, as M. lar display natural upstream migrations and a tendency to move in this direction, it is highly likely that the prawns observed from stations 1 through 9 are slowly repopulating this section of stream from areas further downstream. This may also explain why M. lar from above the "bamboo berm" have not repopulated "Concrete Pond" downstream. Furthermore, it is also highly plausible that the lack of recruitment into "Concrete Pond" from downstream is a result of the physical barrier that the concrete weir presents. On the other hand, P. reticulata are considerably more mobile and less sedentary in their behavior than M. lar, which may explain their consistent prevalence across the entire survey.

Figure 4. Photo taken upstream of "Concrete Pond" in Pahe'e he'e Stream near survey station 10, taken on September 10, 2020.

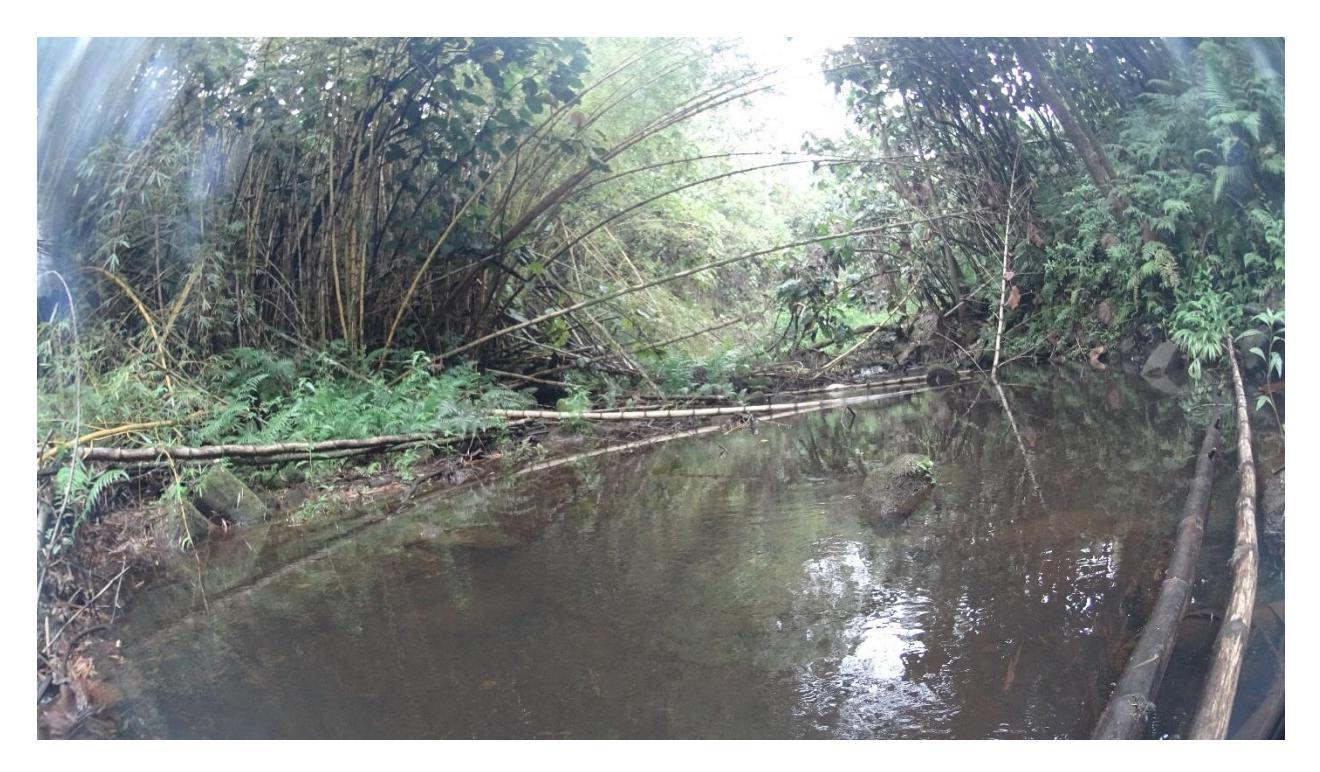
Figure 5. Photo taken upstream above the "bamboo berm" in Pahe'e he'e Stream near survey station 15, taken on September 10, 2020.
