Regional Sediment Management (RSM) Program

Hawaii Regional Sediment Management Needs Assessment

Thomas D. Smith and Linda S. Lillycrop

July 2014

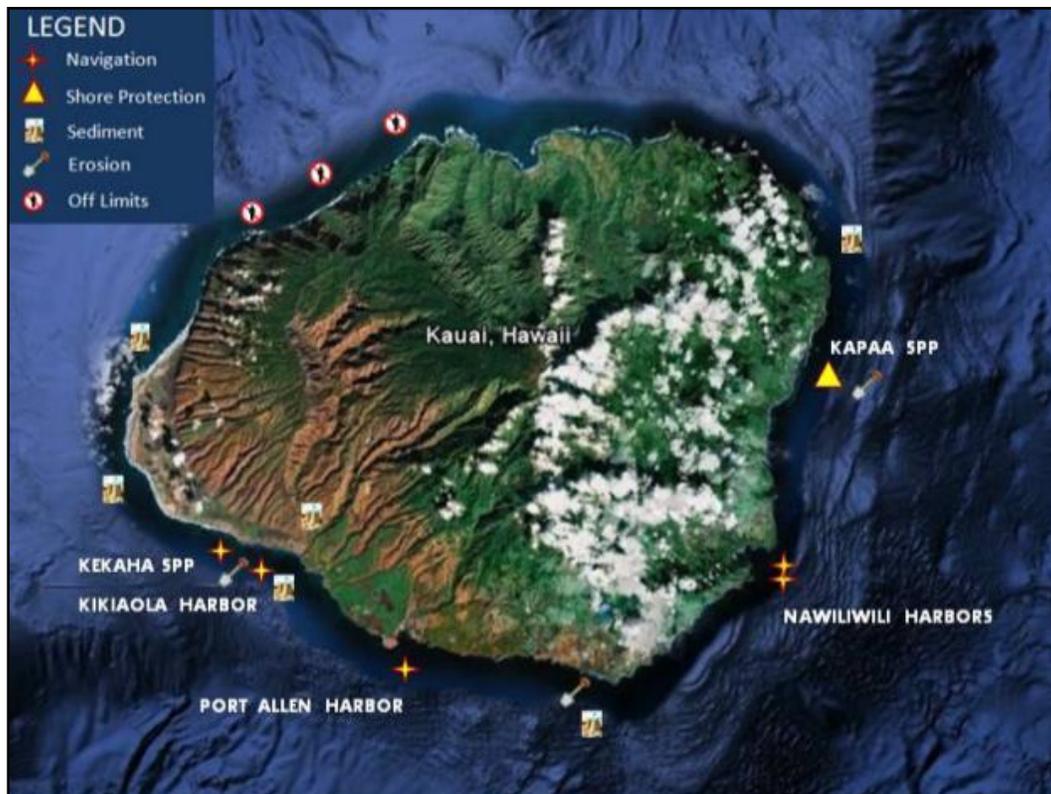
Figure 2. Locations of federally authorized navigation projects (stars) and shore protection projects (yellow triangles) on Island of Kauai that could benefit from RSM activities.

The federally authorized projects of interest on Island of Kauai include (a) Kikiaola Shallow Draft Harbor, (b) Port Allen Deep Draft Harbor, (c) Nawiliwili Deep Draft Harbor, (d) Nawiliwili Small Boat Harbor, (e) Kapaa Shore Protection Project, and (f) Kekaha Shore Protection Project.

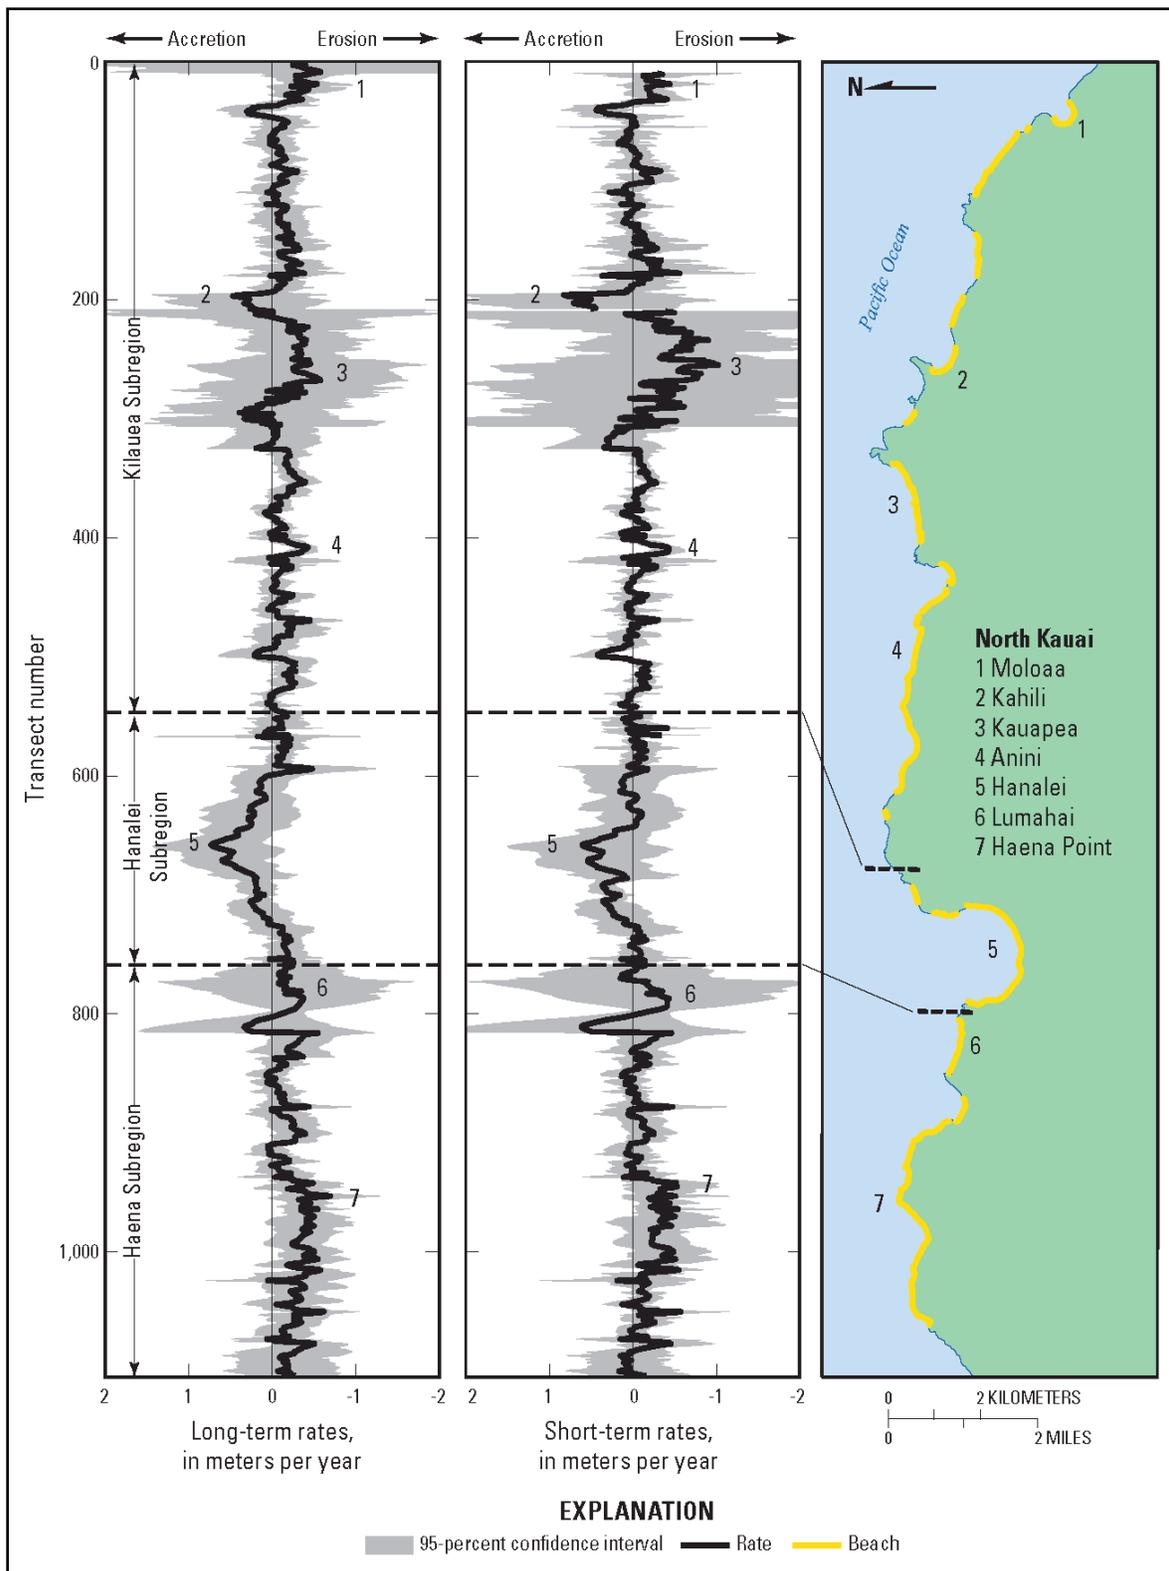
Figure 4. Long-term (all available years) and short-term (1940s to present) shoreline change rates, North Kauai (location shown in Figure 3) (Figure 16 of Fletcher et al. 2012; by permission).

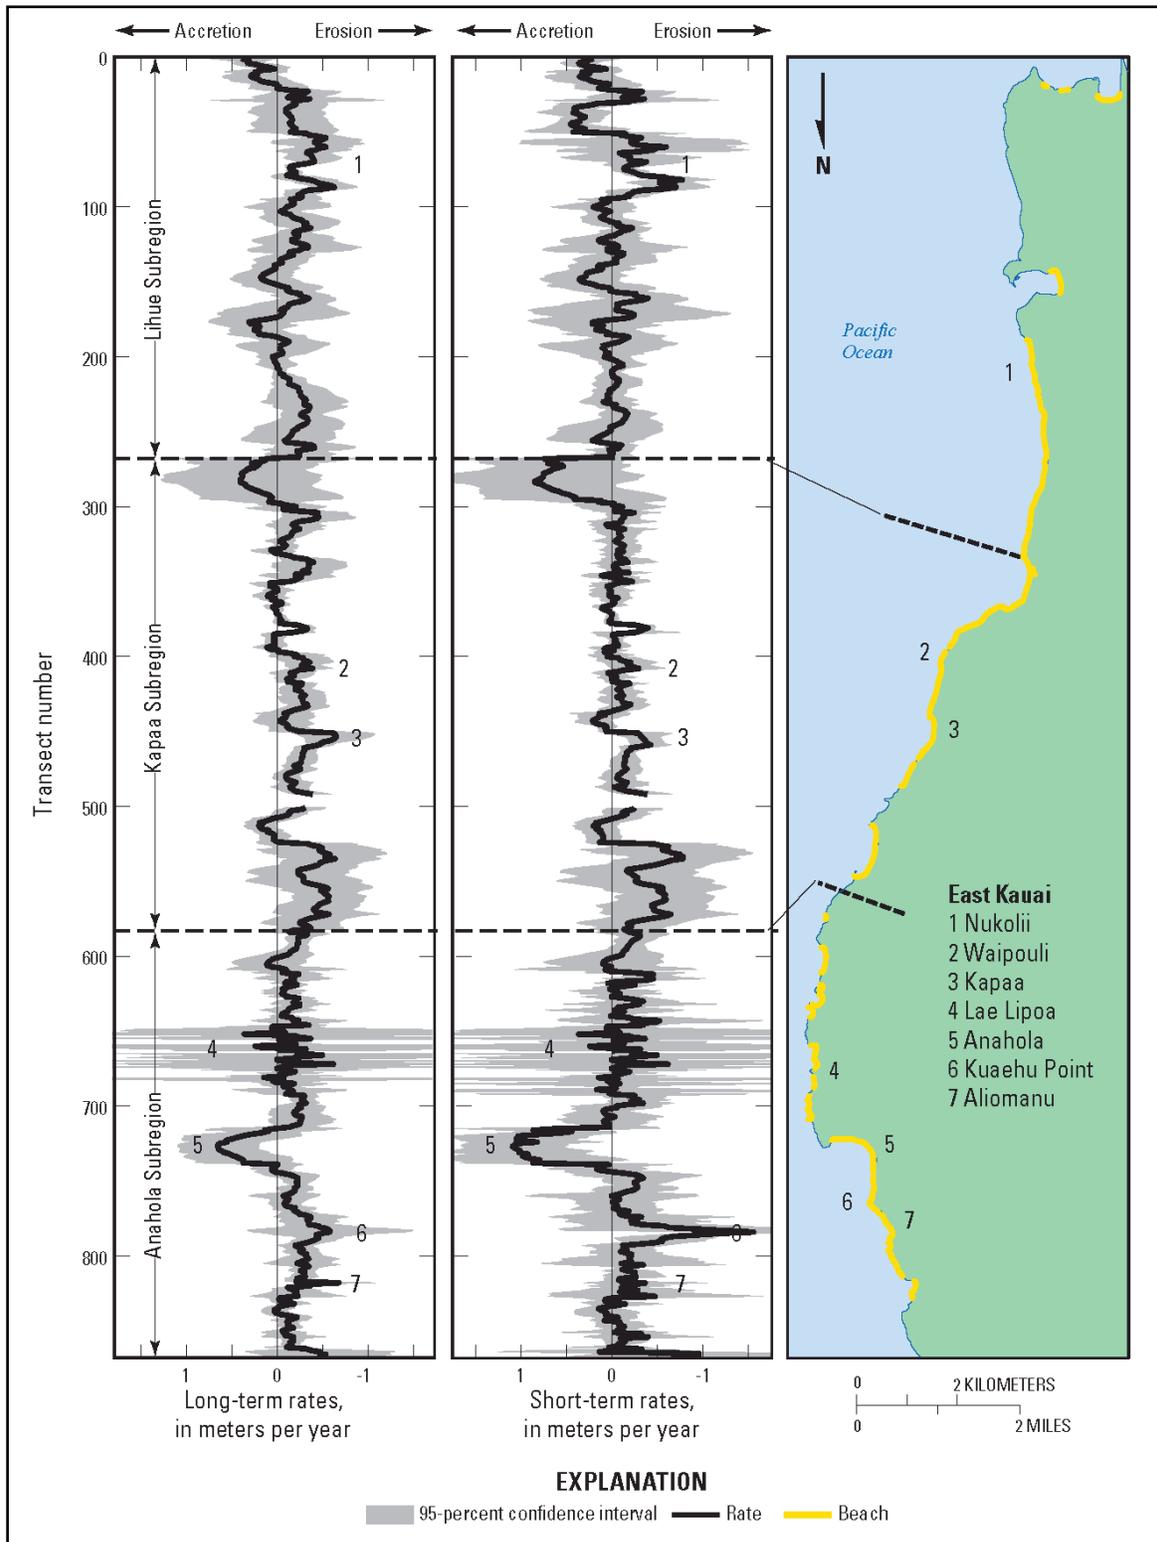
Figure 5. Long-term (all available years) and short-term (1940s to present) shoreline change rates, East Kauai (location shown in Figure 3) (Figure 17 of Fletcher et al. 2012; by permission).

Kauai's eastern coast is characterized by embayments and fringing reef systems. The shore is exposed to northeast trade winds. Streams and rivers flow into the embayments, sometimes causing coastal flooding (Fierstein and Fletcher 2004). The Kapaa region of this coast was once a series of embayments, but has been straightened as a result of sediment infilling (Moberly and Chamberlain 1964, Fierstein and Fletcher 2004). East Kauai is the most erosional region of Kauai.¹

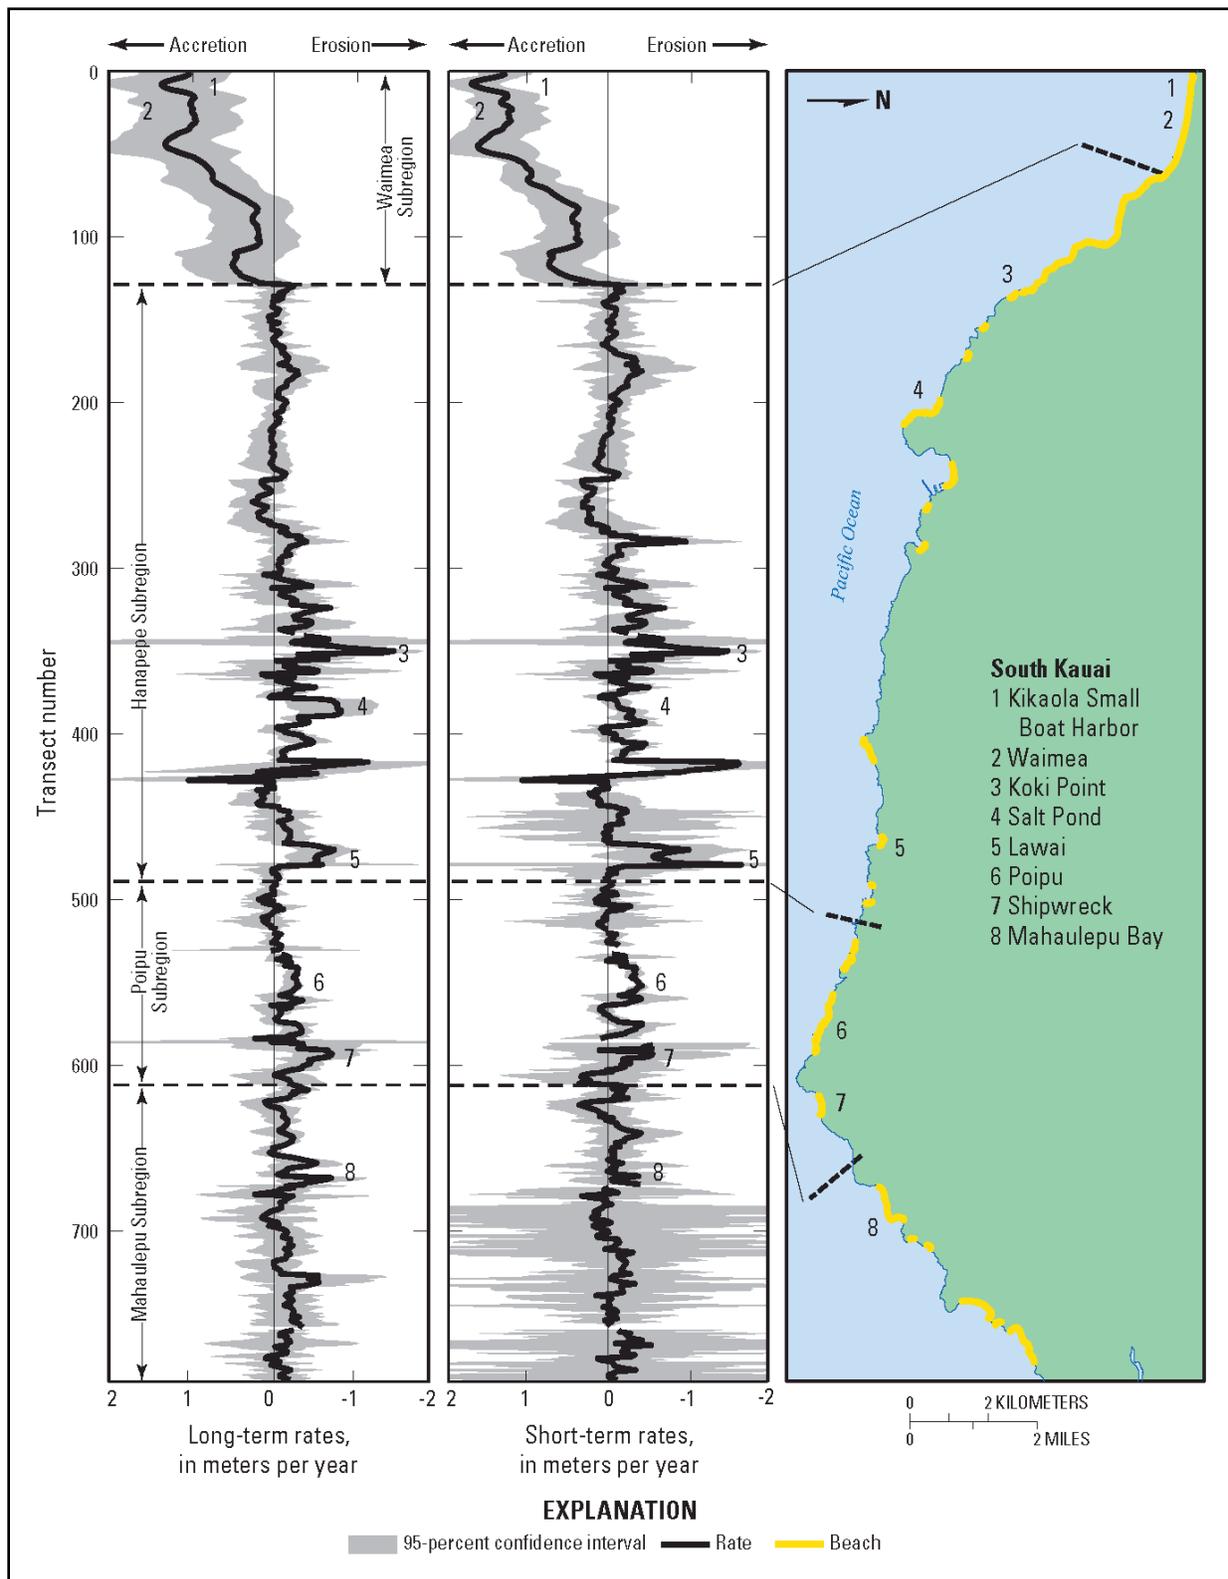
Figure 6. Long-term (all available years) and short-term (1940s to present) shoreline change rates, South Kauai (location shown in Figure 3) (Figure 19 of Fletcher et al. 2012; by permission).

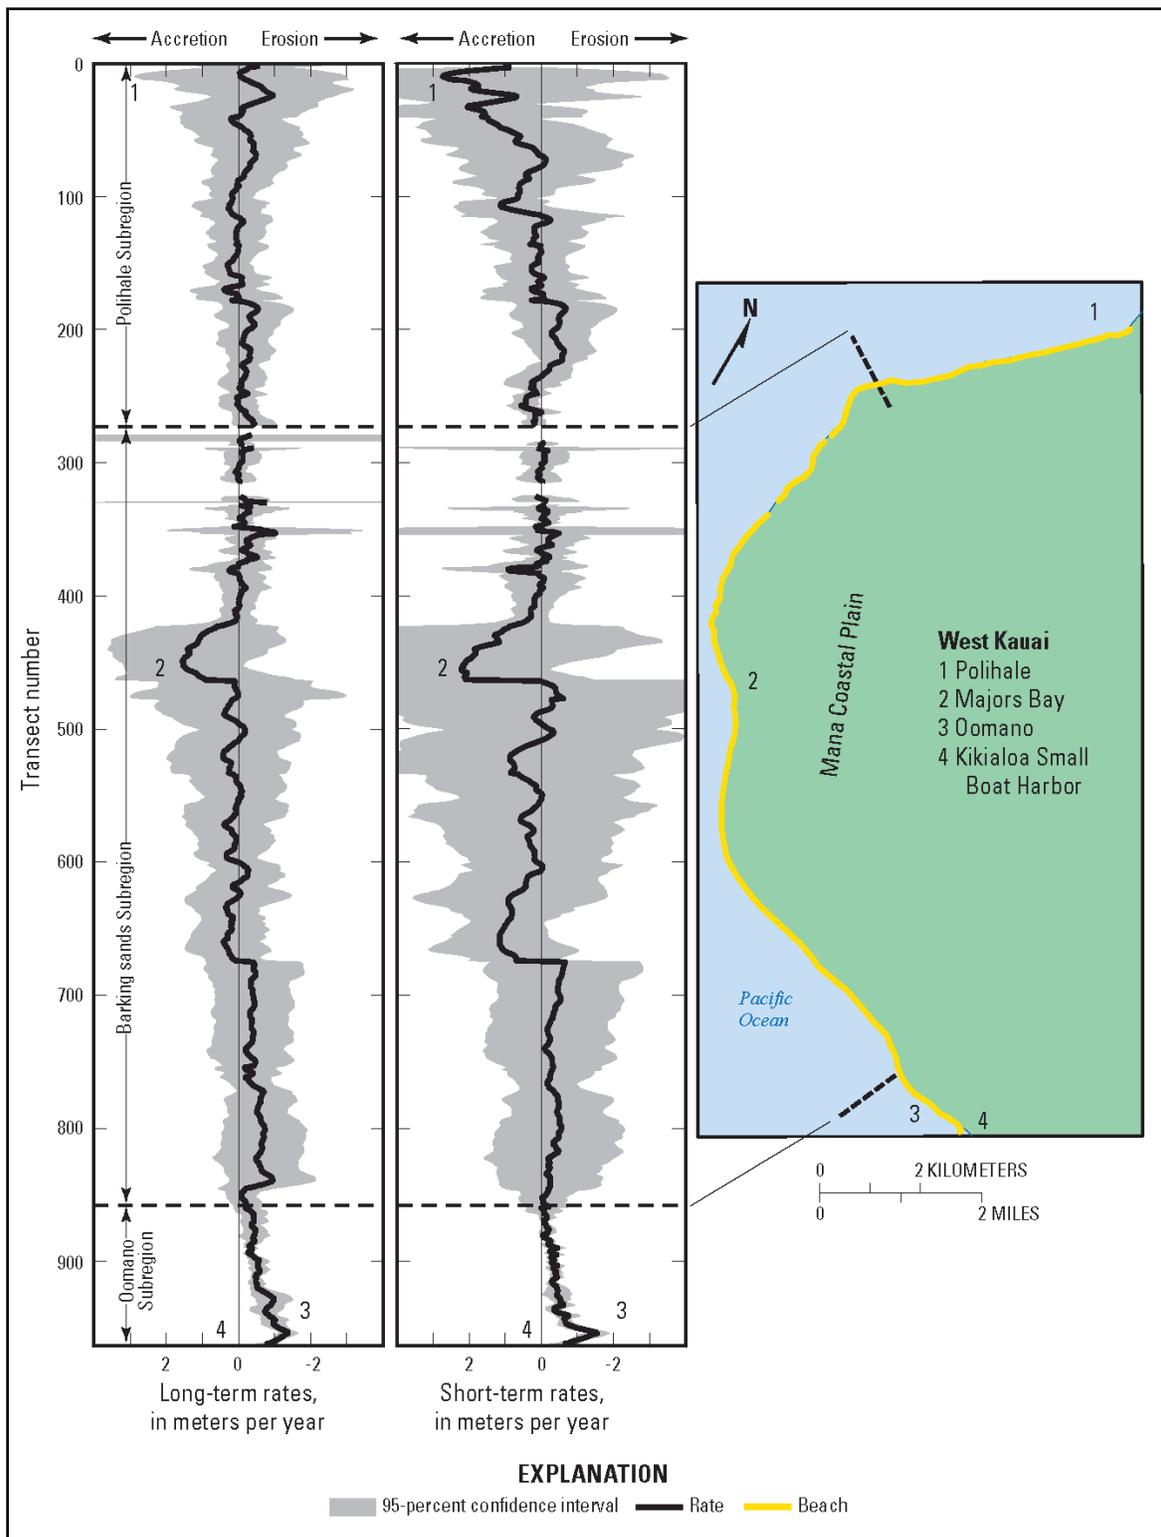
Figure 7. Long-term (all available years) and short-term (1940s to present) shoreline change rates, West Kauai (location shown in Figure 3) (Figure 21 of Fletcher et al. 2012; by permission).

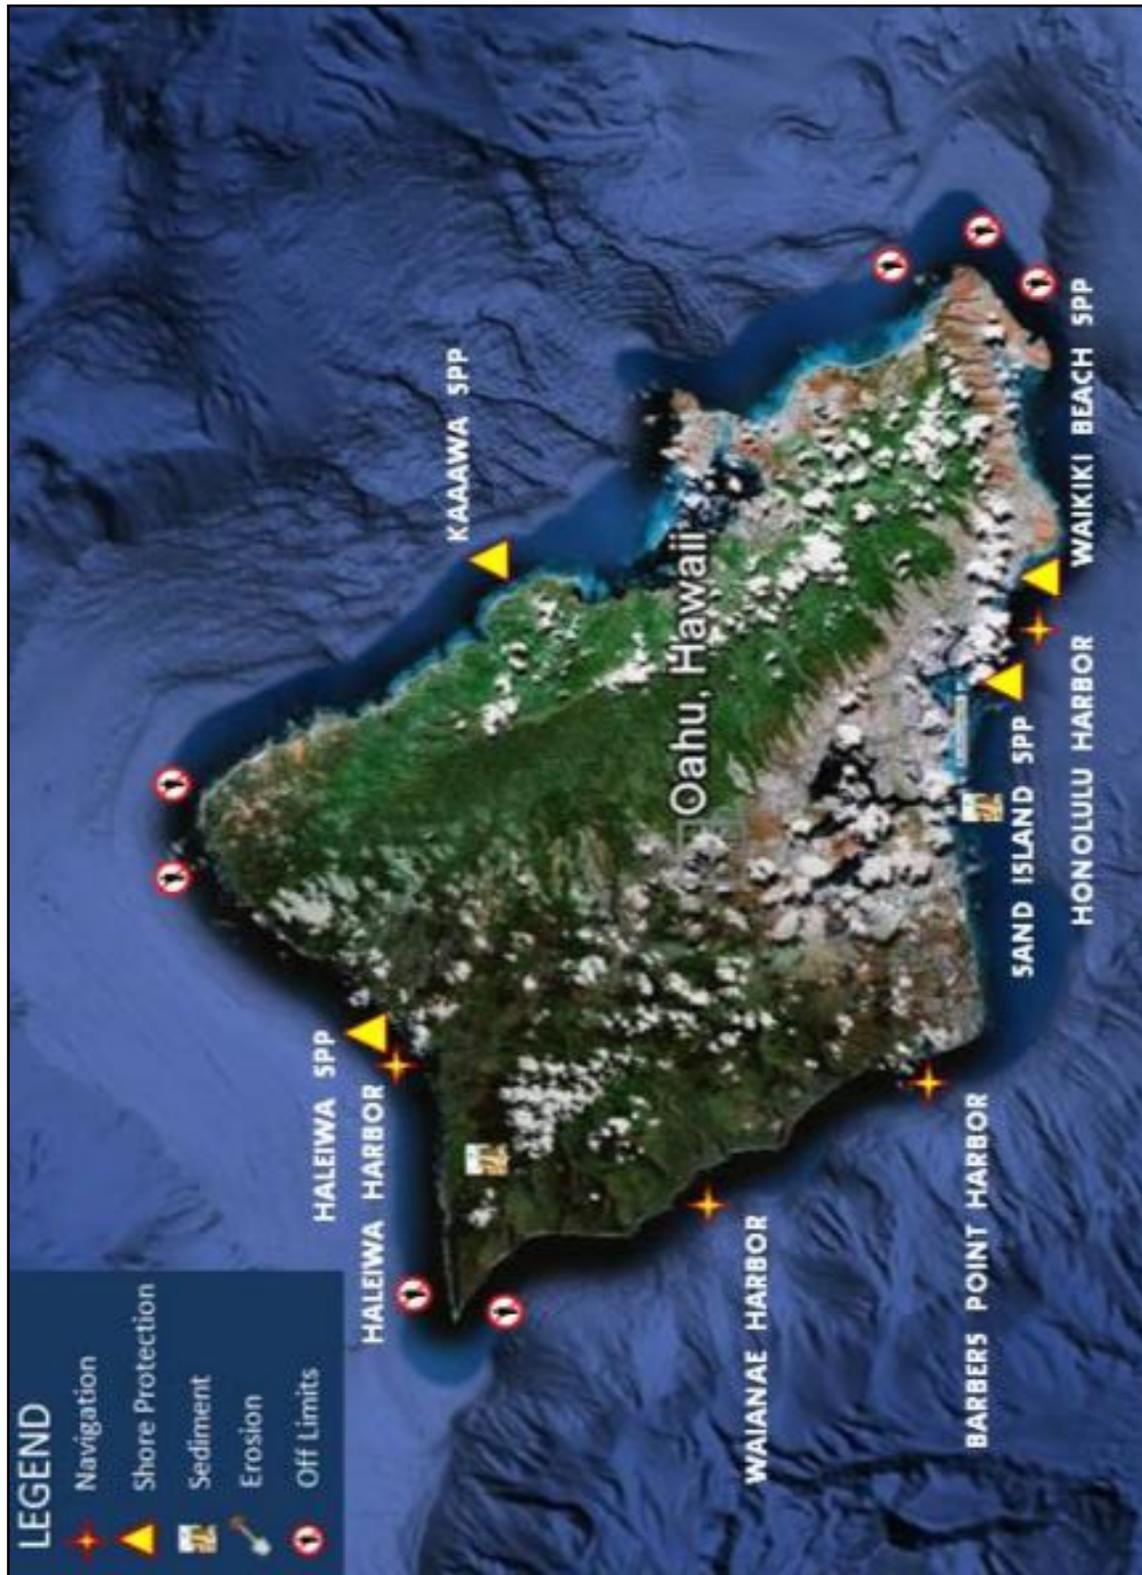
Figure 8. Locations of federally authorized navigation projects (stars) and shore protection projects (yellow triangles) on island of Oahu that could benefit from RSM activities.

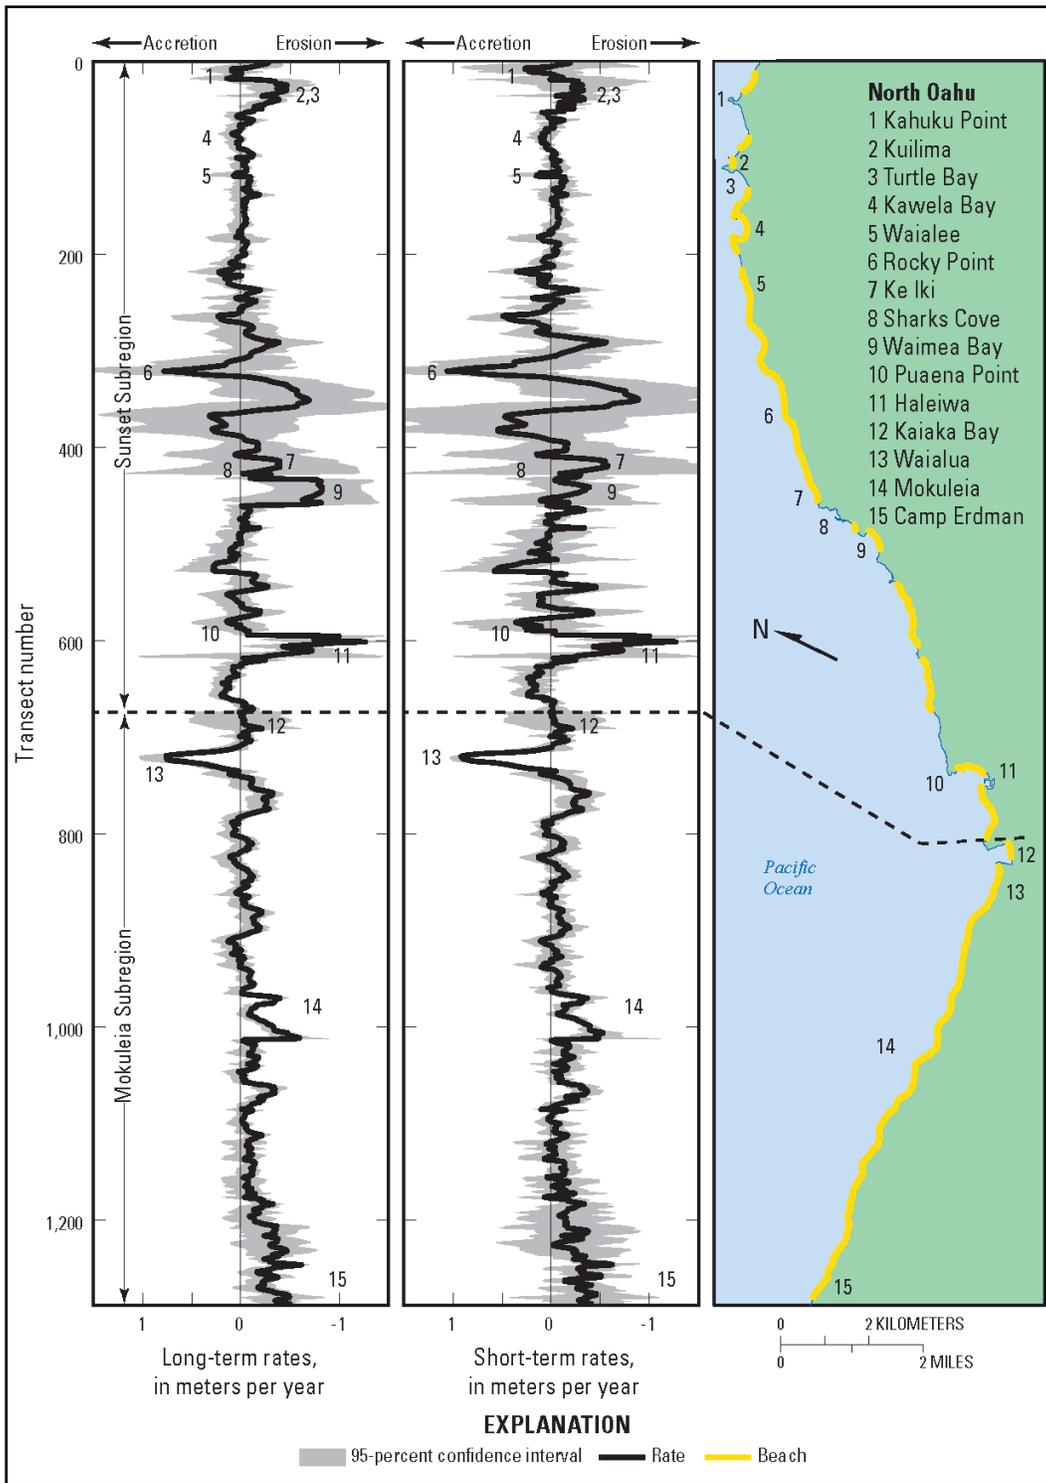
Figure 10. Long-term (all available years) and short-term (1940s to present) shoreline change rates, North Oahu (location shown in Figure 9) (Figure 24 of Fletcher et al. 2012; by permission).

The maximum long-term erosion rate (-1.3 ± 0.8 m/yr) was found at Haleiwa Beach Park at a segment of shoreline behind a small breakwater where the beach has been lost [Figure 10]. This beach has undergone substantial modification throughout its history, including construction of a groin, breakwater, seawall, and two beach nourishment projects (Hwang 1981; Sea Engineering, Inc. 1988).¹

The maximum long-term accretion rate (0.8 ± 0.8 m/yr) was measured at Rocky Point in the Sunset sub-region, though this rate is likely affected by seasonal variability and/or biased toward two summer shorelines at the end of the analysis period.¹

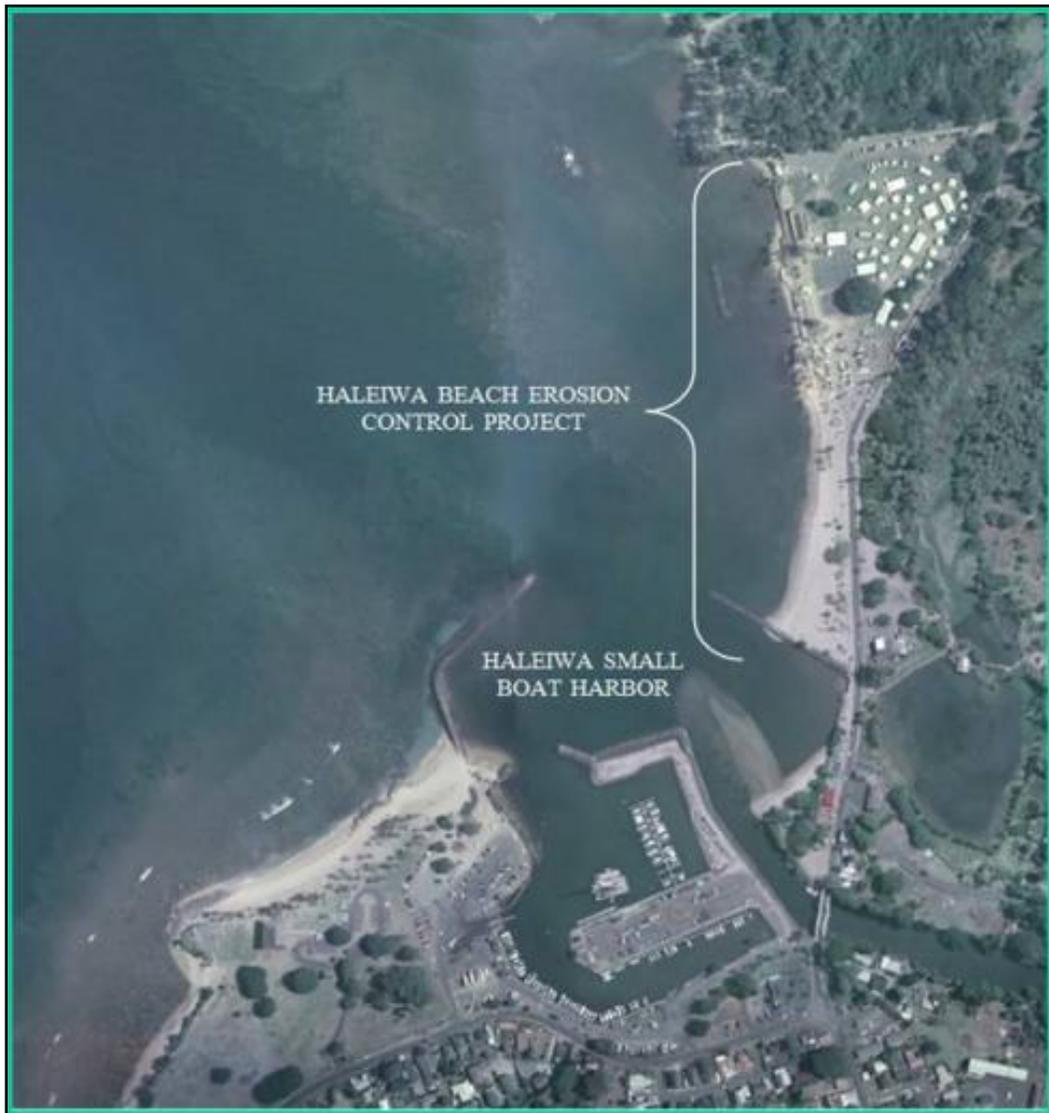
Figure 11. Google image (30 July 2006)–Haleiwa Small Boat Harbor and the Haleiwa Shore Protection Project.

The federally authorized Haleiwa Shore Protection Project includes a 520 ft-long groin, a 160 ft-long offshore breakwater, and beach fill backed by a vertical seawall (Figure 11). Currently, erosion is threatening bathing and restroom facilities located behind the offshore breakwater. Regional sediment management techniques could be used to alleviate the erosion problems currently being experienced at Haleiwa Beach Park.

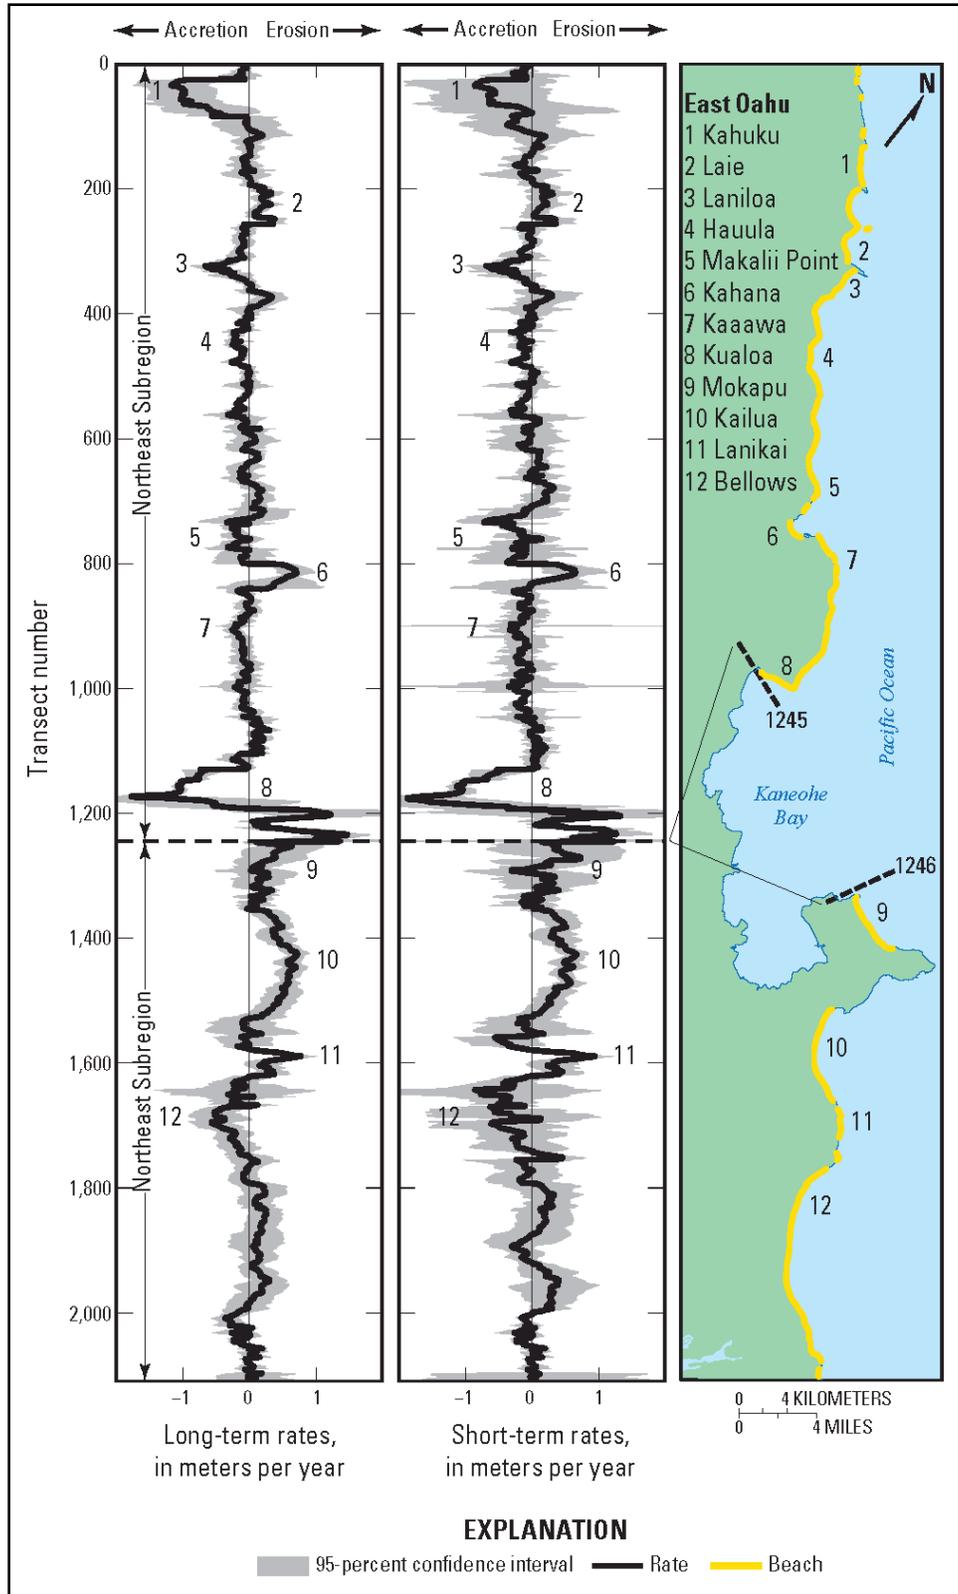
Figure 12. Long-term (all available years) and short-term (1940s to present) shoreline change rates, East Oahu (location shown in Figure 9) (Figure 26 of Fletcher et al. 2012; by permission).

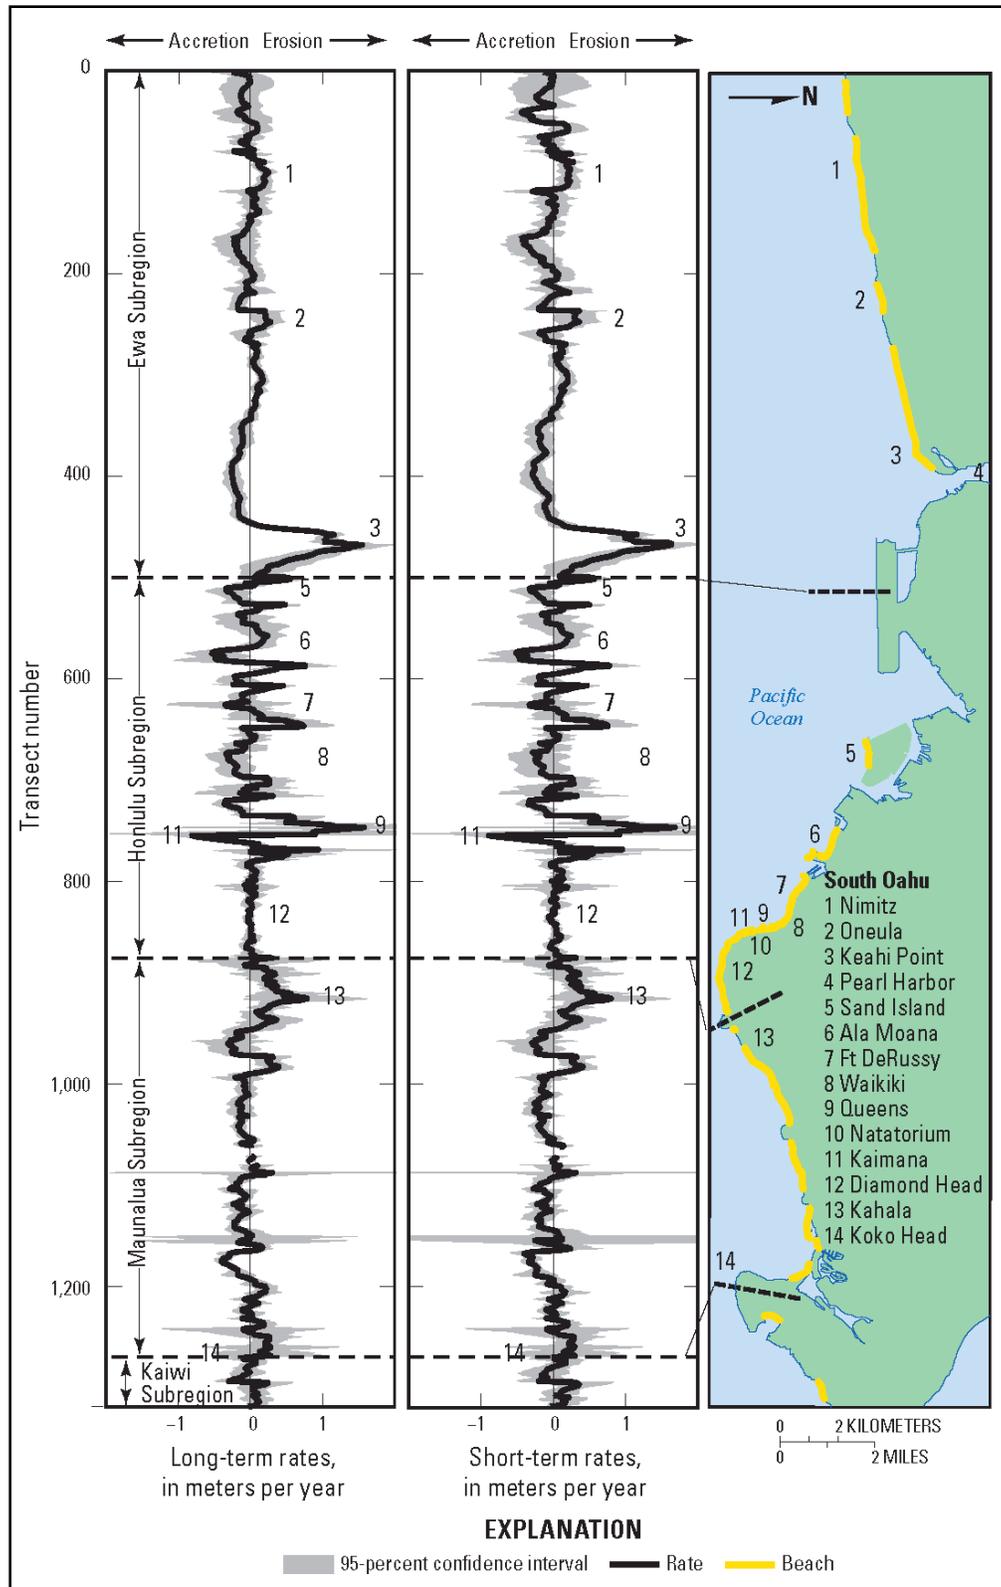
Figure 13. Long-term (all available years) and short-term (1940s to present) shoreline change rates, South Oahu (location shown in Figure 9) (Figure 29 of Fletcher et al. 2012; by permission).

The maximum long-term erosion rate (-1.6 ± 2.7 m/yr) was found at Queens Beach, Waikiki, where the shoreline is hardened and much of the beach disappeared prior to 1975 [Figure 13]. Erosion up to -1.6 ± 0.4 m/yr is also

occurring at the eastern end of the Ewa sub-region near the Pearl Harbor entrance channel (Keahi Point), where erosion of a sandy headland has forced the removal of several homes and prompted construction of a boulder revetment. The maximum long-term accretion rate (0.8 ± 0.2 m/yr) was found at Kaimana Beach in Waikiki, on the eastern side of the natatorium. The natatorium walls act as a groin, disrupting the westerly longshore transport of sediment and resulting in accretion on the eastern side of the natatorium (Kaimana) and erosion on the western side (Queens). The maximum short-term erosion and accretion rates were measured at the same locations as the maximum long-term erosion and accretion rates, respectively (Kaimana and Queens, Waikiki).

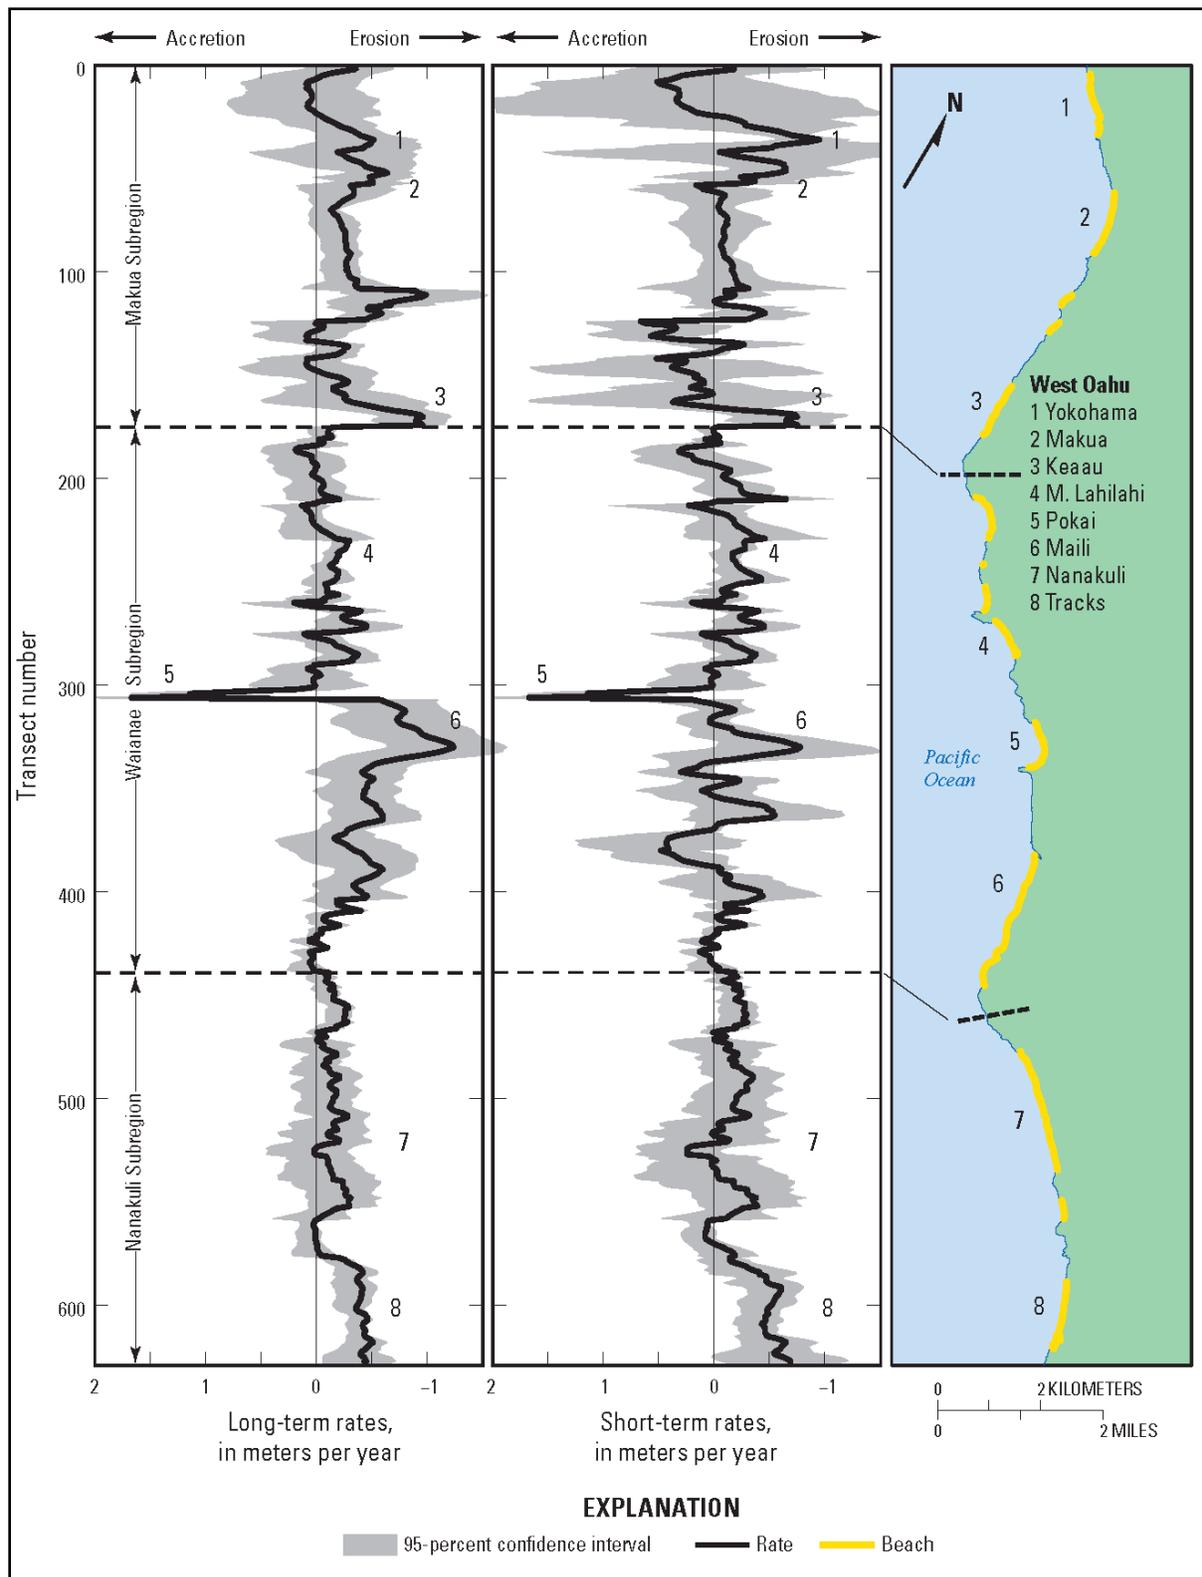
Figure 14. Long-term (all available years) and short-term (1940s to present) shoreline change rates, West Oahu (location shown in Figure 9) (Figure 30 of Fletcher et al. 2012; by permission).

Shoreline position is highly variable at many beaches in this region, as sand shifts alongshore with alternating wave direction between the North Pacific and southern swell seasons. West Oahu is the most erosional region of the Island, with an average long-term rate of -0.25 ± 0.01 m/yr and 83% of transects indicating erosion in the long term. The maximum long-term erosion rate (-1.2 ± 0.5 m/yr) was found in the northern part of Maili Beach [Table 5] and is at least partly the result of removal of sand by mining operations in the mid-1900s (Hwang 1981; Sea Engineering, Inc. 1988). Sand mining was widespread along western Oahu beaches and also likely affects shoreline change rates at Makua and Yokohama (Campbell and Moberly 1978, Hwang 1981).¹

The maximum accretion rate (1.7 ± 0.6 m/yr) was found in the southern part of Pokai Bay [Figure 14]. This section of beach has been accreting since the construction of a breakwater in the 1950s. The short-term rates at Yokohama, Keaau, and Maili are less erosive than the long-term rates, indicating that shoreline recession may have slowed since sand-mining operations ceased.¹

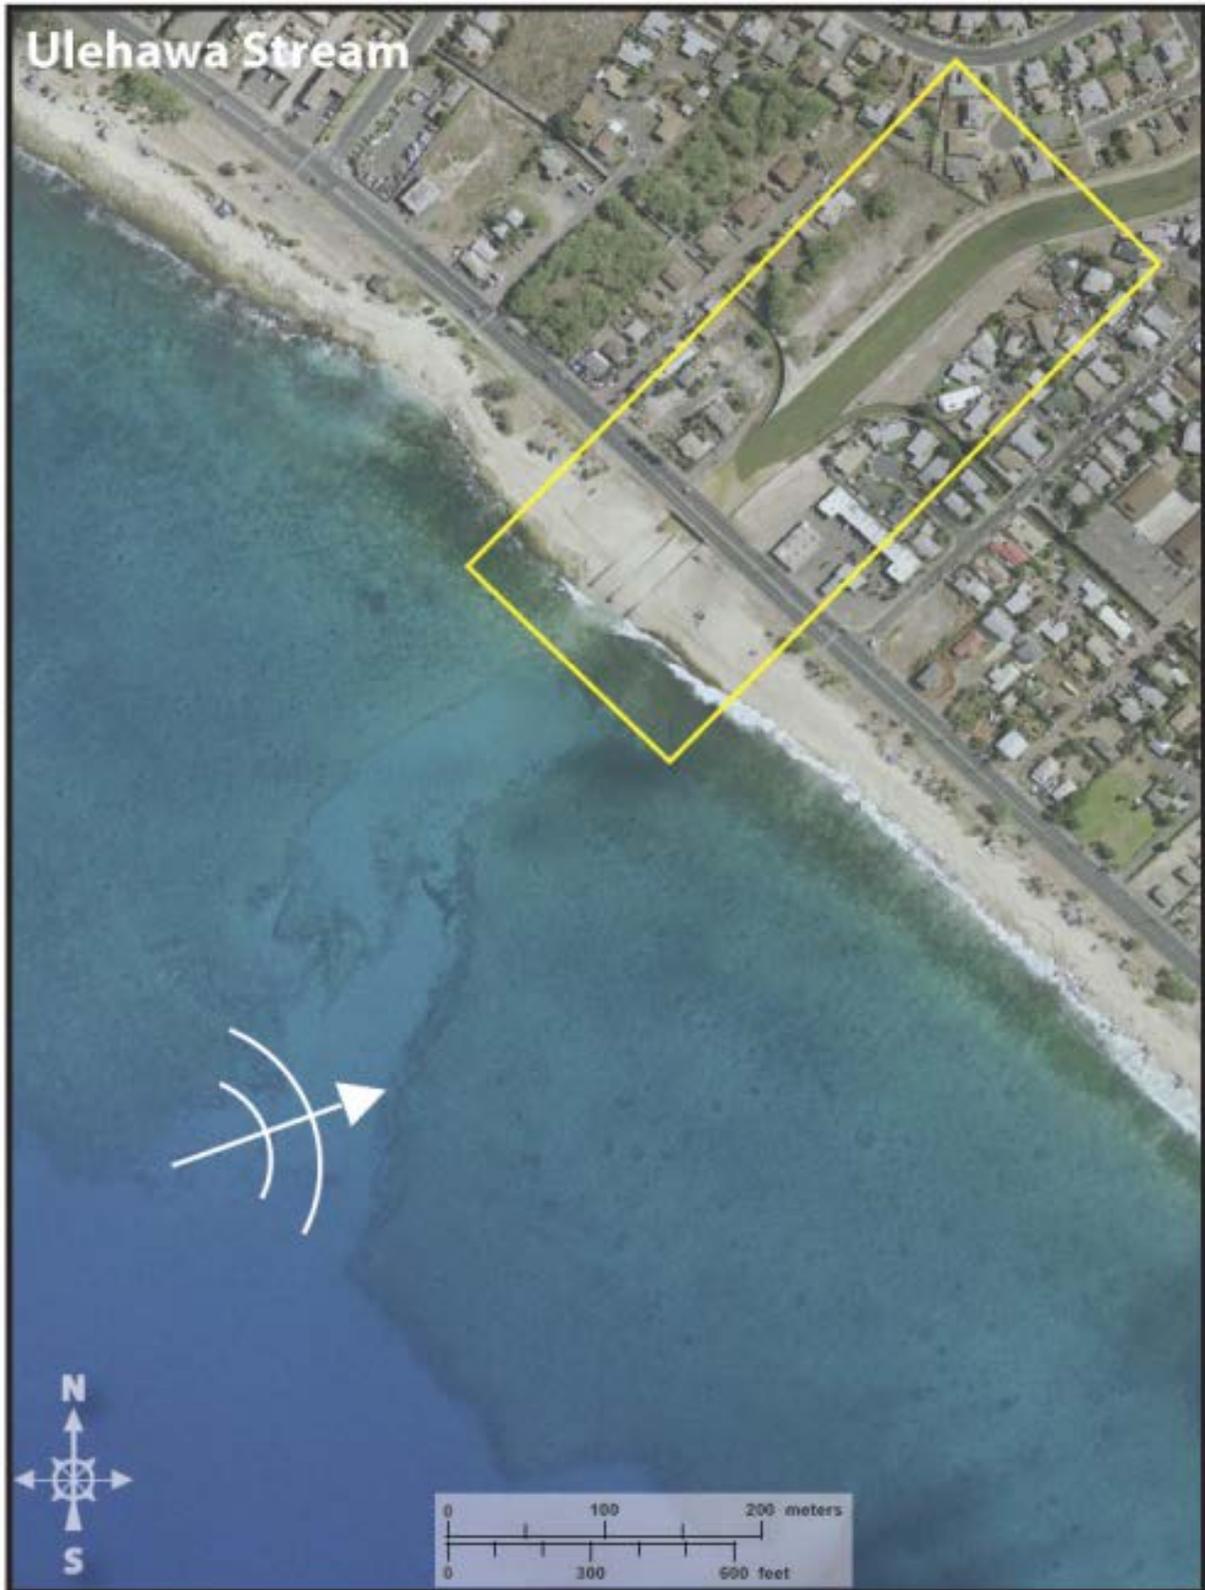
Figure 15. Aerial image of Ulehawa Stream showing sediment clogging the stream mouth.
