Regional Sediment Management (RSM) Program

Hawaii Regional Sediment Management Needs Assessment

Thomas D. Smith and Linda S. Lillycrop

July 2014

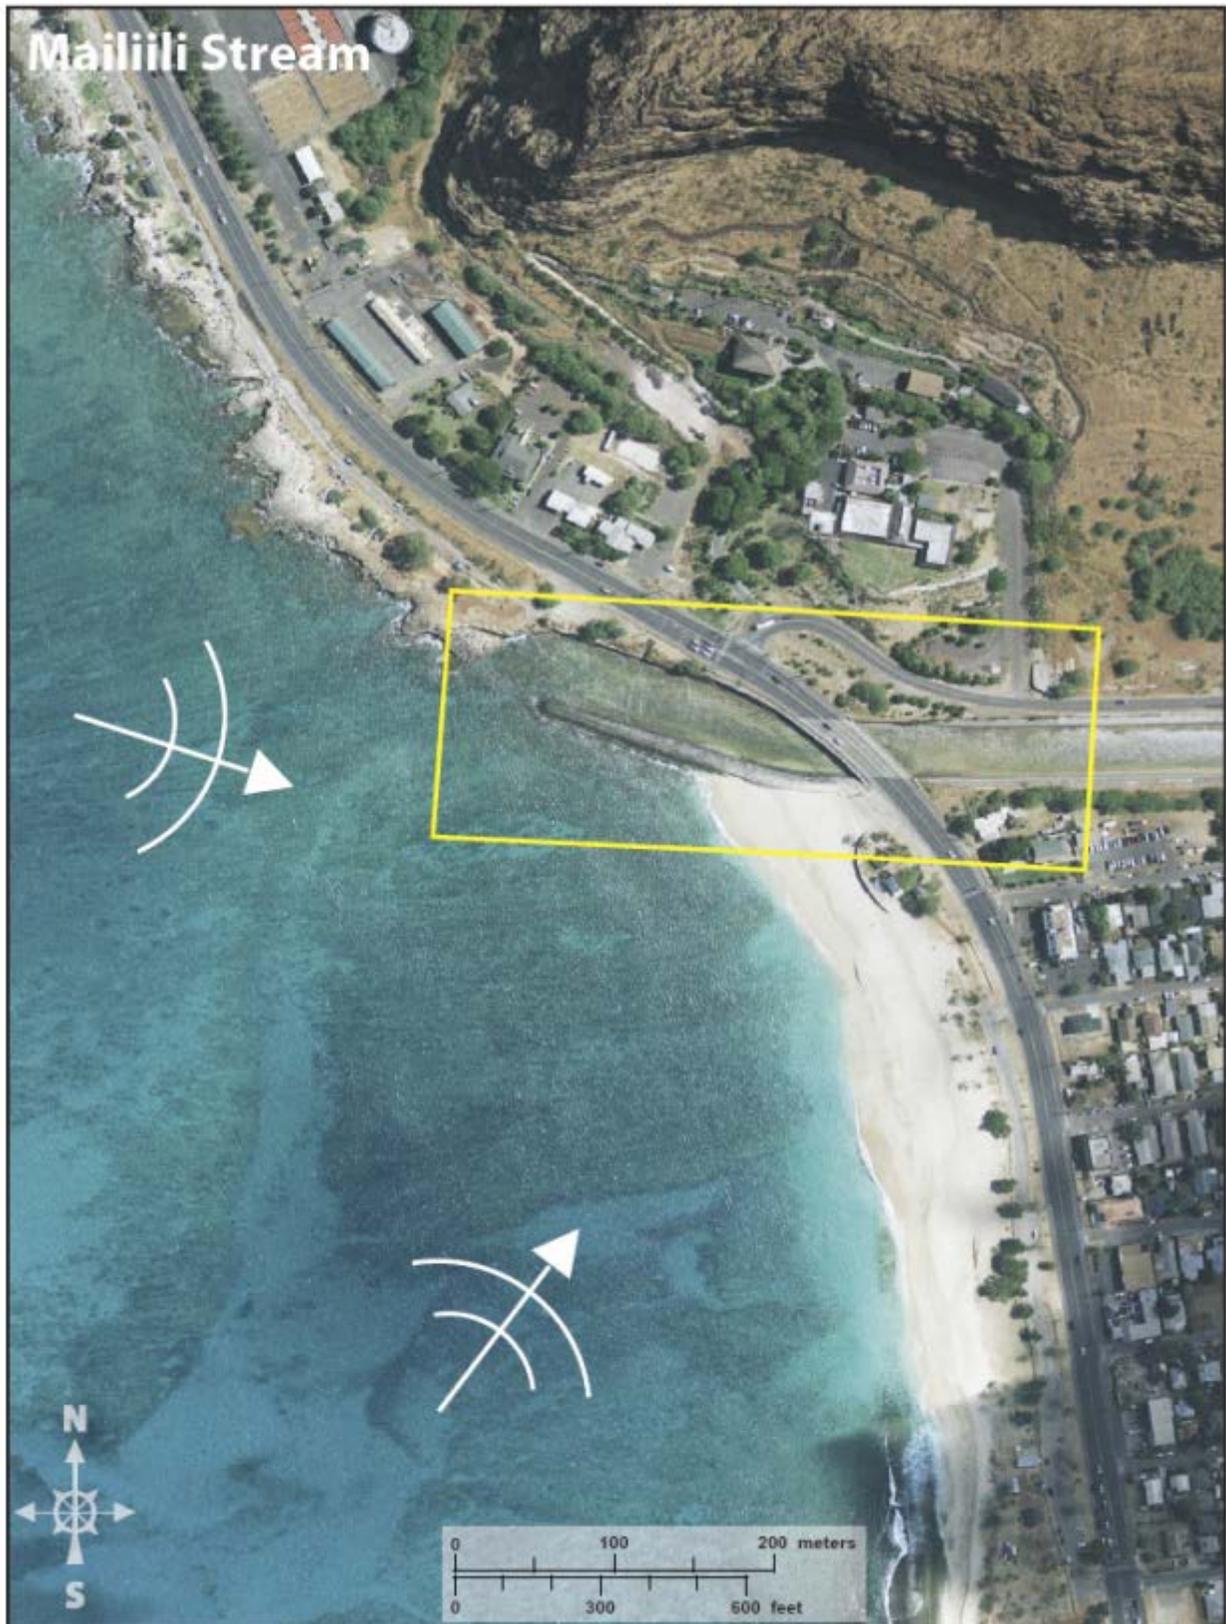
Figure 16. Aerial image of Mailiili Stream illustrating the effective use of a rubble-mound groin to keep sediment from clogging a stream mouth.

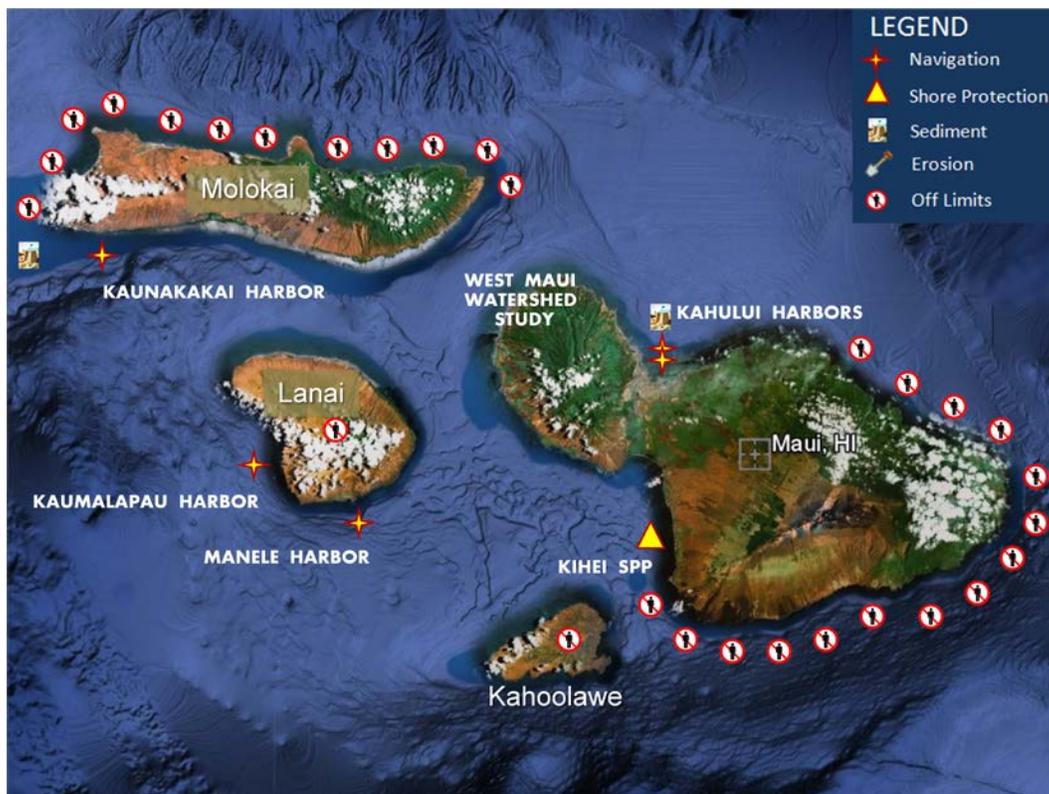
Figure 17. Locations of federally authorized navigation projects (stars) and shore protection projects (yellow triangles) within Maui County that could potentially benefit from RSM activities.

The federally authorized studies and projects of interest in Maui County include (a) West Maui Watershed Study, (b) Kahului Deep Draft Harbor, (c)

Kahului Light Draft Harbor, (d) Kihei Shore Protection Project, (e) Manele Small Boat Harbor, (f) Kaunalapau Harbor, and (g) Kaunakakai Harbor.

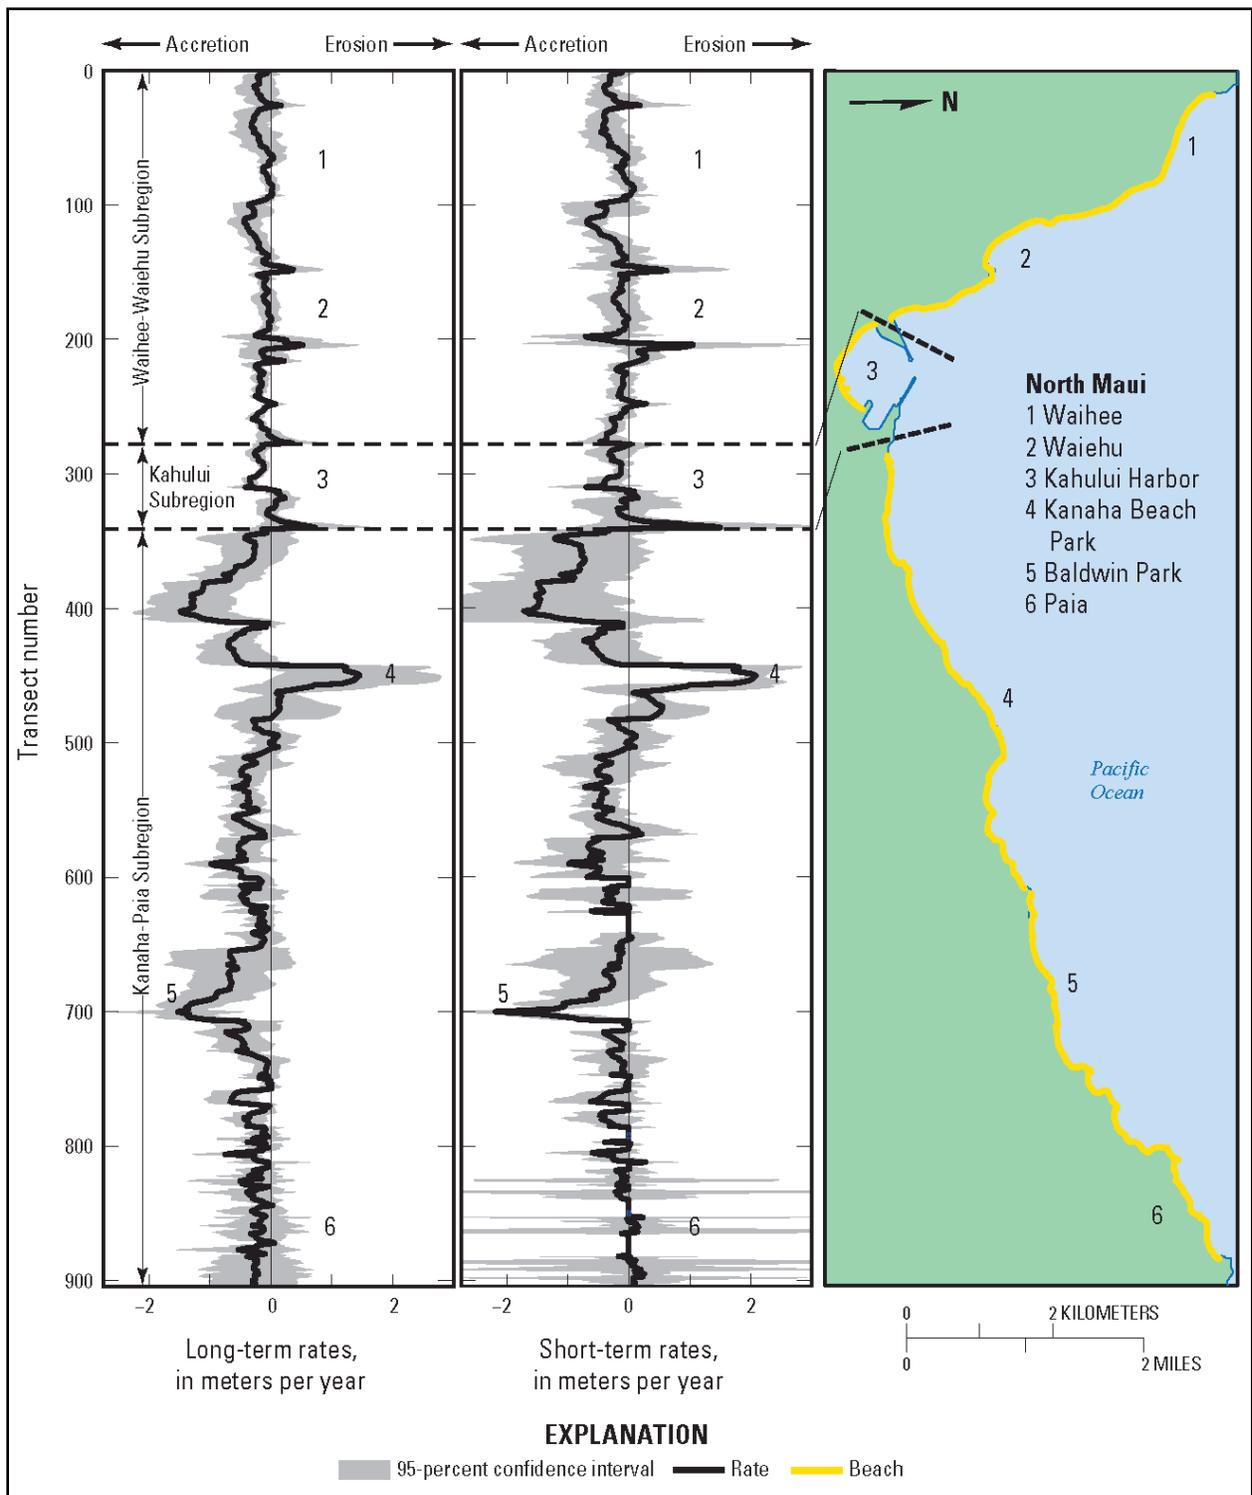
Figure 19. Long-term (all available years) and short-term (1940s to present) shoreline change rates, North Maui (location shown in Figure 18) (Figure 33 of Fletcher et al. 2012; by permission).

The maximum erosion rate (-1.5 ± 1.1 m/yr) was found in front of an offshore rock bench at Baldwin Park [Figure 19]. Shoreline recession at Baldwin is, in part, the result of sand-mining operations for a now-defunct lime kiln. A bench of beach rock was previously linked to the beach by a tombolo, but is now isolated offshore (Genz et al. 2009). Other areas of significant erosion were found at Waiehu Beach Park (up to -0.5 ± 0.3 m/yr, long term) and Kanaha Beach Park (up to -1.5 ± 0.7 m/yr, long term). The maximum long-term accretion rate (1.5 ± 1.3 m/yr) was measured between two groins at Kanaha Beach Park.

The average short-term shoreline change rate for North Shore beaches, -0.22 ± 0.03 m/yr, is roughly the same as the average long-term rate. Seventy-four percent of the beach is erosional in the short term. The maximum short-term erosion rate (-2.2 ± 1.1 m/yr) was found in the same location as the maximum long-term erosion rate (Baldwin Park). The maximum short-term accretion rate (2.1 ± 0.2 m/yr), like the maximum long-term accretion rate, was found in Kanaha Beach Park. Short-term and long-term rates follow a similar pattern, though uncertainty is higher in the short-term rate because of the truncated data set.

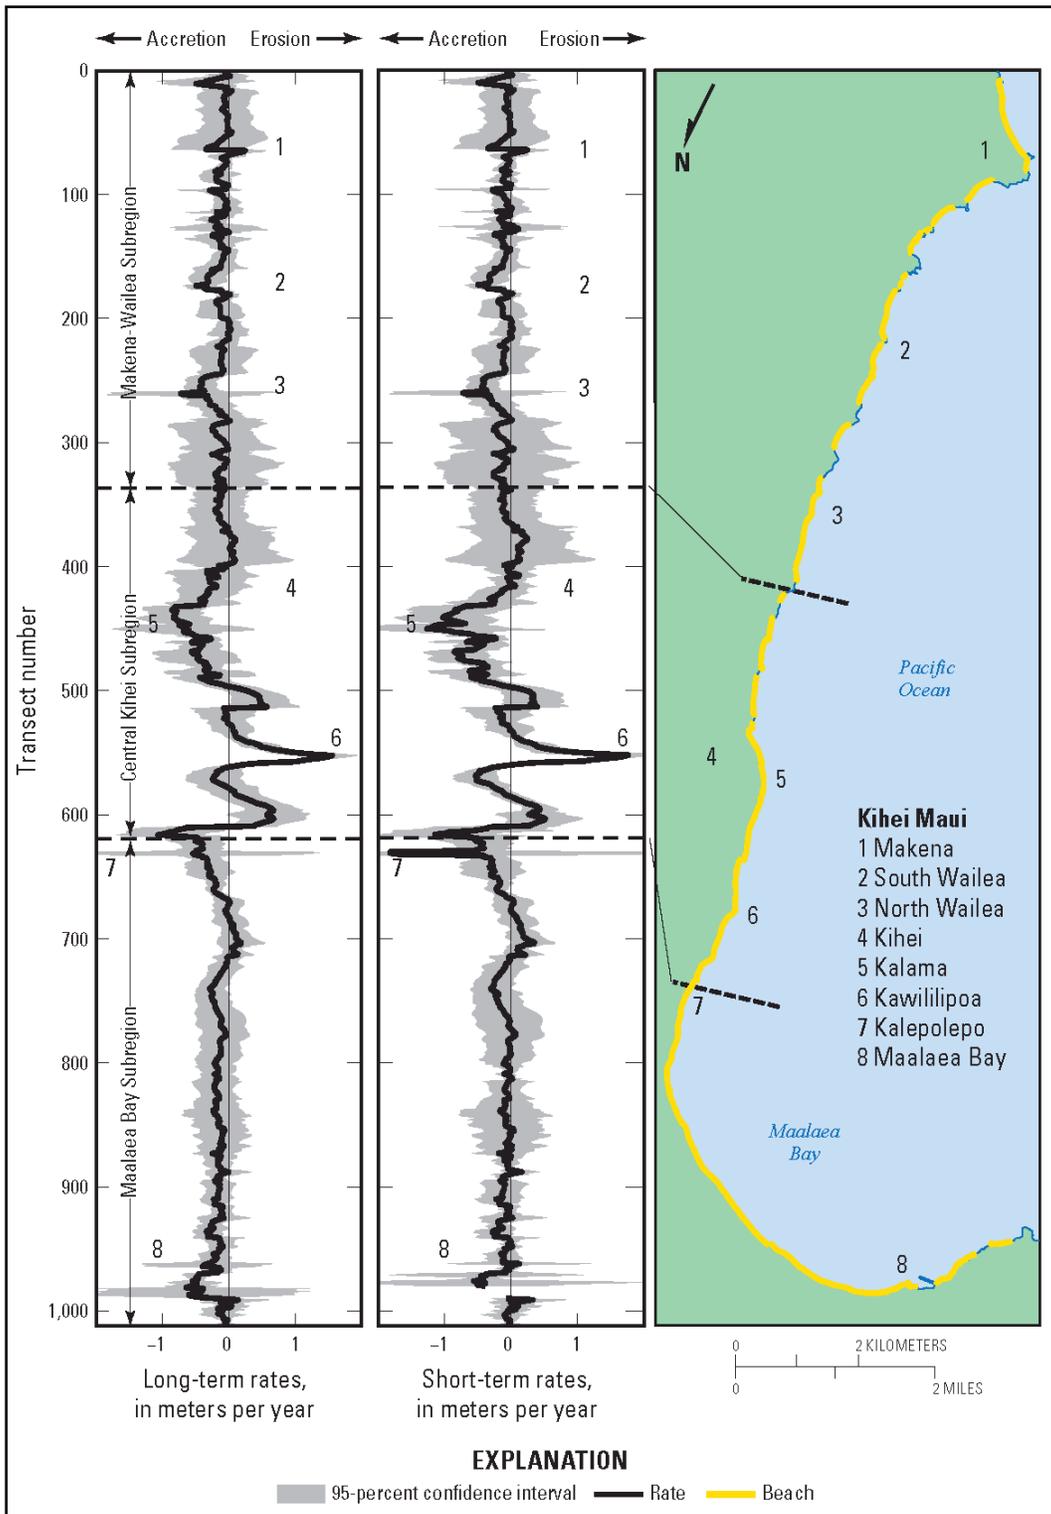
Figure 20. Long-term (all available years) and short-term (1940s to present) shoreline change rates, Kihei Maui (location shown in Figure 18) (Figure 35 of Fletcher et al. 2012; by permission).

The maximum long-term erosion rate (-1.1 ± 0.6 m/yr) was found at Kawililipoa, in the remains of a fish pond [Figure 20]. Other areas with substantial long-term erosion include South Wailea (up to -0.5 ± 0.2 m/yr), North Wailea (up to -0.4 ± 0.2 m/yr), Kalama Park (up to -0.8 ± 0.5 m/yr; beach lost), and Maalaea (up to -0.6 ± 0.2 m/yr). The maximum long-term accretion rate (1.6 ± 0.4 m/yr) was also found at Kawililipoa, along an accretional cusp.

The average short-term rate is -0.12 ± 0.02 m/yr, and 77% of the short-term rates are erosional. The maximum short-term erosion rate (-1.8 ± 7.5 m/yr) was found at Kalepolepo Beach Park, where the beach has been completely lost to erosion. The maximum short-term accretion rate was found at the same location as the maximum long-term accretion rate (Kawililipoa, 1.8 ± 0.8 m/yr). Long- and short-term rates have similar overall trends.

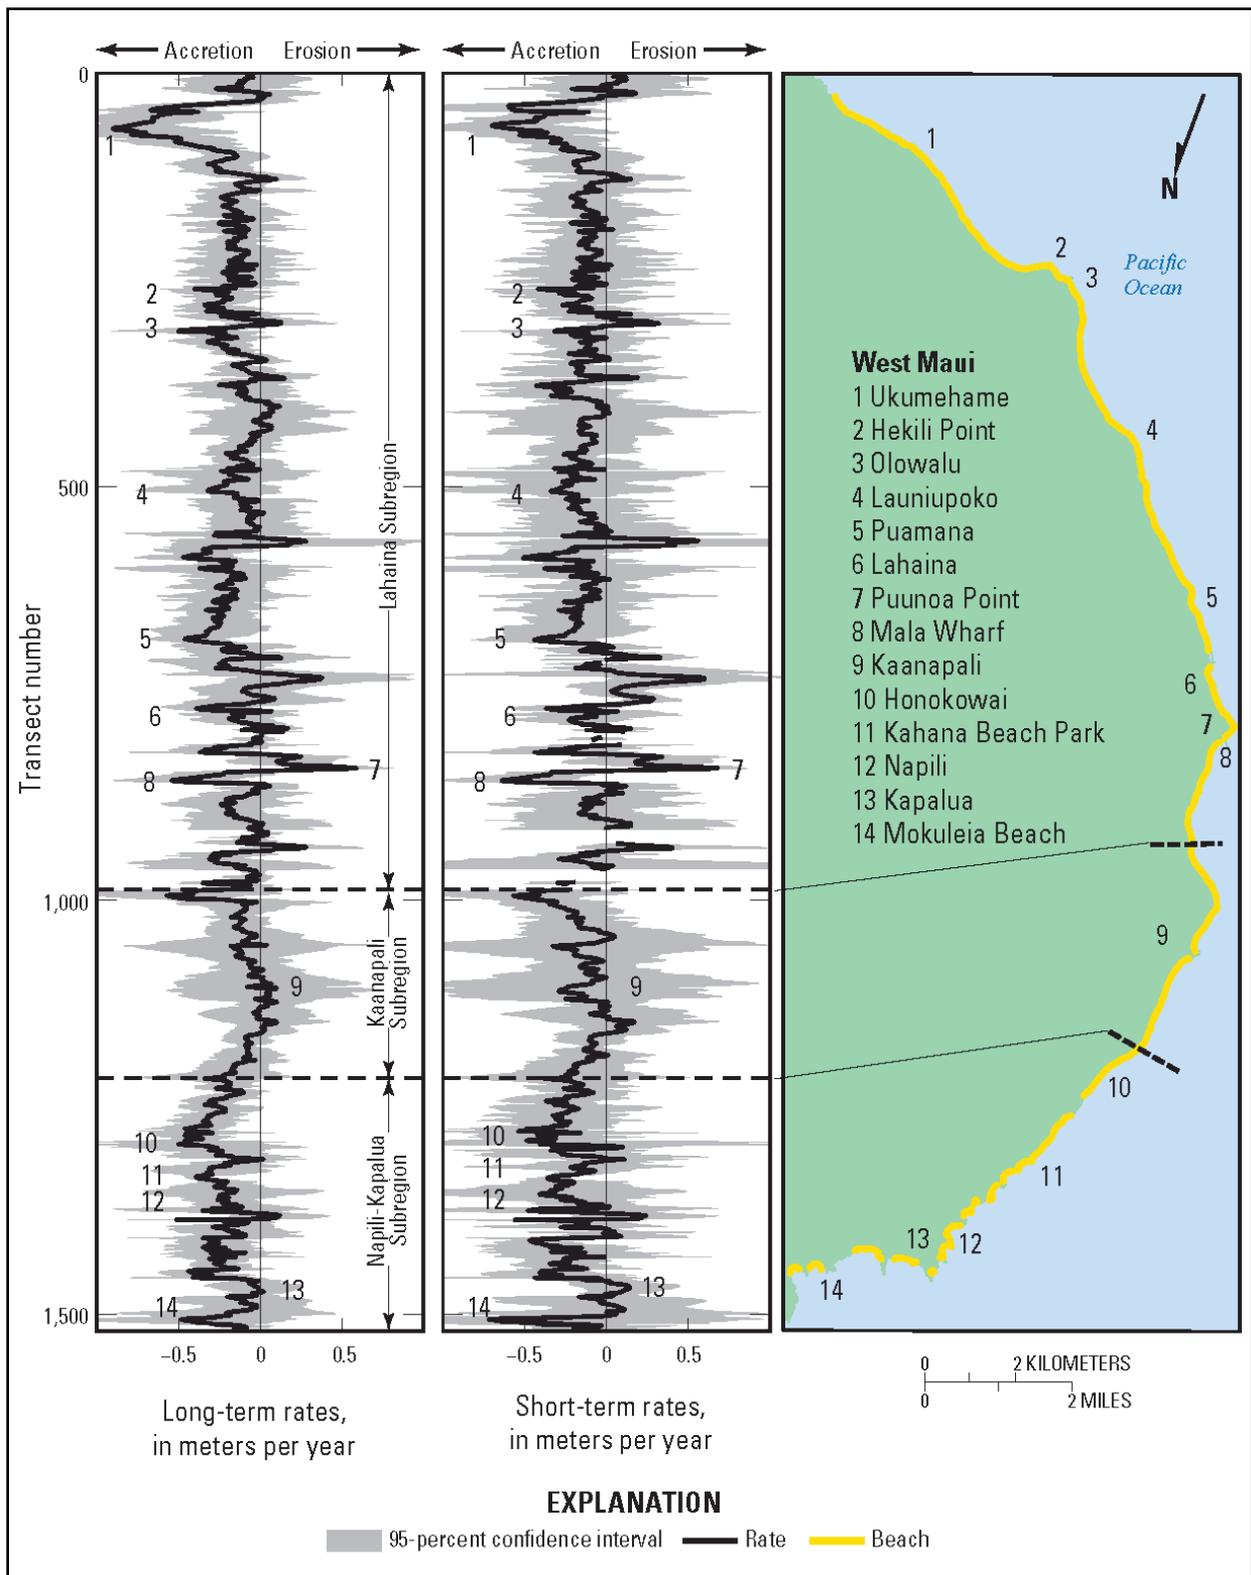
Figure 21. Long-term (all available years) and short-term (1940s to present) shoreline change rates, West Maui (location shown in Figure 18) (Figure 38 of Fletcher et al. 2012; by permission).

The average of all long-term rates for West Maui is -0.15 ± 0.01 m/yr and 85 percent of transects are erosional in the long term [Figure 21]. All subregions in West Maui are erosional in the long and short term based on average rates. The Napili-Kapalua subregion has the highest average erosion rates, -0.22 ± 0.02 m/yr in the long term and -0.19 ± 0.03 m/yr in the short term. The maximum erosion rate (-0.9 ± 0.6 m/yr) was found at Ukumehame adjacent to a boulder revetment installed to protect the coastal highway. Other areas of significant long-term erosion include Hekili Point (up to -0.3 ± 0.2 m/yr), Olowalu (up to -0.3 ± 0.2 m/yr), Launiupoko (up to -0.5 ± 0.3 m/yr), Puamana (up to -0.5 ± 0.2 m/yr), Mala Wharf (up to -0.5 ± 0.4 m/yr), Honokowai (up to -0.5 ± 0.4 m/yr), Kahana (up to -0.4 ± 0.1 m/yr), and Napili Bay (up to -0.4 ± 0.2 m/yr).

Erosion at West Maui is slightly lower in the short-term than in the long-term rate, with an average short-term rate of -0.13 ± 0.01 m/yr, and 77% of transects are erosional. The maximum short-term erosion rate (-0.7 ± 1.7 m/yr) was found at Mokuleia Beach. The percentage of accretion increased from 14% (for long-term rates) to 18% (for short-term rates). The maximum short-term accretion rate was found at the same location as the maximum rate in the long-term analysis (Puunoa Point at Lahaina).

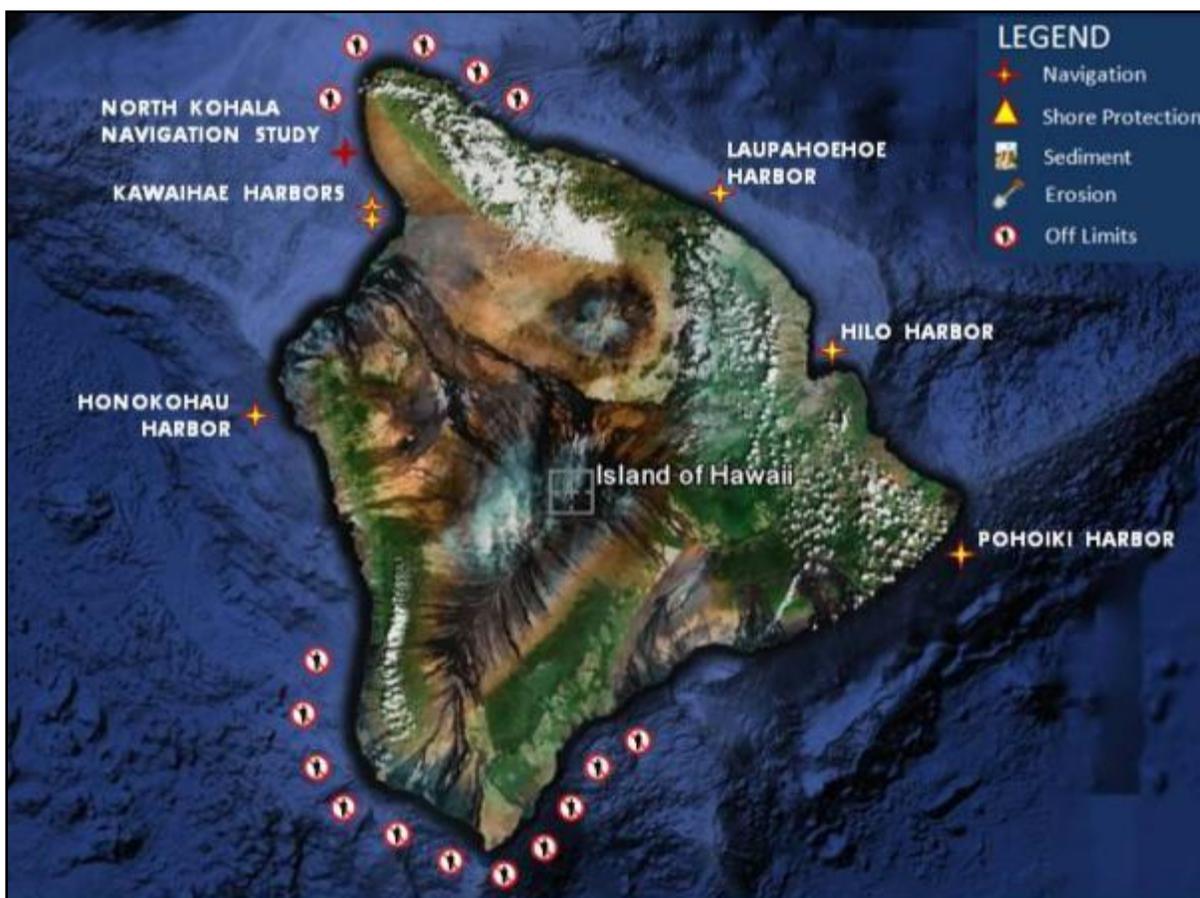
Figure 22. Locations of federally authorized navigation projects (stars) on Island of Hawaii that could potentially benefit from RSM activities.

The federally authorized studies and projects of interest on the Island of Hawaii include (a) Hilo Deep Draft Harbor, (b) Kawaihae Deep Draft Harbor, (c) Kawaihae Small Boat Harbor, (d) Honokohau Small Boat

Harbor, (e) Laupahoehoe Navigation Improvements, (f) Pohoiki Navigation Improvements, and (g) North Kohala Navigation Study.

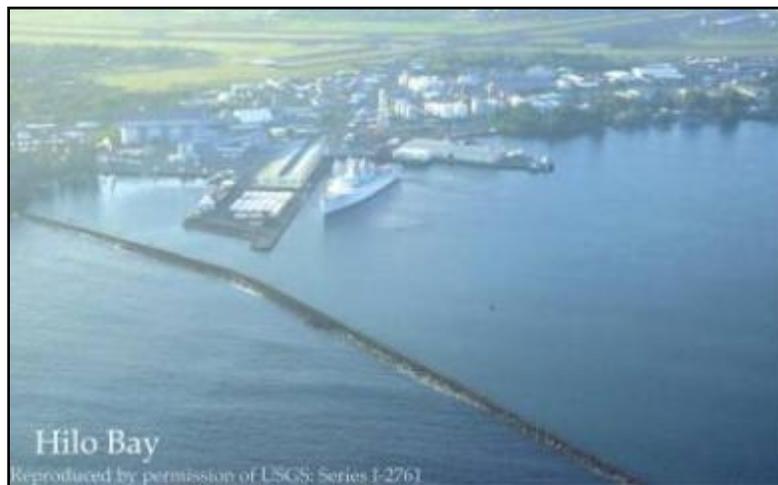
Figure 25. Hilo Harbor breakwater and berthing areas, Island of Hawaii. The Hilo Small Boat Harbor is also visible in the upper left portion of the photograph (uncaptioned figure of UH CGG 2012; by permission).

The Hilo Harbor breakwater is nearly 2 miles long and affects the circulation within the Bay. Modification of the breakwater is recommended by County staff to improve circulation and ultimately water quality within the Bay. Future deepening of various channels and berthing areas in Hilo Harbor are being considered. Additionally, POH plans to conduct maintenance dredging at all deep-draft harbors in the State that are below project depth in FY15. Material dredged during these and other operations should be considered for beneficial use.

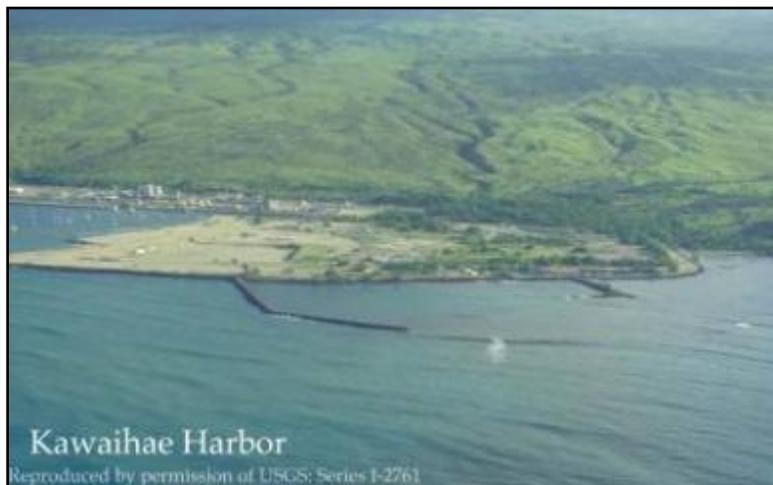
Figure 29. Kawaihae Small Boat Harbor (pictured in the foreground) is located adjacent to Kawaihae Deep Draft Harbor (uncaptioned figure of UH CGG 2012; by permission).
