1. Name of PropertyHistoric name: The House at 2017 Lanihuli Drive

N/A**2. Location**Street & number: 2017 Lanihuli DriveCity or town: Honolulu State: Hawaii County: HonoluluNot For Publication: ☐ Vicinity: ☐

Colonial Revival/Arts & Crafts

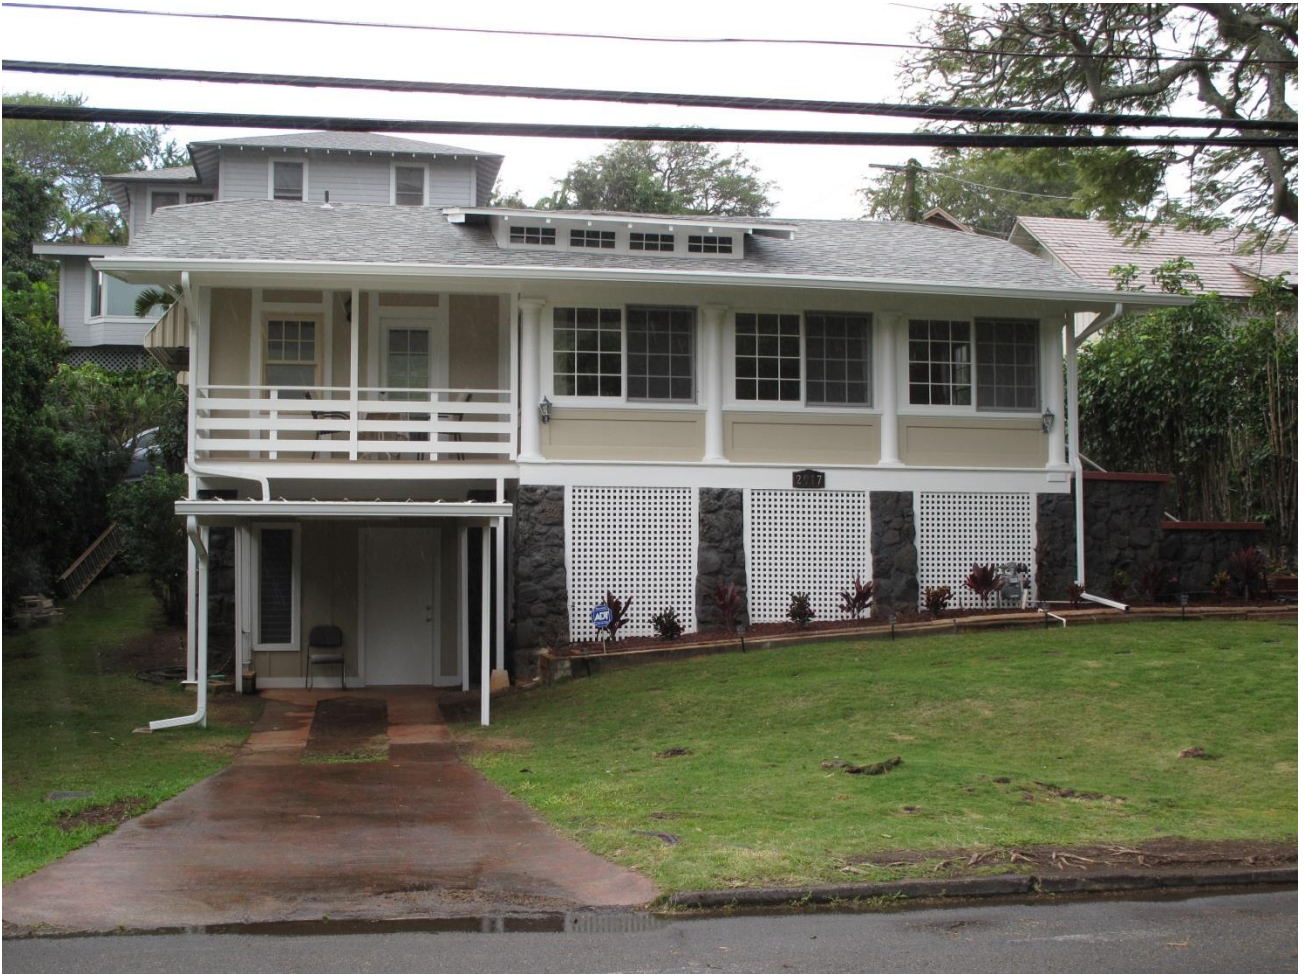
1 of 29

The House at 2017 Lanihuli Drive, Front Elevation-View to the SW---December, 2019

The lava-tone piers, the white lattice foundation skirt, the Colonial-Tuscan columns, and the windows are character defining elements of the front elevation.

The front elevation of the home is composed and framed by Tuscan-Colonial columns in antis that provide the definition of the bays of the house that are lighted and vented by wooden divided lite windows. The windows slide, side-to-side. The columns and the windows are definitive elements of the Colonial Revival style components of this house and contribute to its character. The southern corner of the home has an added small lanai off the front bedroom. The materials (nominal contemporary lumber) of the lanai suggest that it is a recent addition.

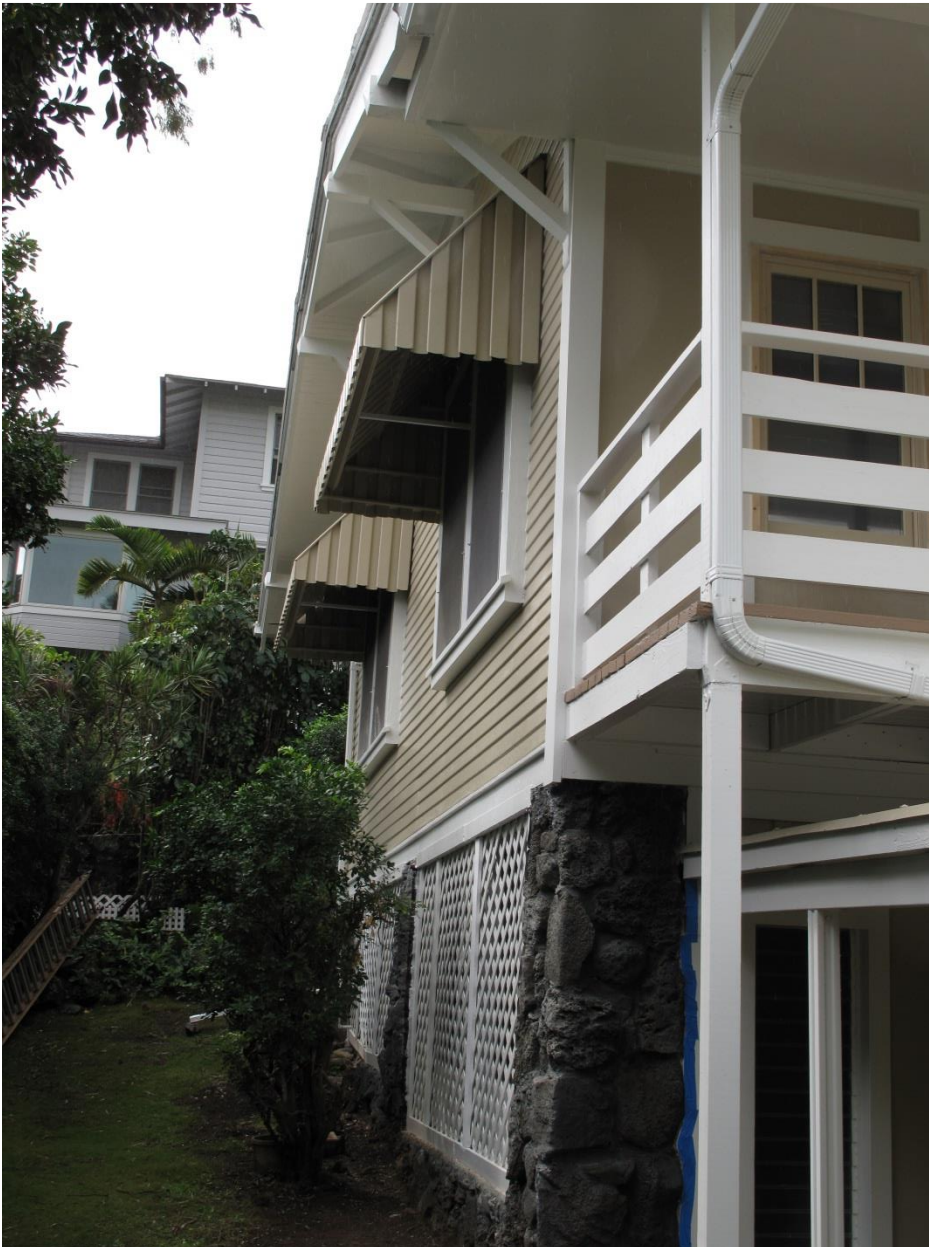
Photo 2 of 29

The House at 2017 Lanihuli Drive, Side (South) Elevation—December, 2019

The south elevation has a two, double set of symmetrically placed wooden, double hung windows, its original wooden clapboards, the brackets and the bead-board sheathed eaves like the other side of the house. The edge of the lot here is defined by a mock orange hedge, approximately 10' in height.

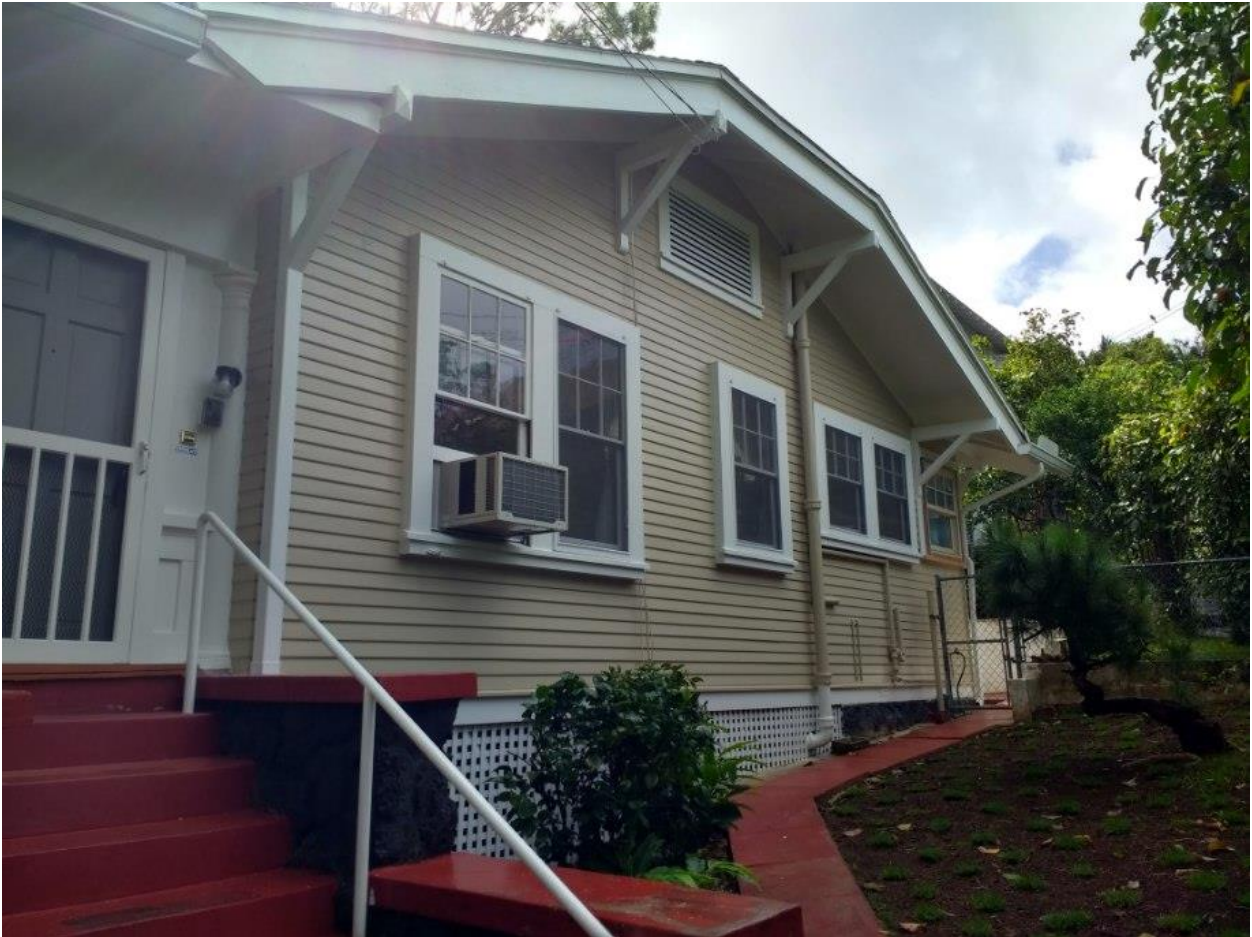
Photo 3 of 29

The House at 2017 Lanihuli Drive—Entry Side—North Elevation—December, 2019

The north side of the house has a double set of six-over-one windows with a single six-over-one and another double set of six-over-one, wooden windows (these are shorter than the others for the kitchen windows are above the sink). The main stairs of the house, leading to the front entrance, are made of lava-stone and concrete plinths, forming cheeks for the concrete stairs. The staircase appears to be original to the house. The front door that faces north appears to be a replacement, but is an appropriate raised panel door, mounted on butt hinges.

The north side of the house has a grassy lawn (~20' outward from the house to the edge of the lot, edged with a chain link fence) with a sidewalk leading to a gate at the back yard. The side foundation of the house is like the front with lava-stone piers and a foundation skirt of white lattice between the piers. The slope of the lot creates an angle that makes the foundation elements practically disappear at the rear.

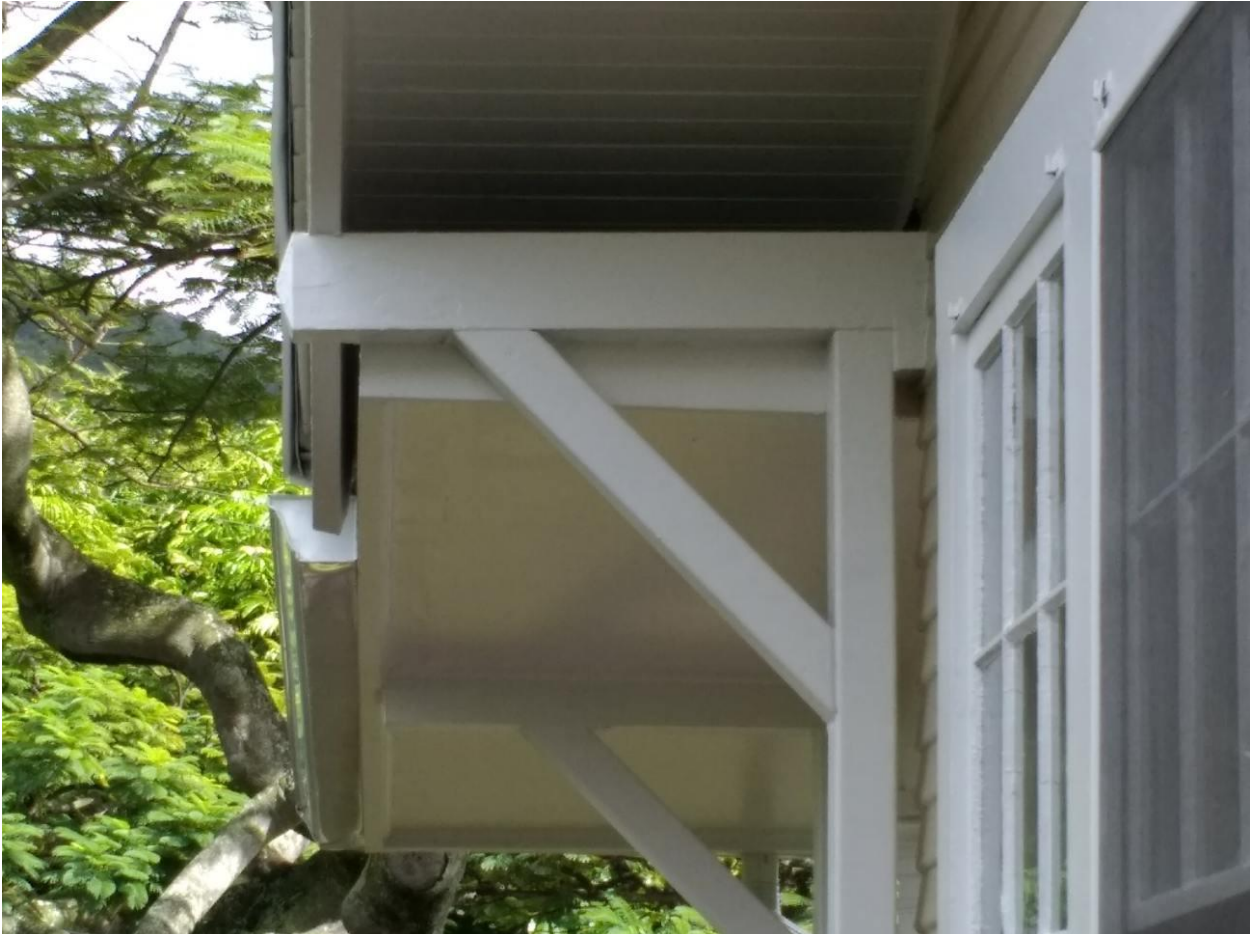
Photo 4 of 29

The House at 2017 Lanihuli Drive—Decorative Bracket in the Eave (typical)—December, 2019

The two sides of the home are not the same (i.e. the fenestration pattern), being slightly different on each side. The house's wood clapboarding is extant. The clapboarding has a 4" reveal. The house appears to have most of its original wooden sash, double hung windows. The tympanum of the house is vented by a wooden louvered opening to the attic. The louvered opening is framed with 6" boards with an apron. Four decorative brackets, on each side, support the eave.

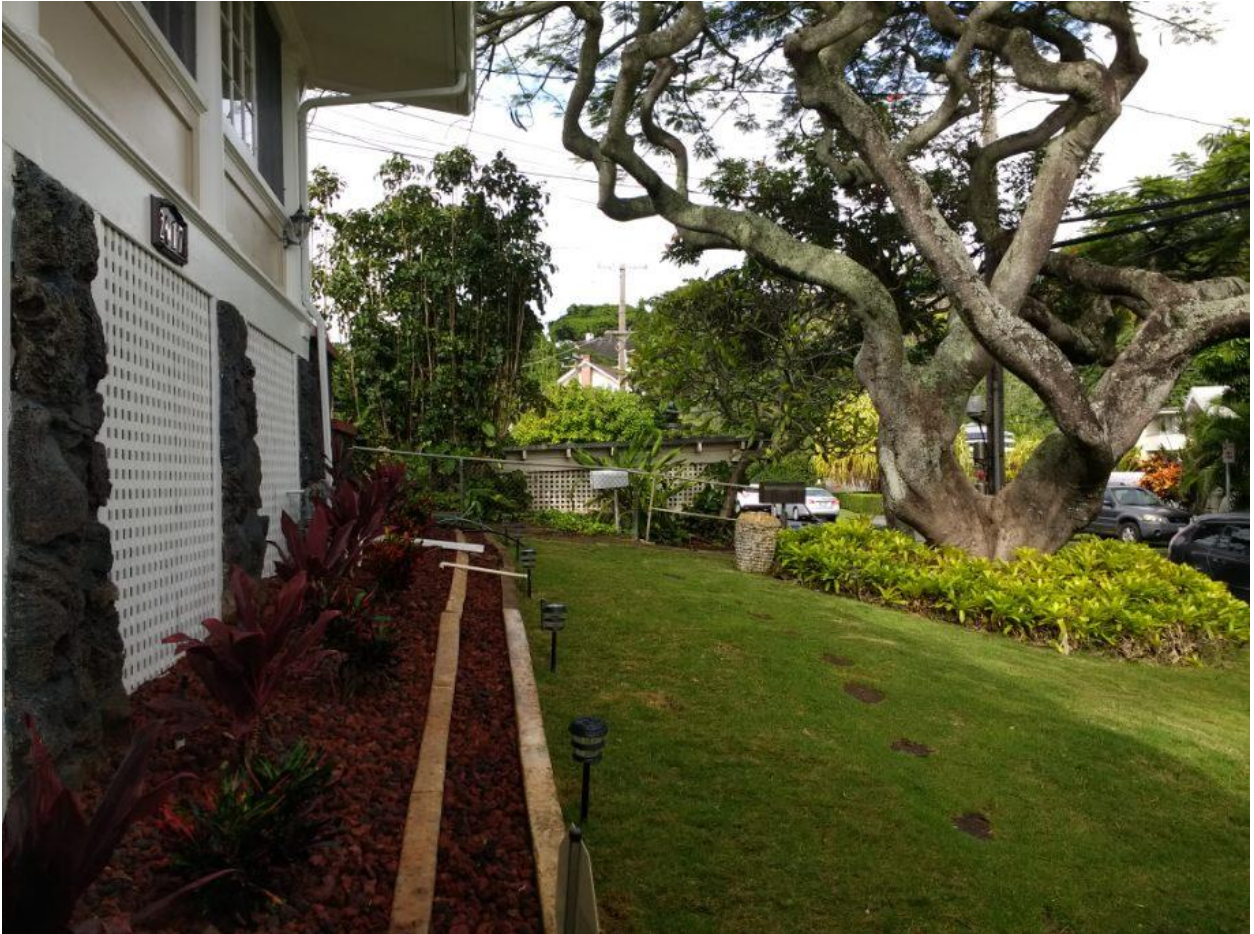
Photo 5 of 29

The House at 2017 Lanuhuli Drive—Front Lawn---View to North—December, 2019

The house has a ~30' setback from the road. The set back is a green (grassy) lawn. Lanihuli Drive does not have sidewalks at the border of the lawn and the street. There are curbs. A large (~25' high) red Poinciana tree is on the front lawn on its north-east corner that appears to be at least 50 years old. This tree, the set back and the grassy lawn are contributing elements. The lot of this house is ~52' wide. The lot is equipped with a driveway on its south-east corner. The driveway leads to an original garage that has since been enclosed and converted to an apartment. A carport is covering the closest end of the driveway. It is a late addition (less than 15 years) and is not contributing.

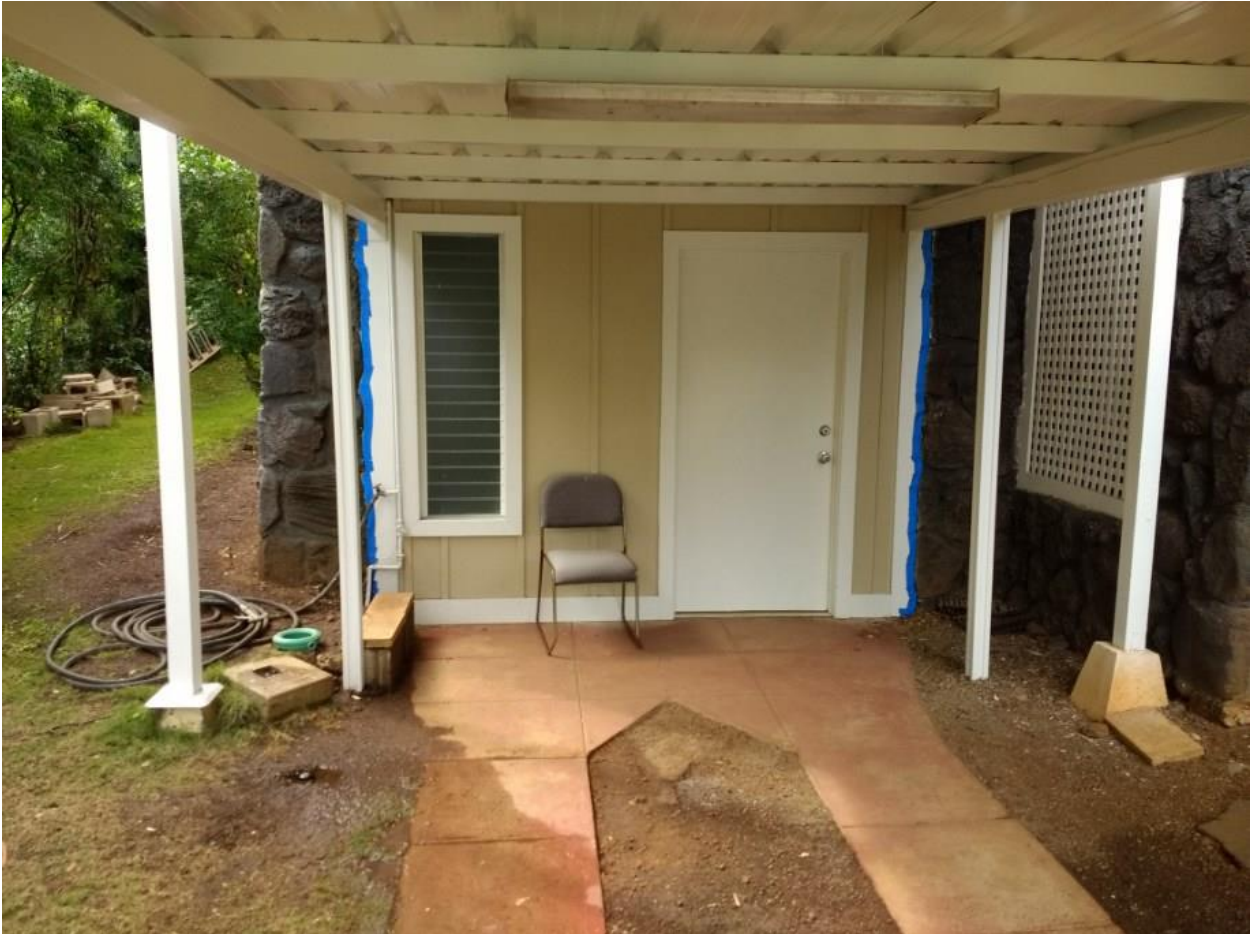
Photo 6 of 29

The House at 2017 Lanihuli Drive—Enclose garage Entry, Front Elevation---December, 2019

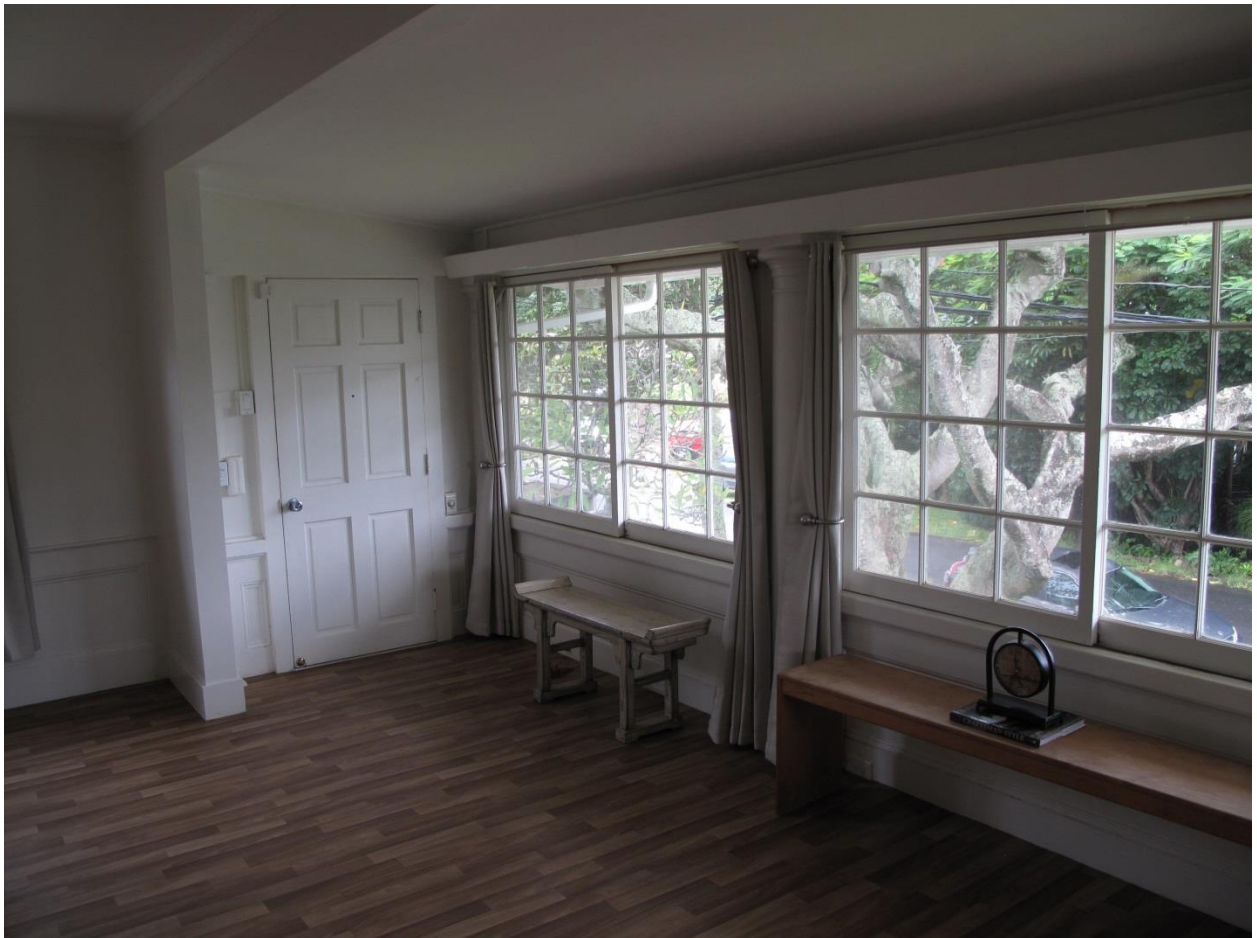
Photo 7 of 29

The House at 2017 Lanihuli Drive—Interior—Main Entry—December, 2019

The house is accessed at the front by a side entrance (north). The entrance allows access to an open hall plan into a living room 23' x 18.5' in dimension. The room has a wainscot of Colonial Revival recessed panels, encircling the entire room. The base of the panels provides the baseboard for the walls, 7" in height. The wooden panels vary in length to accommodate the walls. The wainscot terminates at the window sills, ~29" from the floor. The wainscot panels are accentuated by quirked ogee trim, 1" in width. The stiles and stretchers of the panels are 6" wide.

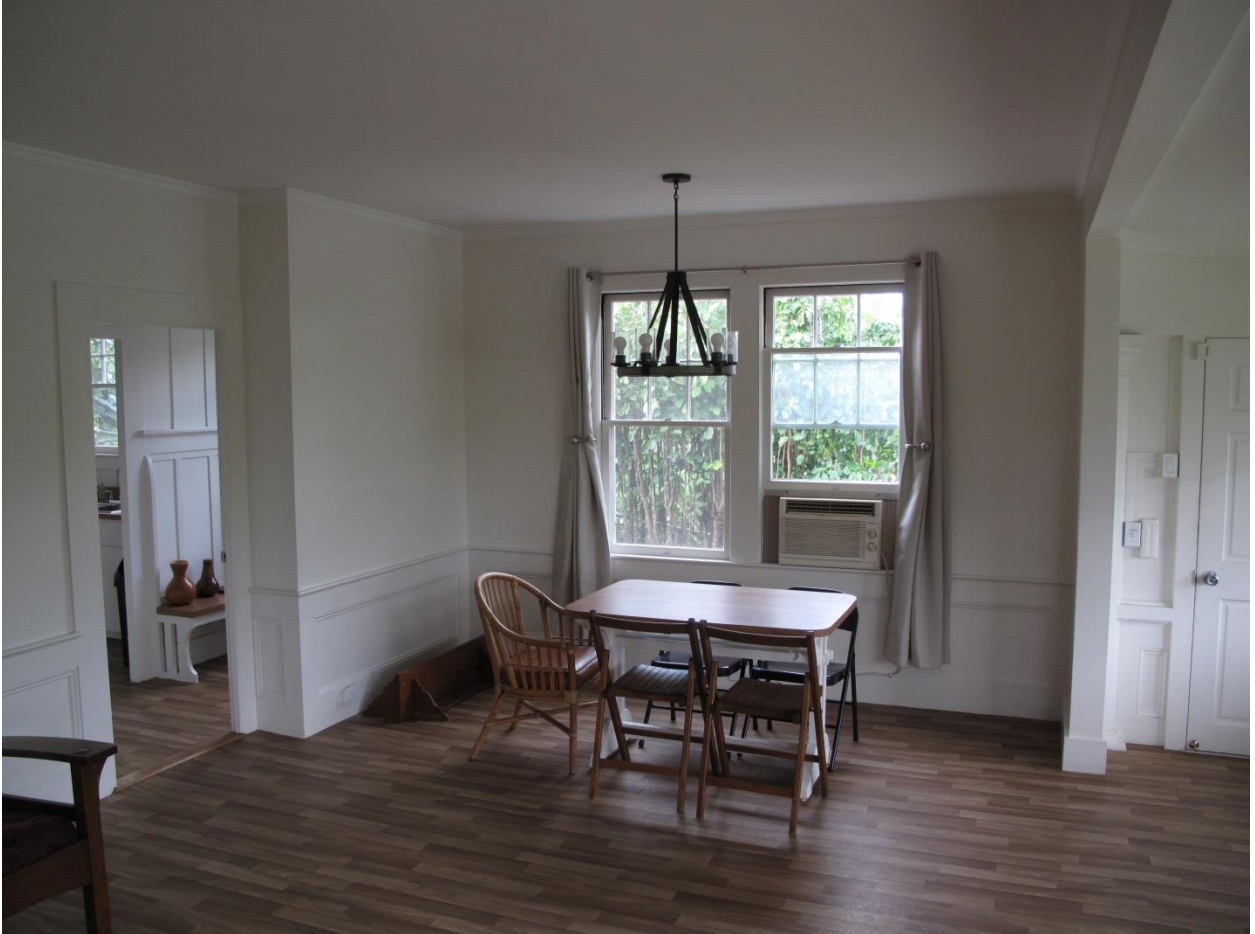
Photo 8 of 29

The House at 2017 Lanihuli Drive—Interior Dining Area---December 2019

The northern wall is lighted and vented by a double set of six-over-six, double hung wooden windows. The windows are symmetrically placed in the center of the wall of the room. A center mullion separates the windows that are 6" in width. The casing trim is 4" wide. The interior trim and window sill are finished out with a 1 3/4" cyma reversa trim. The living room also functions as the dining area along the northern edge of the room, closest to the kitchen as there is an overhead hanging lamp to illuminate the dining table. The southern wall provides a small closet.

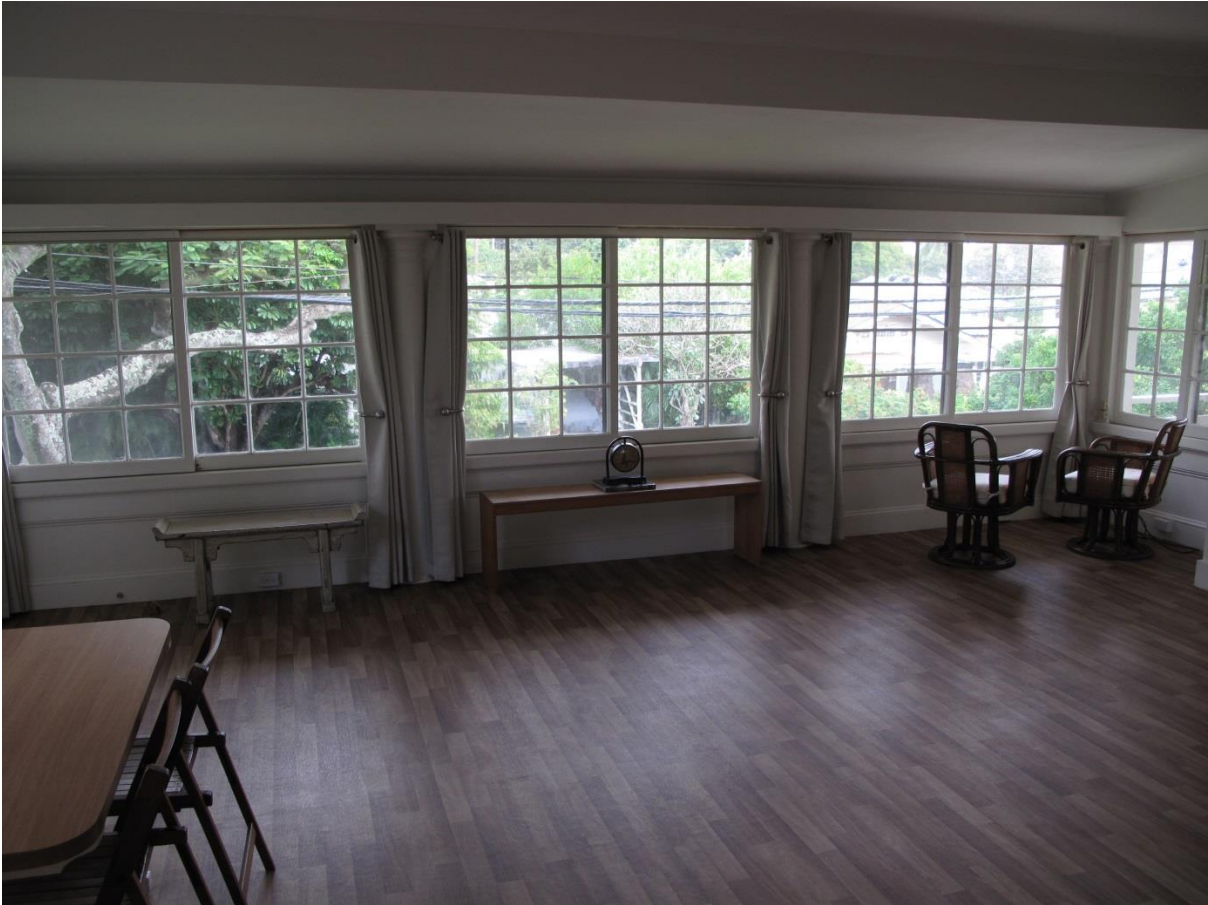
Photo 9 of 29

The House at 2017 Lanihuli Drive—Main Living Room—View to the East—December, 2019

The living room's east facing elevation is composed of three bays of 12 divided lite (10, 1/4" x 10, 1/2" panes) windows in the Colonial Revival style. The 1" muntins are corbelled. The windows slide, side-to-side. The windows (and the bays) are 6'-3" in width. The Tuscan-Colonial columns in antis provide for a framing of the fenestration. The view of out through the windows is an impressive natural feature of Oahu (the Ko'olau Mountains). The columns are 6'-5" in height and ~24" in diameter. The columns are tapered, however, from 24" at the base to 22" at the neck. The windows and the columns, along with the wainscot, are character defining features of this space. The ceiling in the living room at the front-most end has a slope downward of ~15 degrees.

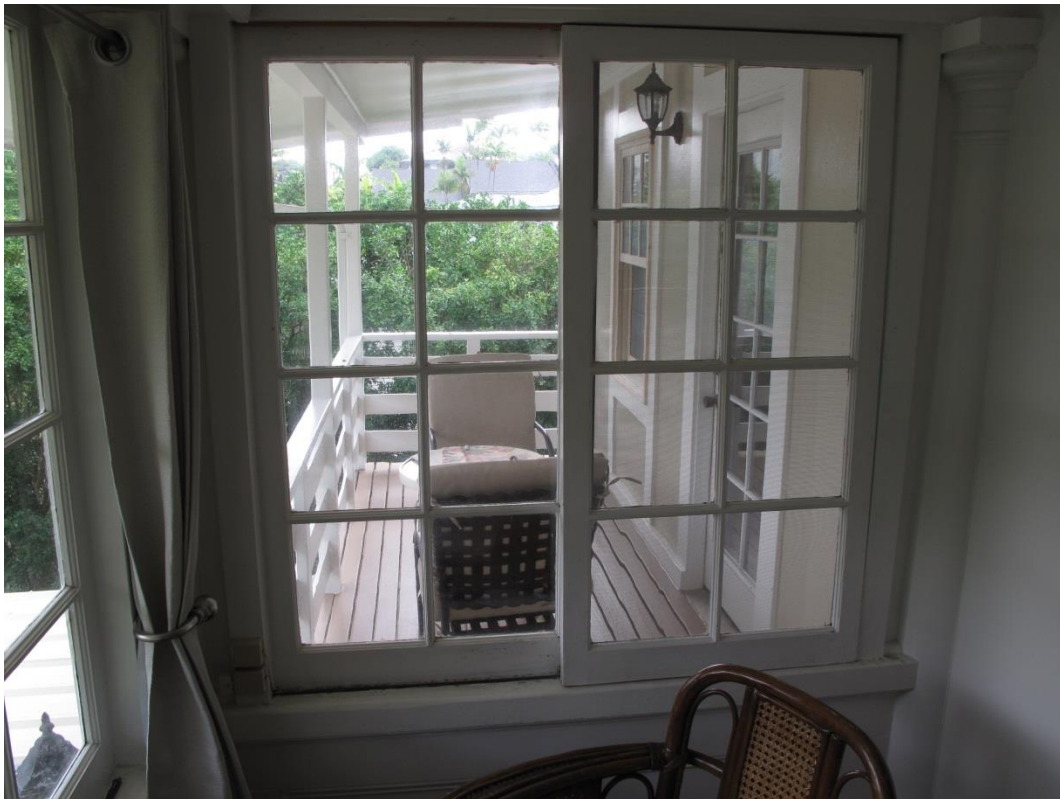
Photo 10 of 29

View out of the Living Room window to added lanai—December, 2019

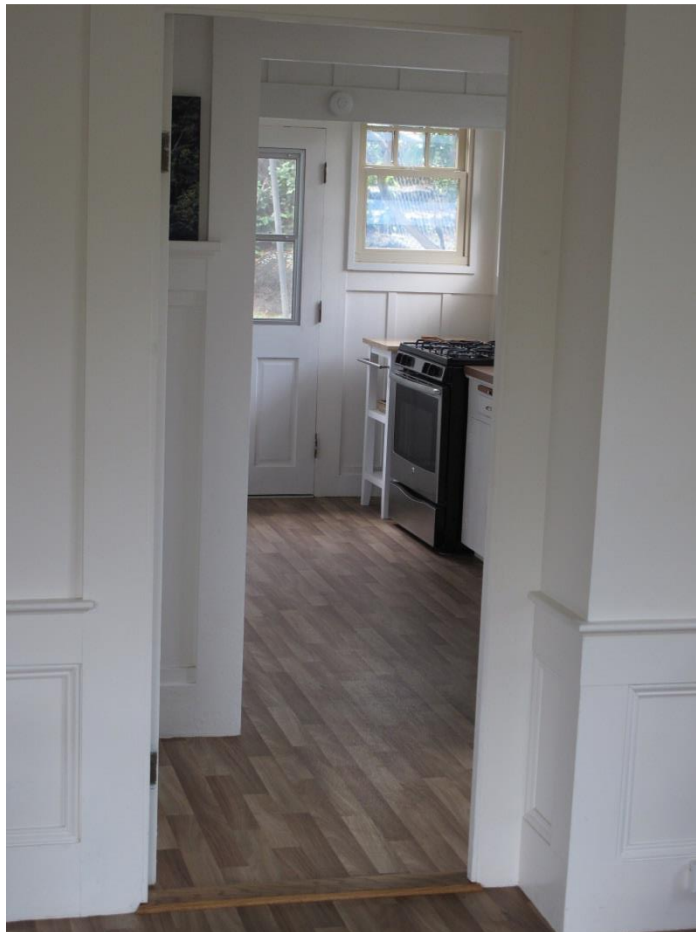
Photo 11 of 29

View from the Living Room Through the kitchen—December, 2019

The western wall of the living room provides access to the kitchen and the hallway for the bedrooms. The kitchen is equipped with a breakfast nook that is 4'-6" x 5' in dimension. The breakfast nook is lighted and vented by with a single double hung window, milled like the other windows in the house.

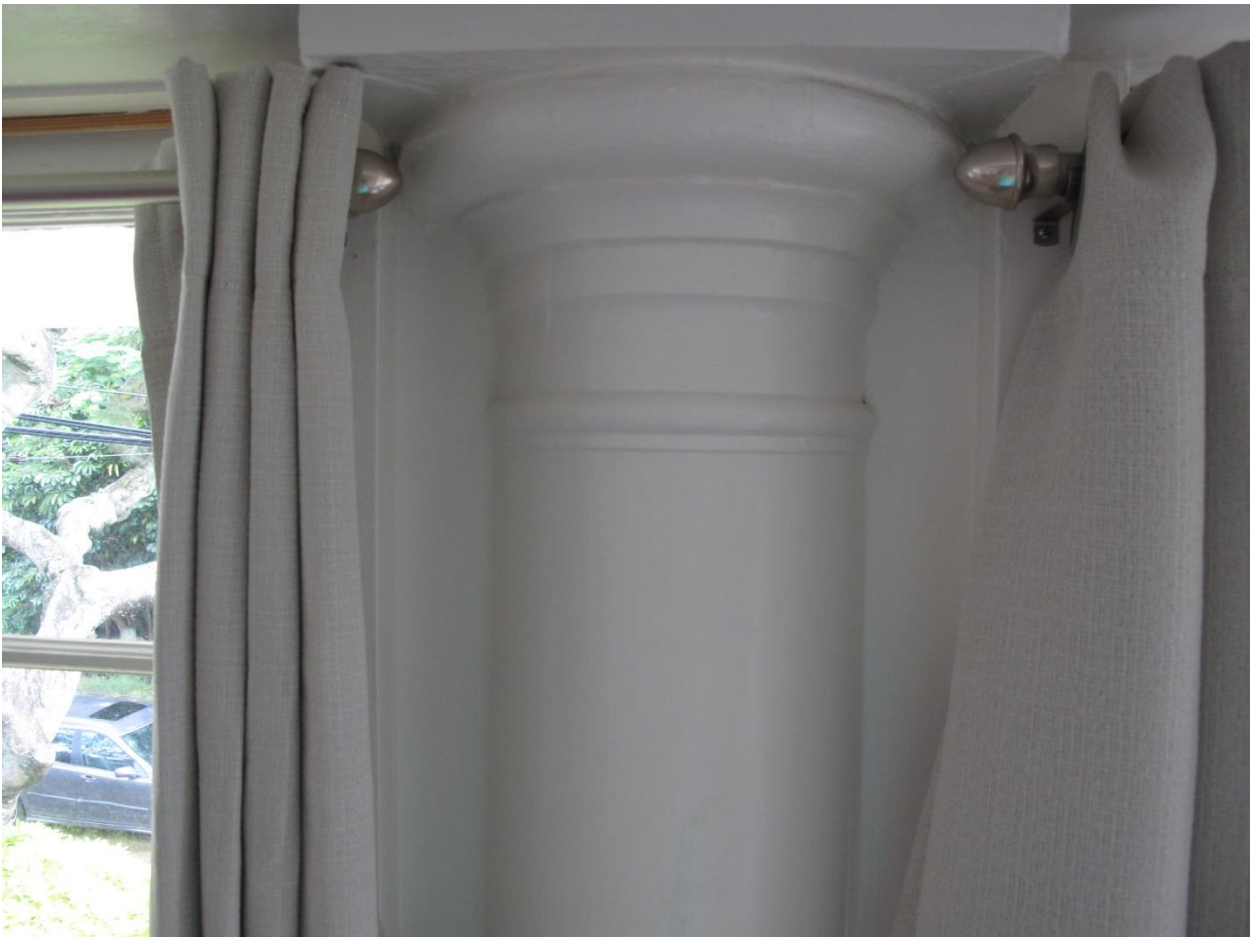
Photo 12 of 29

Image of Column Capital in the Living Room---December, 2019

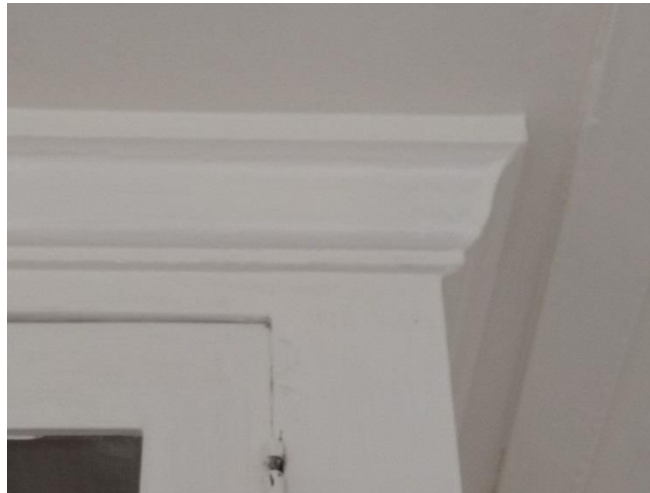
Photo 13 of 29

Crown Molding---December, 2019

The walls above the wainscot are composed of smooth plaster. The walls terminate at a 3 1/4" crown molding in the ogee profile. The ceiling is smooth plaster and is 9' in height. This ceiling height is consistent throughout the house. The floors in this portion of the house are a replacement of vinyl wood plank floors that are complimentary to the home as a substitute for the original Douglas fir wooden floors. The current owners relay that they purchased the home in this condition and that the floors were replaced by the previous owners.

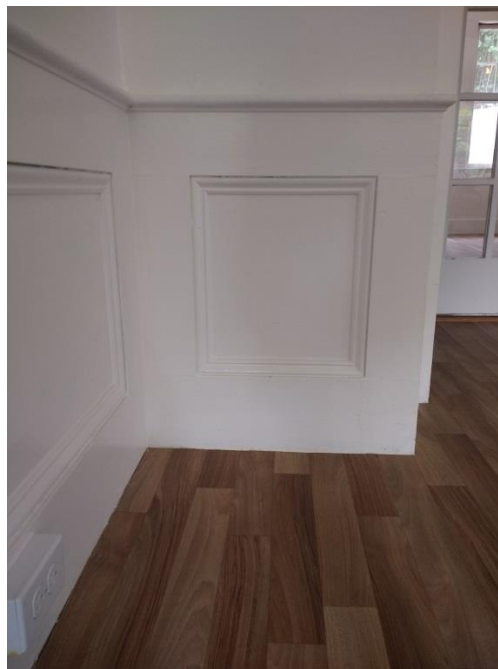
Photo 14 of 29

Wainscot (dado)—December, 2019

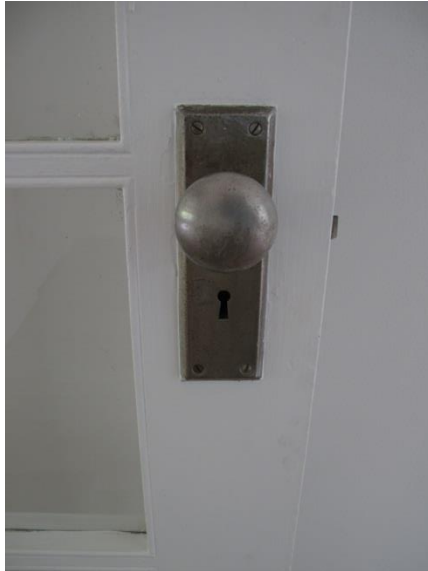
Photo 15 of 29

Interior Historic Door Hardware—Type 1—DEC, 2019

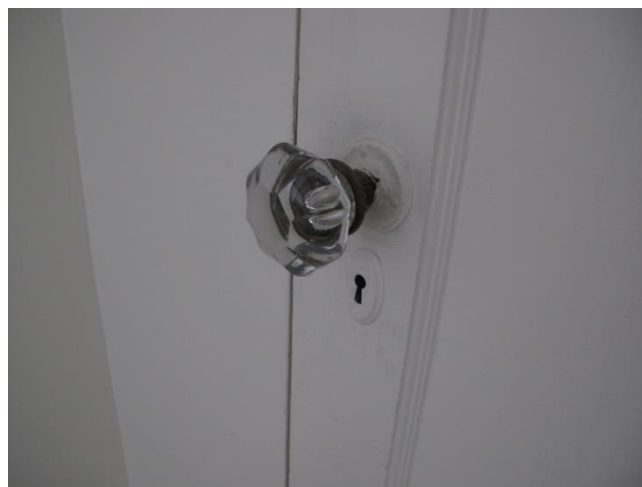
Photo 16 of 29

Interior Historic Hardware ---Type 2---DEC, 2019

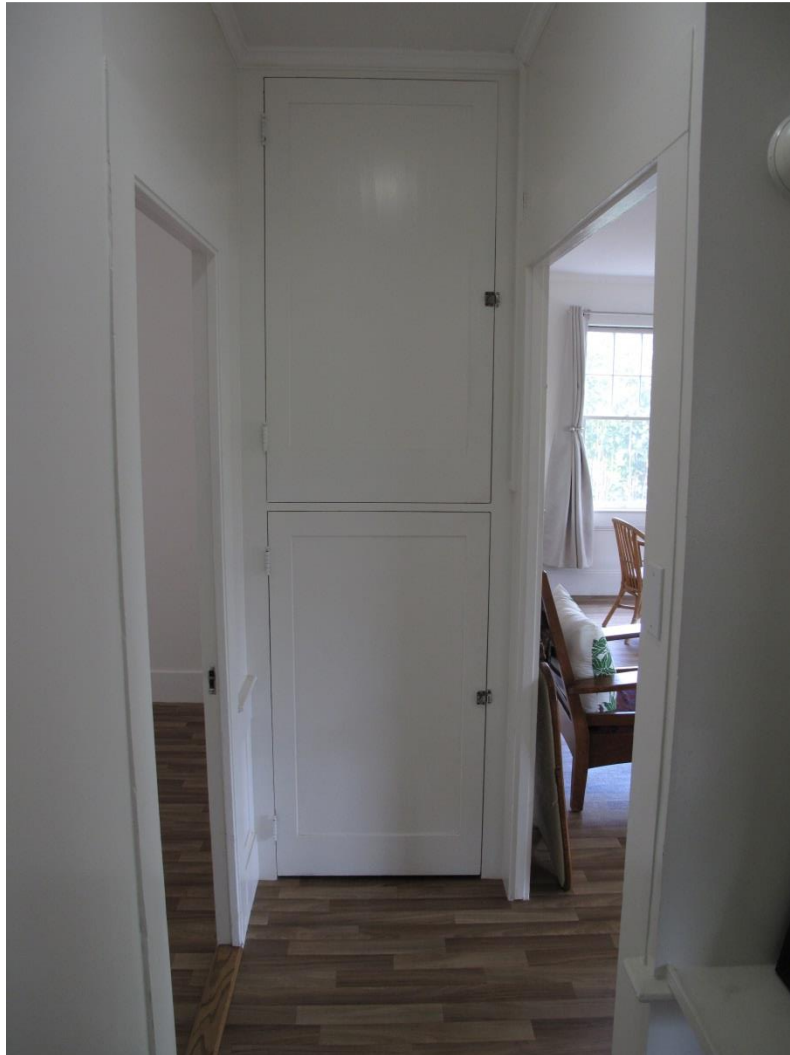
Photo 17 of 29

Bedroom Hall Built in Cabinetry—December, 2019

The bedroom hall has built in cabinets on the northern wall. These appear to be original to the house. The house has 3 bedrooms:

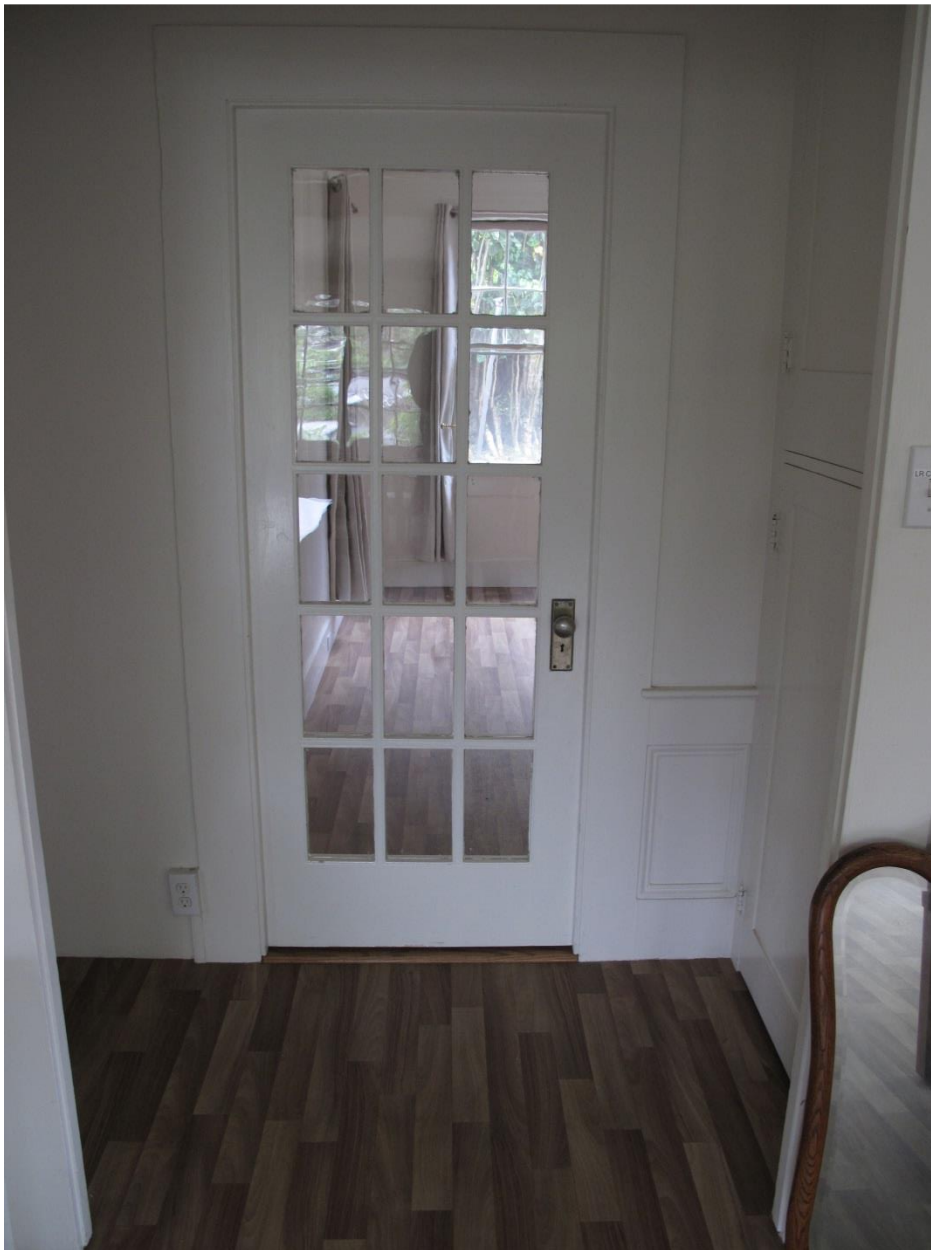
Photo 19 of 29

French Door Entry Into Bedroom 1 (or Den)—December, 2019

Bedroom 1---a 15 lite French door leads to the bedroom from the center hallway. It appears to be original to the house. The French door here may indicate that this room was used as a den instead of a bedroom. The adjoining doorway to the kitchen also bolsters that theory. The room is 10' x 14' in dimension. The rear wall is lighted and vented by a double set of six-over-one, double hung windows. The southern wall has a single window of the same type. The walls are plaster. The room has 2 3/4" ogee crown molding with 6" baseboards. A flush wooden door leads into the kitchen. The closet door with its glass knob appears to be original to the house.

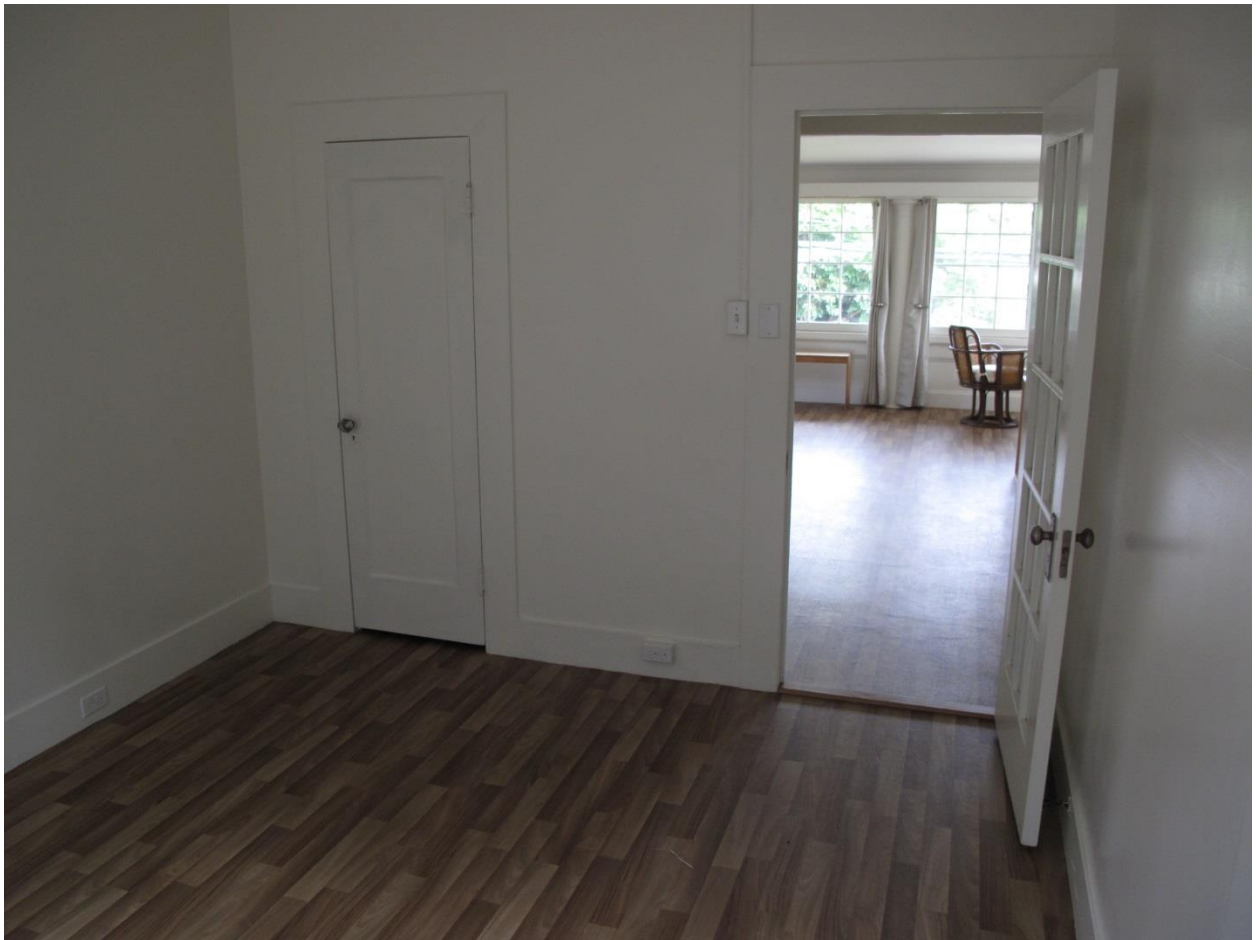
Photo 20 of 29

Bedroom 1 (den) with both original door types (i.e. French and recessed panel)—DEC, 2019

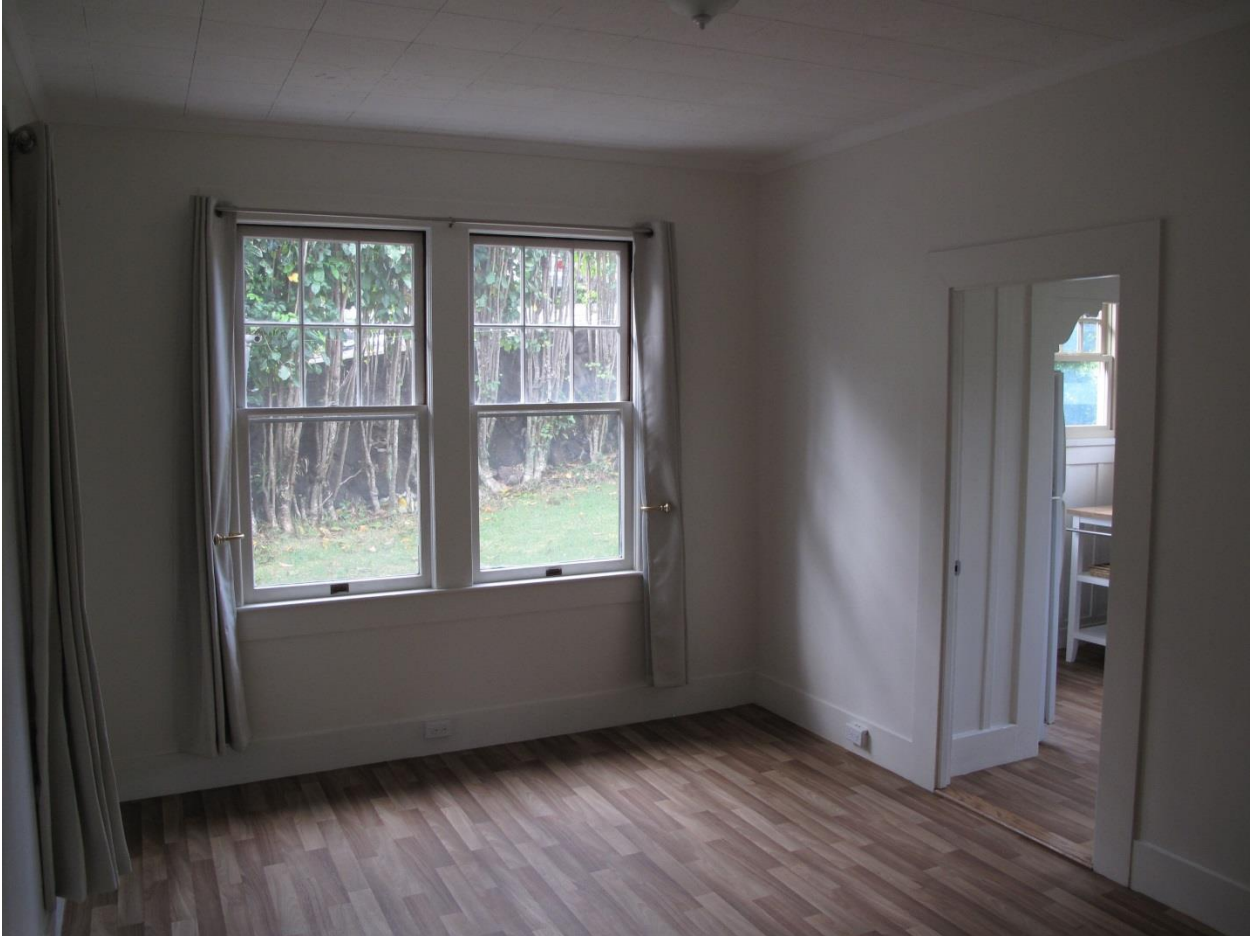
Photo 21 of 29

Bedroom 1 (den) rear wall and entry into kitchen---DEC, 2019

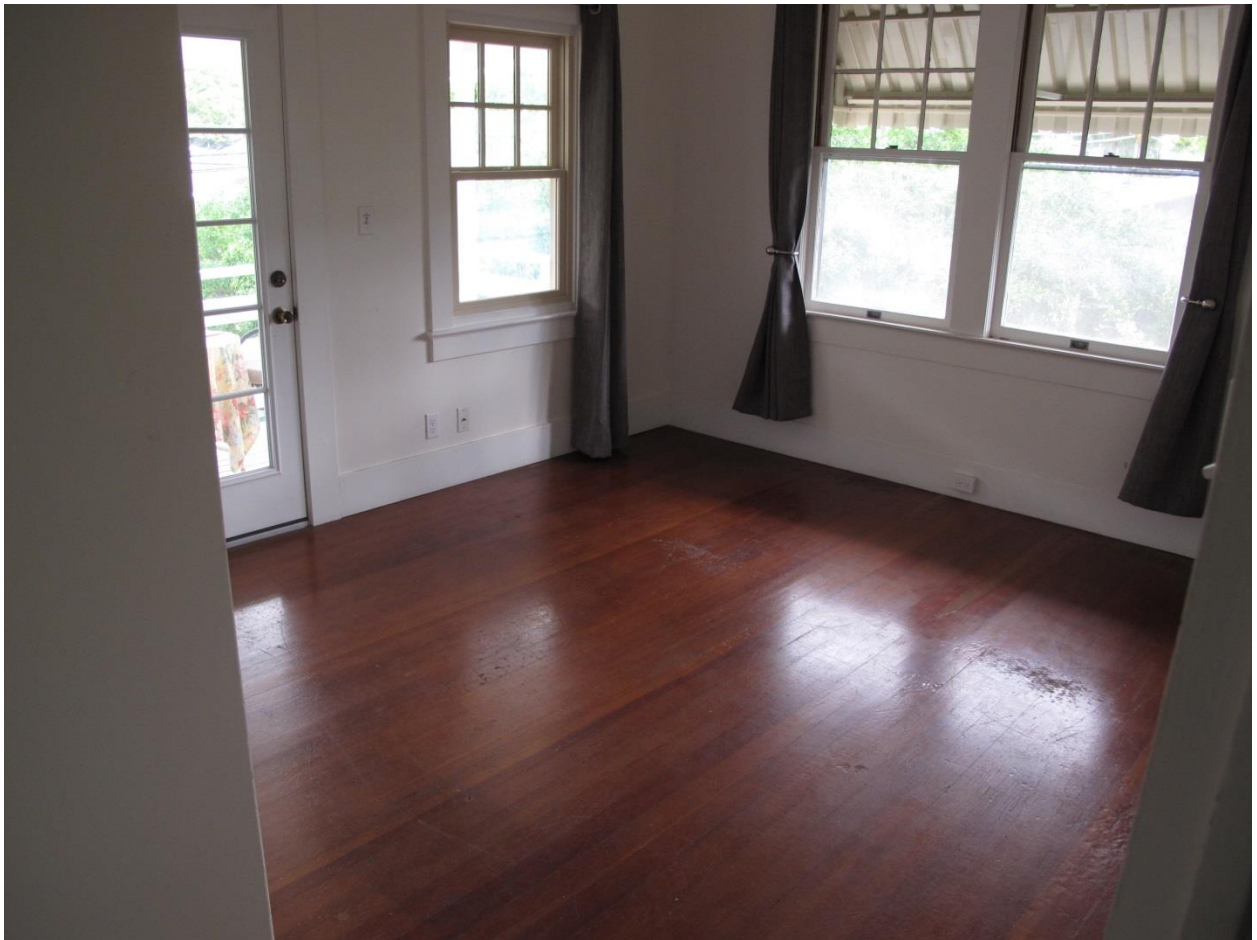
Photo 22 of 29

Bedroom 2—at the SE corner of the house—DEC 2019

Bedroom 2---The front bedroom is 12'x 9' in dimension. The floor in this room is Douglas fir and is probably original to the house. The closet door in the room with its glass knob appears to be original. The front wall has a newer door (French door) and window made of aluminum that leads to a small covered lanai on the front elevation of the house. The door, window and lanai appear to be recent additions to the house. The walls and ceiling of this room are sheathed in Canec with beveled edges. The room is lighted and vented on the side elevation by a double set of wooden, divided lite sash windows. The upper sash of one window is a mis-match, but appears to be of considerable age with the house.
