1. Name of PropertyHistoric name: The House at 2017 Lanihuli Drive

N/A**2. Location**Street & number: 2017 Lanihuli DriveCity or town: Honolulu State: Hawaii County: HonoluluNot For Publication: ☐ Vicinity: ☐

Colonial Revival/Arts & Crafts

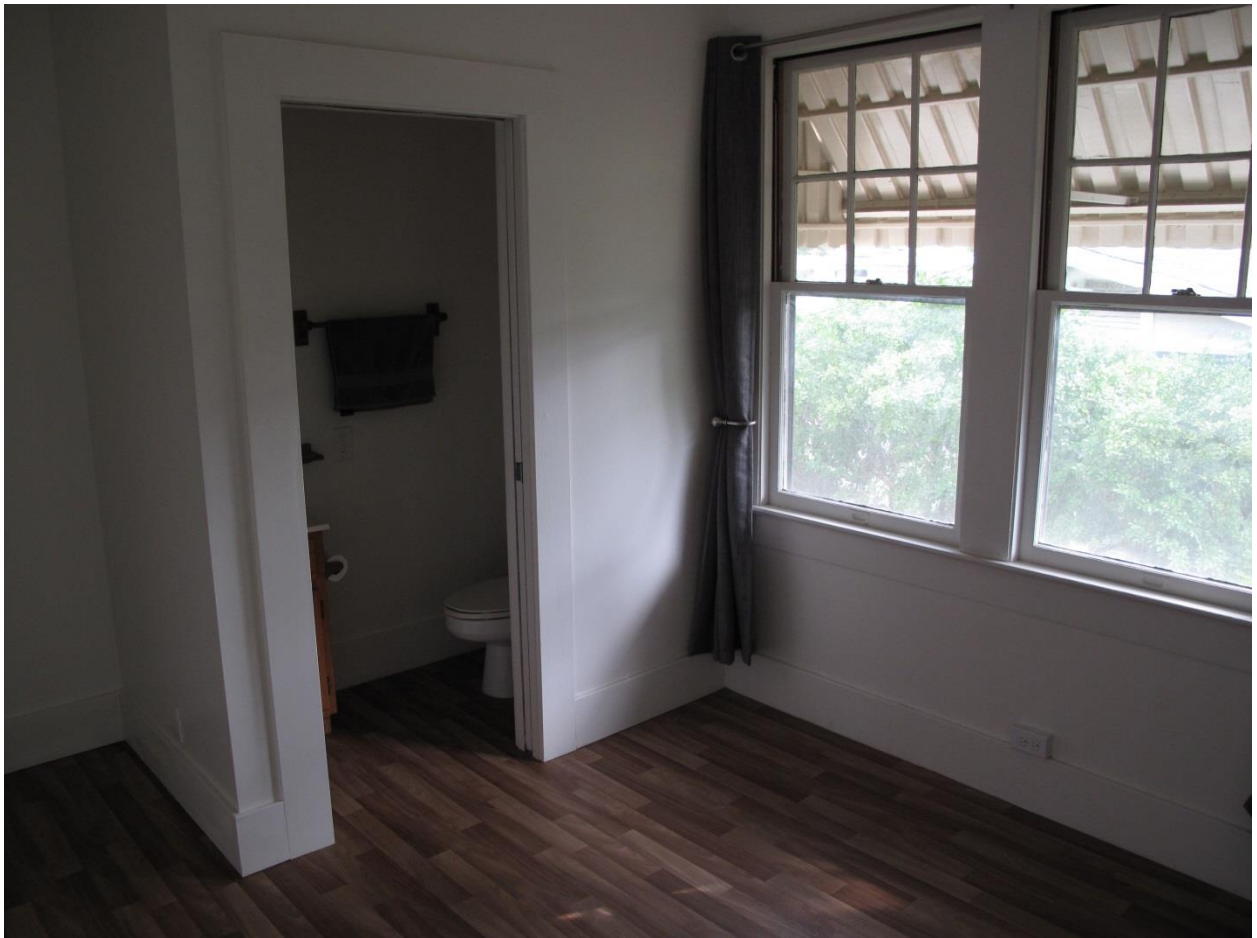
Photo 23 of 29

Bedroom 3 with added half bath—DEC 2019

Bedroom 3----the smaller bedroom is accessed by a flush wooden door. The floors are carried over from the living room and hallway. The walls appear to be drywall. The walls are topped off with 5" cyma recta crown molding. The room has 7" baseboards. The room is partially partitioned off with an added ½ bathroom. The closet door (recessed panel) with its glass knob appears to be the original. The room is lighted by 2 sets of the wooden double hung windows.

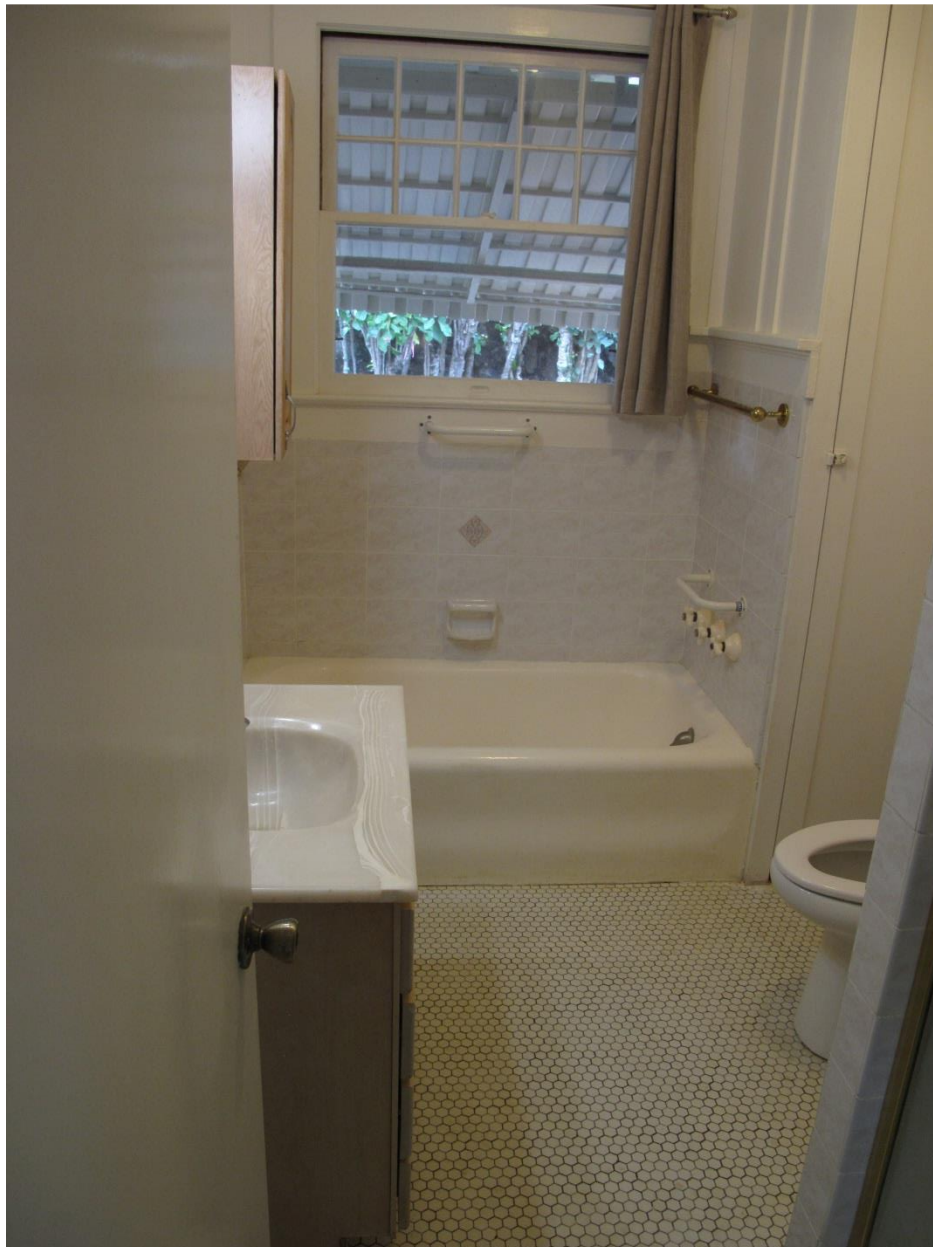
Photo 24 of 29

Main Bathroom—with original cast iron tub, original flooring, original built in cabinet and original window—DEC, 2019

Main Bathroom---The bathroom is 7'-4" x 6'-7" in dimension. The bathroom has a heavy cast iron enameled bath tub. The hardware on the tub appears to be original. The room retains its original 1" hexagonal white porcelain floor tiles.

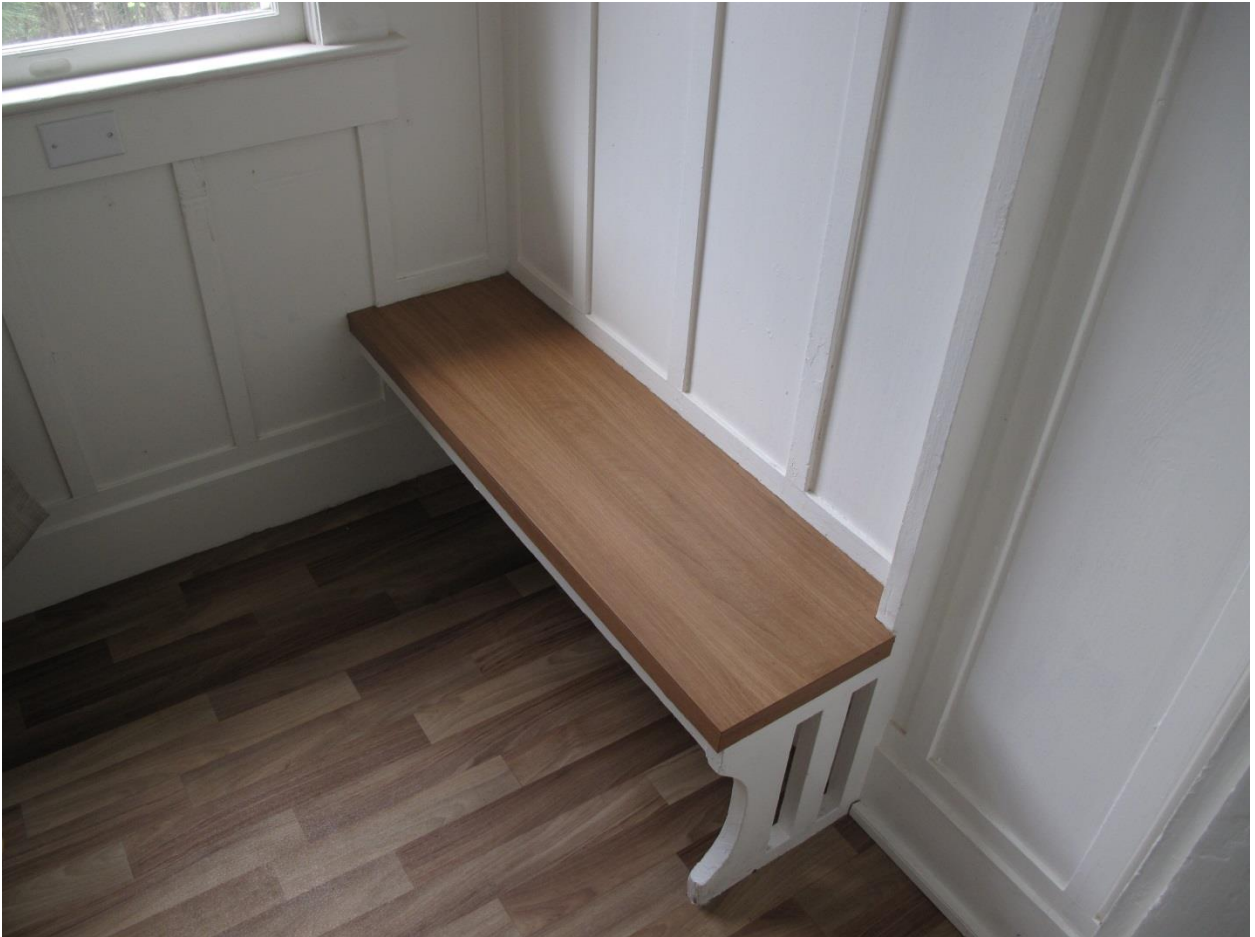
Photo 25 of 29

Original Breakfast Nook Built in Benches and Board-and-batten walls—DEC, 2019

The western wall of the living room provides access to the kitchen and the hallway for the bedrooms. The kitchen is equipped with a breakfast nook that is 4'-6" x 5' in dimension. The breakfast nook is lighted and vented by with a single double hung window, milled like the other windows in the house.

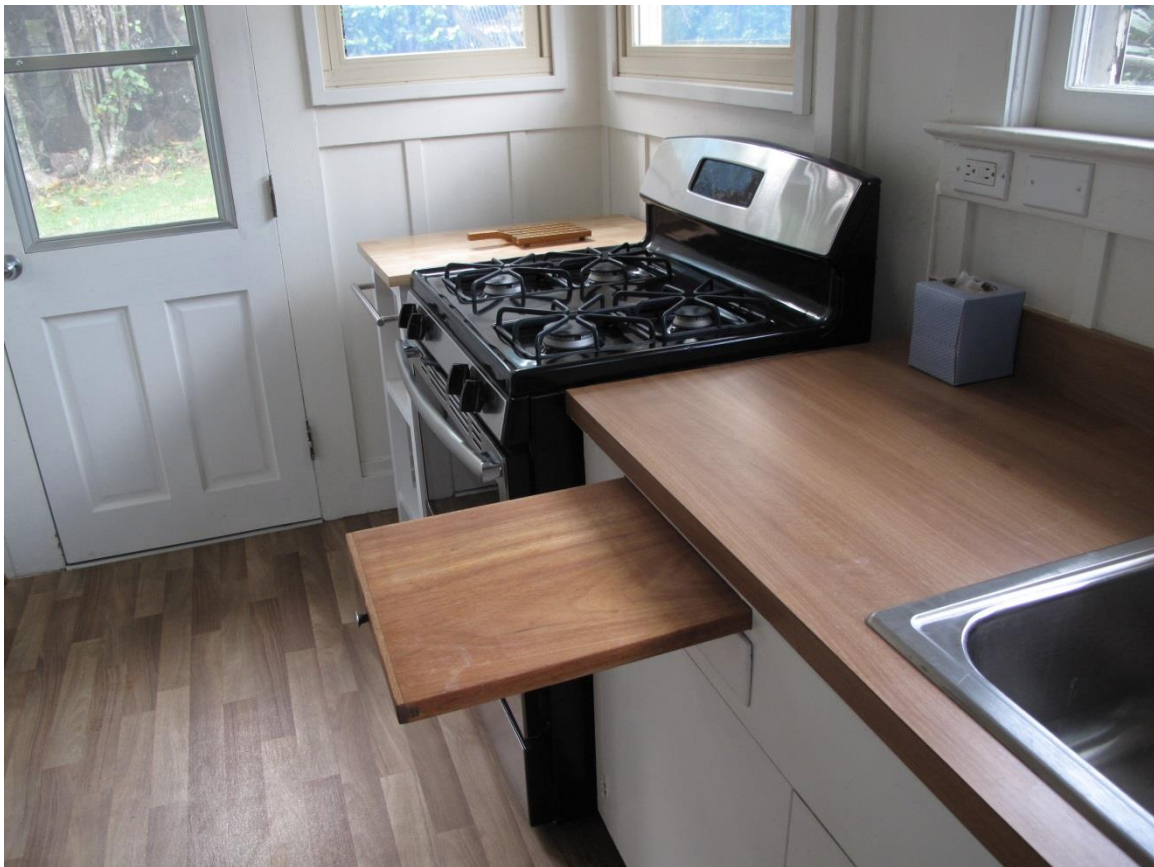
Photo 26 of 29

Kitchen—Interior and rear entry door---DEC 2019

The kitchen is 12'-6" x 9' in dimension. The kitchen provides a direct line access to the rear door of the house. The wooden cabinets (35" high) appear to be original. The counter-tops, however, are replacements. The tops may emulate the original sugar maple counter tops. The built in cutting board remains of that wood. The walls of the kitchen are sheathed in board-and-batten walls. The kitchen walls are finished and terminate with a 2 3/4" cyma recta ogee crown molding. The rear most 4' of the kitchen is semi-partitioned off with a bracketed flat arch that forms an entry from the rear of the house.

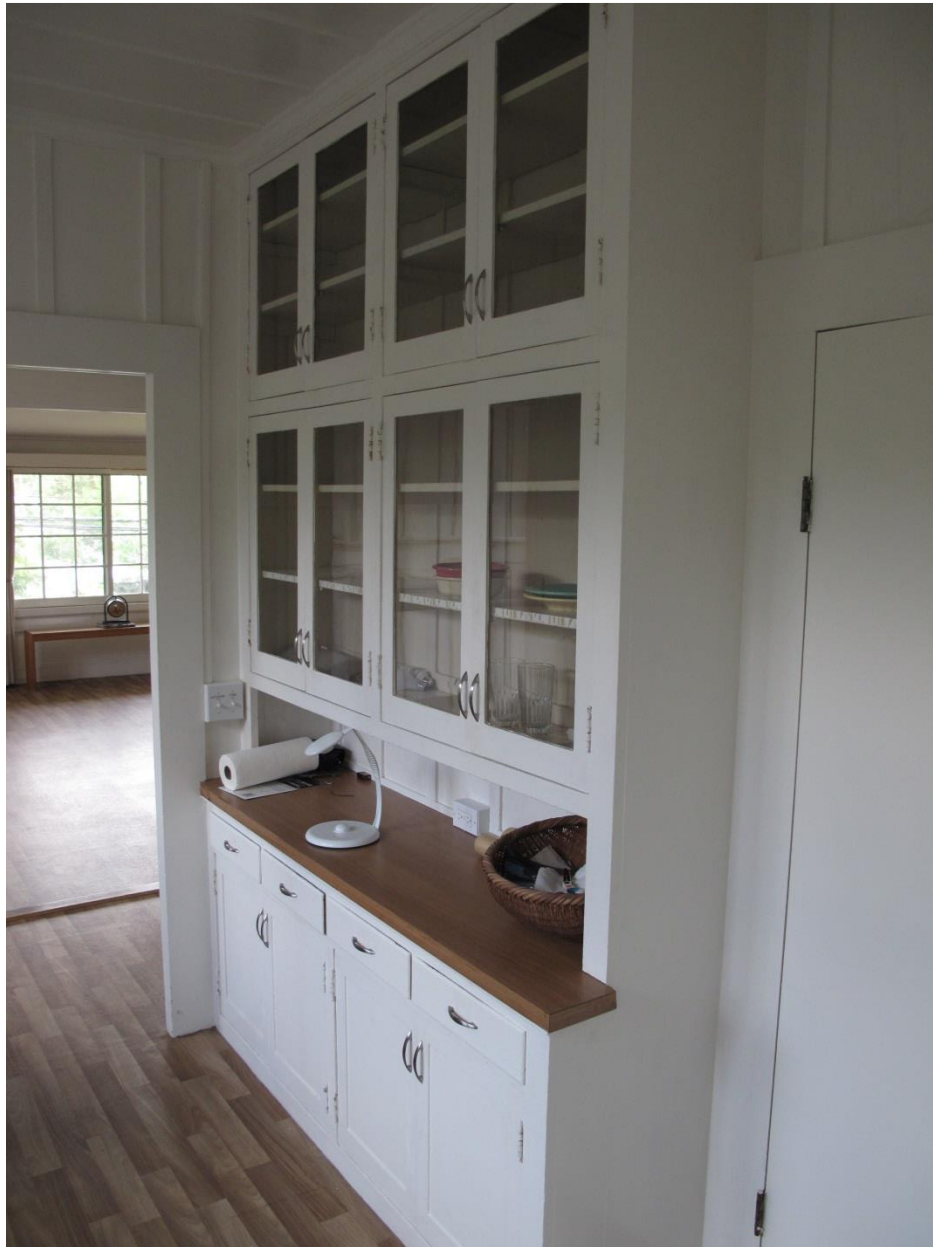
Photo 27 of 29

Original Built-in China Hutch—DEC, 2019

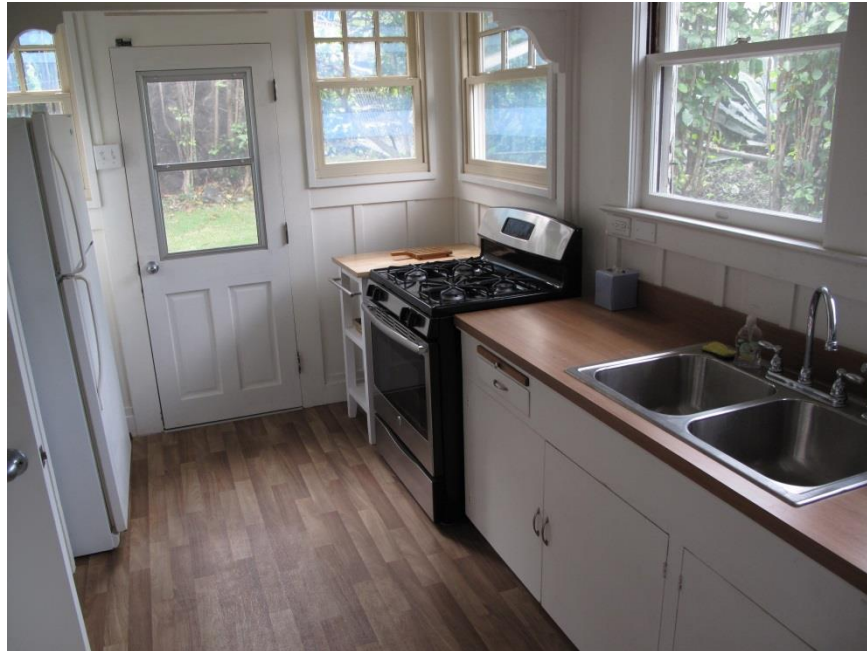
Photo 28 of 29

Kitchen—original cabinet bases, windows and replacement entry door—DEC, 2019

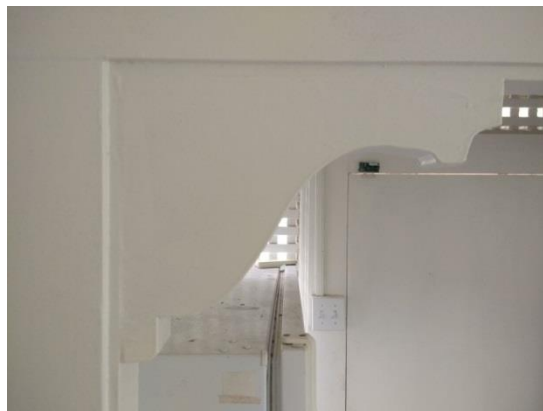
Photo 29 of 29

Decorative Bracket in Kitchen—DEC, 2019
