National Register of Historic Places Registration Form

Historic name: Wood Tenement Buildings behind Tong Fat Co.

Street & number: 425 N. King Street

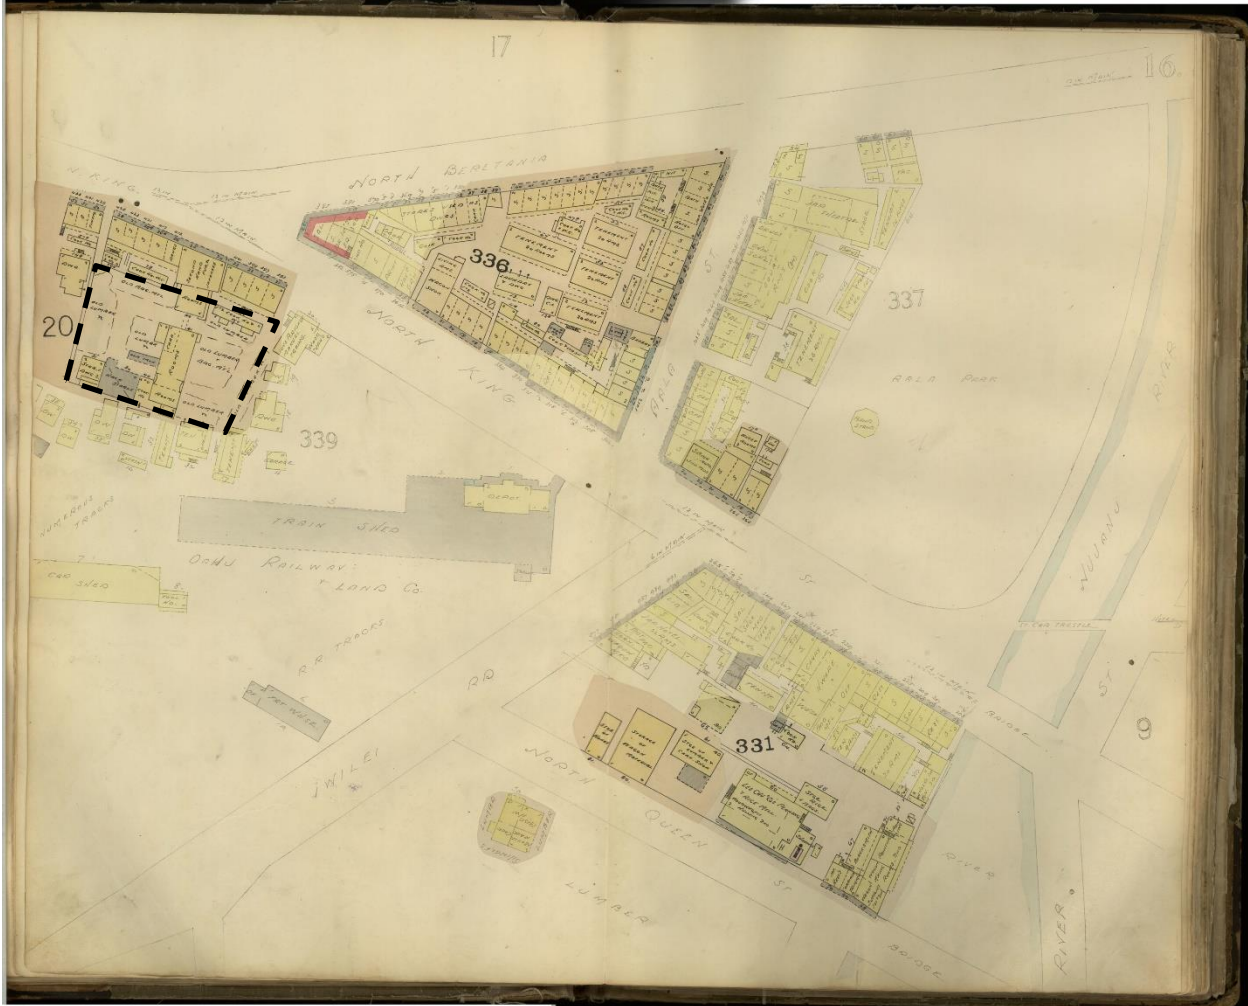
1906 Dakin Map of the area showing the rail property to the south of the site where the Tenements would be constructed (Property indicated by dashed line).

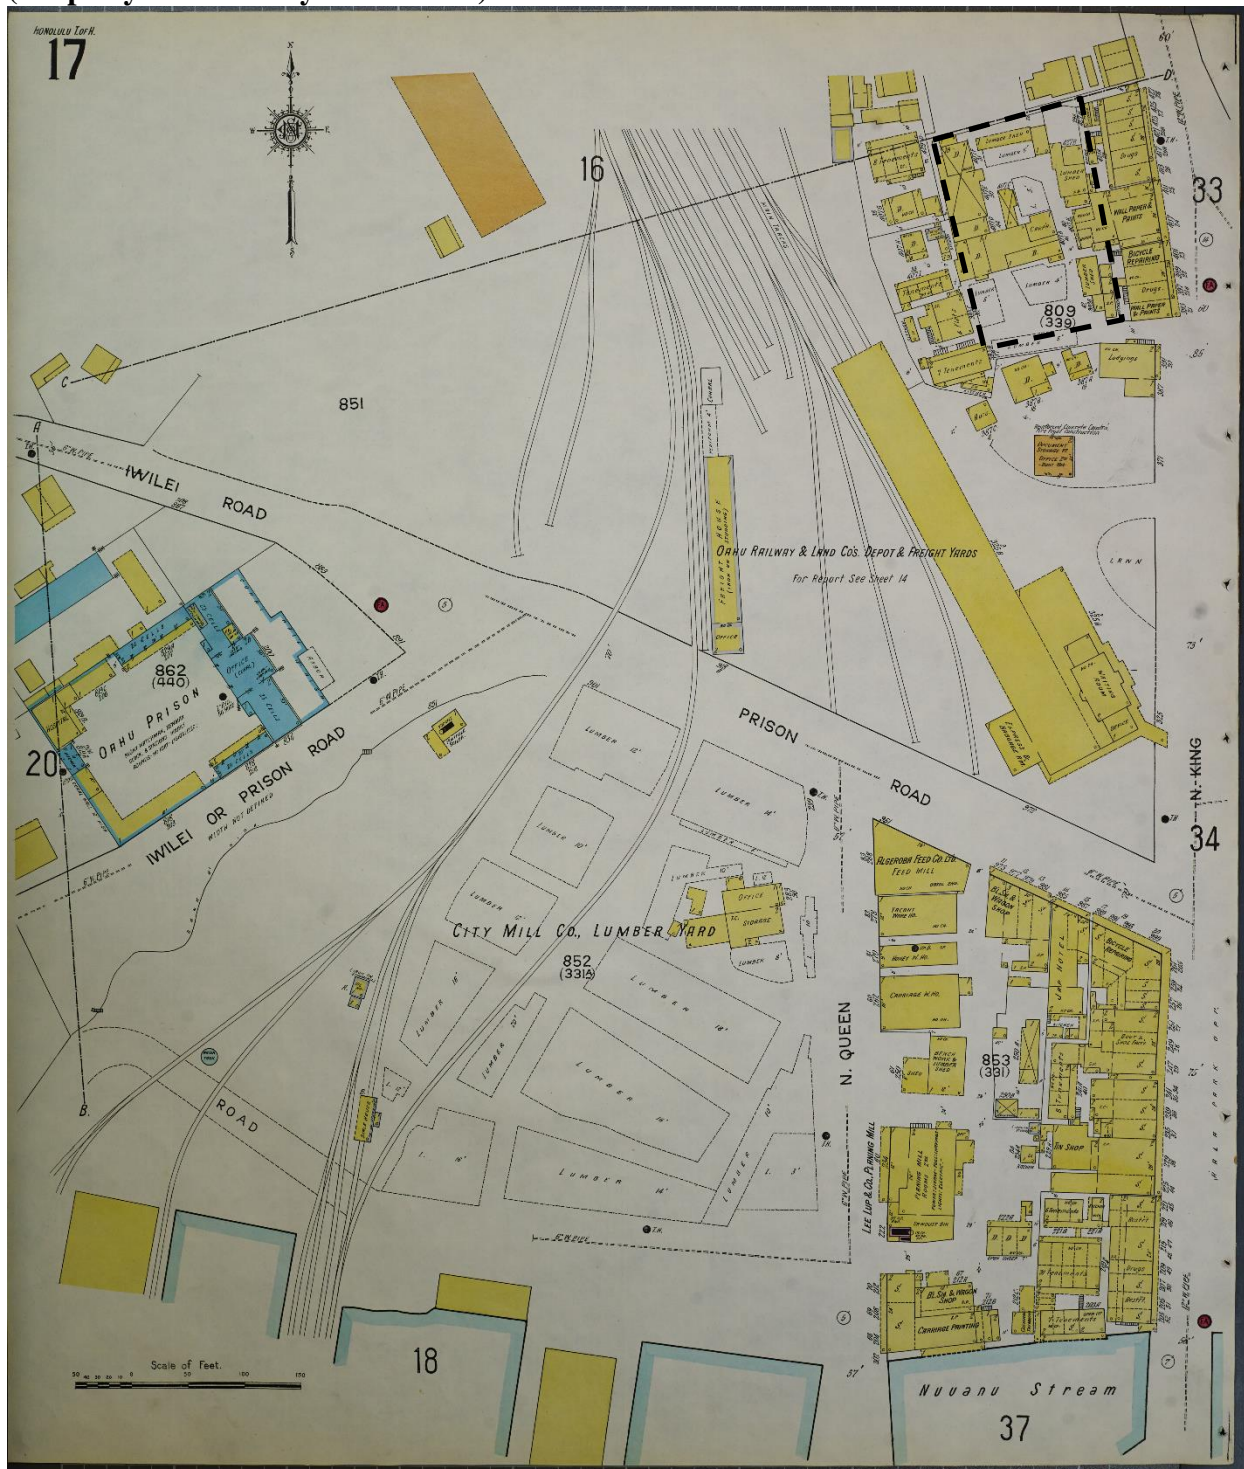
**1914 Sanborn Map showing proximity of Tenement buildings location to OR&L Depot
(Property indicated by dashed line)**

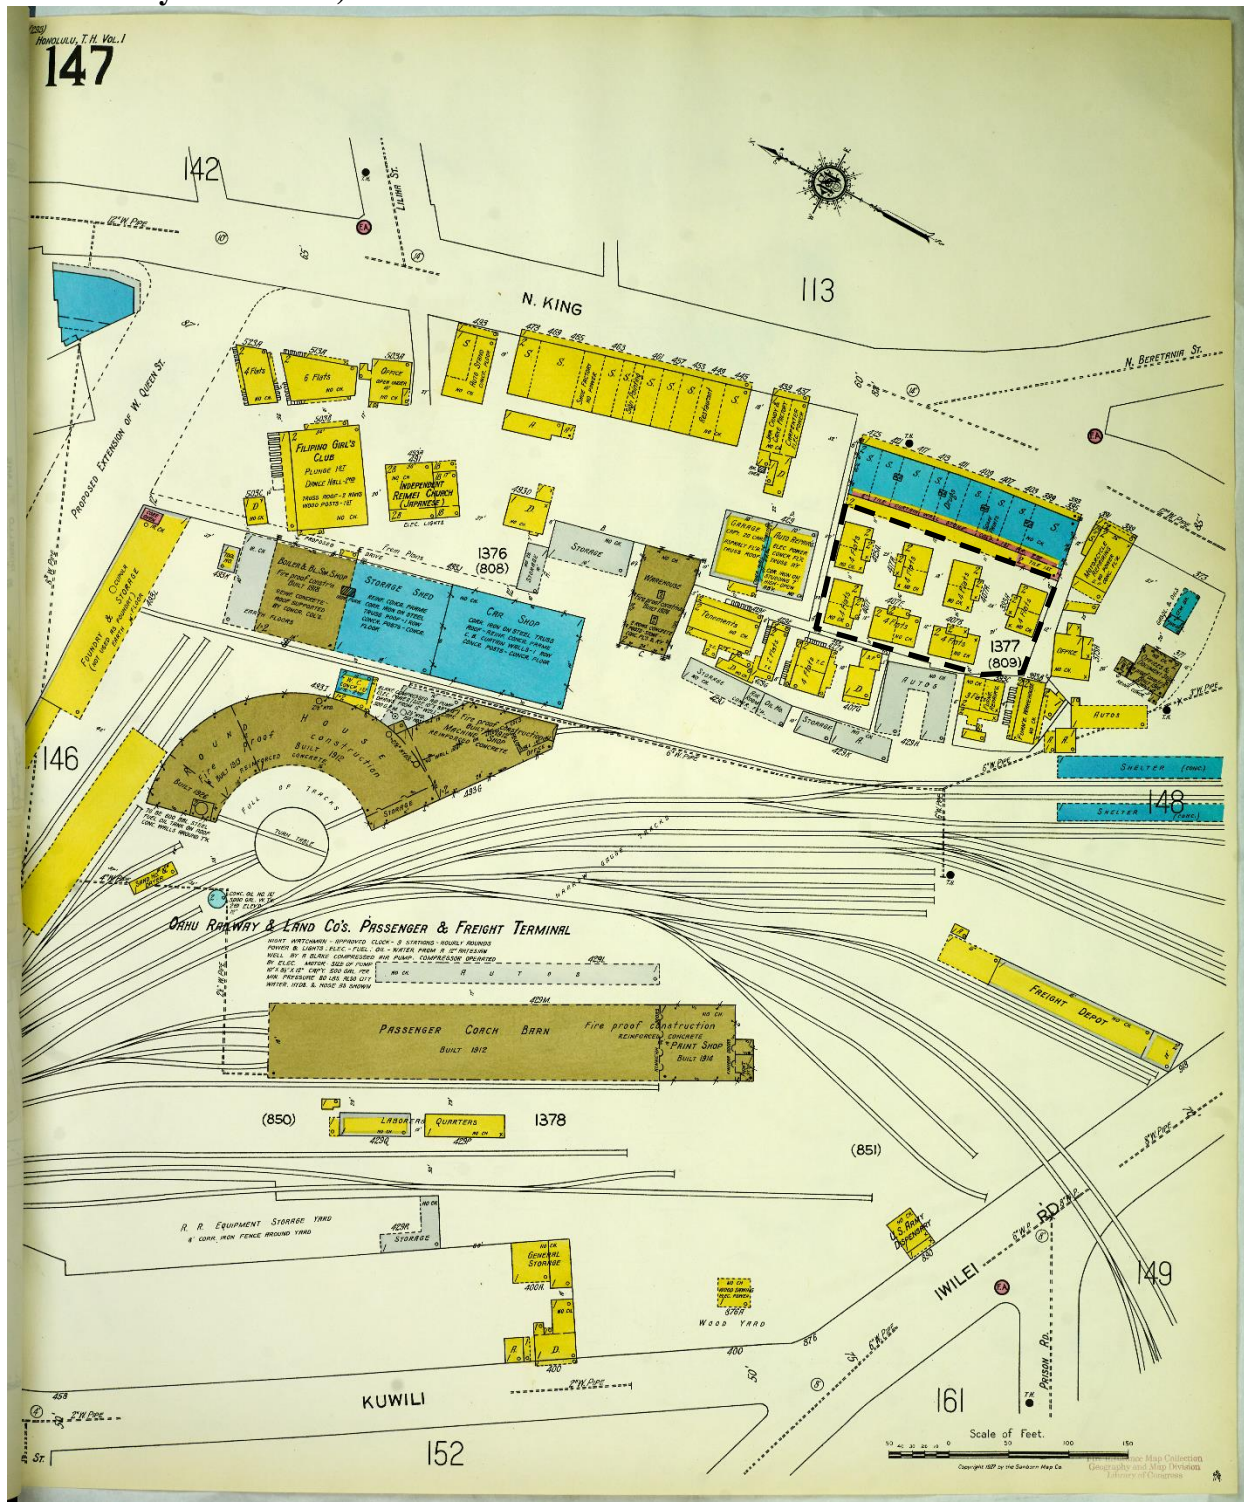
1927 Sanborn Map showing Tenements and their proximity to the OR&L lines (south and west) and the recently constructed Tong Fat Co. Building (east). (Tenement buildings indicated by dashed line)

A 1927 Sanborn maps shows that in just in the blocks bordered by North King Street, Robello Lane, Liliha Street and the railyard, there were nine of these type of housing groups, ranging from single family dwellings to eight unit apartment complexes, the vast majority of which were single-story.⁶ One set of apartments off King Street appear to have been very similar to the buildings behind Tong Fat; they were two-stories, with four apartments each, and had porches in the same configuration as the buildings behind Tong Fat. As shown on Sanborn fire insurance maps, a number of one-story courtyard houses and apartments still stood as late as 1975, though many had been replaced by apartment buildings that were more modern.⁷ Among those that were replaced with new buildings, were the group of two-story apartments off King Street, leaving the Four Houses behind Tong Fat Co. the only surviving apartments of their type in the A'ala/Chinatown area.

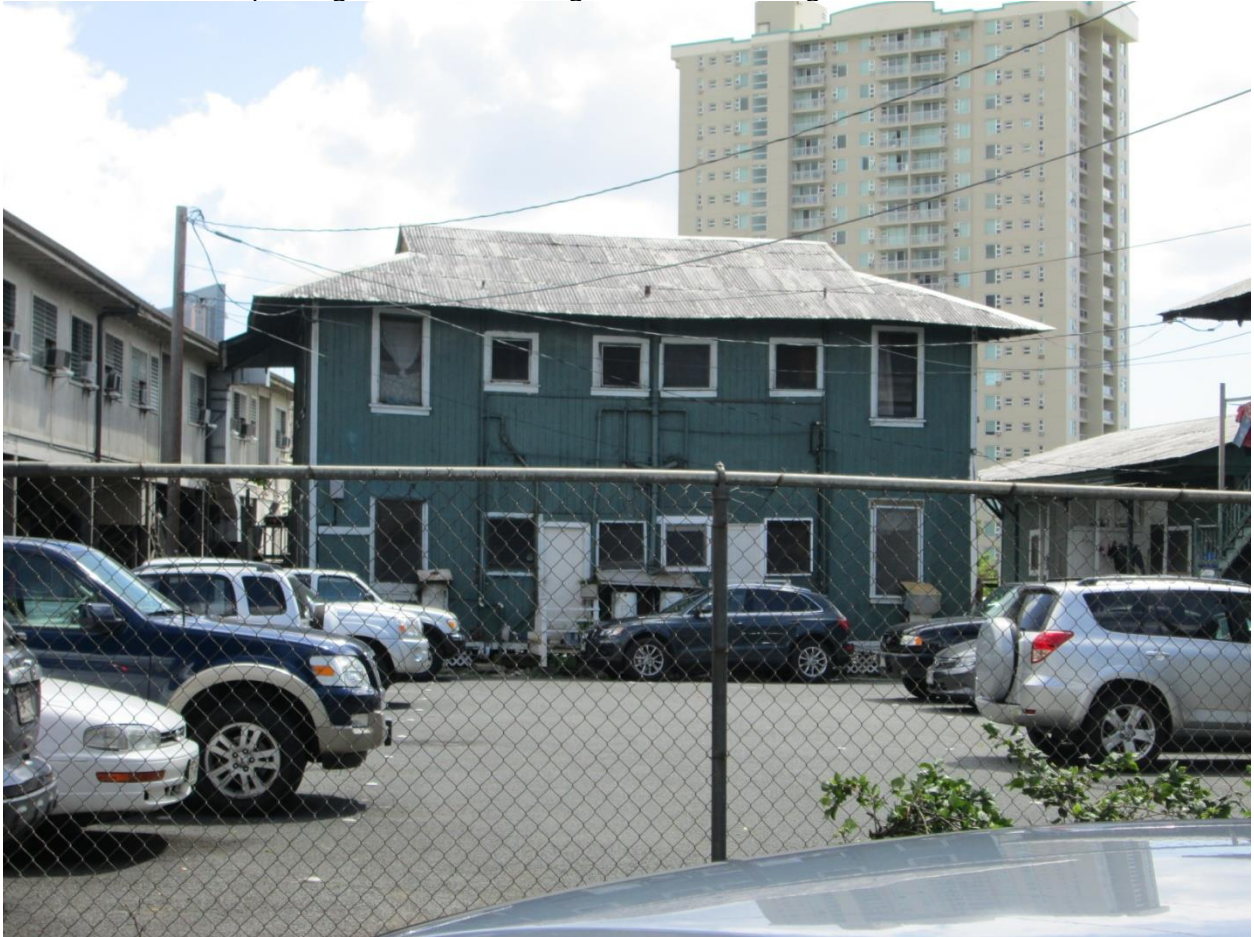
HI_Honolulu County_FourHousesBehindTongFat_0001

1 of 5. Overview of parking area and Building D. Camera facing southeast.

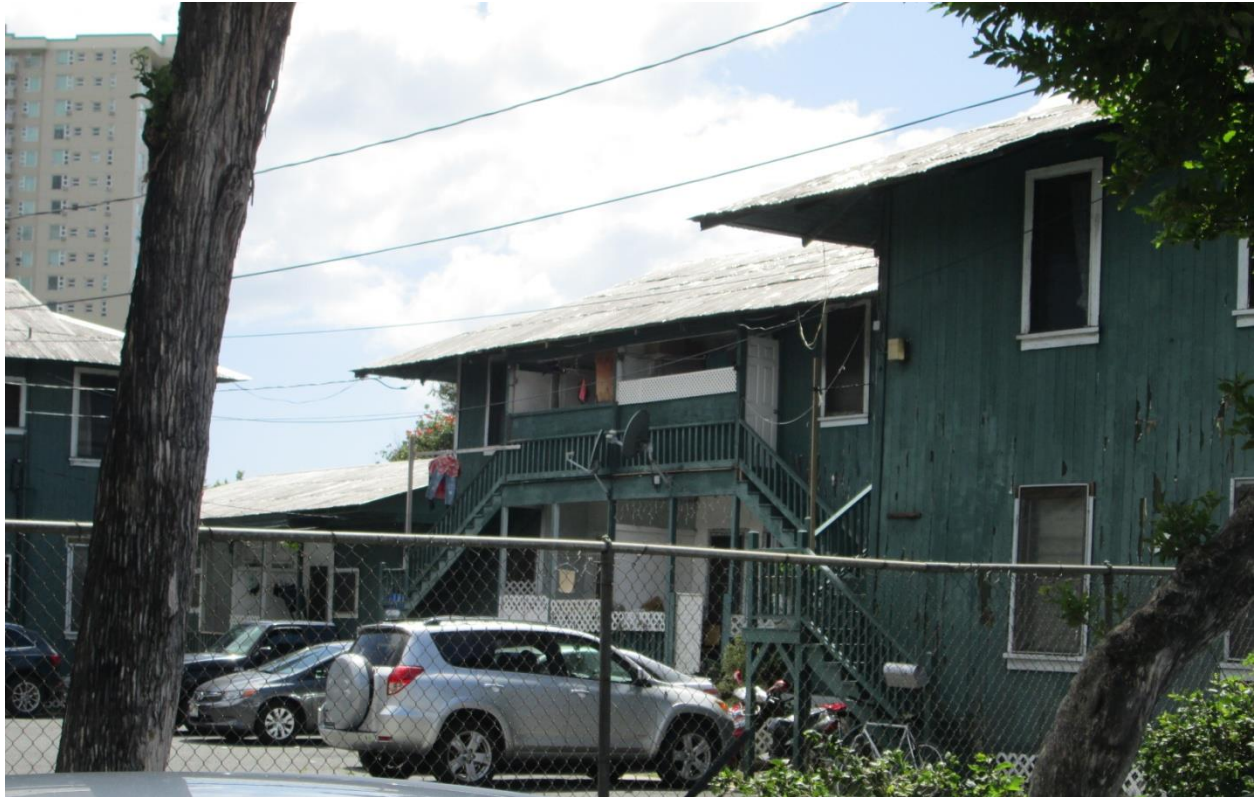
HI_Honolulu County_FourHousesBehindTongFat_0002
2 of 5. Overview of Buildings A, B, and C. Camera facing southwest.

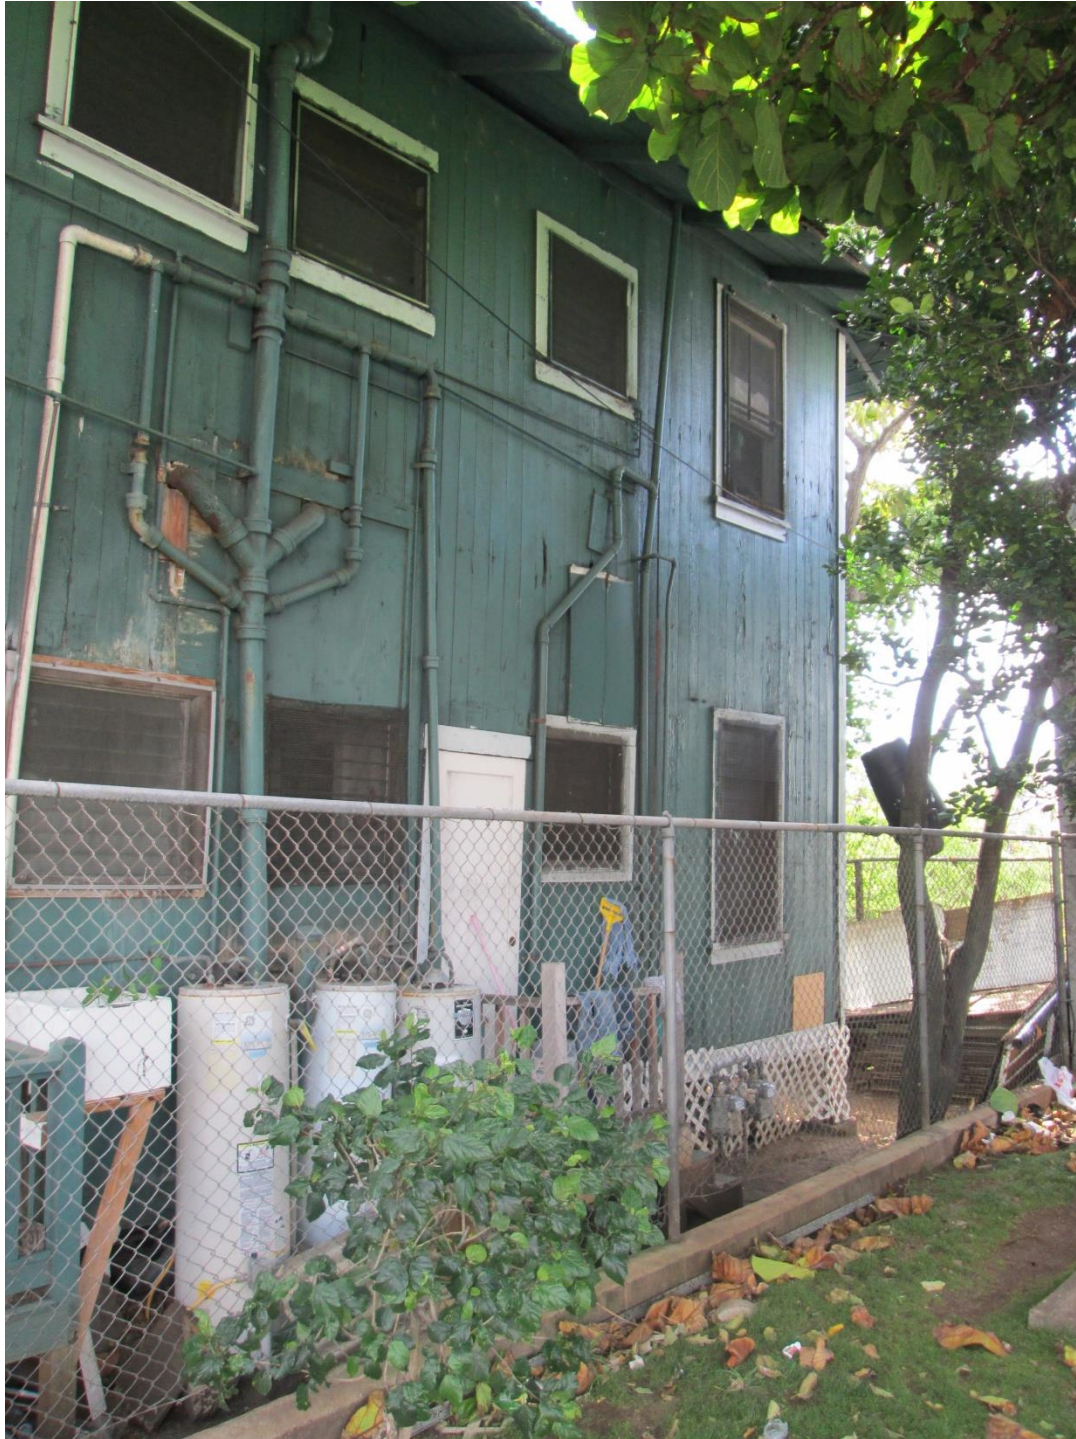
HI_Honolulu County_FourHousesBehindTongFat_0003
3 of 5. Oblique of Building A, camera facing southwest.

The three four-plex buildings (A, B and D) exteriors are identical in design. These two-story structures have gable-on-hip roofs, and front porches that are stacked one above the other. The roofs are clad with corrugated metal panels with wide, projecting eaves. Wood staircases lead to the second floor front entries and first floor rear entries. Concrete stairs with lava rock cheekwalls access the first floor front entrances. Walls are vertical tongue-and-groove wood planks, which extend from the first floor plate to the eaves, with horizontal girts on some side walls where the first floor meets the second. Some portions of the tongue-and-groove walls have been repaired or replaced with assorted types of wood or pressed wood panels. This has

mainly been done at the rear of Building A. On the rear exterior walls, plumbing lines extend vertically from the first to second floor. The fenestration pattern indicates that apartments next to one another within the same building have mirror image floor plans, and the apartments above and below one another have identical floor plans, with the exception of additional rear entry doors at each of the ground floor apartments.

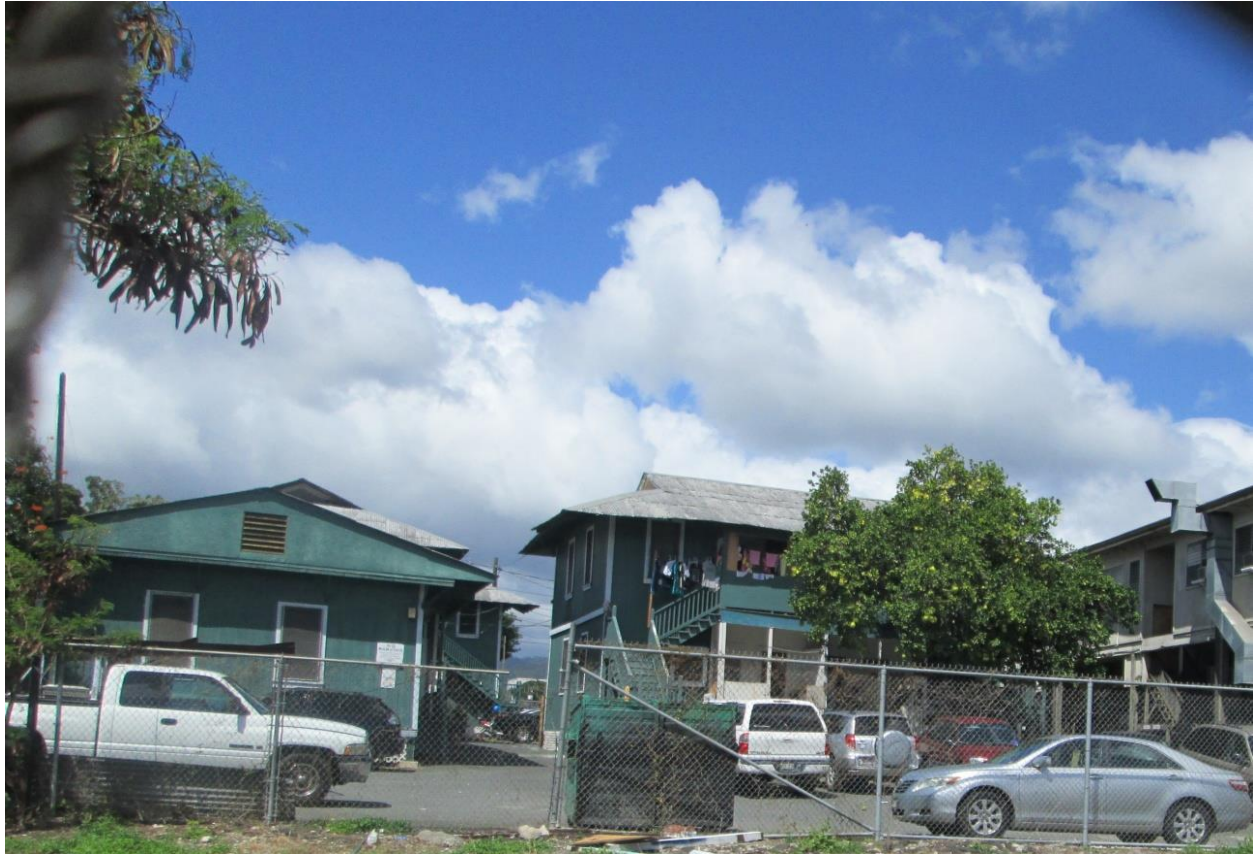
HI_Honolulu County_FourHousesBehindTongFat_0004

4 of 5. Overview of Four Buildings Behind Tong Fat Co.. Camera facing northeast.

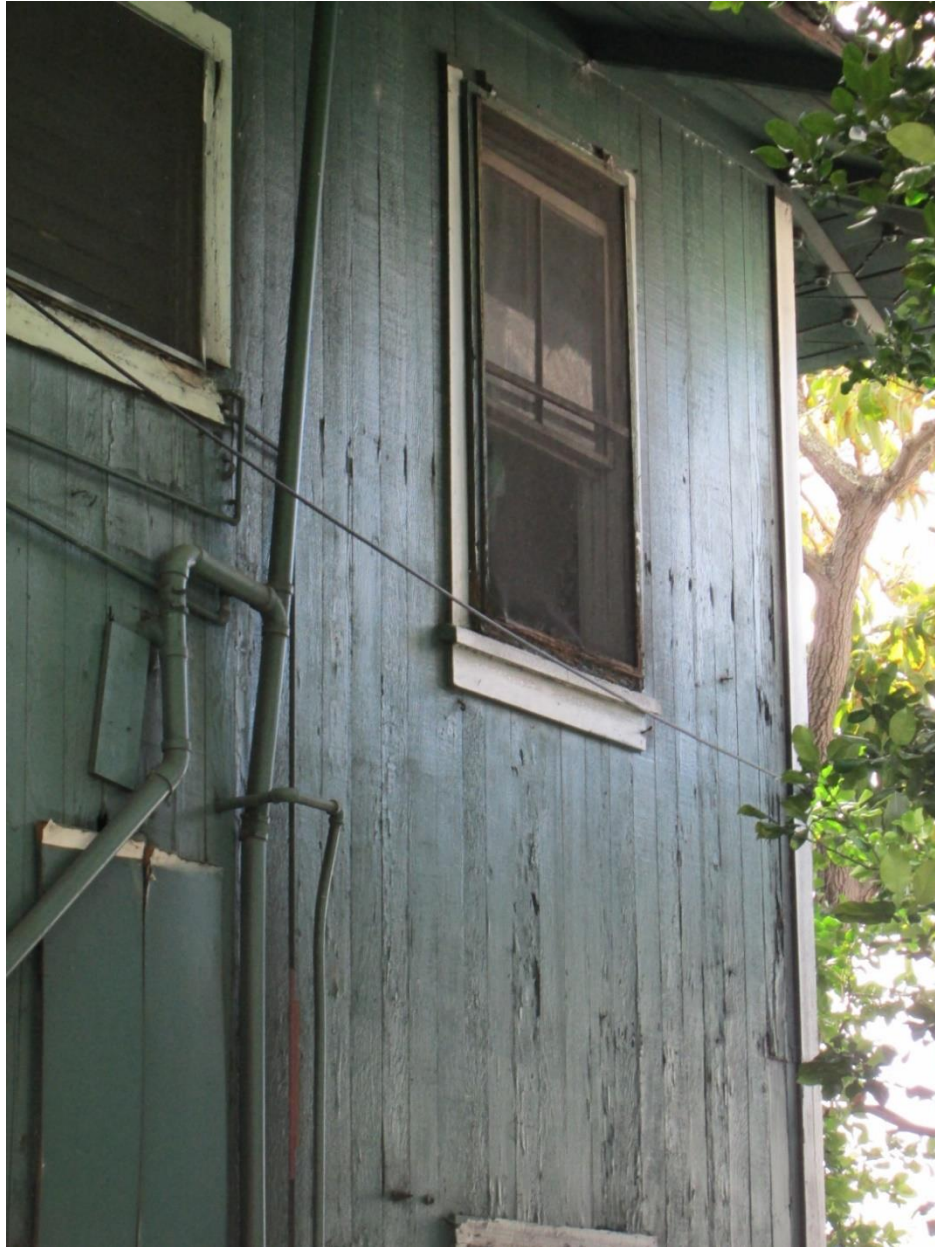
HI_Honolulu County_FourHousesBehindTongFat_0005

5 of 5. Partial elevation detail of Building A showing remaining original window. Camera facing southwest.

The fenestration pattern is the same at Buildings A, B, and D, although the glazing varies, with both historic two-over-two double hung windows and replacement glass jalousies. Window surrounds and aprons are constructed of narrow wood trim pieces. The front of the apartments have two large windows at each level (one at each apartment). At the rear of Buildings A, B, and D, the top and bottom floors have identical sets of window openings. In addition, the windows of the two halves of each building mirror one another, with a larger window closest to the outer edges of the walls, and four smaller windows between them, giving each floor six rear windows, with one large and two small at each apartment. At each level of both sides, are two large windows that are evenly spaced along the wall.

Buildings A, B, and D do not appear to have any significant alterations or additions. The only notable change has been to the windows, where glass jalousies have replaced most of the original two-over-two windows.
