United States Department of the Interior
National Park Service**National Register of Historic Places Registration Form**

1. Name of PropertyHistoric name: Russell and Jacqueline Jensen ResidenceOther names/site number: La Pietra Condominium Unit 17

Russell and Jacqueline Jensen Residence
Name of Property

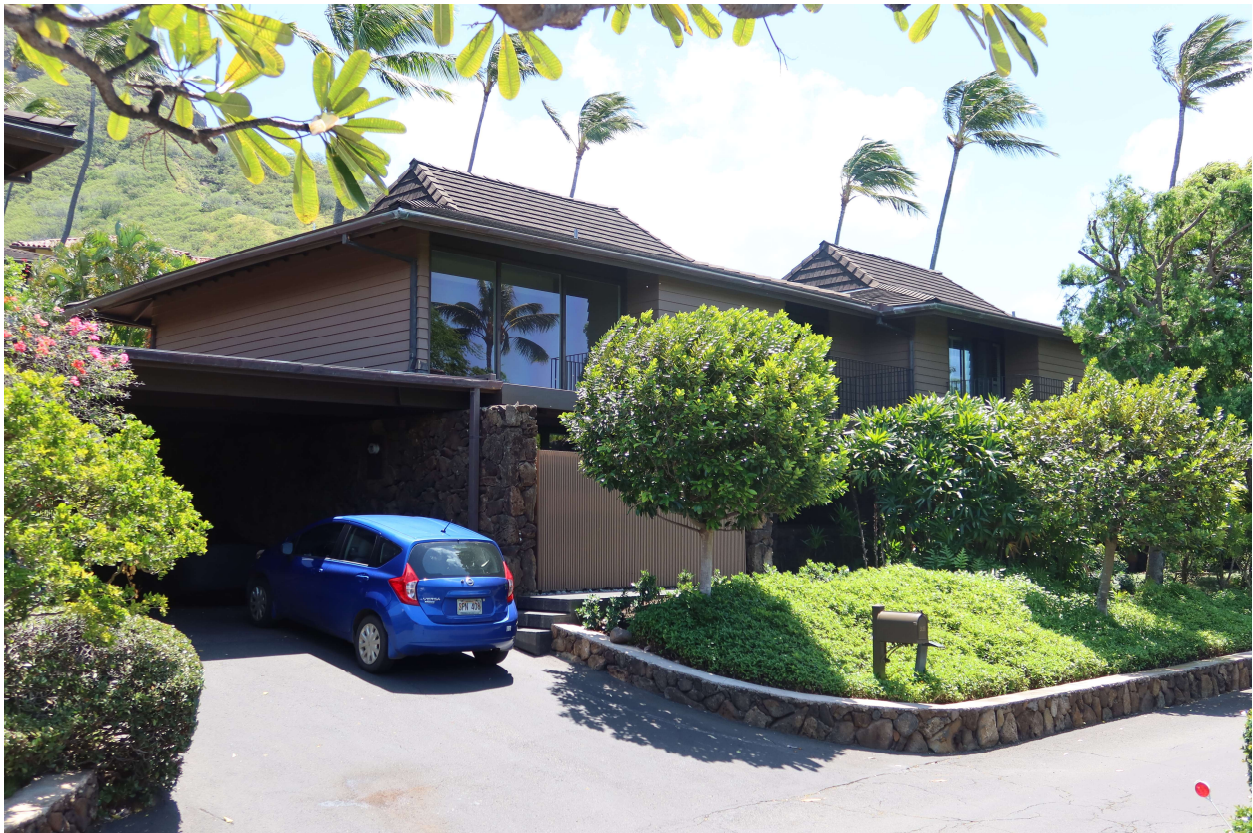
1 of 14

View of the front the duplex, unit 17 in the foreground, from the northwest

The balanced, asymmetric façade of the unit is two bays wide with three projecting, 8' high lava rock walls demarcating the bays, with a wall extending out from each corner of the unit and another from the middle. The left bay has at the ground level a pair of sliding doors flanked by single pane fixed windows. The doors lead out to a flagstone paved lanai, which is screened from the street by a vertical slat fence.

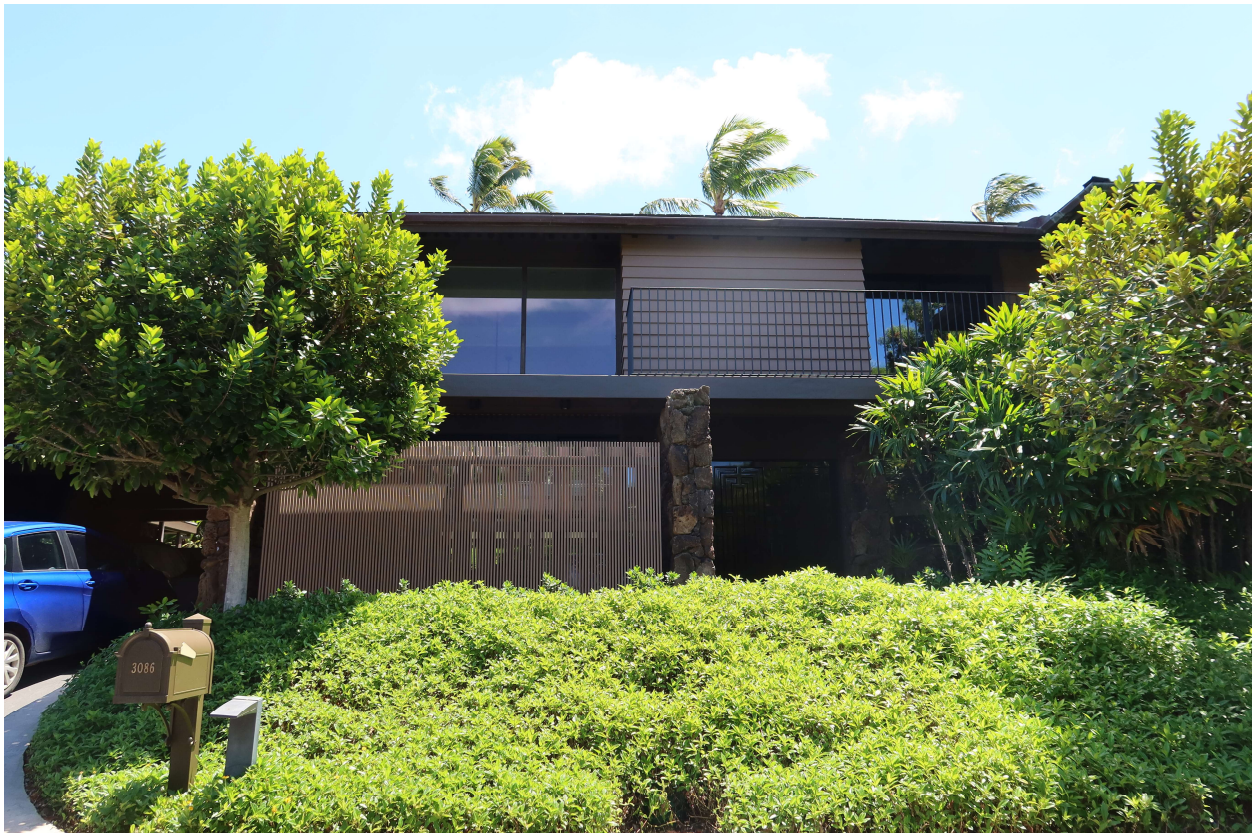
2 of 14

View of the front of unit 17 from the west

The right bay contains the right-of-center entry as well as a pair of single pane sliding windows. The entry is framed by the center projecting wall on its left side and a lava rock pilaster on the right. The windows, like all windows and exterior sliding doors in the townhouse complex, are bronze anodized aluminum, and if not original, replaced the originals in-kind. In front of the windows grow lady palms (*Rhapis excelsa*). The entry lanai's floor flows out to the sidewalk and utilizes the same type of pavers. A projecting second story balcony runs cross the unit's facade.

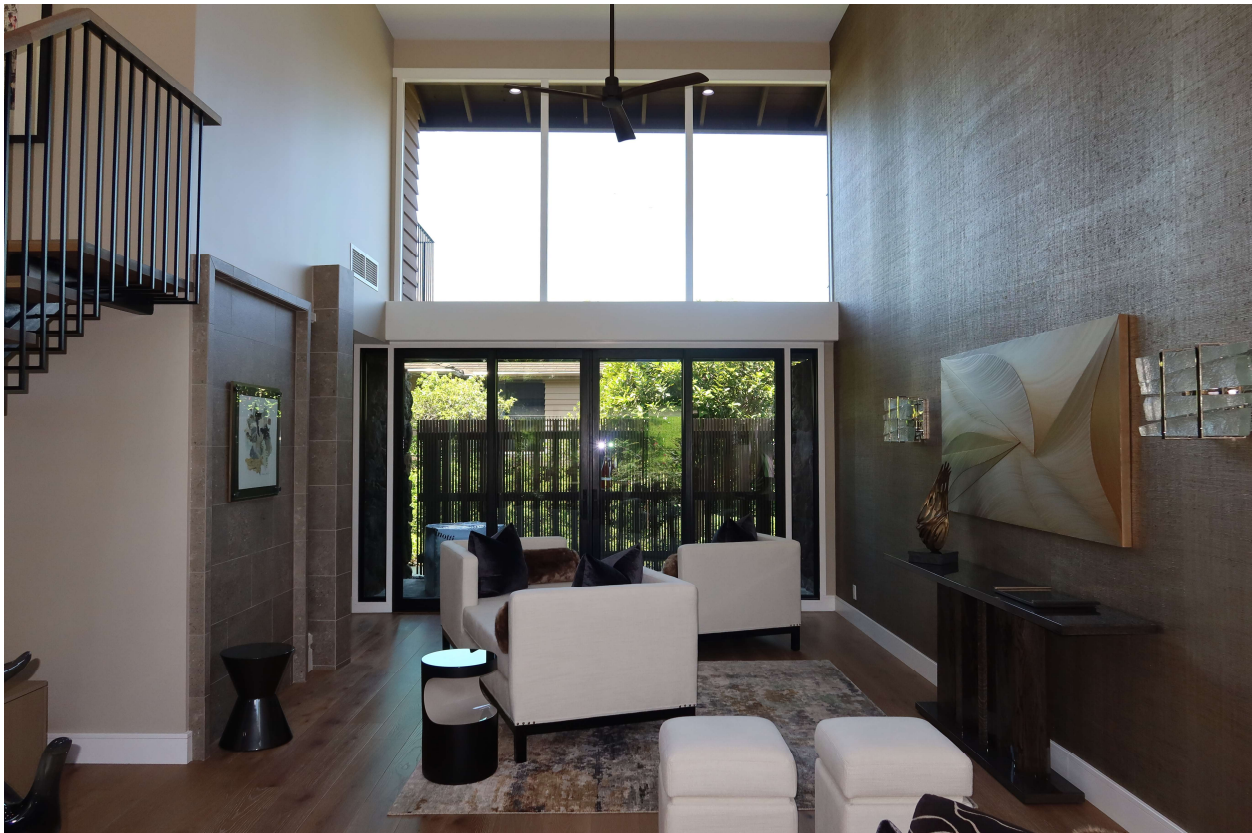
3 of 14

View of the living room front windows and doors from the east

An 8' high opening on the foyer's north side flows into the living room. The living room has a two story, 17' high ceiling with three historic open beams. In the front wall, a pair of 8' high, single pane sliding doors, which are flanked on either side by a fixed single pane window, open on a front lanai. A door in the living room's west wall opens on a laundry room, and a door, in the living room's south wall, adjoining the laundry room door, opens on a former first floor bedroom, which now serves as an exercise room. Immediately opposite the entry to the room, a pair of sliding doors opens on a closet. The exercise room has a set of three non-historic bronzed anodized, aluminum windows in its west wall, with the center window fixed and the other two casement. A door in the east wall of the room opens on a bathroom which has been completely remodeled. The room's two historic, exposed ceiling beams remain intact.

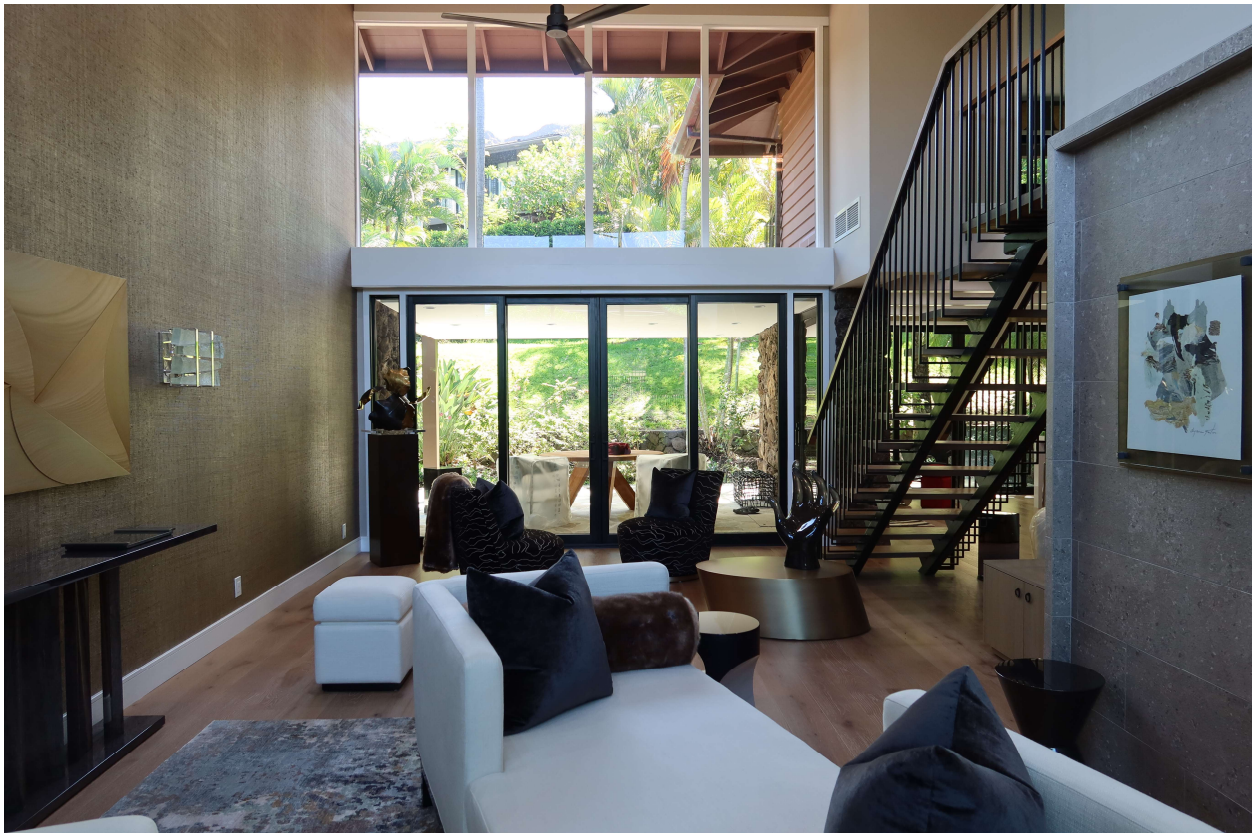
4 of 14

View of the living room from the west

The rear, east, wall of the living room features a pair of 8' high, single pane, sliding doors flanked by single pane fixed windows on either side. These doors and windows are surmounted by four, single pane fixed windows. The doors lead out to a rear patio.

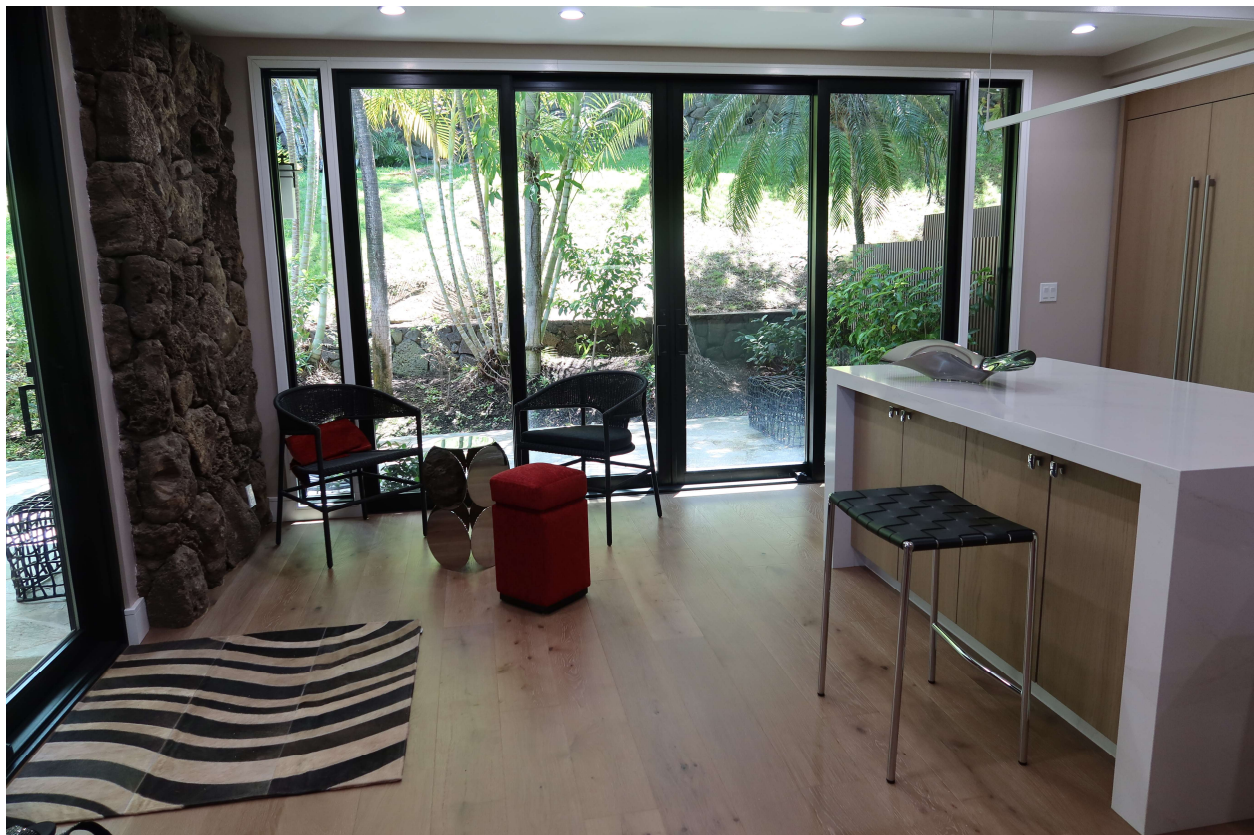
5 of 14

View of the dining-kitchen, from the west

An original lava rock column marks the south terminus of the living room's rear wall, and to its southeast is the dining area and kitchen. The dining area has an 8' high ceiling. The kitchen has been remodeled and wraps around the south wall and west walls and has an island counter. The north wall of the dining area is of lava rock and has a pair of 8' high single pane sliding doors,

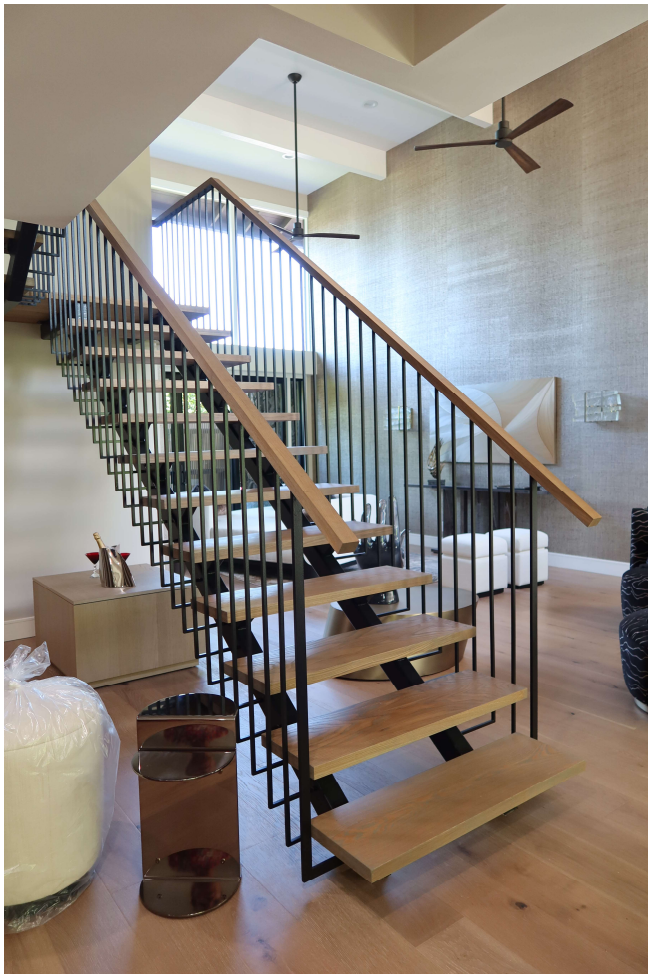
6 of 14

View of the stairs and living room from the dining area from the southeast

A modern stair with a wood hand rail and a round metal rod balustrade accesses the second floor and its bedroom, office and bath. The white oak treads are floating and there are three balusters per tread. The dogleg stair is not original, but is in the original location and follows the design of the original in new materials. It has twelve steps ascending to a landing from which three additional steps go up to the second floor. The stair opens on a front-to-rear running hall which overlooks the living room on its south side. The hall's floor is white oak, which is found throughout the second floor, except in the bathroom. The hall's ceiling is 7'- 11" high, and the handrailing along its north side follows the design of the stair's balustrade.

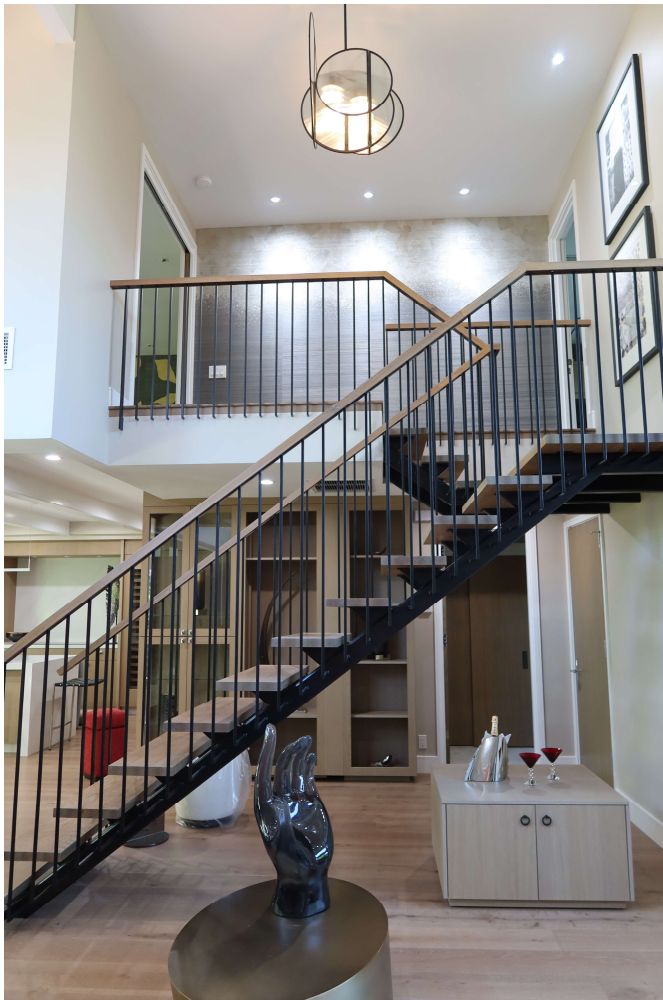
7 of 14

View of the living room stair and second floor hall from the north

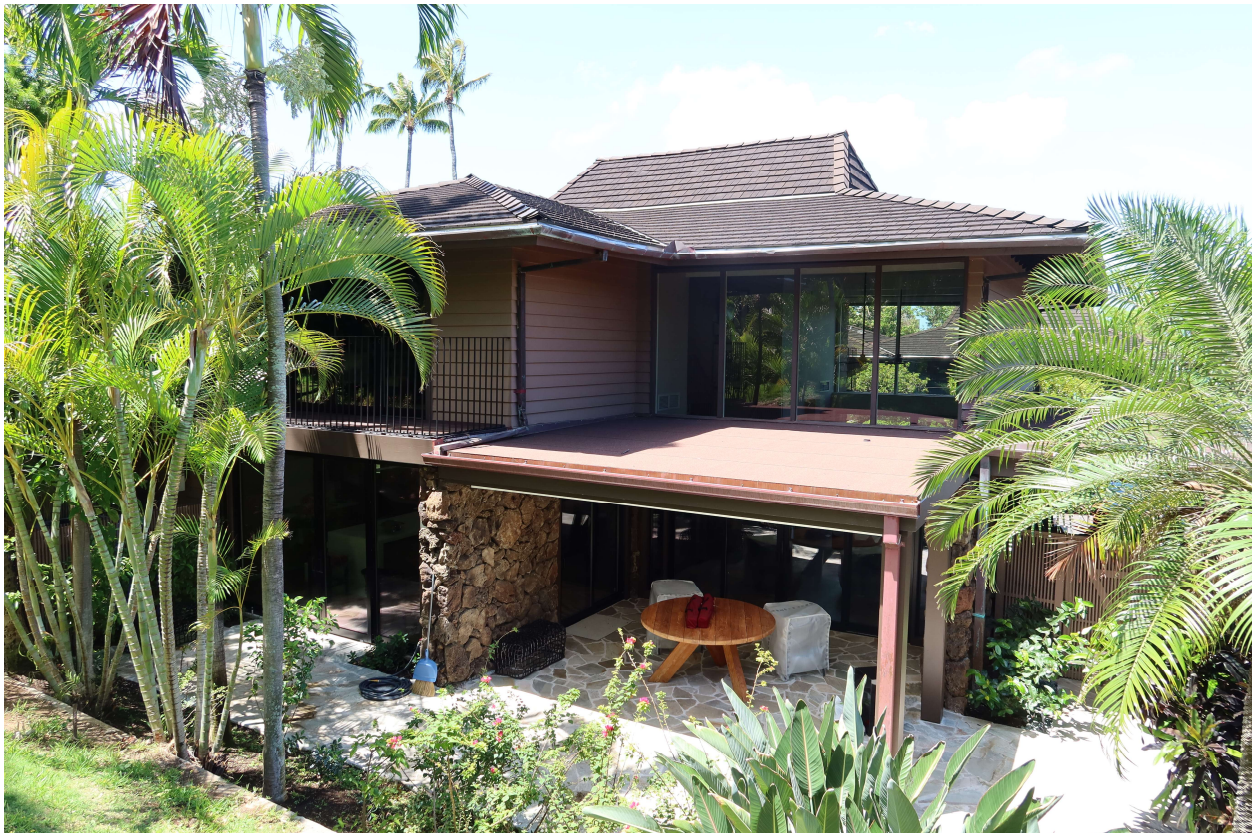
8 of 14

View of the rear from the northeast

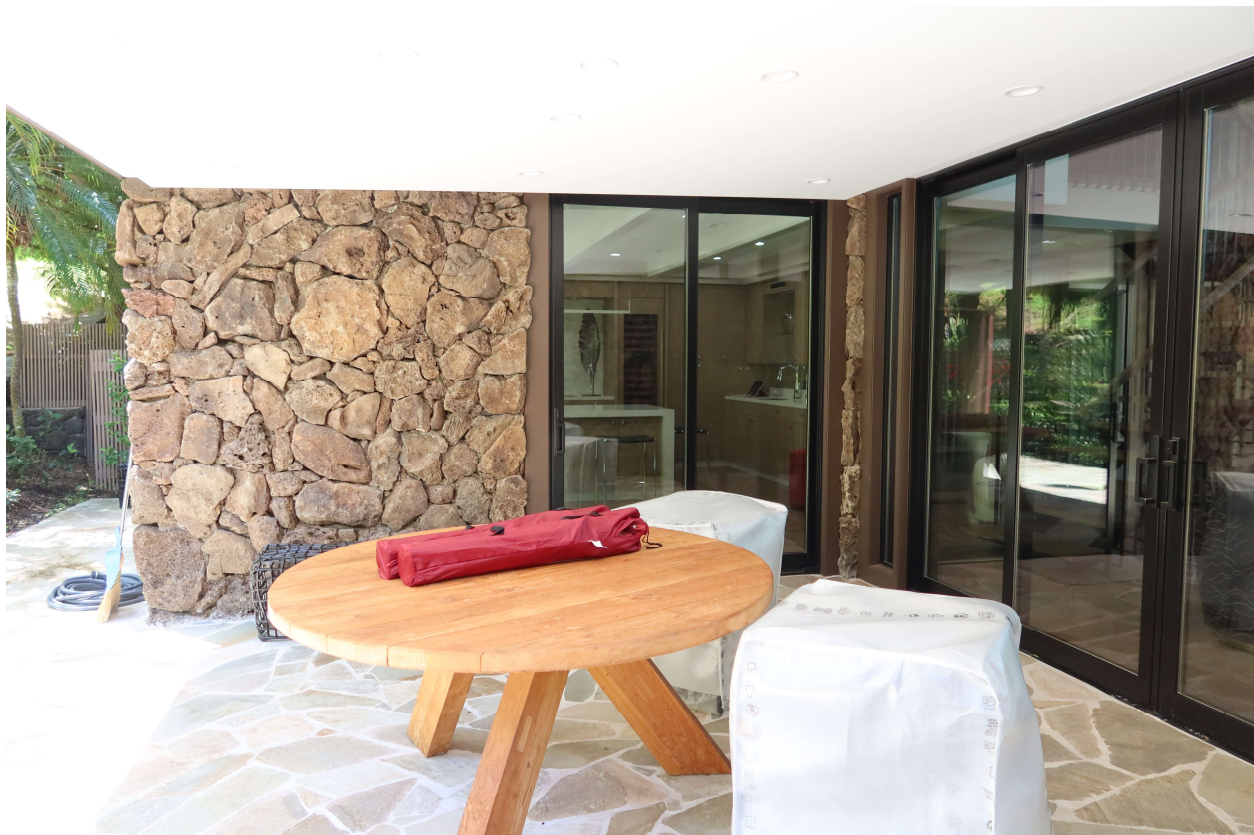
9 of 14

View of the lanai from the north

The covered lanai has a tar paper covered, flat roof, with two 8" x 8" wood columns supporting its north edge and corner. The lanai and patio are flagstone paved, with the patio flowing out into the back yard and in front on the kitchen/dining room's rear doors. The patio is squared off at its outer edge and beyond it is a garden area which runs along the rear edge of the unit's backyard. The planted area contains a variety of tropical plants including areca palm (*Chrysalidocarpus lutescens*), a coconut palm (*Cocos nucifera*), a Manila palm (*Veitchia merrillii*), bougainvillea (*Bougainvillea sp*), bird of paradise (*Strelitzia reginae*), ixora (*Ixora casei*), croton (*Codiaeum variegatum*), and two pygmy date palms (*Phoenix rebelenii*). At the rear of the planted area is an approximately 20" high lava rock retaining wall, and beyond the wall the ground slopes upward and is planted in grass. A balcony projects from the dining-kitchen area's rear wall and is supported by the lava rock walls extending from the rear of the unit. On the back yard's south side a 6' high wood slat fence demarcates the boundary with the neighbor, while a similar fence is at the south end of the yard. The latter wraps around the west side of the yard and separates the yard from a carport shared with unit 16. A gate in the fence accesses the carport. The two car carport has a flat roof and lava rock walls to either side.

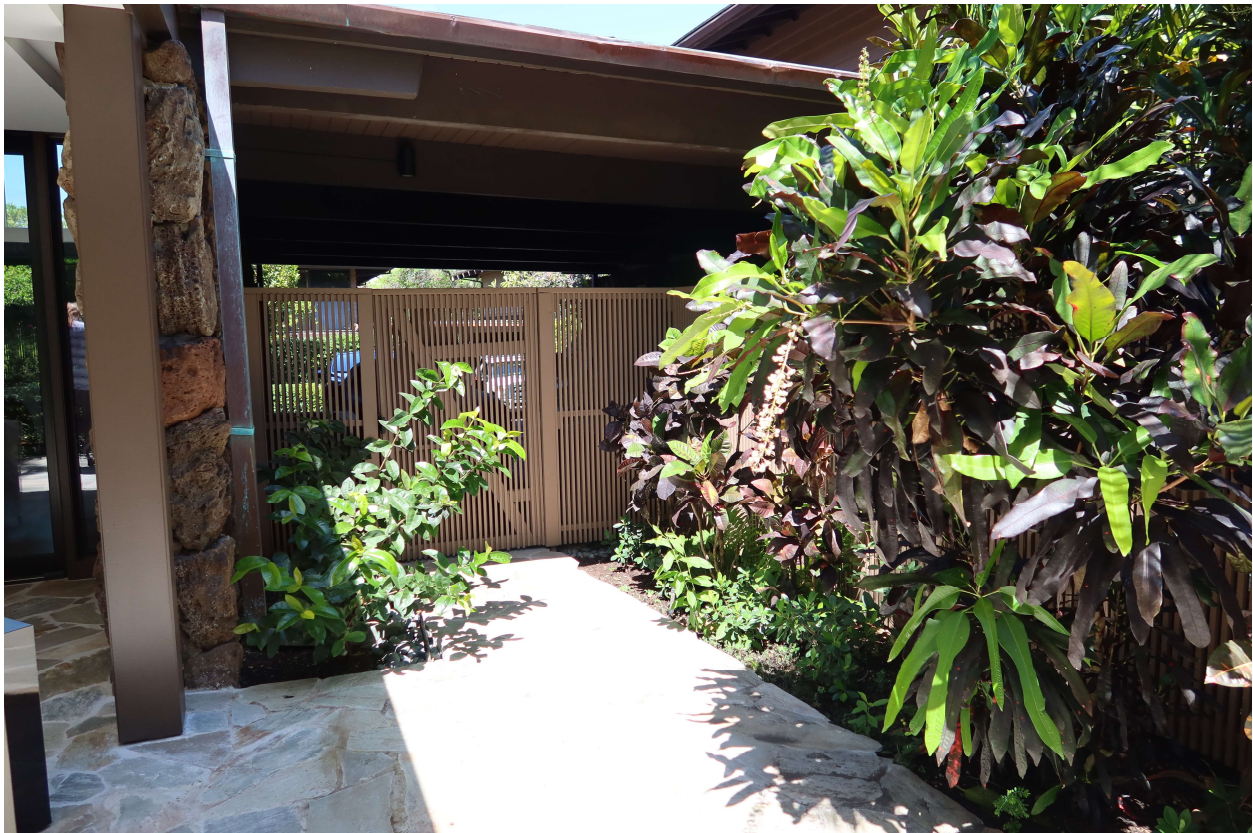
10 of 14

View of the access to carport from the east

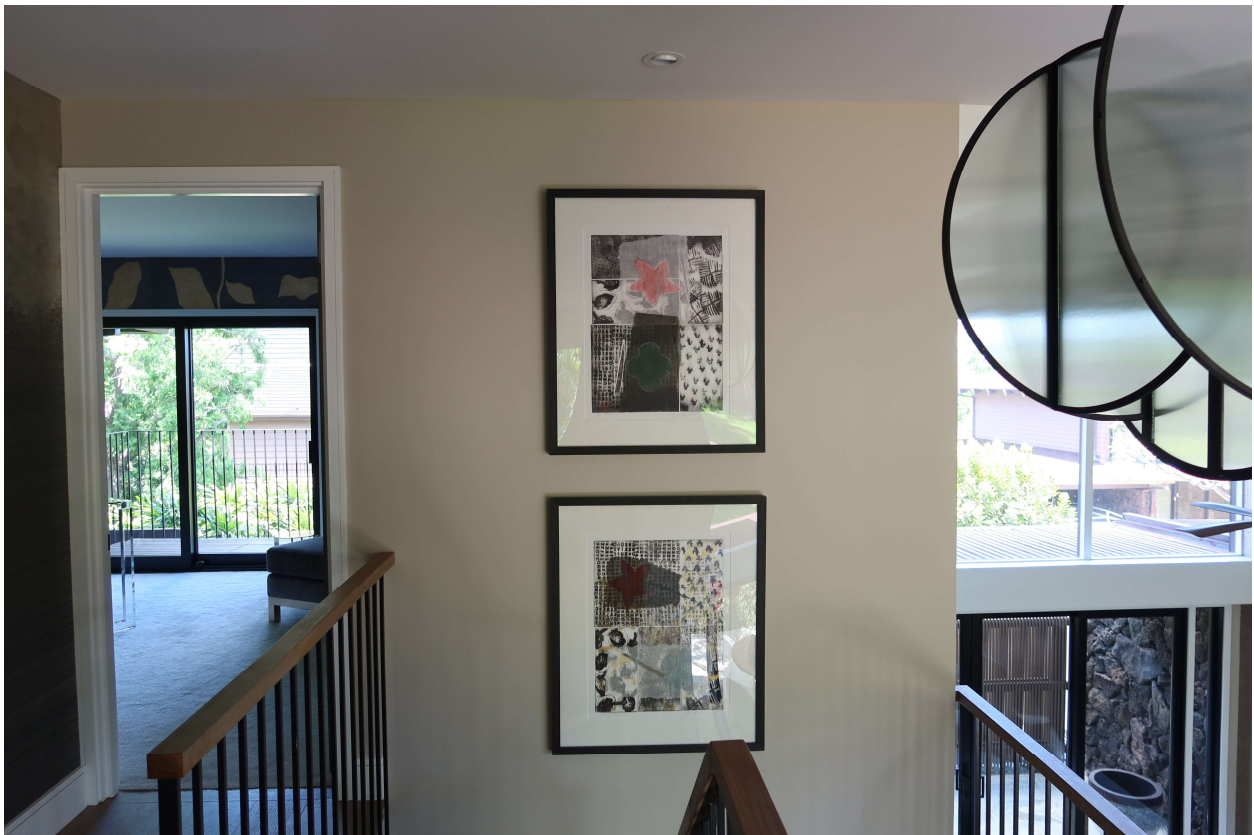
13 of 14

View of the second floor hallway with front office and living room windows in background from the east

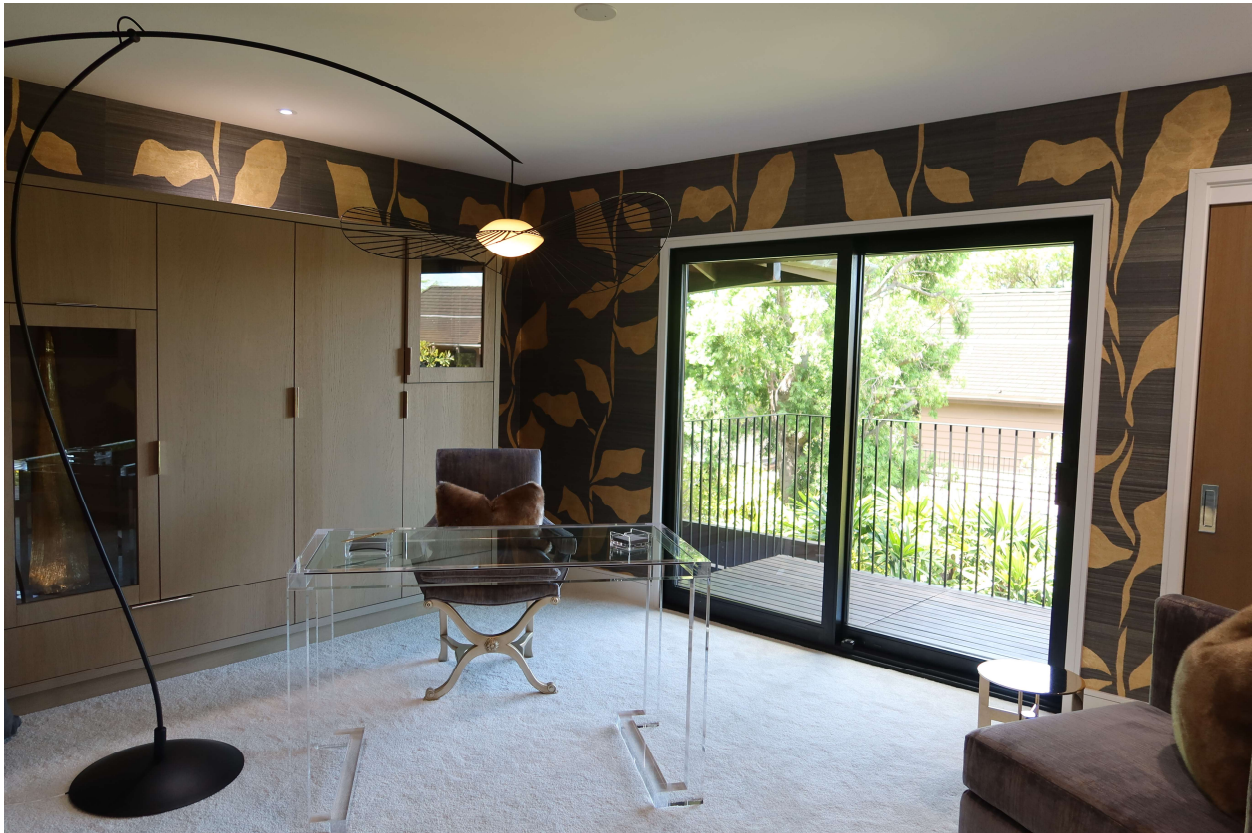
14 of 14

View of the second floor front office from the northeast

A door at the east terminus of the hall opens on the former front bedroom, which has been converted into an office. In the office's west wall is a pair of 7' high, single pane sliding doors. The doors lead out to a 52" wide balcony which has a wood slat floor and a 44" high metal railing. It runs the length of the office, and the front wall of the unit jogs near the north end of the balcony to accommodate an interior closet. A pair of sliding doors in the office's west wall services that closet. An opening in the north wall of the office flows into a remodeled bathroom with marble walls and floor.
