National Register of Historic Places Registration Form

Historic name: Martin J. and Mary Condon Residence

Street & number: 3011 Vista Place

City or town: Honolulu State: Hawaii County: Honolulu

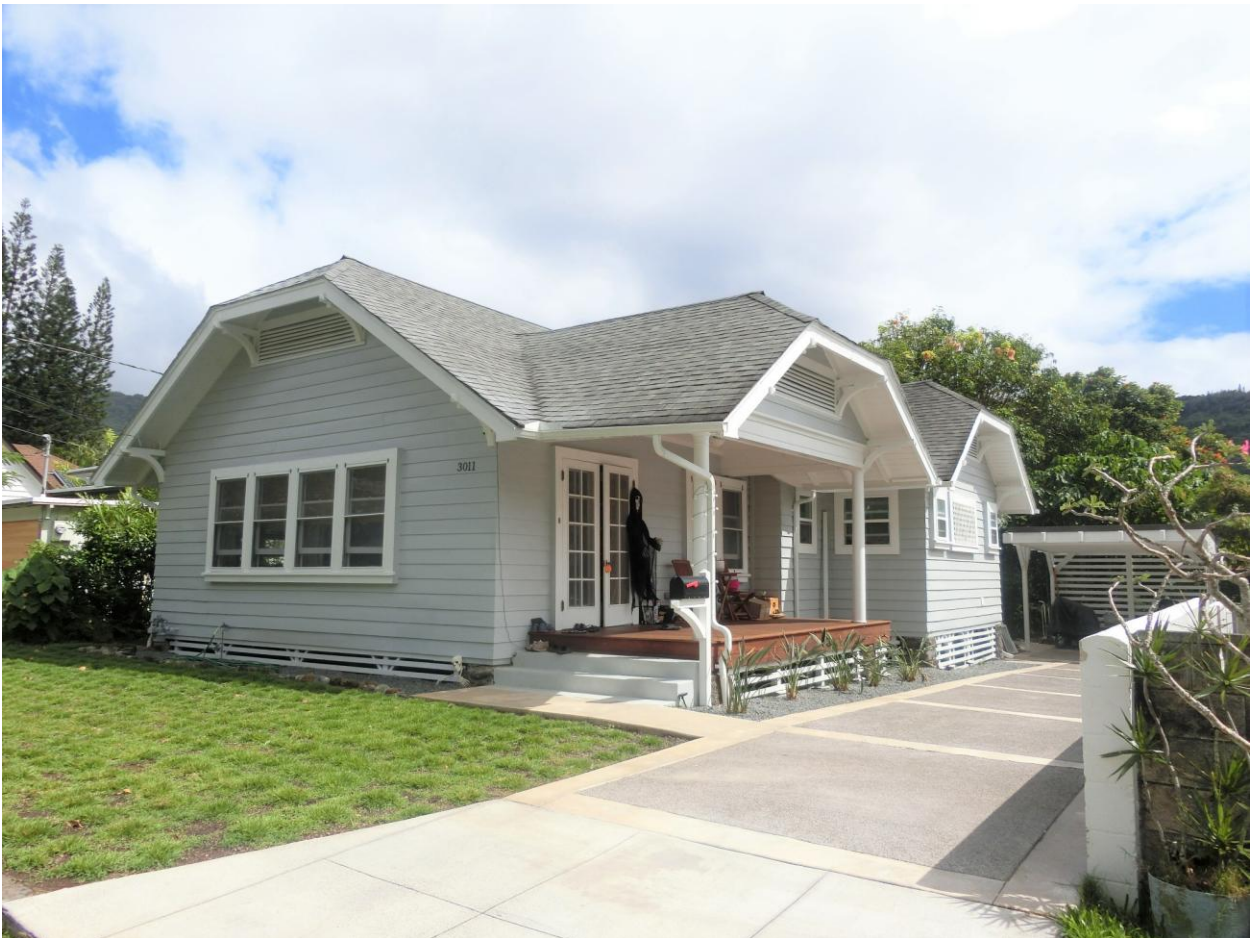
1 of 9

View of the house from the west

The Martin J. and Mary Condon Residence is situated in a quiet residential neighborhood on a short, dead end street, Vista Place, in Manoa valley. It sits on a small, level, 4,654 square foot lot with a lawn on all four sides. The single story, bungalow style dwelling's lateral running composition shingled, clipped gable roof runs perpendicular to the street, and features brackets, overhanging eaves and exposed rafter tails. The house is distinguished by two projecting porches, one open and one enclosed, on its front, southwest facing, side. Both of these porches have clipped gable roofs. The single wall, double board house sits on a lava rock and post and pier foundation with a horizontal slat apron, and has 7" wide horizontal lap sided walls. The 1,200 square foot house is in good condition and very much retains its integrity of design, materials, workmanship, location, setting, feelings and associations.

The Condon residence is a good example of a bungalow from the 1920s built in Honolulu. It differs from the typical bungalow of the period by its use of clipped gable roofs, both on the main body of the house and also its two projecting porches. The orientation of the house, with its façade facing the side of the lot rather than the street is also distinctive and not very commonly seen in Honolulu. Another unusual feature of the house is the placement of the "front" and "rear" porches adjacent to each other. Also the use of Tuscan columns elevates the house above the typical bungalow form, which often employed battered or paneled columns. However, the dwelling's projecting porches with their front facing clipped gable roofs and figure four brackets, as well as the use of local lava rock in the foundation are all typical of the bungalow style, and readily convey the style to the passerby. Similarly the roof's open,

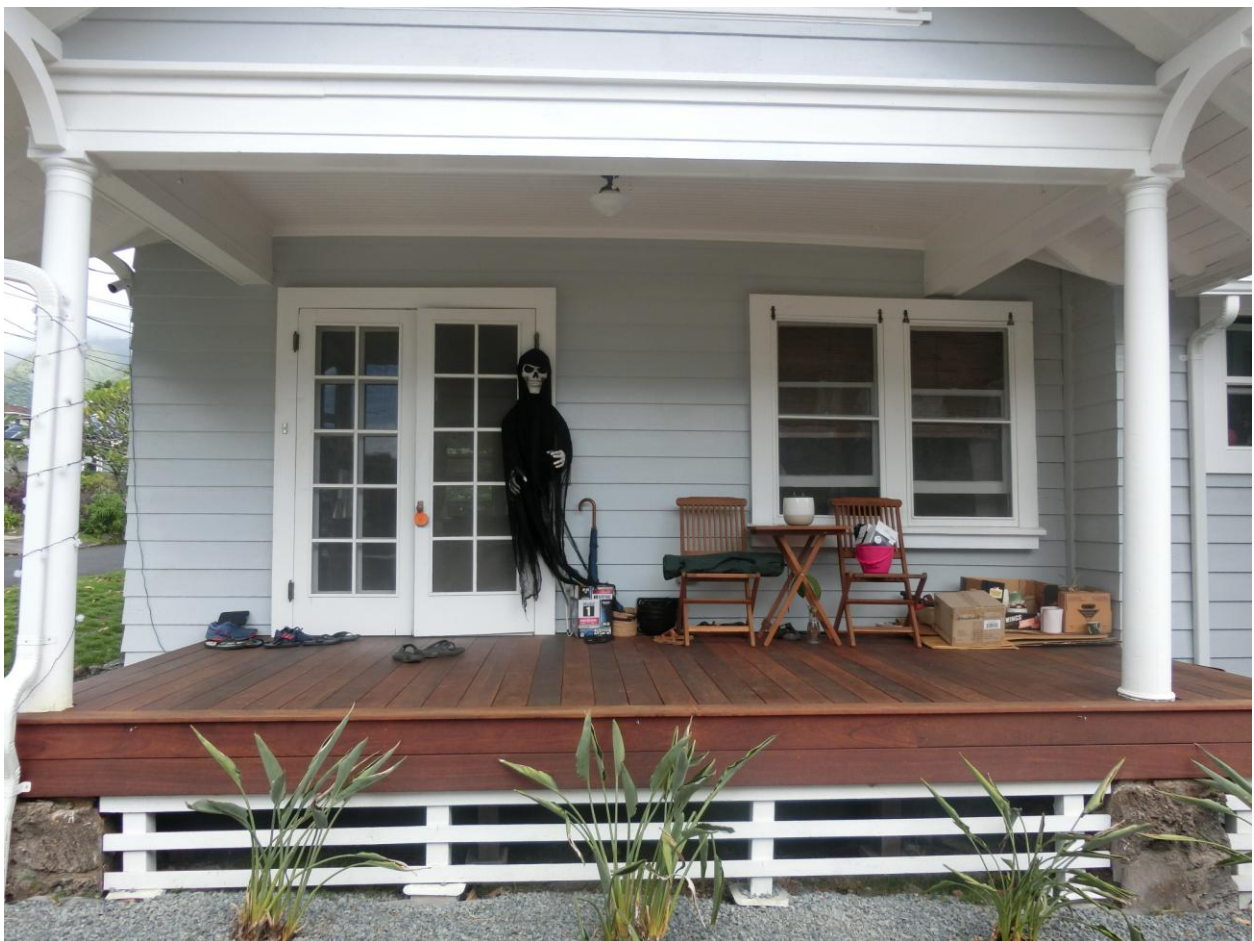
2 of 9

View of the front porch from the southwest

Here three concrete steps access the northwest, street, side of the front porch. The 8' x 18' porch has no balustrade but Tuscan columns support its two outside corners. The porch is 27" above the ground and has a tongue and groove floor and ceiling. The floor boards run front to back, while the ceiling boards run laterally. The rear wall of the porch has a pair of entry doors to the left and a pair of 1 x 1 double hung sash windows to the right. The screen and entry doors are both intact. Each of the entry doors has ten lites and both retain their original glass knobs and hardware.

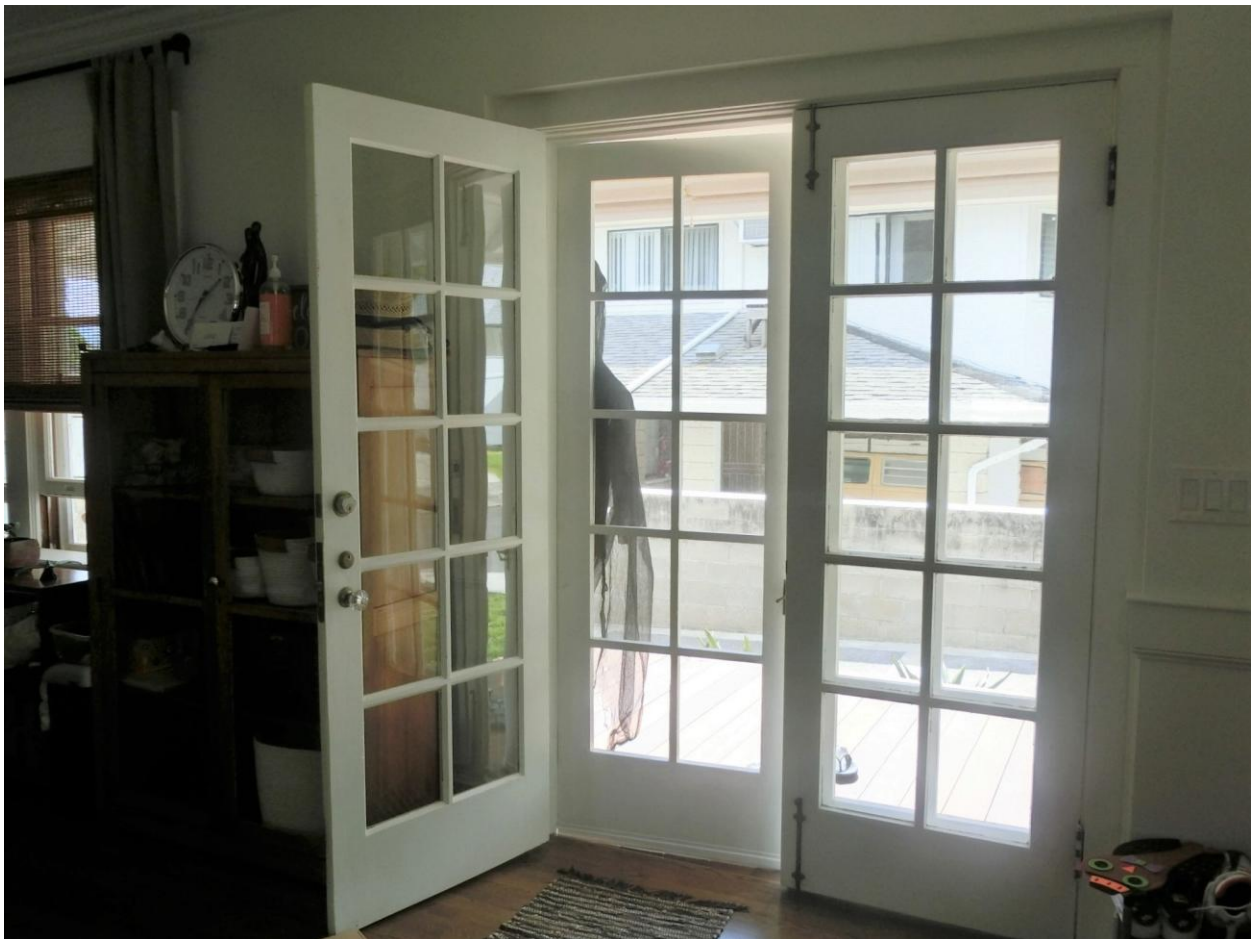
3 of 9

View of the front doors from the north

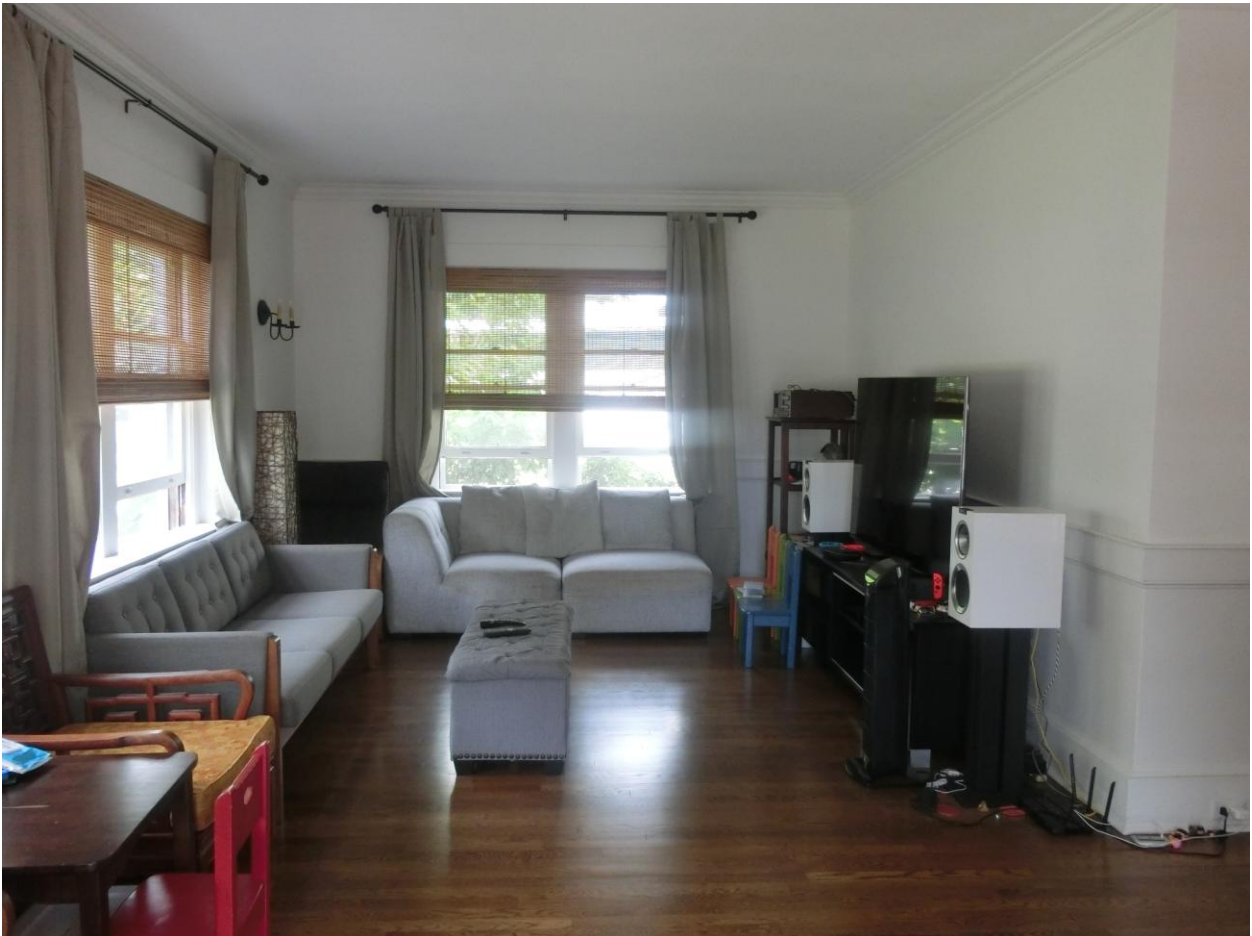
4 of 9

View of the living room from the southwest

The entry doors lead into an L shaped living-dining room. The living room space runs the entire length of the northwest side of the house, while the dining area runs partially across the front of the house. The two spaces have a 9' high gypsum board ceiling and oak floors with 9" high baseboards. The room has paneled walls which terminate with a simple crown molding. A band with a 1" x 1.5" rail runs around the room, 38" from the floor, providing the wall with a wainscoted appearance. The northwest facing wall has a set of four 1 x 1 double hung sash windows facing the street, and a pair of similar double hung sash windows is in the northeast wall. New sconces supporting a pair of "candles" graces the wall on either side of the bank of four windows. Another pair of 1 x 1 double hung sash windows is in the front wall of the dining space.

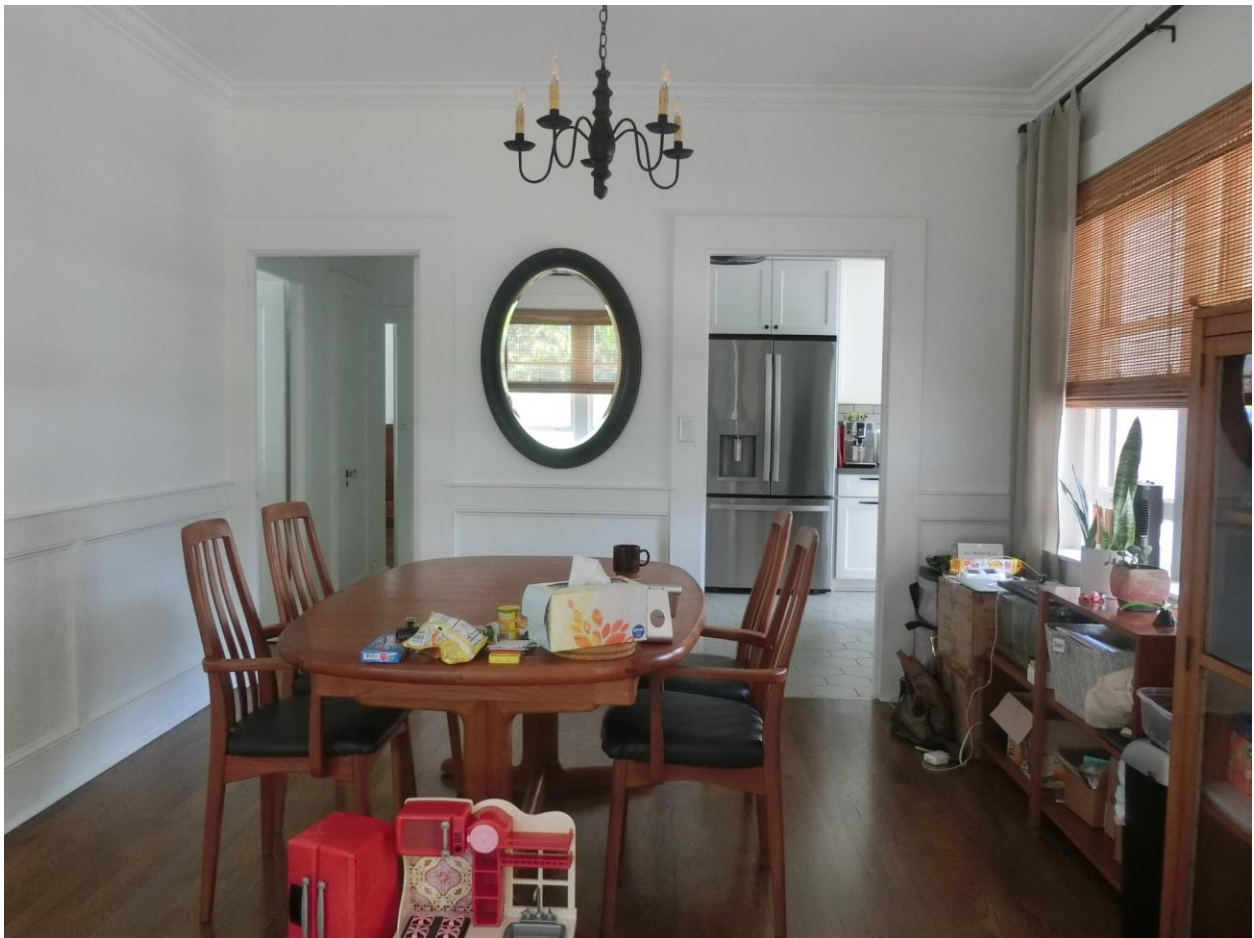
5 of 9

View of the front door and dining area from the northwest

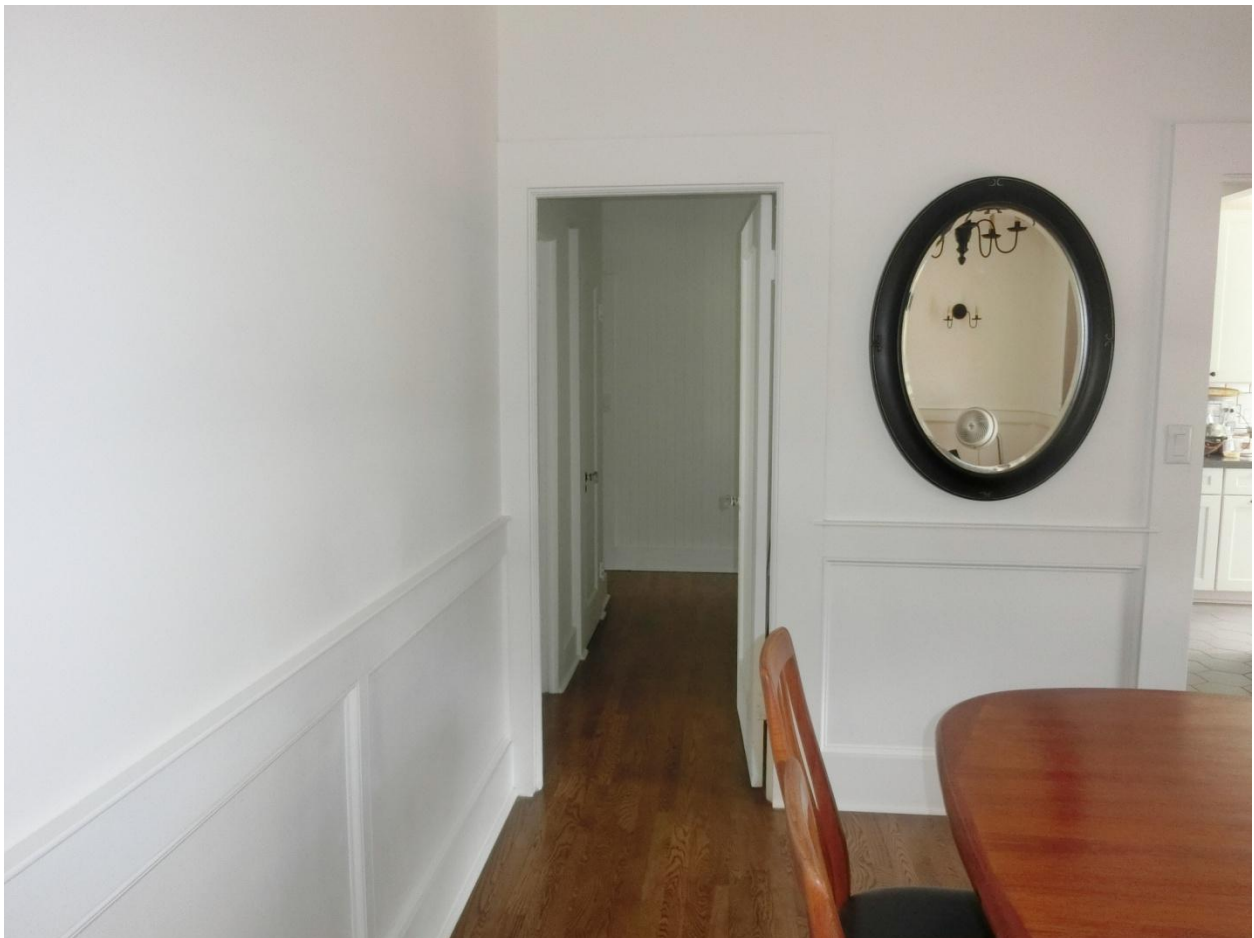
6 of 9

View of the hall from the northwest

The lateral running hallway terminates in a T at its southeast end. Doors open on each of the three bedrooms, the bathroom and the kitchen. The hall has an oak floor, v-joint tongue and groove walls and a gypsum board ceiling. A simple crown molding, similar to that in the living-dining room, mediates the wall-ceiling transition. There are two doors in the northeast wall of the hallway. The one furthest from the living-dining room has a historic glass knob and opens on the hall linen closet. The door closest to the living room opens on a bedroom. This room has oak floors, as do all the bedrooms. Also, it has v-joint tongue and groove walls and ceiling, and features a picture rail running around the four walls of the room. The other two bedrooms also share these same features. The room's closet door has its original metal knob. A pair of original 1 x 1 double hung sash windows are in its northeast wall.

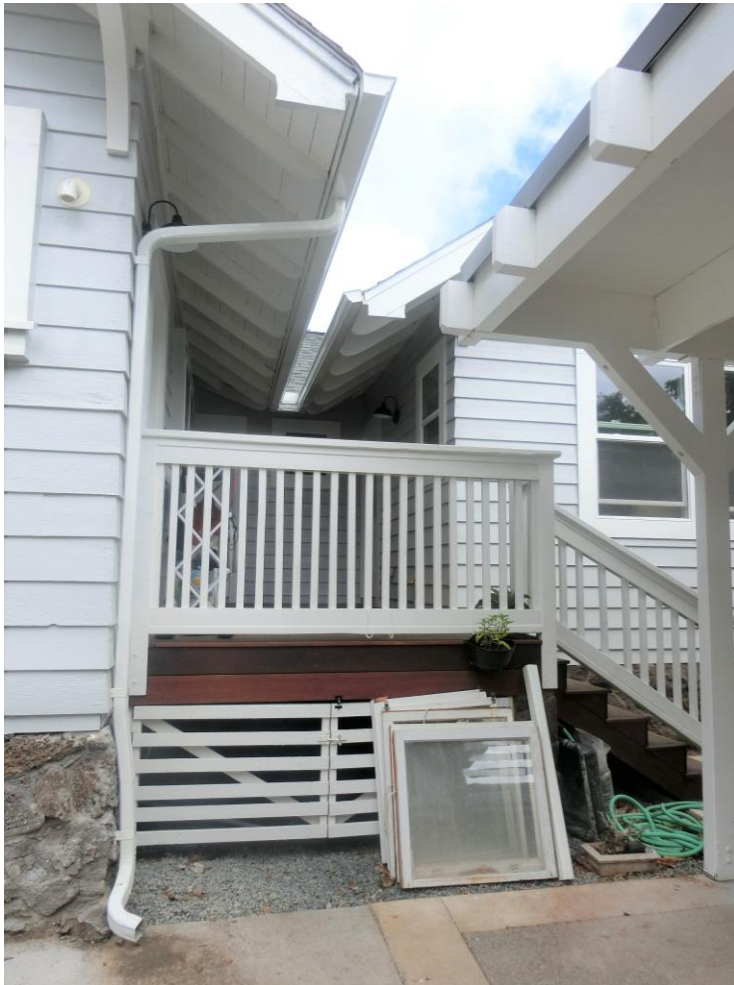
9 of 9

View of the addition from the southwest

The Condon residence retains a high degree of integrity, reflecting its original design. The only major changes have occurred in such secondary spaces as the bathroom, kitchen and laundry room. It retains almost all its original windows and doors, and the few windows that had jalousies now have vinyl double hung sash windows. These openings are on a side elevation and not readily visible to the street. The single story addition is at the rear of the property and not visible from the street. It is L-shaped and has a southwest facing gable roof. It is connected to the house via the deck and the wing extending from the rear, east corner of the house. The connecting wing contains the master bedroom bath and the northeast-southwest running main body of the addition contains a bedroom and a bath. The addition is compatible with the original house in terms of scale, and has similar walls, a composition shingle roof and a post and pier foundation. A practiced eye will notice that the exposed rafter tails in the addition's overhanging eaves are a different dimension than the original house's rafters and also differently spaced.
