# National Register of Historic Places Registration Form

Historic name: Frank and Gladys Koyanagi Residence

Street & number: 3870 Nikolo Street

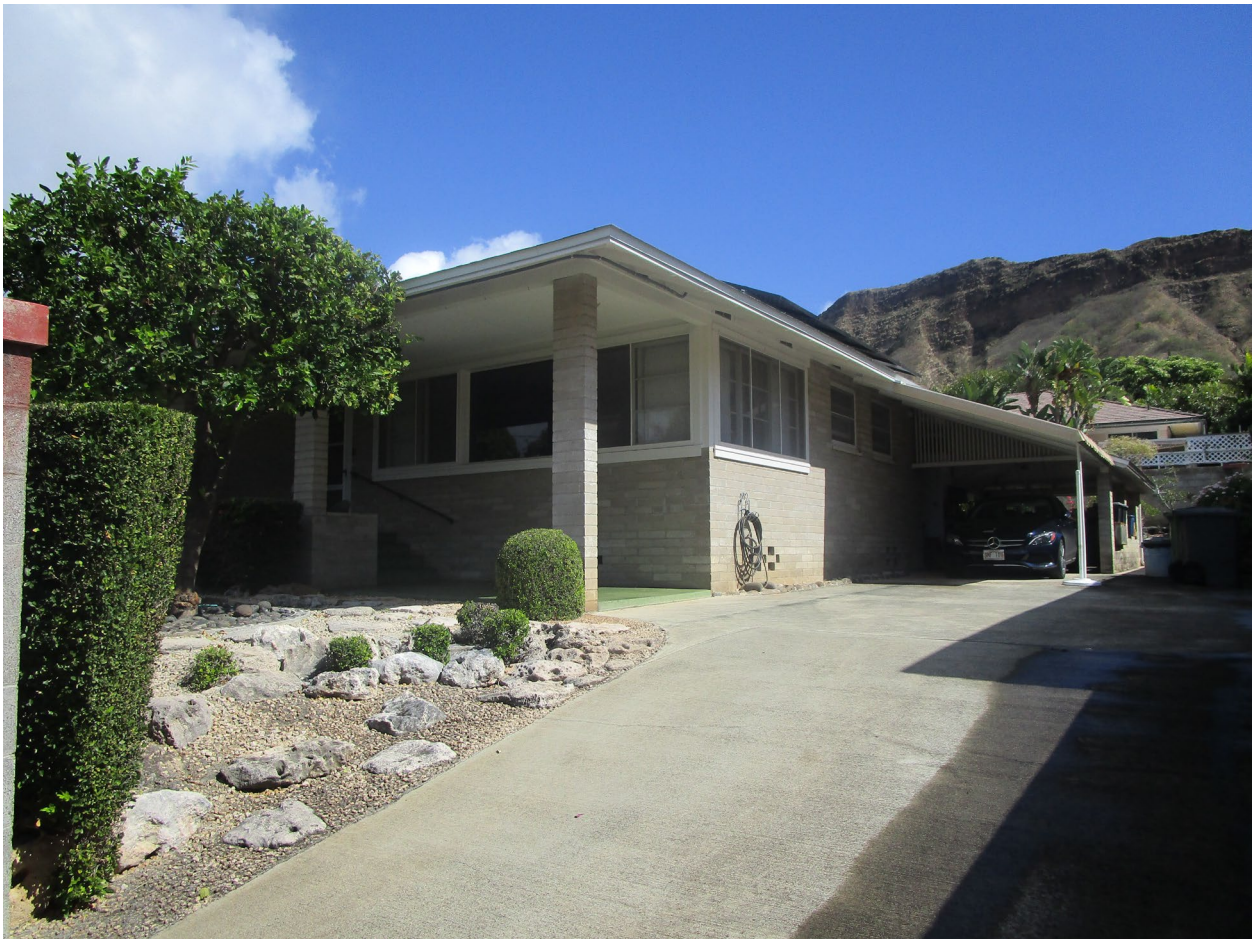
1 of 9

View of the house from the southwest

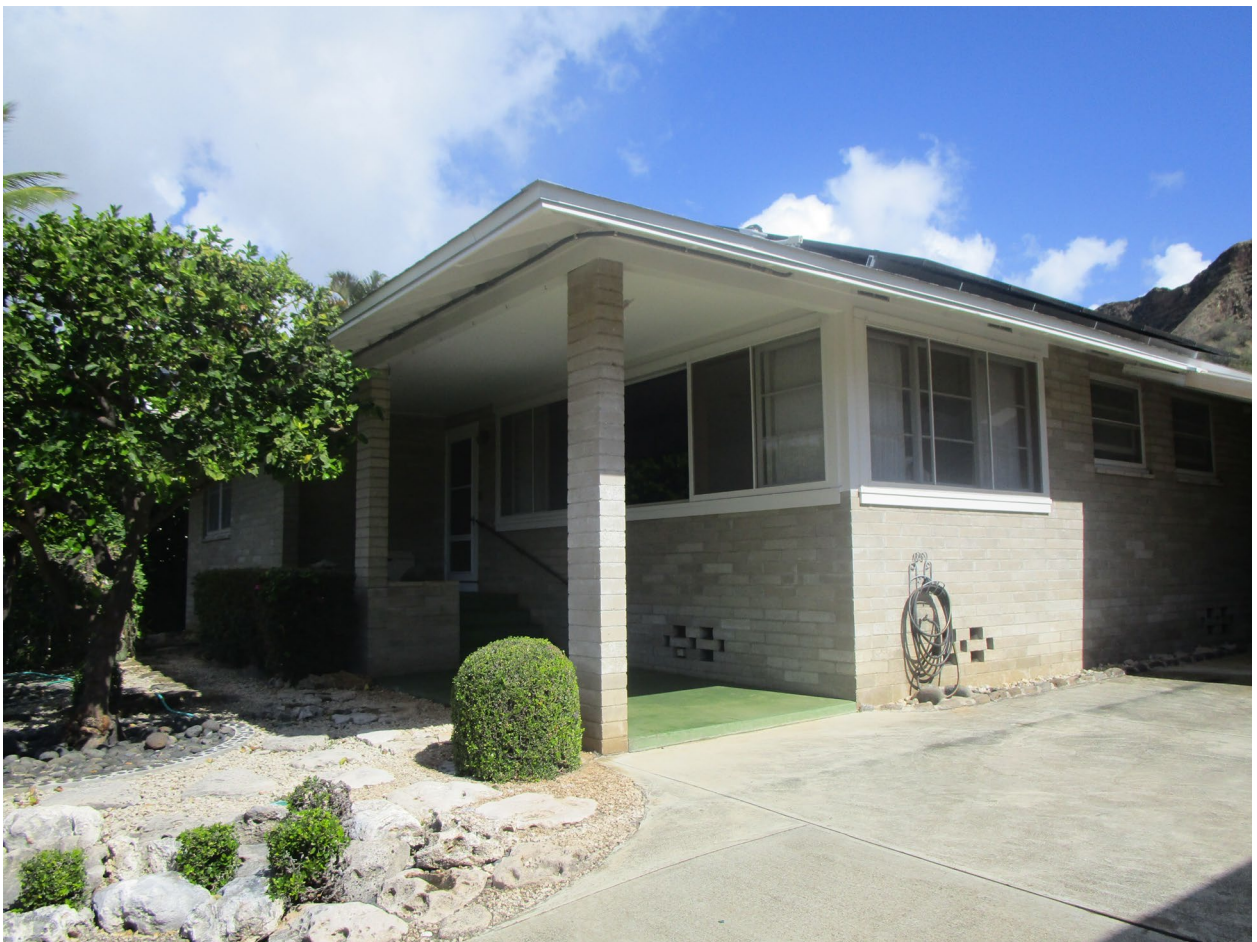
2 of 9

View of the facade from the southwest

The front yard of the house is landscaped with stone and gravel in a Japanese garden style and features *tamazukuri*-pruned shrubs and trees. The driveway juts out to the yard to adjoin the front corner of the house. A scored, green stained, concrete walkway is elevated one step above the driveway and yard and runs parallel to the house under its eaveline. It leads to three green stained concrete steps which ascend to the entry porch. Three cmu columns support the eave of the roof in front of the walkway/steps/porch. The porch is further defined by a cmu planter box on its street facing side. A mock orange hedge grows in front of the planter box. The planter box echoes the front yard with a stone and gravel landscape.

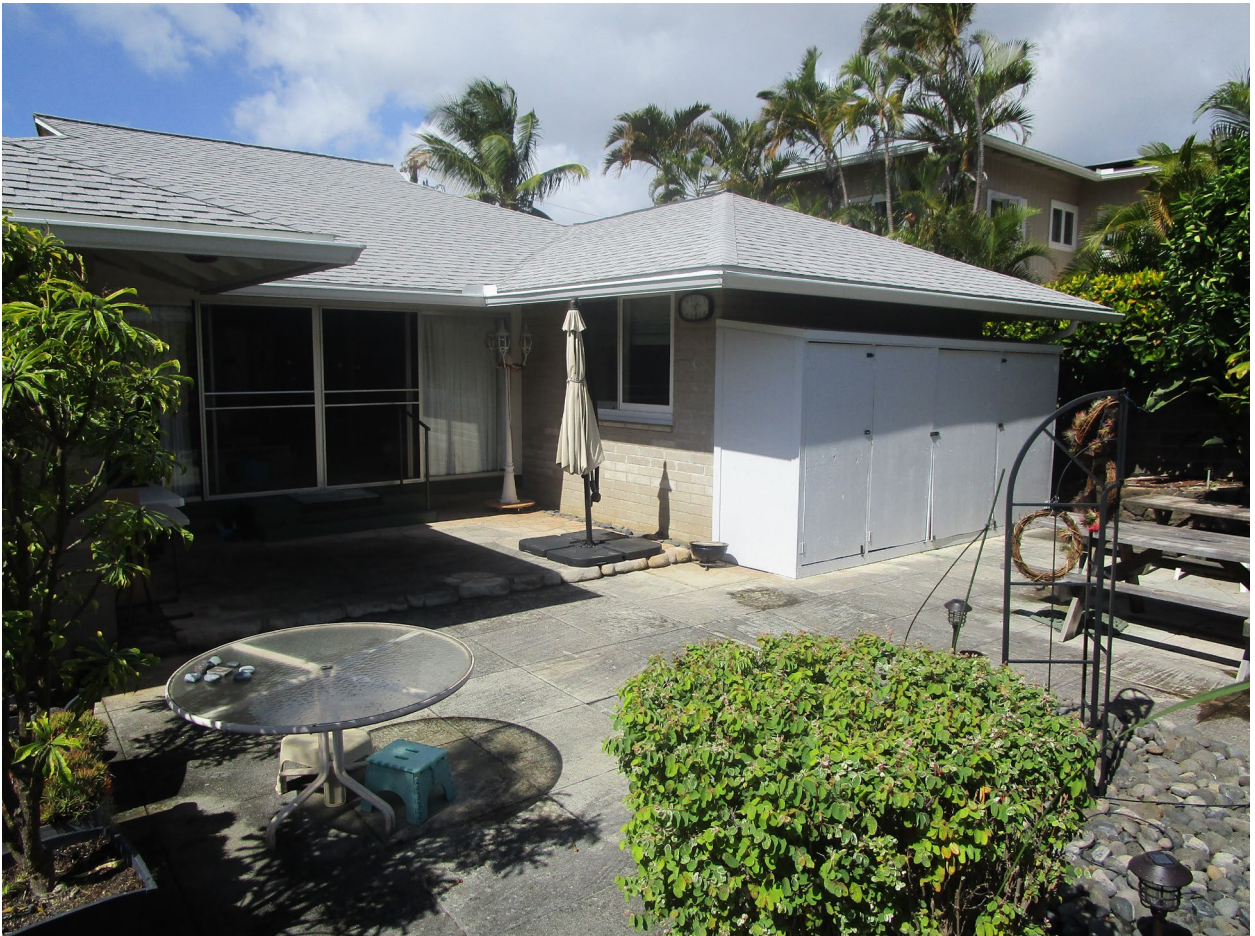
3 of 9

View of the rear from the southeast

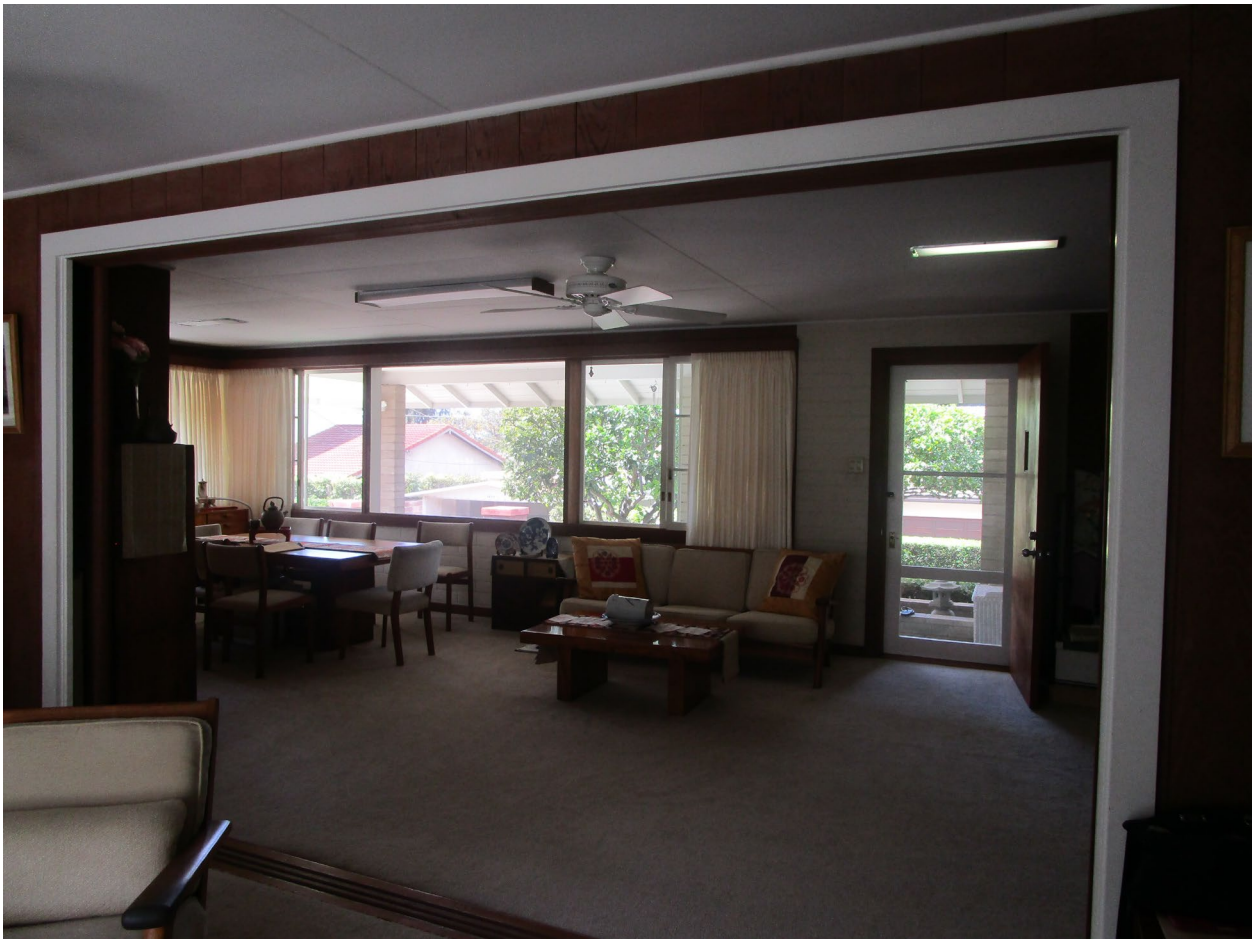
4 of 9

View of the living room from family room from the southeast

A wood door with a single pane keep window opens on the living-dining room. The door knob is not original. The 14' x 28' living-dining room has an 8' high canec ceiling, which is found throughout the house except in the kitchen and bathroom. The room has an ohia floor and features concrete block walls on its outer perimeter and 8" redwood tongue and groove interior walls, which are used on all the interior walls in the house. A simple 3" baseboard transitions the walls and floor, and is also found throughout the house. Two, original, rectangular, recessed fluorescent lights provide illumination. The front wall features a picture window, which is flanked on either side by a pair of sliding windows, with each window having three horizontal panes. The southwest wall of the room has three sliding windows of similar design. Inscribed on the handles for the locks of these windows is, "Made in Occupied Japan."

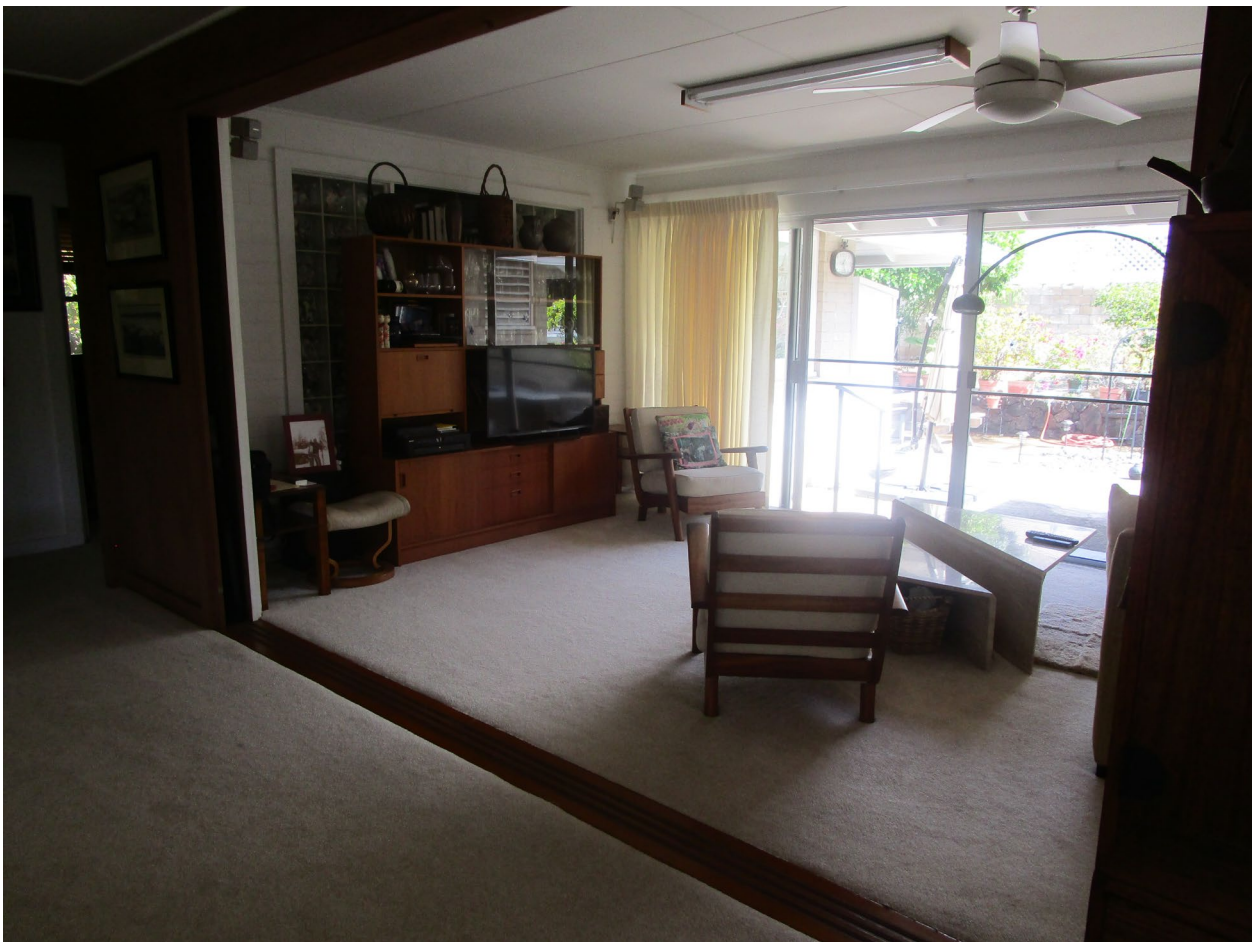
5 of 9

View of the family room from the west

Originally a pair of pocket doors opened the rear wall of the living room to a 12' x 16' covered lanai with a scored concrete floor. In the 1950s the pocket doors were removed and the lanai was enclosed by placing aluminum sliding doors as a rear wall. The kitchen window in the lanai's southwest wall was removed, although its frame and sill remain. Also in this wall is an opening without a door which leads into the kitchen. Originally a door was in the lanai's northeast wall, but following the enclosure the doorway was sealed; however, the glass block walls which flanked the door remain intact. The original aluminum sliding doors still remain and open up to three concrete steps which lead out to a paved patio. The floor of the patio features irregular shaped concrete pavers set in concrete. The patio is one step above the back yard, which is paved with scored concrete.

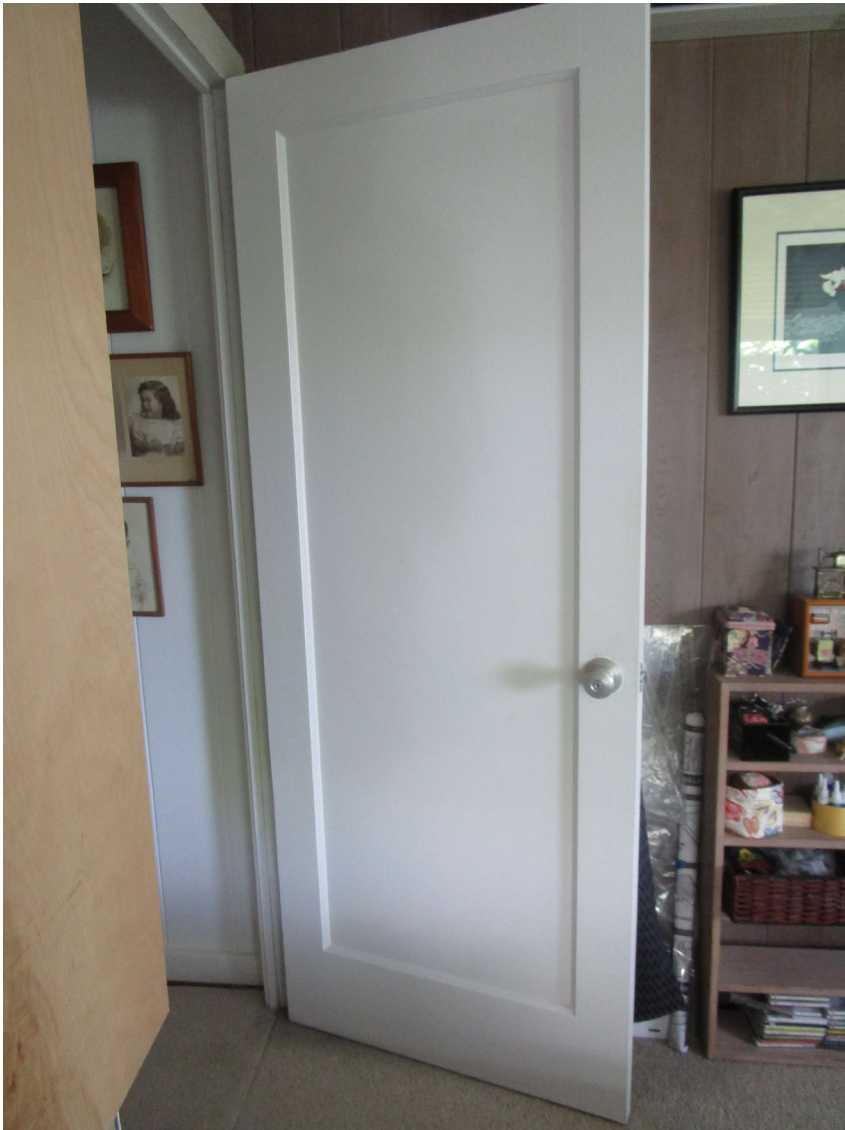
6 of 9

View of the rear bedroom door from the southwest

An opening without a door in the living room's northeast wall opens on the bedroom wing's hallway, which runs front to back. The 3'- 6" wide hallway leads to a bedroom at either end, and doors in its northeast wall access the bathroom and a third bedroom. The bedroom doors all retain their single panel doors as well as their original knobs and hardware. The hallway retains its original ceiling light and linen closet. The hallway and all the rooms in this wing, except the bathroom, have pine floors. The front bedroom has a pair of 1 x 1 double hung sash windows in its two exterior walls, as well as two closets, each with wood sliding doors. The bathroom has been completely remodeled, including its window, which now is vinyl sliding. The windows in the rear bedroom have also been replaced with vinyl sliding windows, but the middle bedroom retains its pair of 1 x 1 double hung sash windows. The middle bedroom and rear bedroom each have one closet with their original sliding doors similar to those in the front bedroom.

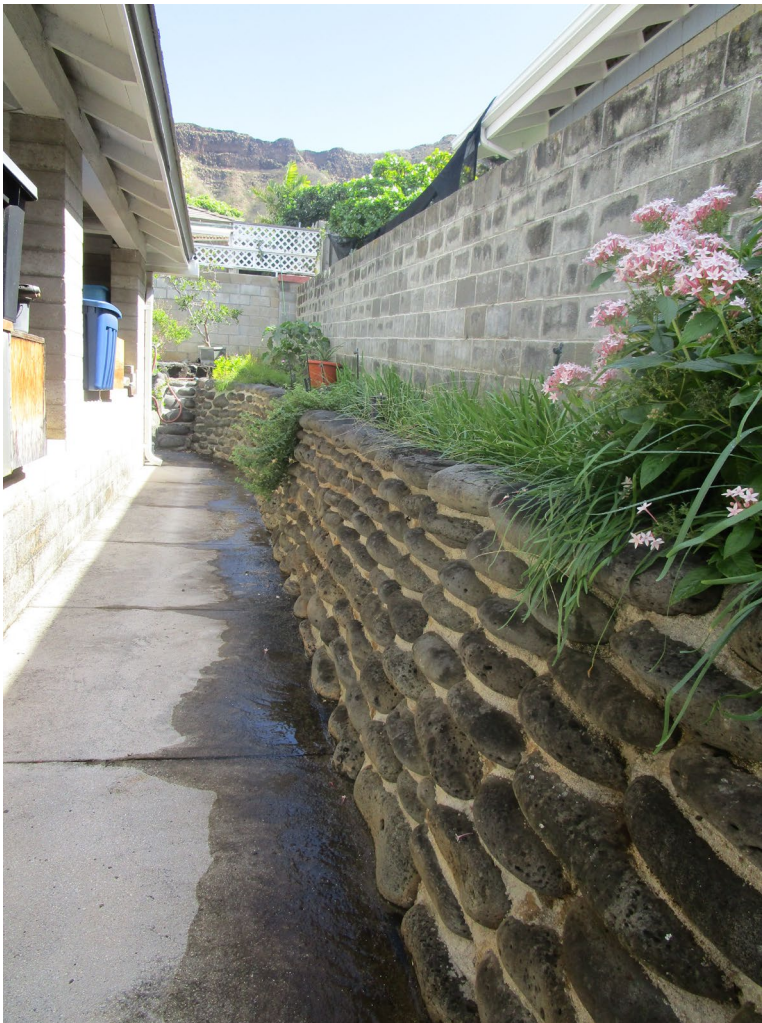
7 of 9

View of the river rock wall from the northwest

The back and side yards were all made by Mr. Koyanagi over a period of ten to fifteen years, following the completion of the house in 1950. A planter box constructed of river stone runs down the southwest boundary wall with a concrete sidewalk between it and the carport. The back yard is terraced, with a low, river stone retaining wall holding the southwest end of the terrace and a basalt wall retaining the northeast end and running down the northeast boundary wall. Concrete stepping stones form a pathway down the northeast side of the house. Three steps made of river rock lead up to the upper terrace.

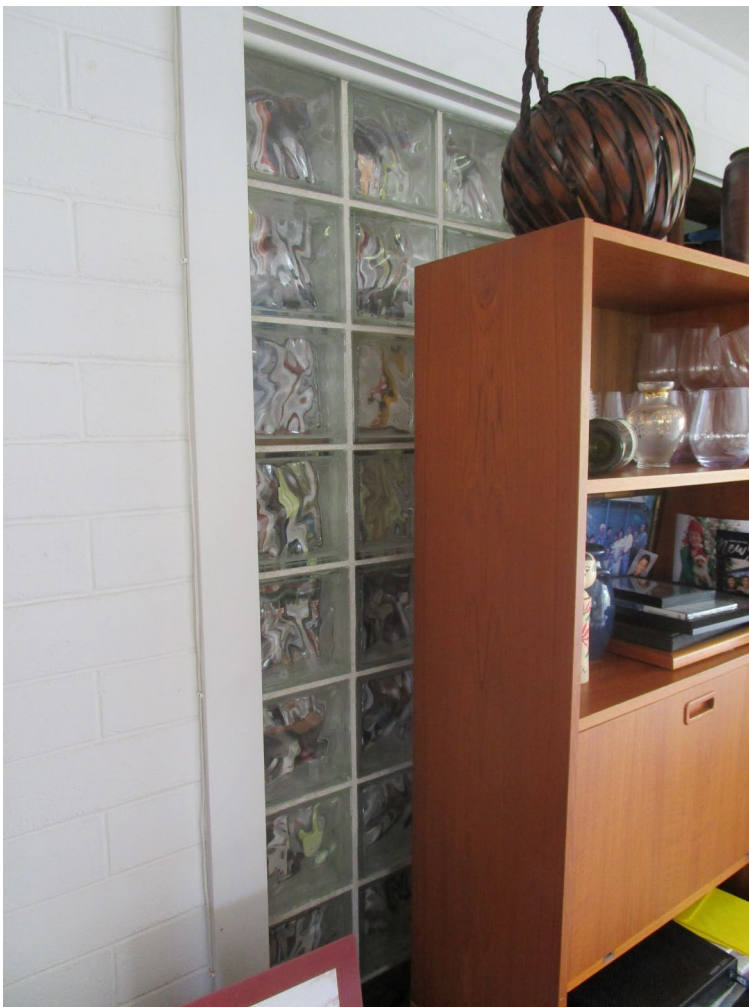
8 of 9

View of the family room glass block wall from the west

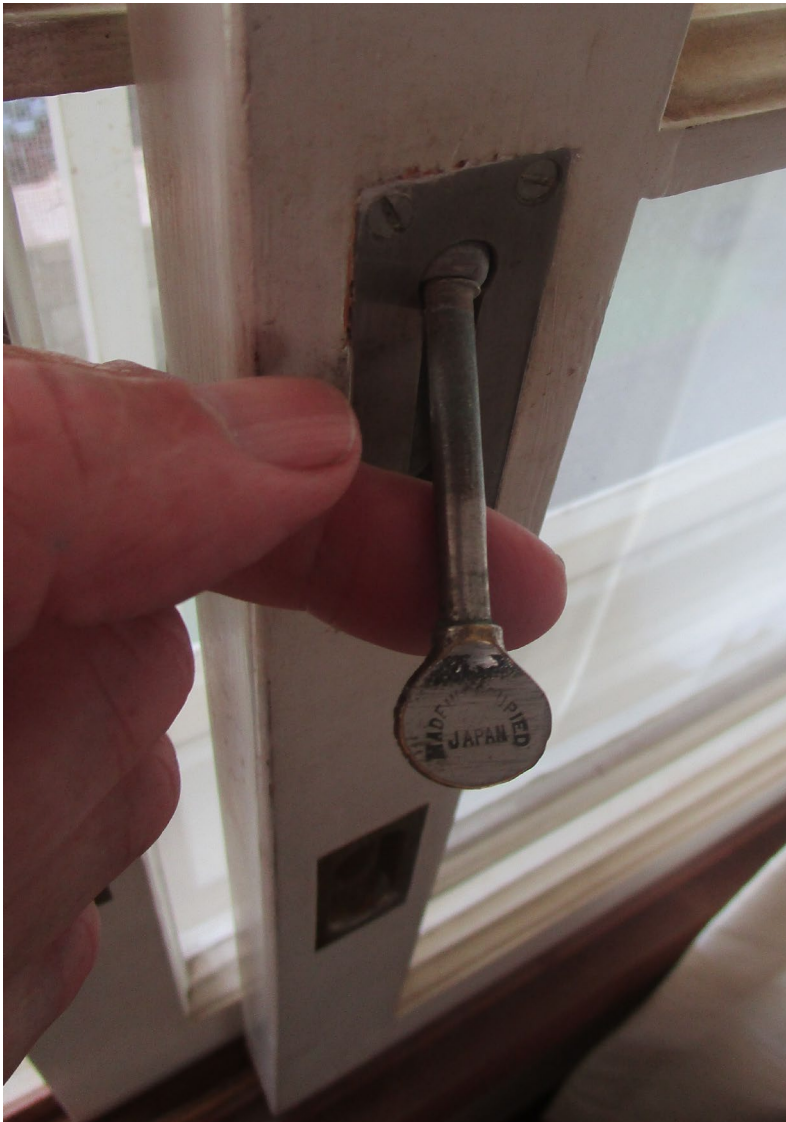
9 of 9

View of the window lock from the southeast
