**STATE OF HAWAII**  
**DEPARTMENT OF LAND AND NATURAL RESOURCES**  
**OFFICE OF CONSERVATION AND COASTAL LANDS**  
**Honolulu, Hawai'i**

June 9, 2017

**REGARDING:** Conservation District Use Application OA-3784  
Royal Hawaiian Groin Improvement Project

# *Royal Hawaiian Groin Replacement*

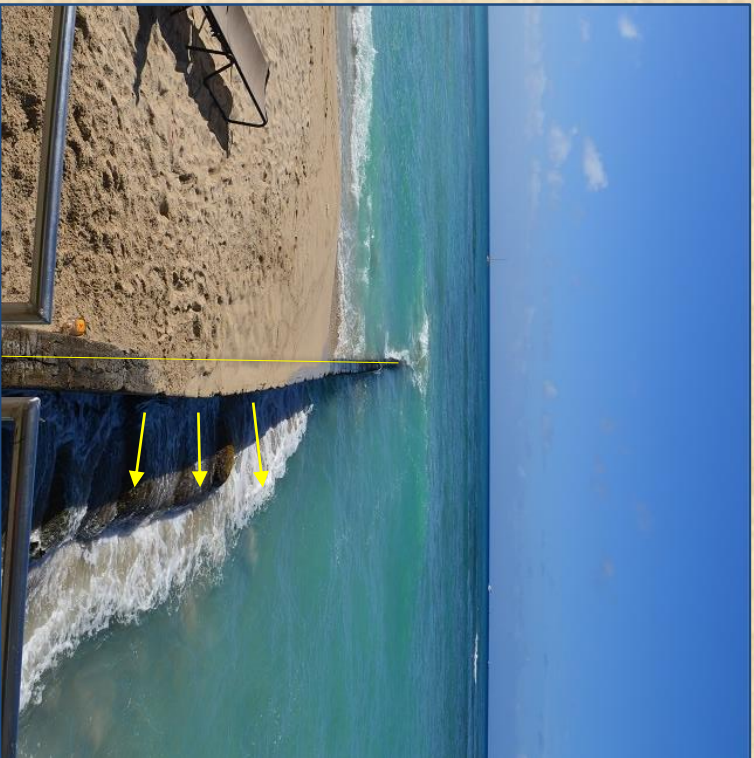
- RHG Initially constructed in 1927 (170 feet)
- Lengthened in 1930 (370 feet)
- Grouted concrete blocks with stone buttress on west side—stones removed at some point
- RHG is the only groin remaining of about 10 groins constructed around that time
- Landward-most 100 feet is above water, remaining 270 feet submerged

Yellow line for reference

The main concern is that the landward portion of the groin is leaning to the west, severely undermined, and missing a significant portion of the inter-block concrete grout. This has resulted in large sinkholes developing on the east side of the groin that have needed to be repaired. In December 2012, approximately 45 geotextile sandbags were placed against the west side of the groin to buttress the groin and prevent it from collapsing (**Exhibit 5**). The top row of sand bags has since been displaced by wave action. This has resulted in a loss of contact with the groin, which decreases the effectiveness in stabilizing the groin. These sandbags were intended to be a temporary measure until a permanent groin improvement plan could be implemented.

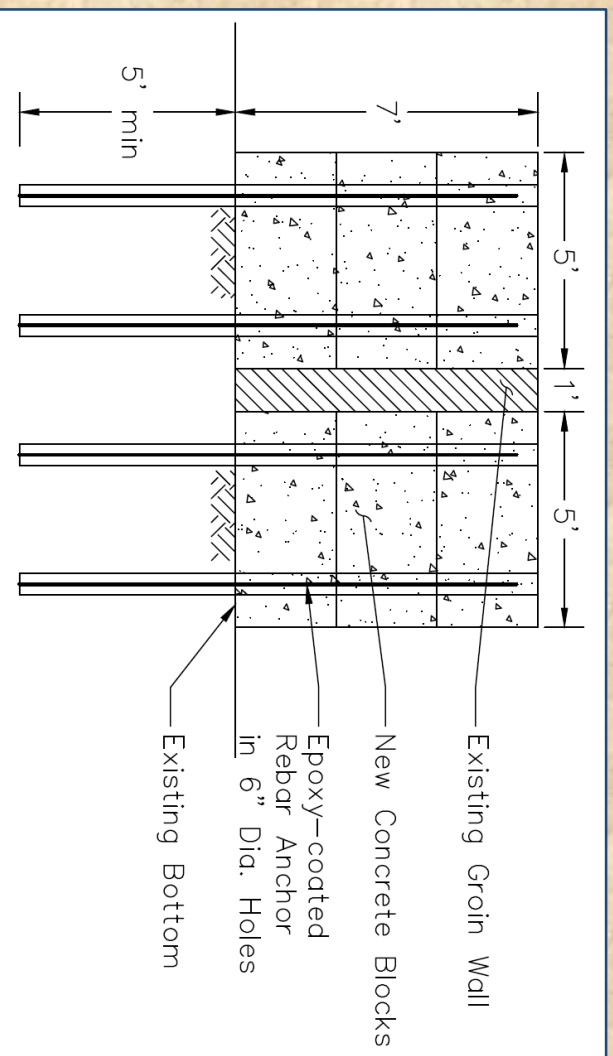
- Structural analysis determined that the existing RHG cannot withstand the design wave forces
- Strengthening existing wall to withstand design wave forces requires 5' wide by 7' tall concrete blocks on both sides of the existing wall

Groin strengthening

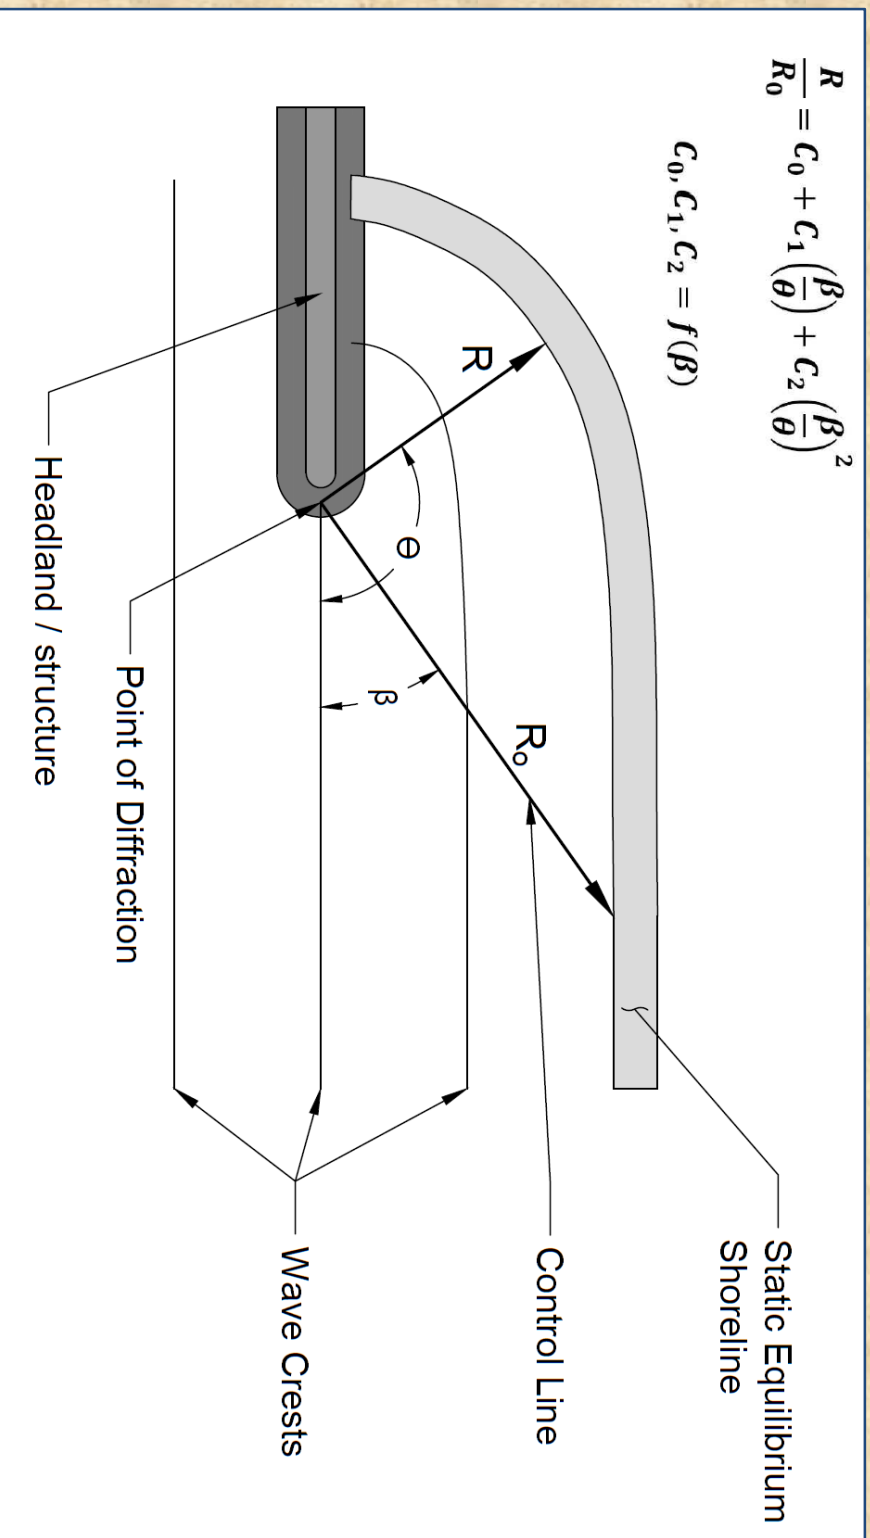
Headland bay plan shape

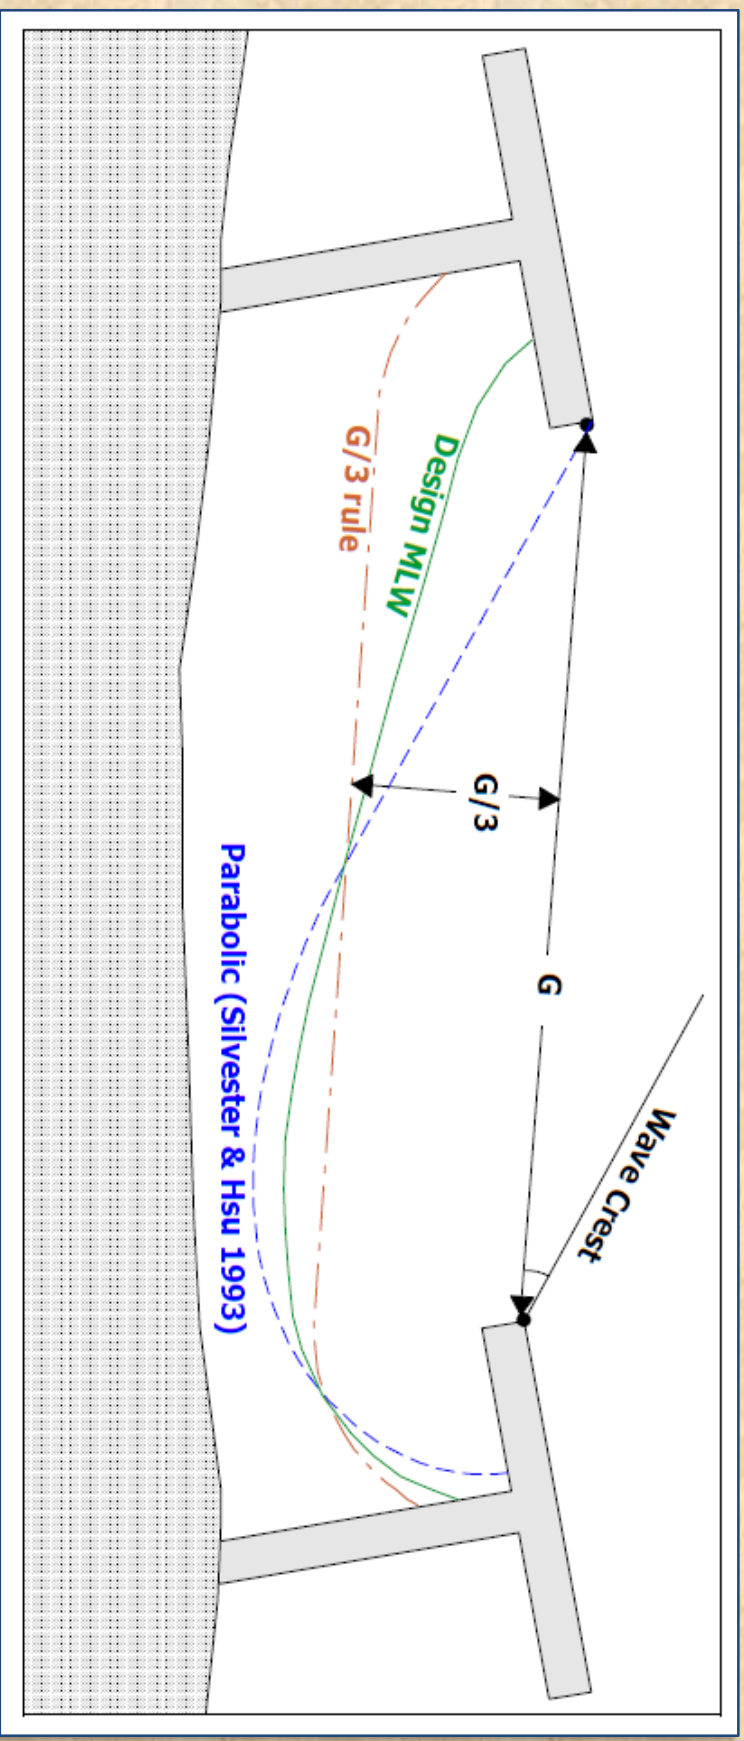
Bodge method prediction of shoreline in T-head groin compartments

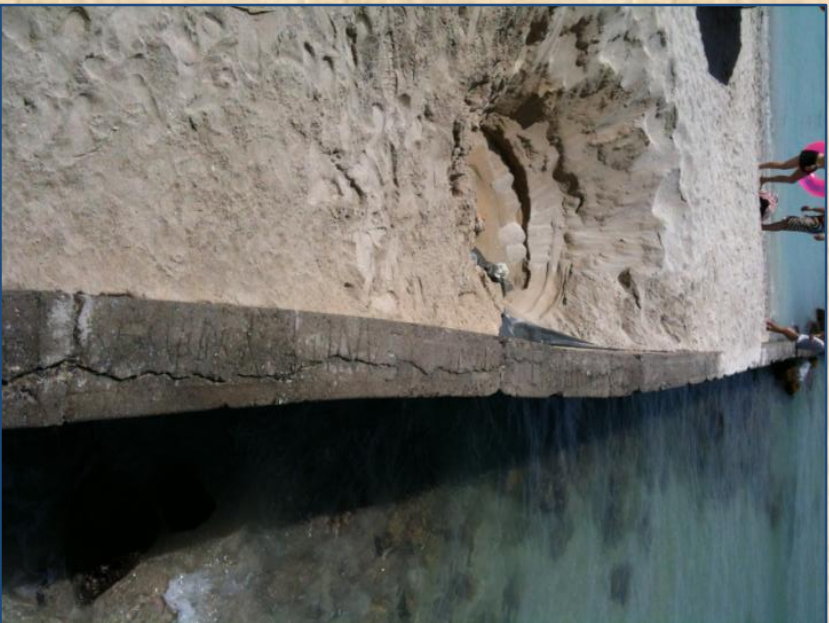
15

- Groin is leaning and bowed toward the west
- Sinkholes developed following the 2012 beach maintenance project
- Geotextile lining was placed to inhibit migration of sand under and through the groin

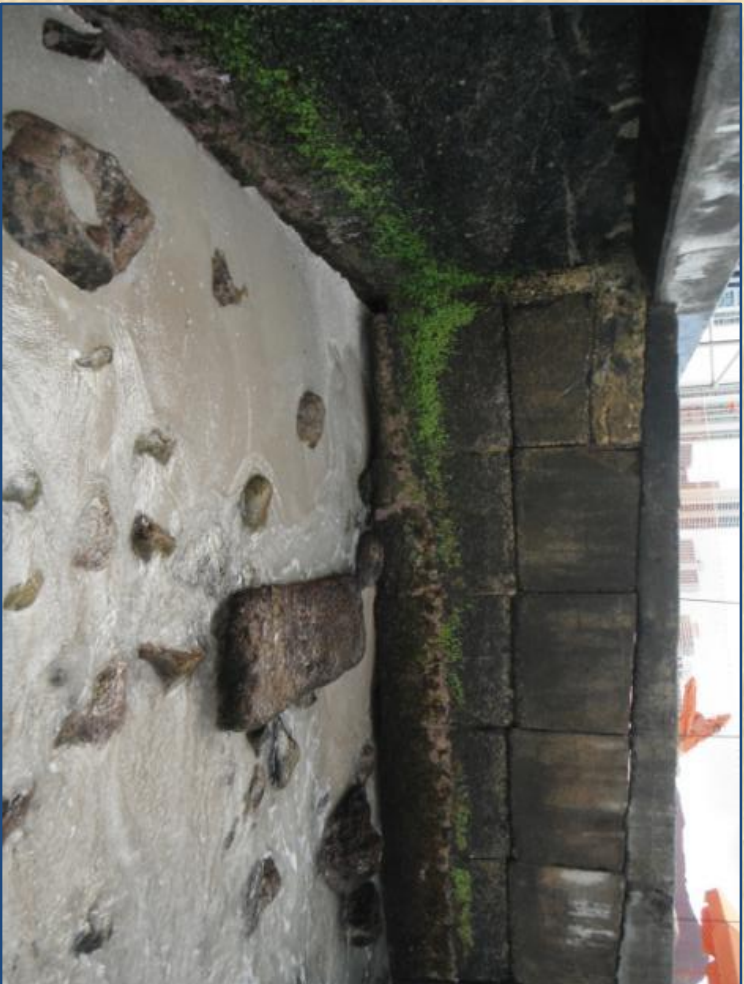
16

- Grout between blocks is missing
- Daylight can be seen
- Blocks are undermined
- Water flows under the base
- What is holding the blocks together?

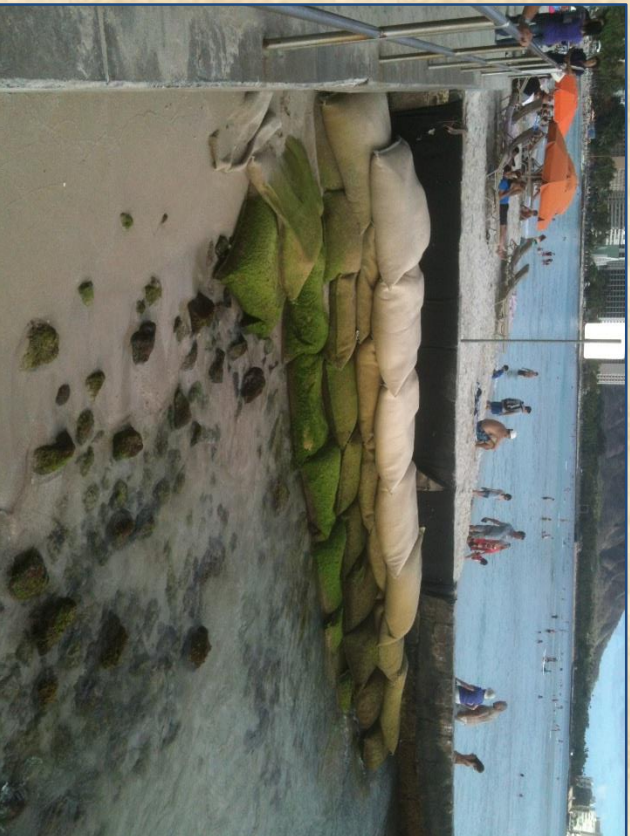
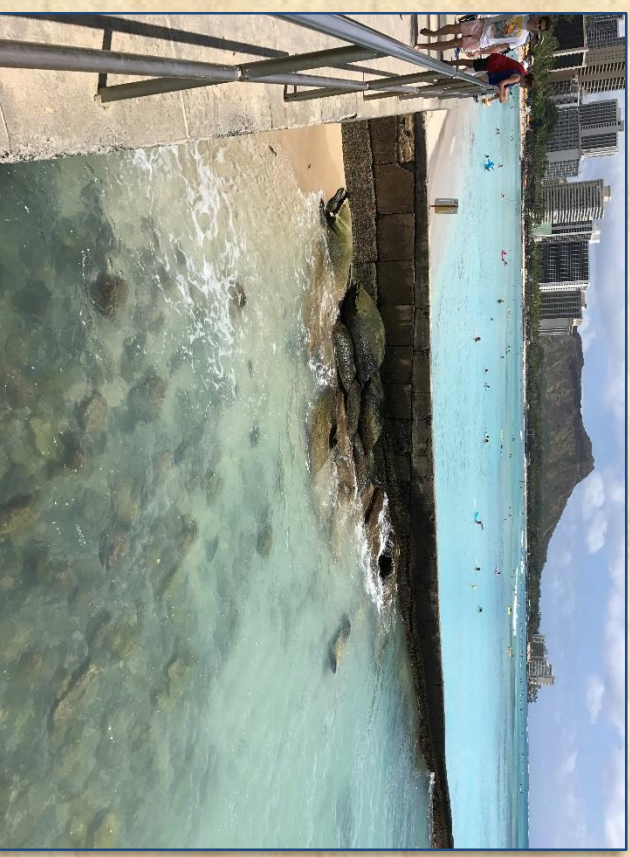
- 45 ElcoRock bags were placed in 2012 to support groin
- Temporary solution
- Majority of bags have been displaced

2013

2017

*The Department accomplished an emergency repair in 2012, in which 3,000 pound sandbags were stacked along the west side of the groin to buttress it and help prevent it from toppling over. The sandbags are currently in a deteriorated condition and the entire top row of bags has been displaced. These sandbags were installed as a temporary measure until a permanent improvement plan could be implemented.*

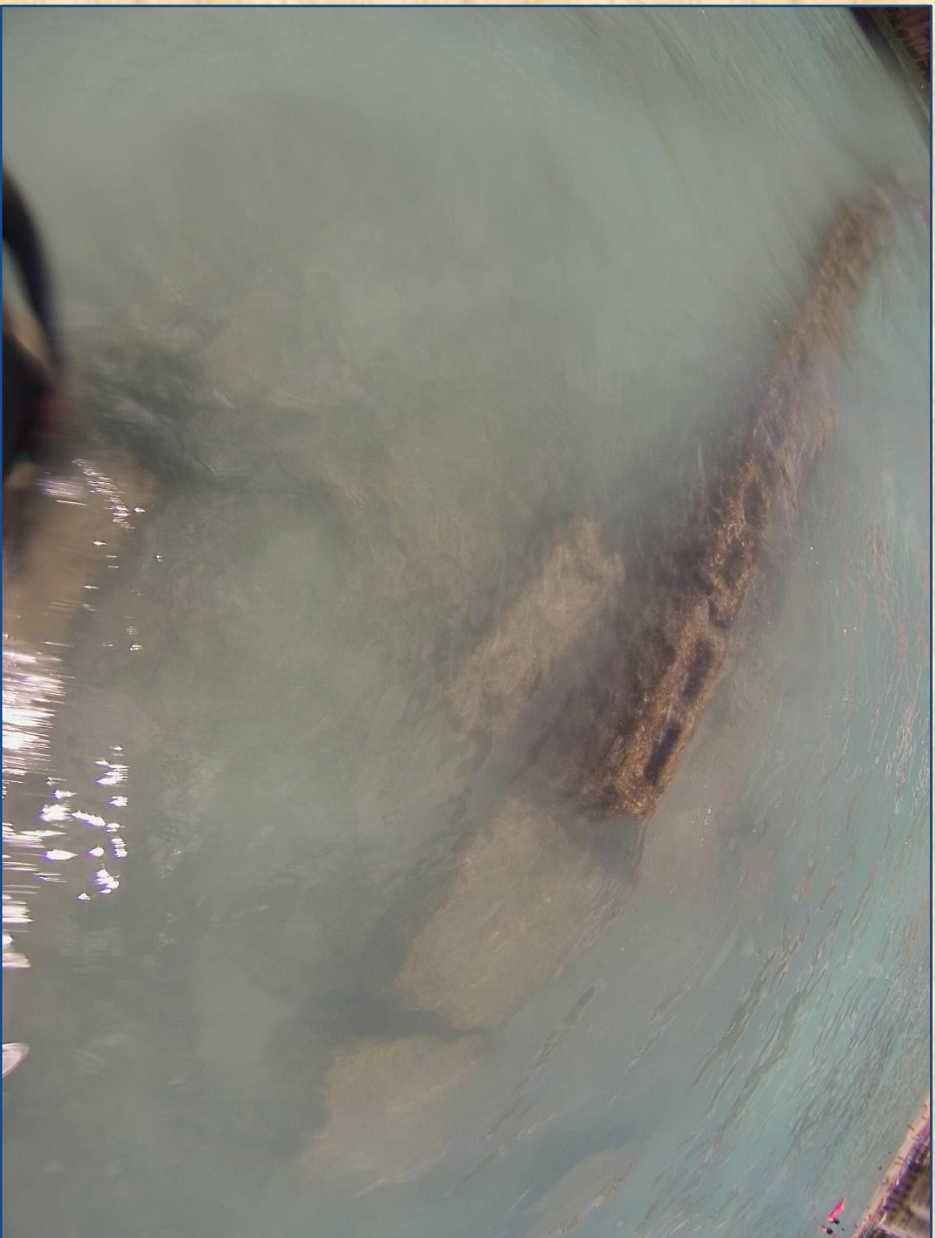
Submerged blocks offshore

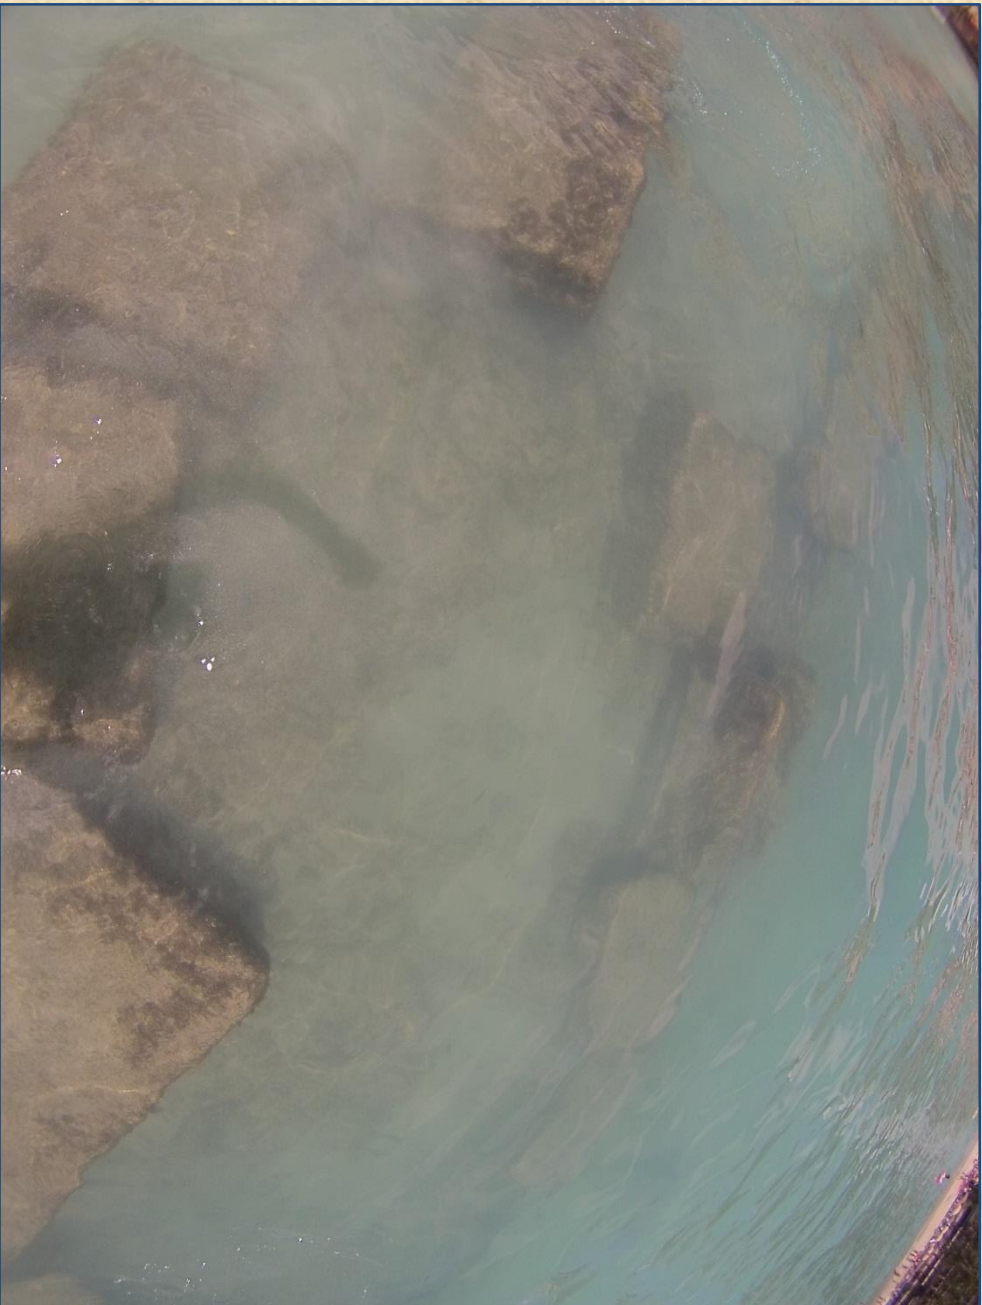
Collapsed blocks offshore

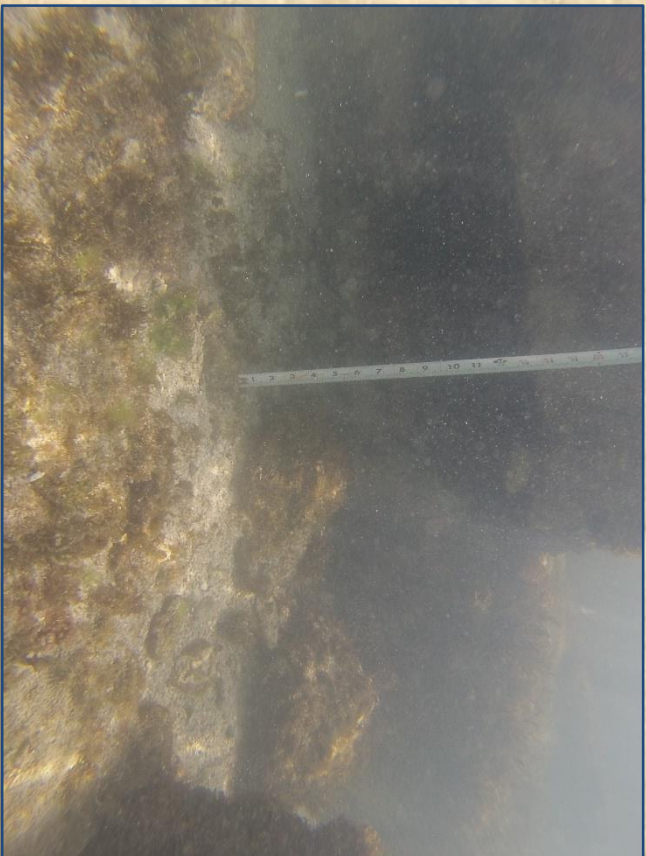
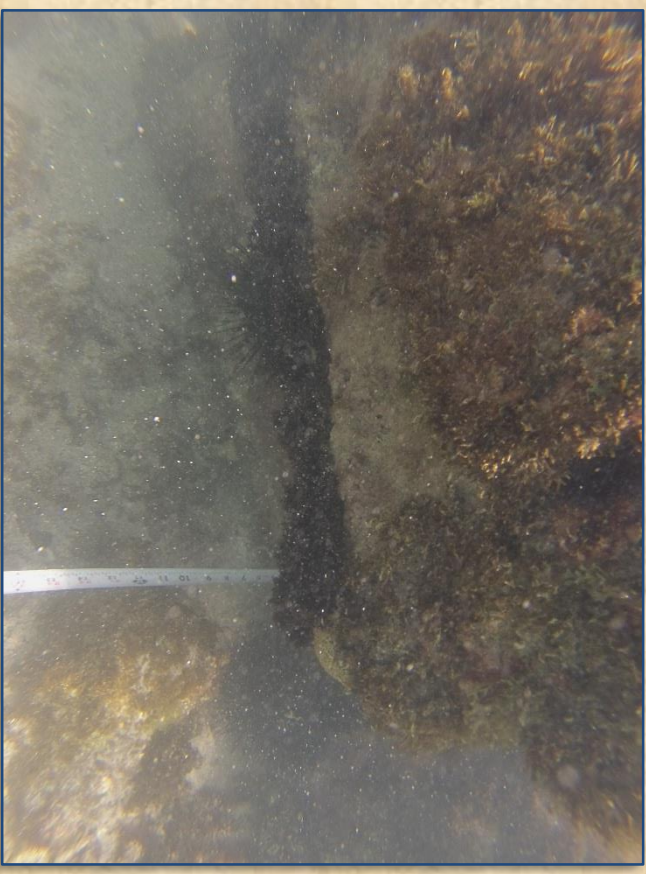
Undermining of nearshore blocks

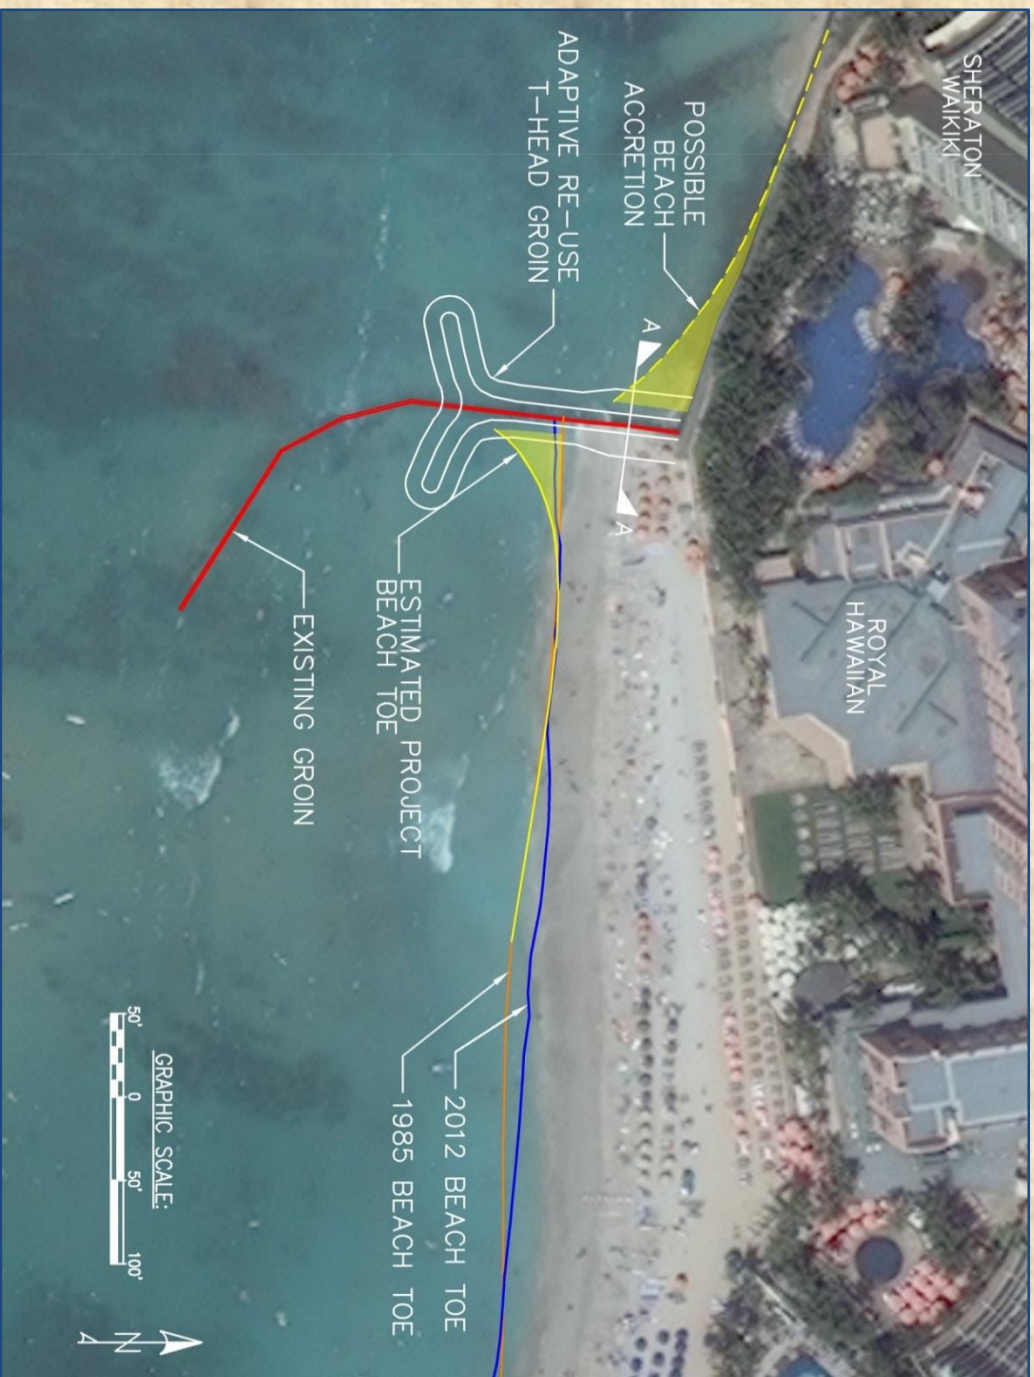
Adaptive reuse 180-foot T-head groin

The existing groin is in a very deteriorated state, but it would be possible to construct a rock rubblemound groin structure around what remains of the existing groin (**Exhibit 10**). The existing groin would be the core wall to prevent sand migration through the structure. This option would consist of a 130-foot-long stem centered on the existing groin and a 30-foot-long L-head extending to the east. Incorporation of the existing groin would require installing a temporary barrier on the east side of the groin to hold the sand back while sand is excavated to place stone. A temporary boulder causeway would be constructed from the beach to the location of the new groin head for construction access. This would be removed as construction proceeded back towards the beach. This option would have a total length of 160 feet and a footprint of 5,990 square feet. Approximately 255 cubic yards of armor stone and 410 cubic yards of underlayer stone would be used.

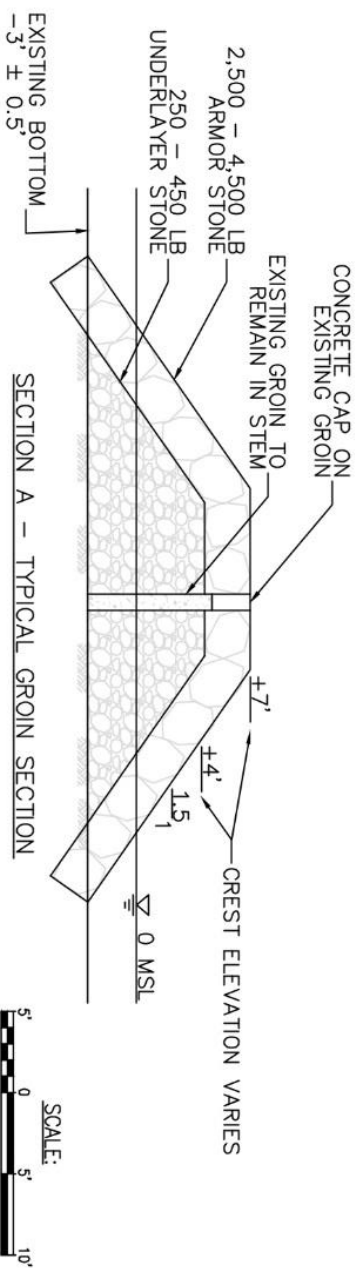
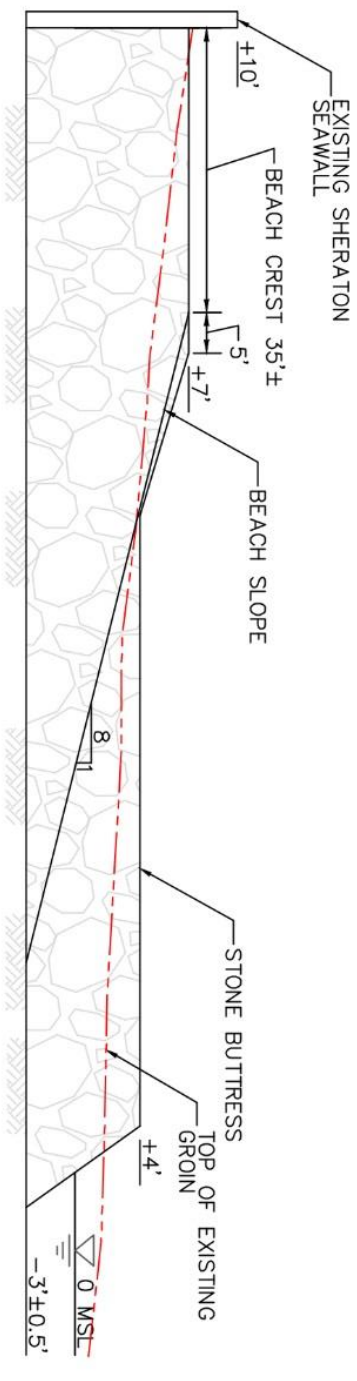
Adaptive reuse groin section and elevation views

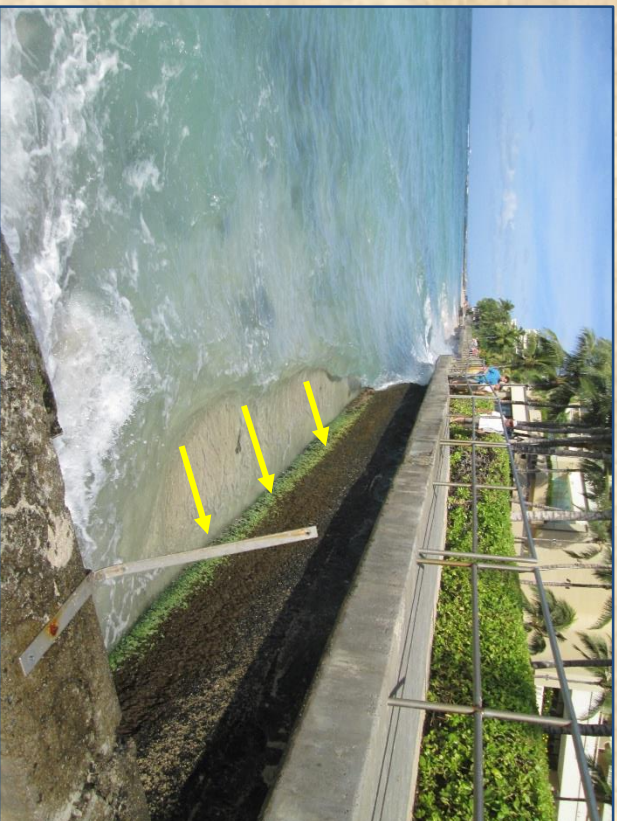
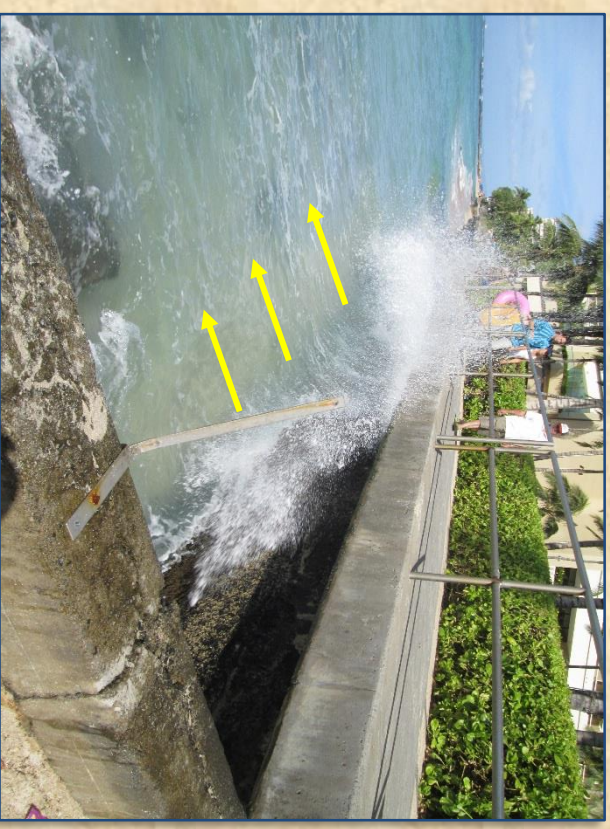
- Vertical walls are generally undesirable for coastal engineering projects
- High wave reflectivity coefficient relative to beach and sloped rubble mound structures
- Reflected waves propagate offshore towards surf breaks

Incoming wave

Reflected wave

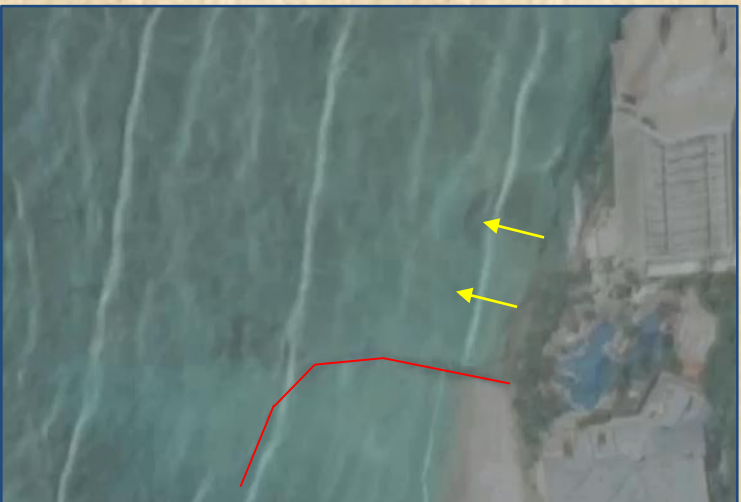
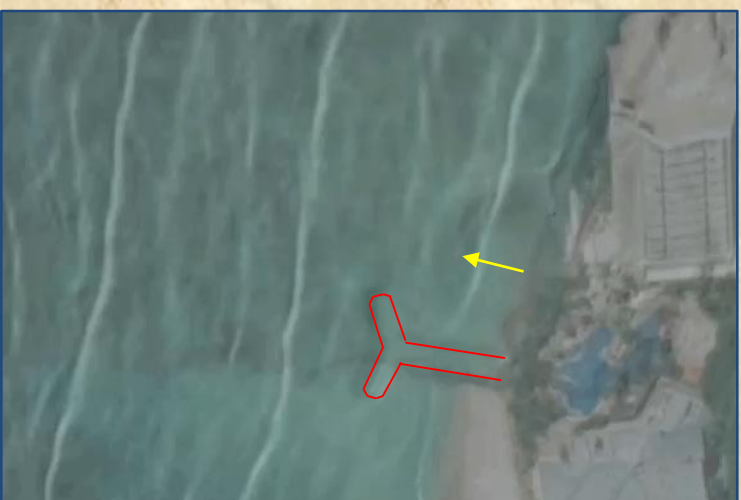
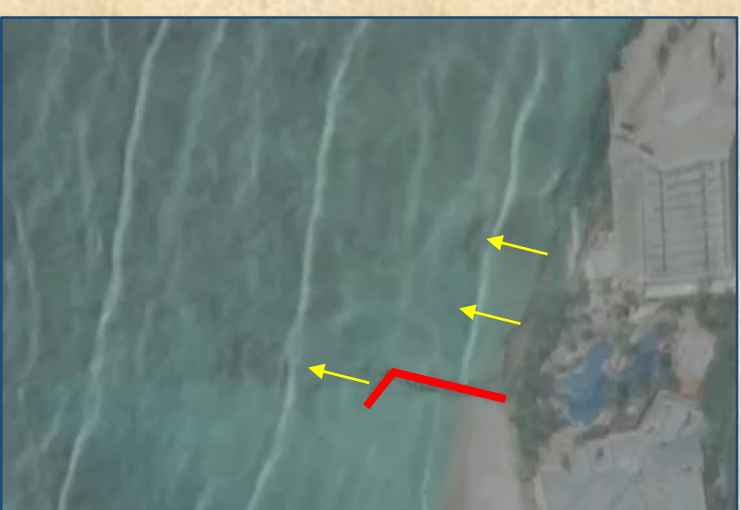
## Boussinesq Numerical Wave Modeling of Wave Reflection

Existing condition

Rock T-head groyne

Vertical L-wall

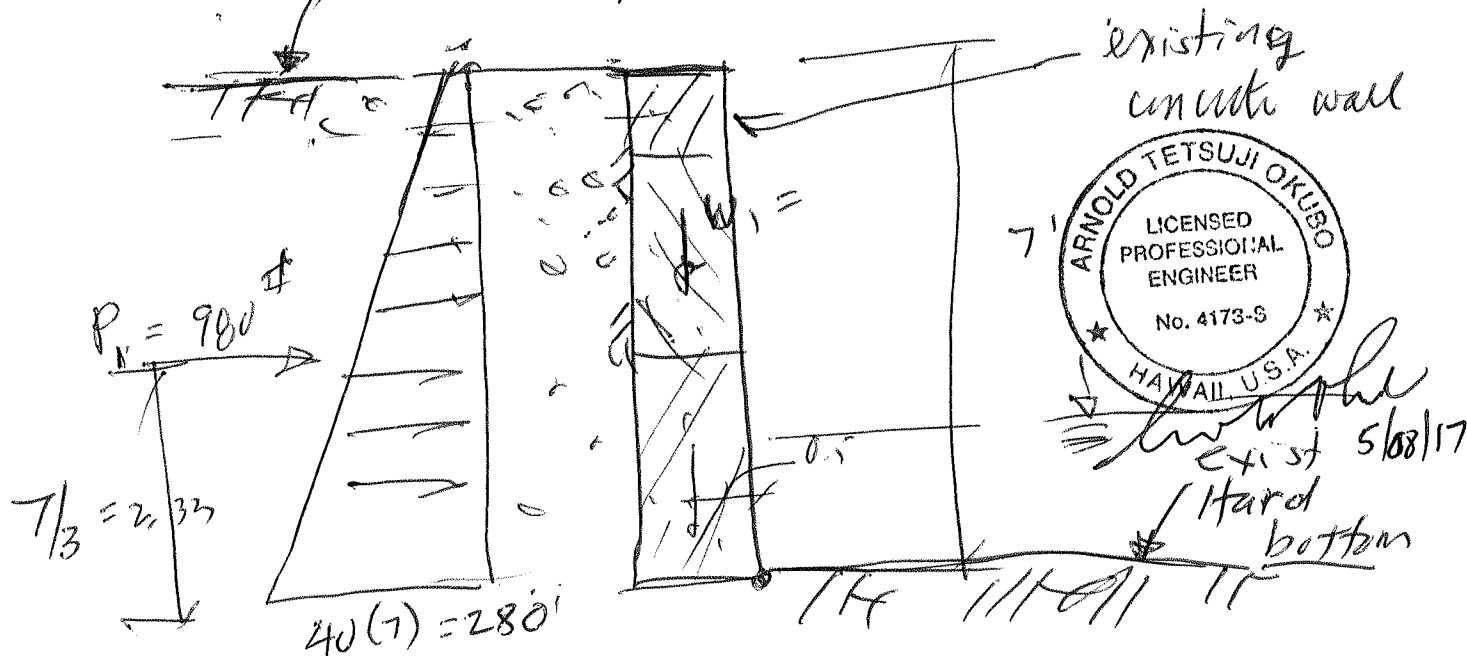
Shf B1/B5

$w_a = 40 \text{ pcf active pressure}$   
 $P_1 = 1/2 (280)(7) = 980 \text{ lbs}$

$w_1 = 1 \times 7 \times 1 \times 150 = 1050 \text{ lbs}$

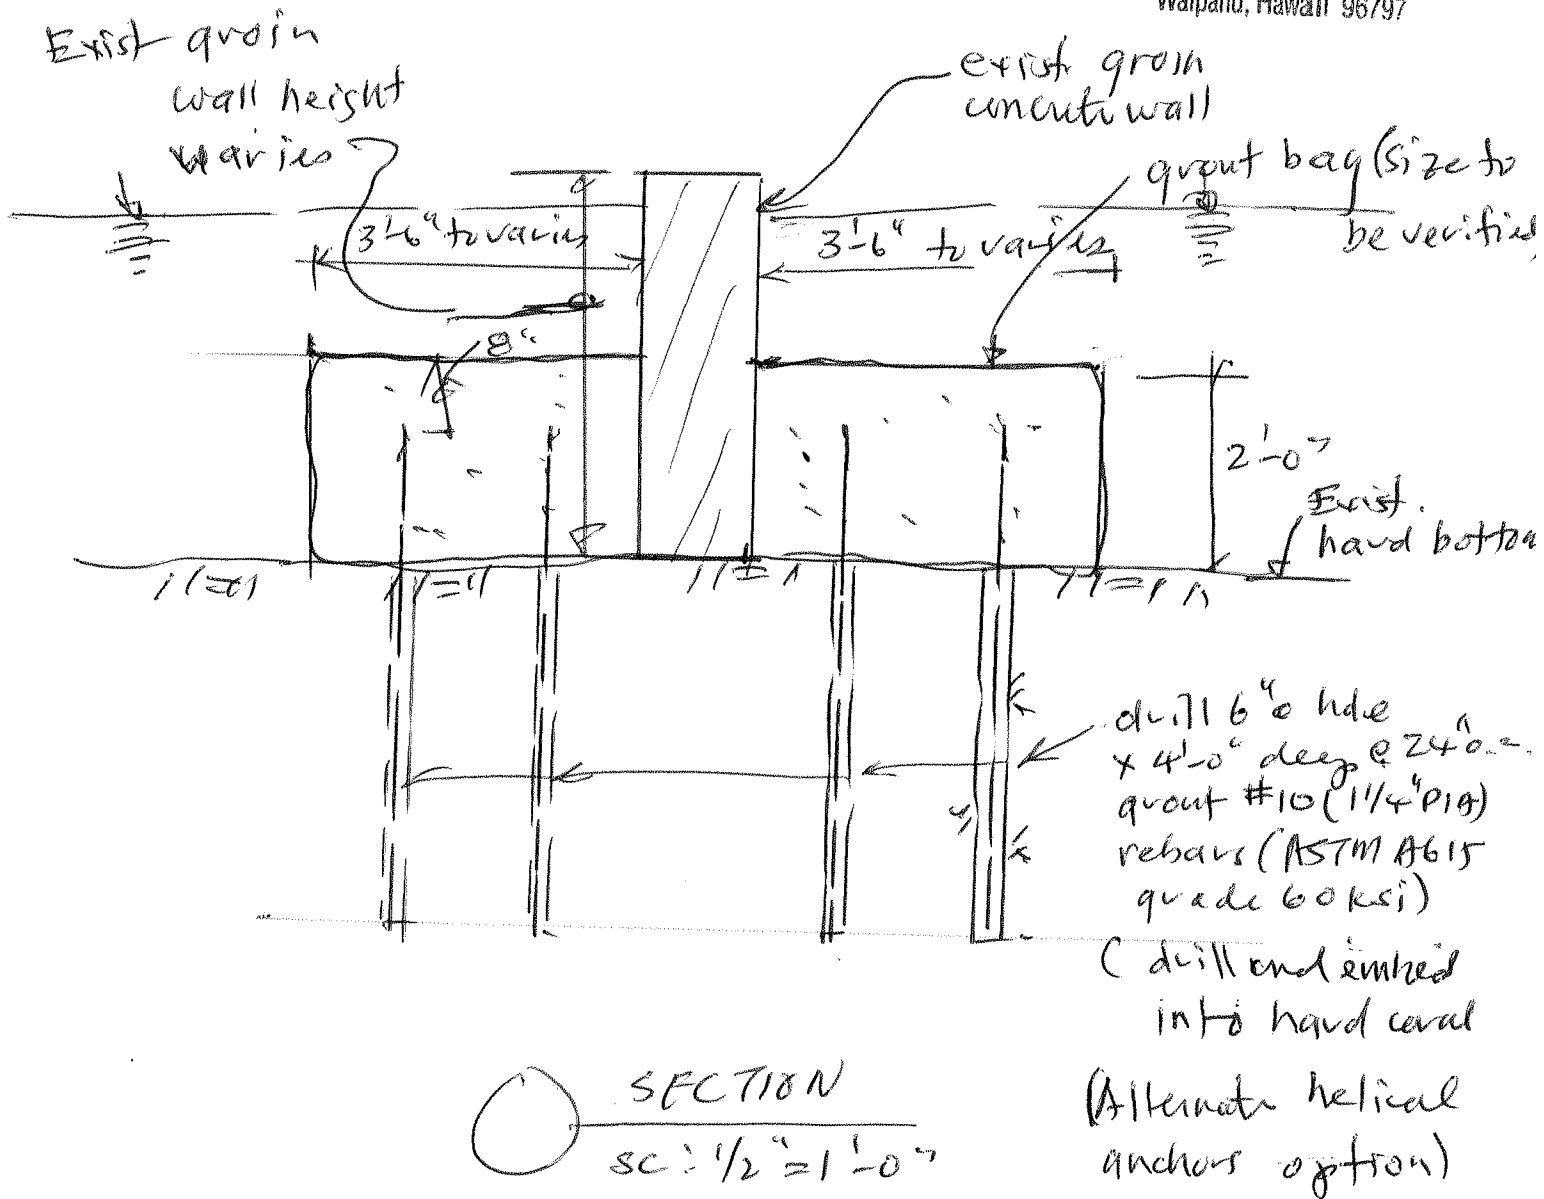
SHT B5/B5

PROPOSED STRENGTHENING OF  
EXIST. ROYAL HAWAIIAN GROIN

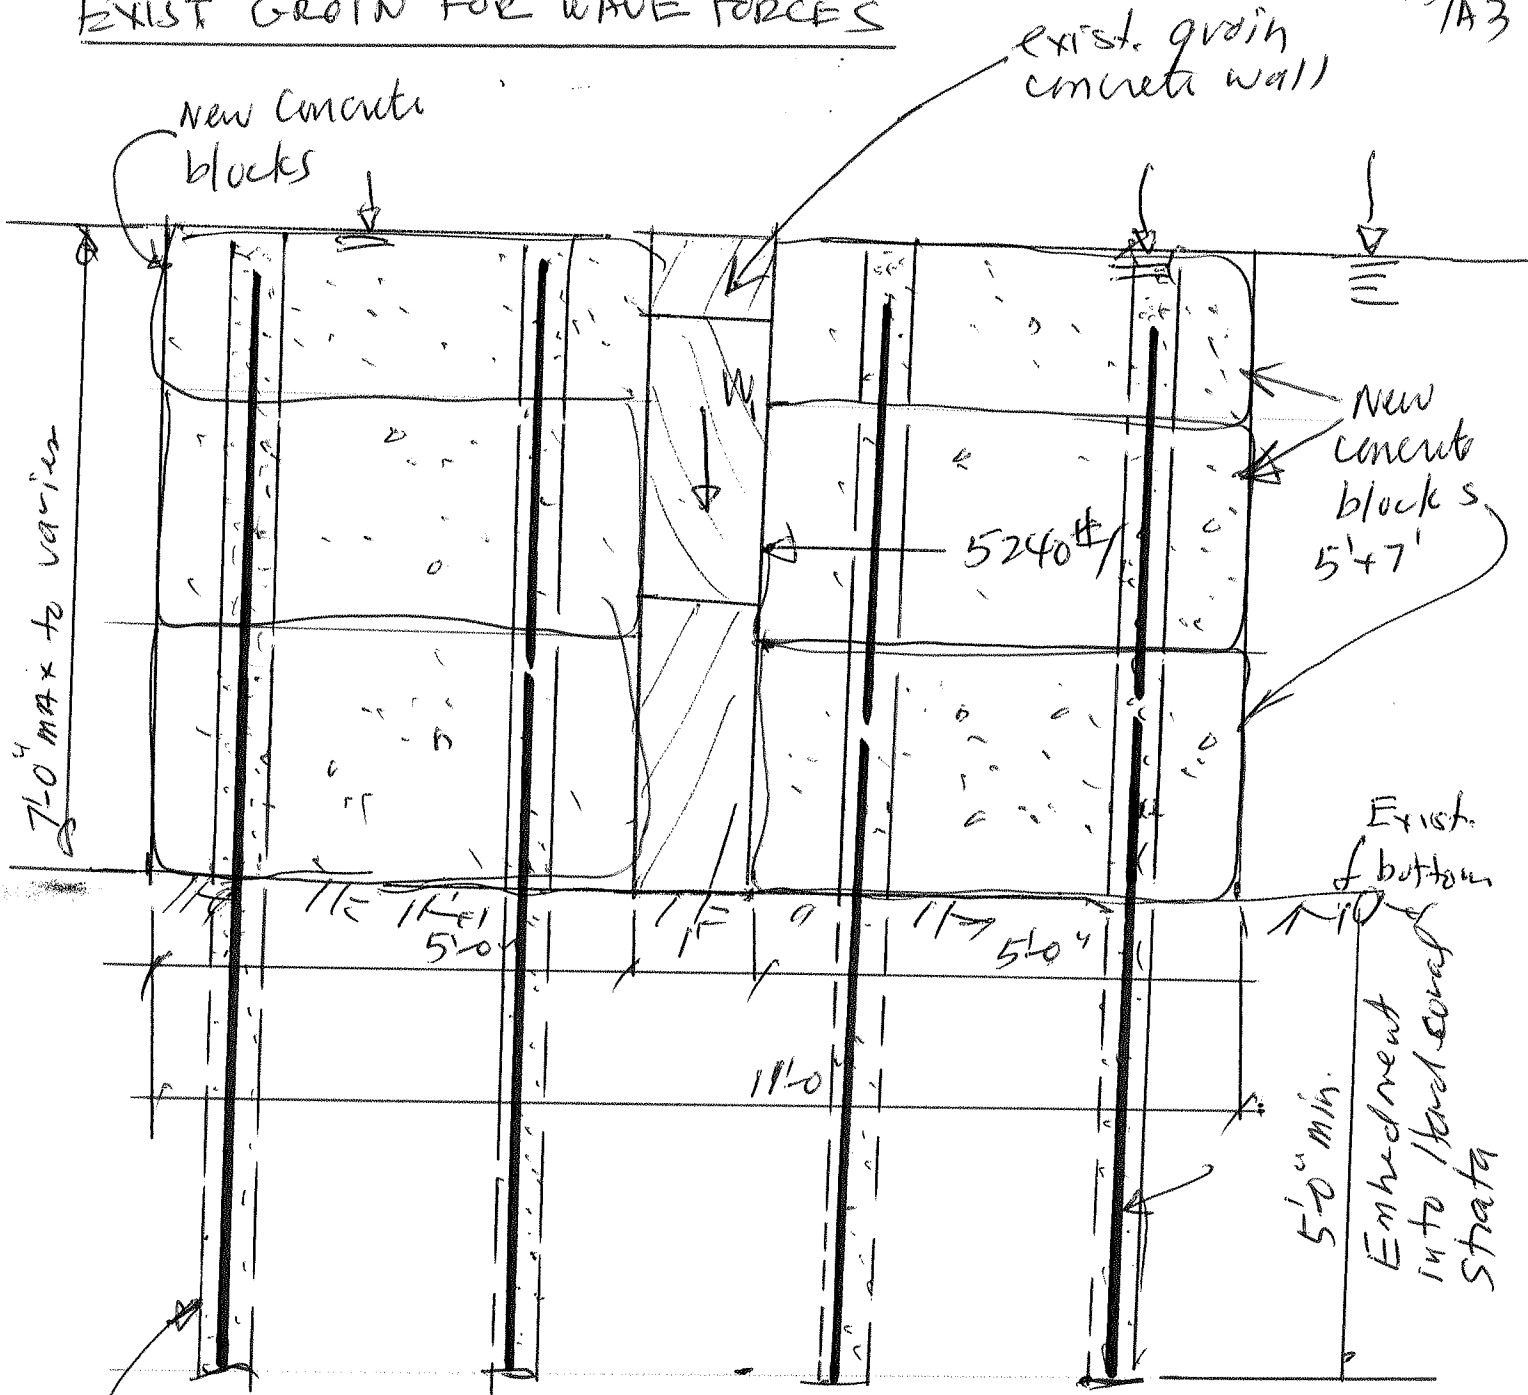
Sh. A3/A3

# ALTERNATE STRENGTHENING EXIST GROIN FOR WAVE FORCES

## REPAIR EXIST. GROIN WALL

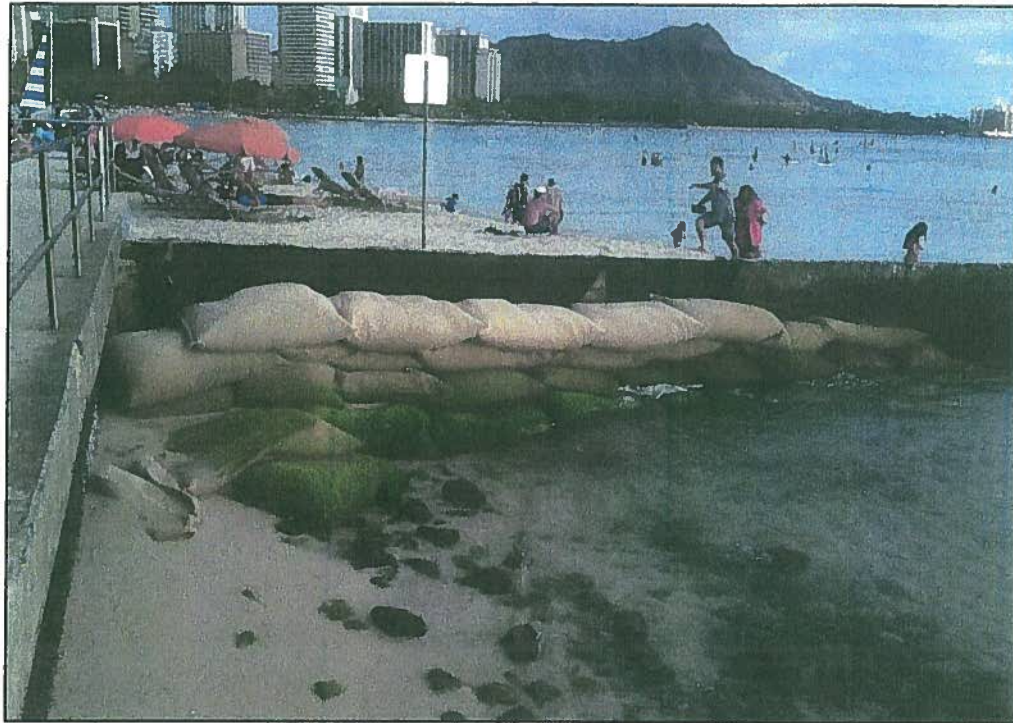
**ElcoRock sand bags one month after placement (photo date January 21, 2013)**

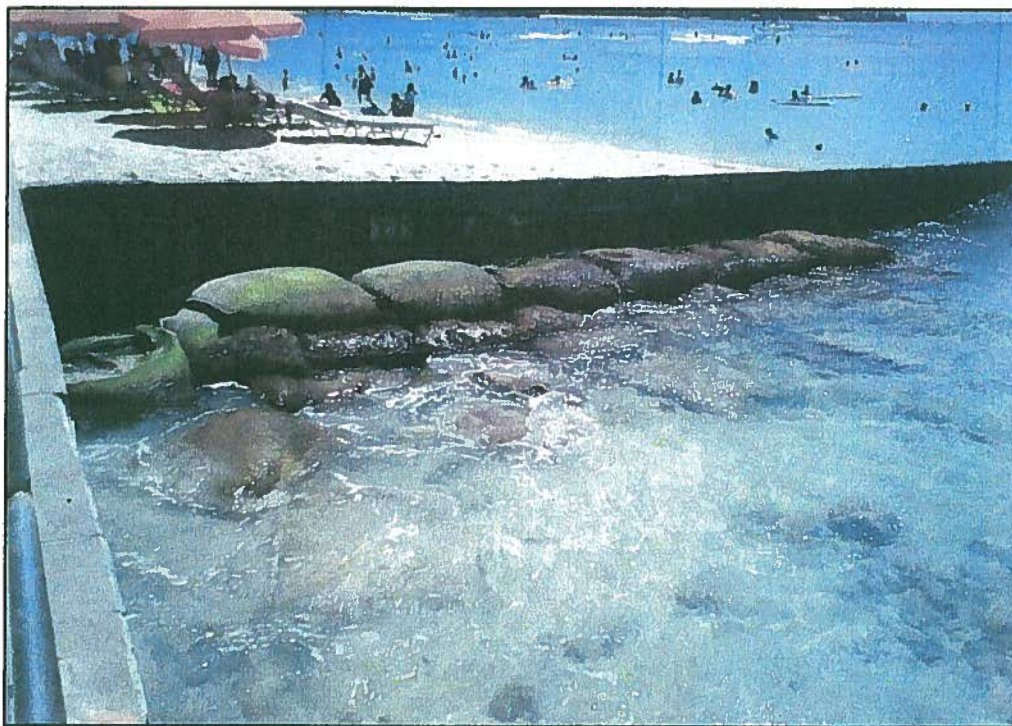
**Several displaced ElcoRock sand bags (photo date September 24, 2014)**

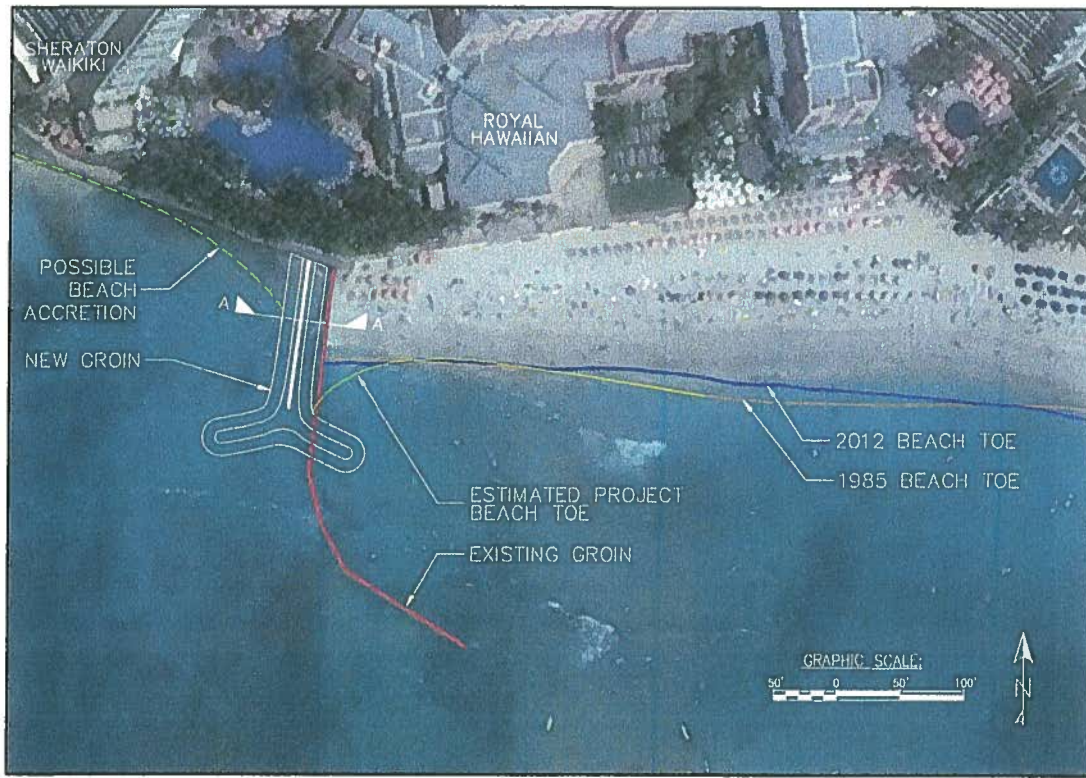
Plan view of 180-foot long groin
