**STATE OF HAWAII**  
**DEPARTMENT OF LAND AND NATURAL RESOURCES**  
**OFFICE OF CONSERVATION AND COASTAL LANDS**  
**Honolulu, Hawai'i**

June 9, 2017

**REGARDING:** Conservation District Use Application OA-3784  
Royal Hawaiian Groin Improvement Project

# *Royal Hawaiian Groin Replacement*

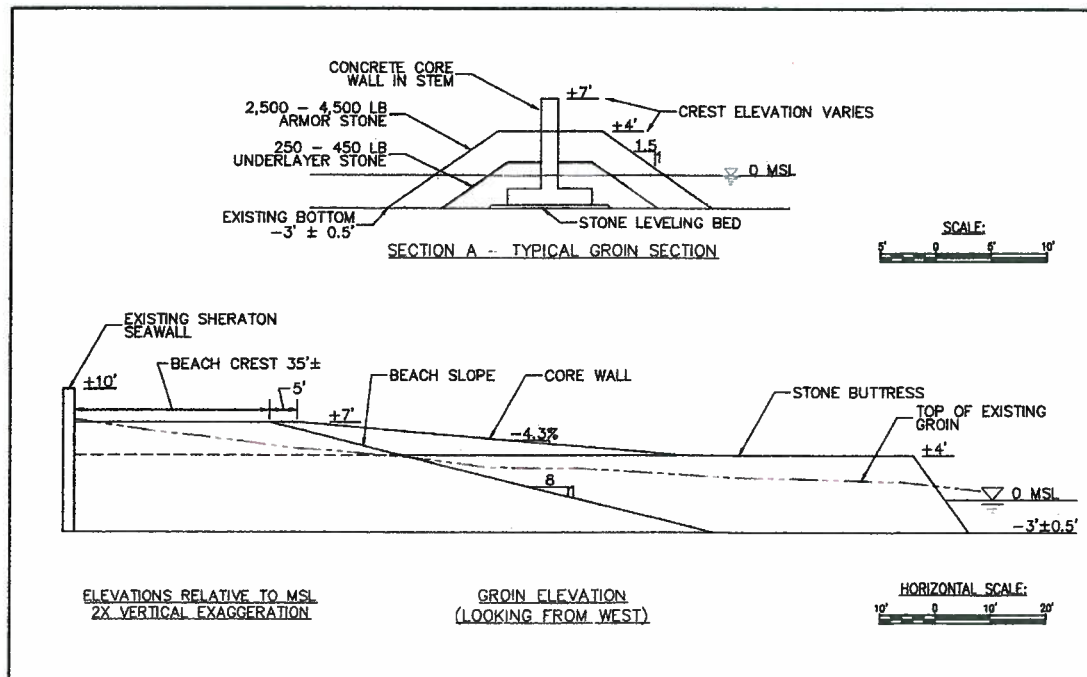
Groin section and elevation views

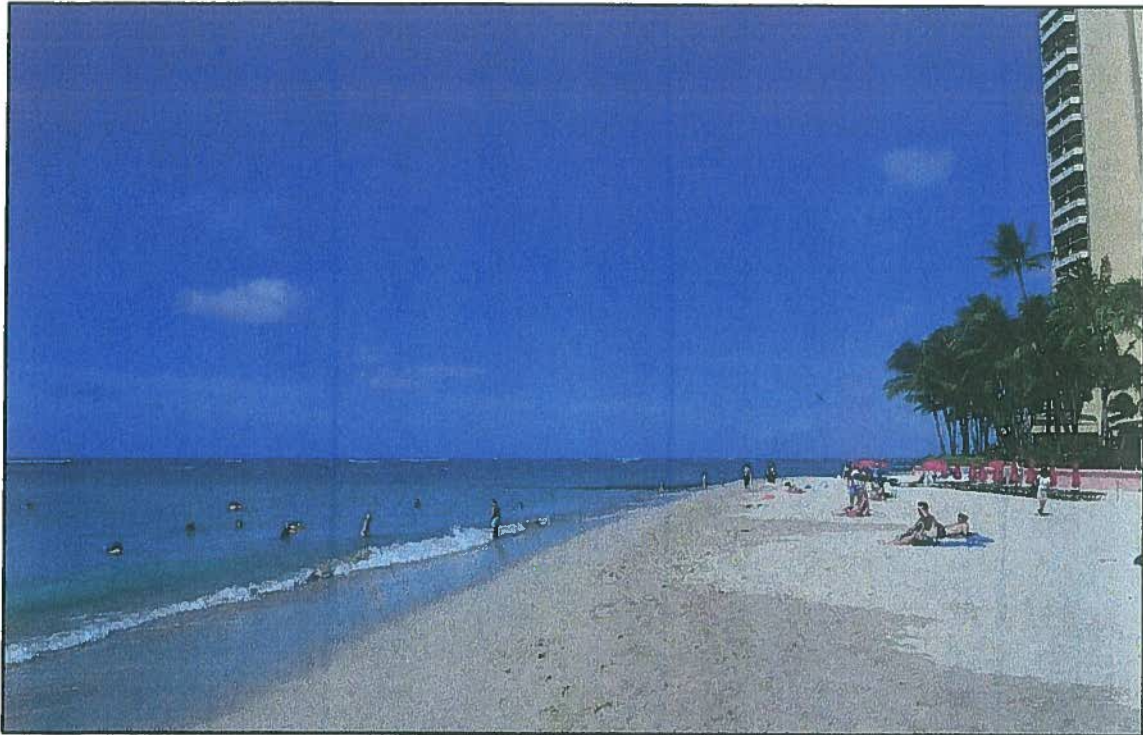
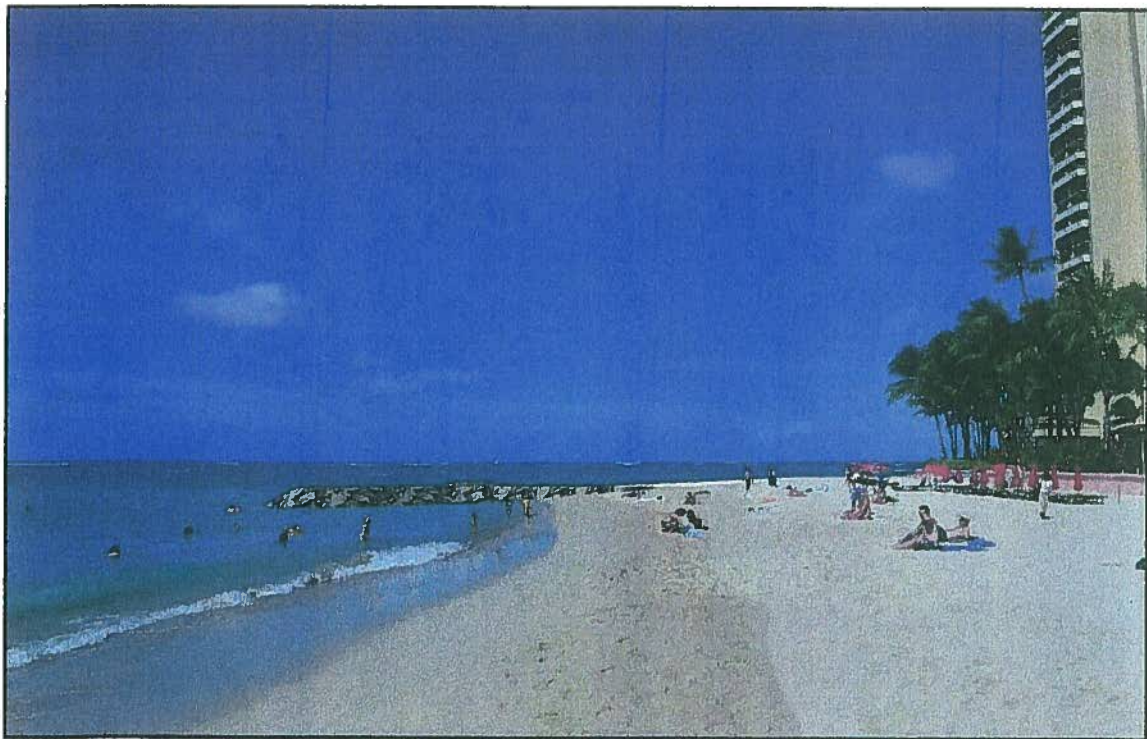
Project site looking west: (a) existing condition, (b) with 180-ft rock groin option

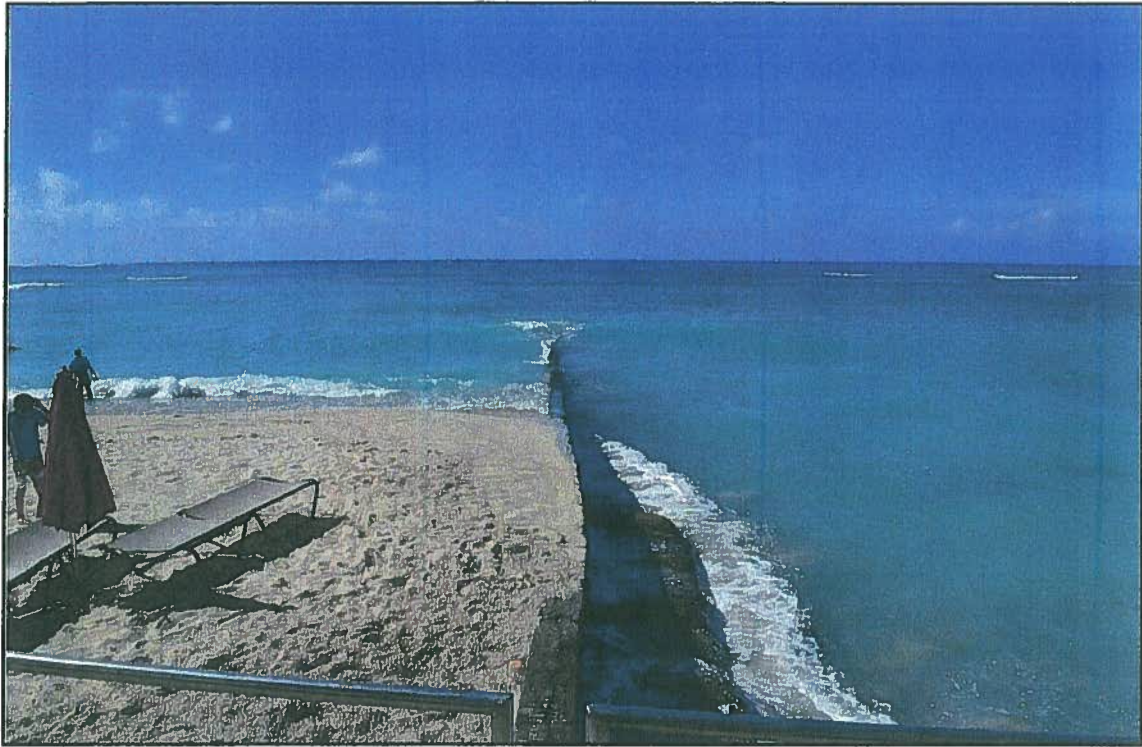
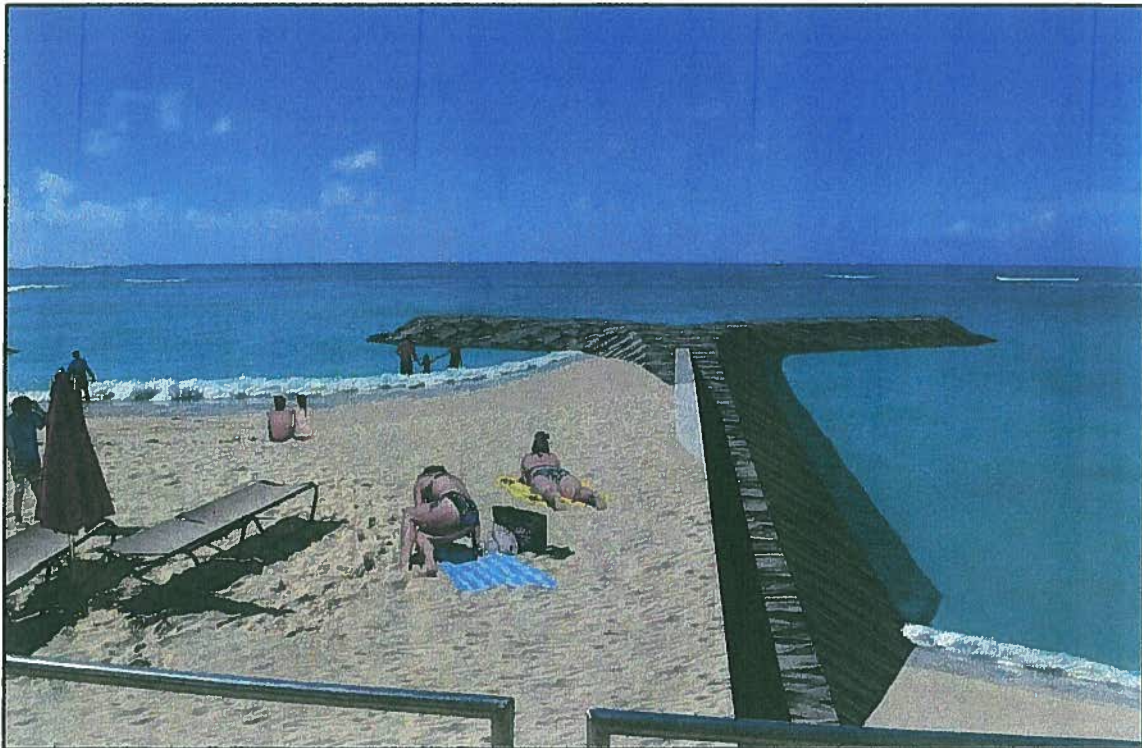
Project site looking offshore: (a) existing condition, (b) with 180-ft rock groin

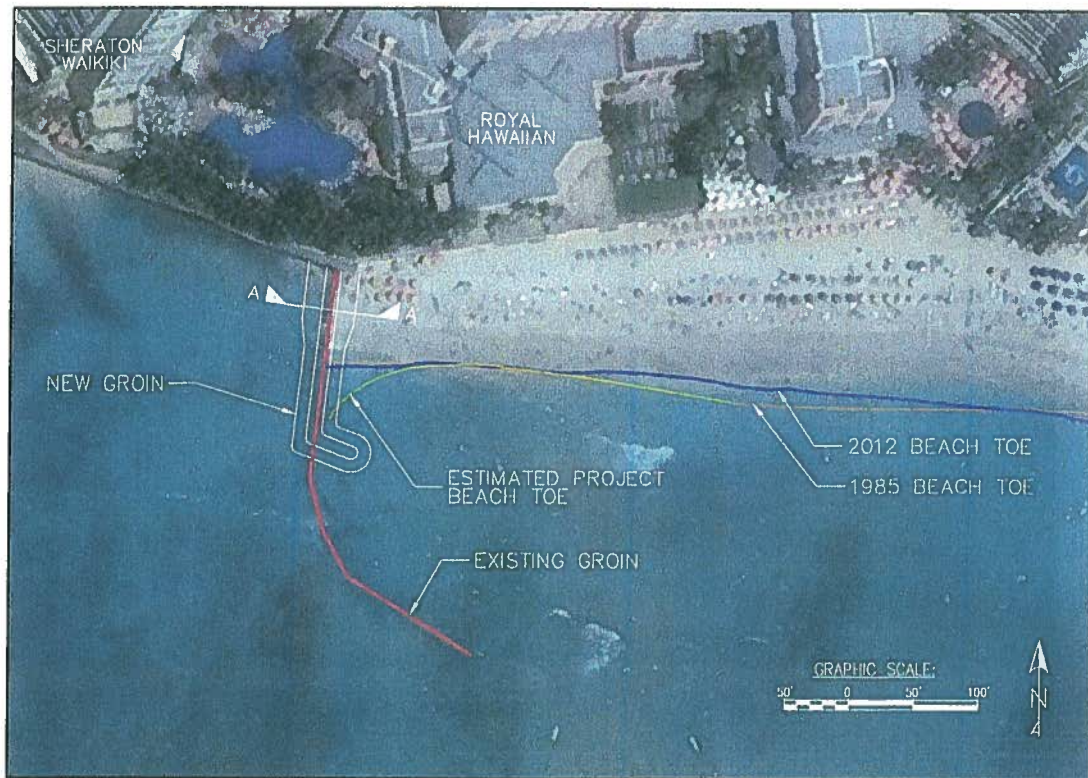
**Adaptive Reuse groin plan view**

The existing groin is in a very deteriorated state, but it would be possible to construct a rock rubblemound groin structure around what remains of the existing groin (**Exhibit 10**). The existing groin would be the core wall to prevent sand migration through the structure. This option would consist of a 130-foot-long stem centered on the existing groin and a 30-foot-long L-head extending to the east. Incorporation of the existing groin would require installing a temporary barrier on the east side of the groin to hold the sand back while sand is excavated to place stone. A temporary boulder causeway would be constructed from the beach to the location of the new groin head for construction access. This would be removed as construction proceeded back towards the beach. This option would have a total length of 160 feet and a footprint of 5,990 square feet. Approximately 255 cubic yards of armor stone and 410 cubic yards of underlayer stone would be used.

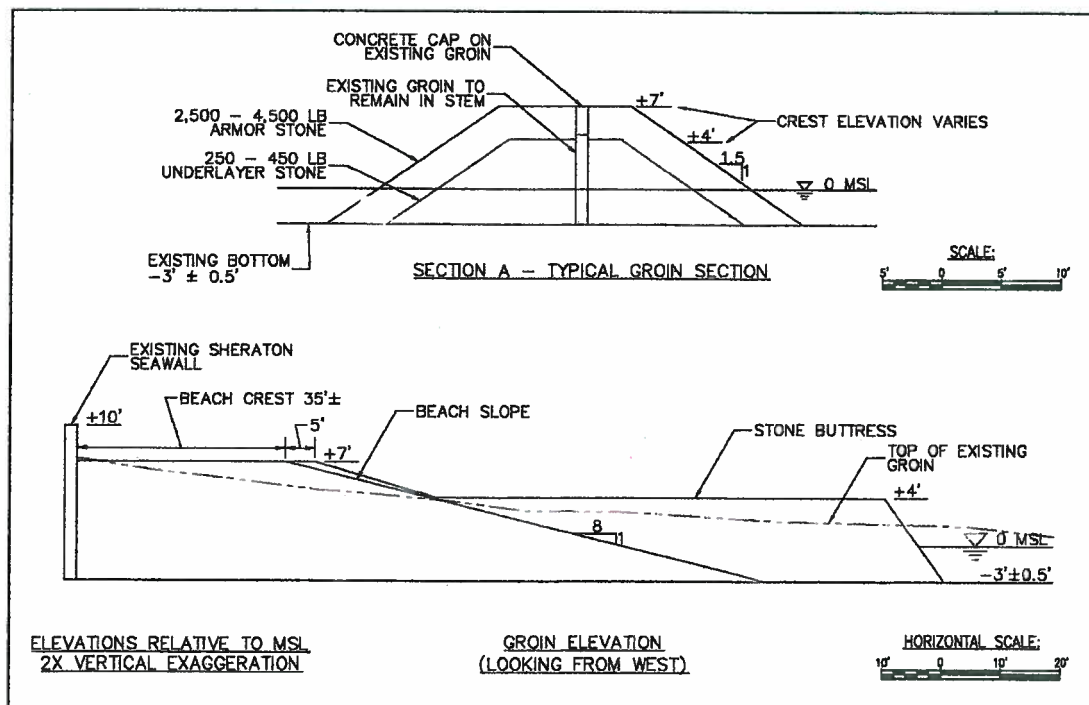
**Adaptive Reuse groin section and elevation**

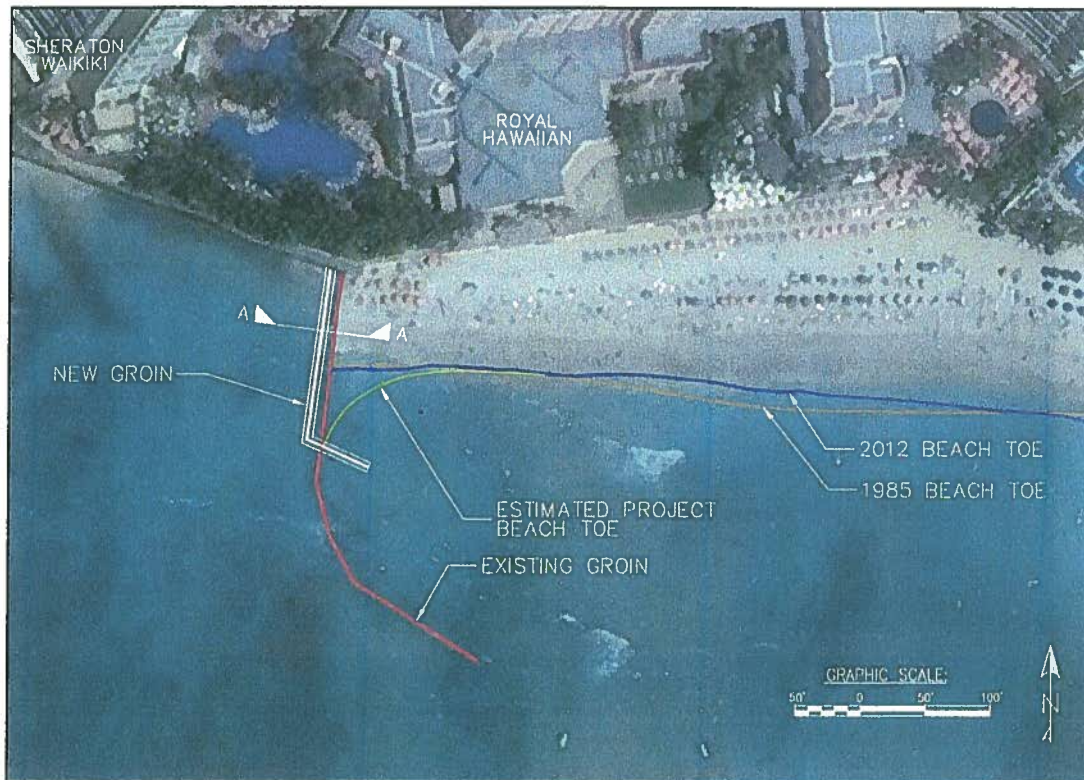
Concrete wall groin plan view

This option would be a vertical concrete wall, similar to the existing groin (**Exhibits 11 & 12**). The groin would have a 130-foot-long stem and a 30-foot-long L-head. This groin would be constructed immediately to the west of the existing groin. A temporary boulder causeway would be constructed from the beach to the location of the new groin head for construction access. This would be removed as construction proceeded back towards the beach. This option would be 160 feet long and the footprint would be 1,100 square feet. Approximately 120 cubic yards of pre-cast concrete and 35 cubic yards of marine cast-in-place "tremie" concrete would be used.

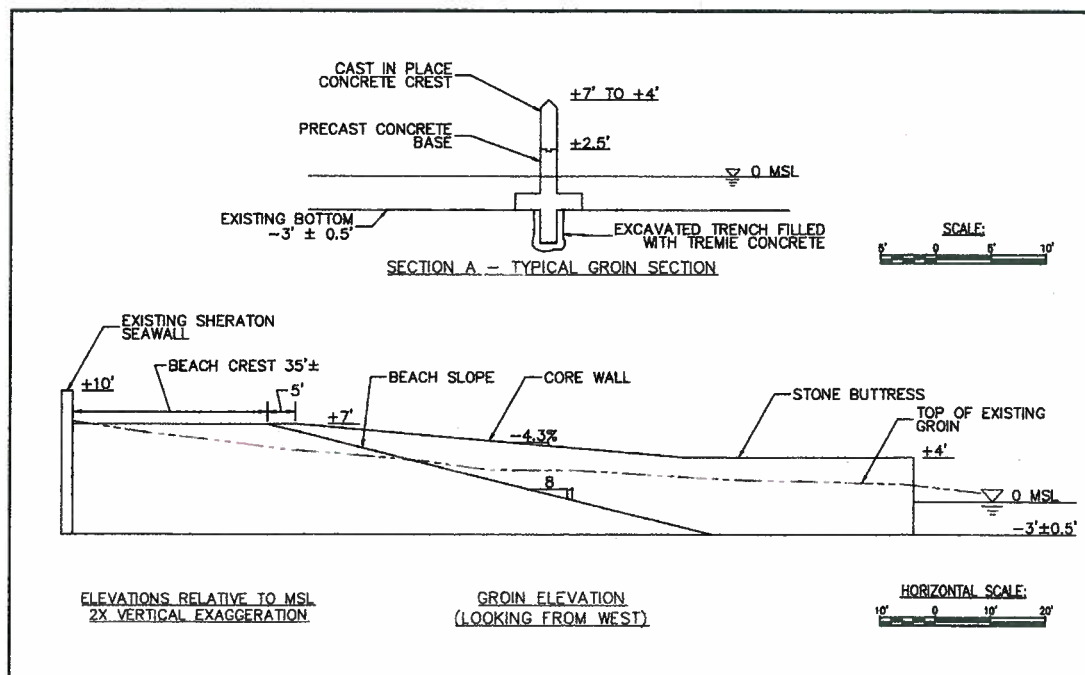
Concrete wall groin section and elevation

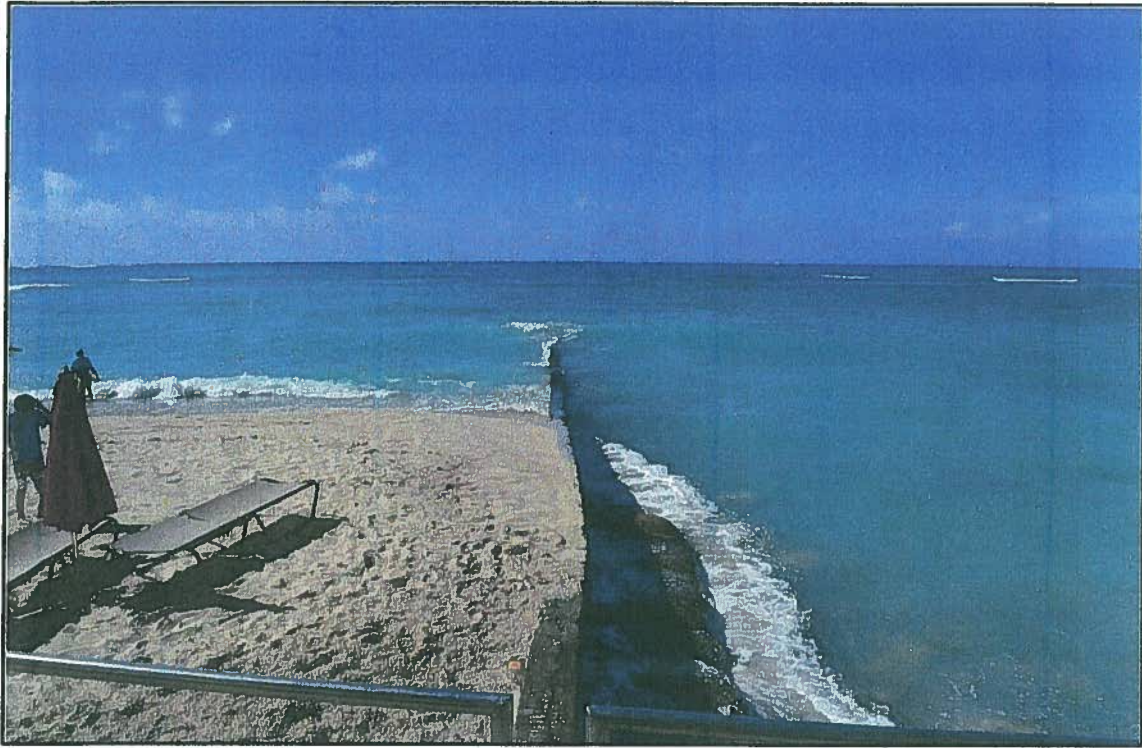
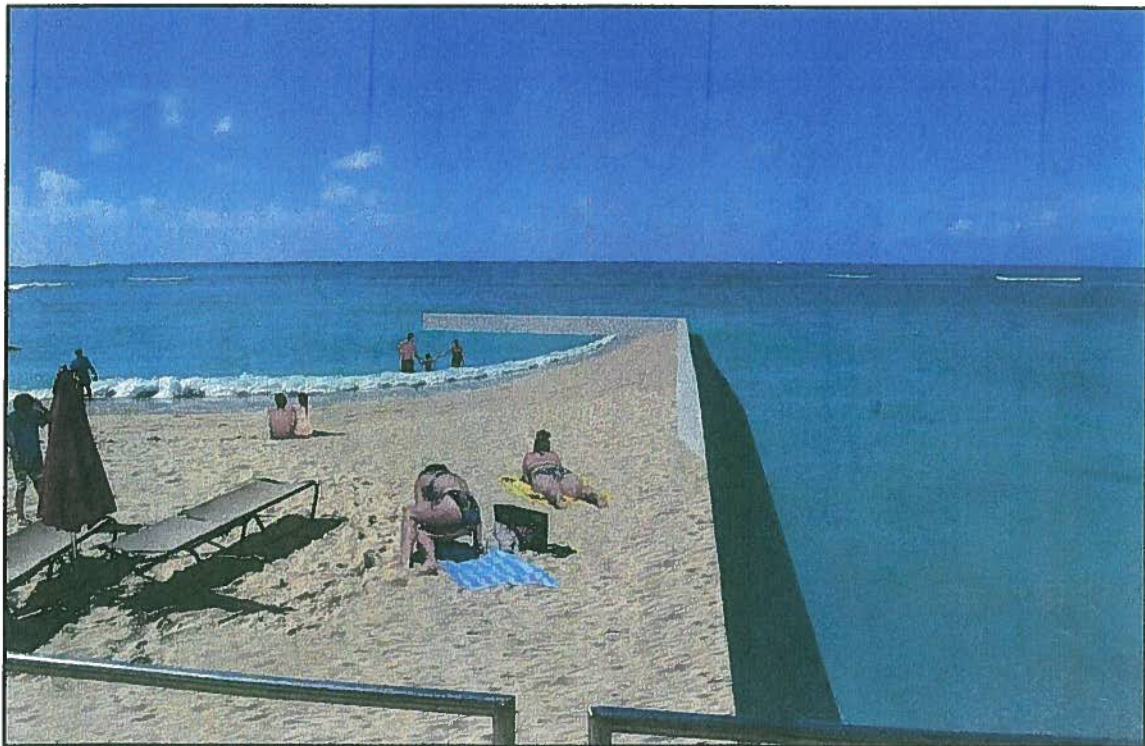
Project site looking offshore: (a) existing condition, (b) with 160-ft concrete wall groin

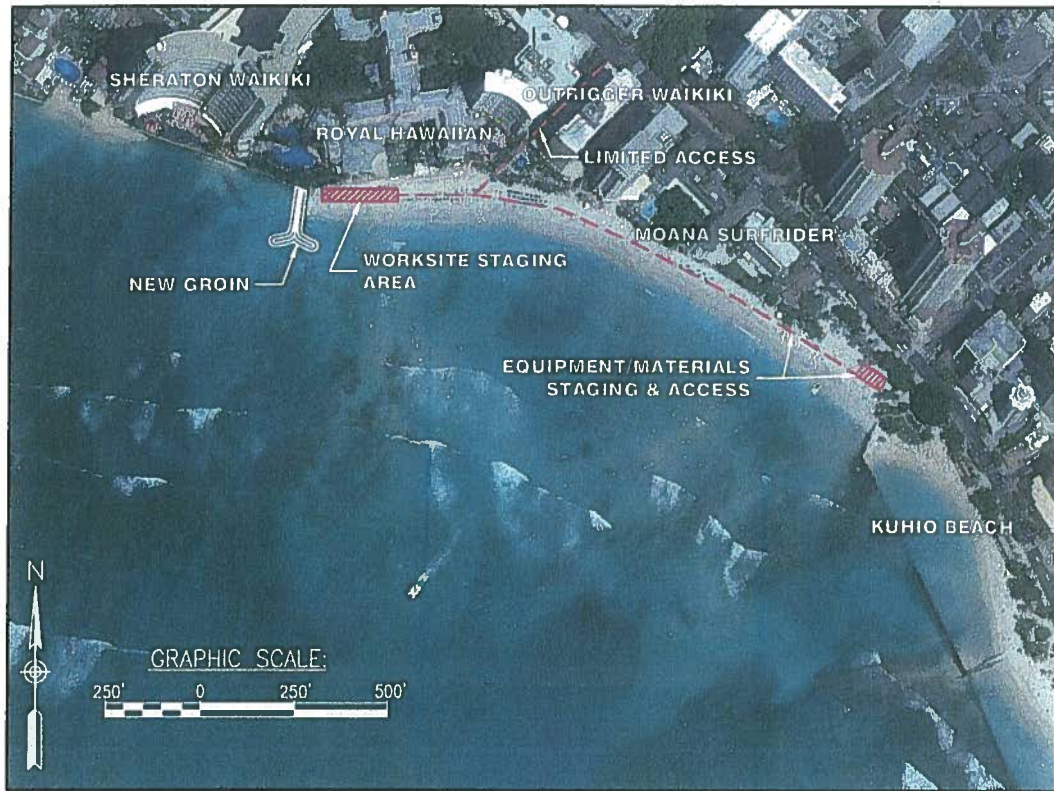
**Construction access and staging areas**

- 1) All loose material would be cleared fronting the seawall on the west side of the existing groin. Construction of the groin stem would begin from the west side of the existing groin. The landward portion of the stem would be temporarily overbuilt with stone, as necessary, for construction equipment and material access.

- 2) Starting from shore, all loose material would be cleared from the seafloor on the west side of the existing groin. The leveling stone bed would be placed first, followed by the precast concrete wall section, and then the core stone and armor stone would be placed up to +2.5 feet MSL. Additional armor stone would be temporarily placed on both sides of the newly constructed groin stem, as necessary, to provide for equipment access along the stem.
